# Lakeview Village Shoreline Hazard Assessment

Mississauga

February 14 2020 | 13012.101

13012.101

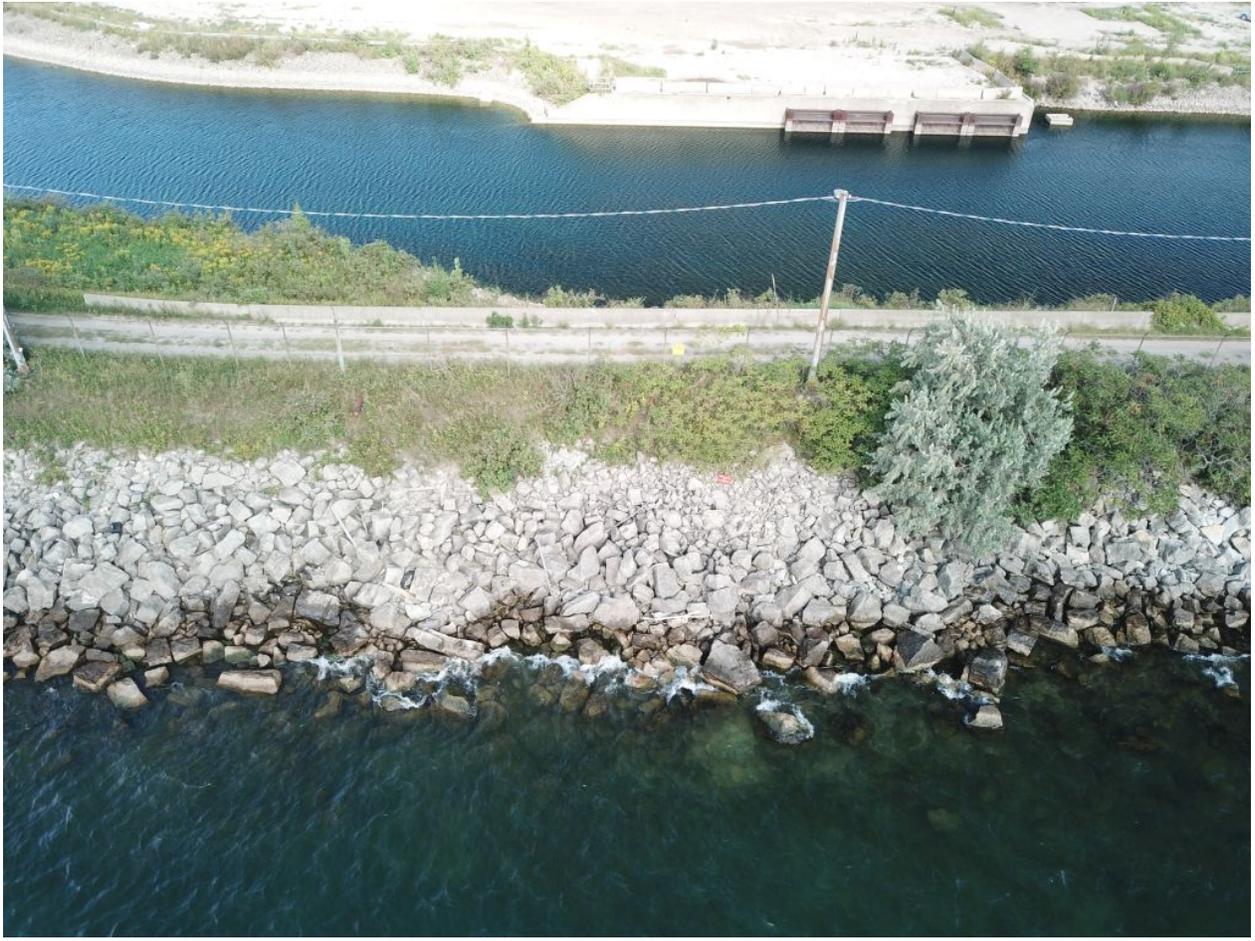
The stone protection appears to be in satisfactory condition and functional with some evidence of deterioration. The top elevation of the protection has been adequate for wave uprush and overtopping, as it has experienced nearly 60 years of exposure, including high water levels in 2017 and record levels in 2019, with an acceptable level of damage. The residual design life of the existing protection has not been specifically determined at this time, but it is less than 60 years. Regardless, the existing protection work will be upgraded and incorporated into the new shoreline design in accordance with accepted engineering practice. The design life of the new protection will be 60 years. The works will be designed by a professional engineer with experience and qualifications in coastal engineering.

Figure 2.24: Example of stone protection at easterly portion of Outer Shore (this view around OS500)

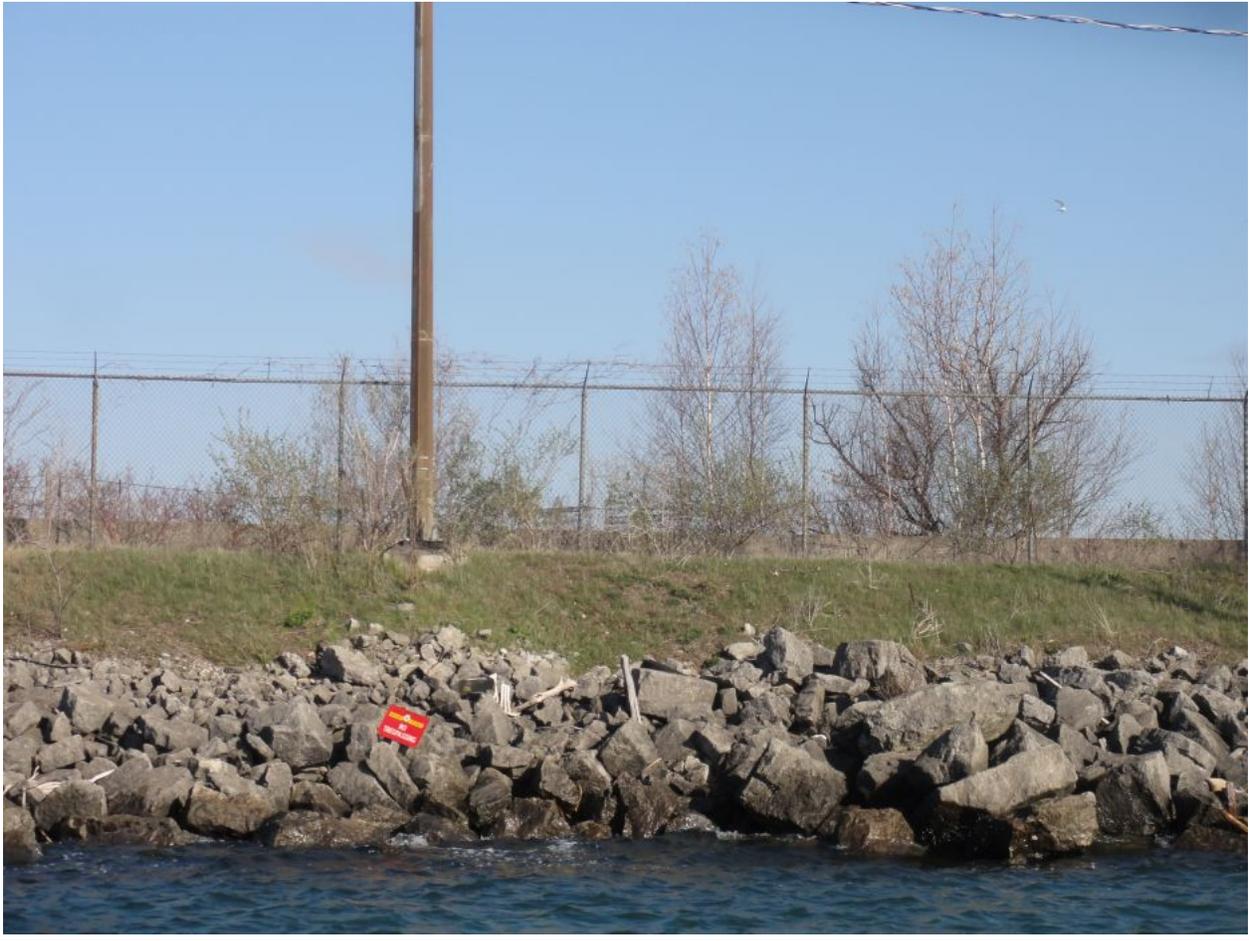
Figure 2.25: View from water of typical protection at easterly portion of Outer Shore (OS184 to OS590)

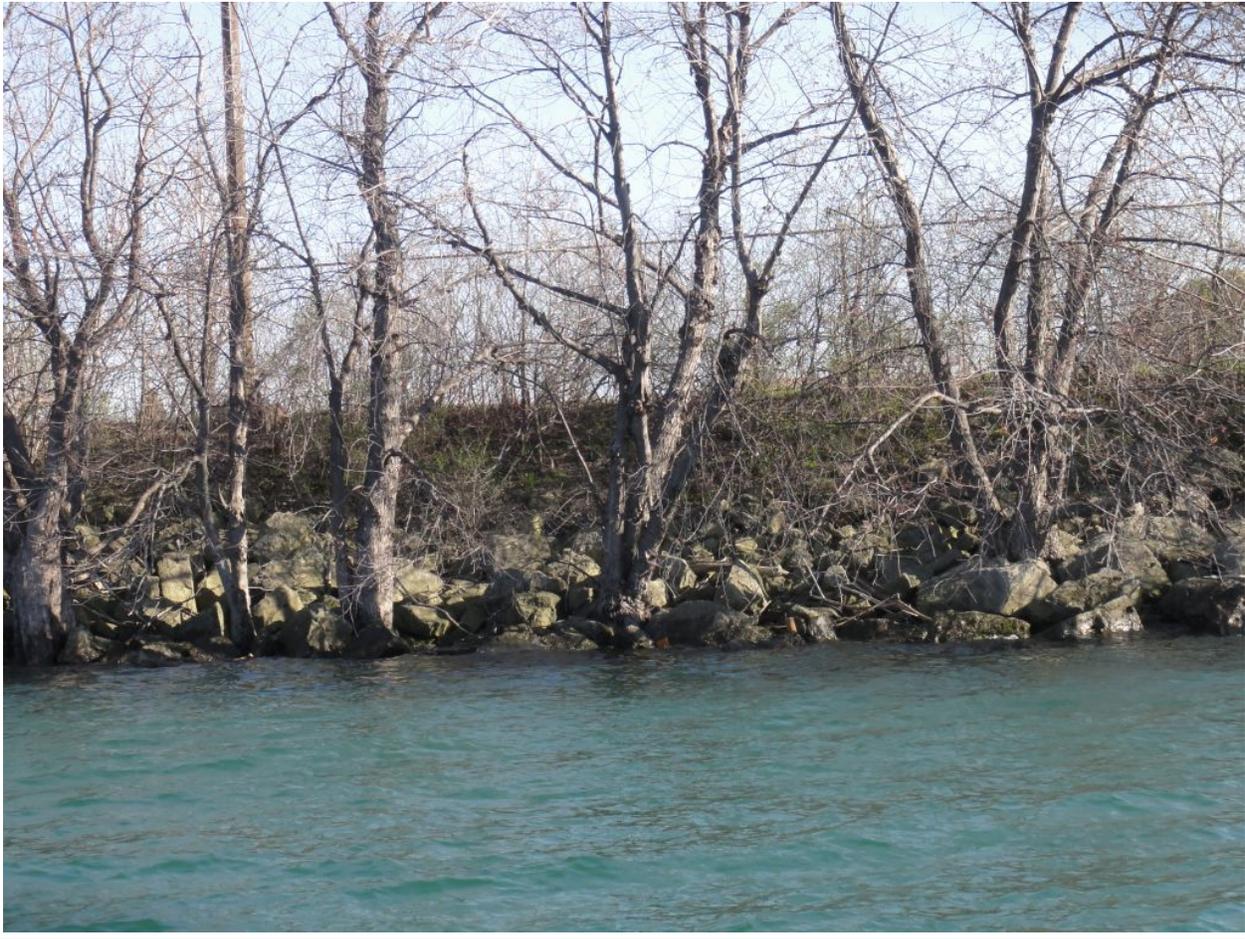
**Figure 2.28: Example of established vegetation at Outer Shore (OS190 to OS330)**

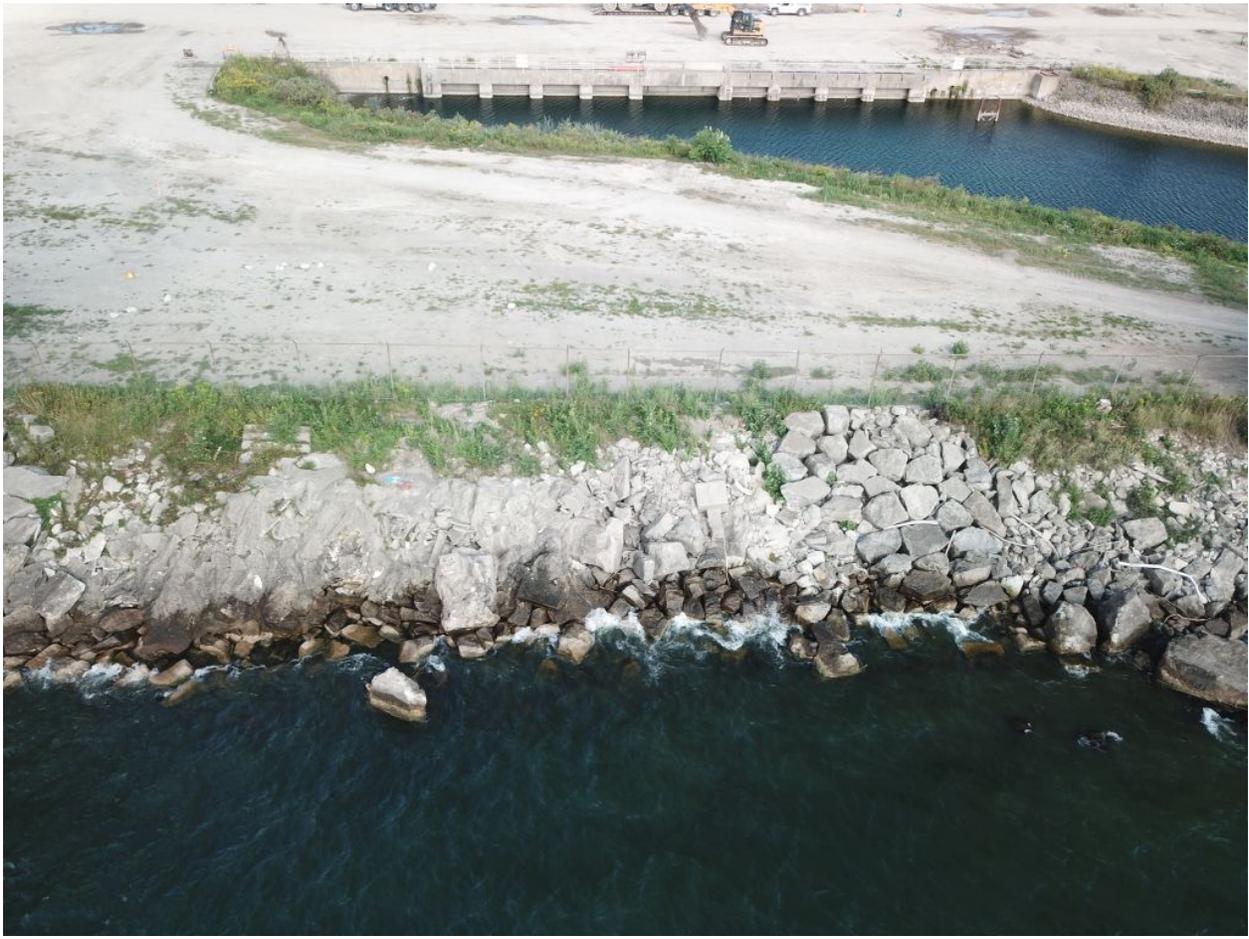
**Figure 2.29: Mixture of armouring at westerly portion of Outer Shore (near OS610 to OS640)**

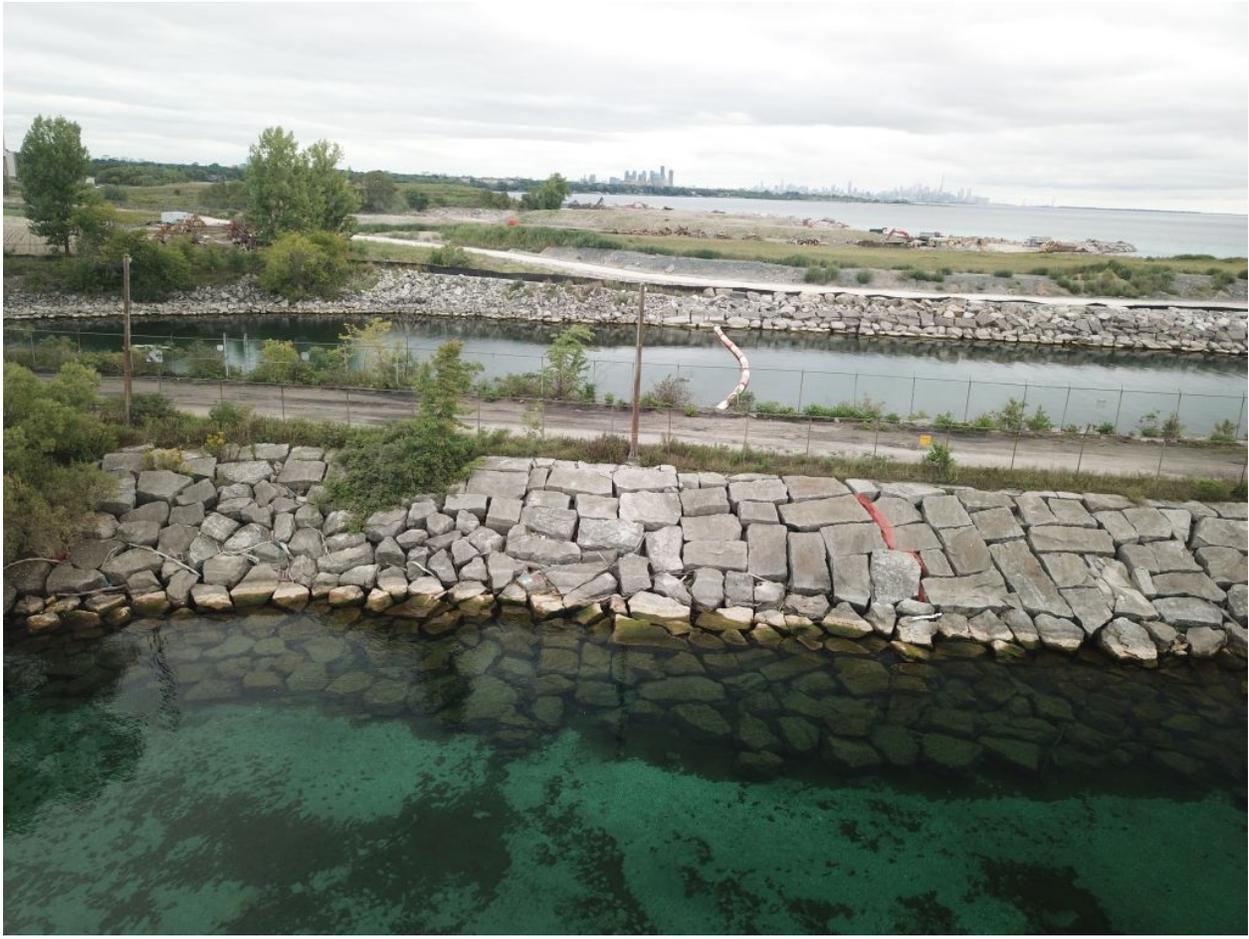
At the easterly end of the Outer Shore, the shoreline transitions to the rubble mound mole portion of the Western Pier (Figure 2.3). The rubble mound mole is protected with large, tightly placed armour stone in good condition (Figure 2.35 and Figure 2.36). The rubble-mound mole was reviewed as part of the Level I and Level II Investigation for the Western Pier. No repairs or upgrades are required for this shoreline.

Figure 2.35: Tightly placed armour stone on west side of shore-end of Western Pier rubble mound mole

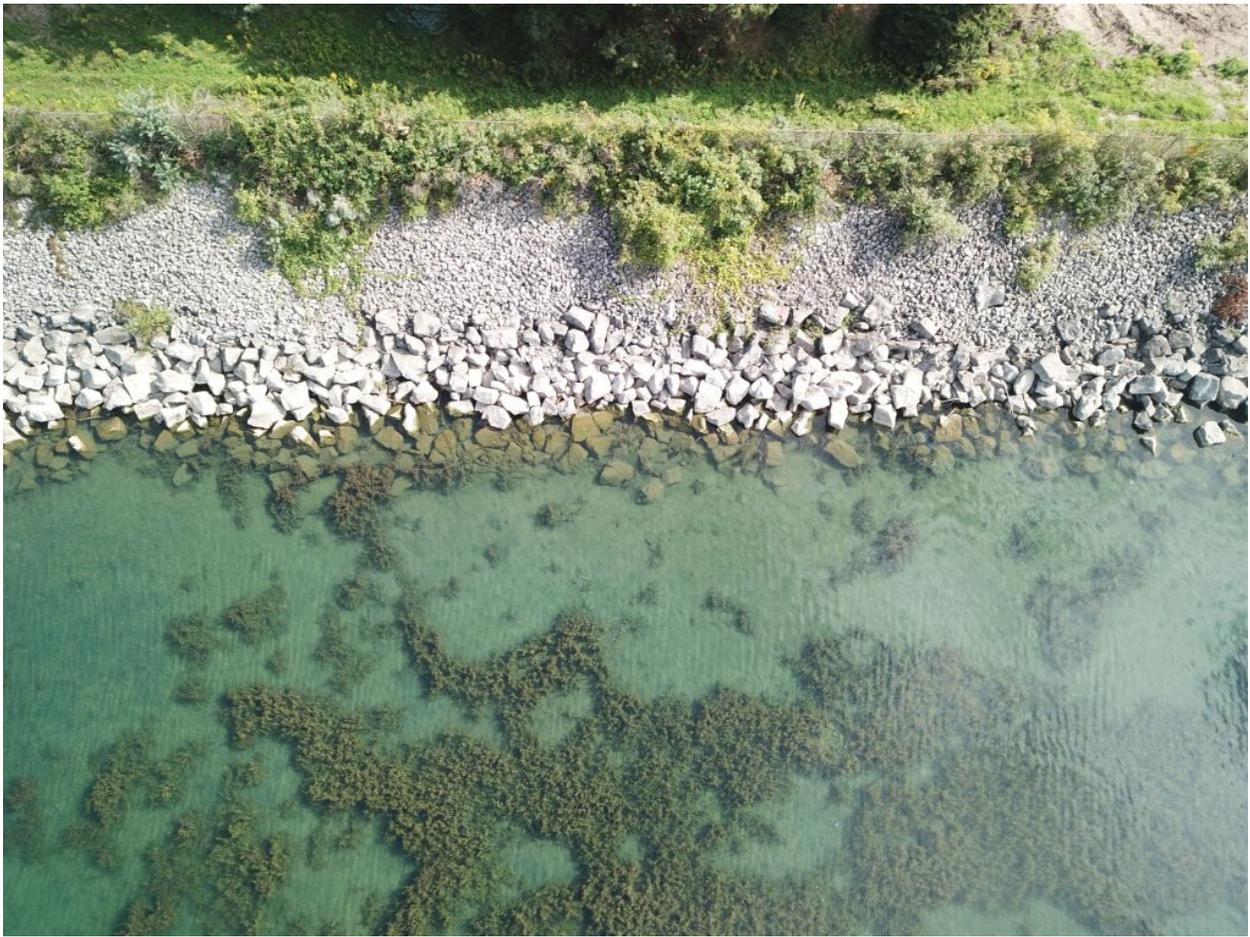
The West Shoreline protection appears to be in good condition and can readily be repurposed and integrated into the Masterplan. Primarily, future work required at the West Shoreline facing the marina basin will be guided by consideration of public use and landscape design, to bring the public closer to the water's edge and dealing with the miscellaneous structures to make them safe for the public (e.g., removal, closing off, adding railings). Naturalization features and aquatic habitat elements will be incorporated into the protection works where appropriate. The existing shoreline protection structure will be incorporated into the new shoreline design in accordance with accepted engineering practice. The works will be designed by a professional engineer with experience and qualifications in coastal engineering. The design life of the new protection will be 60 years.

**Figure 2.37: West Shoreline armour stone and riprap shore protection**

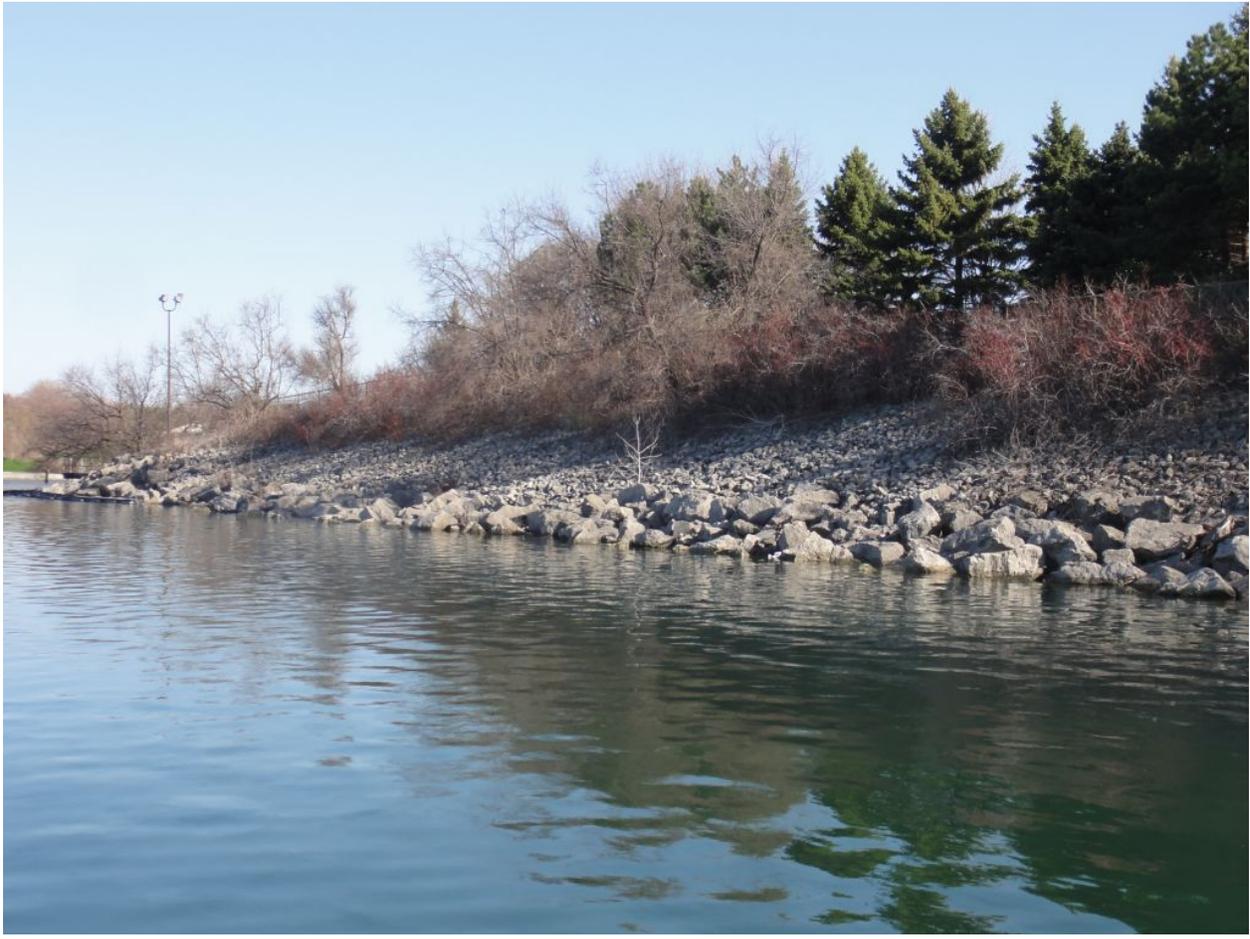
**Figure 2.38: View from water of West Shoreline with armour stone at water's edge and riprap up the slope**

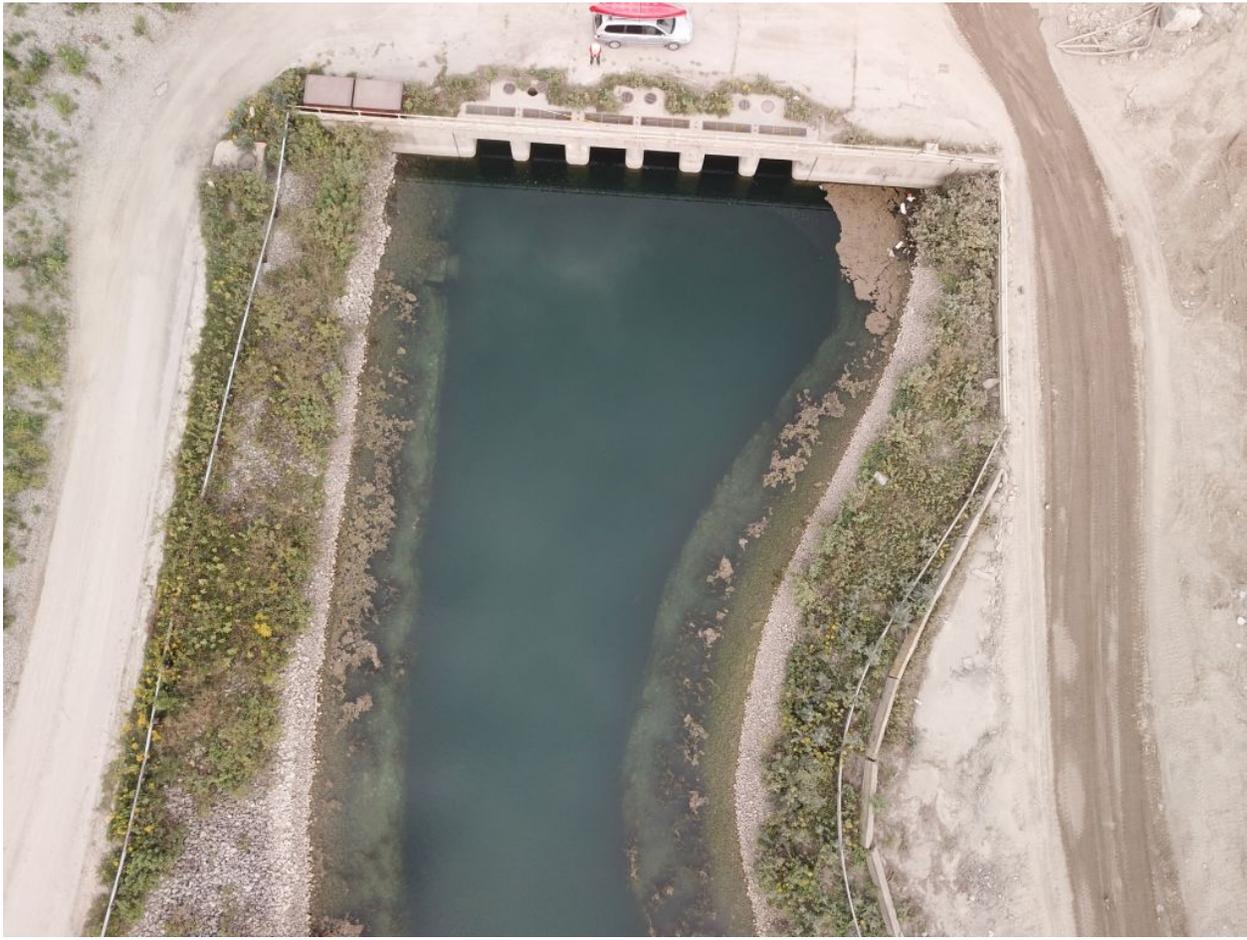
**Figure 2.42: Headwall for discharge tunnels (Units 1 to 6) and channel excavated into bedrock**

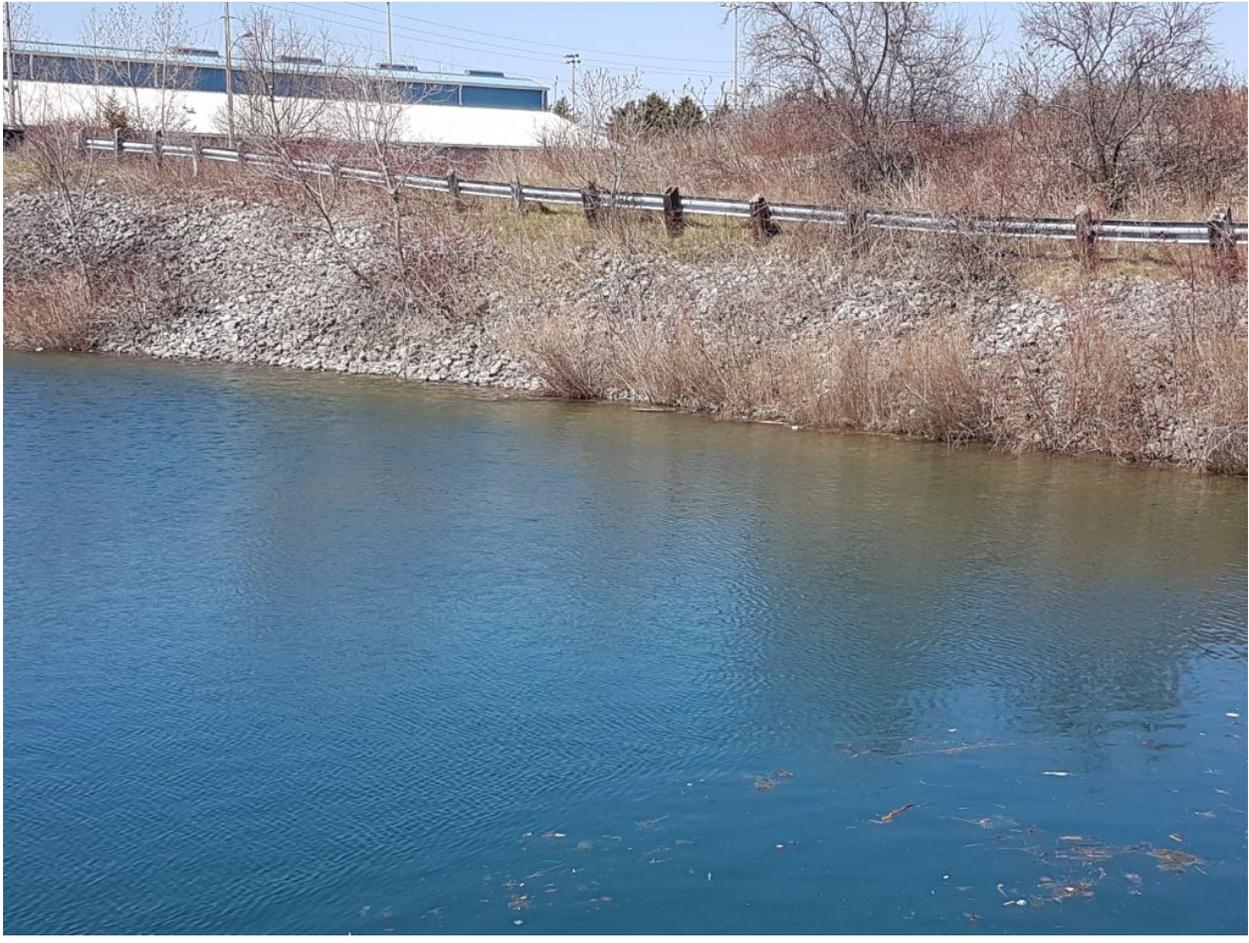
Figure 2.46: Discharge Channel West – vegetated riprap slope

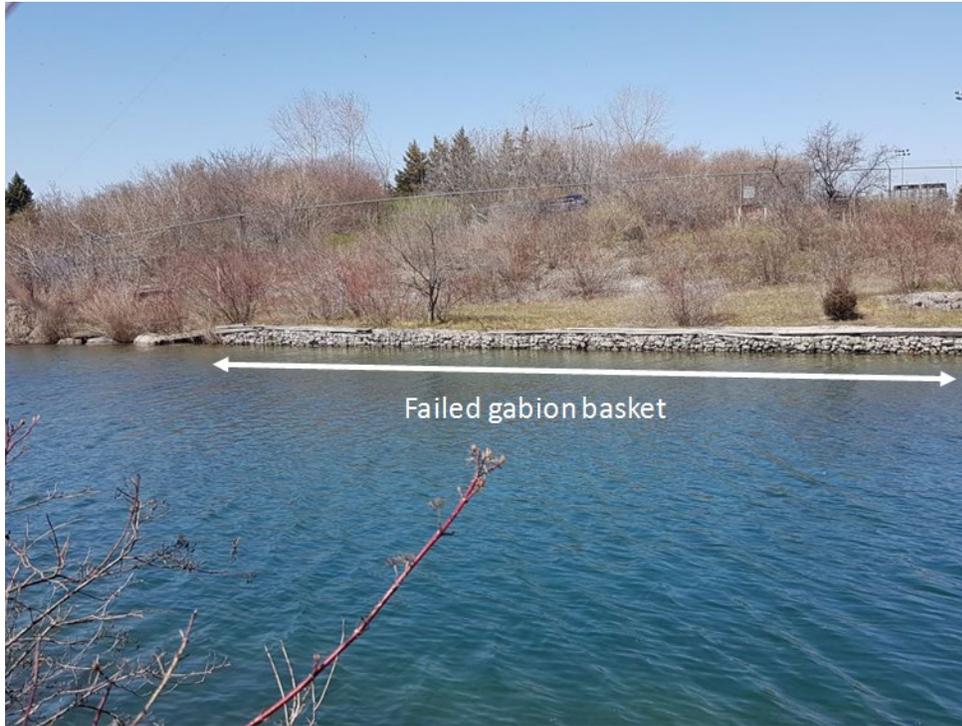
Figure 2.47: Discharge Channel West – failed gabion basket protection and gradual backshore slope

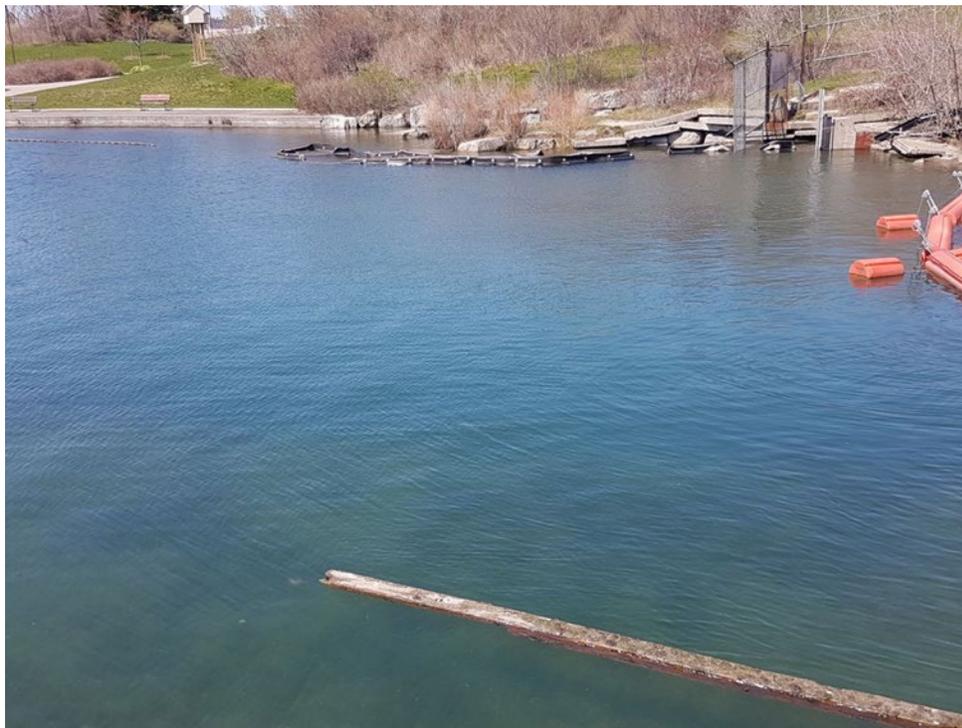
The section of shoreline from DW130 to DW180 is comprised of various structures and ad hoc protection (e.g., concrete slabs; see Figure 2.48) and will need to be addressed to make it suitable for public use.

Figure 2.48: Discharge Channel West Side between DW130 to DW180 with rubble and miscellaneous structures

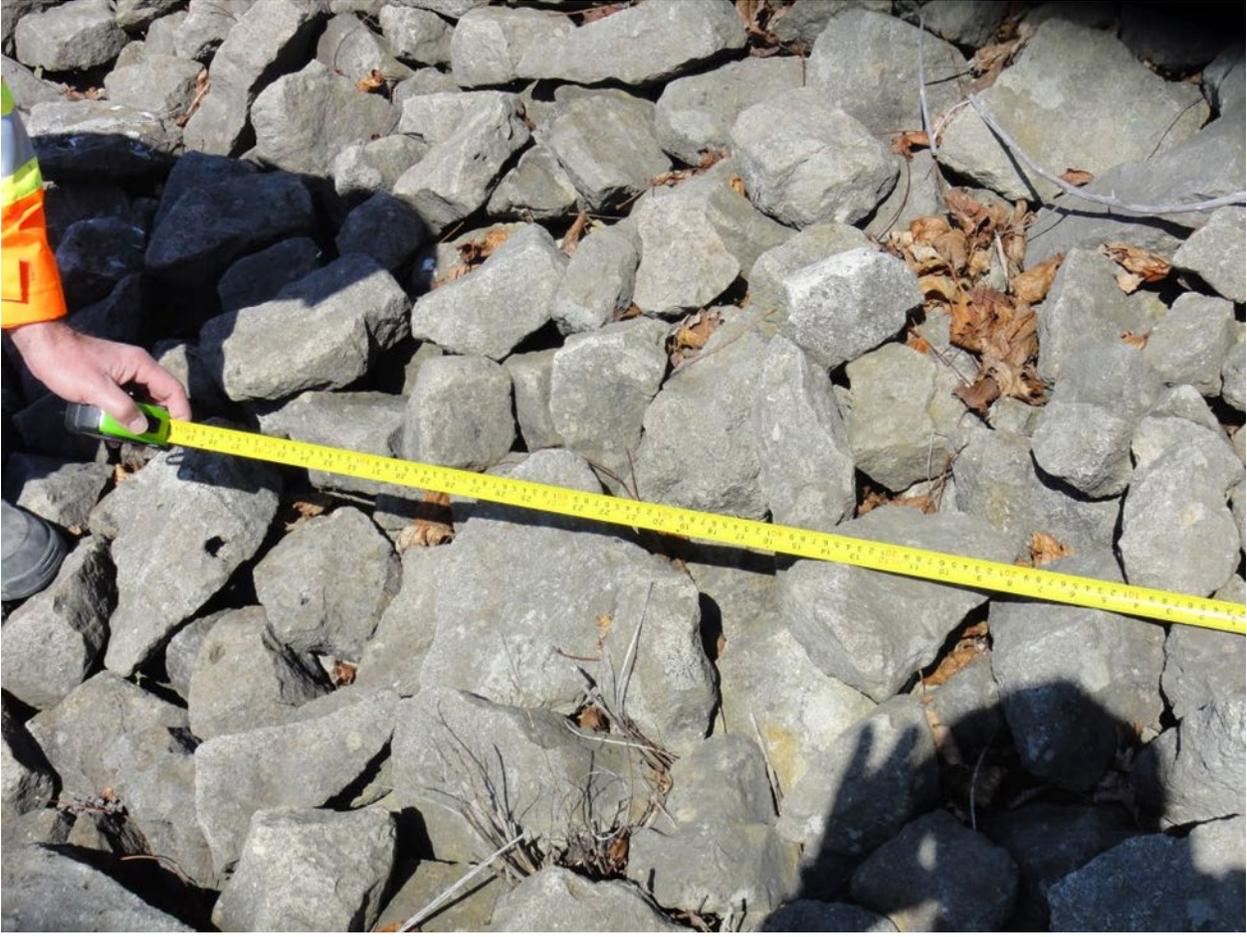
Figure 2.53: Example of riprap stone size at revetment along Intake Forebay/Channel North (between IFN660 and IFN735)

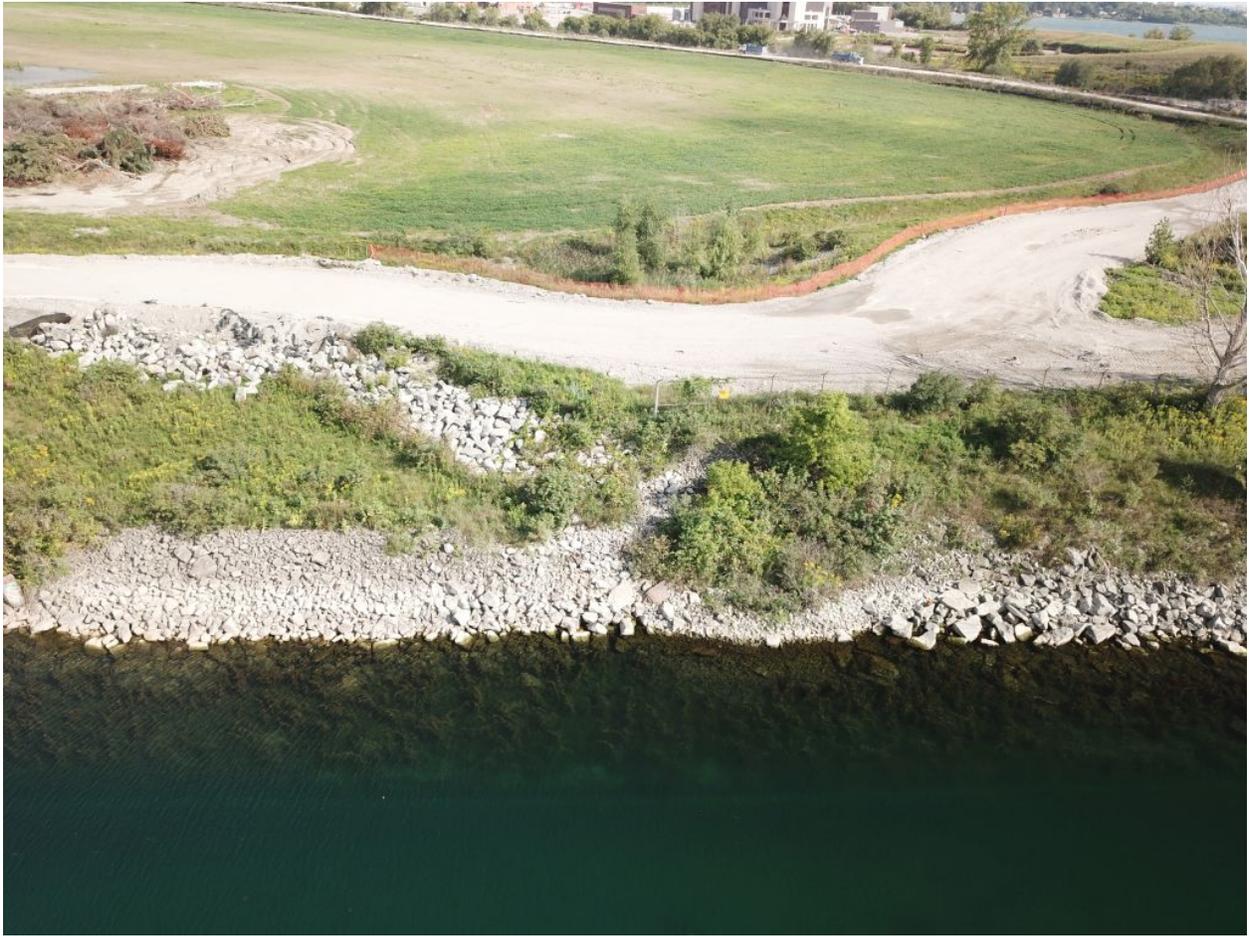
**Figure 2.54: Transition of stone size at easterly end of Intake Forebay/Channel North (more sheltered from wave action to the left; less sheltered from wave action to the right)**

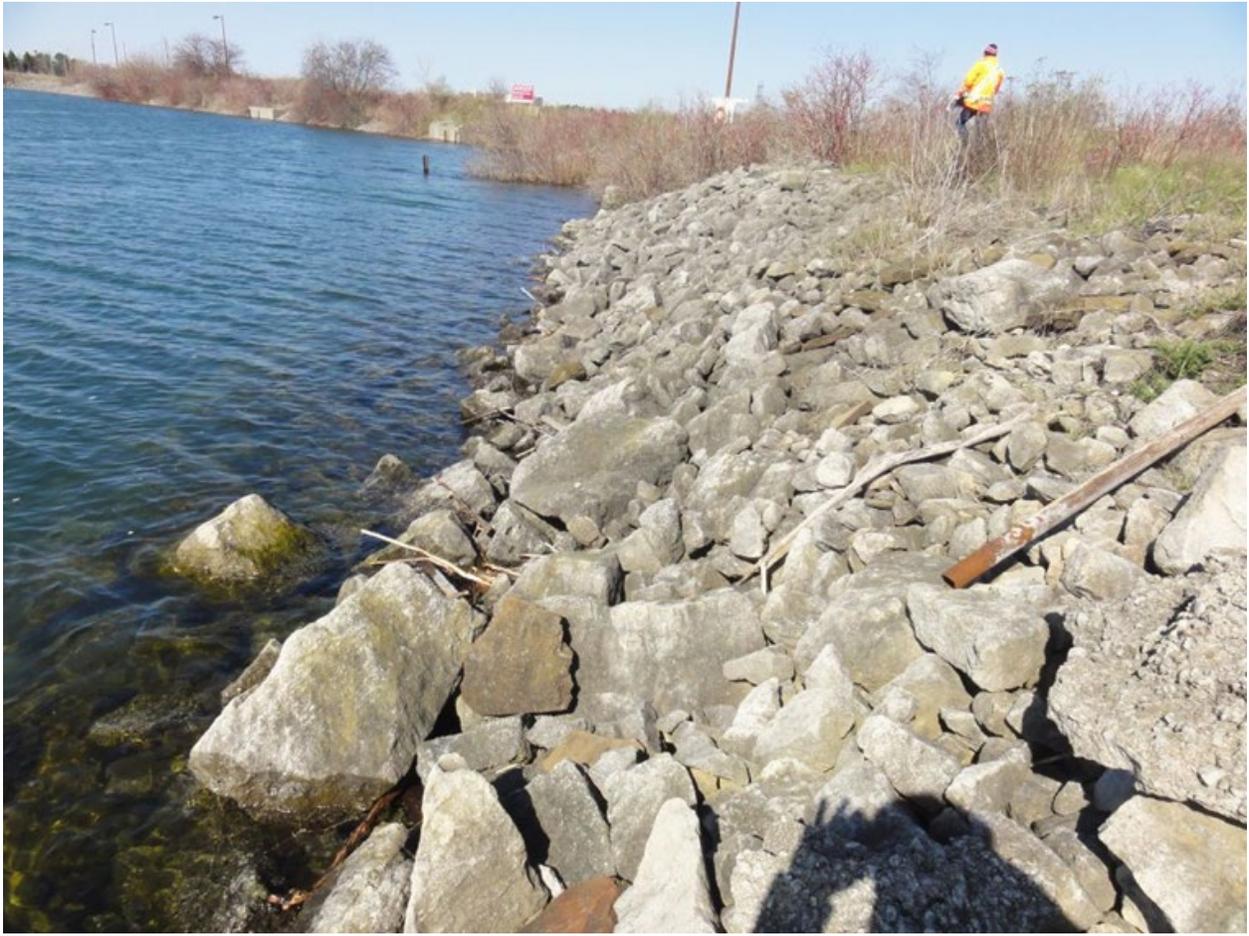
Figure 2.55: Intake Forebay/Channel North – larger riprap slope protection near easterly end, closer to entrance channel between piers

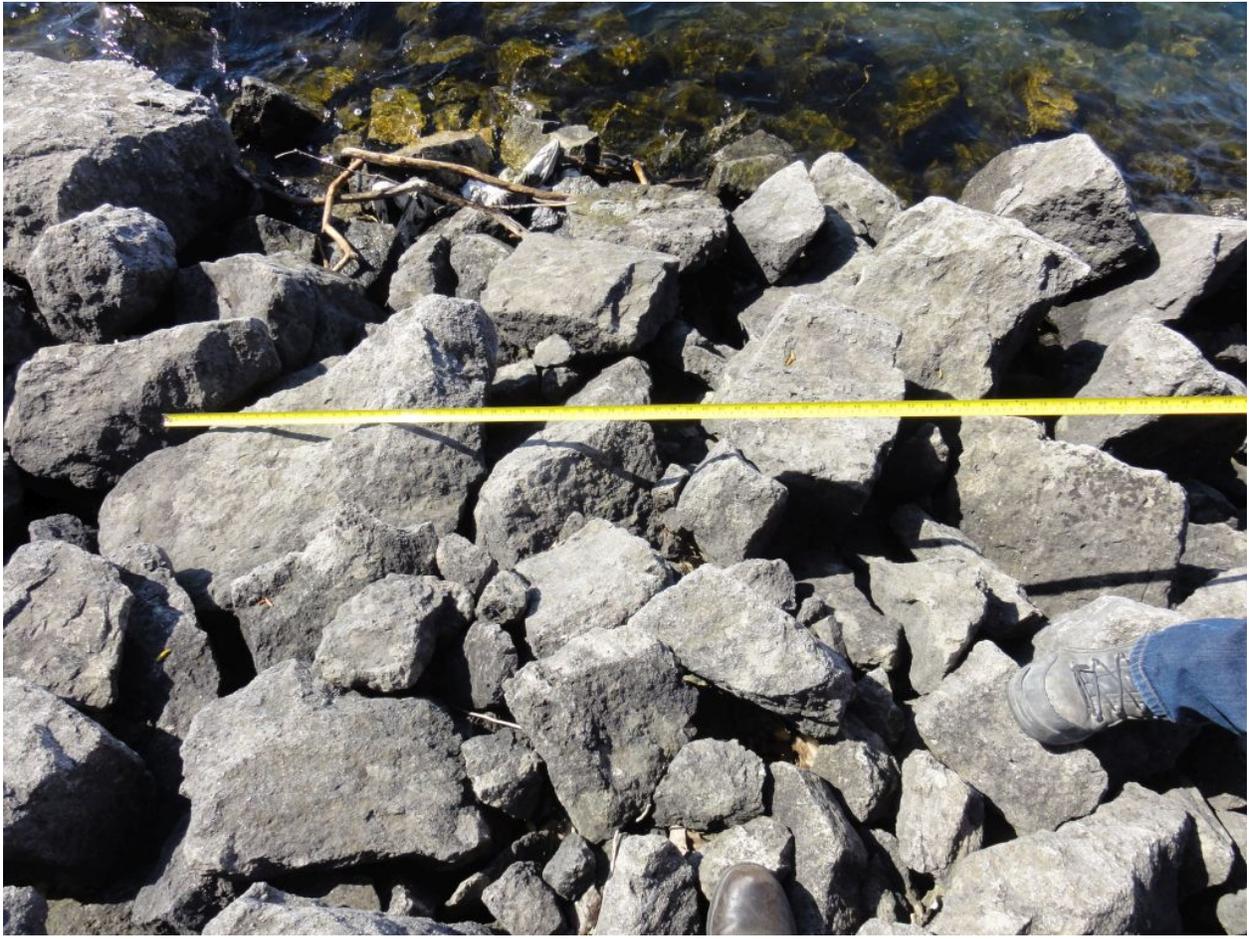
Figure 2.56: Larger riprap stone size along IFN shoreline nearer entrance

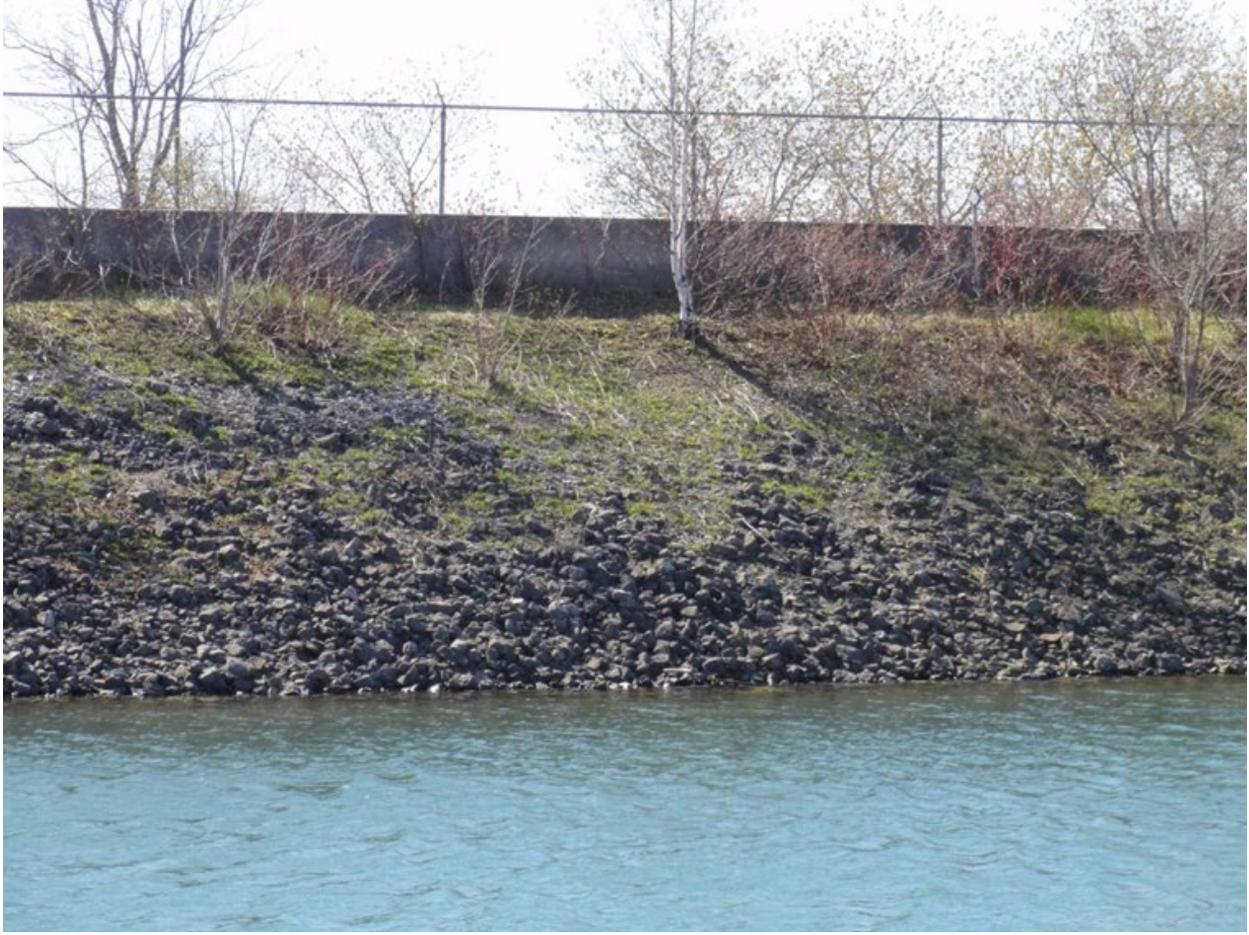
Figure 2.58: Example of riprap slope protection with some vegetation at Intake Forebay/Channel South

The existing protection work will be upgraded and incorporated into the shoreline Masterplan in accordance with accepted engineering practice. The design life of the new protection will be 60 years. Naturalization features and aquatic habitat elements will be incorporated into the protection works where appropriate.

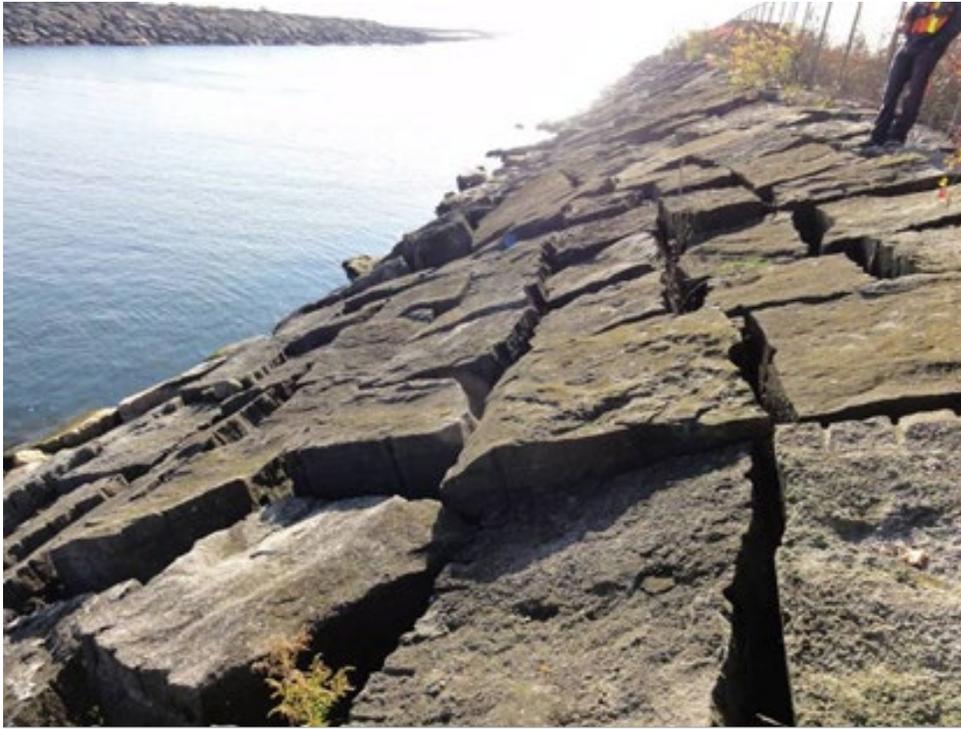
**Figure 2.82: Typical section on east side of rubble mound mole portion of Western Pier**
