Project: 18-748-100 July 30, 2019

**RE:** Geotechnical Comments on Ditch Slope Stability

5150 & 5170 9<sup>th</sup> Line Mississauga, Ontario

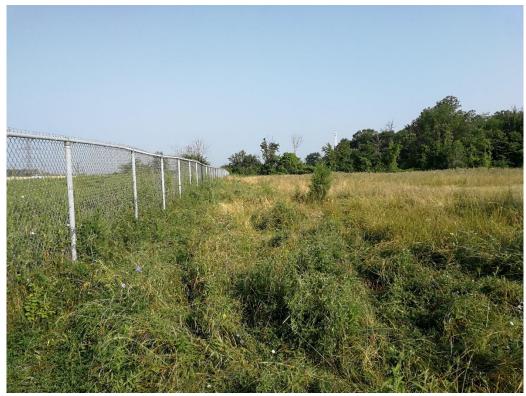
- In property No. 5170, there is a ditch along the east side of the back fence, as shown on the survey map in Appendix B. The general surface conditions in the ditch area are shown in Photos A1 and A2 in Appendix A. The ditch slope is less than 1 m in height and is 5 horizontal to 1 vertical (5H:1V) or flatter in steepness. The ditch bottom and slope are covered with dense grass. No water was found in the ditch during our site visit. The ditch slope is considered stable in terms of long-term stability. The top of ditch line shown in the survey map in Appendix A can be considered to be the top of ditch slope (i.e. top of bank), which is stable in terms of long-term stability.

Photo A1: Ditch area near back fence of No. 5170 (looking north)

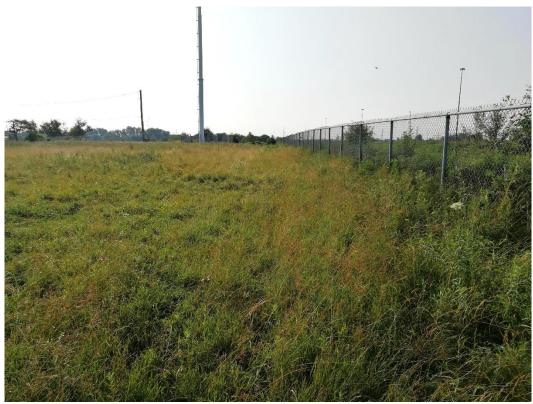
Photo A2: Ditch area near back fence of No. 5170 (looking south)

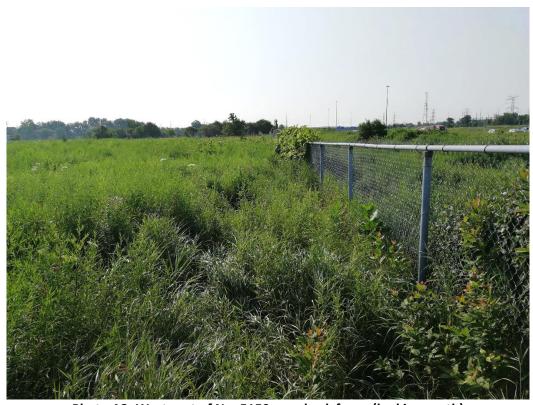
- The surface conditions in the west part of No. 5150 along the back fence are shown in Photos A3 and A4 in Appendix A, which are generally flat and covered with dense grass. At the northwest corner of No. 5150 near the back fence, there is a gentle slope of less than 1 m in height and 5 horizontal to 1 vertical (5H:1V) or flatter in steepness, which is considered stable in terms of long-term stability.

Photo A3: West part of No. 5150 near back fence (looking south)

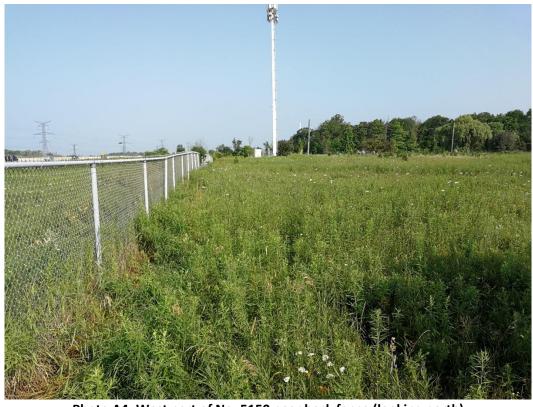
Photo A4: West part of No. 5150 near back fence (looking north)

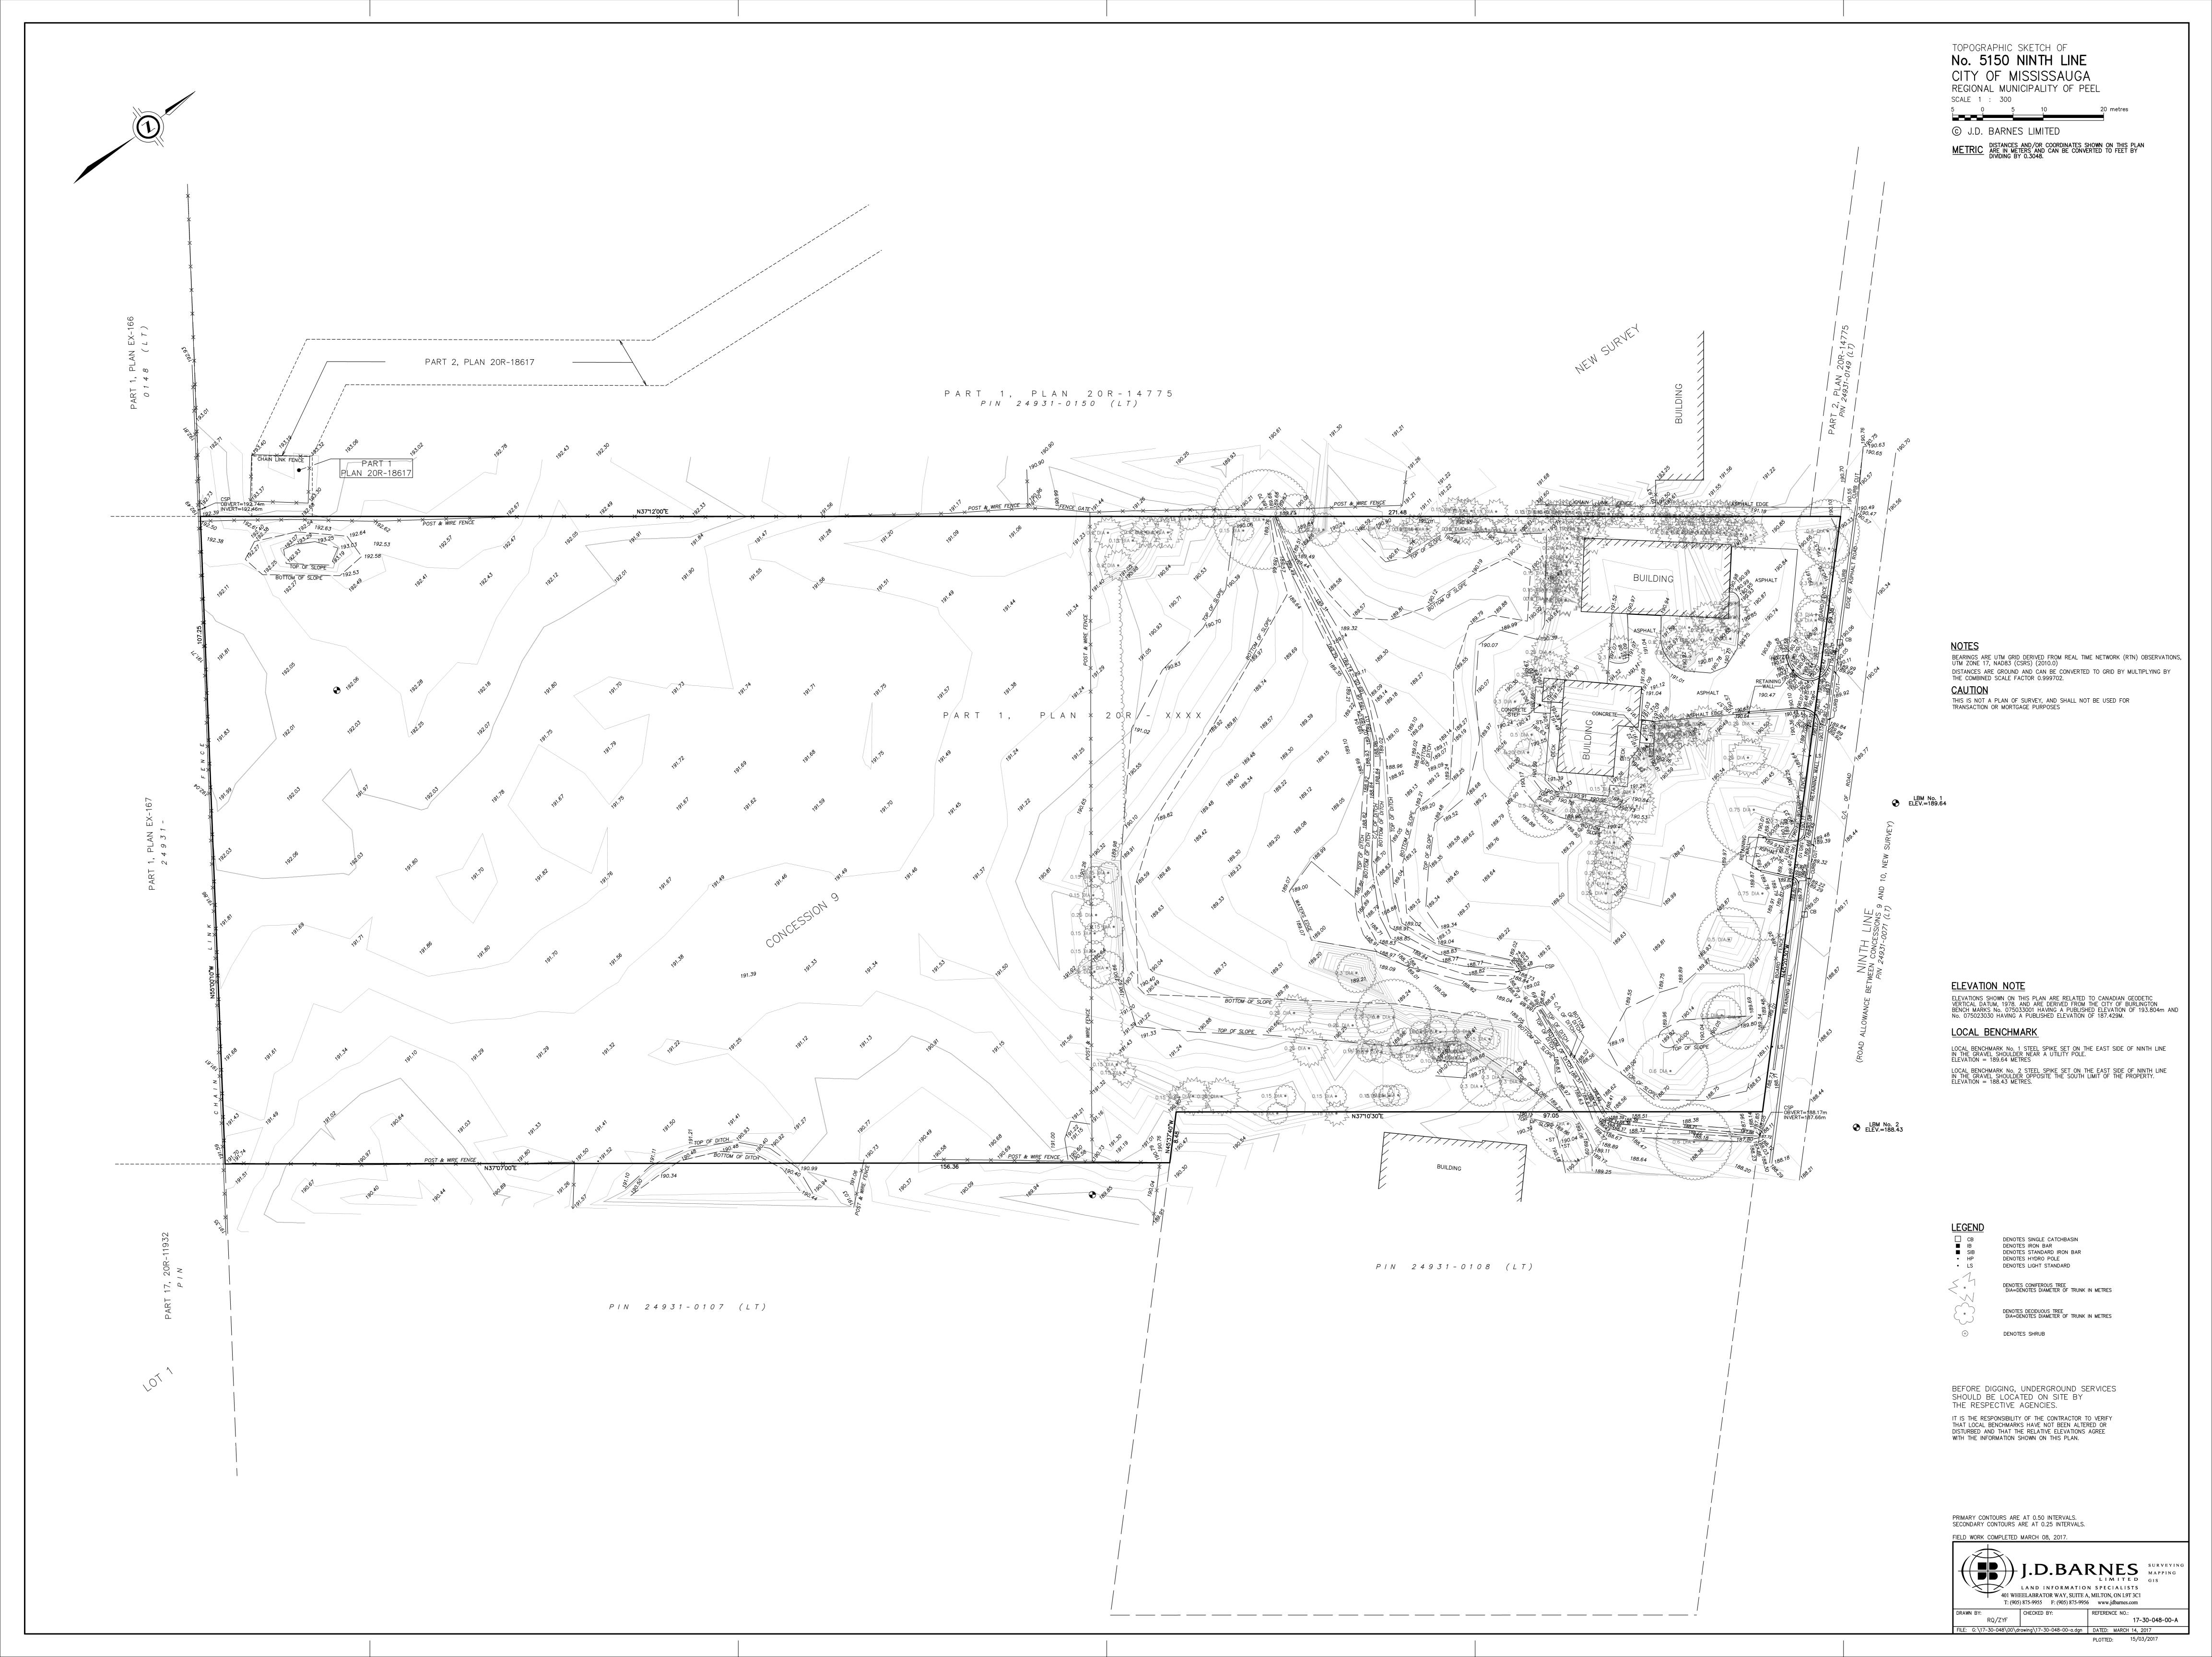
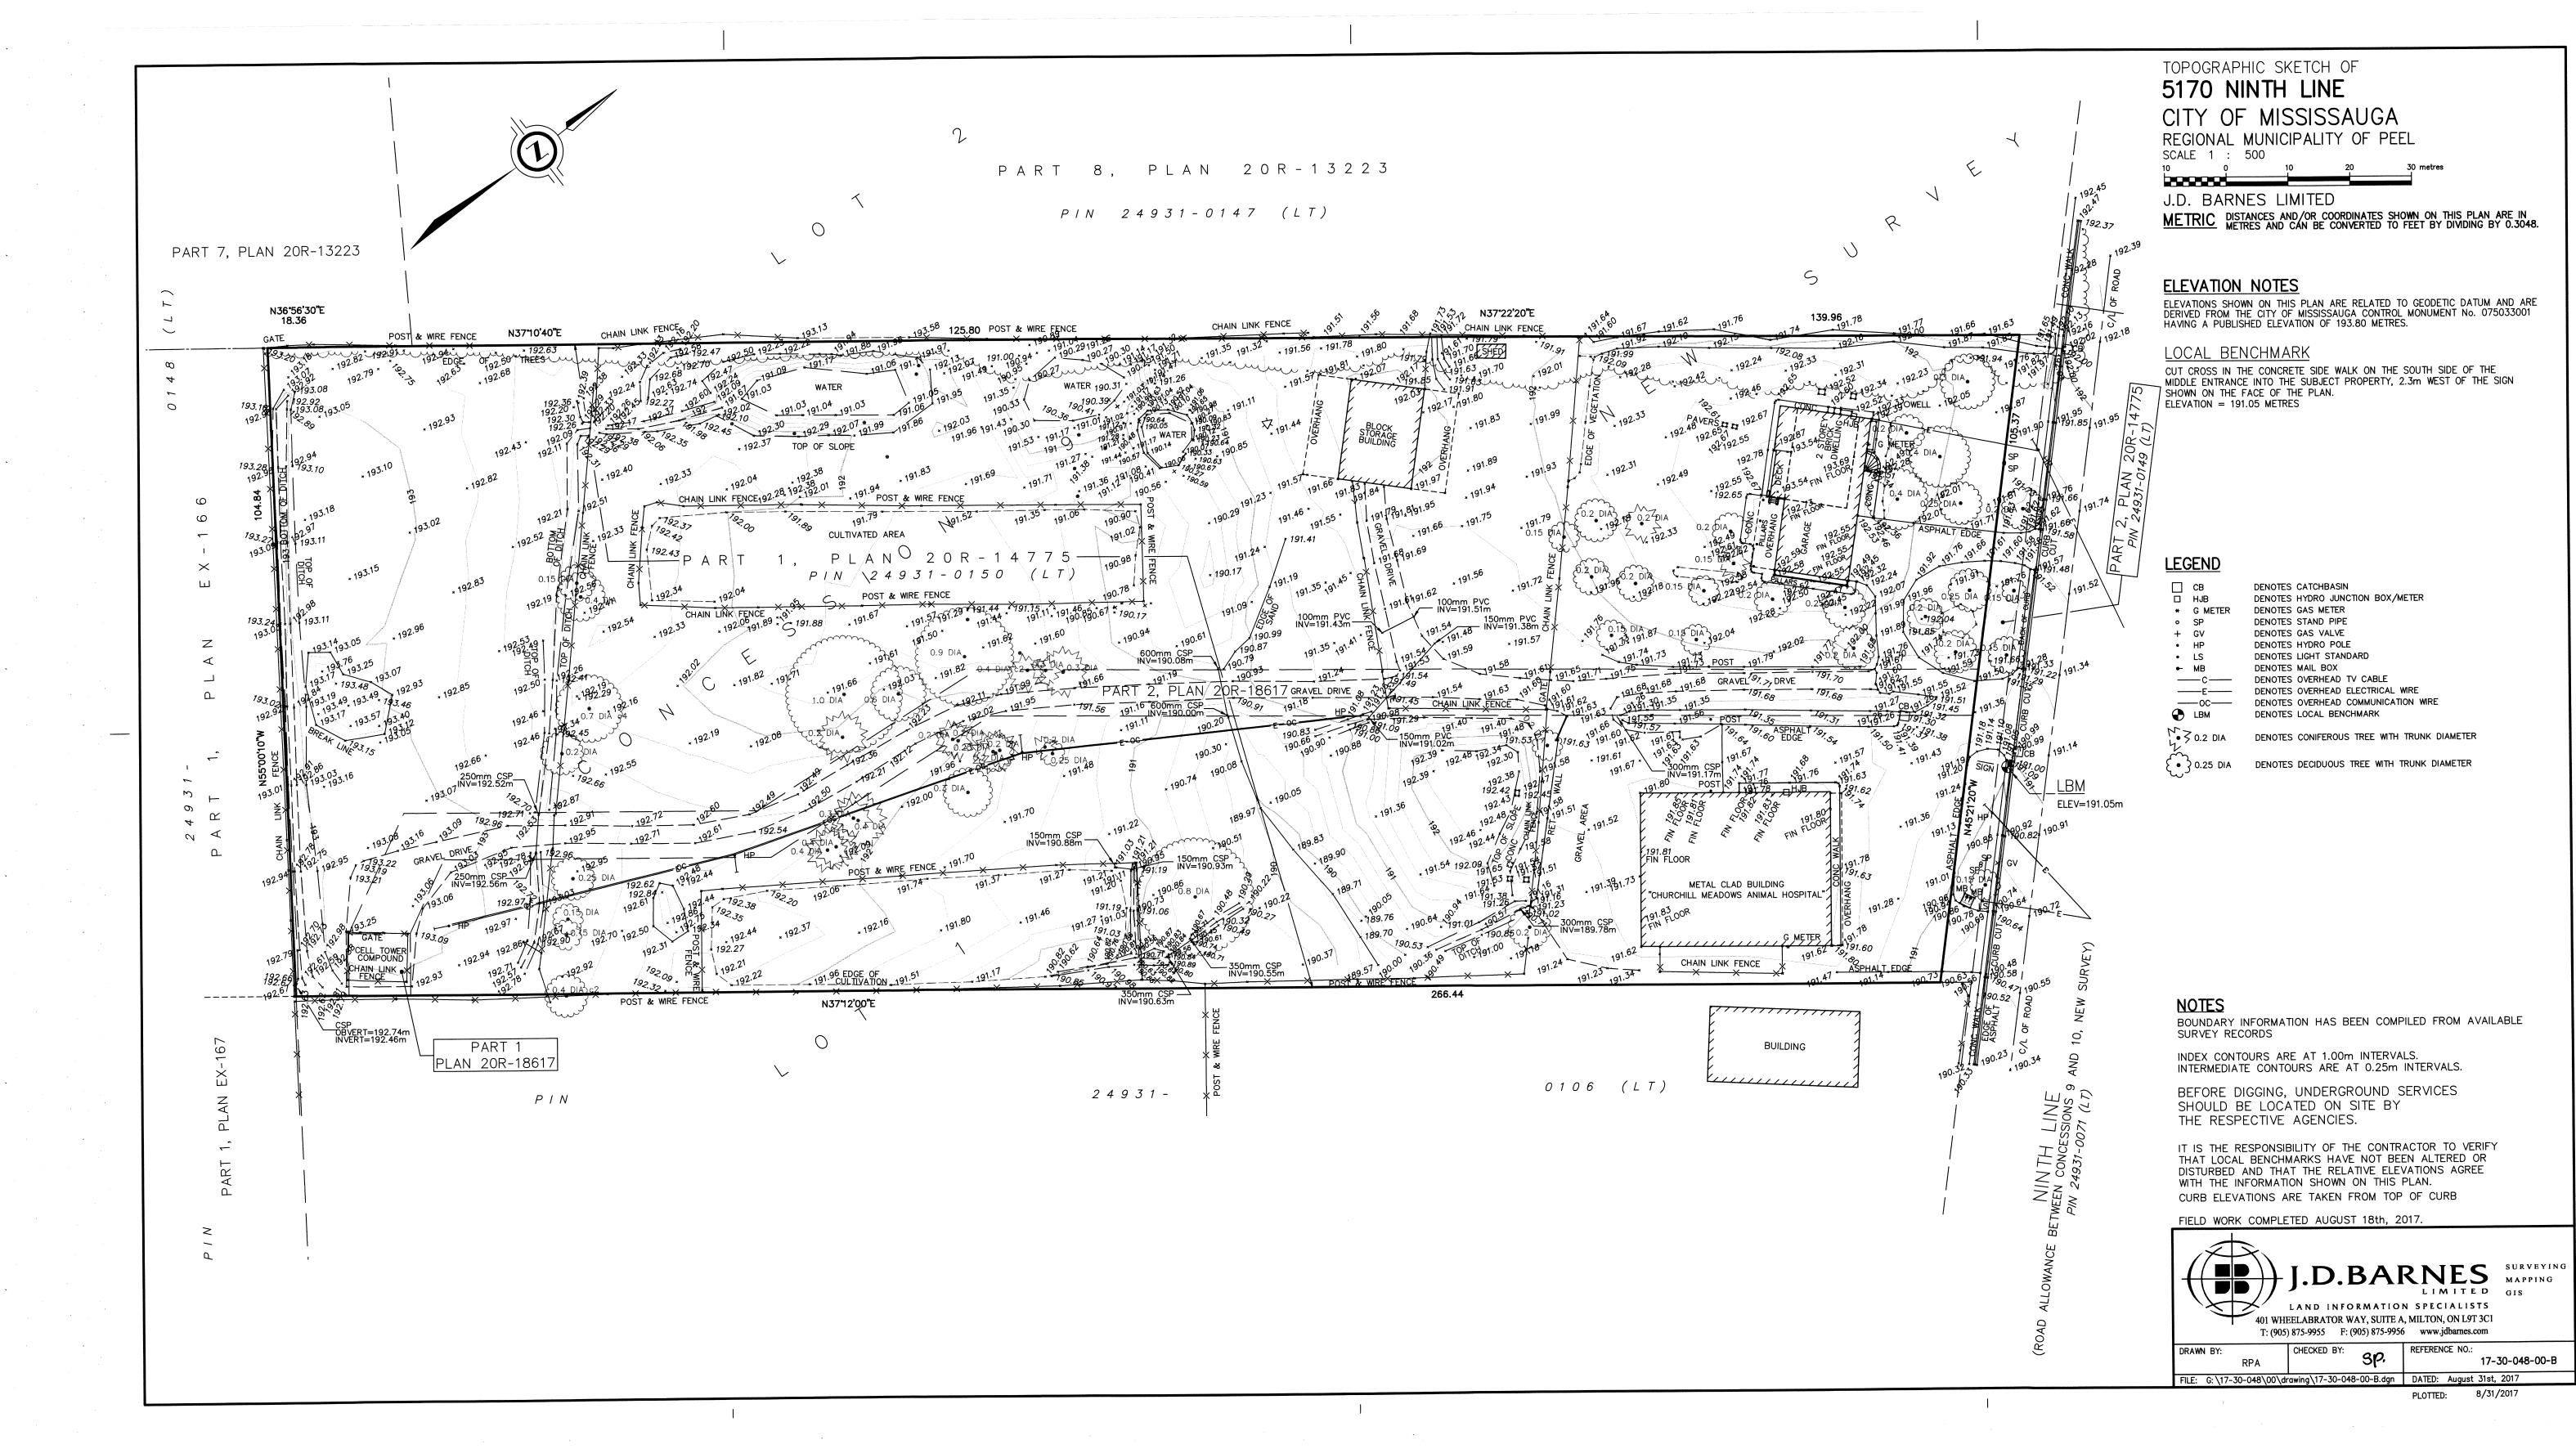
Appendix B – Topographic Survey Maps of No. 5150 and 5170 (by J.D. Barnes)

As shown in the survey maps in Appendix B, there is a ditch in No. 5170 at about 30 to 50 m east of the beak fence. There is also a ditch crossing the middle and east part of No. 5170, and crossing the east part of No. 5150. The slopes in these ditch areas are generally less than 1 m in height and is 5 horizontal to 1

vertical (5H:1V) or flatter in steepness, which are considered stable in terms of long-term stability. We understand that these ditches are located in future residential area, where re-grading with engineered fill will be carried out. Requirements for grading with engineered fill are presented in our geotechnical report to be submitted to Mattamy.
