# **ARBORIST REPORT & PLAN OF PRESERVATION**

7211 & 7233 AIRPORT ROAD

CITY OF MISSISSAUGA

TA-16-033

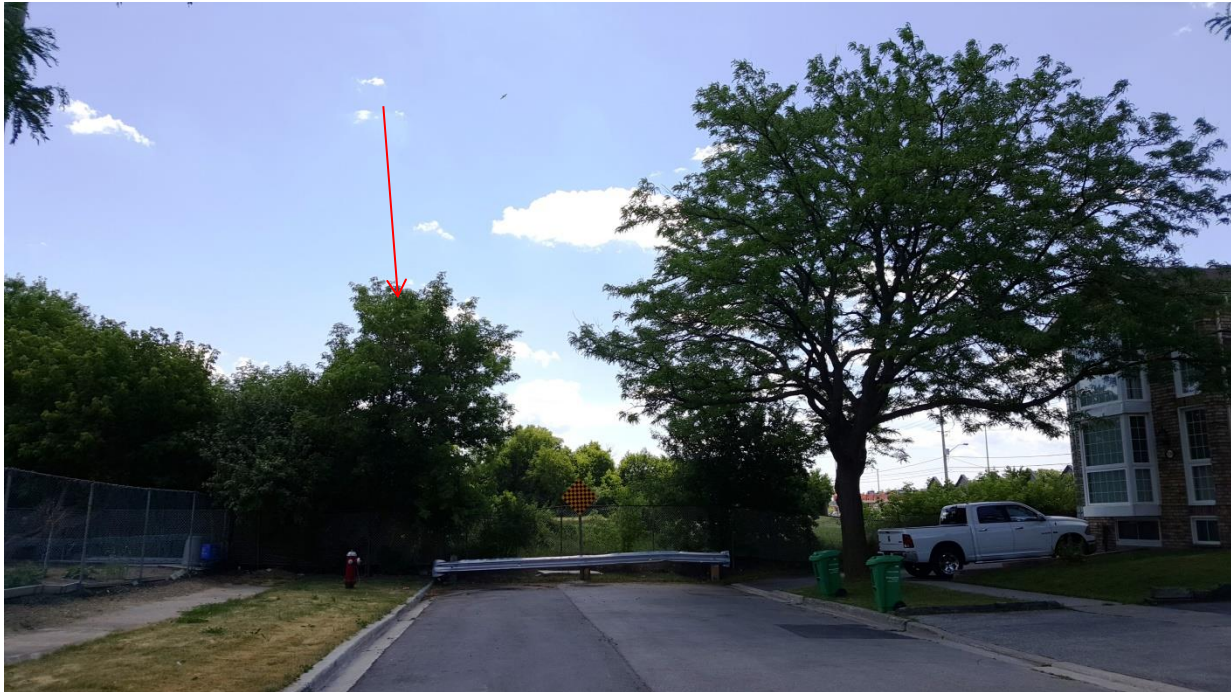
**Trees #1736 & #1703.** Large Honeylocust on municipal road allowance of Collette Road (right). Manitoba Maple located on east side of Collette Road (Left, red arrow)

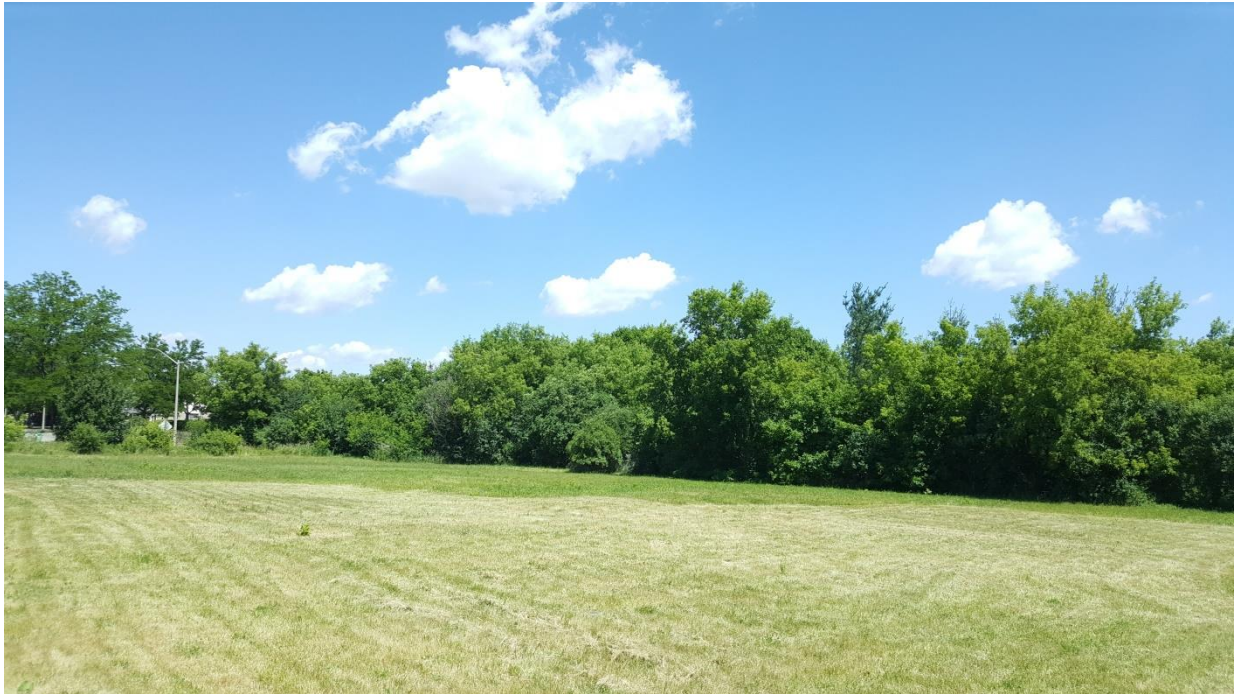
Northeast side of site, Collette Road at the left of the photo. Trees along this boundary are dense and naturally regenerated .

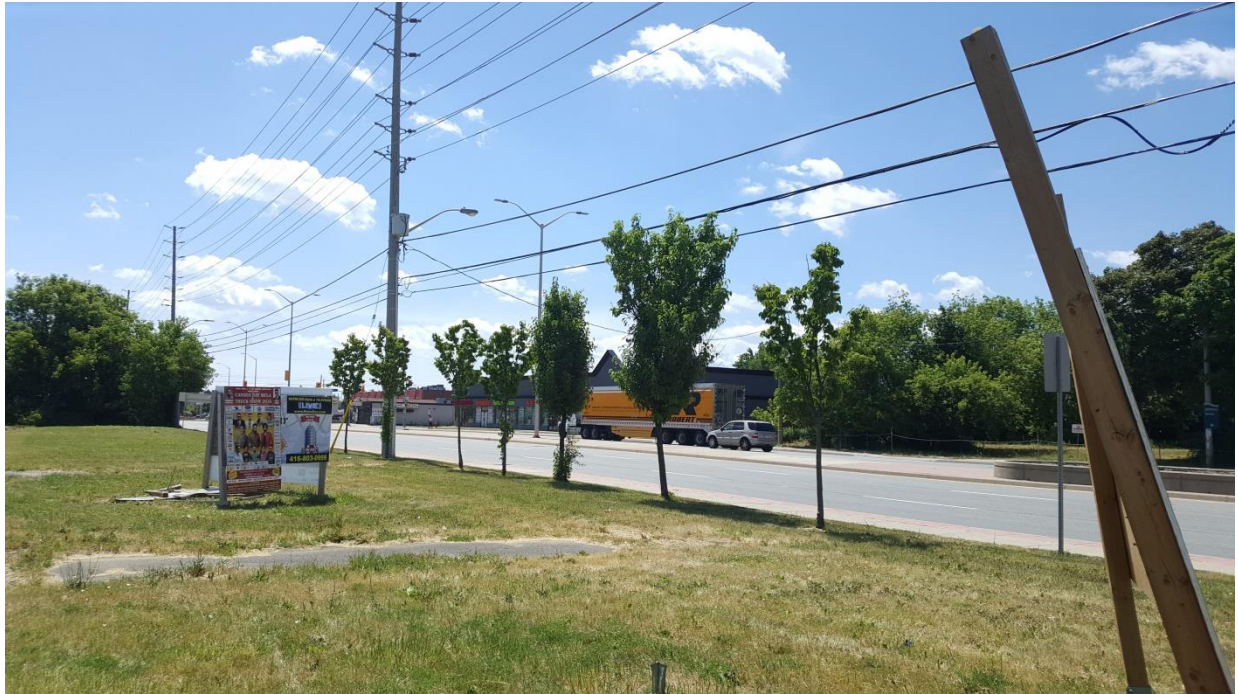
Facing southwest (towards Airport Road) viewing trees #1729-1735 along regional road allowance

Tag #	Common Name	Latin Binomial	DBH (cm)	Condition	Category	Remarks	Rationale for Removal
1732	Japanese Tree Lilac	<i>Syringa reticulata</i>	6	Poor	MT	Regional tree 90 mm Cal. Branch dieback throughout crown Epicormic branching along bole	Due to construction of right turning lane, removal will be required
1733	Callery Pear	<i>Pyrus calleryana</i>	10	Poor	MT	Regional tree Epicormic branching from base Branch and tip dieback throughout	Due to construction of right turning lane, removal will be required
1734	Callery Pear	<i>Pyrus calleryana</i>	12	Poor	MT	Regional tree Epicormic branching from base Branch and tip dieback throughout	Due to construction of right turning lane, removal will be required
1735	Japanese Tree Lilac	<i>Syringa reticulata</i>	7	Fair	MT	Regional tree 100 mm Cal. Crown is thin; tip dieback throughout	Due to construction of right turning lane, removal will be required
