Construction Arborist Report: 0 Bernida Road, Mississauga, Ontario

Prepared on behalf of the property owner

Date: April 17th, 2020

Prepared by: Serg Litvinov, B.Sc., ISA # ON-2281A
Consulting Arborist - Tree Doctors Inc.
SLitvinov@treedoctors.ca

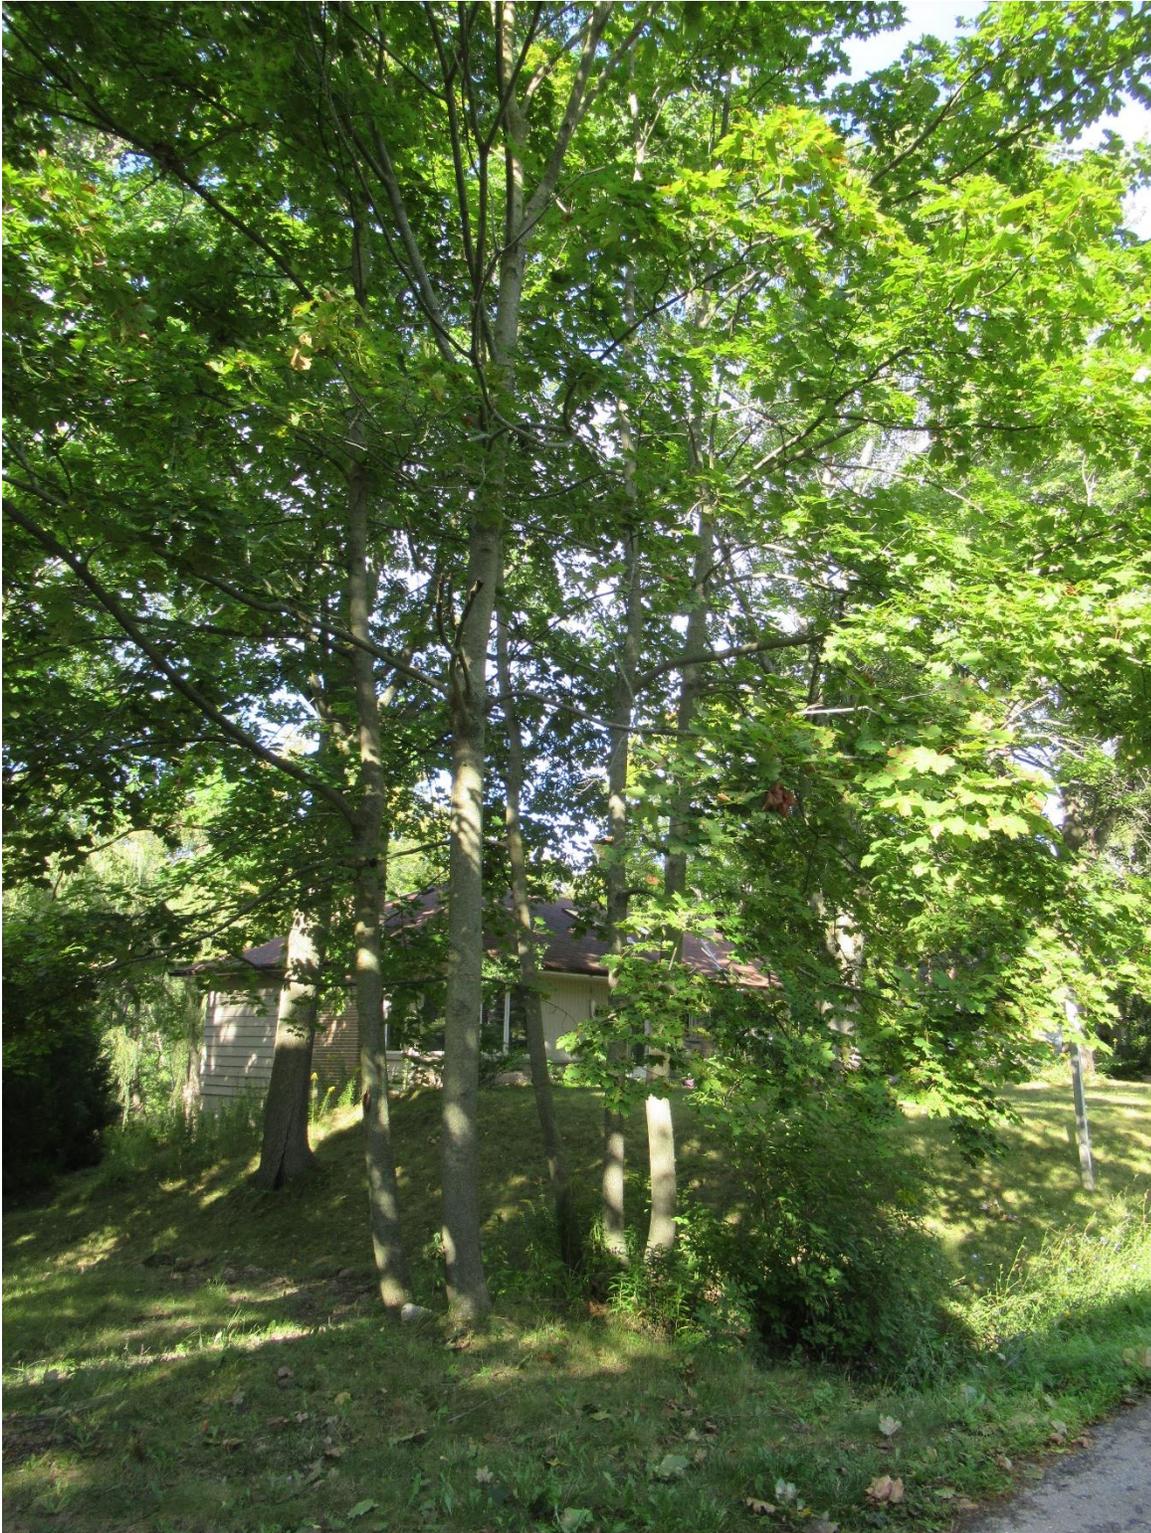
Picture 1: Trees #1-4

Tree #2 is a young City tree in Good/Fair condition located on the road allowance to the property. The tree has a few insignificant flaws such as minor amount of small diameter deadwood in the crown, none of which are life threatening to the tree or potentially hazardous for its surroundings.

Tree #4 is a young City tree in Good/Fair condition located on the road allowance to the property. The tree has a few insignificant flaws such as minor amount of small diameter deadwood in the crown, none of which are life threatening to the tree or potentially hazardous for its surroundings.

Tree #1 is a semi-mature City tree in Fair condition located on the road allowance to the property. The tree has a few significant flaws such as oozing from a large seam on its main trunk, girdling roots, and included bark at the main stem union.

Although such tree is not in exceptional form and botanical condition, its condition is not life threatening to the tree or hazardous for its surroundings.

Pre-emptive removal of the tree is recommended.

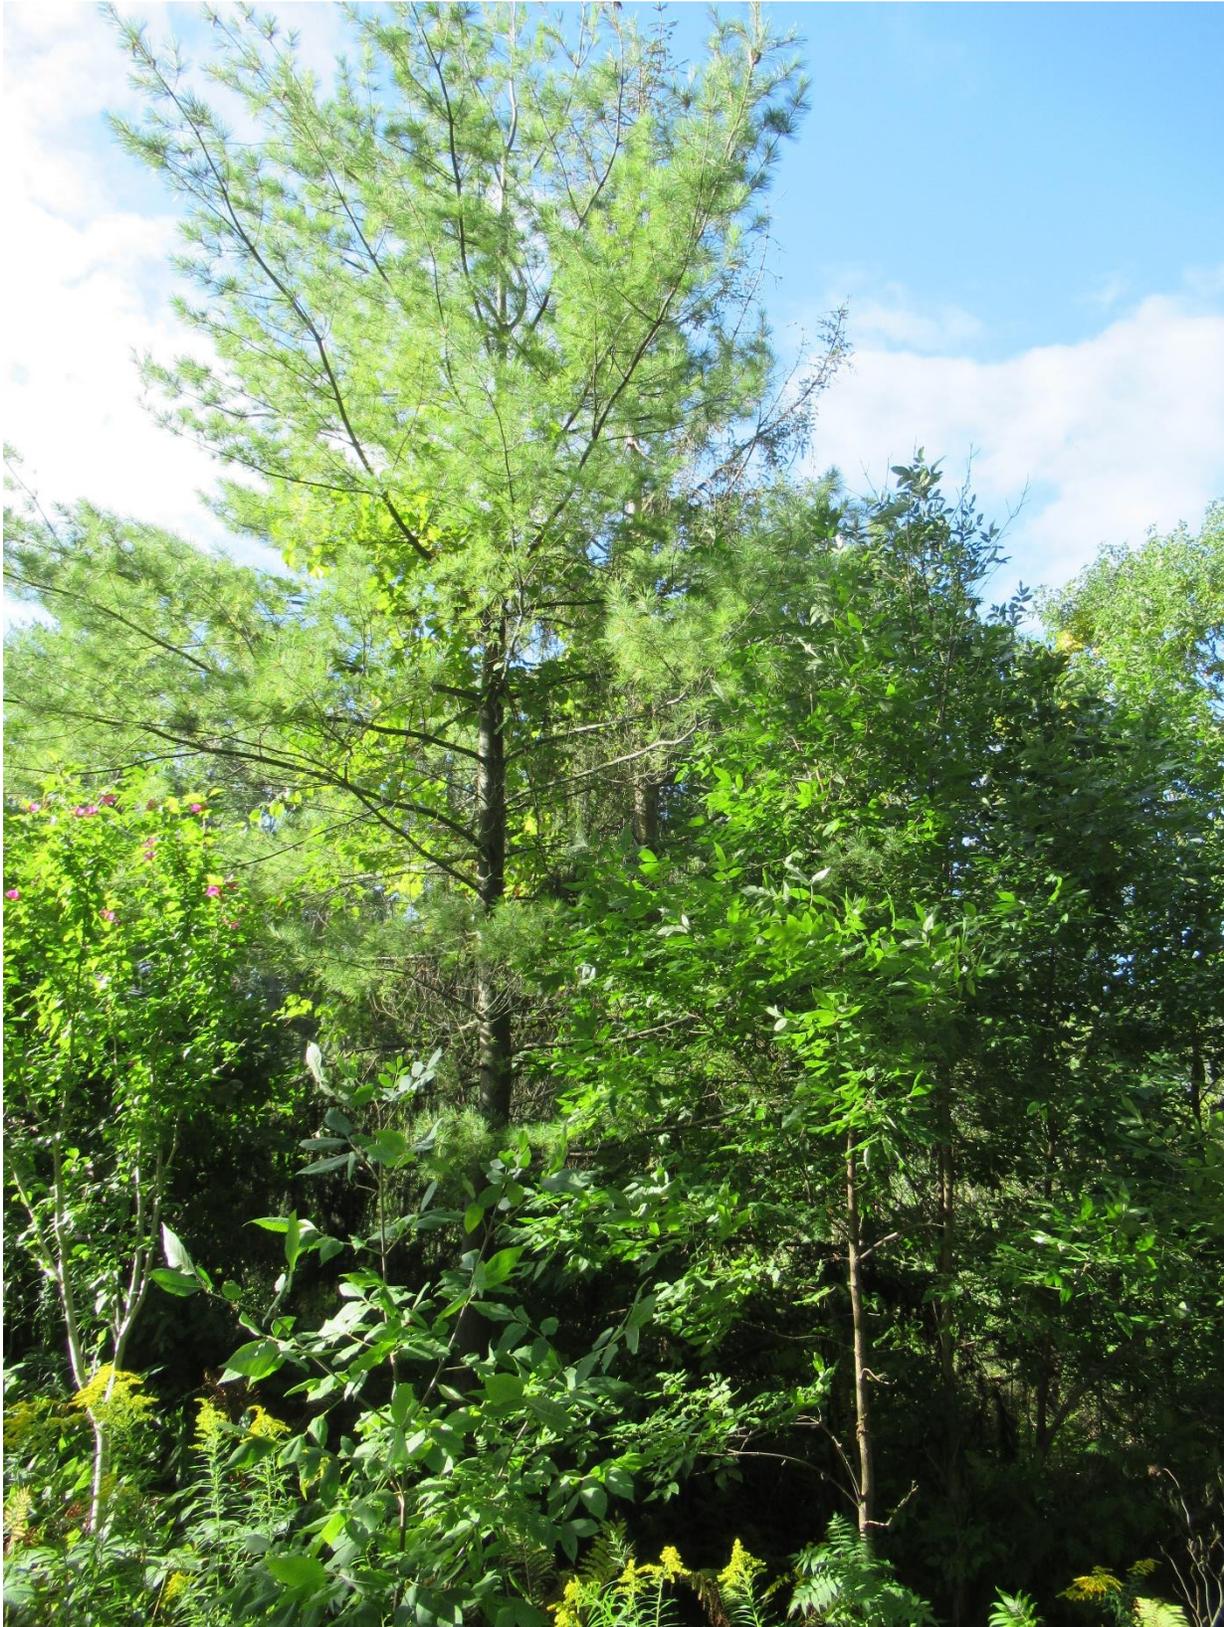
Picture 6: Trees #9 and #10

Tree #9 is a young Private tree in Good condition located on the road allowance to the property. The tree is in exceptional condition with no botanical or structural flaws.

Tree #10 is a semi-mature Private tree in Fair condition located on the road allowance to the property. The tree has a significant flaw- it is in health decline and has significant amount of

small to m such as minor amount of small diameter deadwood in the crown, none of which are life threatening to the tree or potentially hazardous for its surroundings.

Pre-emptive removal of the tree is recommended.

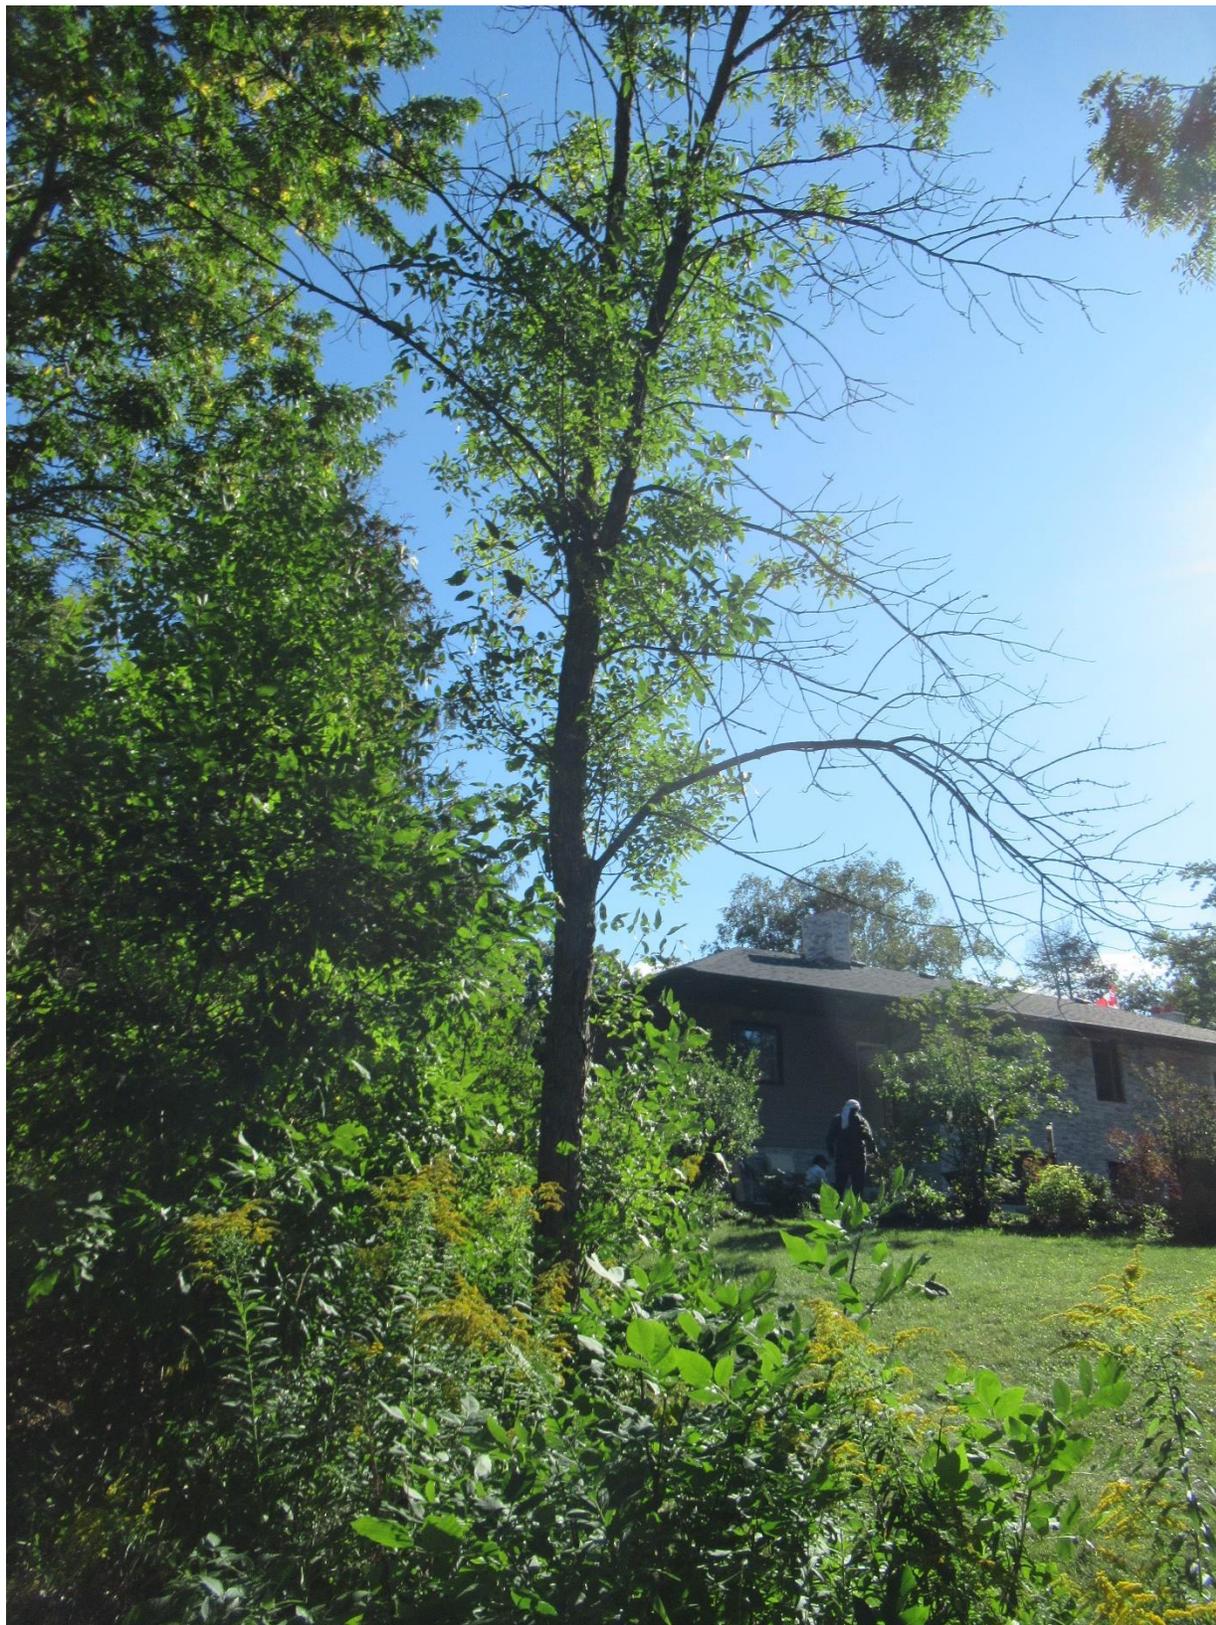
Picture 7: Tree #11

Tree #11 is a young multistem Private tree in Good/Fair condition located on the road allowance to the property. **The tree has a good appearance however, it is infected with Emerald Ash Borer (EAB) and represents immediate danger to the surrounding environment.**

Pre-emptive removal of the tree is recommended.

Pre-emptive removal of the tree would remain recommended even in cases when the road access location or size are adjusted to preserve some of the trees on the property.

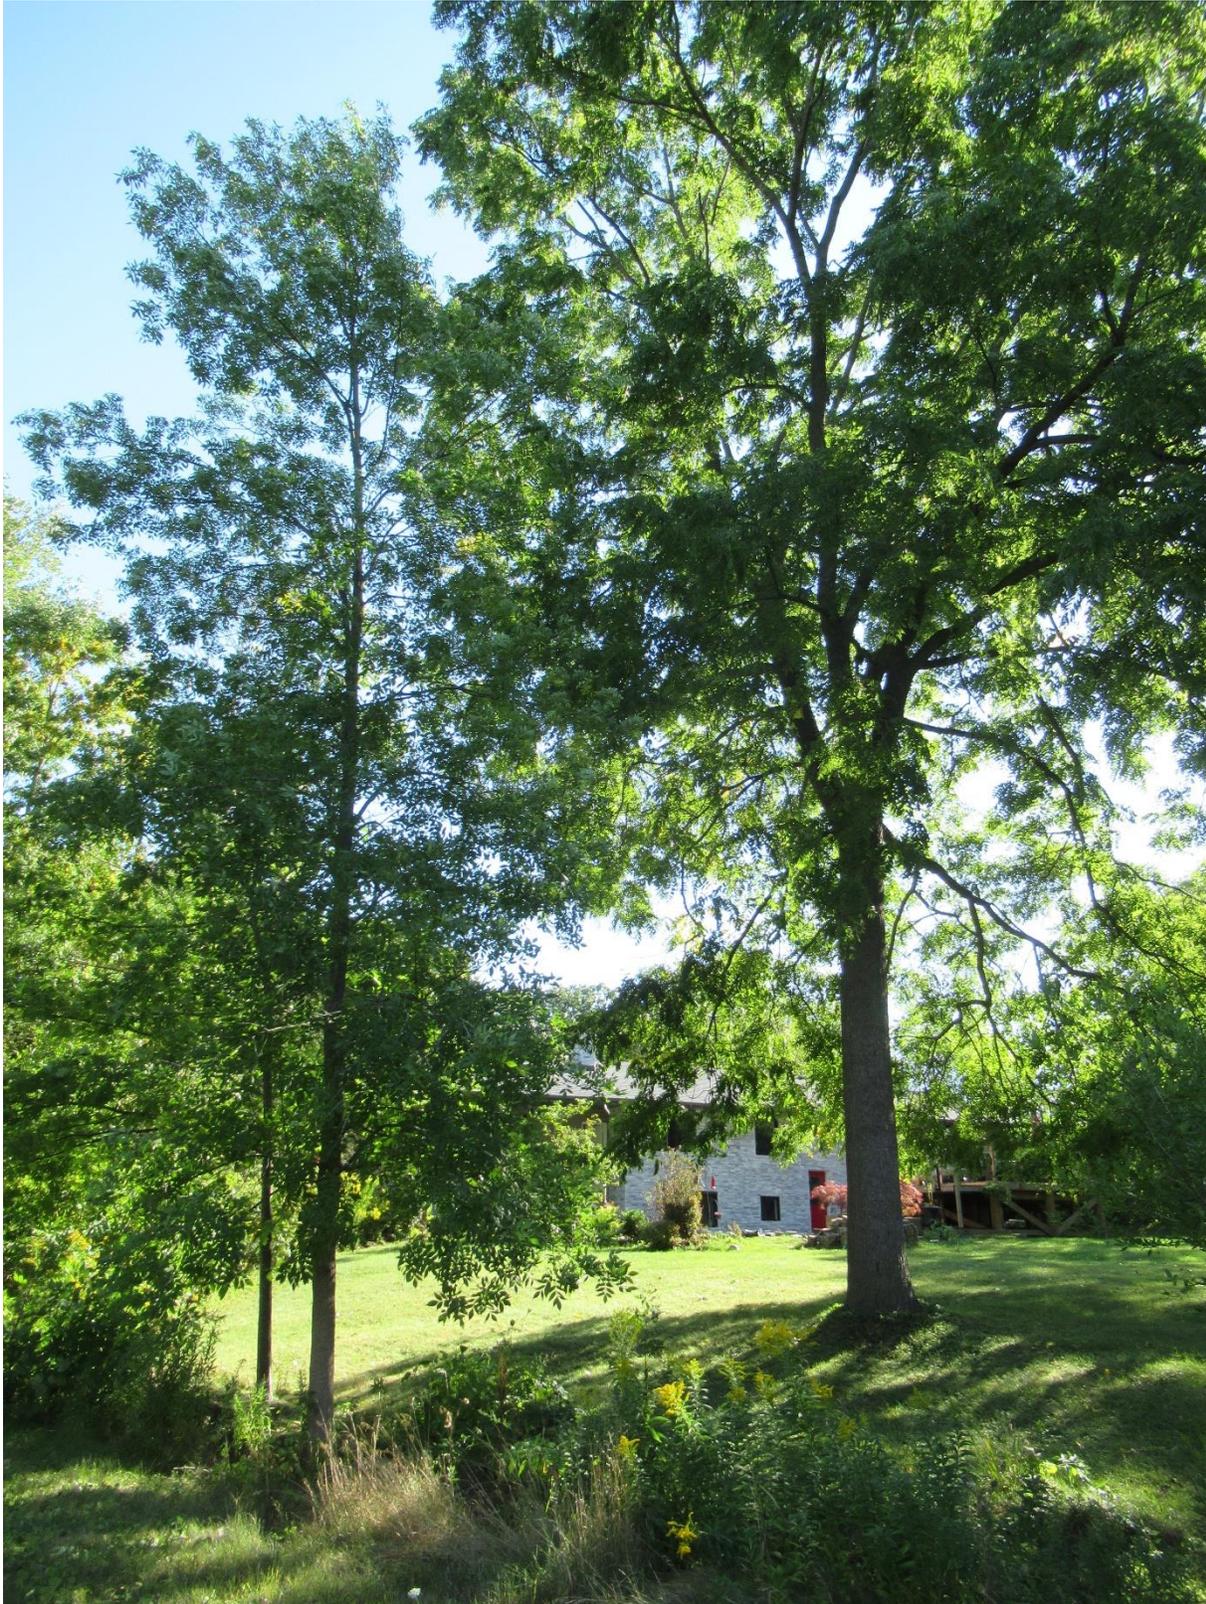
Picture 8: Trees #12-15

Tree #12 is a semi-mature Private tree in Poor condition located on the road allowance to the property. The tree is in advanced health decline and over 30% of its crown is dead.

Tree #13 is a young Private tree in Good condition located on the road allowance to the property. The tree is in exceptional condition and has no obvious botanical or structural flaws.

Tree #14 is a young Private tree in Fair/Poor condition located on the road allowance to the property. The tree is in overall health decline and is probably infected with Emerald Ash Borer (EAB).

Pre-emptive removal of the tree is recommended.

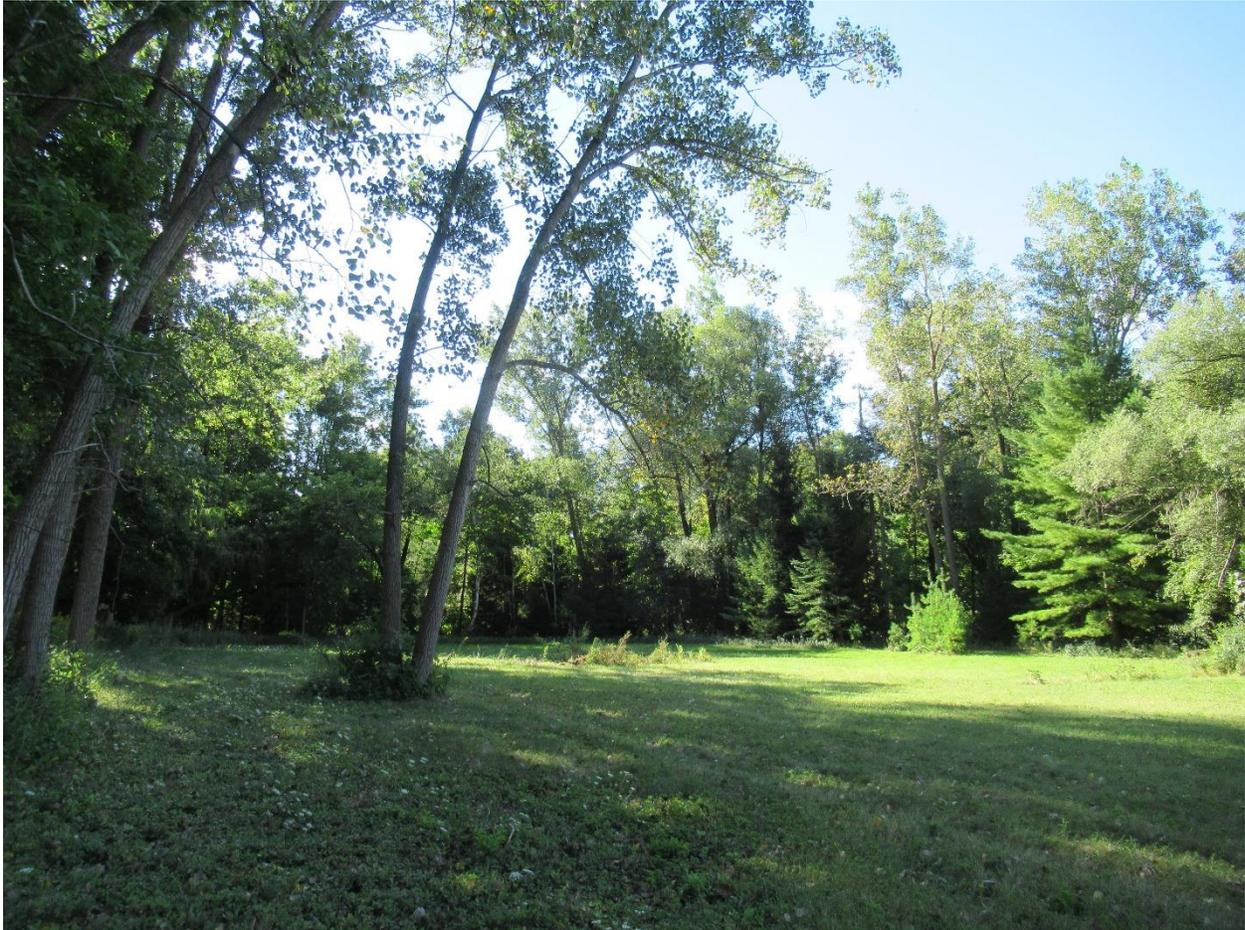
Picture 11: Tree #33

Tree #33 is a semi-mature Private tree in Fair condition located on the road allowance to the property. The tree is showing minor signs of decline such as presence of moderate amount of small diameter deadwood, moderate trunk lean and asymmetrical crown due to shading of adjacent trees.

Pre-emptive removal of the tree is recommended.

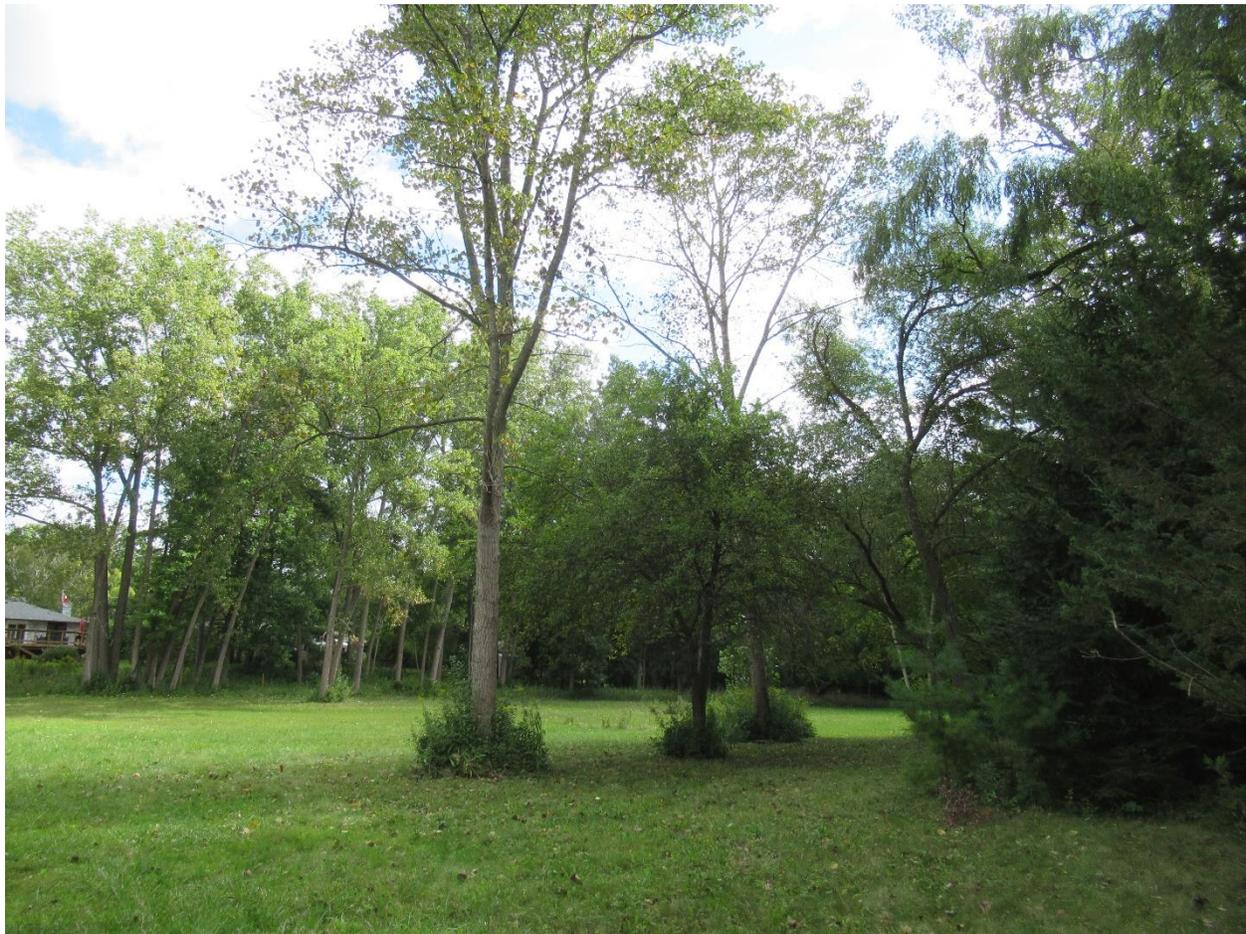
Picture 21: Trees #52-55

Tree #52 is a semi-mature Private tree in Fair condition located on the road allowance to the property. The tree is showing minor signs of decline such as presence of moderate amount of small diameter deadwood, moderate trunk lean and asymmetrical crown due to shading of adjacent trees.

Pre-emptive removal of the tree is recommended.

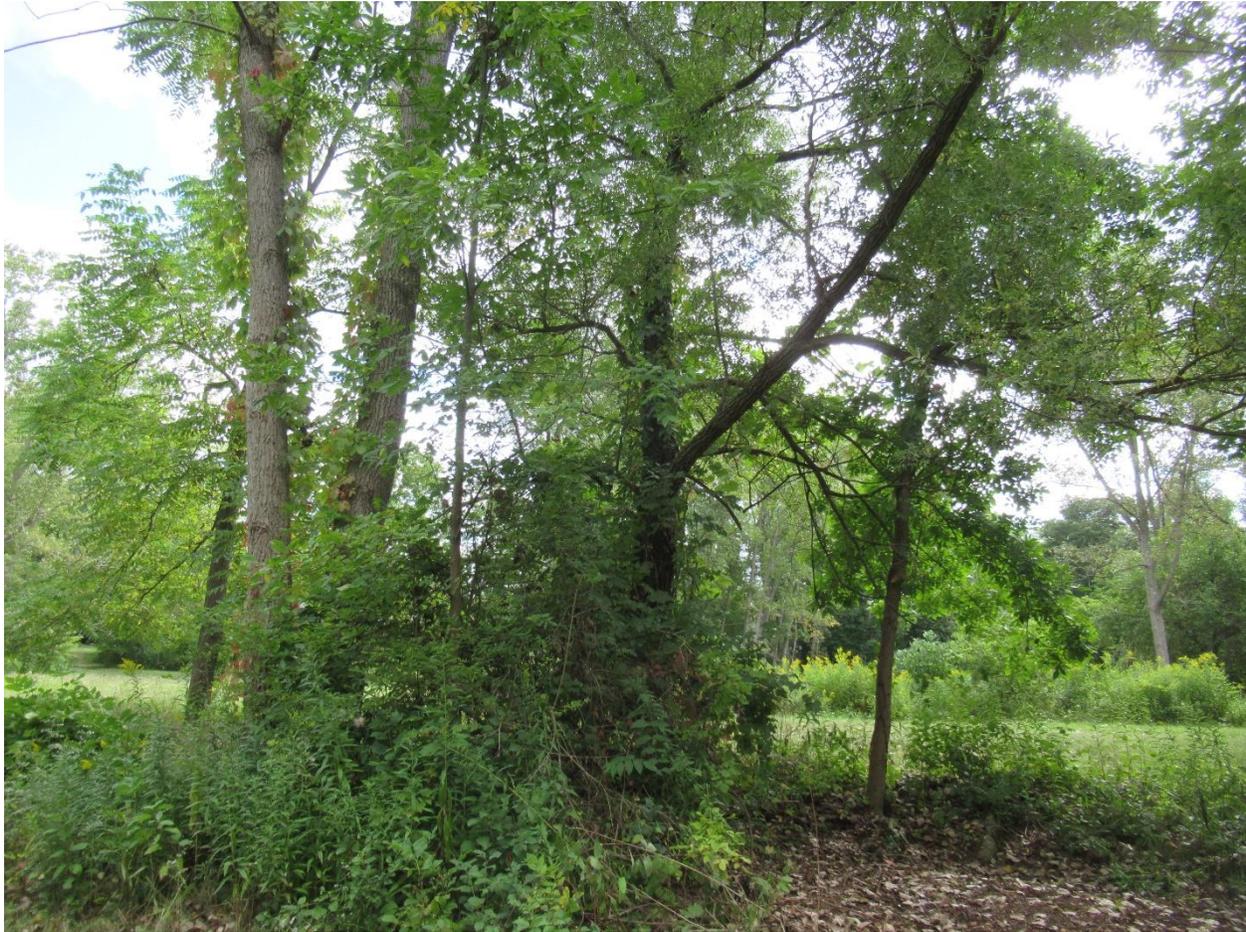
Picture 27: Tree #62-65

Tree #65 is a young Private tree in Fair condition located on the road allowance to the property. The tree is showing signs of decline such as vine covered trunk, and recently torn limb.

Pre-emptive removal of the tree is recommended.

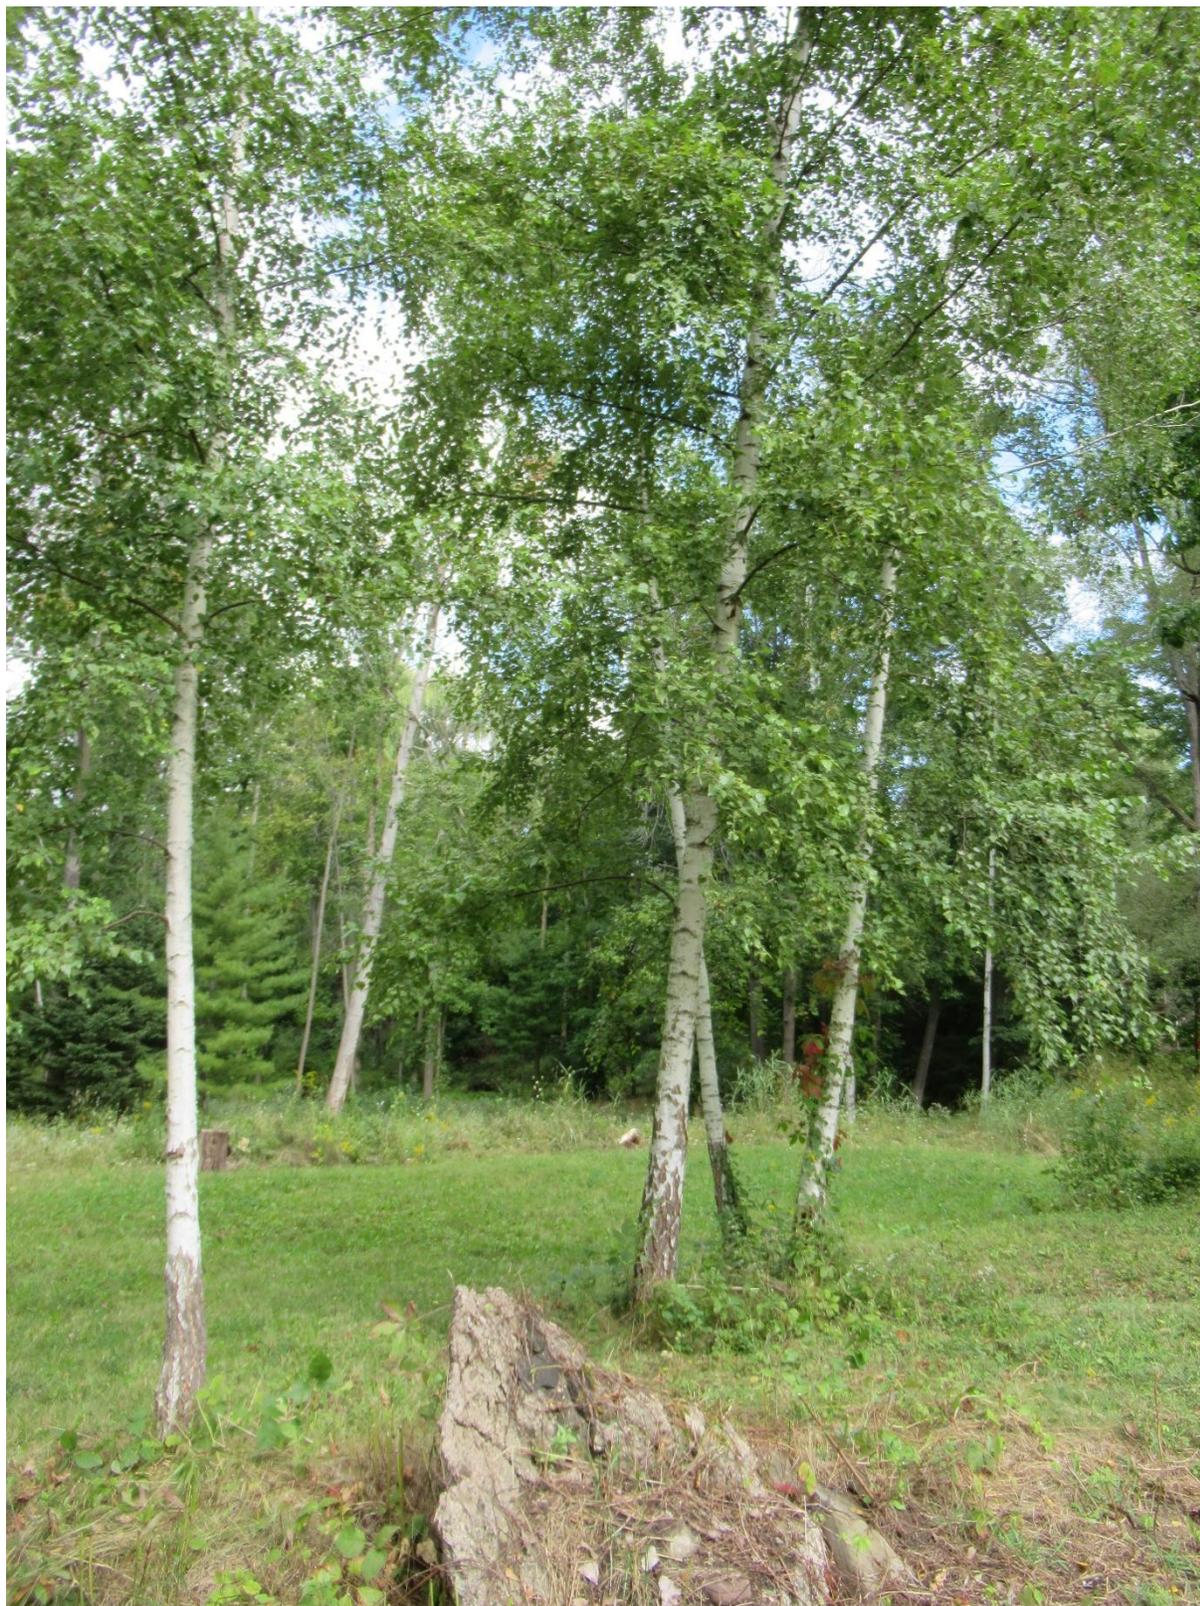
Picture 28: Tree #66

Tree #66 is a young Private tree in Good condition located on the road allowance to the property. The tree is in exceptional condition with no signs of obvious structural or botanical flaws.

The tree will however, require removal in order to allow for construction of proposed 6.5m wide road access. The tree is located directly within the footprints of the proposed road access and could not be retained. Pre-emptive removal of the tree is recommended.

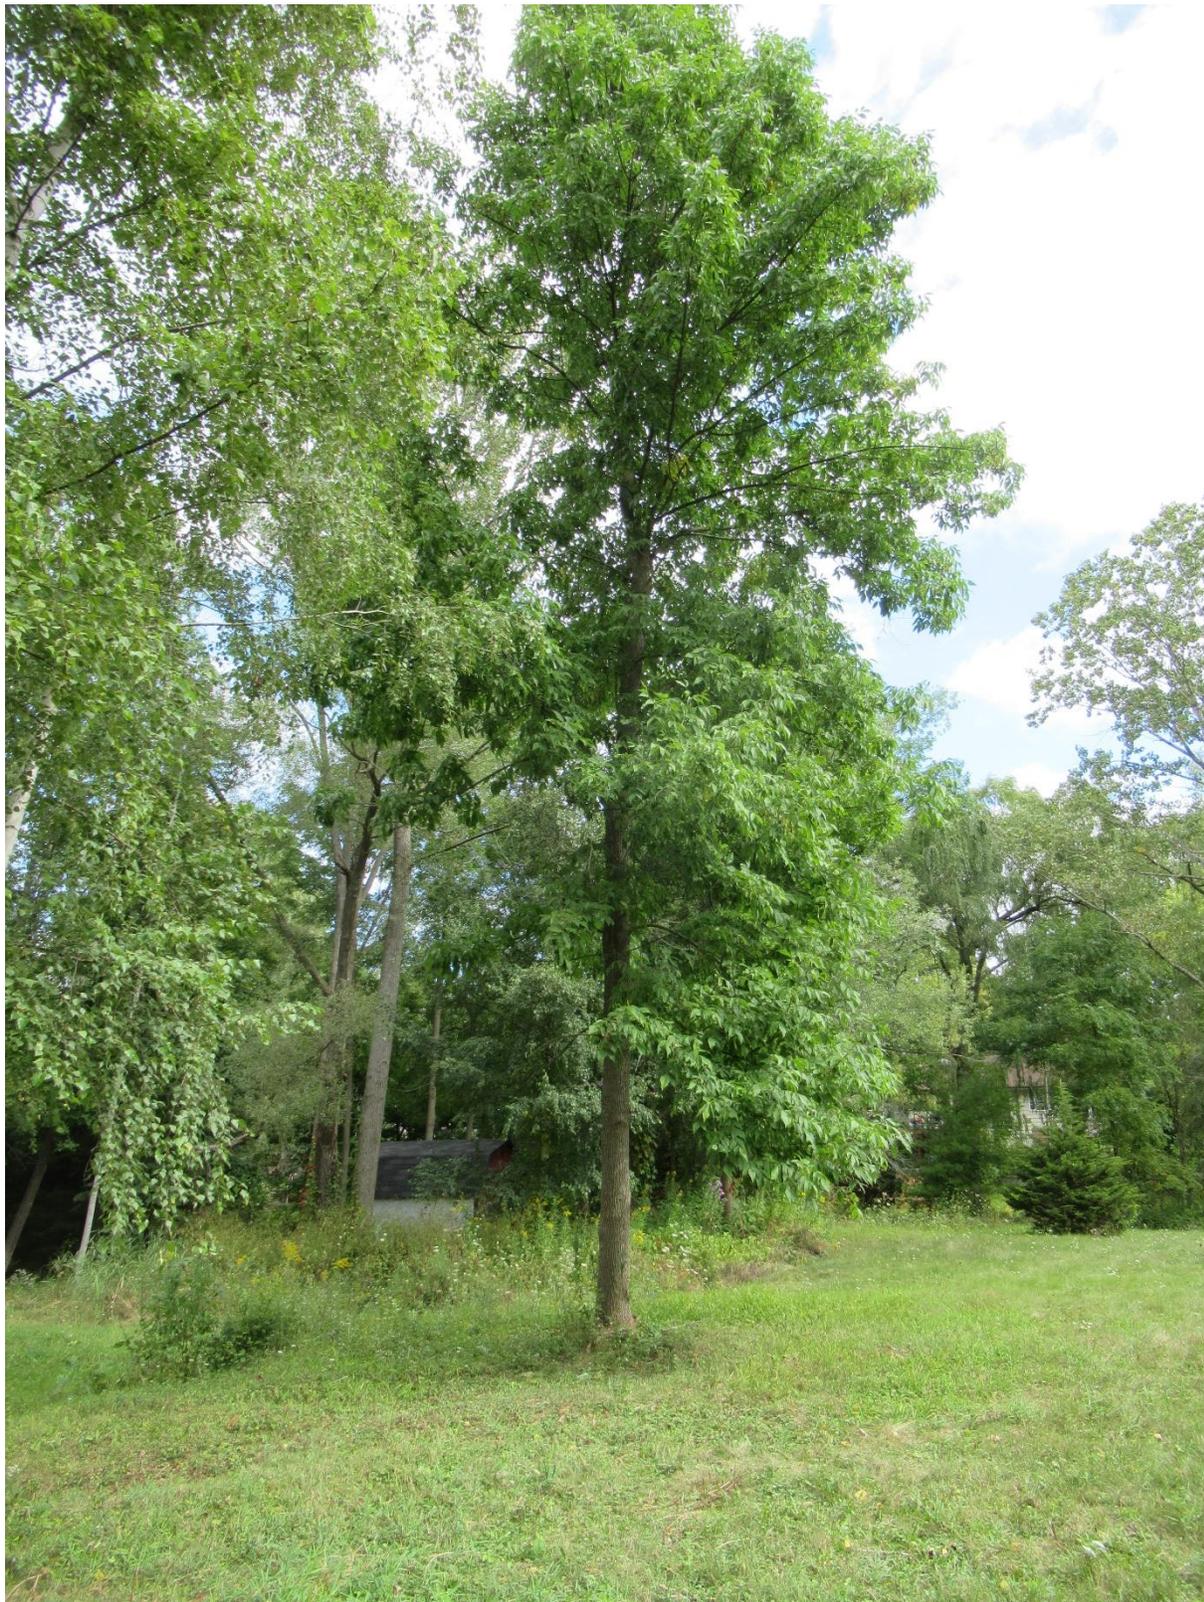
Picture 29: Tree #67

Tree #67 is a young Private tree in Good/Fair condition located on the road allowance to the property. The tree has a few insignificant flaws such as minor amount of small diameter deadwood in the crown however, no structural or significant botanical decline signs were noted during the site visit.

Pre-emptive removal of the tree is recommended.

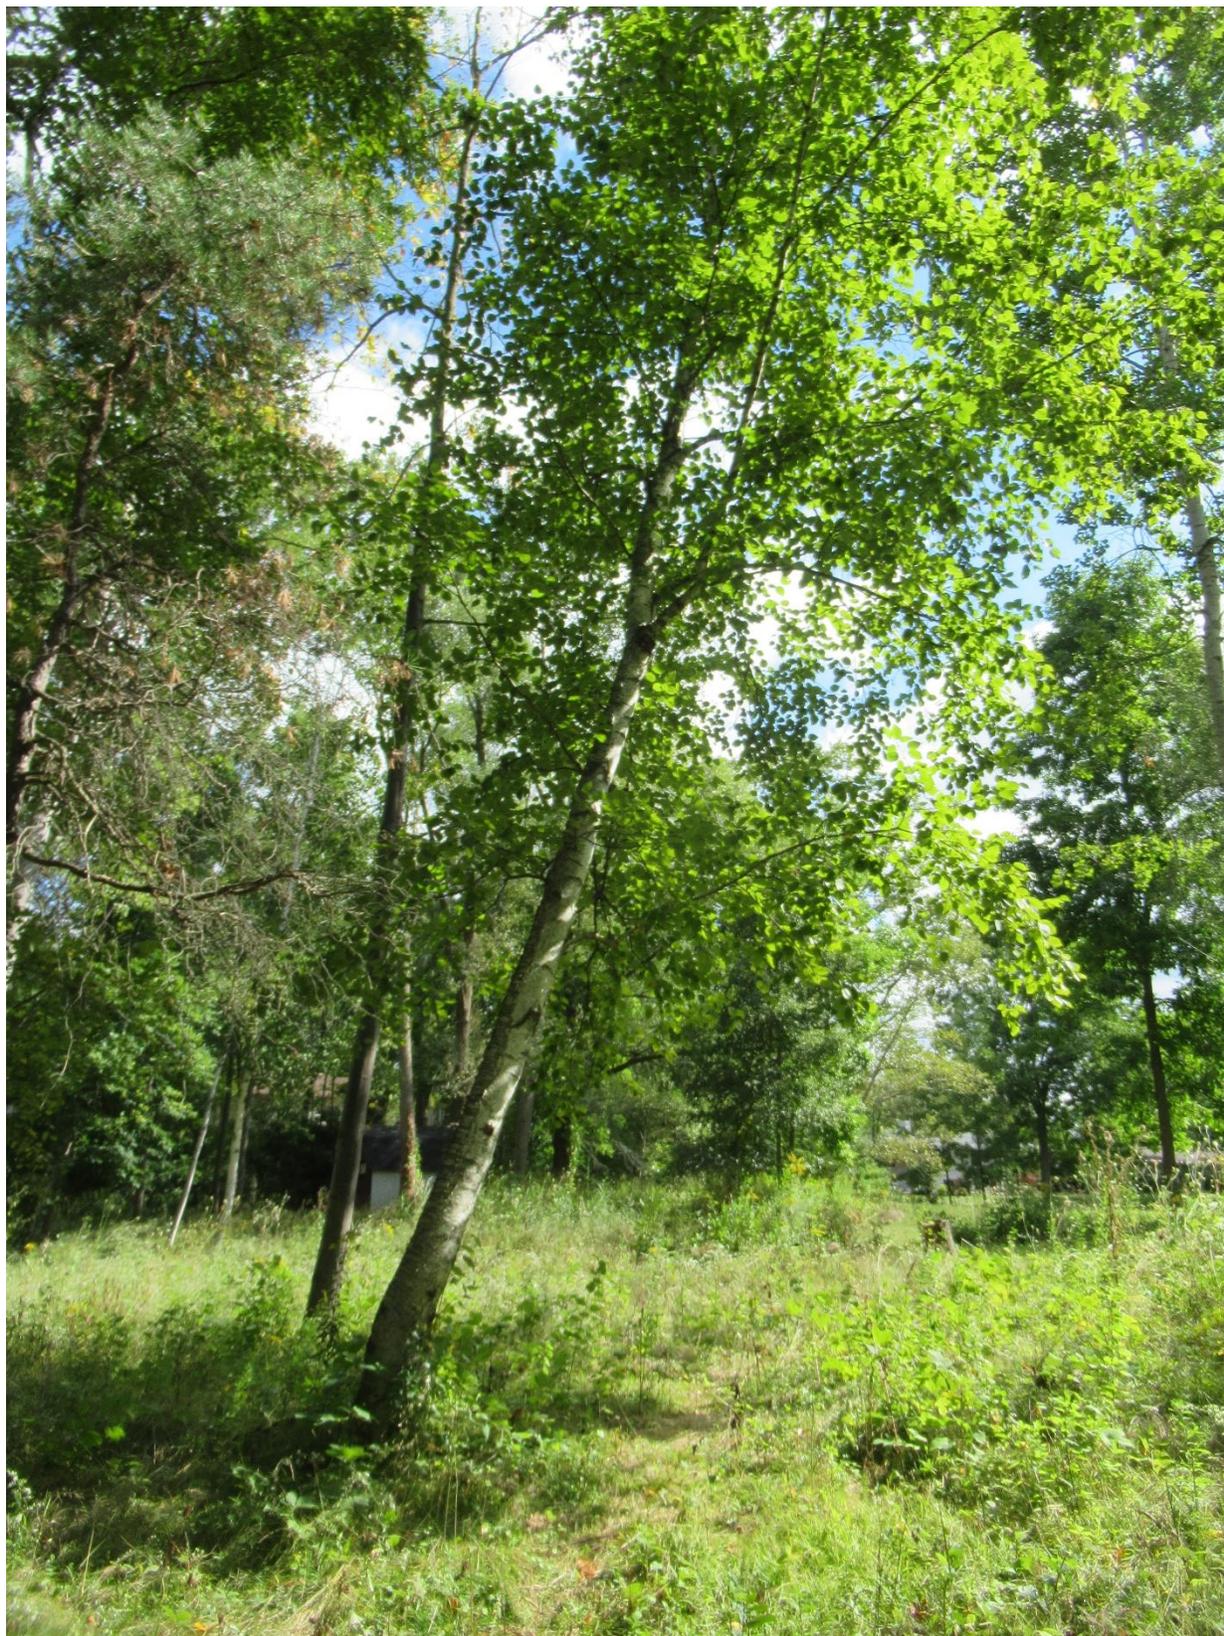
Picture 32: Trees #74 and #75

Tree #74 is a young Private tree in Good/Fair condition located on the road allowance to the property. The tree has a few insignificant flaws such as minor amount of small diameter deadwood in the crown however, no structural or significant botanical decline signs were noted during the site visit.

Tree #75 is a young Private tree in Good/Fair condition located on the road allowance to the property. The tree has a few insignificant flaws such as minor amount of small diameter deadwood in the crown however, no structural or significant botanical decline signs were noted during the site visit.

Pre-emptive removal of the tree is recommended.

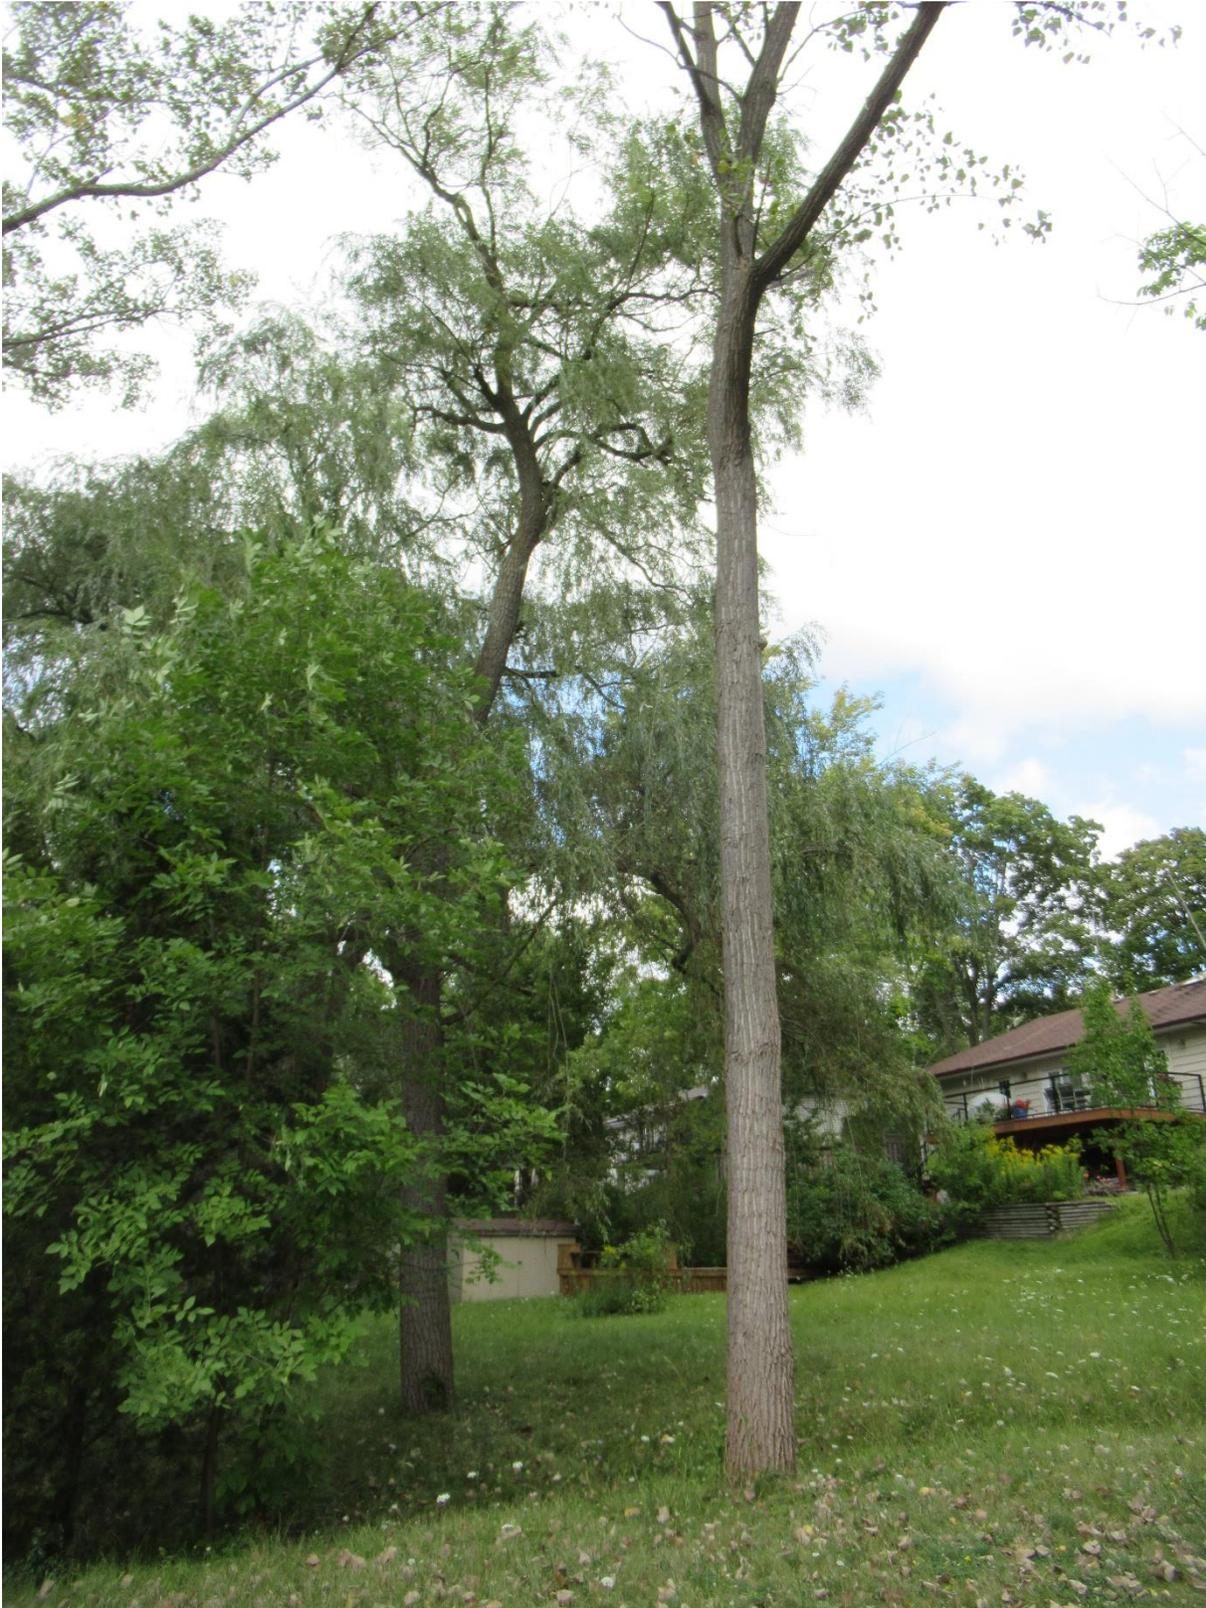
Picture 40: Tree #93

Tree #93 is a semi-mature Private tree in Fair condition located on the road allowance to the property.

The tree has a few notable flaws such as moderate amount of small diameter deadwood in the crown, sparse crown and asymmetrical crown, none of which are life threatening to the tree or potentially hazardous for its surroundings, however these factors do affect tree's expected longevity.

Pre-emptive removal of the tree is recommended.

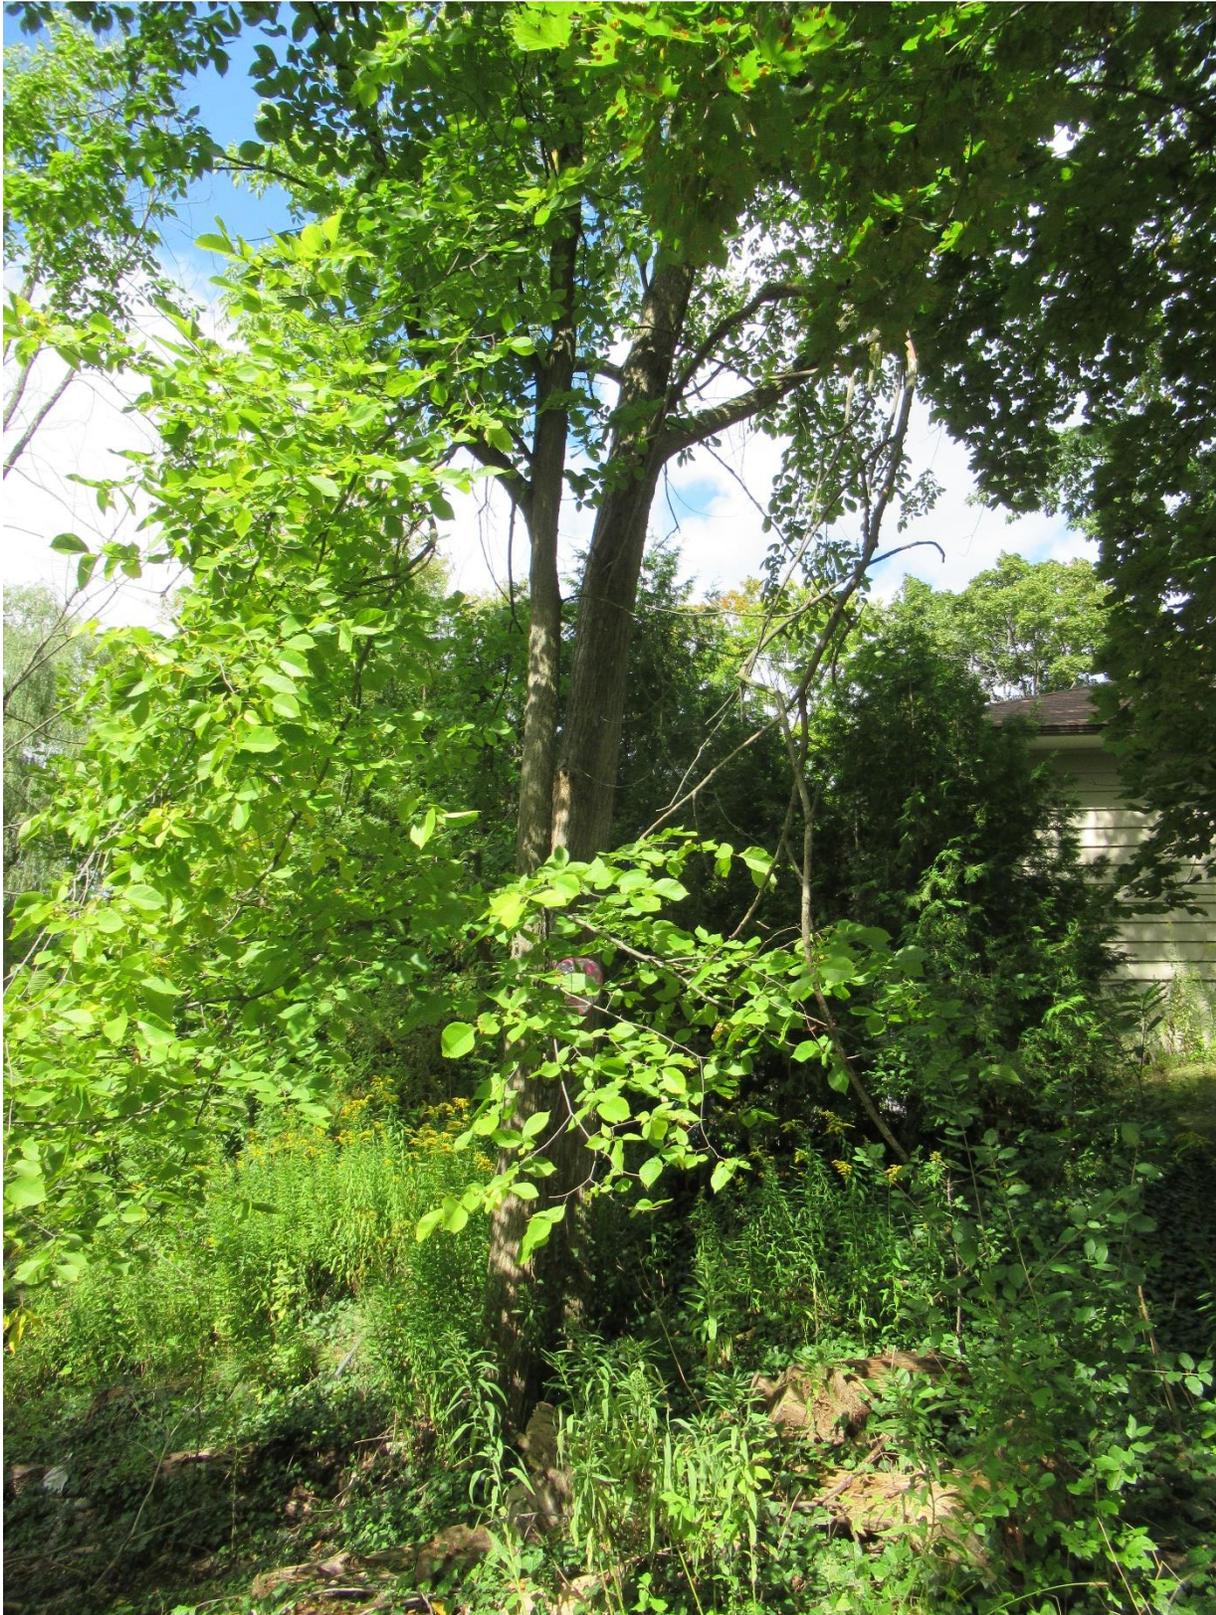
Picture 42: Tree #95

Tree #95 is a semi-mature Private tree in Good/Fair condition located on the road allowance to the property. The tree has a few insignificant flaws such as minor/moderate amount of small diameter deadwood in the crown and raised crown, none of which are life threatening to the tree or potentially hazardous for its surroundings.

Pre-emptive removal of the tree is recommended.
