Construction Arborist Report: 0 Bernida Road, Mississauga, Ontario

Prepared on behalf of the property owner

Date: April 17th, 2020

Prepared by: Serg Litvinov, B.Sc., ISA # ON-2281A
Consulting Arborist - Tree Doctors Inc.
SLitvinov@treedoctors.ca

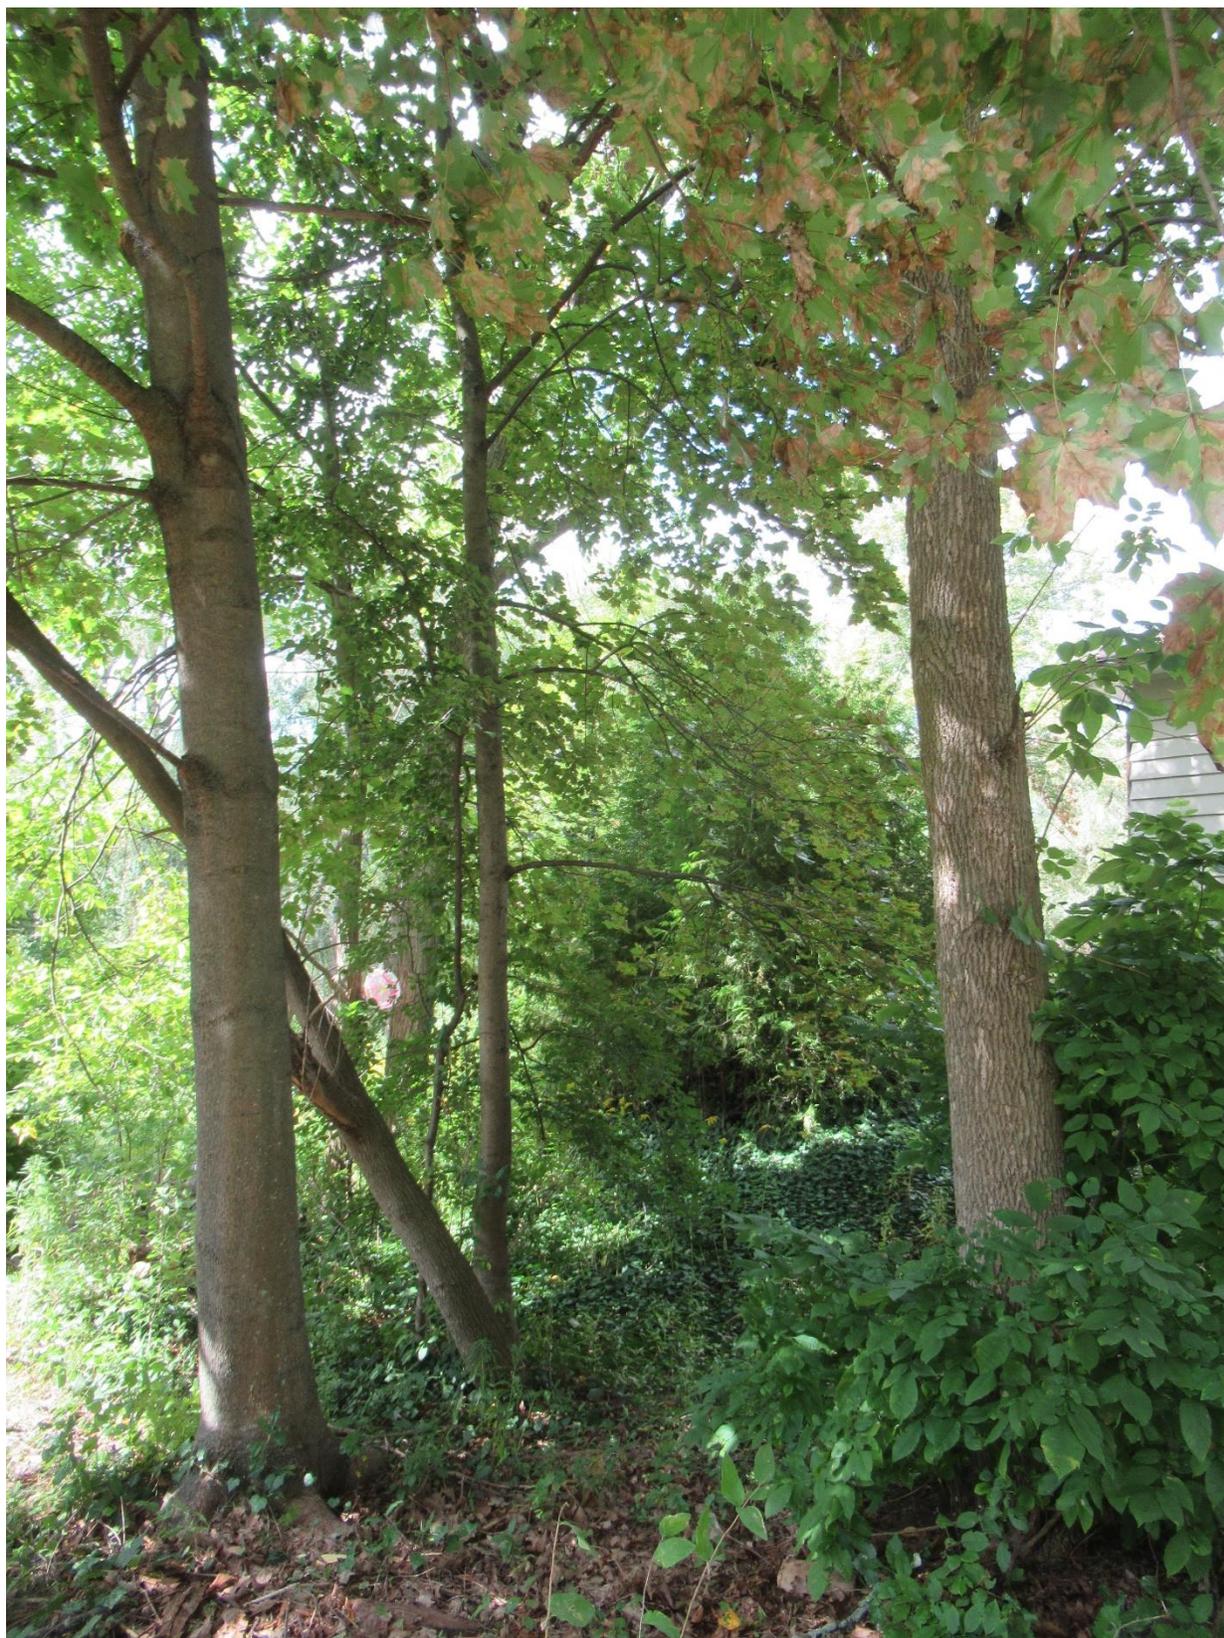
Picture 44: Tree #98-102

Tree #98 is a semi-mature Private tree in Good/Fair condition located on the road allowance to the property.

The tree has a few insignificant flaws such as minor/moderate amount of small diameter deadwood in the crown and raised crown, none of which are life threatening to the tree or potentially hazardous for its surroundings.

It is, overall, in exceptional condition for its species and age.

Tree #99 is a semi-mature Private tree in Good condition located on the road allowance to the property.

It has a few insignificant flaws such as minor/moderate amount of small diameter deadwood in the crown which is not a condition considered life threatening to the tree or potentially hazardous for its surroundings.

Tree #100 is a semi-mature Private tree in Fair condition located on the road allowance to the property. **The tree is infected with Emerald Ash Borer (EAB) and represents immediate danger to the surrounding environment.**

Tree #102 is a semi-mature Private tree in Good condition located on the road allowance to the property.

It has a few insignificant flaws due to being shaded by adjacent trees, however that is not a condition considered life threatening to the tree or potentially hazardous for its surroundings. It is, overall, in exceptional condition for its species and age.

The tree will require removal in order to allow for construction of proposed 6.5m wide road access. It is located directly within the footprints of the proposed road access and could not be retained. Pre-emptive removal of the tree is recommended.

Pre-emptive removal of the tree would remain recommended even in cases when the road access location or size are adjusted to preserve some of the trees on the property.

The tree will require removal due to its condition and in order to allow for construction of proposed 6.5m wide road access. It is located directly within the footprints of the proposed road access and could not be retained. Its removal is recommended.

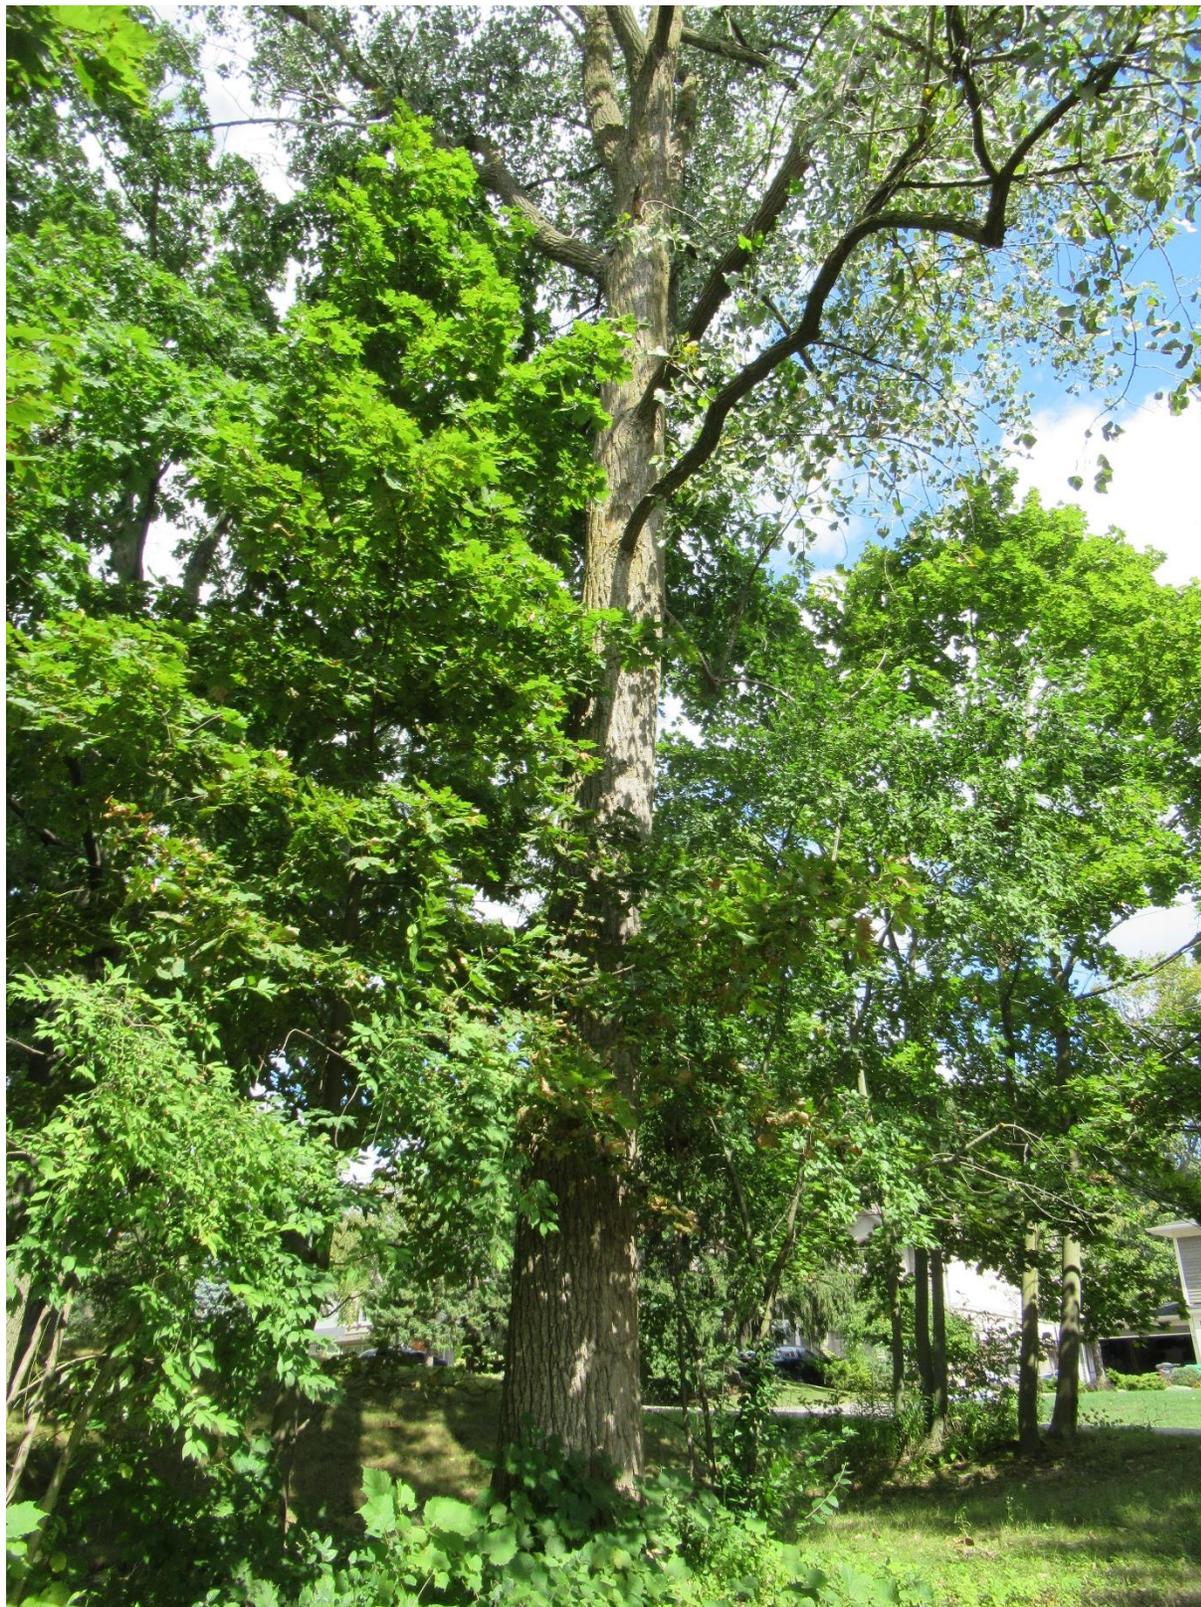
Picture 45: Tree #103

Tree #103 is a mature Private tree in Fair condition located on the road allowance to the property. It has a few flaws such as moderate amount of small diameter deadwood in the crown which is not a condition considered life threatening to the tree or potentially hazardous for its surroundings.

The tree will require removal in order to allow for construction of proposed 6.5m wide road access. It is located directly within the footprints of the proposed road access and could not be retained. Pre-emptive removal of the tree is recommended.
