Schedule B Class Environmental Assessment – Project File

**Applewood Creek Erosion Control Project –
Lakeview Golf Course**

A project file submitted by:
Aquafor Beech Ltd.

August 31st, 2020

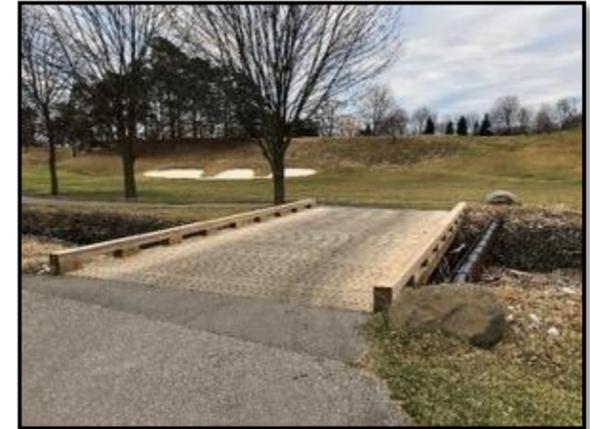
E. Bridge #8 in good condition with irrigation main in saddle.

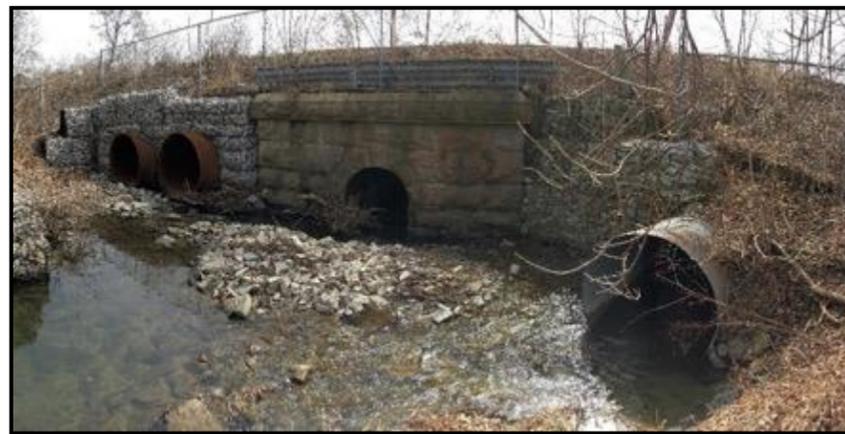
A. Downstream culverts under CN railway, with mixed headwall materials – historical brick and more recent gabion baskets.

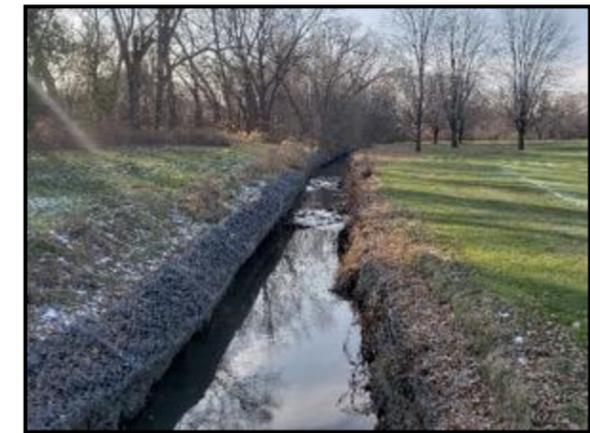
F. Deteriorated gabion baskets with top layer leaning towards the creek, posing safety risks to golf course users

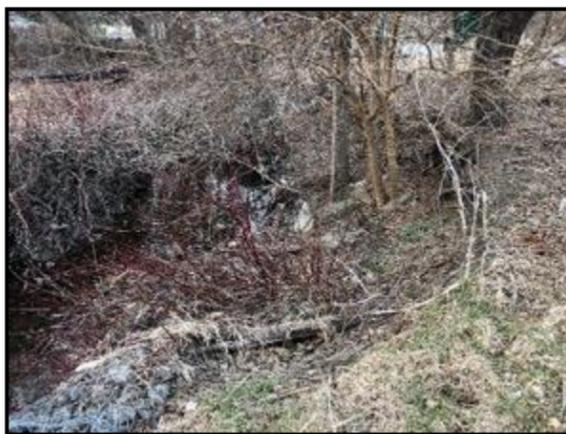
B1. Bank scour and planform adjustment due to failure of gabion baskets.

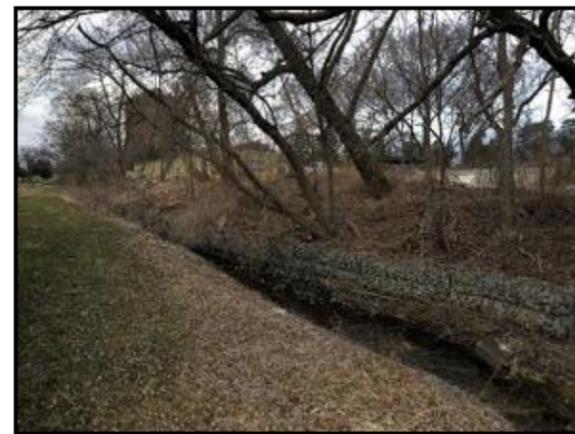
C. Failure of gabion and unstable slope undermining mature vegetation in proximity to maintenance building & parking

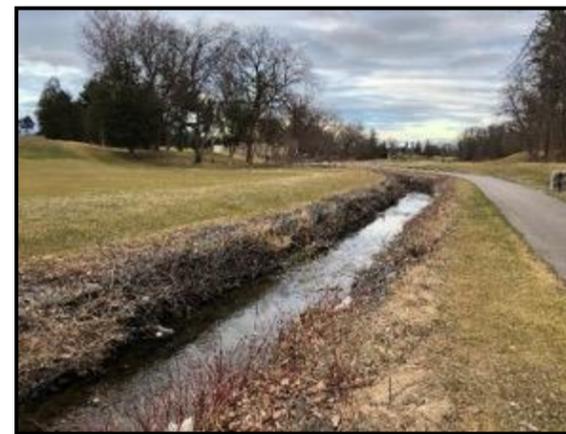
D. Creek in proximity to 12th fairway and 16th green. Constraints of limited space to form natural meanders.

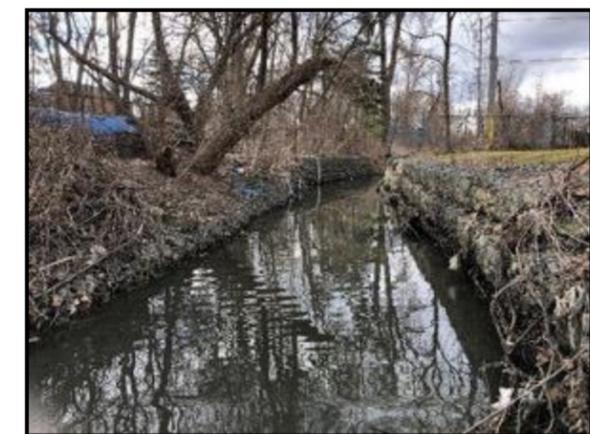
G. Applewood Creek at the upstream limit of the golf course, through a confined channel adjacent to Dixie Mall.

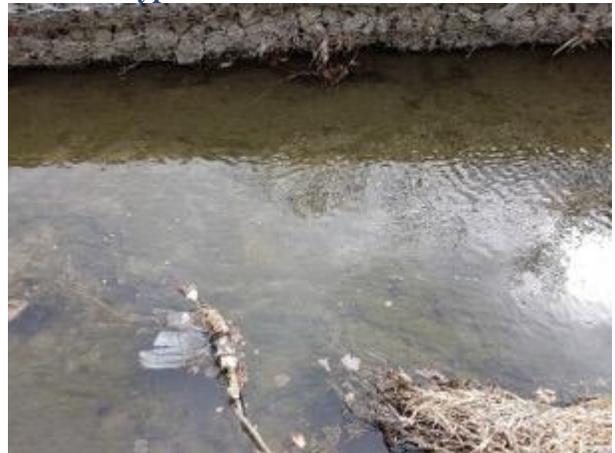
Photo 5. Failed Gabion Bank.

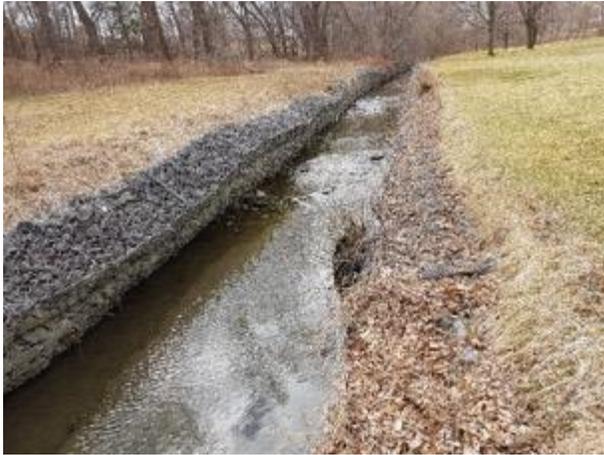
As discussed, nearly all of the banks consist of gabion baskets, all of which observed to be leaning at an angle of 45 degrees or greater. The gabion baskets exhibit undercutting, which presents an acute risk of failure (as shown in **Photo 9**). Some gabions have already failed as discussed above.

Photo 9. Failing Gabion Bank Protection.

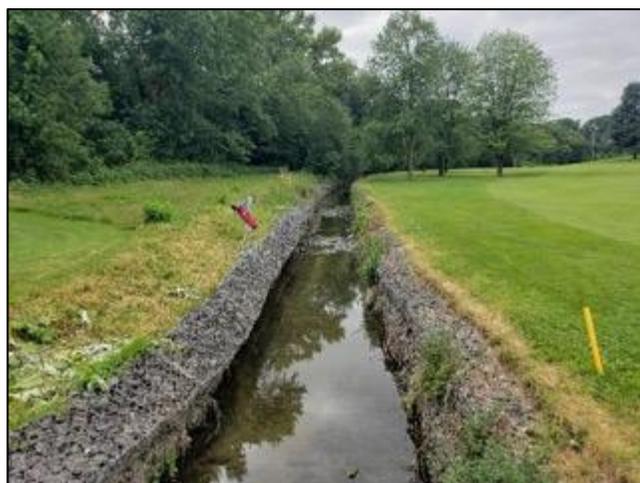
Figure 4-1. Existing Conditions of Applewood Creek with Failing Gabion Banks.

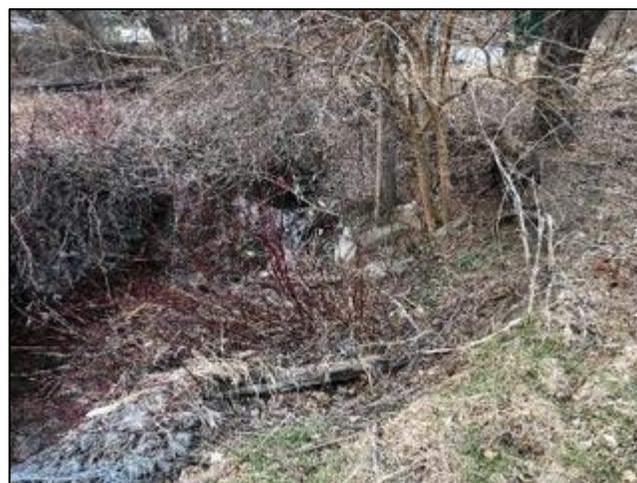
Figure 4-2. Bank Erosion and Loss of Tableland due to Gabion Basket Failure.

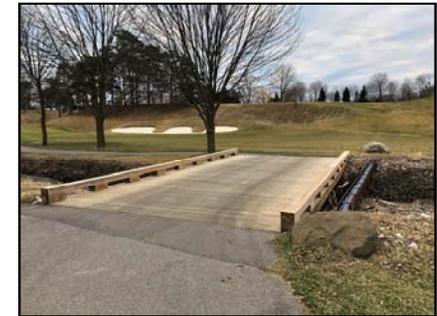
E. Bridge 8 in good condition with irrigation main in saddle.

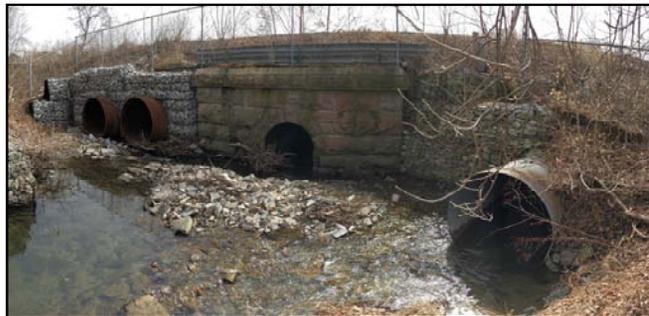
A. Downstream culverts under CN railway, with mixed headwall materials - historical brick and more recent gabion baskets.

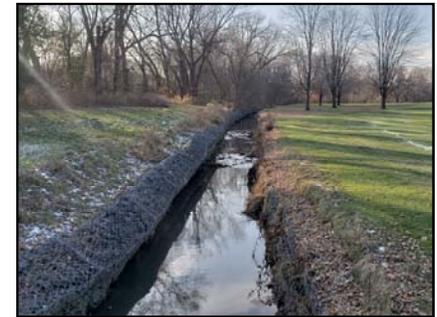
F. Deteriorated gabion baskets with top layer leaning towards the creek, posing safety risks to golf course users.

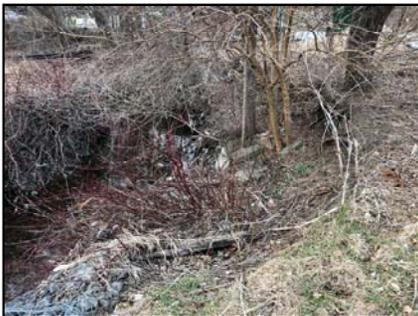
B. Bank scour and planform adjustment due to gabion basket failure.

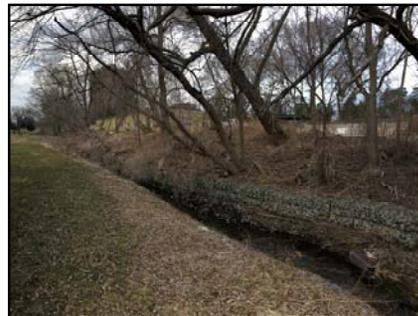
C. Failure of gabion baskets and unstable slope undermining mature vegetation in proximity to maintenance building & parking.

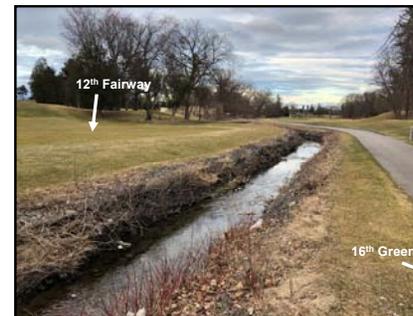
D. Creek in proximity to 12th fairway and 16th green. Constraints of limited space to form natural meanders without impacting golf course features.
