Appendix E **ARBORIST REPORT**

**Living Arts Drive Extension,
Mississauga, Ontario
Arborist Report**

165011016

November 20, 2017

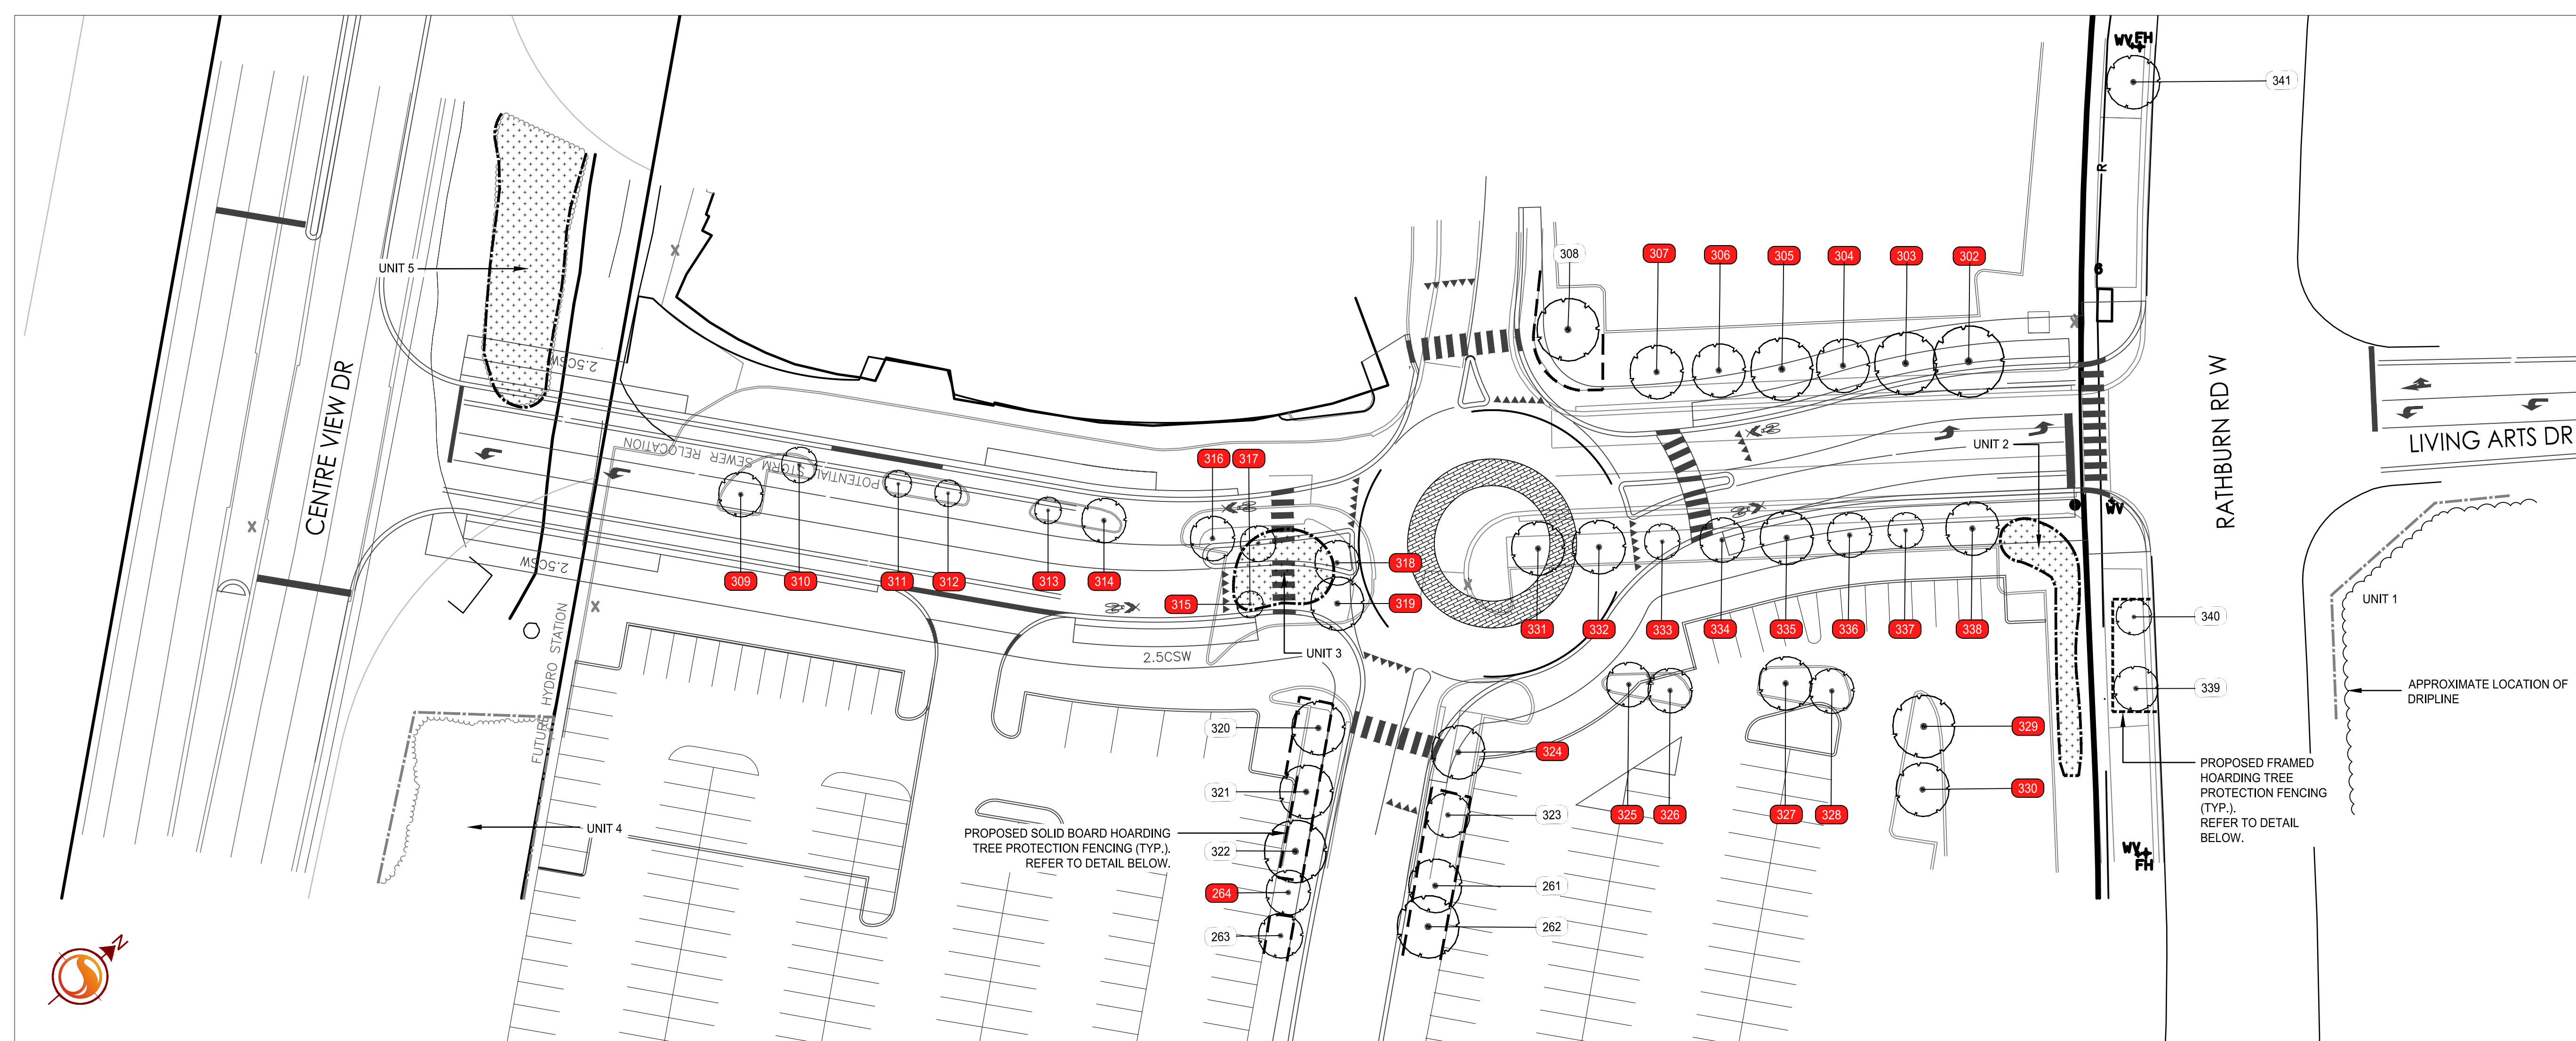
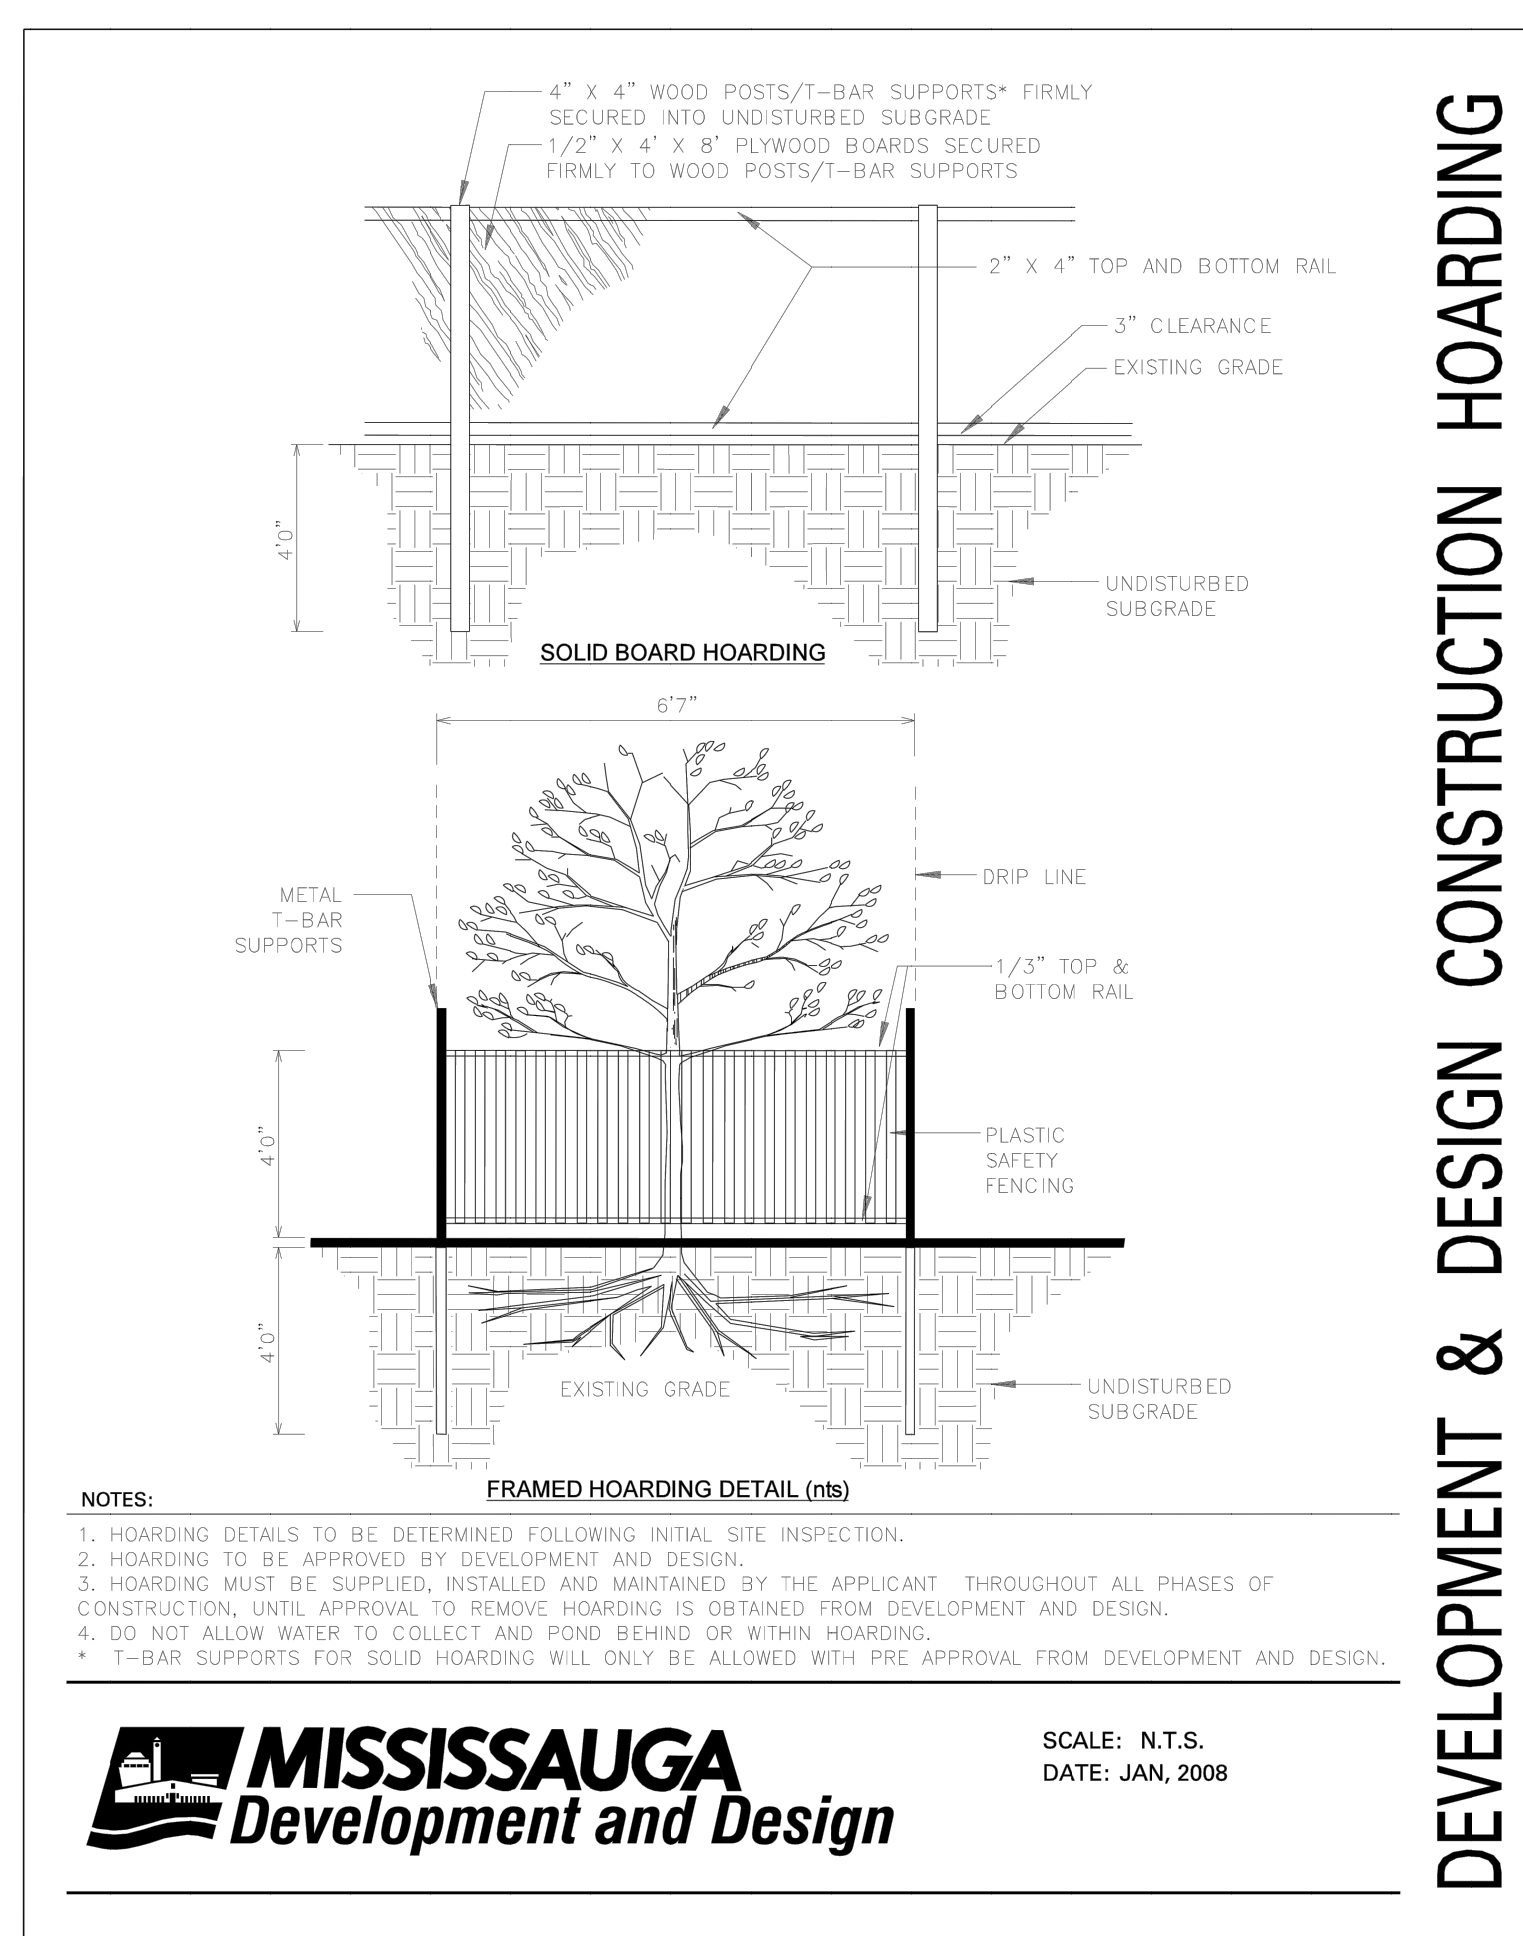
Trees locations have been provided through a legal survey provided by the City. The tree locations have been identified on the Tree Management Plan, Drawing L-900, located in Appendix 'A' along with the preliminary design. The tree data and locations were reviewed in conjunction with the preliminary project design to identify trees recommended for preservation or removal.

Proposed Tree Protection Fencing (TPF) has been identified on the Tree Management Plan (TMP) drawing to protect trees to be retained during construction. Sediment control may also be required depending on how close the trees to be preserved are to the construction area.

L-900 in Appendix 'A' for locations of the trees to be retained and proposed locations of Tree Protection Fencing.

1. Tree protection fencing shall be installed to protect trees identified for preservation. TPF installation must conform to details and City of Mississauga Development and Design Construction Hoarding standards identified on drawing L-900 located in Appendix 'A'. Upon installation of the tree protection fencing, the Contractor shall contact the Project Arborist to review and approve the fencing and its location prior to commencement of any site work. This shall be coordinated with City staff for approval. The protection fencing shall remain intact throughout the entire protection. The fencing will be inspected weekly and, if required, repaired. The fencing shall be removed at the completion of all site works.
