## **HANCOCK PROPERTY (NURSERY) - 2151 CAMILLA ROAD, MISSISSAUGA**

# **Building Condition Report**

**Report Number:** 09-1113-6182(5001)

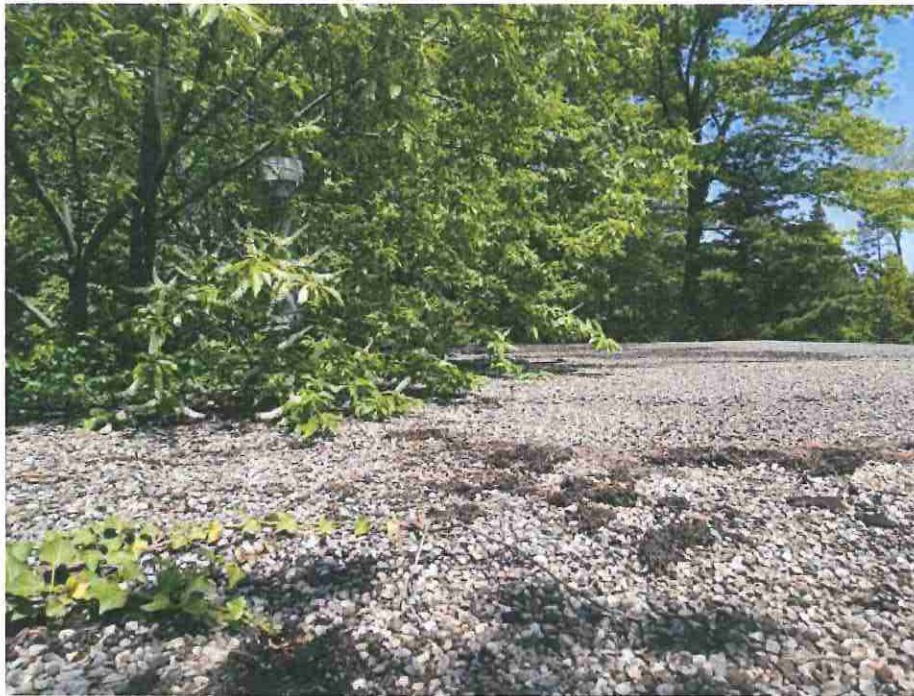
**Photograph 3:** Recently replaced conventional built-up roofing assembly over Bldg. 1.

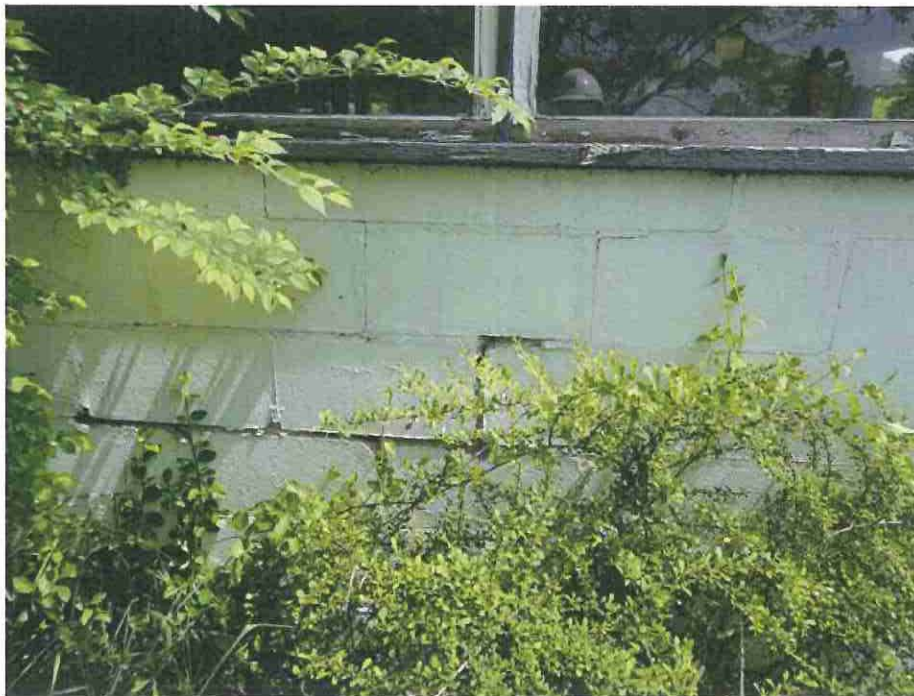
**2B)** Exterior exposed portions of wall had signs of step cracking in mortar joints and missing mortar. The associated cost to repair cracked and missing mortar joints in concrete block walls is included in our Capital Table.

**Photograph 4:** Stepped crack through the concrete block retaining wall on the southwest elevation of Bldg. 1.

2.1 Bldg.1 Office - Concrete block wall repair (\$2,200)

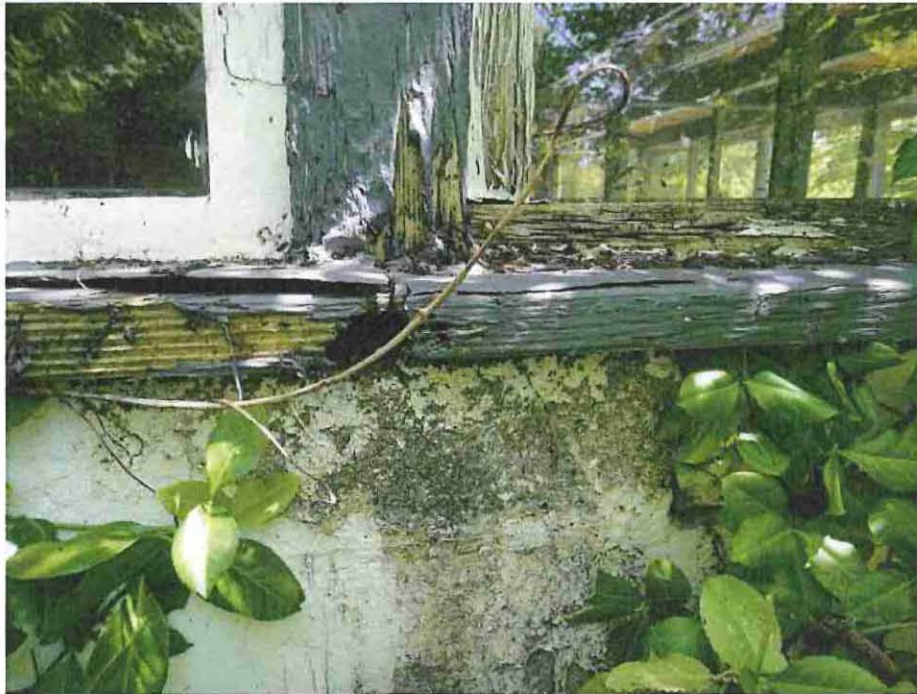
Photograph 5: Deteriorated and damaged wood window frames at Bldg. 1.

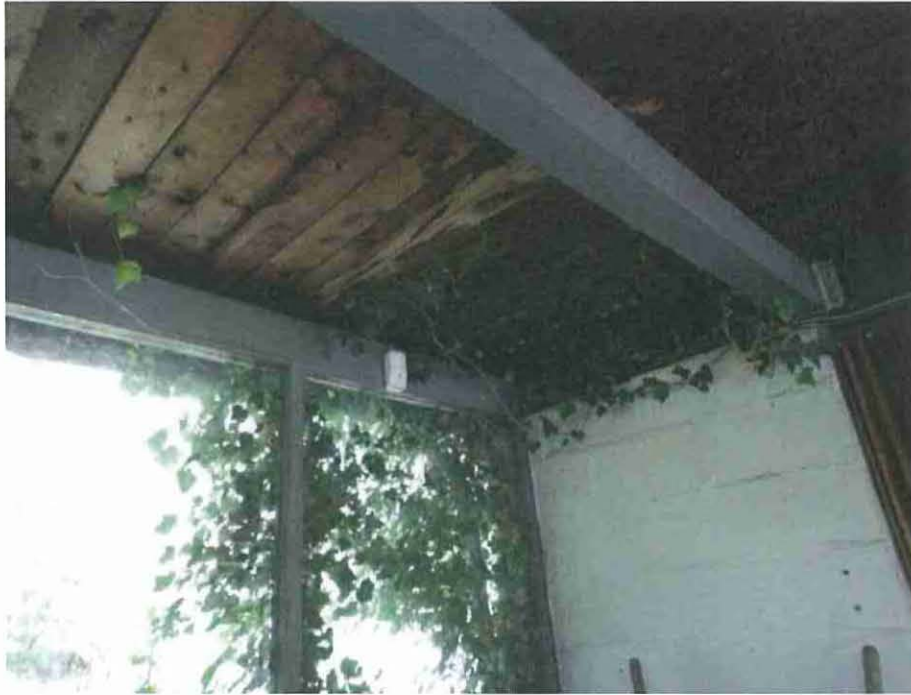
**3A)** Evidence of previous leakage is observed on the interior wood decking at the perimeter and on the northeast concrete block wall of Bldg. 1 (see photograph 7). The Point of Contact reported that the built-up roof was recently replaced. Further monitoring is recommended. Localized roof repairs can be performed at a cost less than the Capital Threshold.

**Photograph 7:** Vegetation growing into the interior and along the stained wood strip decking of Bldg. 1.

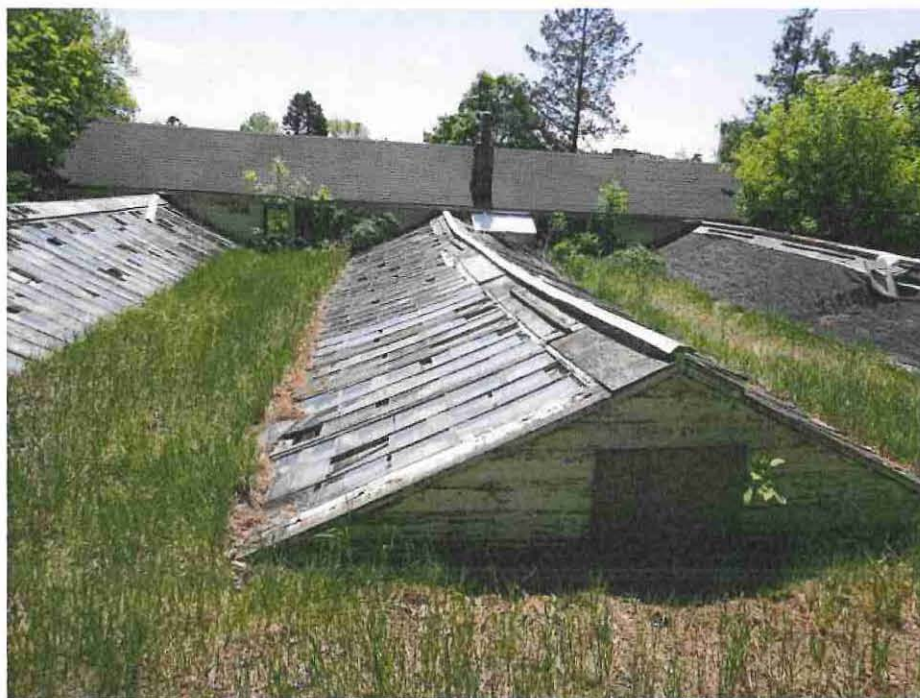
Minor curling of the asphalt shingles is observed over the Header House of Bldg. 2. In addition, there are numerous damaged, cracked and missing glass tiles over the three Greenhouses. There is also evidence of ongoing leaks at the northeast wall of the Header House where the Greenhouses are attached. Complete removal of the glass tiles and roof structure of the three greenhouses are required. See Section 2.2 – **Structure (Bldg. 2)** for more details. The future plans for the Greenhouses are unknown and therefore based on the recommendations outlined in the Landplan Historical Report, the cost for replacement of the Greenhouse Roofs is not included in the Capital Table.

**Photograph 14:** General view of the Greenhouses attached to the north side of Bldg. 2.

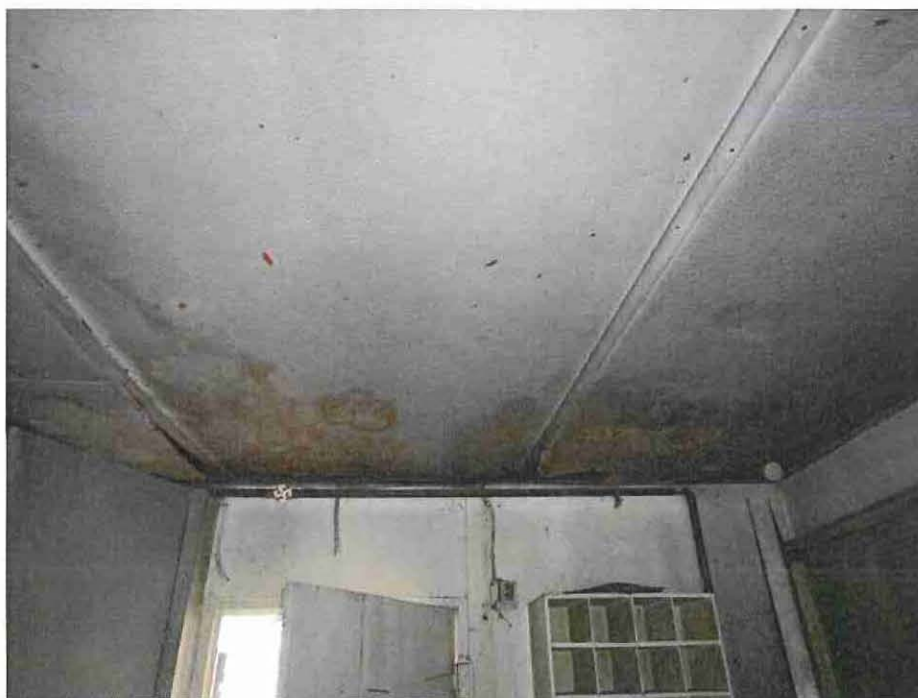
**Photograph 18:** Deteriorated and damaged ceiling panels over the entrance to the Greenhouses in Bldg. 2.

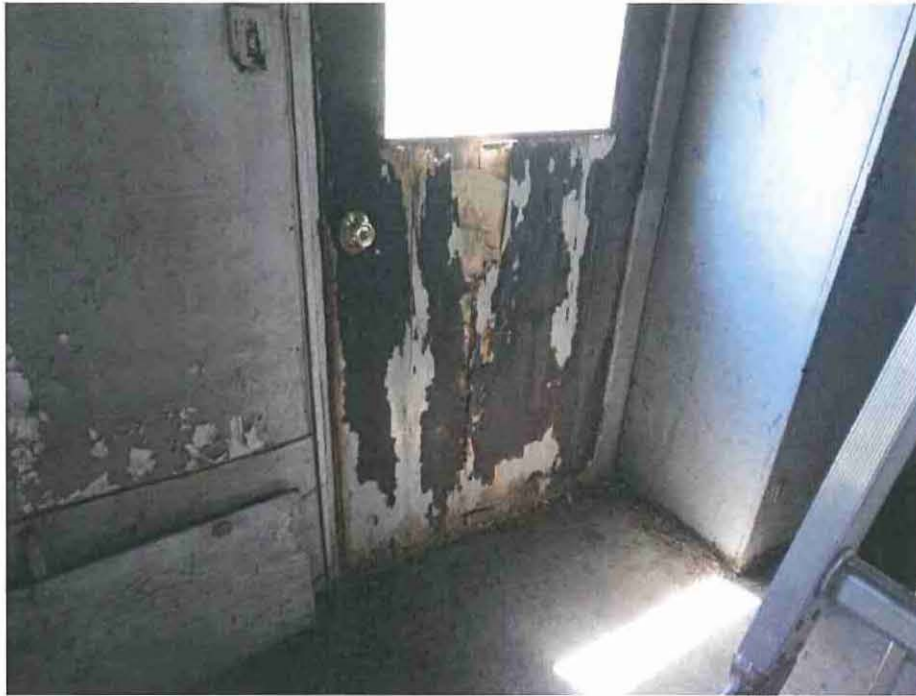
Photograph 19: Deteriorated and damaged wood door in Bldg. 2.

4.3 Bldg. 2 Header House - Replace/repair wood doors at the header house (\$2,000)

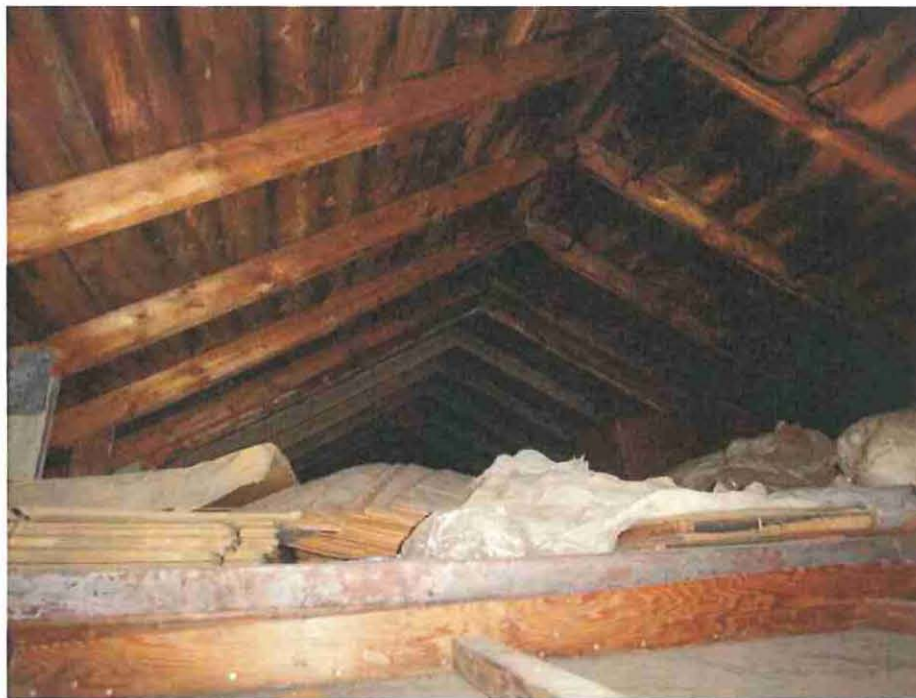
Roof	Greenhouses wood framed glass skylights. Header House wood plank deck supported by wood framed roof rafters (see photograph 20).	Greenhouse wood framed glass skylights have collapsed in sections and are deteriorated beyond repair. See Notes 2B and 2C.

**2C)** Header House some water staining identified on underside of roof deck and from the exterior one area of the roof deck appears to have deflected. Further review of the roof deck in the Header House is required in the area that appeared deflected.

Photograph 20: General view of the wood rafter and plank deck over Bldg. 2.

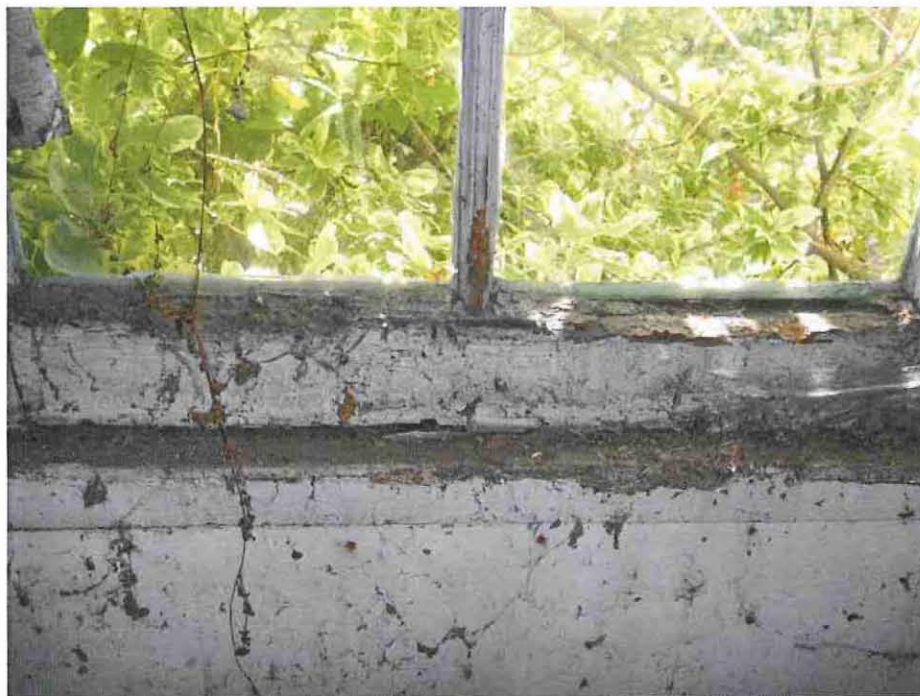
Photograph 21: Deteriorated wood framed windows at Bldg. 2.

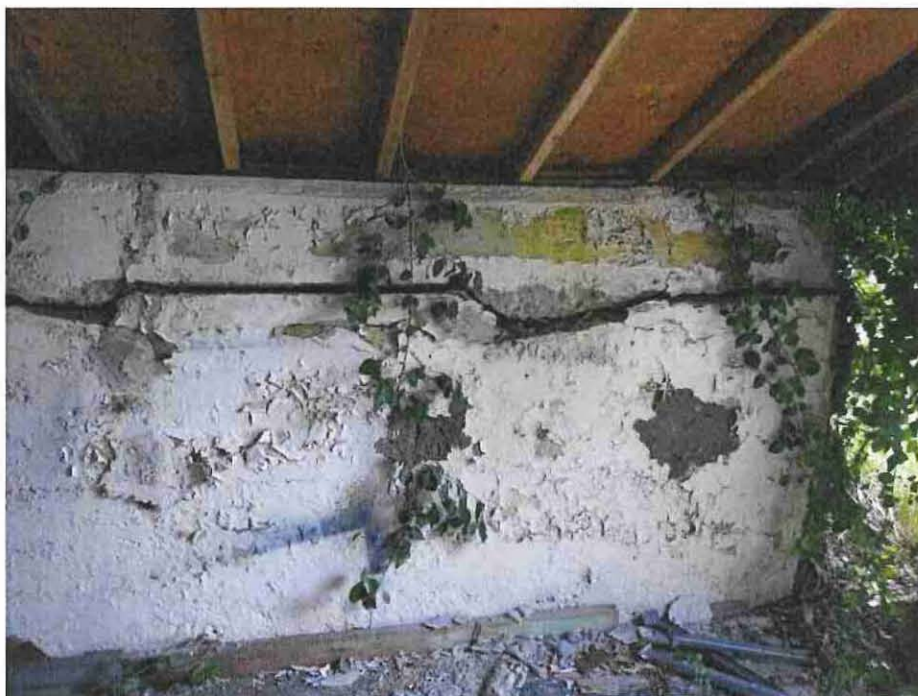
**2A)** Cast in place concrete wall is cracked, visibly deflected and is in a state of collapse. Wall is beyond repair and building is recommended to be demolished. Foundation work (excavation and new cast-in-place reinforced concrete) is costly due to the backfill height surrounding the garage. The associated costs for complete demolition and reconstruction including the contractor's labour and materials for a new garage in the same location as the existing are included in the Capital Table.

**Photograph 29:** Cracked and displaced concrete foundation wall in Bldg. 3.
