Heritage Advisory Committee
OCT 22 2013

Long Branch Outdoor Rifle Range

Cultural Heritage Assessment

Re: Heritage Facilities Restoration and Repairs Report – Benares Estate

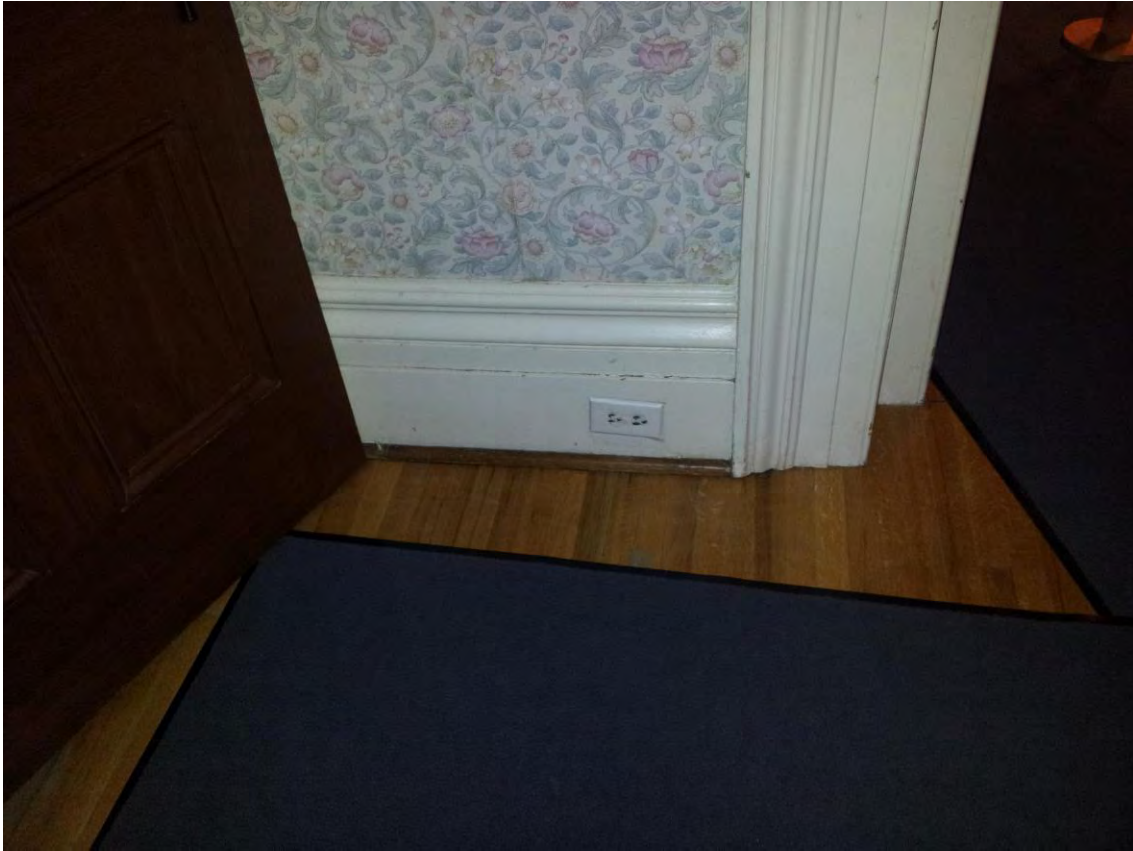
much like original would have looked, and is in relatively good condition. The intention now is to remove the upper layer of wood flooring on the Ground Floor, exposing the original plank flooring and have it repaired and restored to match upstairs. The condition of the grand staircase appears to be in good shape. It has also not been covered up similar to upstairs and appears to be generally good condition. It will be determined during the restoration of the Ground Floor whether the stairs would be restored in a similar manner.

5.2.2. Main House – Sample of deterioration and wear of upper layer of wood floor finish.

- 3.1 Main House – The existing upper wood flooring on the Ground Floor is to be carefully removed, so as to minimize disturbance of original plank floor below, in an inconspicuous location to determine if the original plank flooring remains and to what condition. Once it is determined that the course of action described above can be achieved, the remainder of upper wood flooring layer is to be carefully removed, taking care around any features along any perimeter point. A review of the final conditions at mechanical equipment, floor grilles, baseboard and all trims will be performed on site with the Contractor and City Staff to determine proper procedure and process at these locations. The condition of the wood stairs is to be reviewed once a portion of the carpet runner has been carefully removed exposed to determine next course of action. Once the upper layer of flooring has been removed, the original wood plank flooring will be repaired and restored to the finish and colour of the original 2nd floor wood flooring.

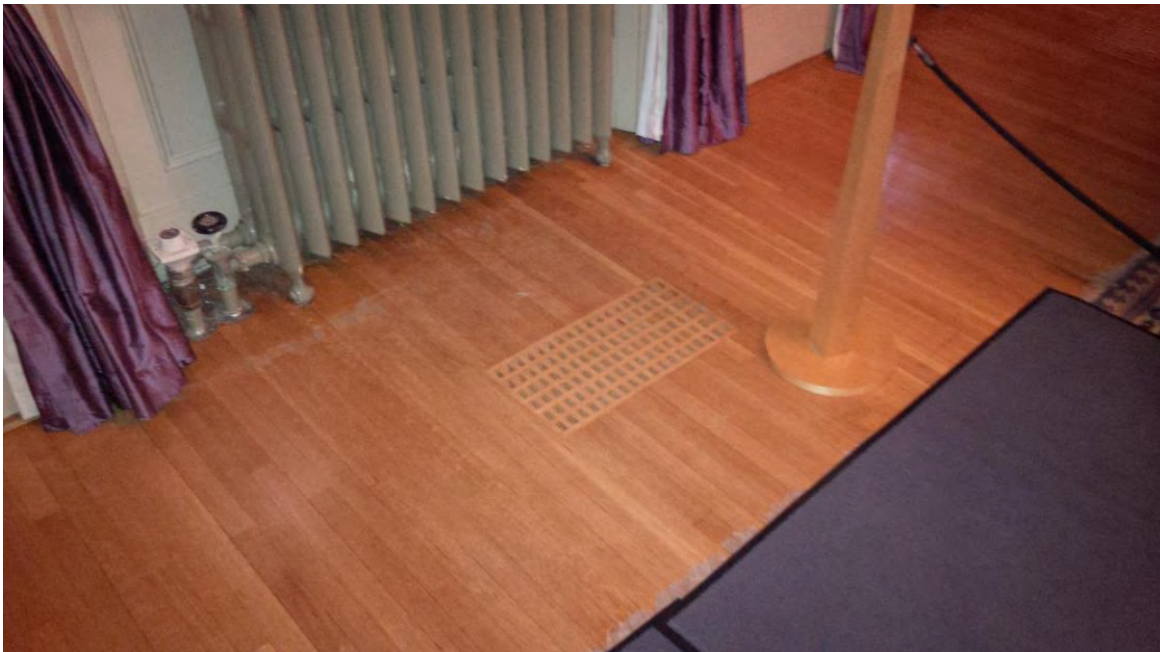
5.2.3. Main House – Sample of deterioration and wear of upper layer of wood floor finish.

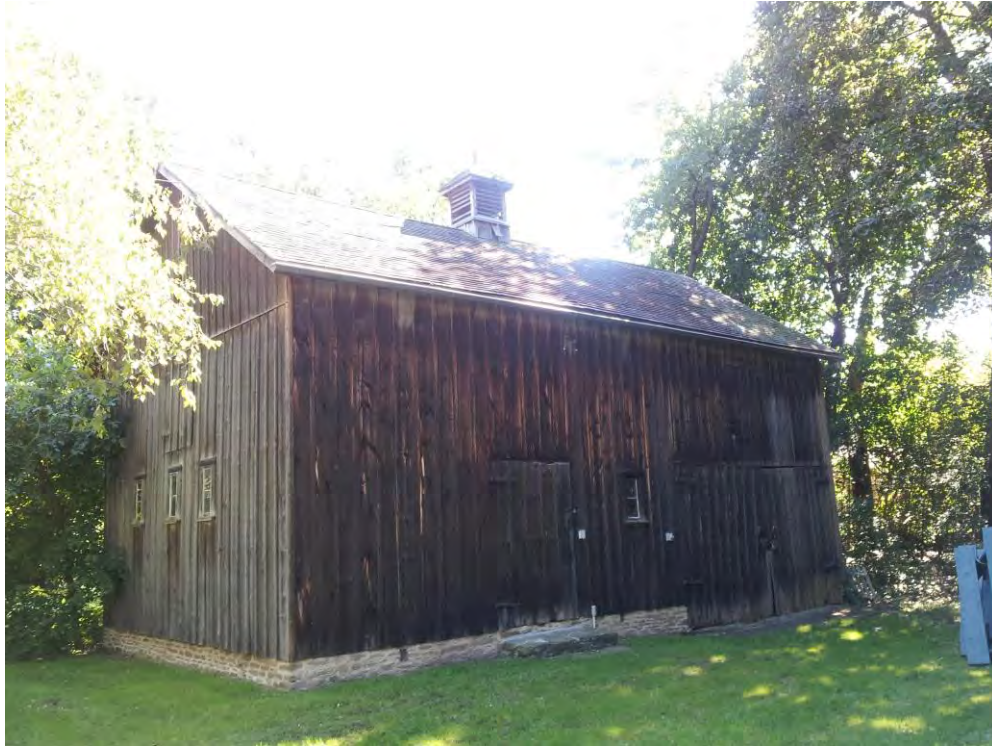
- 2.2 Dairy House – Access to the inside of the Dairy House was not possible as the lock has been seized up and not able to open. In reviewing the exterior structure, the existing cedar shingles appear to be distressed and in need of replacement. The condition of the underlying sheathing boards is not know at this time, as is the condition of the wood roof framing, and would therefore need to be reviewed either during the construction, or prior if possible.

5.2.6. Dairy House – Sample of deterioration and weathering of cedar shingles and fascia boards.

- 3.2 Dairy House – Once access to the inside of the Dairy House is provided, a review of the conditions of the roof structure can proceed. The exterior cedar shingles is to be removed including all trims. The existing board sheathing and fascia boards will be reviewed to determine the extent of repairs and or replacement that is required. New cedar shingles, to match style and appearance of existing, is to be installed including new moisture membranes, ventilation sleepers and flashings per specifications.

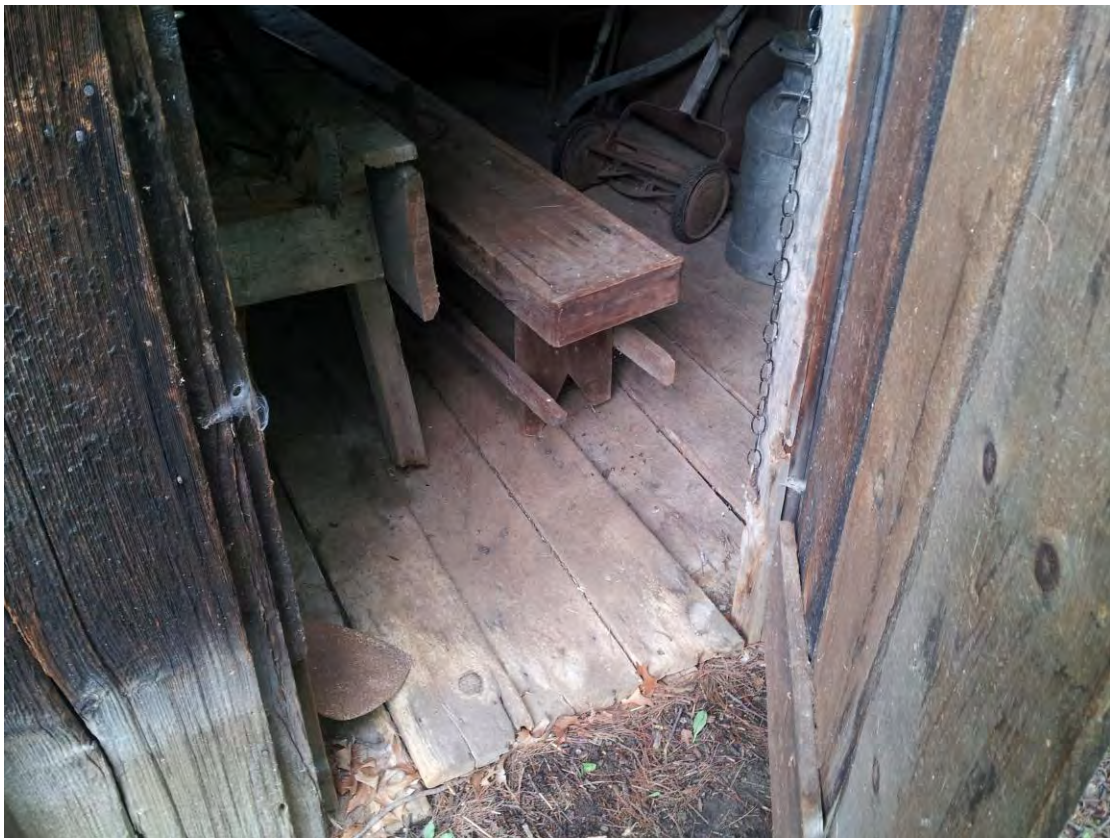
- 2.3 Barn – Upon visual inspection of the interior public spaces of the Barn, it was reviewed that some of the floor boards have deterioration, separation and a need for replacement to maintain a safe environment for the public and City Staff. It was discussed with City Staff that the boards being removed from the Bradley Museum restoration work can be milled for possible replacement at the Benares Barn and Shed.

5.2.9. Typical example of deterioration and wear of Barn and Potting Shed floor boards.

- 3.3 Barn – A review and inventory of existing boards that are deteriorating and in need of repair and / or replacement will be performed prior and during early stages of removal. Once boards have been identified and removed, the condition of the underlying presumed earth will be reviewed and extent of repair and preventative maintenance will take place. It is recommended that a lean concrete mix ‘mud mat’ to help prevent further movement and minimize moisture migration. Existing floor boards are to be modified and re-installed where possible, with excess material coming from milling board material salvaged from the Bradley Museum works.
- 4.4 Potting Shed – Repairs and restoration will be of similar nature and procedures as the Barn above.

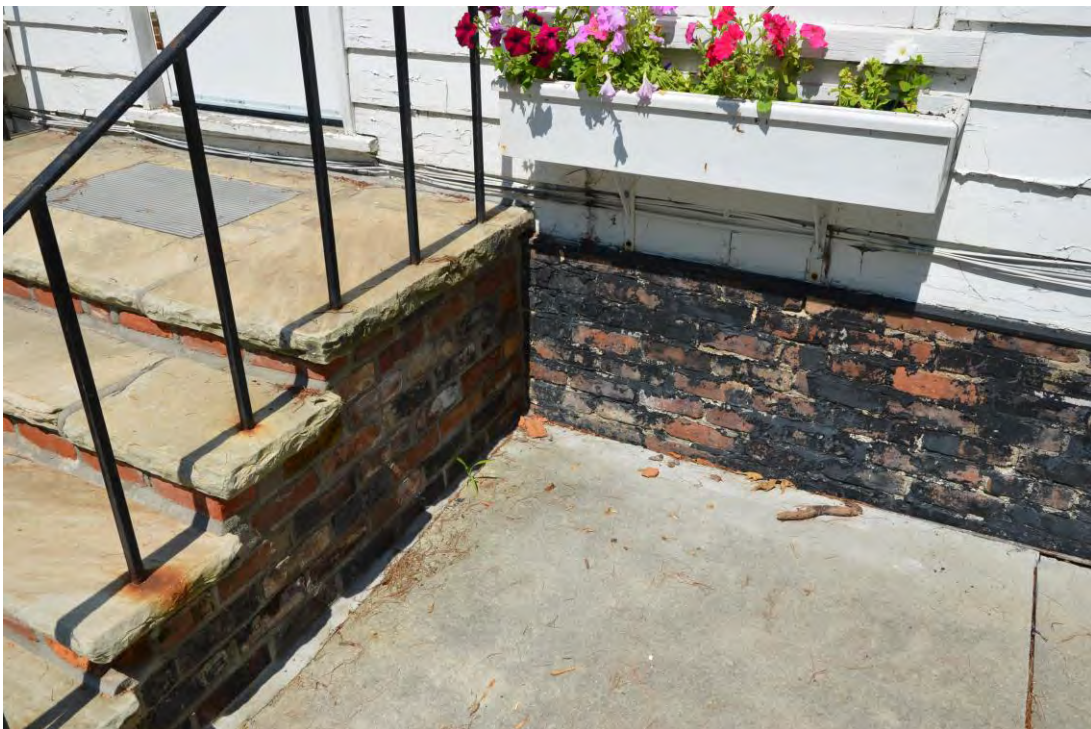
5.2.1. North Building Elevation – Sample of existing window well condition, foundation wall, and existing stair.

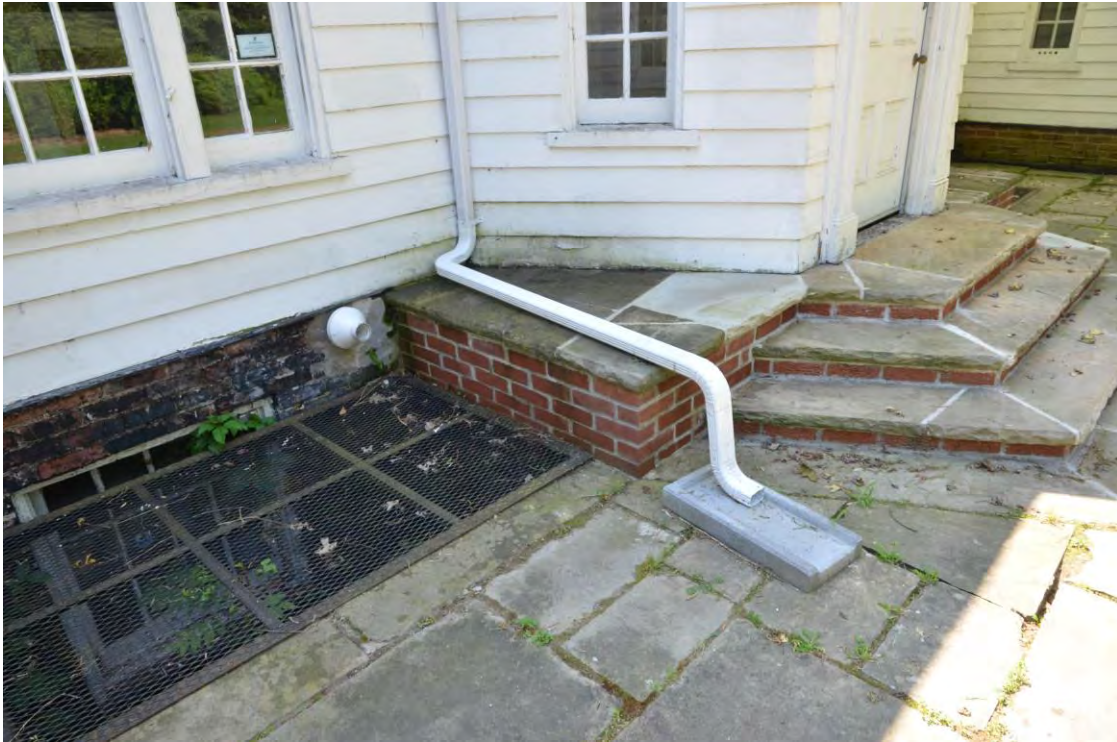
5.2.2. North Building Elevation – existing conditions of foundation wall and entrance stairs.

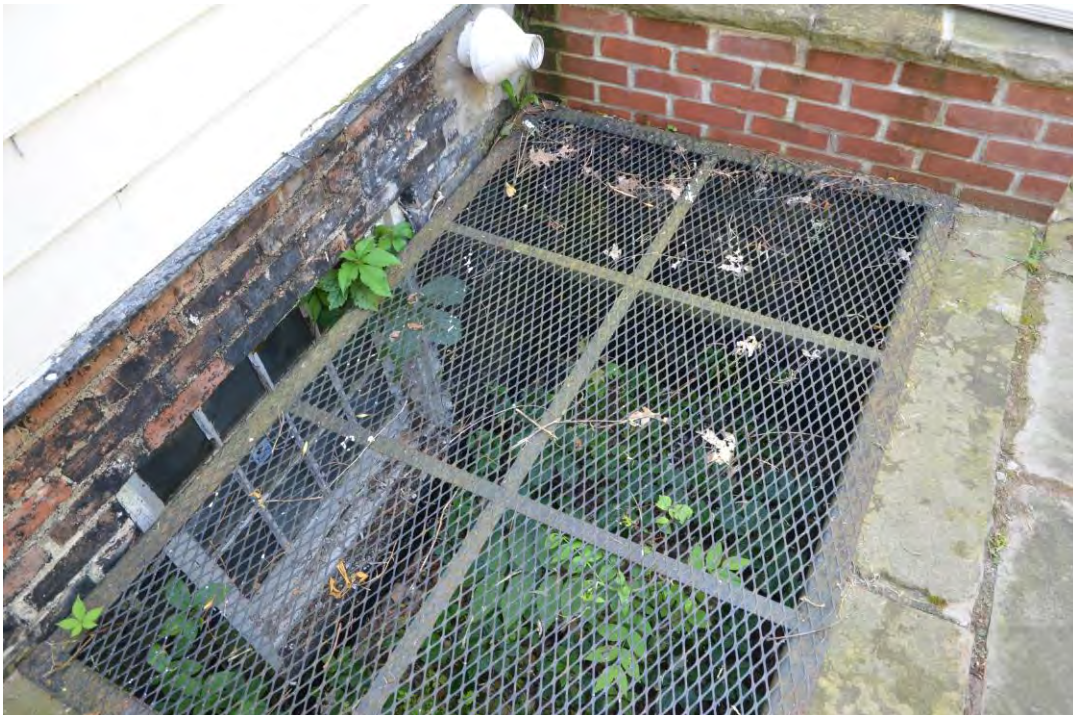
5.2.3. South Building Elevation – Newly reconstructed stairs, foundation and existing window well conditions.

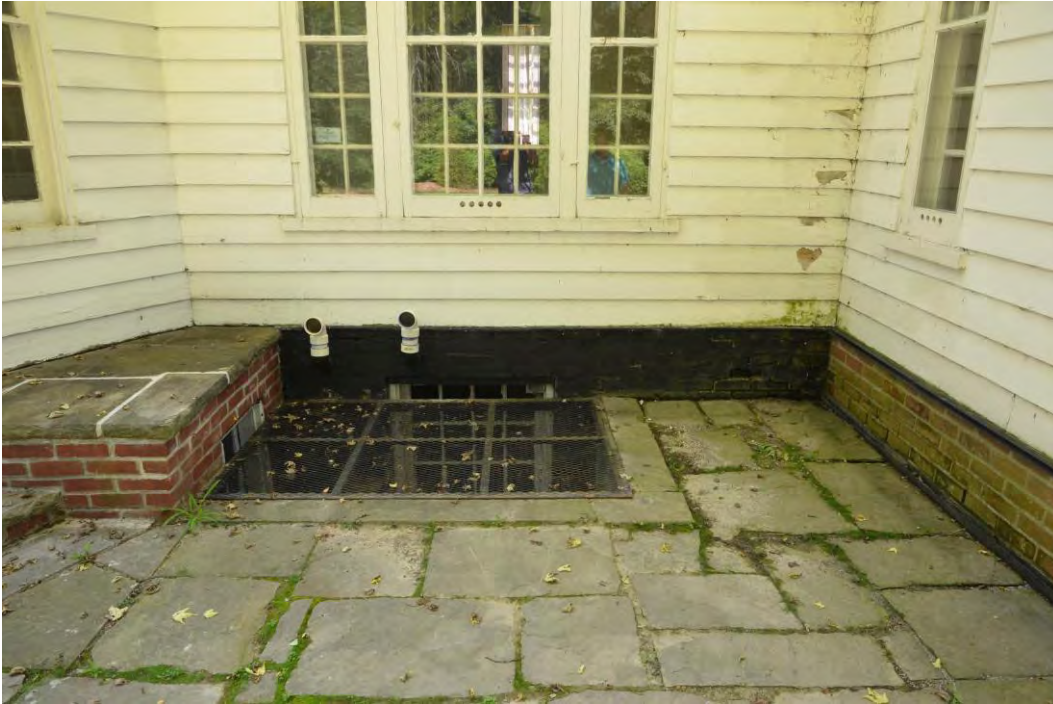
5.2.4. South Building Elevation – Detail sample of existing condition of window well.

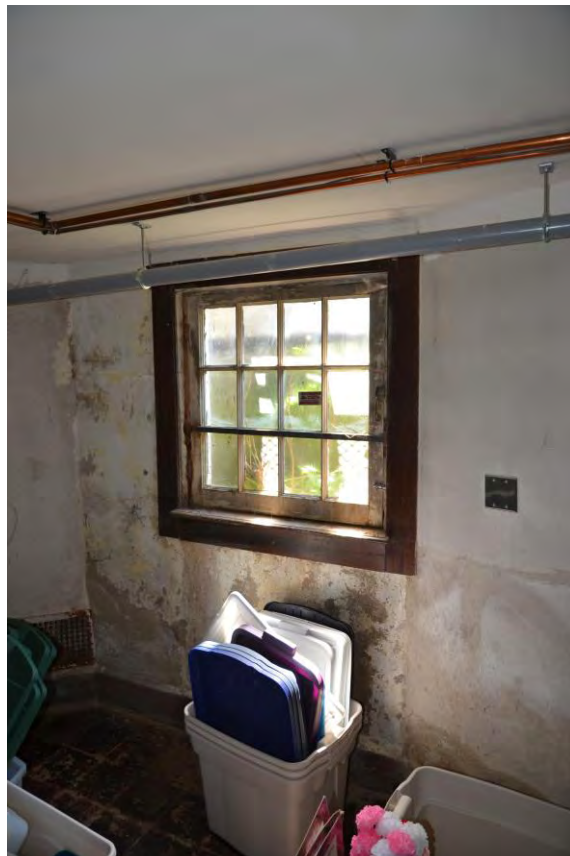
5.2.5. South Building Elevation – Sample of existing foundation wall and window well conditions.

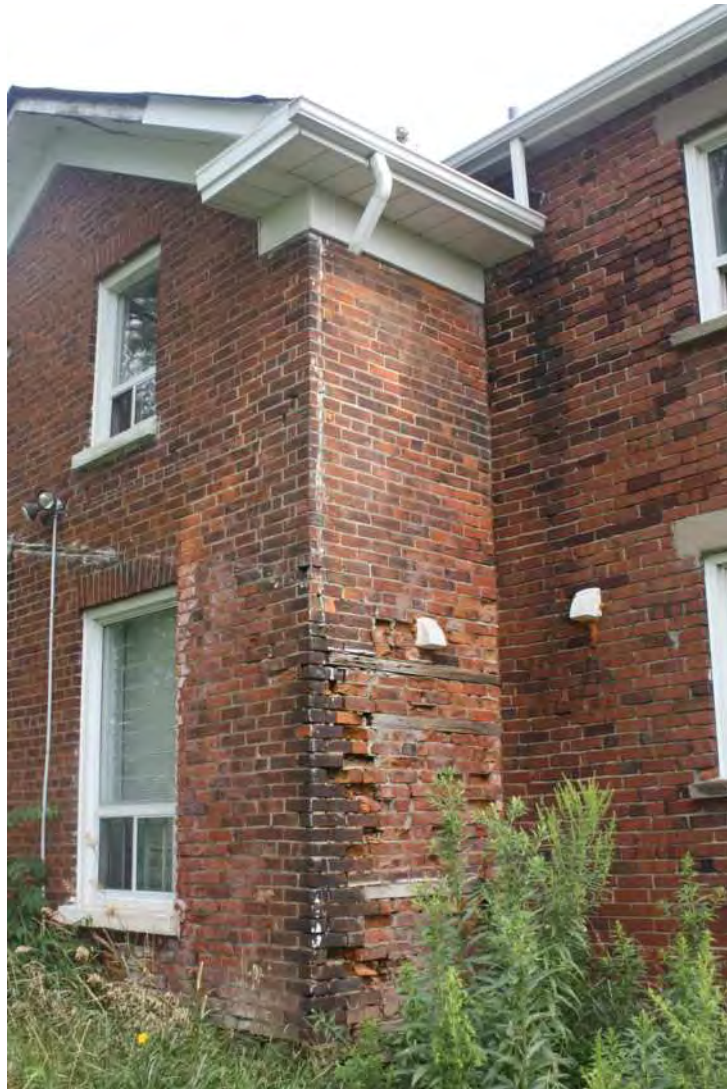
the building has suffered serious deterioration in recent years (figure 28).

*Figure 29 Deteriorating brickwork at the southwest corner of the original farmhouse, 2013
(Photo by author.)*

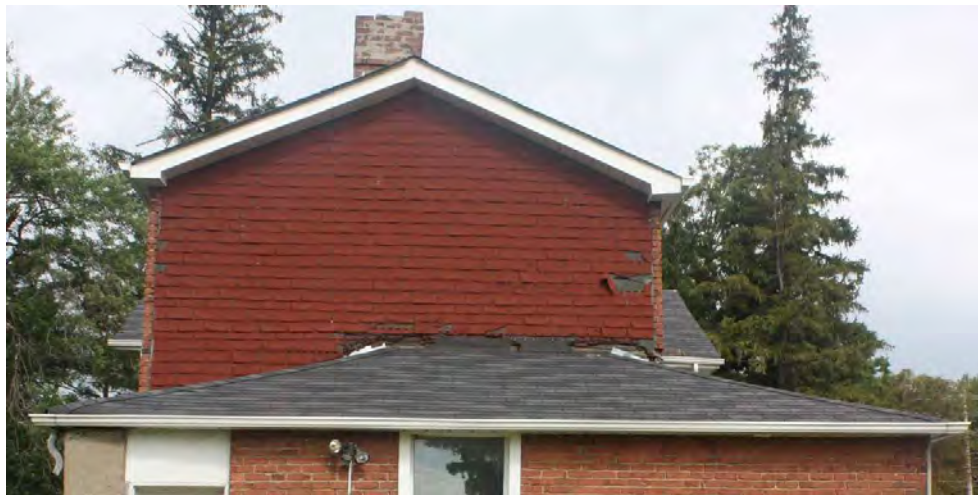
shingling which has suffered substantial deterioration. The brick chimney servicing the addition

Figure 33 The south elevation of the two storey extension, 2013 (Photo by author.)

also shows signs of deterioration.

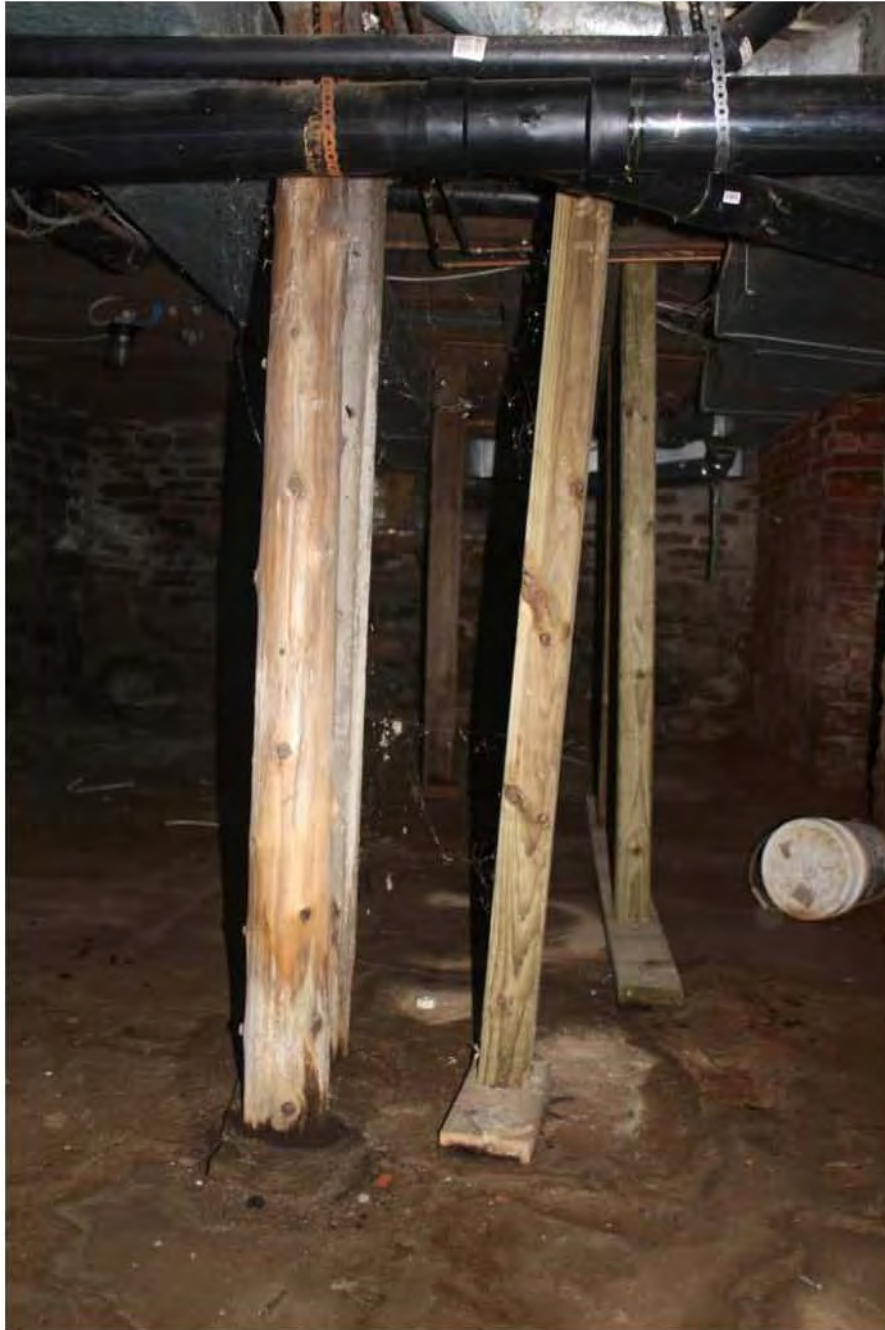
Significant flooding occurred in the basement in 2010 and timbers have been introduced to stabilize the building.²⁵ There is also an interior brick wall in the basement of the original farmhouse, part of which has collapsed or been removed. The structural integrity of the

Figure 50 timber supports in the basement of the original farmhouse, 2013 (Photo by author.)

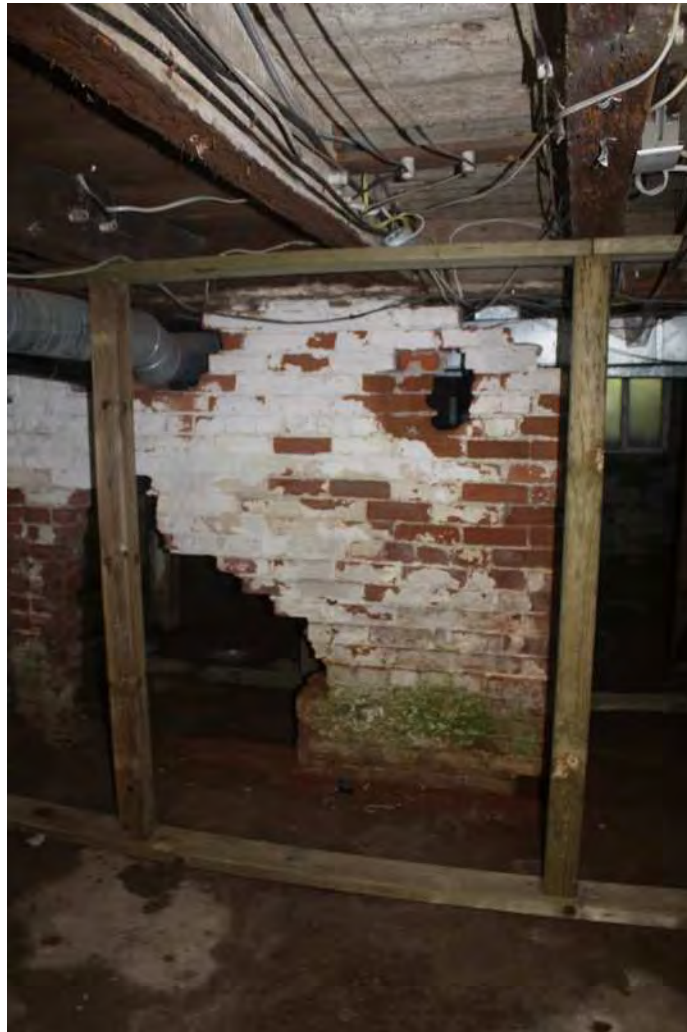
Figure 51 A gap in the interior basement wall of the original farmhouse and supporting timbers, 2013 (Photo by author.)

farmhouse and its addition may have been compromised by this water damage, but an engineering study would be required to determine this. There is visual evidence, shown above, of recent stabilizing efforts .
