Heritage Conservation Management Plan
William Barber House
5155 Mississauga Road, Mississauga

**Heritage Conservation Management Plan
William Barber House
5155 Mississauga Road, Mississauga**

Date:	September 21, 2016	No. of Pages:	9 + Encl.
Project:	Barber House	Project No.:	TE-28594-16
Address:	5155 Mississauga Road, Mississauga	Permit No.:	n/a
Client:	City Park (Streetsville) Inc.		
Dist.:	Owen Scott John Beresford	CHC Limited Flanagan Beresford & Patteson	oscott87 @rogers.com johnb@fbparch.com

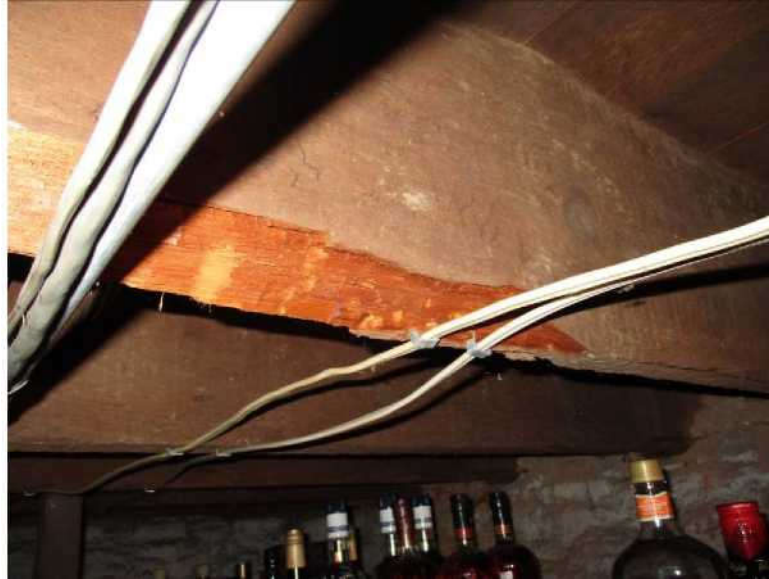
Figure 1: Deteriorated floor framing

Limited areas of the main floor framing appear to have sustained some deterioration, likely due to moisture exposure.

The floor joist shown in Figure 1 can be found below the central hallway. It is estimated that between 5 and 10 of these joists will require some form of remedial work. The majority of the basement ceiling has been fire-rated and as such the framing was not visible at the time of the review. A more comprehensive review of the floor framing should be carried out during any proposed renovation design work.

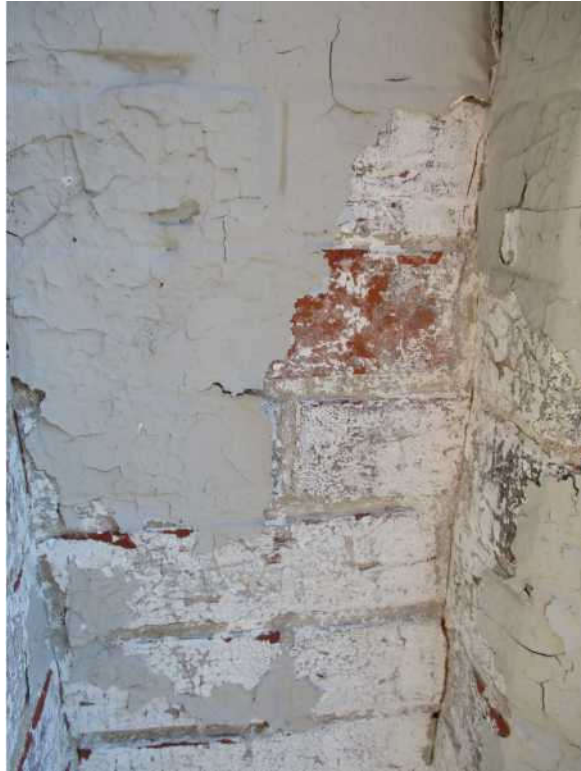
Figure 2: Exterior coatings

The outermost coating is very thick and has flaked off in many locations, most notably at interior corners or other locations more prone to moisture accumulation. The coatings exposed below are in varying states of decay, and have deteriorated to a form of powder, possible lime, in some locations. Where exposed below the coatings, the brick was found to be extremely soft.

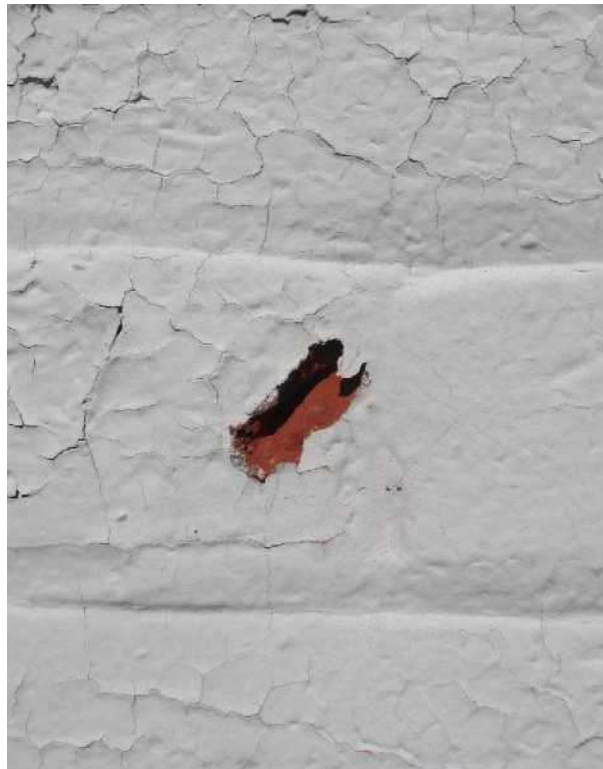
Figure 3: Soft brick exposed below coatings

It was possible to scrape a depression of up to deep into the brick with a screwdriver and moderate pressure.

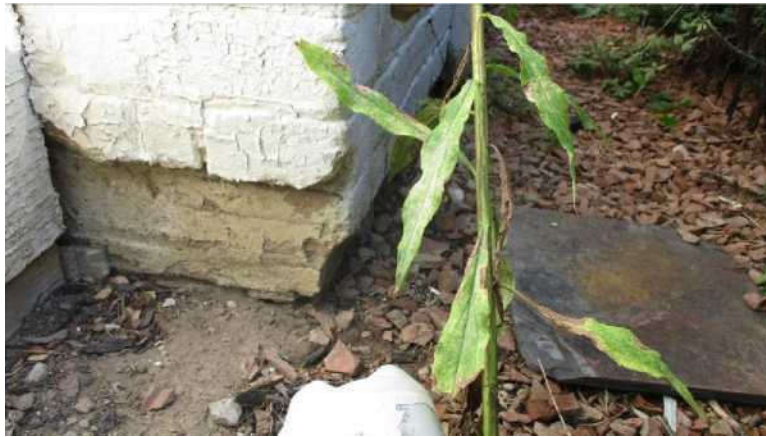
Figure 4: Deteriorated coatings near grade

Coatings at or near grade are showing signs of more advanced deterioration, particularly where the wall is sheltered by gardens.

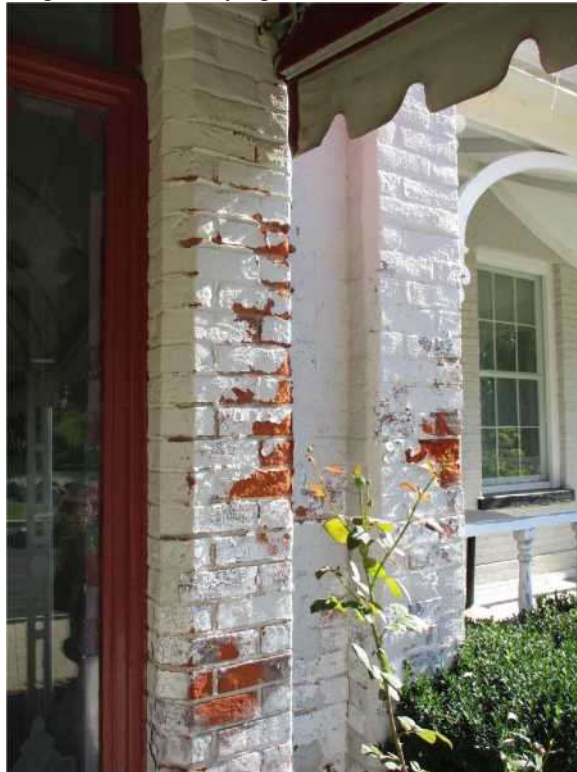
Figure 5: Deterioration on south side of entry canopy

Advanced deterioration of the coatings and the underlying brick was noted on the south side of the entry canopy.

It appears that the concentration of run-off from the canopy has resulted in saturation of the brick at this location, and the loss of coatings has lead to advanced deterioration of the brick.

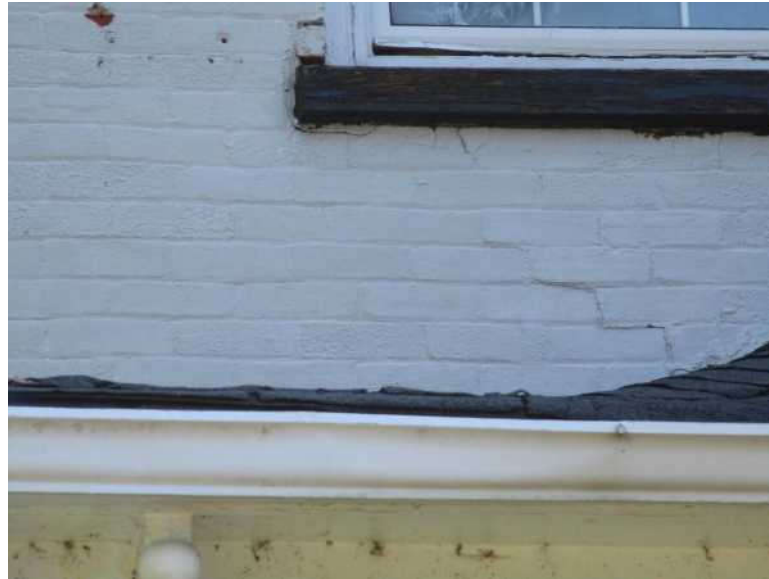
Figure 7: Step cracking below second storey window

A step crack was noted on the front elevation below the second storey north window. The presence of the coatings precludes comment on the extent or width of the crack.
