Heritage Conservation Management Plan
William Barber House
5155 Mississauga Road, Mississauga

**Heritage Conservation Management Plan
William Barber House
5155 Mississauga Road, Mississauga**

Date:	March 21, 2016	No. of Pages:	9 + Encl.
Project:	Barber House	Project No.:	TE-28594-16
Address:	5155 Mississauga Road, Mississauga	Permit No.:	n/a
Client:	City Park (Streetsville) Inc.		
Dist.:	Owen Scott John Beresford	CHC Limited Flanagan Beresford & Patteson	oscott87@rogers.com johnb@fbparch.com

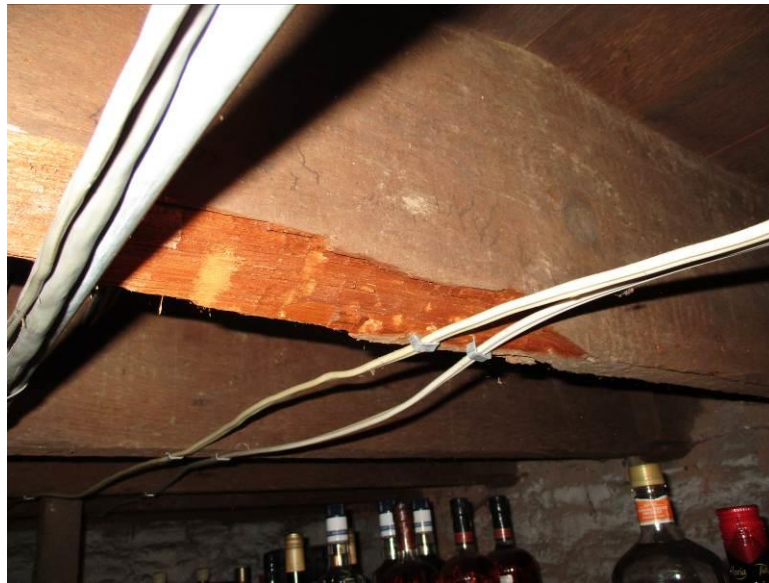
Figure 1: Deteriorated floor framing

Limited areas of the main floor framing appear to have sustained some deterioration, likely due to moisture exposure.

The floor joist shown in Figure 1 can be found below the central hallway. It is estimated that between 5 and 10 of these joists will require some form of remedial work. The majority of the basement ceiling has been fire-rated and as such the framing was not visible at the time of the review. A more comprehensive review of the floor framing should be carried out during any proposed renovation design work.

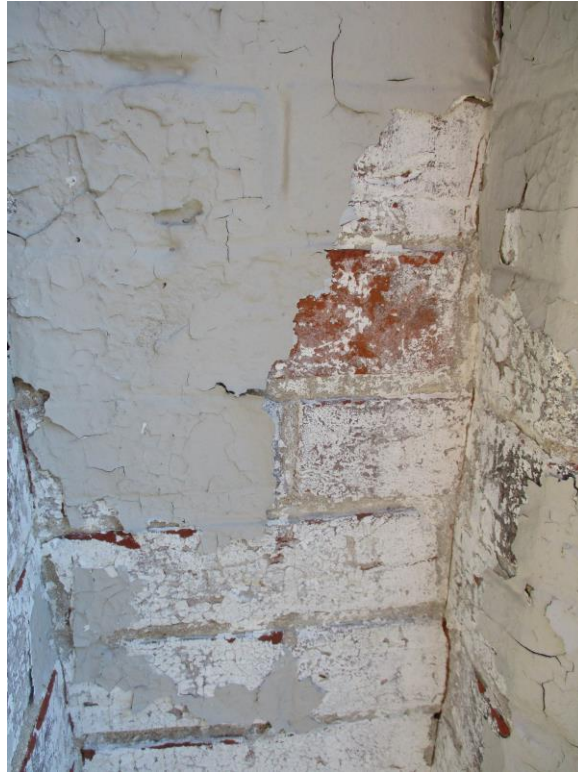
Figure 2: Exterior coatings

The brick has been coated with at least two (2) different coatings. Remnants of a third coating were visible, and it is possible that this lowest layer is a composite of a repeated lime wash, known to have been applied to other buildings of a similar vintage and construction.

The outermost coating is very thick and has flaked off in many locations, most notably at interior corners or other locations more prone to moisture accumulation. The coatings exposed below are in varying states of decay, and have deteriorated to a form of powder, possible lime, in some locations. Where exposed below the coatings, the brick was found to be extremely soft.

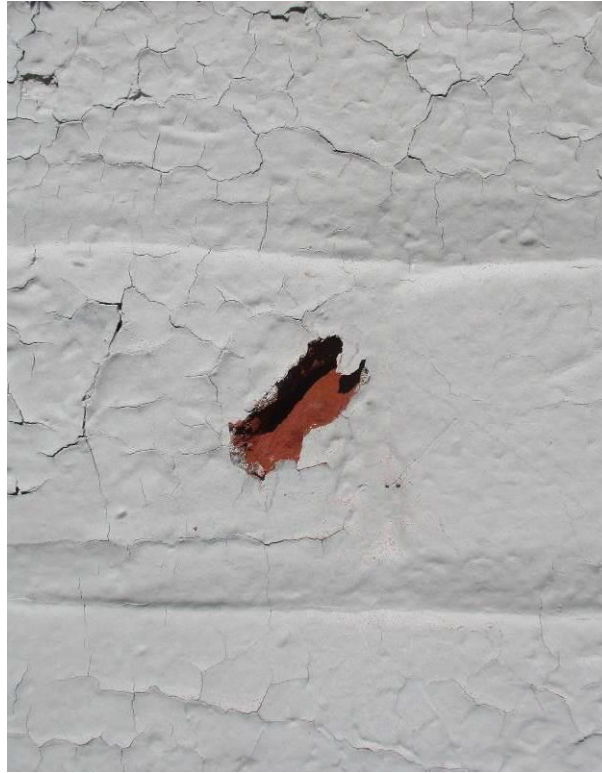
Figure 3: Soft brick exposed below coatings

It was possible to scrape a depression of up to $\frac{3}{4}$ " deep into the brick with a screwdriver and moderate pressure.

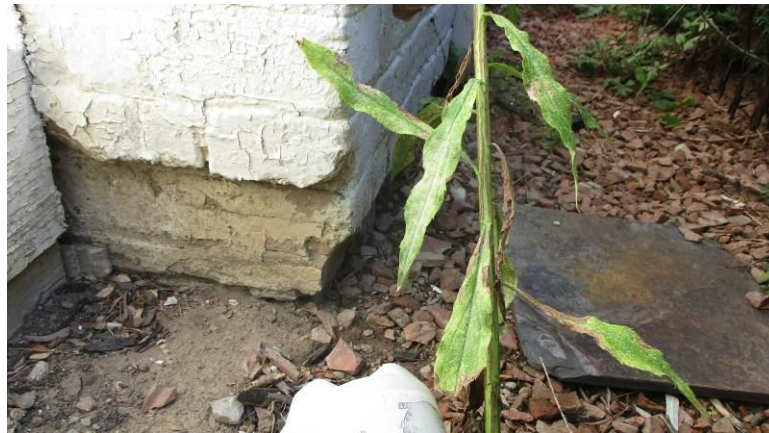
Figure 4: Deteriorated coatings near grade

Coatings at or near grade are showing signs of more advanced deterioration, particularly where the wall is sheltered by gardens.

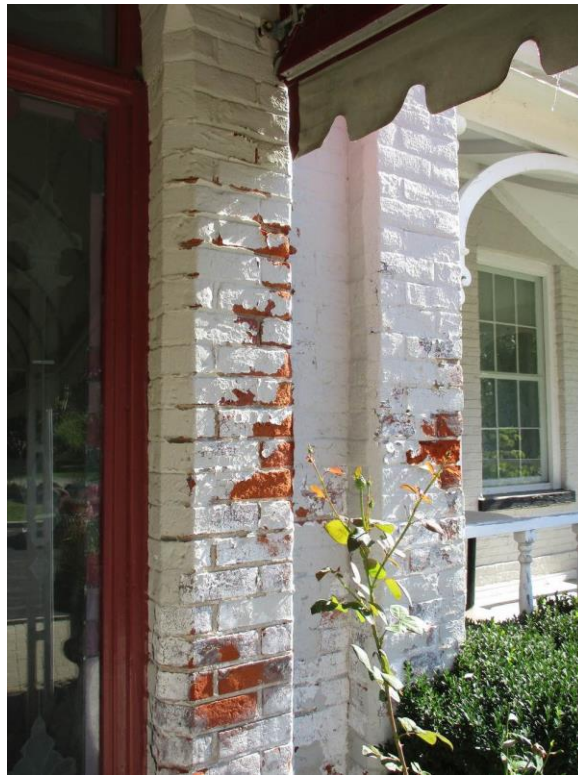
Figure 5: Deterioration on south side of entry canopy

Advanced deterioration of the coatings and the underlying brick was noted on the south side of the entry canopy.

It appears that the concentration of run-off from the canopy has resulted in saturation of the brick at this location, and the loss of coatings has lead to advanced deterioration of the brick.

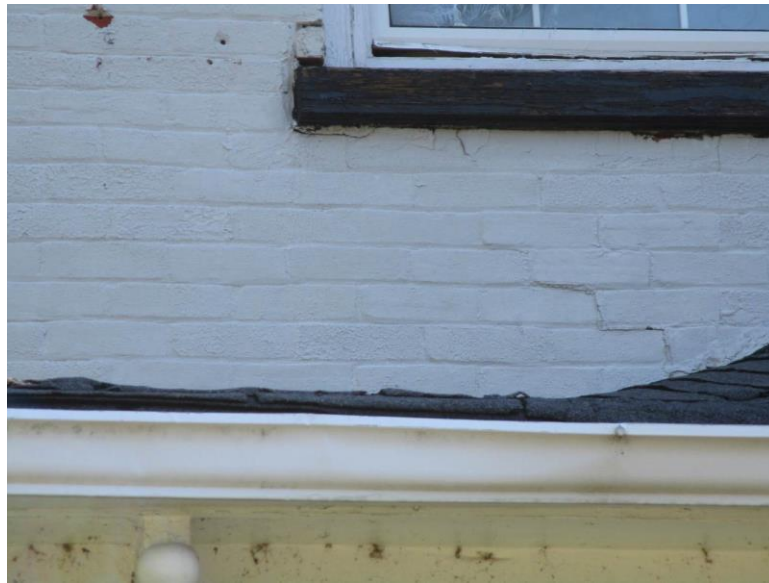
Figure 7: Step cracking below second storey window

A step crack was noted on the front elevation below the second storey north window. The presence of the coatings precludes comment on the extent or width of the crack.
