**Heritage Conservation Management Plan**  
**William Barber House**  
**5155 Mississauga Road, Mississauga**

A residential development is proposed for the William Barber House property at 5155 Mississauga Road in Mississauga that includes the removal of later additions to the building and restoration of the exterior. Prepared by Owen R. Scott, CAHP of CHC Limited and John Beresford, OAA of Flanagan, Beresford, Patteson Architects Inc., with technical input from Tacoma Engineers Inc., this Heritage Conservation Management Plan is for the property which is designated<sup>1</sup> under Part IV of the *Ontario Heritage Act* and is located in the Mississauga Scenic Road Cultural Landscape<sup>2</sup>.

Tacoma Engineers has been retained by City Park (Streetsville) Inc. to carry out a review of the existing conditions at the Barber House located at 5155 Mississauga Road in Mississauga, Ontario.

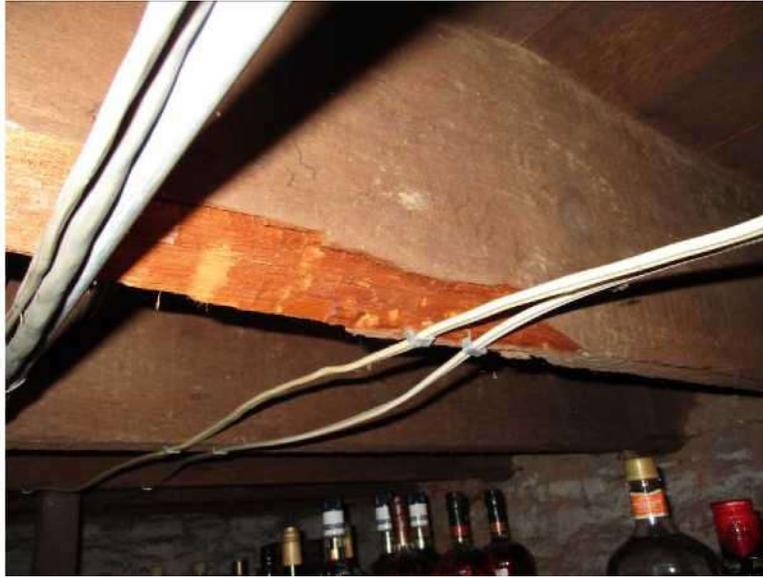
Figure 1: Deteriorated floor framing

Limited areas of the main floor framing appear to have sustained some deterioration, likely due to moisture exposure.

The floor joist shown in Figure 1 can be found below the central hallway. It is estimated that between 5 and 10 of these joists will require some form of remedial work. The majority of the basement ceiling has been fire-rated and as such the framing was not visible at the time of the review. A more comprehensive review of the floor framing should be carried out during any proposed renovation design work.

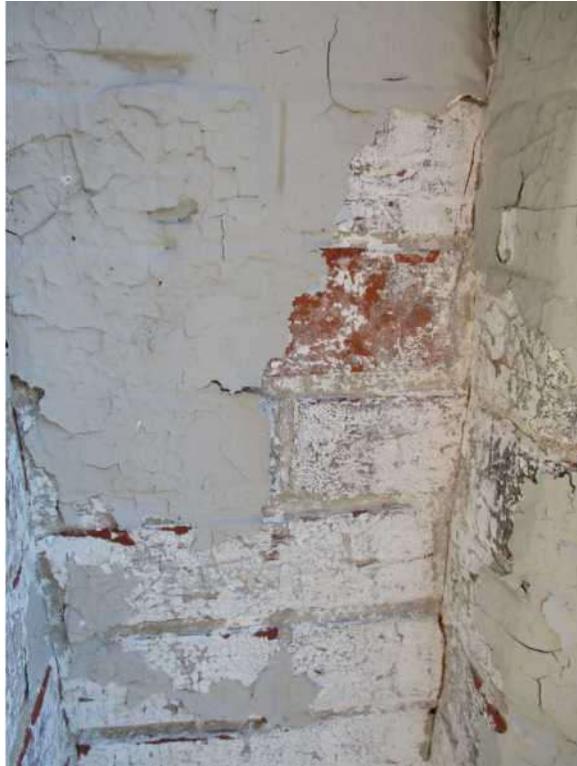
Figure 2: Exterior coatings

The outermost coating is very thick and has flaked off in many locations, most notably at interior corners or other locations more prone to moisture accumulation. The coatings exposed below are in varying states of decay, and have deteriorated to a form of powder, possibly lime, in some locations. Where exposed below the coatings, the brick was found to be extremely soft.

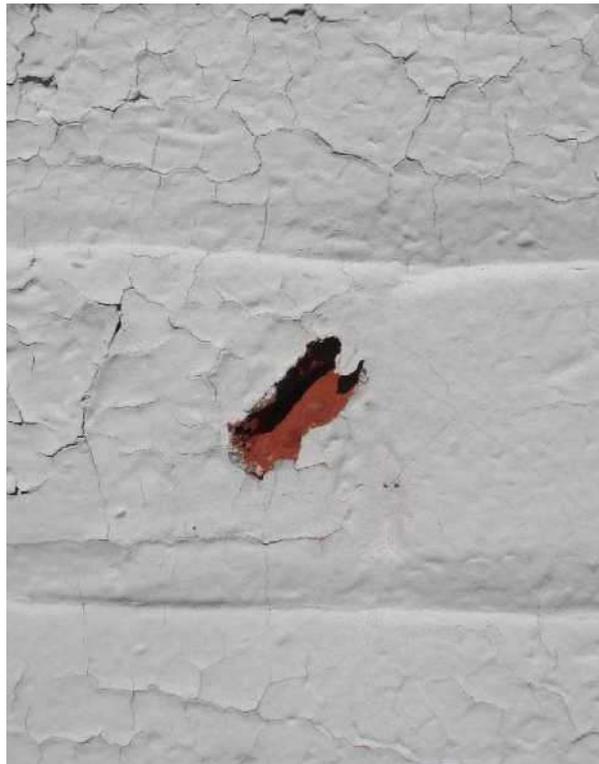
Figure 3: Soft brick exposed below coatings

It was possible to scrape a depression of up to 3/4" deep into the brick with a screwdriver and moderate pressure.

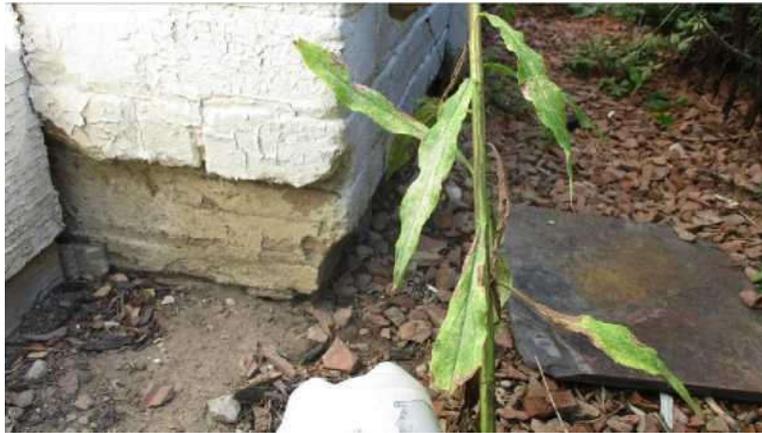
Figure 4: Deteriorated coatings near grade

Coatings at or near grade are showing signs of more advanced deterioration, particularly where the wall is sheltered by gardens.

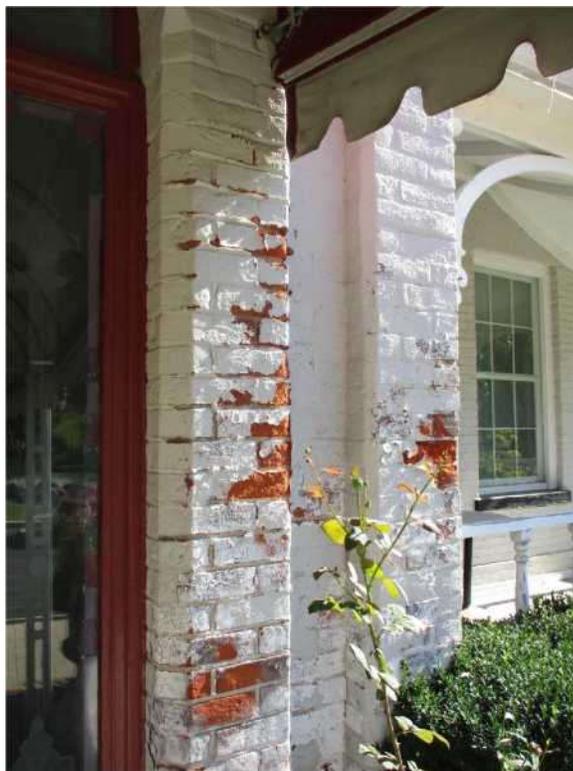
Figure 5: Deterioration on south side of entry canopy

Advanced deterioration of the coatings and the underlying brick was noted on the south side of the entry canopy.

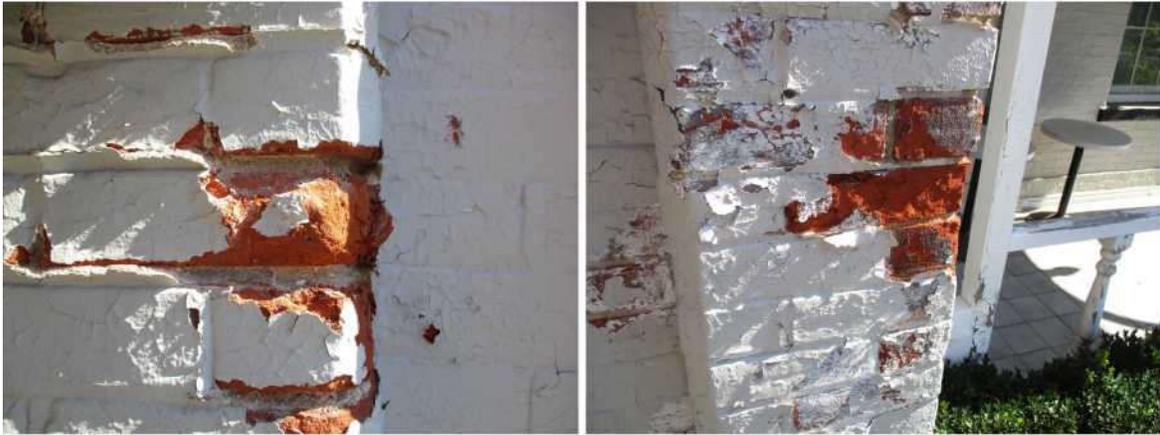
Figure 6a, 6b: Damage to masonry at south side of entry canopy

It appears that the concentration of run-off from the canopy has resulted in saturation of the brick at this location, and the loss of coatings has led to advanced deterioration of the brick.

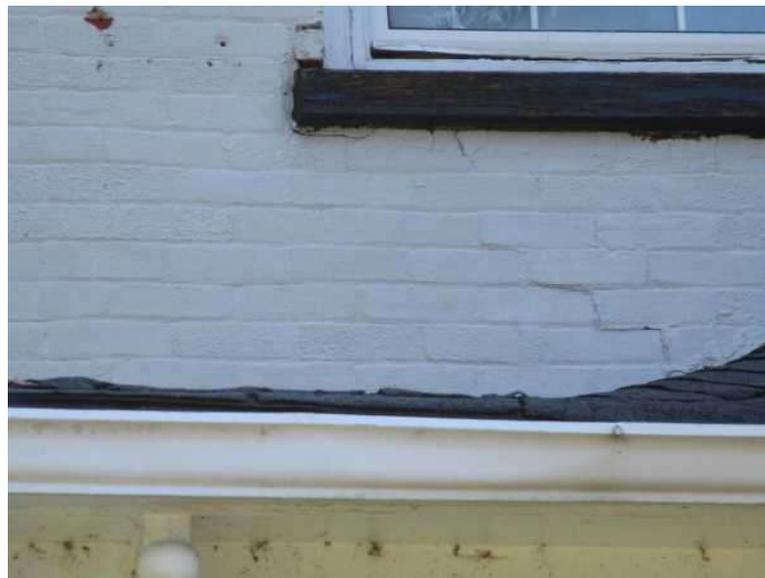
Figure 7: Step cracking below second storey window

A step crack was noted on the front elevation below the second storey north window. The presence of the coatings precludes comment on the extent or width of the crack.
