Lisgar District Basement Water Infiltration Investigation Presentation of Final Report City of Mississauga

March 26, 2015

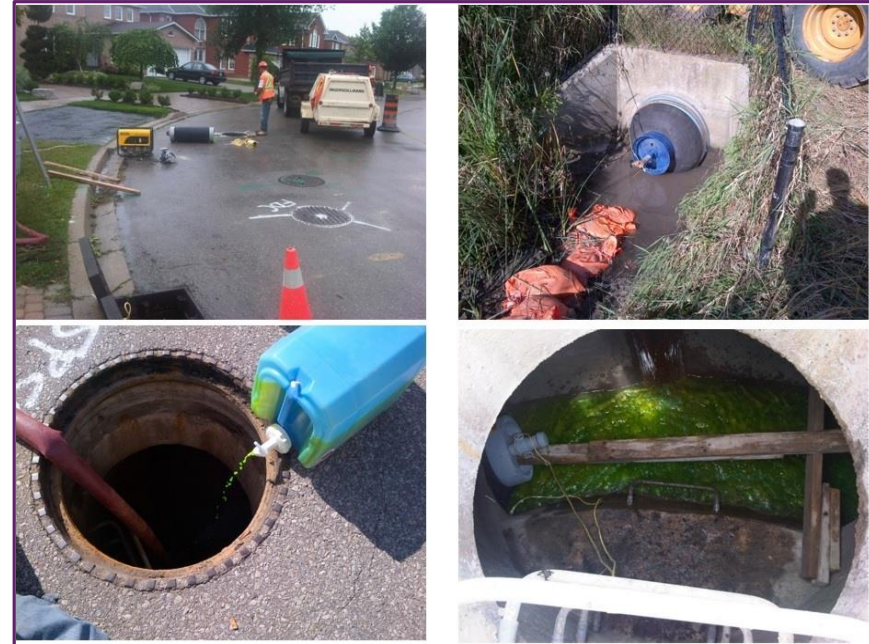
- Undertaken in 2013 at three sites where basement water infiltration occurred in the past
- Intent to confirm whether or not, under high flows, the storm sewer system would be expected to leak and contribute water to the utility trench
- Tests were comprised of:
 - *Blocking the storm sewers and filling them with water to replicate surcharge conditions*
 - *Addition of a safe green fluorescent dye to the storm sewer*
 - *Monitoring of the dye concentrations and water levels in the utility trench, groundwater and FDC system*

- At all three sites, the storm sewers leaked and at two sites the dye was detected in the FDC after only two hours
- Tests have proven that there is a flow path from the storm sewer to the FDC through the utility trench, with a response time consistent with that observed between 'ideal' storm events and instances of reported basement water infiltration

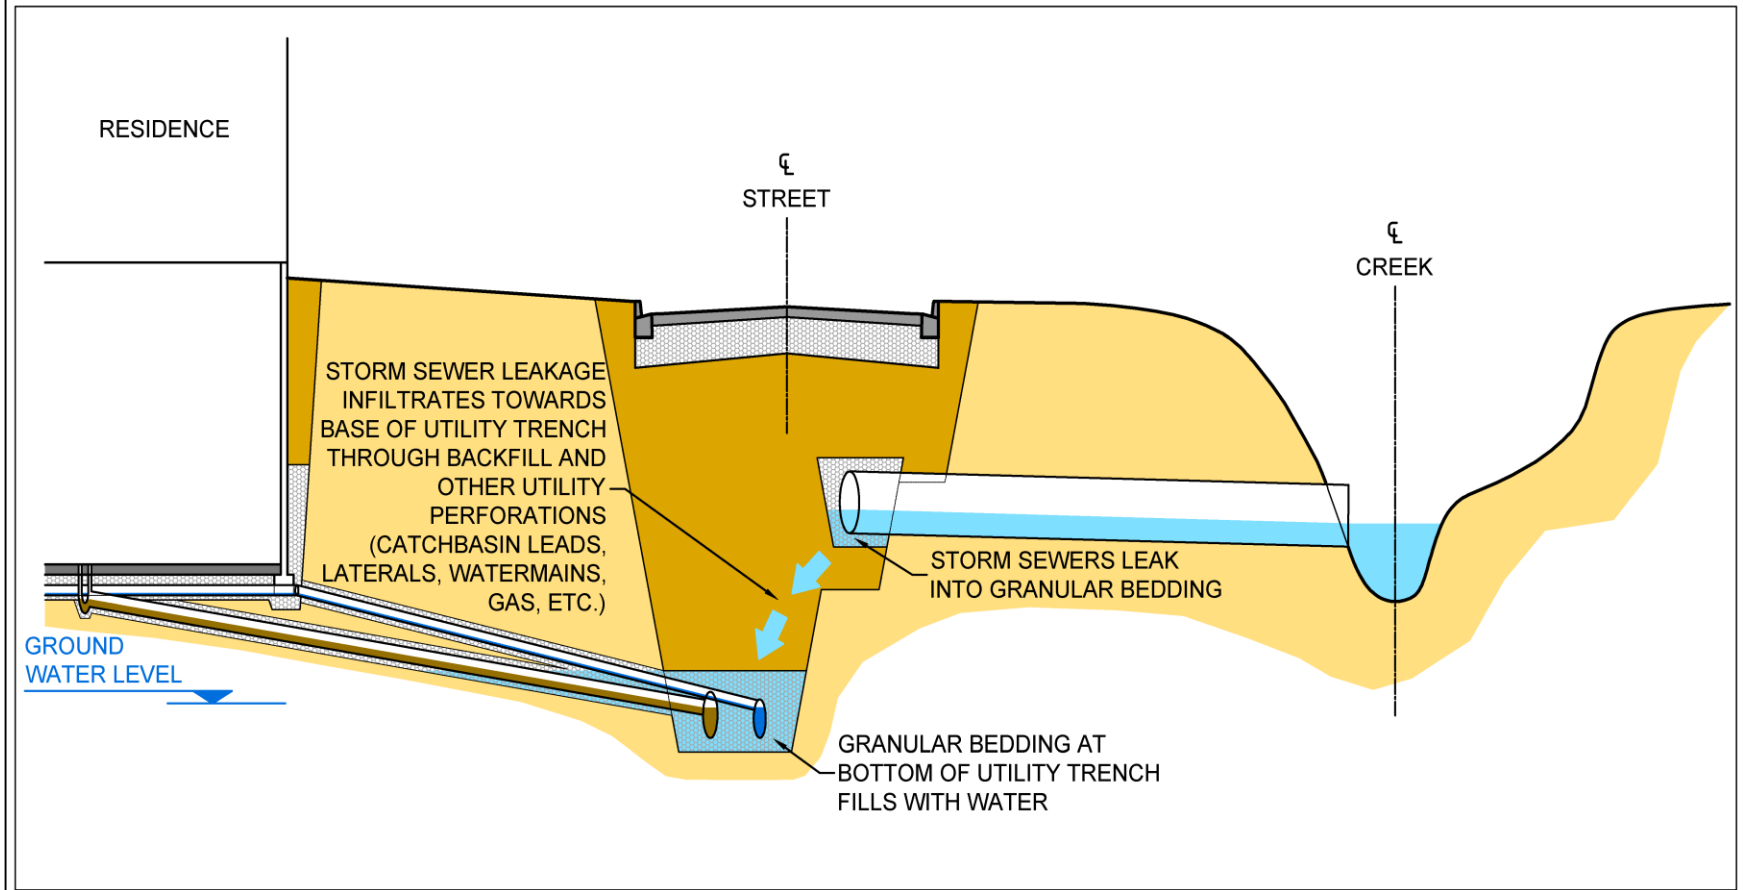
3. UTILITY TRENCH AND BEDDING - TYPICAL STORMS

- Leakage from the storm sewer system (which is a normal and expected occurrence), combined with the presence of slow draining native soils (around the utility trench) results in water build-up
- If the build-up of water is significant, it travels up the bedding material around the Foundation Drain Collector (FDC) laterals servicing the homes and into the foundation weeping tiles
- Water then drains directly into the FDC pipes through the weeping tiles which can surcharge (overload) the system
- This condition, in combination with certain storm conditions (preceding rainfall followed by a sufficiently large storm event) and local lot drainage may lead to water around the home's weeping tiles being unable to drain and potentially seeping into the basements of homes.

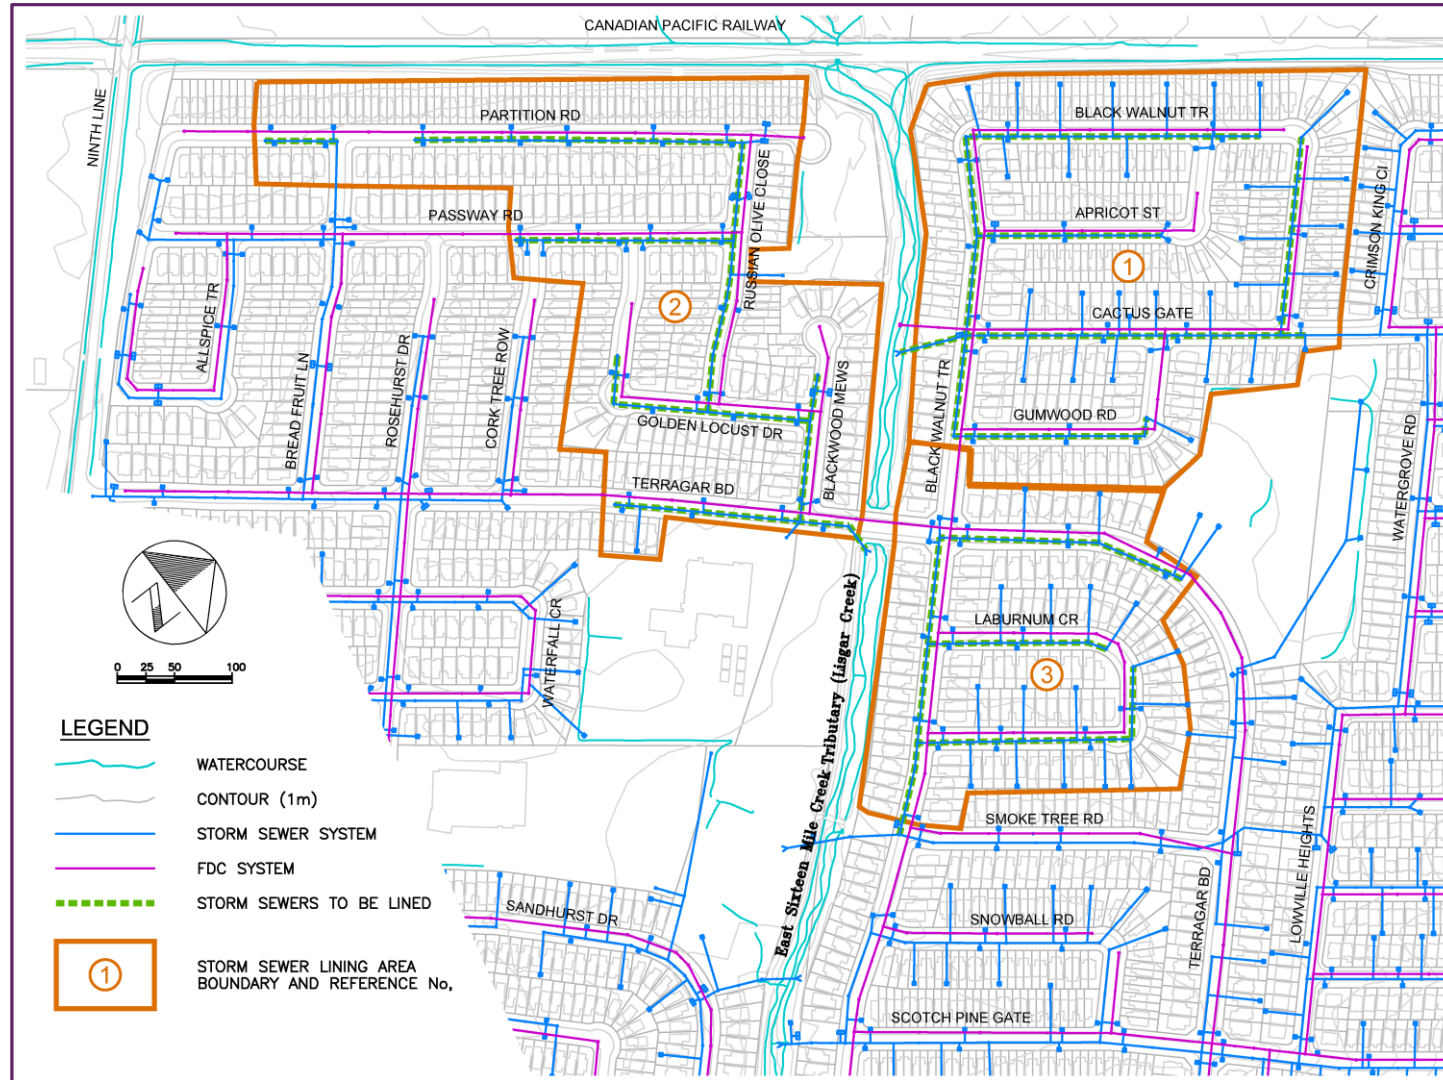
Black Walnut Trail area – *Highest Priority*

A4: *Based on the modelling results for an observed surcharge event in the FDC system along Black Walnut Trail, several areas have been identified as having much higher relative flow contributions to the FDC system. These identified areas are therefore considered a priority for the implementation of mitigation measures*

- a) *Strategic lining of priority storm sewers to minimize leakage (capital cost estimated to be \$8M - \$9M)*
- b) *Construction of a utility trench dewatering system.(capital cost estimated to be \$3M - \$4M)*
- c) *Undertake additional monitoring to assess effectiveness of a) and b) (approximately \$100,000)*
