**LISGAR DISTRICT  
BASEMENT WATER INFILTRATION INVESTIGATION  
SUMMARY REPORT**

**City of Mississauga**  
Mississauga, Ontario

**Amec Foster Wheeler Environment & Infrastructure**  
**A division of Amec Foster Wheeler Americas Limited**  
3215 North Service Road  
Burlington, ON L7N 3G2

**March 2015**

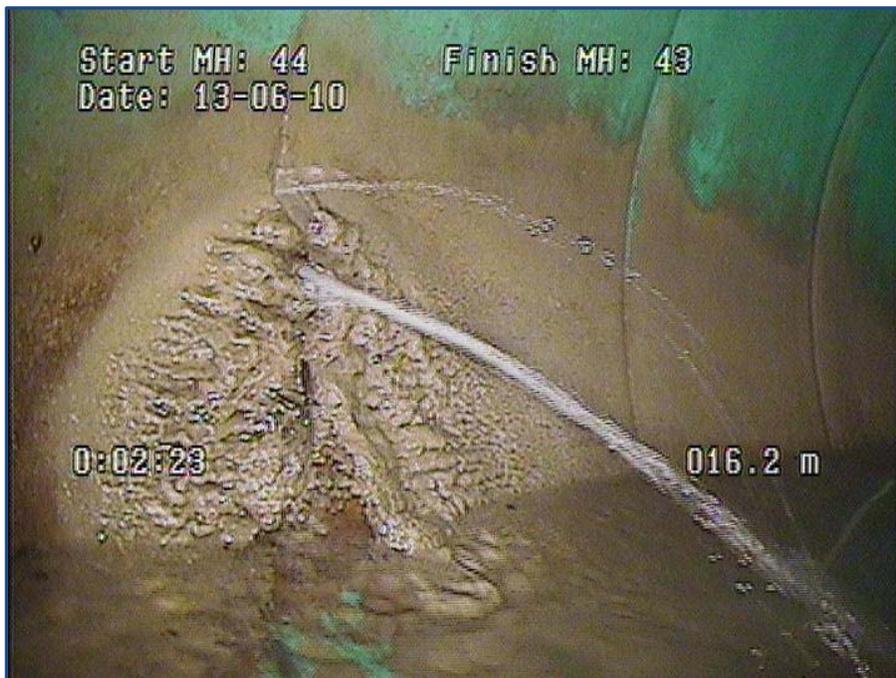
Video inspections of the FDC system and a large portion of the storm sewer system were carried out to identify any potential cracks and leaks (FDC system), as well as debris or obstructions (both systems). Only a few cracks and leaks were detected. Most of them have subsequently been repaired by the City. No significant blockages or debris were observed in either system.

Despite the lack of any significant debris or blockages in the storm and FDC systems, as a further precautionary measure, the FDC system and a portion of the storm sewer system were flushed to clean-out any minor debris accumulations.

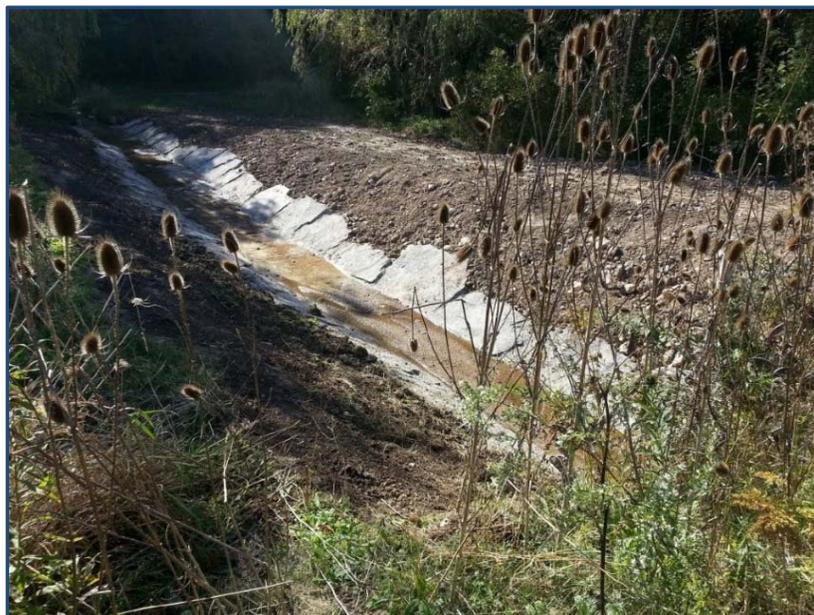
City staff conducted an inspection of the storm sewer outlets to the tributary of the east branch of Sixteen Mile Creek, and identified those where removal of accumulated sediment would benefit the proper operation of the storm sewer system. A total of ten storm sewer outfalls along the tributary between Doug Leavens Boulevard and Osprey Boulevard were subsequently cleaned-out.

Where conditions warranted, the outfalls were also lined with large stones to reduce erosion and ease future clean-out efforts.

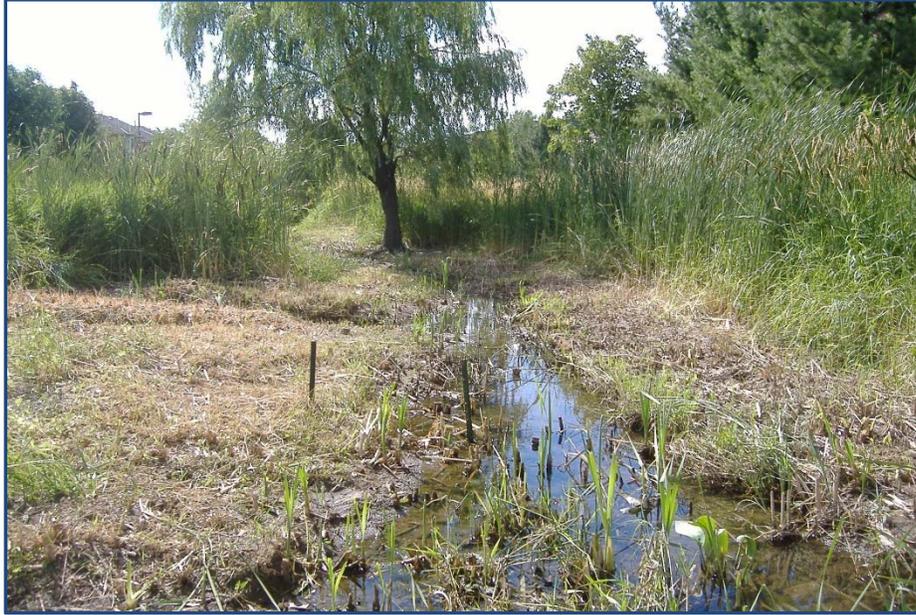
In response to concerns raised by residents, considerable effort and expense was spent by the City to trim the vegetation along the creek corridor between the Canadian Pacific Railway tracks and Doug Leavens Boulevard over the course of 2012. It should be noted that this is not a typical practice for the maintenance and stewardship of a naturalized creek corridor system. The trimmed vegetation re-grew very quickly and has subsequently re-established itself. Further trimming was not undertaken given the findings of this study.

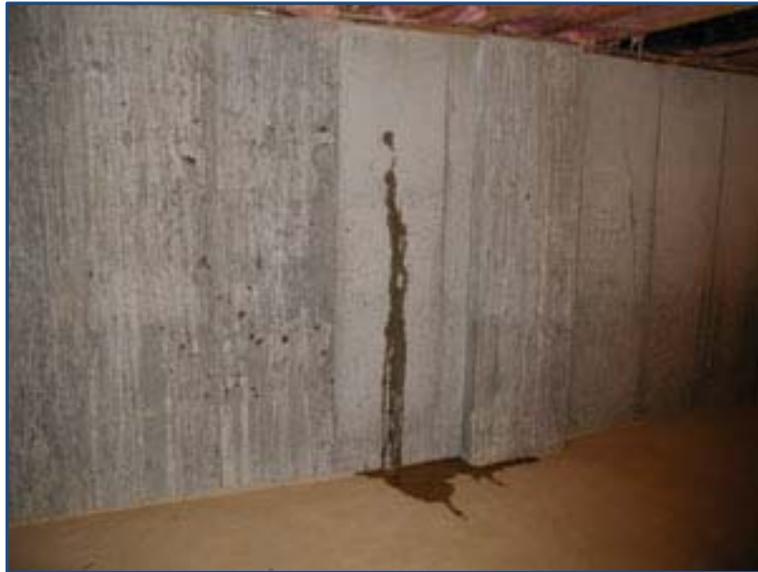
*Aging basement walls and foundations*

Concrete foundations are not resistant to cracks. Cracks in a foundation wall can be caused by a number of factors such as concrete shrinkage, aging, settlement into the soil or poor drainage around the house. These cracks provide the opportunity for water to seep into the basement from the exterior. While cracks in foundations are not uncommon, it is challenging to obtain data to determine the level of influence this may have on basement water infiltration given that foundations are located on private property. As such, this possible cause was not analyzed further.

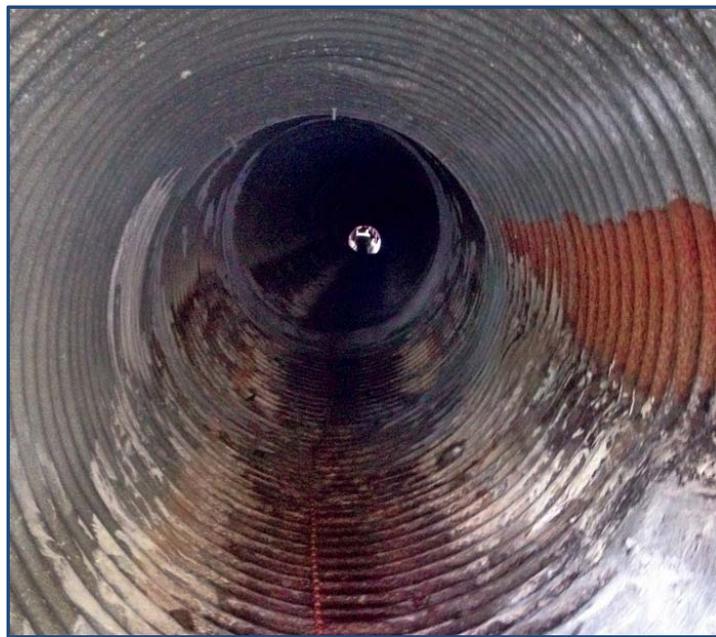
*Aging Infrastructure*

Like all infrastructure, stormwater related infrastructure gradually ages over time and its concrete components, such as pipes and manholes, typically have a service life of approximately 100 years. While the municipal services in the Lisgar District are comparatively young (less than 35 years), leakage from the storm sewer, which is a normal occurrence, can occur due to:

- cracks in manholes
- displaced/settled sewers
- seals and sewer joints breaking down

As storm sewers are not built to remain watertight, leakage from the system is considered normal. However, in locations where a 3-pipe system is used, opportunities may arise where water, which has leaked from storm sewers, may enter into the FDC system. Additional investigative work was carried out with respect to the issue of storm sewer leakage.

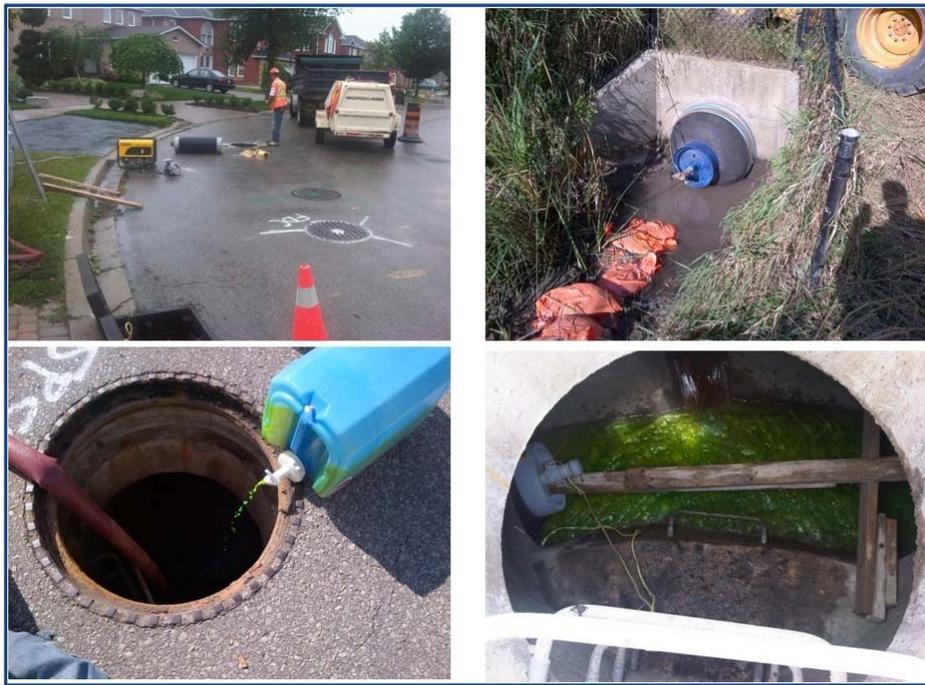
- Storm sewer leakage testing was undertaken in 2013 at three sites where basement water infiltration occurred (Alderwood Trail and Black Walnut Trail at both Wild Cherry Lane and Scotch Pine Gate). The photos above illustrate some of the steps in the leakage testing process;
- The intent of the tests was to confirm whether or not, under high flows, the storm sewer system would be expected to leak and contribute water to the utility trench where the FDC system resides; and
- The tests were comprised of:
  - Blocking the storm sewers and filling them with water to replicate surcharge conditions (under pressure);
  - Addition of a green fluorescent dye to the storm sewer; and
  - Monitoring of the dye concentrations and water levels in the utility trench, groundwater and FDC system.

1. At all three sites, the storm sewers leaked and at two sites (Wild Cherry Lane and Scotch Pine Gate), the dye was detected in the FDC after two hours.
2. Tests have proven that there is a flow path from the storm sewer to the FDC through the utility trench with a response time consistent with that observed between major storm events and instances of basement water infiltration.

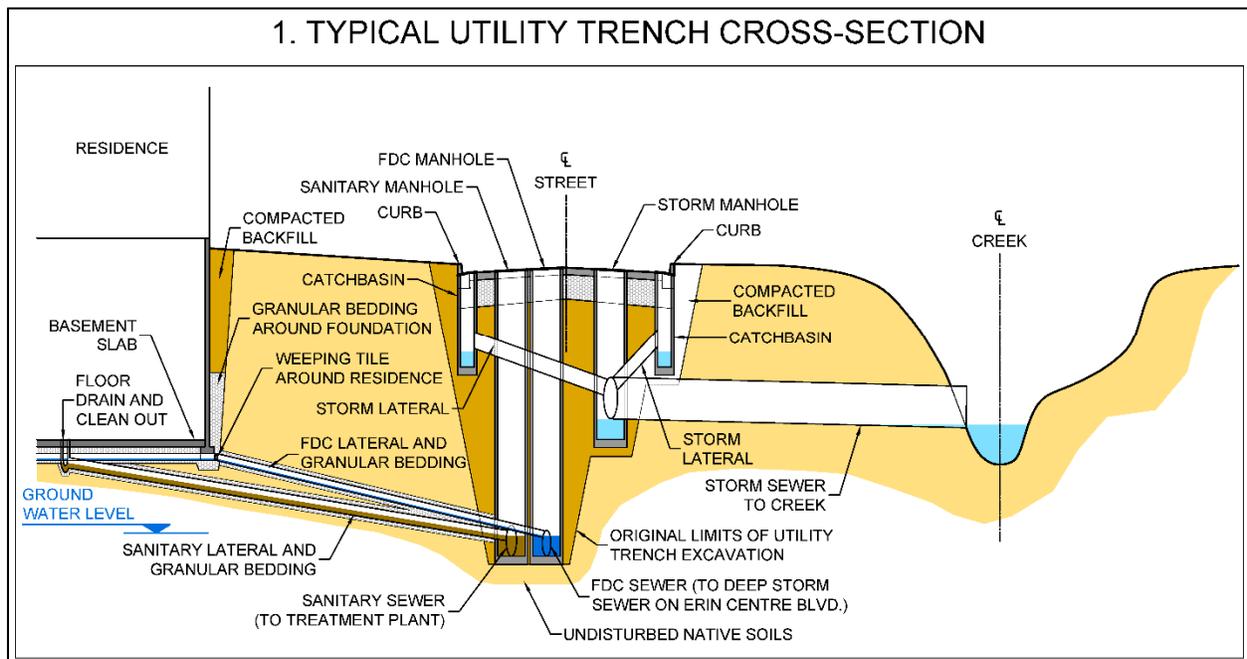
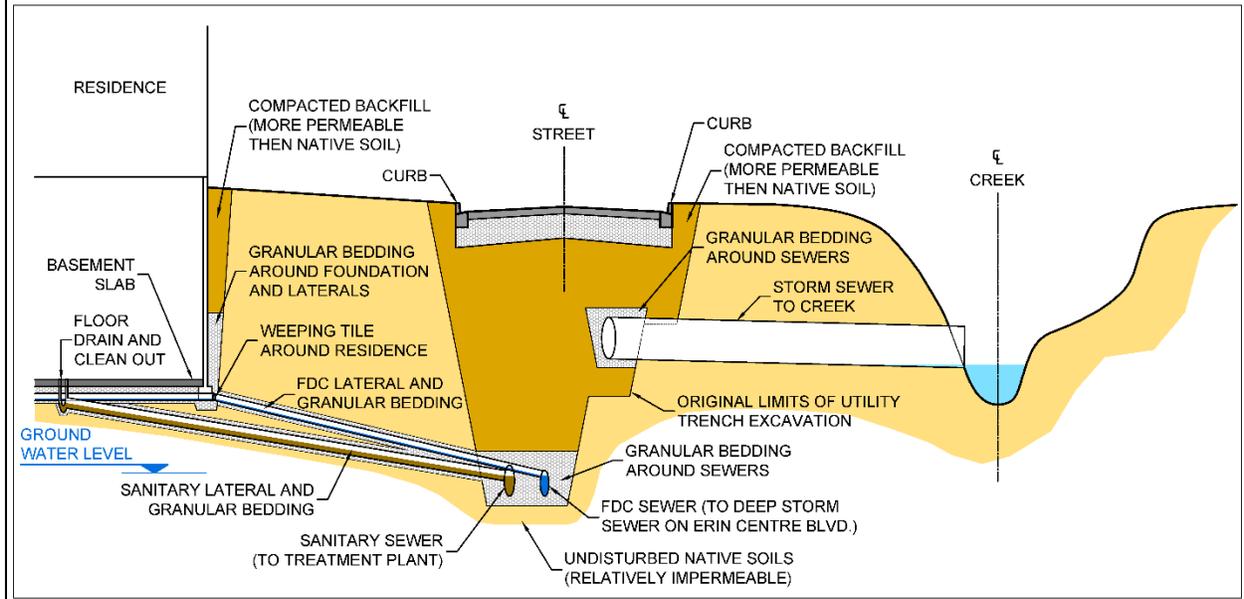
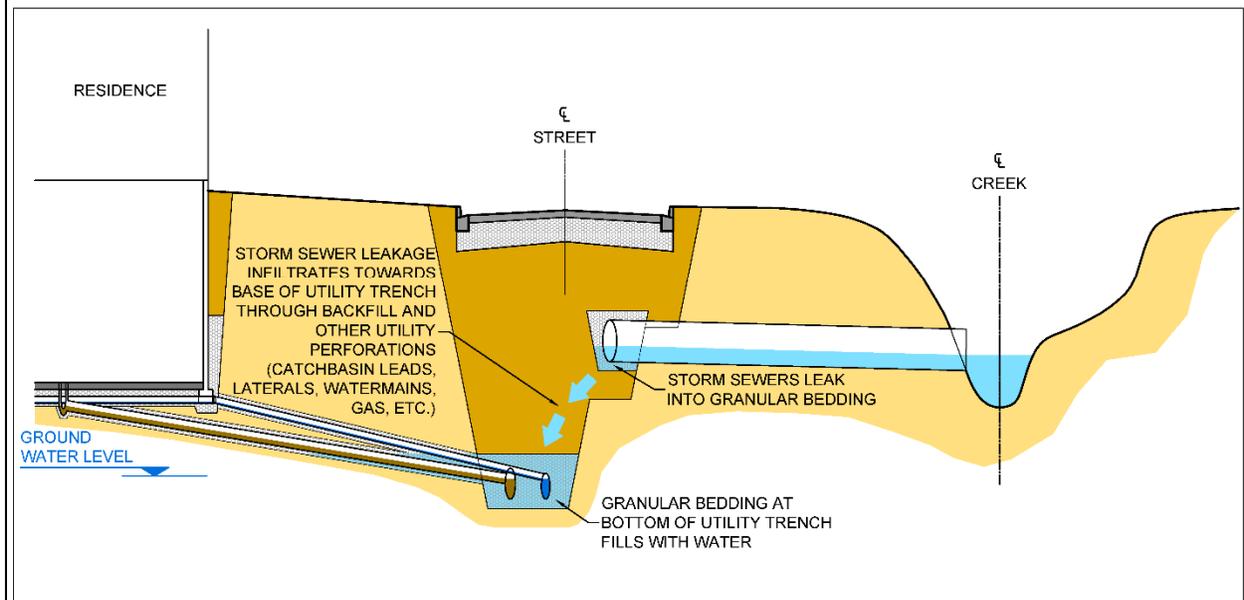
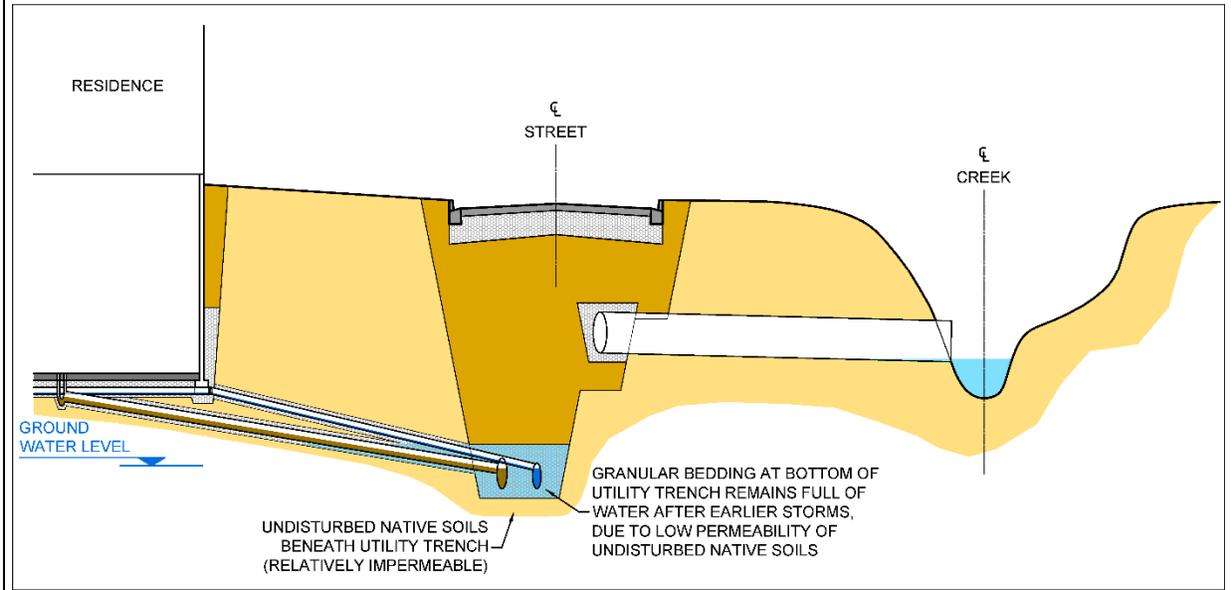
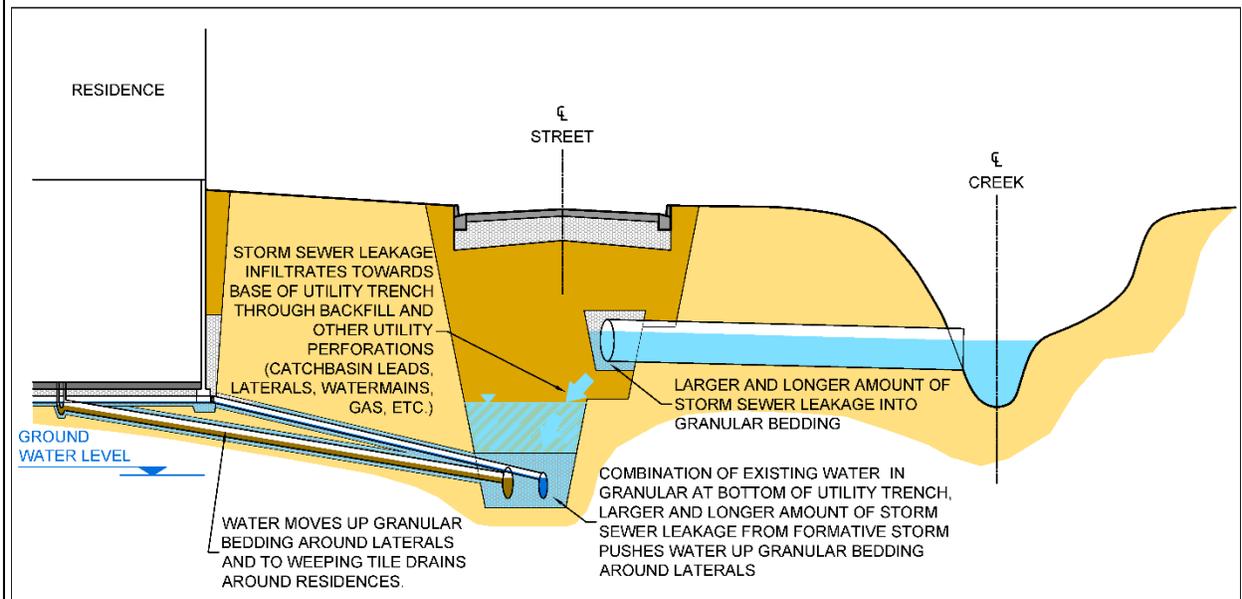
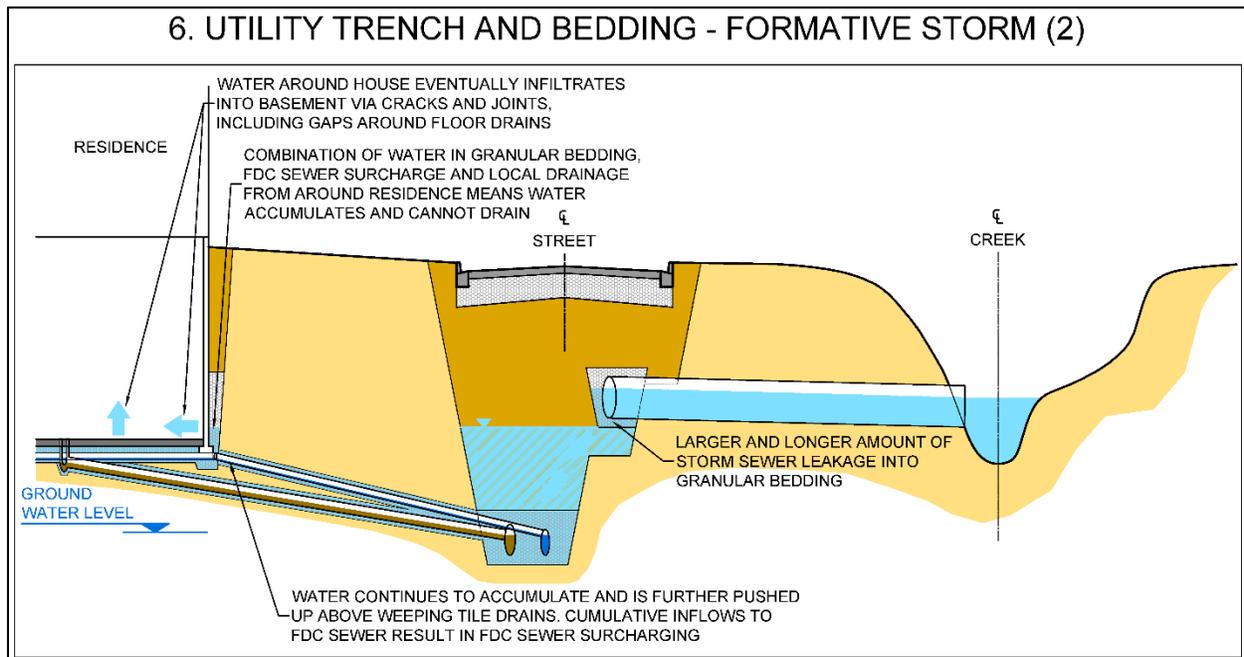
As storm sewers are not built to be watertight, and due to cracks and leaks expected through aging, stormwater is able to leak out during storm events and migrate into the utility trench, where the bedding material, made of gravel and other granular soils can allow water to move very quickly. Over time, water builds up in the utility trench from storm sewer leakage, as well as through other sources (other utilities, groundwater, et cetera), and is unable to drain away quickly due to the relatively impermeable nature of the native soils surrounding the trench.

It is this situation, in combination with certain storm conditions and local lot drainage where issues may arise. For instance, where the ground and utility trench are already wet, possibly from an earlier storm event, and rainfall subsequently occurs, this may create a condition where there is enough leakage from the storm sewer system during the rainfall event to fill an already wet utility trench and push water up the bedding material around the FDC laterals servicing the homes and into the foundation weeping tiles. This water then drains directly into the FDC pipes through the weeping tiles, which may result in excess flow in the FDC system (surcharge). However, this condition by itself may not lead to basement water seepage. It is this condition, in combination with certain storm conditions (preceding rainfall followed by a sufficiently large storm event) and local lot drainage that may lead to water around the weeping tiles being unable to drain and potentially seeping into the basements of homes. This process is illustrated in Figures 8A to 8F.
