Tree Management Plan

MAVIS ROAD CLASS ENVIRONMENTAL ASSESSMENT

ARBORIST REPORT

April 2017

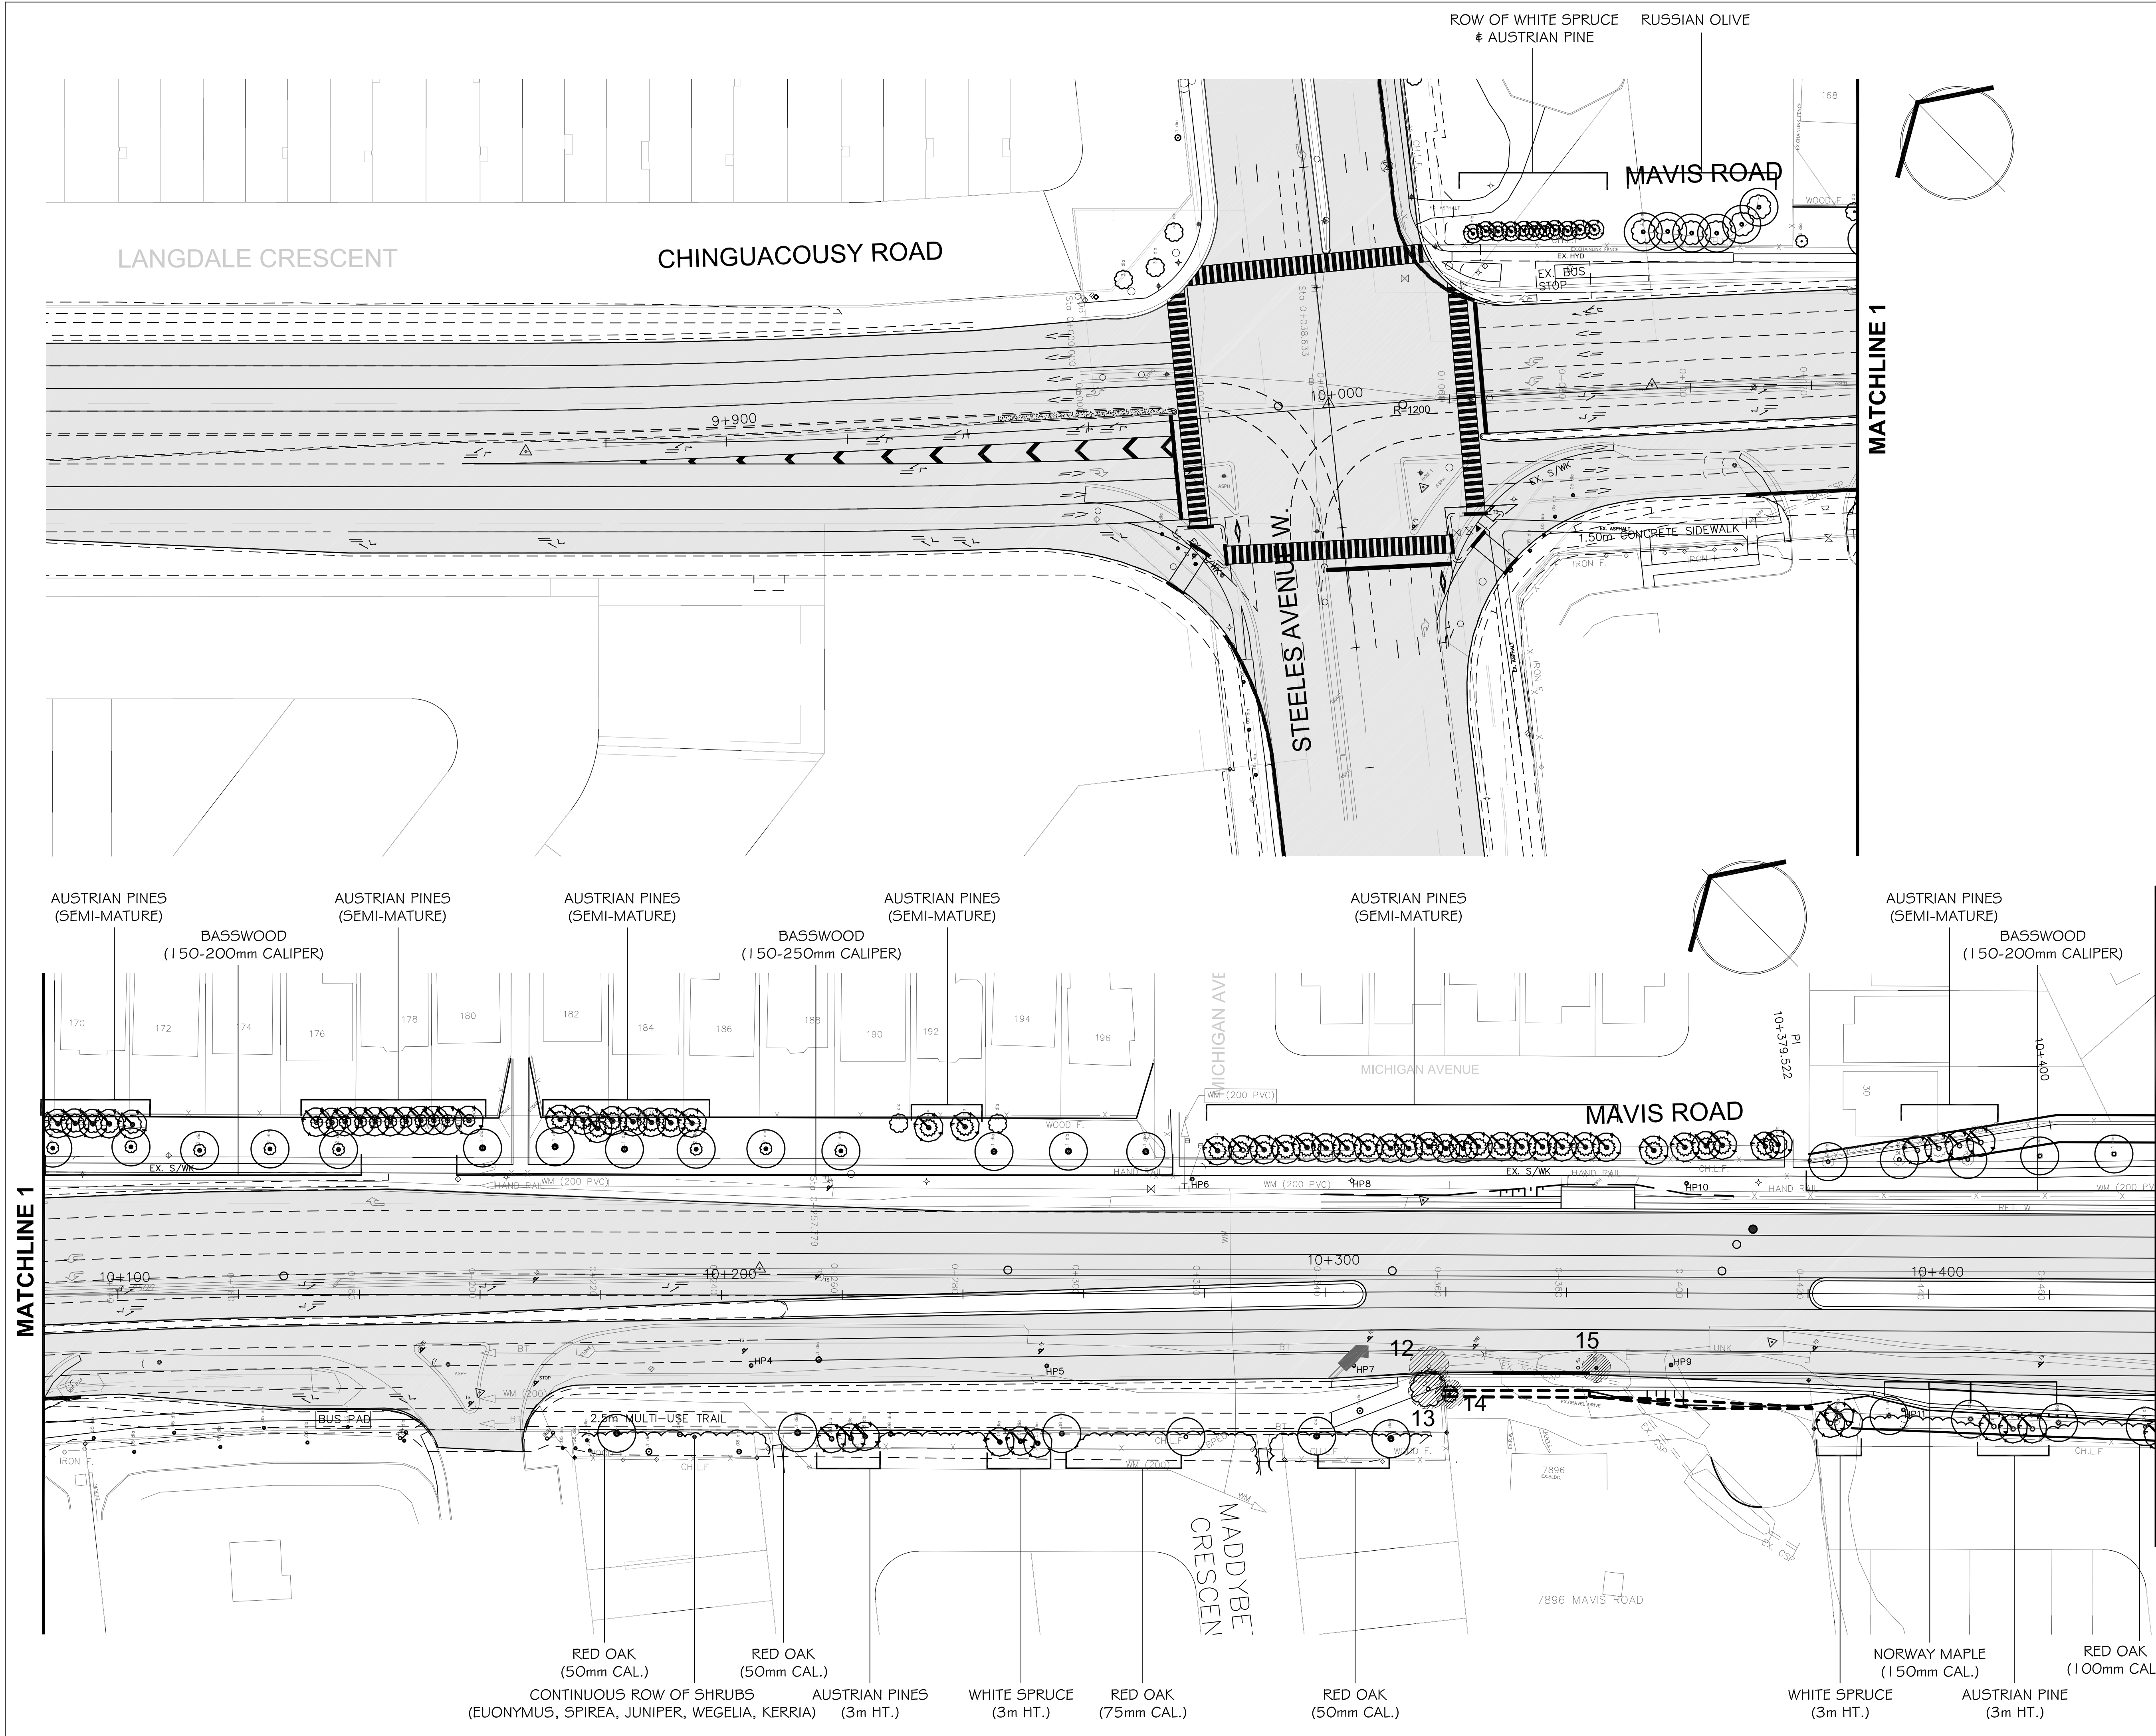
MAVIS ROAD
(FROM STEELES AVE. WEST TO HWY 407)
EXISTING TREE SURVEY

Mavis Road Reconstruction - Trees To be removed*			
Code	Description	Size	Condition
12	Basswood (<i>tilia americana</i>)	multi stem (100-200mm)	fair
13	Manitoba Maple (<i>acer negundo</i>)	700mm	fair
14	Red Cedar (<i>juniperus virginiana</i>)	200mm	fair
15	Mountain Ash (<i>sorbus sp.</i>)	50mm	fair
16	Red Oak (<i>quercus rubra</i>)	100mm	good
17	Red Oak (<i>quercus rubra</i>)	100mm	good
18	Pyramidal English Oak (<i>quercus robur</i>)	200mm	fair
19	Pyramidal English Oak (<i>quercus robur</i>)	225mm	fair
20	Pyramidal English Oak (<i>quercus robur</i>)	175mm	fair
21	Pyramidal English Oak (<i>quercus robur</i>)	200mm	fair
22	Pyramidal English Oak (<i>quercus robur</i>)	225mm	fair
23	Austrian Pine (<i>pinus nigra</i>)	200mm	good
24	Austrian Pine (<i>pinus nigra</i>)	200mm	good
25	Austrian Pine (<i>pinus nigra</i>)	200mm	good
26	Austrian Pine (<i>pinus nigra</i>)	150mm	good
27	White Pine (<i>pinus strobus</i>)	650mm	fair
