Re: 3480 Havenwood Dr and 1480 Williamsport Dr (Ward 3)

Arborist Report – Construction/Tree Protection

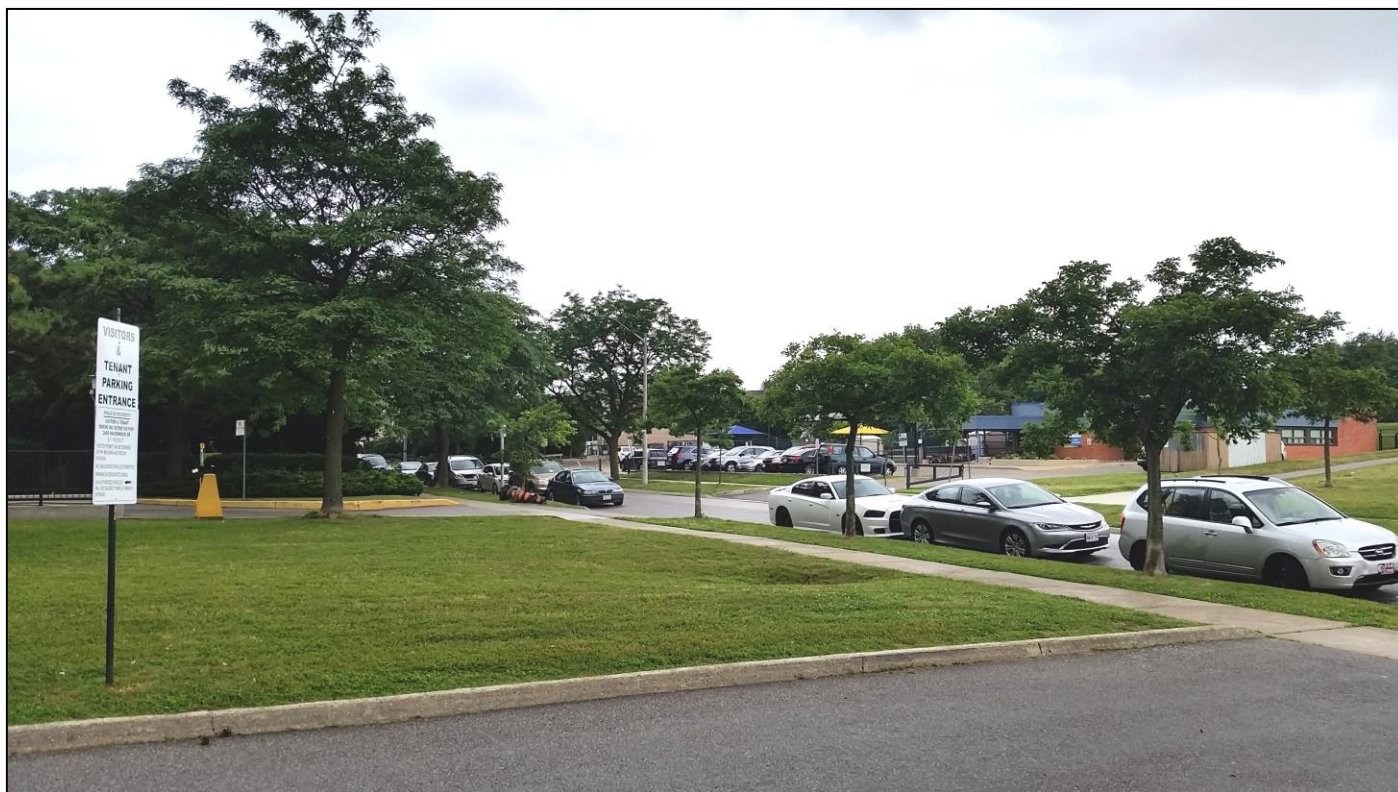
Photo 1: (Left to right) Trees 201, 201C, 201B, and 201A.

The new curb cuts along the north half of Williamsport Drive will encroach up to 0.5m from the base of **tree #243D and 201A**; at these distances, it is expected that structural roots will be encountered, which will cause destabilization if severed. Trees 243D and 201A will require a permit to be removed.

Trees #201B, 201C, 243C, 256A, 256B, 256C, and 256D are located on City property, along the road allowance adjacent to Williamsport Drive. The existing sidewalk, which is currently located approximately 1.0m away from the base of all the subject trees, will remain as is throughout the construction process, with the exception of a few panels to be replaced to accommodate the new curb cuts on Williamsport Drive. Where the sidewalk is slated to remain as is during construction, it is expected that the trees will tolerate the encroachment if all recommendations are adhered to.

Tree #	Species	Latin Name	Health	Structure	Category	DBH (cm)	TPZ (m)	Comments	Recommended Action
201A	Hackberry	<i>Celtis occidentalis</i>	Fair	Fair	3	16	1.8	Leaf galls, trunk wound (sealing) short leaf progression, some decay.	Requires permit to be removed , due to new curb cut.
201B	Hackberry	<i>Celtis occidentalis</i>	Fair	Good	3	15	1.8	Pruned, Leafgall.	Tree requires encroachment into TPZ and is slated for preservation.
201C	Hackberry	<i>Celtis occidentalis</i>	Fair	Fair	3	11	1.8	Wounds at base. Dieback throughout.	Tree requires encroachment into TPZ and is slated for preservation.
201	Honey Locust	<i>Gleditsia triacanthos</i>	Good	Good	2	33	2.4	Small deadwood throughout.	Fully protect
202	Austrian Pine	<i>Pinus nigra</i>	Fair	Fair	1	35	2.4	Topped, Diplodia Tip Blight, small dead wood throughout. Sap seeping from old wounds.	Fully protect
203	Austrian Pine	<i>Pinus nigra</i>	Fair	Fair	1	48.5	3.0	Topped, Diplodia Tip Blight, small dead wood throughout. Sap seeping from old wounds.	Requires permit to be removed , due to new underground parking

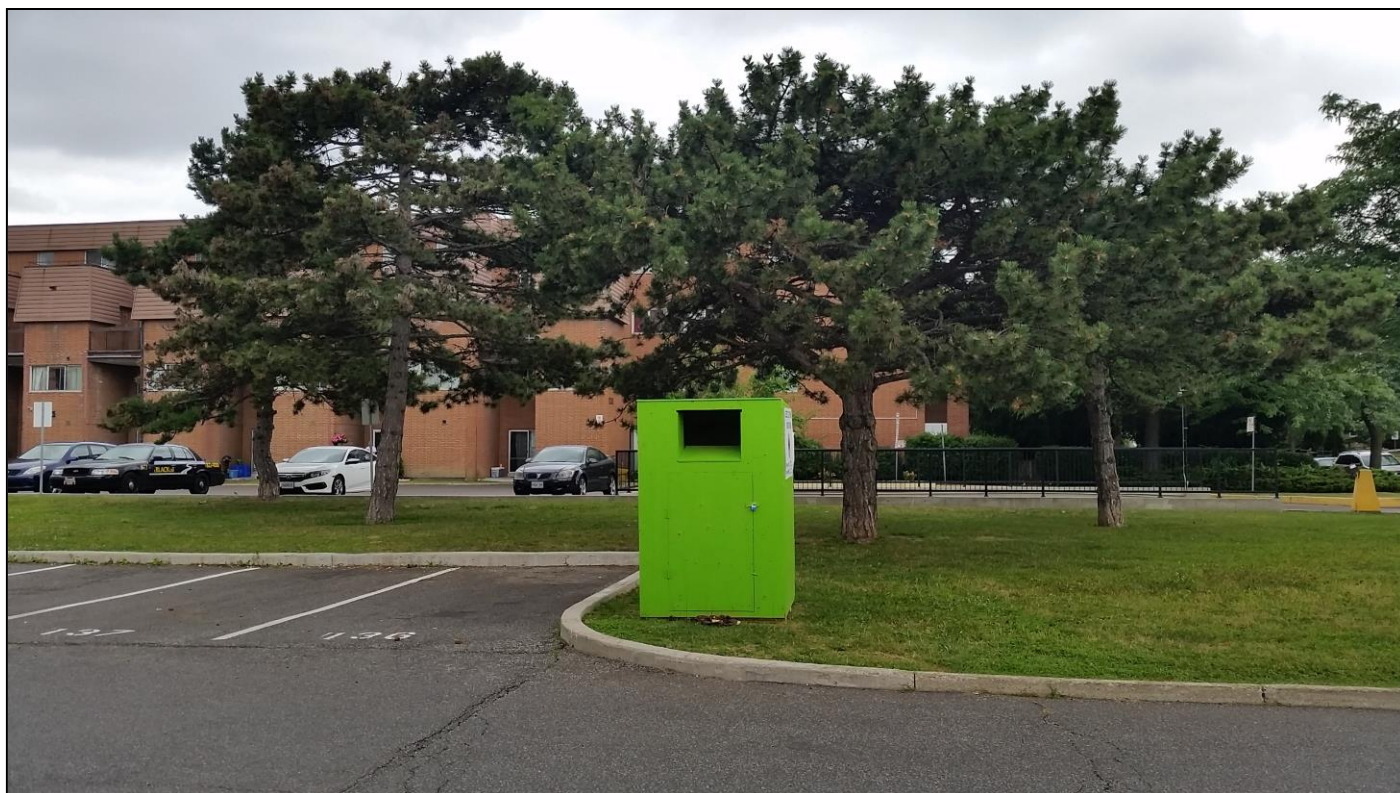
Photo 2: (Left to right) Trees 205, 204, 203, and 202.

204	Austrian Pine	<i>Pinus nigra</i>	Fair	Fair	1	36	2.4	Topped, Diplodia Tip Blight, small dead wood throughout. Leaning a bit.	Tree requires encroachment into TPZ and is slated for preservation.
205	Austrian Pine	<i>Pinus nigra</i>	Fair-Poor	Fair	2	33	2.4	Topped, Diplodia Tip Blight, small dead wood throughout. Sap seeping from old wounds. Blight has infected most of the canopy.	Tree requires encroachment into TPZ and is slated for preservation.
206	Austrian Pine	<i>Pinus nigra</i>	Fair-Poor	Fair	1	48	3.0	Topped, Diplodia Tip Blight, small dead wood throughout. Sap seeping from old wounds. Blight has infected most of the canopy.	Tree requires encroachment into TPZ and is slated for preservation.
207	Austrian Pine	<i>Pinus nigra</i>	Fair	Fair	1	38	2.4	Topped, Diplodia Tip Blight, small dead wood throughout. Sap seeping from old wounds. Blight has infected most of the canopy.	Requires permit to be removed , due to new multi-storey building

Pending exploratory excavation approval, installation of the fence must be completed by hand within the tree protection zone (TPZ) of **trees 204, 205, 206, 209B, 209C, 209D, 209E, 209K, and 209L** with care to minimize the disturbance below grade. If any roots measuring 2cm or greater are encountered, root pruning and documentation must be conducted by a qualified arborist. If significant roots are encountered, the post location shall be adjusted to accommodate the roots. After the completion of the fence, it is recommended that the subject trees receive deep root fertilization as remedial care.

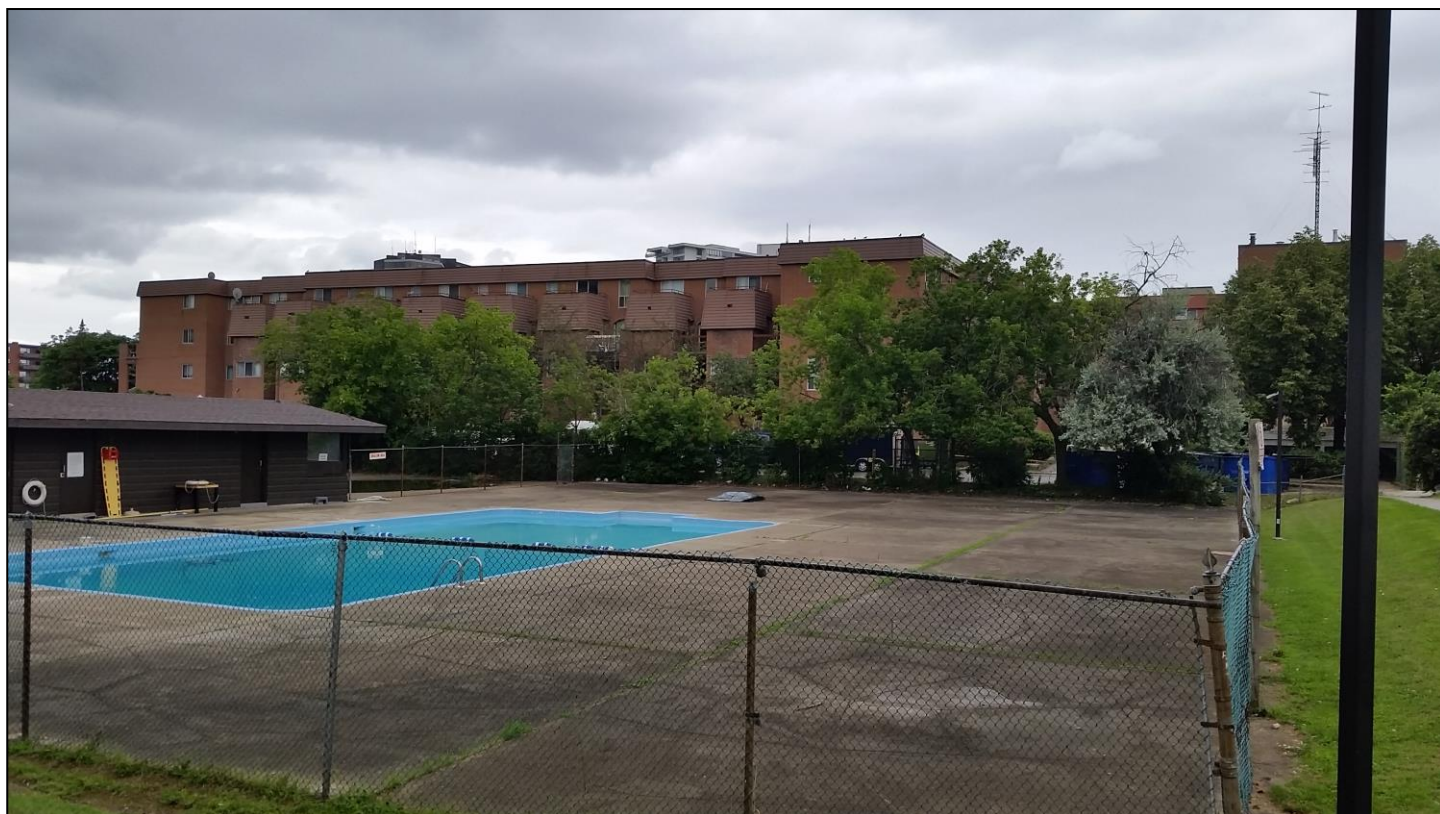
Photo 6: (Left to right) Trees 209L, 209K, 209J, 209I, 209H, 209G, 209F, 209E, 209D, 209C, and 209B.

Trees #209B, 209C, 209D, 209E, 209K, and 209L are located adjacent to the subject property, on privately-owned property. The bases of the subject trees are located within 0.5m of the potential excavation footprint for the new wooden privacy fence; to preserve the subject trees, all recommendations must be adhered to. See 'Recommendations for Fence Installation' for more details.

209 D	Manitoba Maple	<i>Acer negundo</i>	Fair-Poor	Fair	2	18	1.8	Sparse, lots of seeds base suckers	Tree requires encroachment into TPZ and is slated for

209L	Manitoba Maple	<i>Acer negundo</i>	Fair-Poor	Fair	2	37	2.4	Multi Stemmed, dieback throughout, large dead wood throughout	Tree requires encroachment into TPZ and is slated for preservation.
209M	Crabapple	<i>Malus sylvestris</i>	Fair	Fair	2	18	1.8	Twisted branches, potential anthracnose	Not affected by proposed construction
209N	Manitoba Maple	<i>Acer negundo</i>	Fair	Fair	2	20	1.8	Broken Branches, leaning, somewhat sparse.	Not affected by proposed construction
210	Austrian Pine	<i>Pinus nigra</i>	Fair	Good	1	36	2.4	diplodia Tip Blight.	Tree requires encroachment into TPZ and is slated for preservation.
211	Austrian Pine	<i>Pinus nigra</i>	Poor	Fair	1	37	2.4	Large deadwood throughout, about 60% dieback.	Requires permit to be removed , due to resurfacing of existing pathway and poor health
212	Austrian Pine	<i>Pinus nigra</i>	Fair-Poor	Fair	1	40	2.4	Sparse, diplodia, small dead wood throughout.	Requires permit to be removed , due to new parking lot

An exploratory excavation must be conducted by hand to a depth of 1.21m (4ft) for the proposed locations of the fence posts prior to installation. No fence post shall come within 4ft from the base of the subject trees.

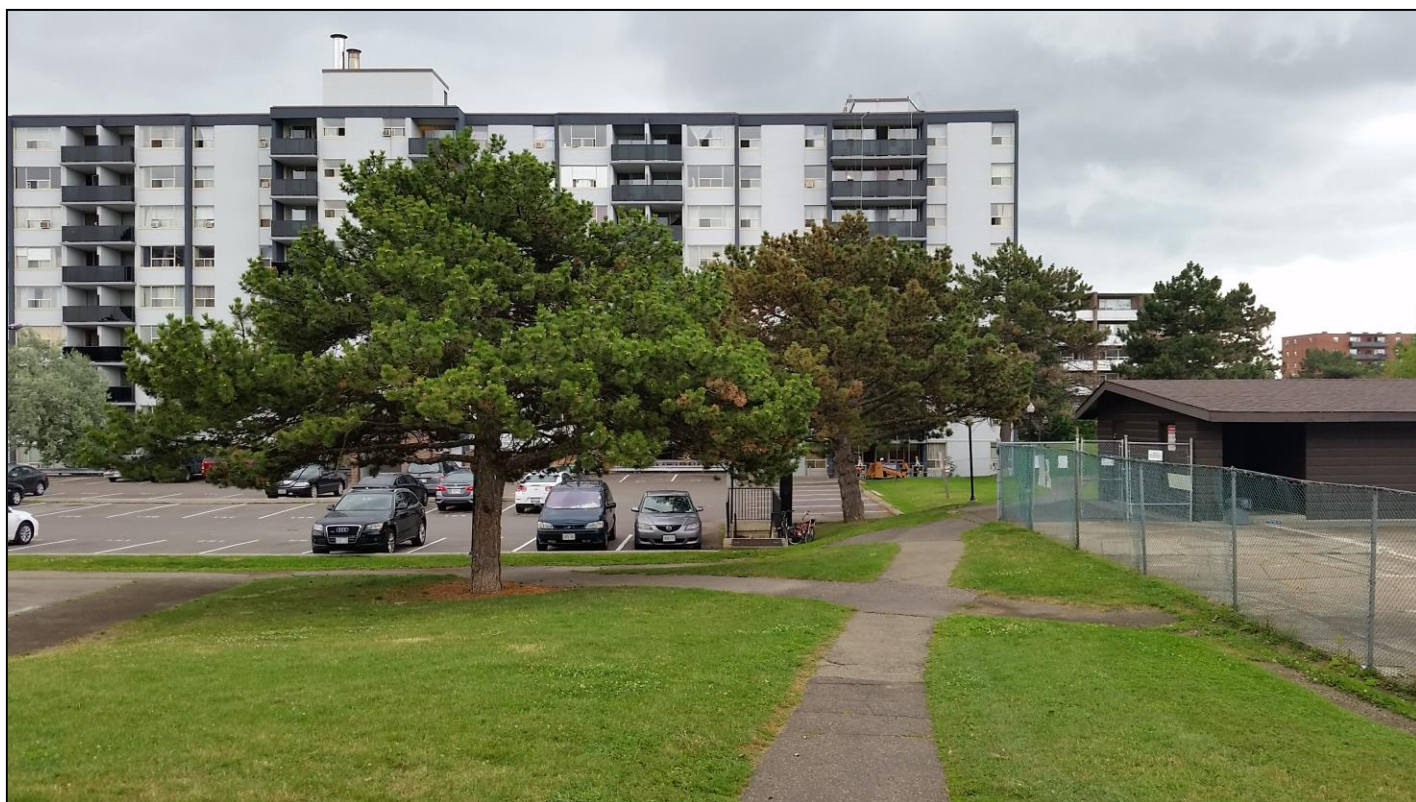
Photo 7: (Left to right) Trees 215 and 214.

A new multi-storey residence is proposed within the centre of the property, between the existing buildings at 1485 Williamsport Drive and 3480 Havenwood Dr. The excavation associated with the new building is expected to extend at least 4.0m beyond the proposed building footprint and will exceed 3.0m in depth. **Trees #207 – 209, 214, 215, 230, and 231** are located within the excavation footprint, and will require permits for removal. In addition, tree 214 is in poor condition, and is recommended for removal on this basis.

213	Austrian Pine	<i>Pinus nigra</i>	Poor	Fair	1	55	3.6	Large deadwood throughout, about 60% dieback.	Requires permit to be removed , due to new parking lot
214	Austrian Pine	<i>Pinus nigra</i>	Poor	Fair	1	55	3.6	Sparse, diplodia, small dead wood throughout.	Requires permit to be removed , due to new multi-storey building
215	Austrian Pine	<i>Pinus nigra</i>	Fair	Fair	1	50	3.0	Small deadwood throughout, diplodia.	Requires permit to be removed , due to new multi-storey building
216	Austrian Pine	<i>Pinus nigra</i>	Good	Good	1	47	3.0	Small deadwood throughout, some diplodia.	Requires permit to be removed , due to new parking lot
216A	Austrian Pine	<i>Pinus nigra</i>	Good	Good	1	52	3.6	Healthy	Requires permit to be removed , due to new access ramp
216B	Austrian Pine	<i>Pinus nigra</i>	Good-Fair	Fair	1	25	1.8	Bendy trunk, somewhat sparse, some diplodia.	Requires permit to be removed , due to new access ramp

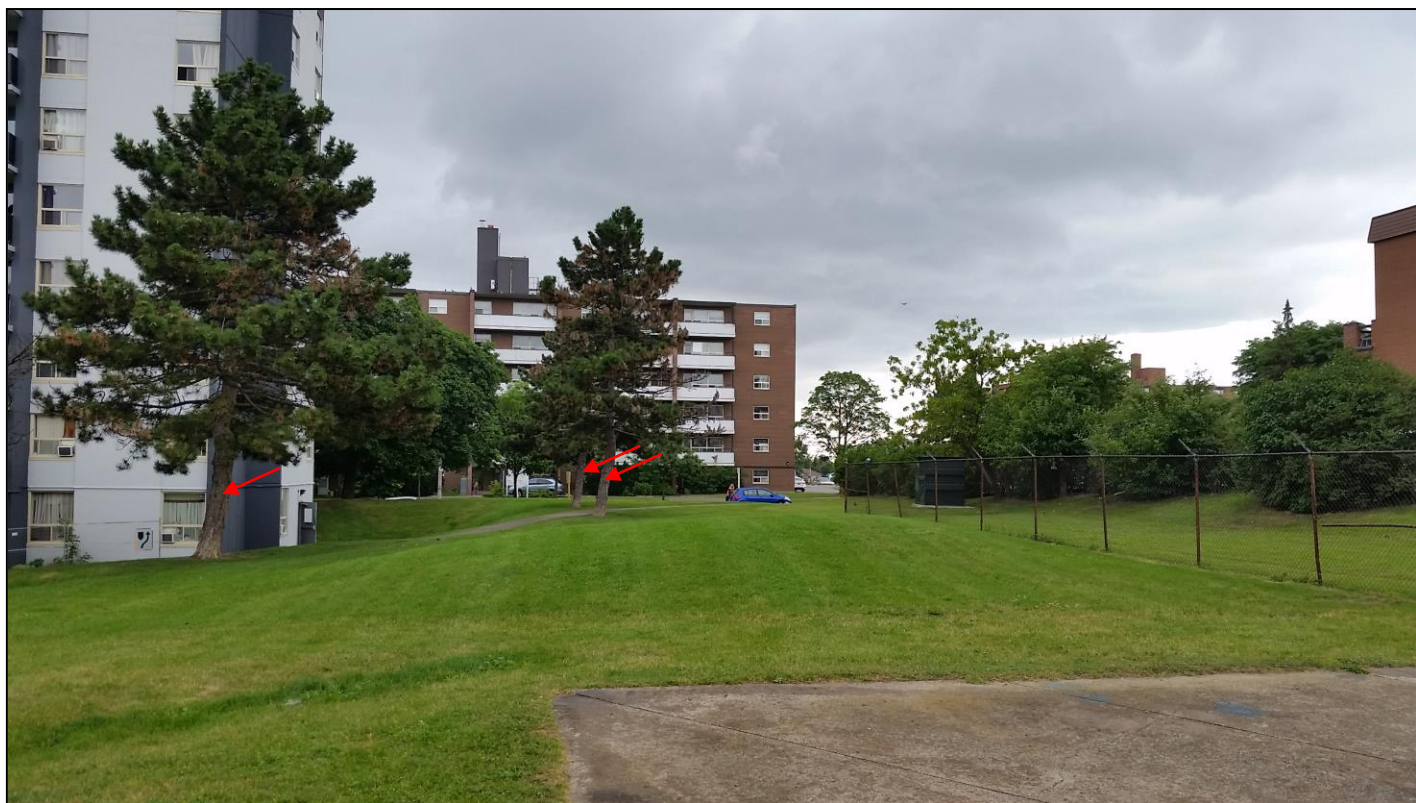
Photo 8: (Left to right) Trees 212, 210, and 211.

Trees #210 and 211 are located on private property, south of the existing 9-storey residential building on the southwestern end. The existing walkway, which is currently located 1.5m away from the base of tree 210 and 0.5 from the base of tree 211, will be modified to accommodate the new underground parking lot. All portions matching the existing footprint will remain as is throughout the construction process.

With the existing portions of the walkway remaining unchanged during the construction process, it is expected that tree 210 will tolerate encroachment within its TPZ if all recommendations are adhered to. Although the modified walkway occurs away from the critical root zone, tree 211 is in poor condition with approximately 60% of its canopy lost to Diplodia Tip Blight; for this reason, tree 211 is proposed for removal.

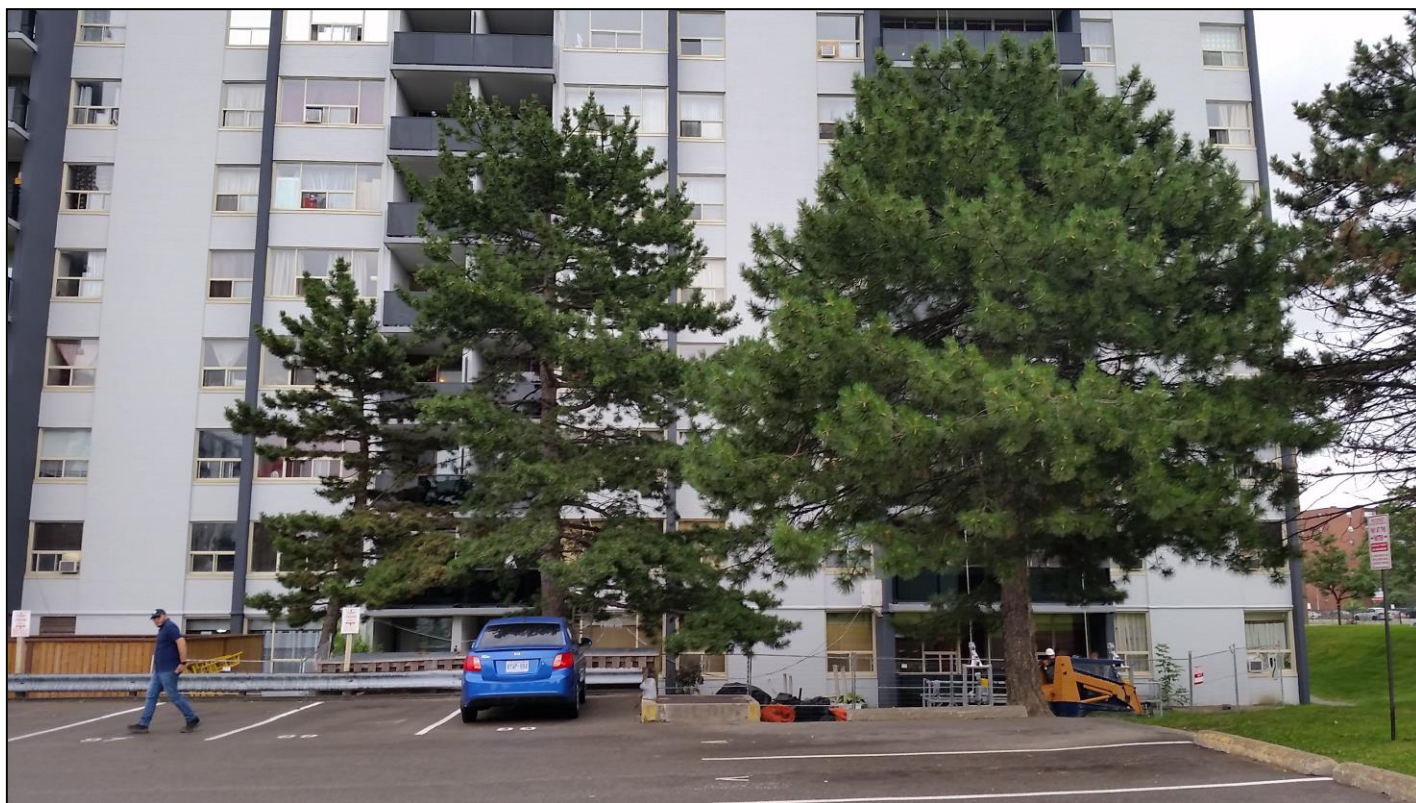
Photo 10: (Left to right) Trees 216B, 216A, and 216.

Across from 1480 Williamsport Drive, a new access ramp is proposed on the south side of the proposed building. The excavation associated with the new access ramp will encroach up to 0.5m from the base of **trees #216A and 216B**. At this distance, it is expected that structural roots would be encountered, which will cause destabilization if the roots were to be severed. Trees 216A and 216B require permits to be removed.

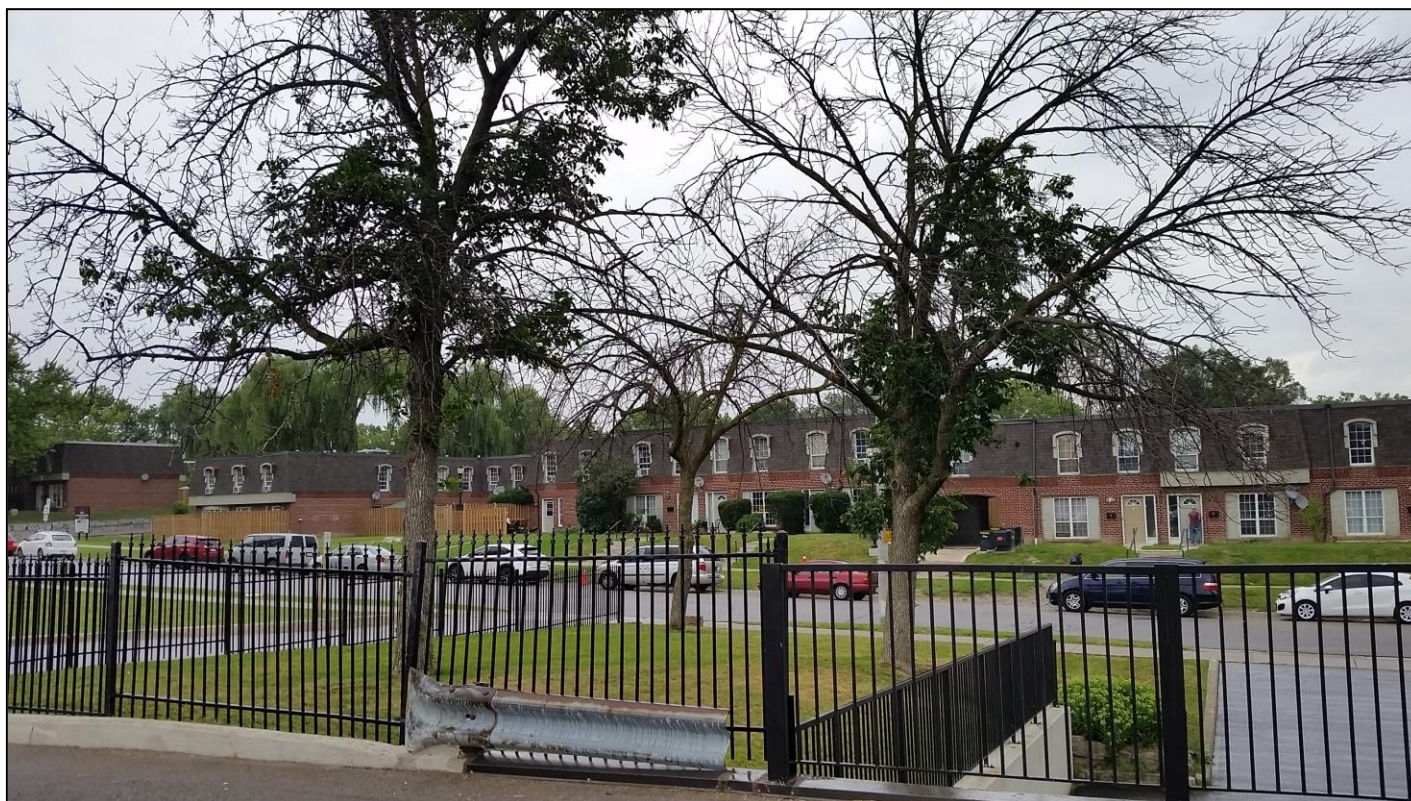
Photo 14: (Left to right) Trees 227, 225, and 226.

Trees #223 – 227, 241, and 242 are located within the subject property. The subject trees are Ash trees that have succumbed to Emerald Ash Borer (EAB) infestation and will require a permit to be removed.

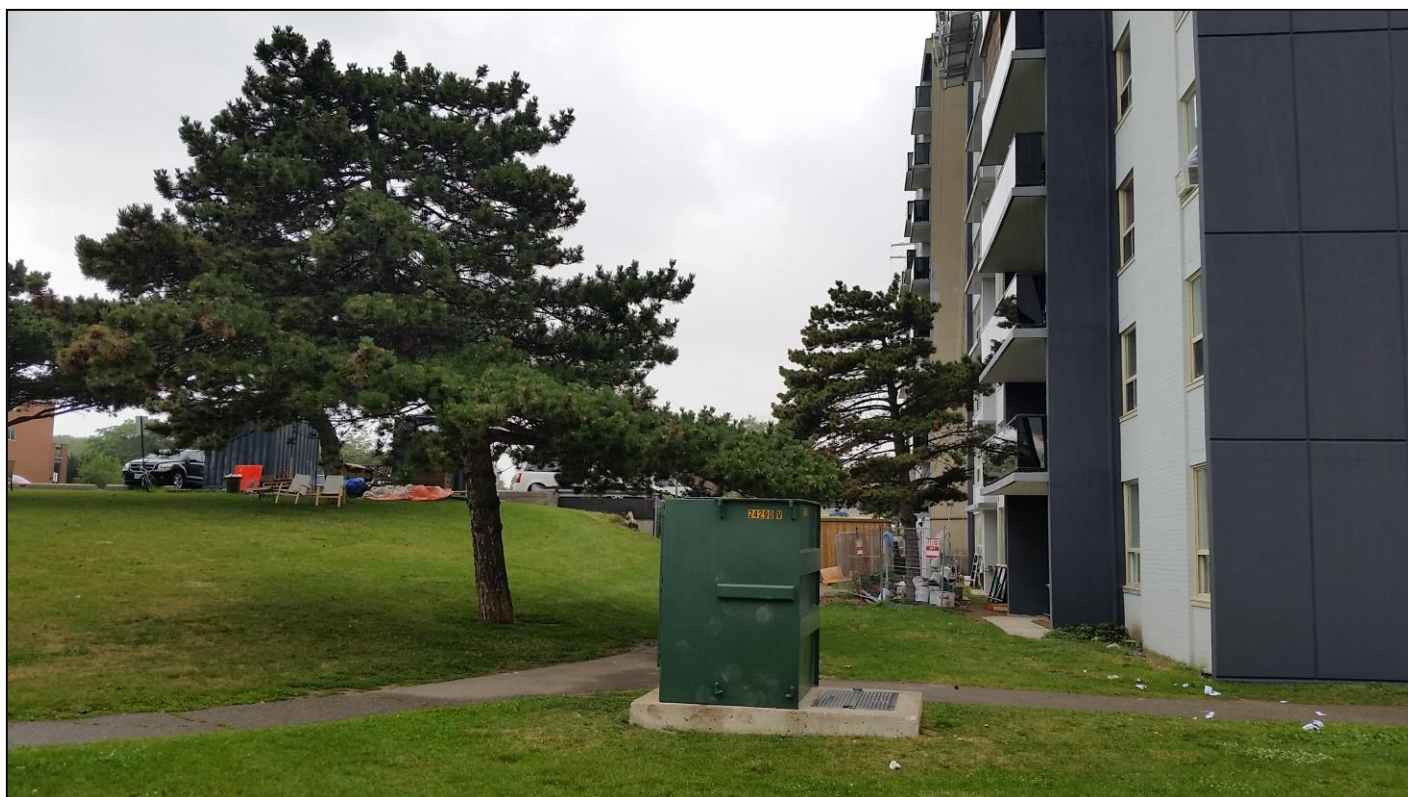
Photo 15: (Left to right) Trees 229 and 229A.

On the eastern side of the existing building at 3480 Havenwood Dr, a new walkway is proposed. The excavation associated with the new walkway will encroach up to the base of **tree #229A**; at this distance, it is expected that structural roots would be encountered, which would cause destabilization if severed. Tree 229A requires a permit to be removed.

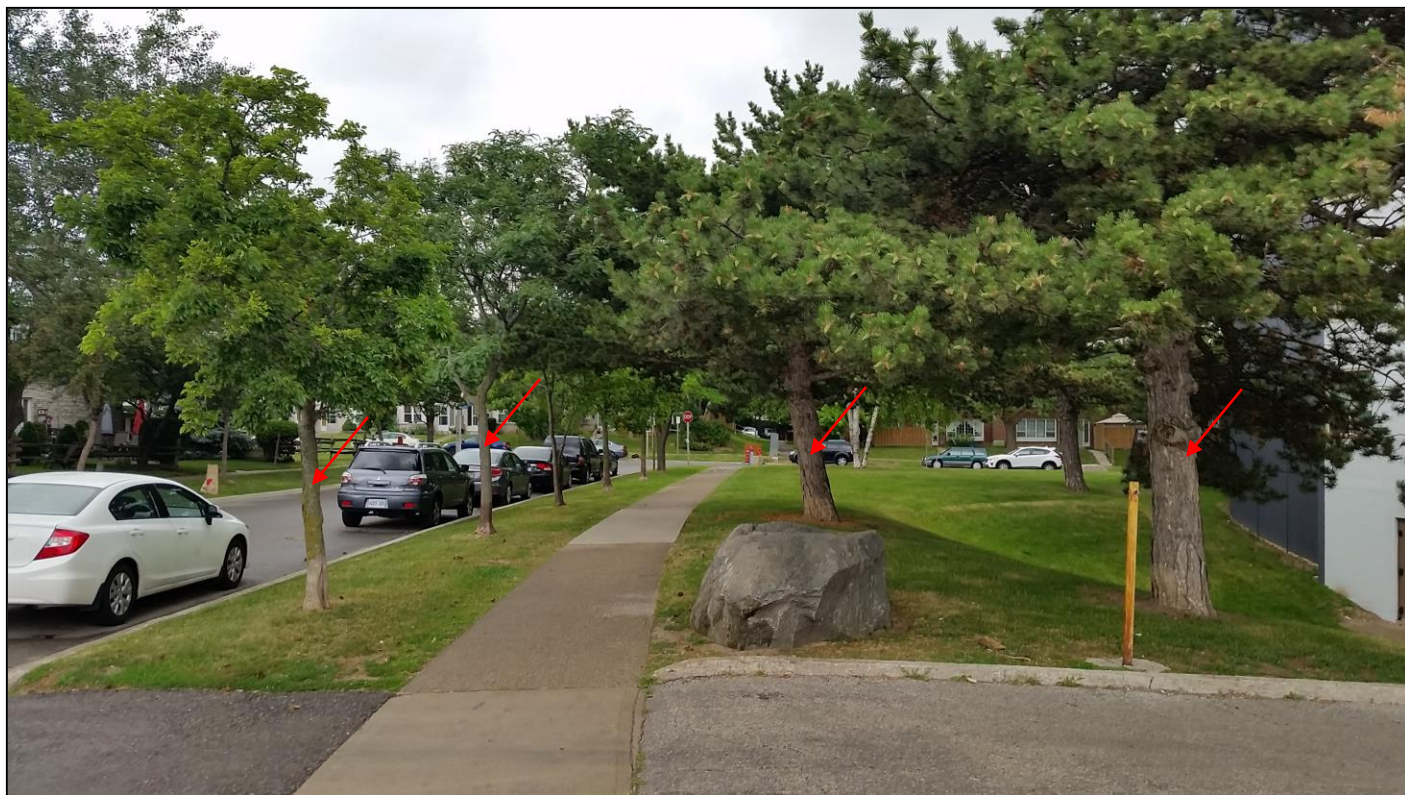
Photo 19: (Left to right) Trees 243D, 243C, 243B, and 243A.

Tree #243B and 243A are located within the subject property. The proposed driveway turnout close to Williamsport Drive is currently located approximately 2.0m away from the base of tree 243B and 1.0m from the base of tree 243A. At this distance, tree 243A cannot be preserved, as it is expected that structural roots would be encountered; an exploratory excavation must be conducted to determine whether tree 243B can be preserved. Tree 243A requires a permit to be removed.

243C	Honey Locust	<i>Gleditsia triacanthos</i>	Good	Fair	3	17	1.8	Recent failures, trunk wounds	Tree requires encroachment into TPZ and is slated for preservation.
243D	Hackberry	<i>Celtis occidentalis</i>	Fair	Fair	3	15	1.8	Wounds at base. dieback throughout. Small dead wood throughout	Requires permit to be removed , due to new curb cut
243E	Honey Locust	<i>Gleditsia triacanthos</i>	Good	Good	3	15	1.8	Small dead wood throughout	Fully protect
243F	Ash	<i>Fraxinus sp.</i>	Good	Good	3	18	1.8	Healthy, holes Emerald Ash Borer infested	Fully protect
243G	Honey Locust	<i>Gleditsia triacanthos</i>	Fair-Poor	Good	3	9	1.2	Sparse, small dead wood throughout	Fully protect

Under the current plan, exploratory excavation is required within the minimum Tree Protection Zone (TPZ) of **Tree #243B** for the installation of the new driveway turnout to assess impact to the root system.

- A qualified arborist must be on site for the complete duration of each dig. It is the arborist's duty to instruct the laborers and minimize damage to the trees.
- The arborist is also responsible for all root pruning, and to promote 'working around' roots whenever possible.
- All excavation/digging is to be done by hand down to a depth of 0.45m
- Roots with a diameter 4cm and under may be pruned according to proper arboricultural standards – clean cuts with sharp and sanitized tools; exposed root end to be covered with soil
- If roots with a minimum diameter of 5cm or a plethora of roots are encountered during the excavation, the garage must be redesigned to accommodate the roots
- All excavation within the TPZ of a protected tree is to be documented; a report of the findings should then be submitted to Urban Forestry
