## ARBORIST REPORT

DATE: OCTOBER 23, 2017

1315 SILVER SPEAR ROAD  
CITY OF MISSISSAUGA

MBTW PROJECT No: SIS 001

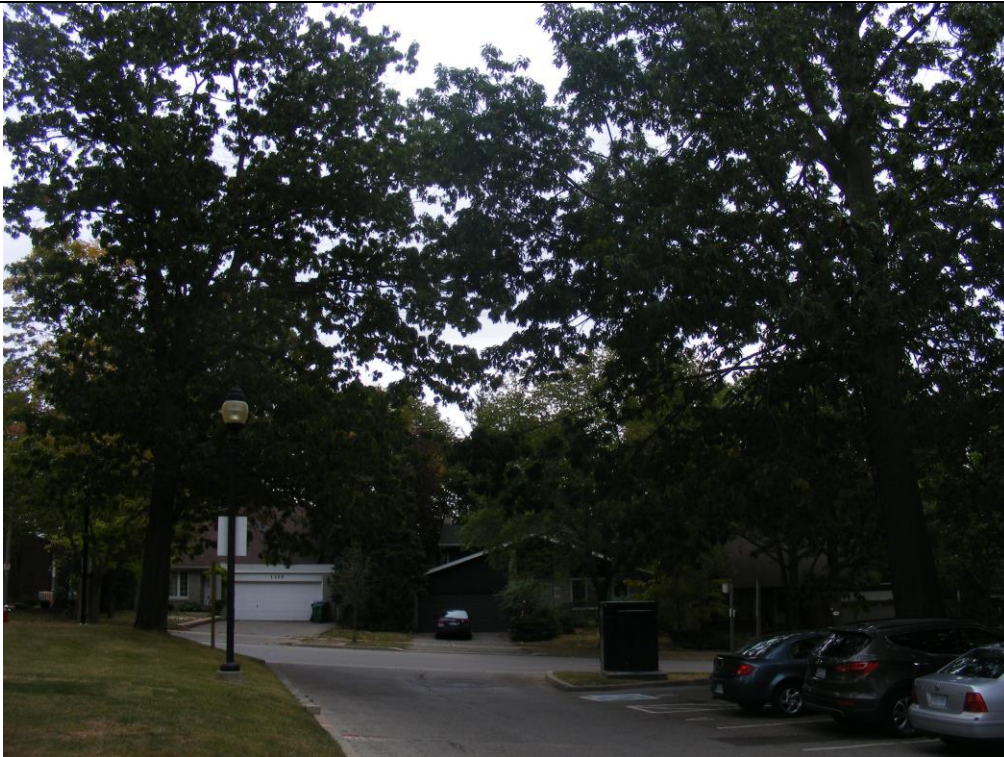
Image #1: View south of trees #571 (left) and #501 (right)

The three trees numbered 501, 532 and 546 can be retained but it is anticipated that they will be injured due to proposed excavation located within the dripline of their canopy. It is recommended that tree root pruning and canopy reduction be conducted by an ISA Certified Arborist prior to construction so that the likelihood for machinery damage to the tree roots and canopy can be reduced.

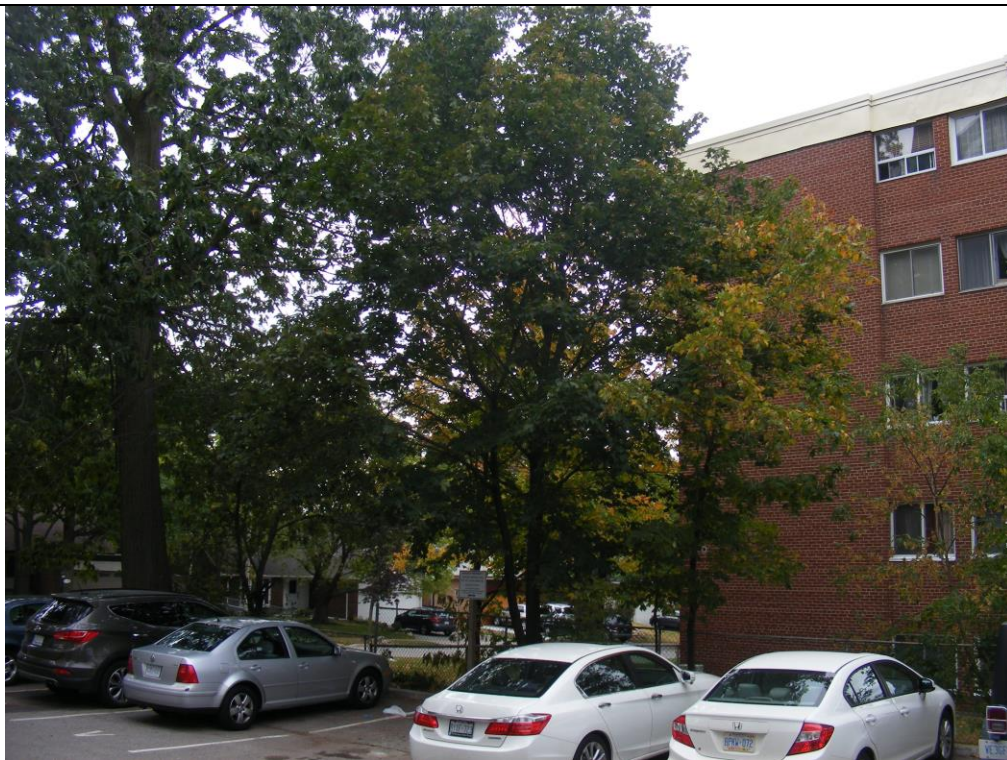
Tree # 503 is a 24cm dbh Norway Maple that is growing through the existing chain link fence and the trunk is girdled as a result. It is recommended that this tree be removed due to its existing trunk damage.

Two trees below 15cm in dbh were documented to be growing along the shared property boundary with 1275 Silver Spear Road. The Sugar Maple # 504 at 12cm in dbh was observed to be damaged due to girdling of the trunk by the adjacent chain link fence. It is recommended that this tree be removed.

Image #2: View southwest to trees #501 (left) to #504 (right).

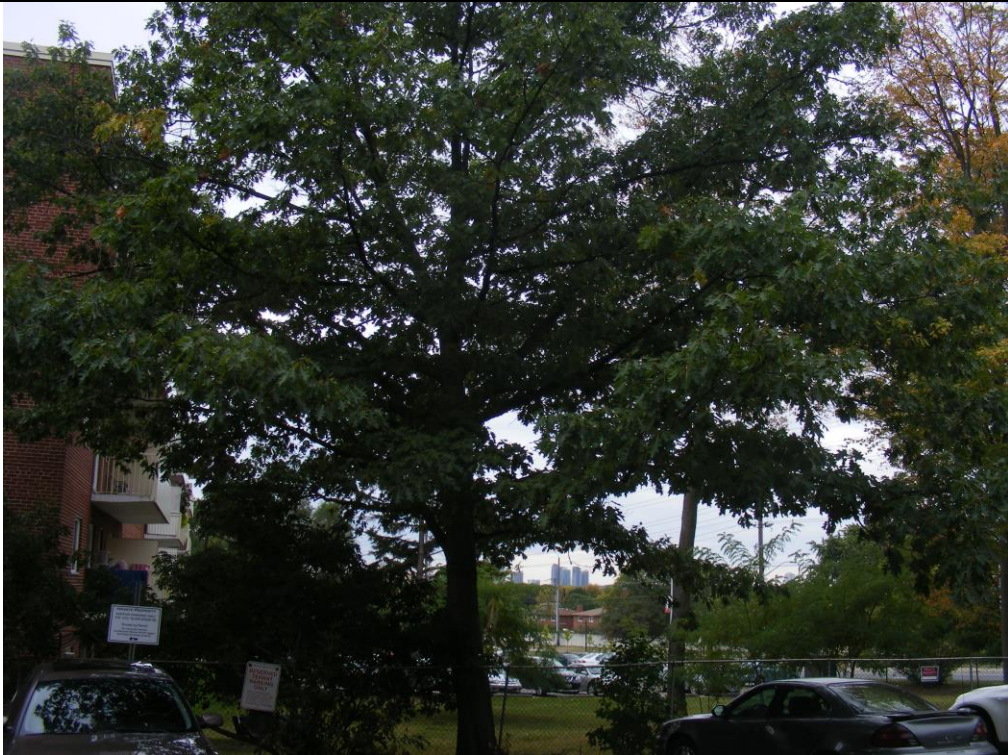
The tree #505 is a 48cm dbh Red Oak tree located on the west side of the chain link fence. This tree will be severely damaged by the proposed parking lot structure as the excavation and grading work will necessitate the removal of the eastern half of the root plate of this tree. The anticipated scope of injury is very severe and it is anticipated that the loss of the root ball will likely cause the tree to die and predispose the tree to collapse during high wind events. It is the recommendation of the arborist the tree #505 be removed due to conflicts with the proposed underground parking layout.

Image #3: View west to tree #505.

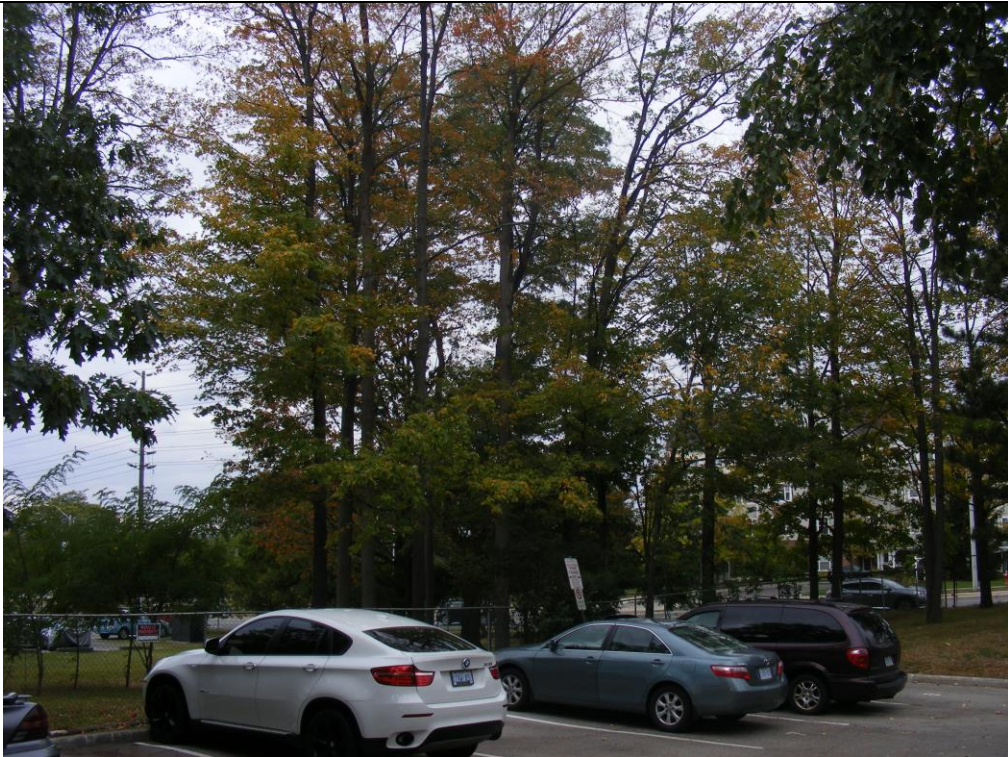
Tree # 506 is a White Ash tree at 12cm in dbh that is located on the shared property boundary with 1275 Silver Spear Road. This tree is infected with the Emerald Ash Borer at the time of inspection and it is anticipated that this tree will die from the feeding activities of the borer in 2 to 3 years. It is the professional opinion of the arborist that this tree be removed.

Image #4: View northwest of trees #506 to #508

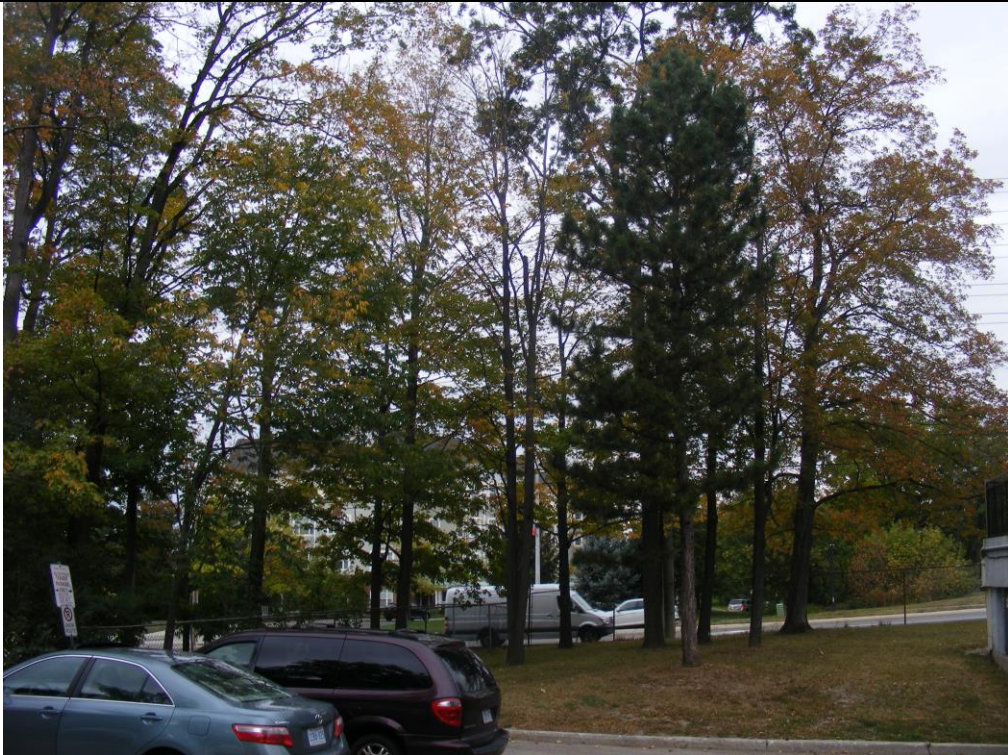
Image #5: view north of trees #507 to #513.

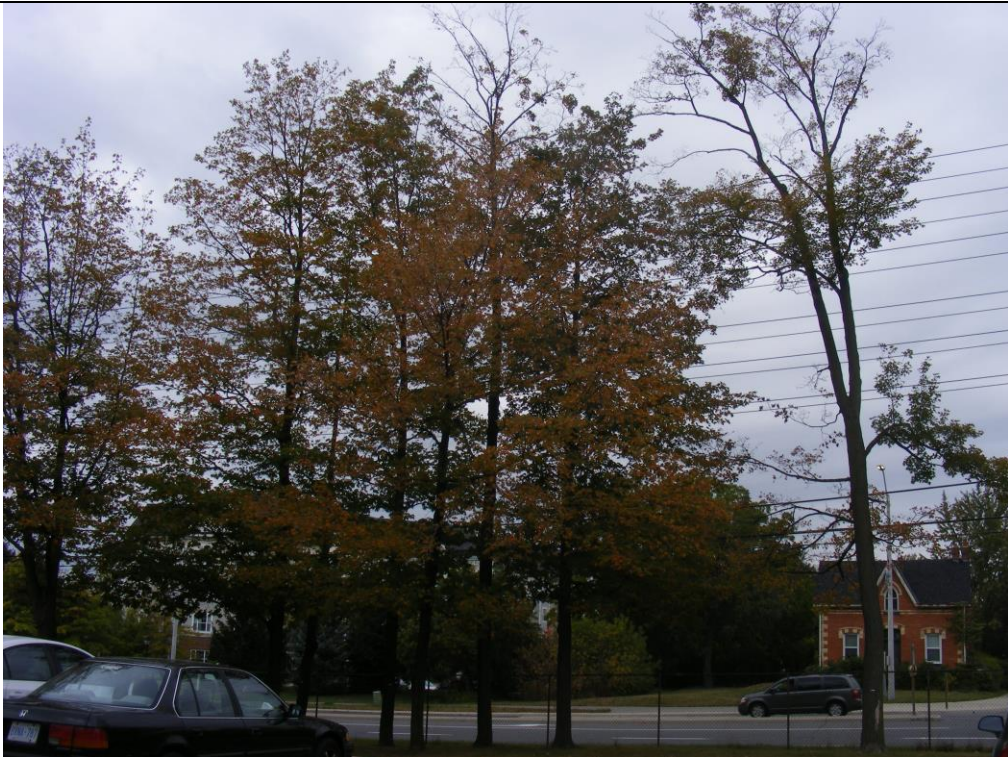
Image #6: View north of trees #514 (left) to #521 (far right)

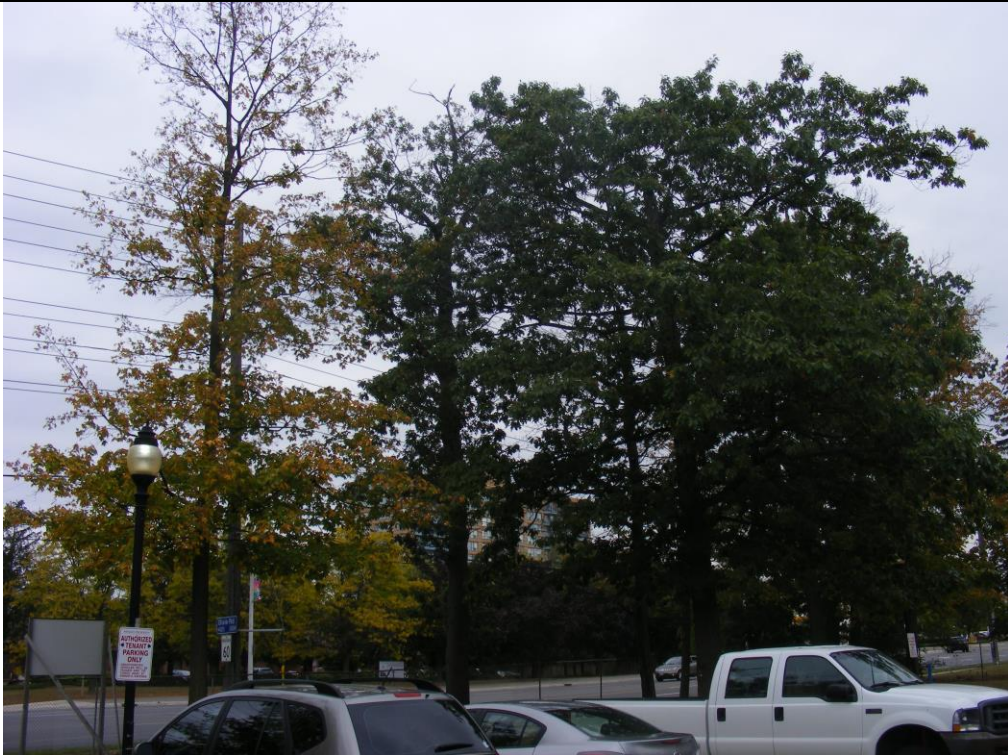
Image #7: View north of trees #522 (left) to #532 (far right)

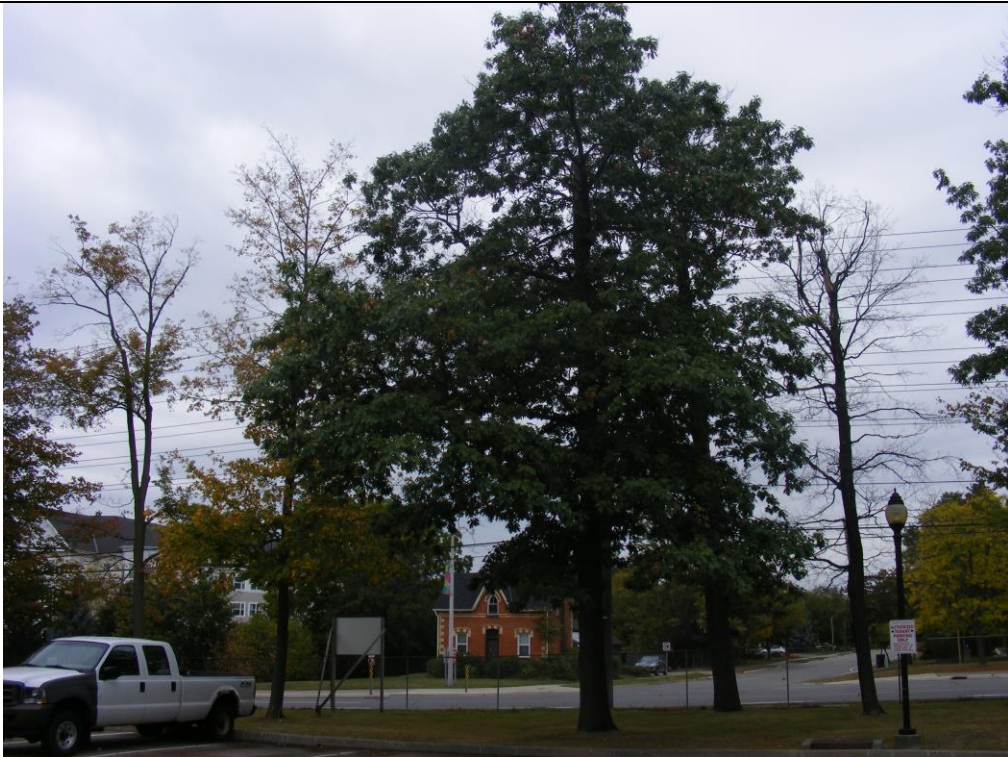
Image #8: View north of trees #523 (middle) and dead tree #525 (right)

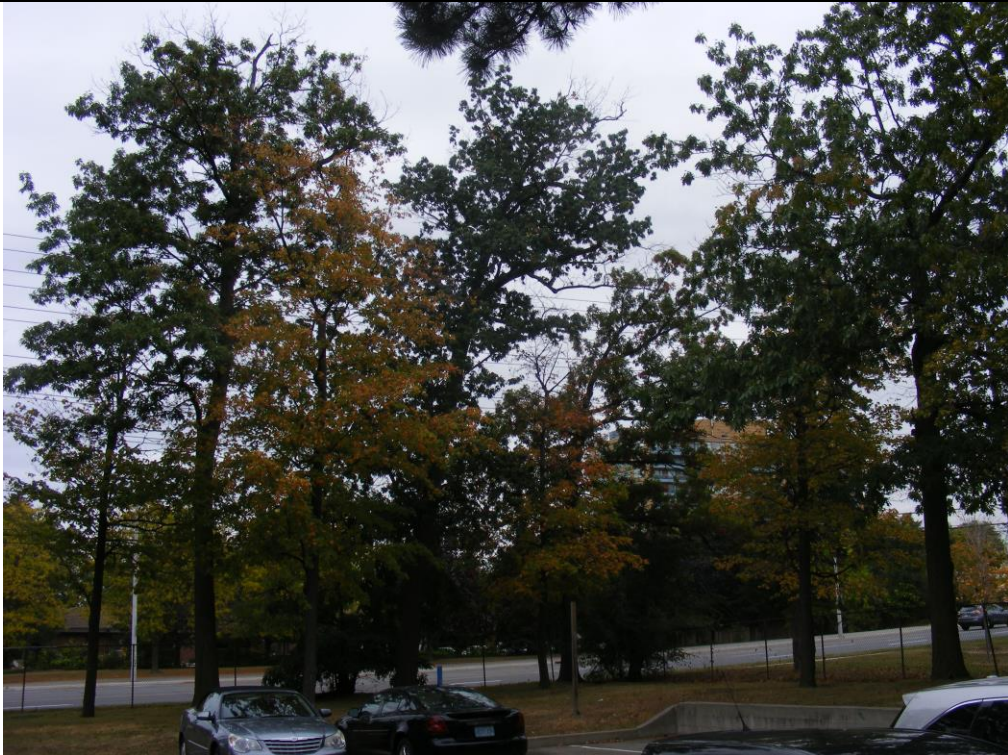
Image #9: View northeast of trees #526 (left) to #535 (right)

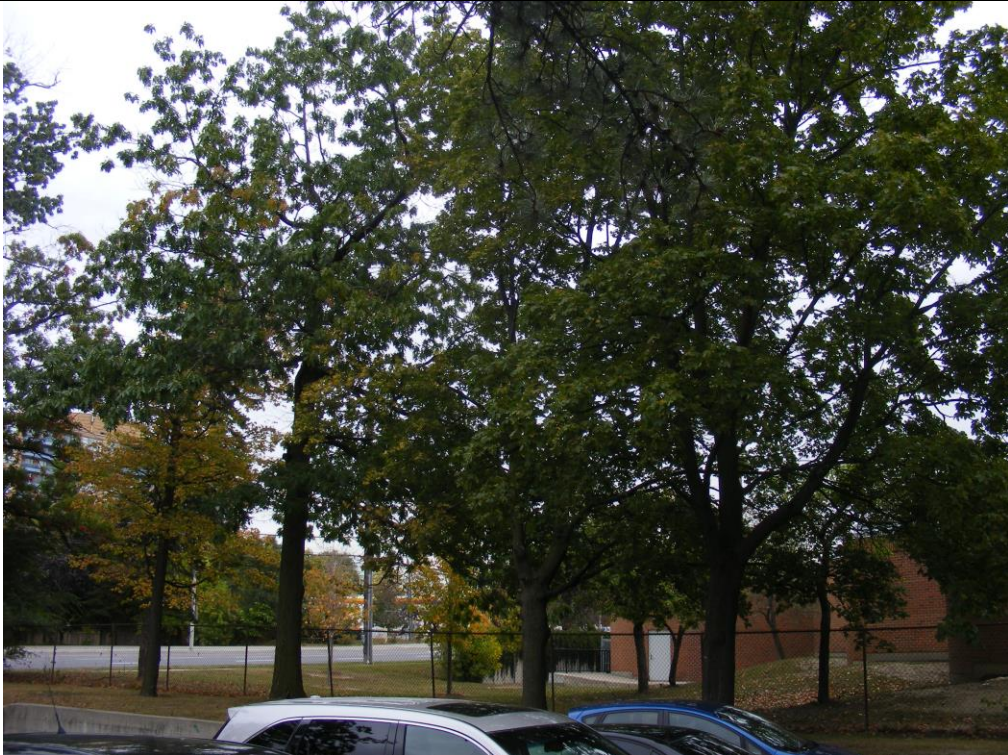
Image #10: View east of trees #534 (left) to #537 (right)

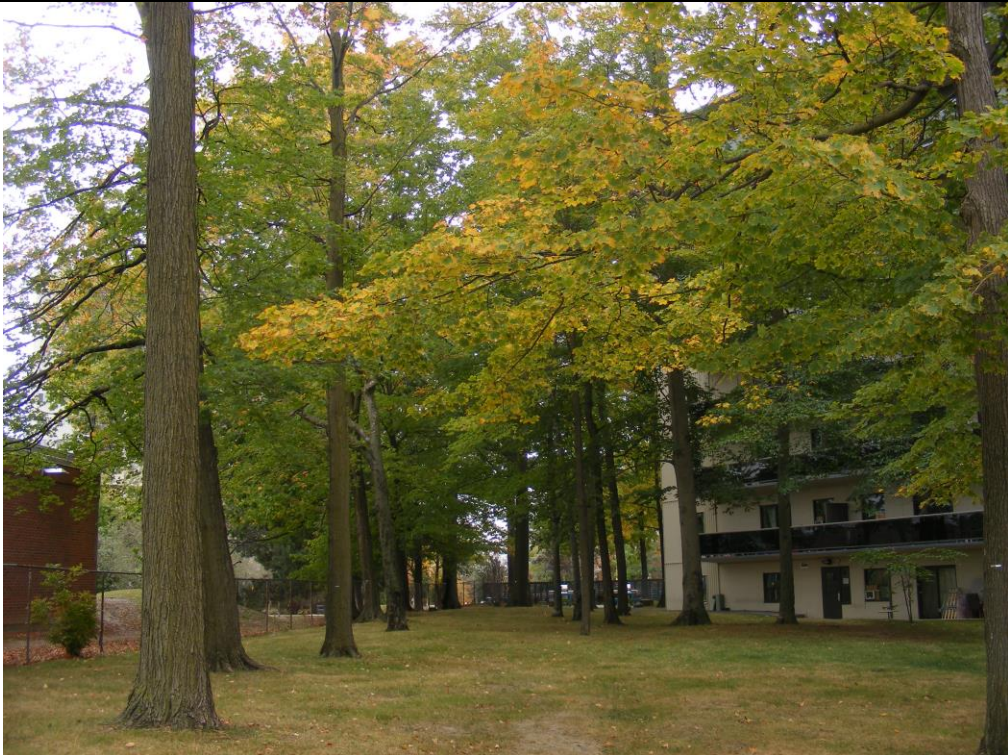
Image #11: View south of trees cluster #538 to #566, east of existing apartment building.

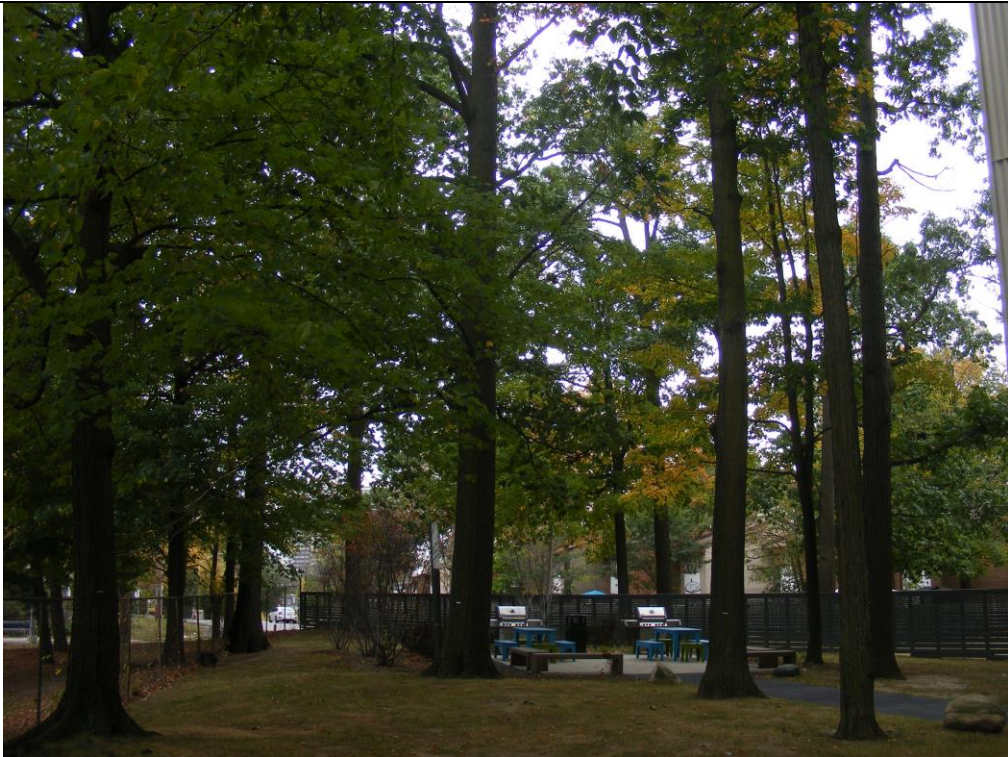
Image #12: View of southeast of tree cluster around existing BBQ station (trees #559 to #565)

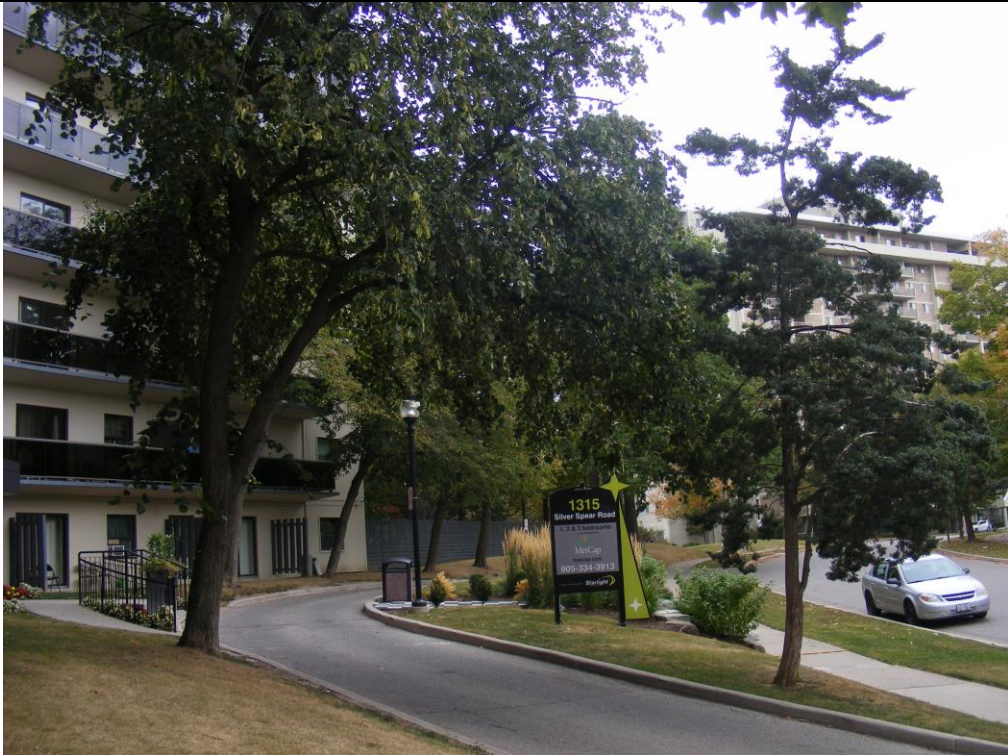
Image #13: View east from of circular driveway on the south entrance of apartment complex (trees #572 to #576 and #581)

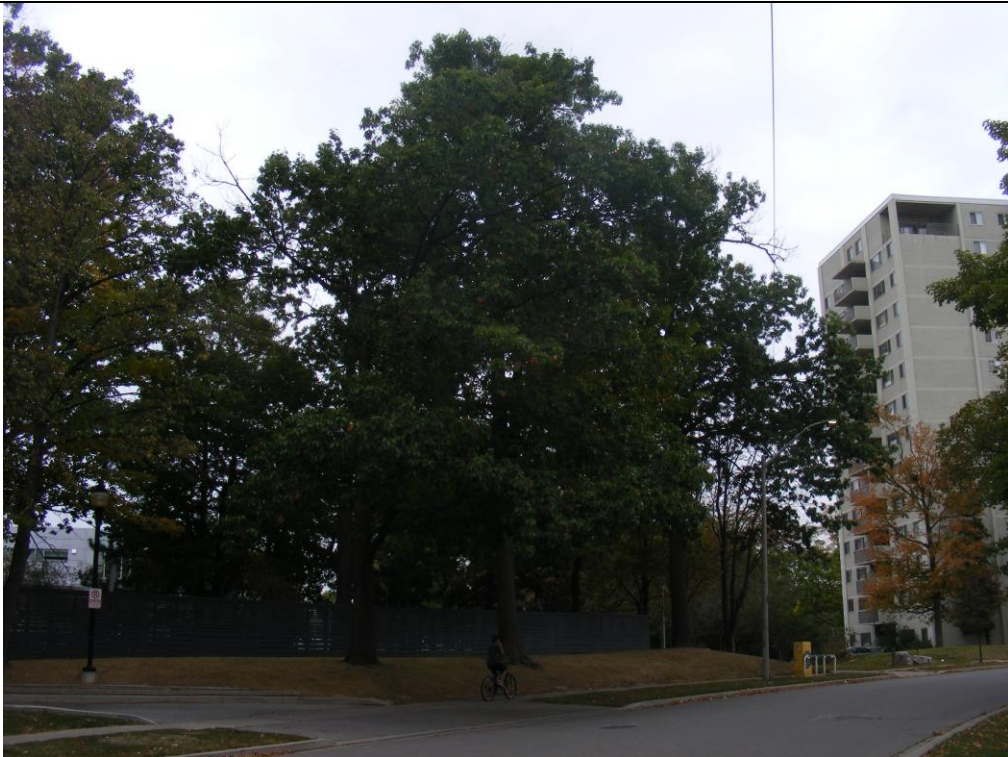
Image #14: View north of trees along Silver Spear Road frontage of property. Trees #577 (left) to #580 (right).
