BEL 217069

Re: Arborist Report for 51 and 57 Tannery Street and 208 Emby Ave, Mississauga, ON

PROJECT: **51 & 57 TANNERY STREET MISSISSAUGA**

SHEET TITLE: **TREE INVENTORY AND PRESERVATION PLAN**

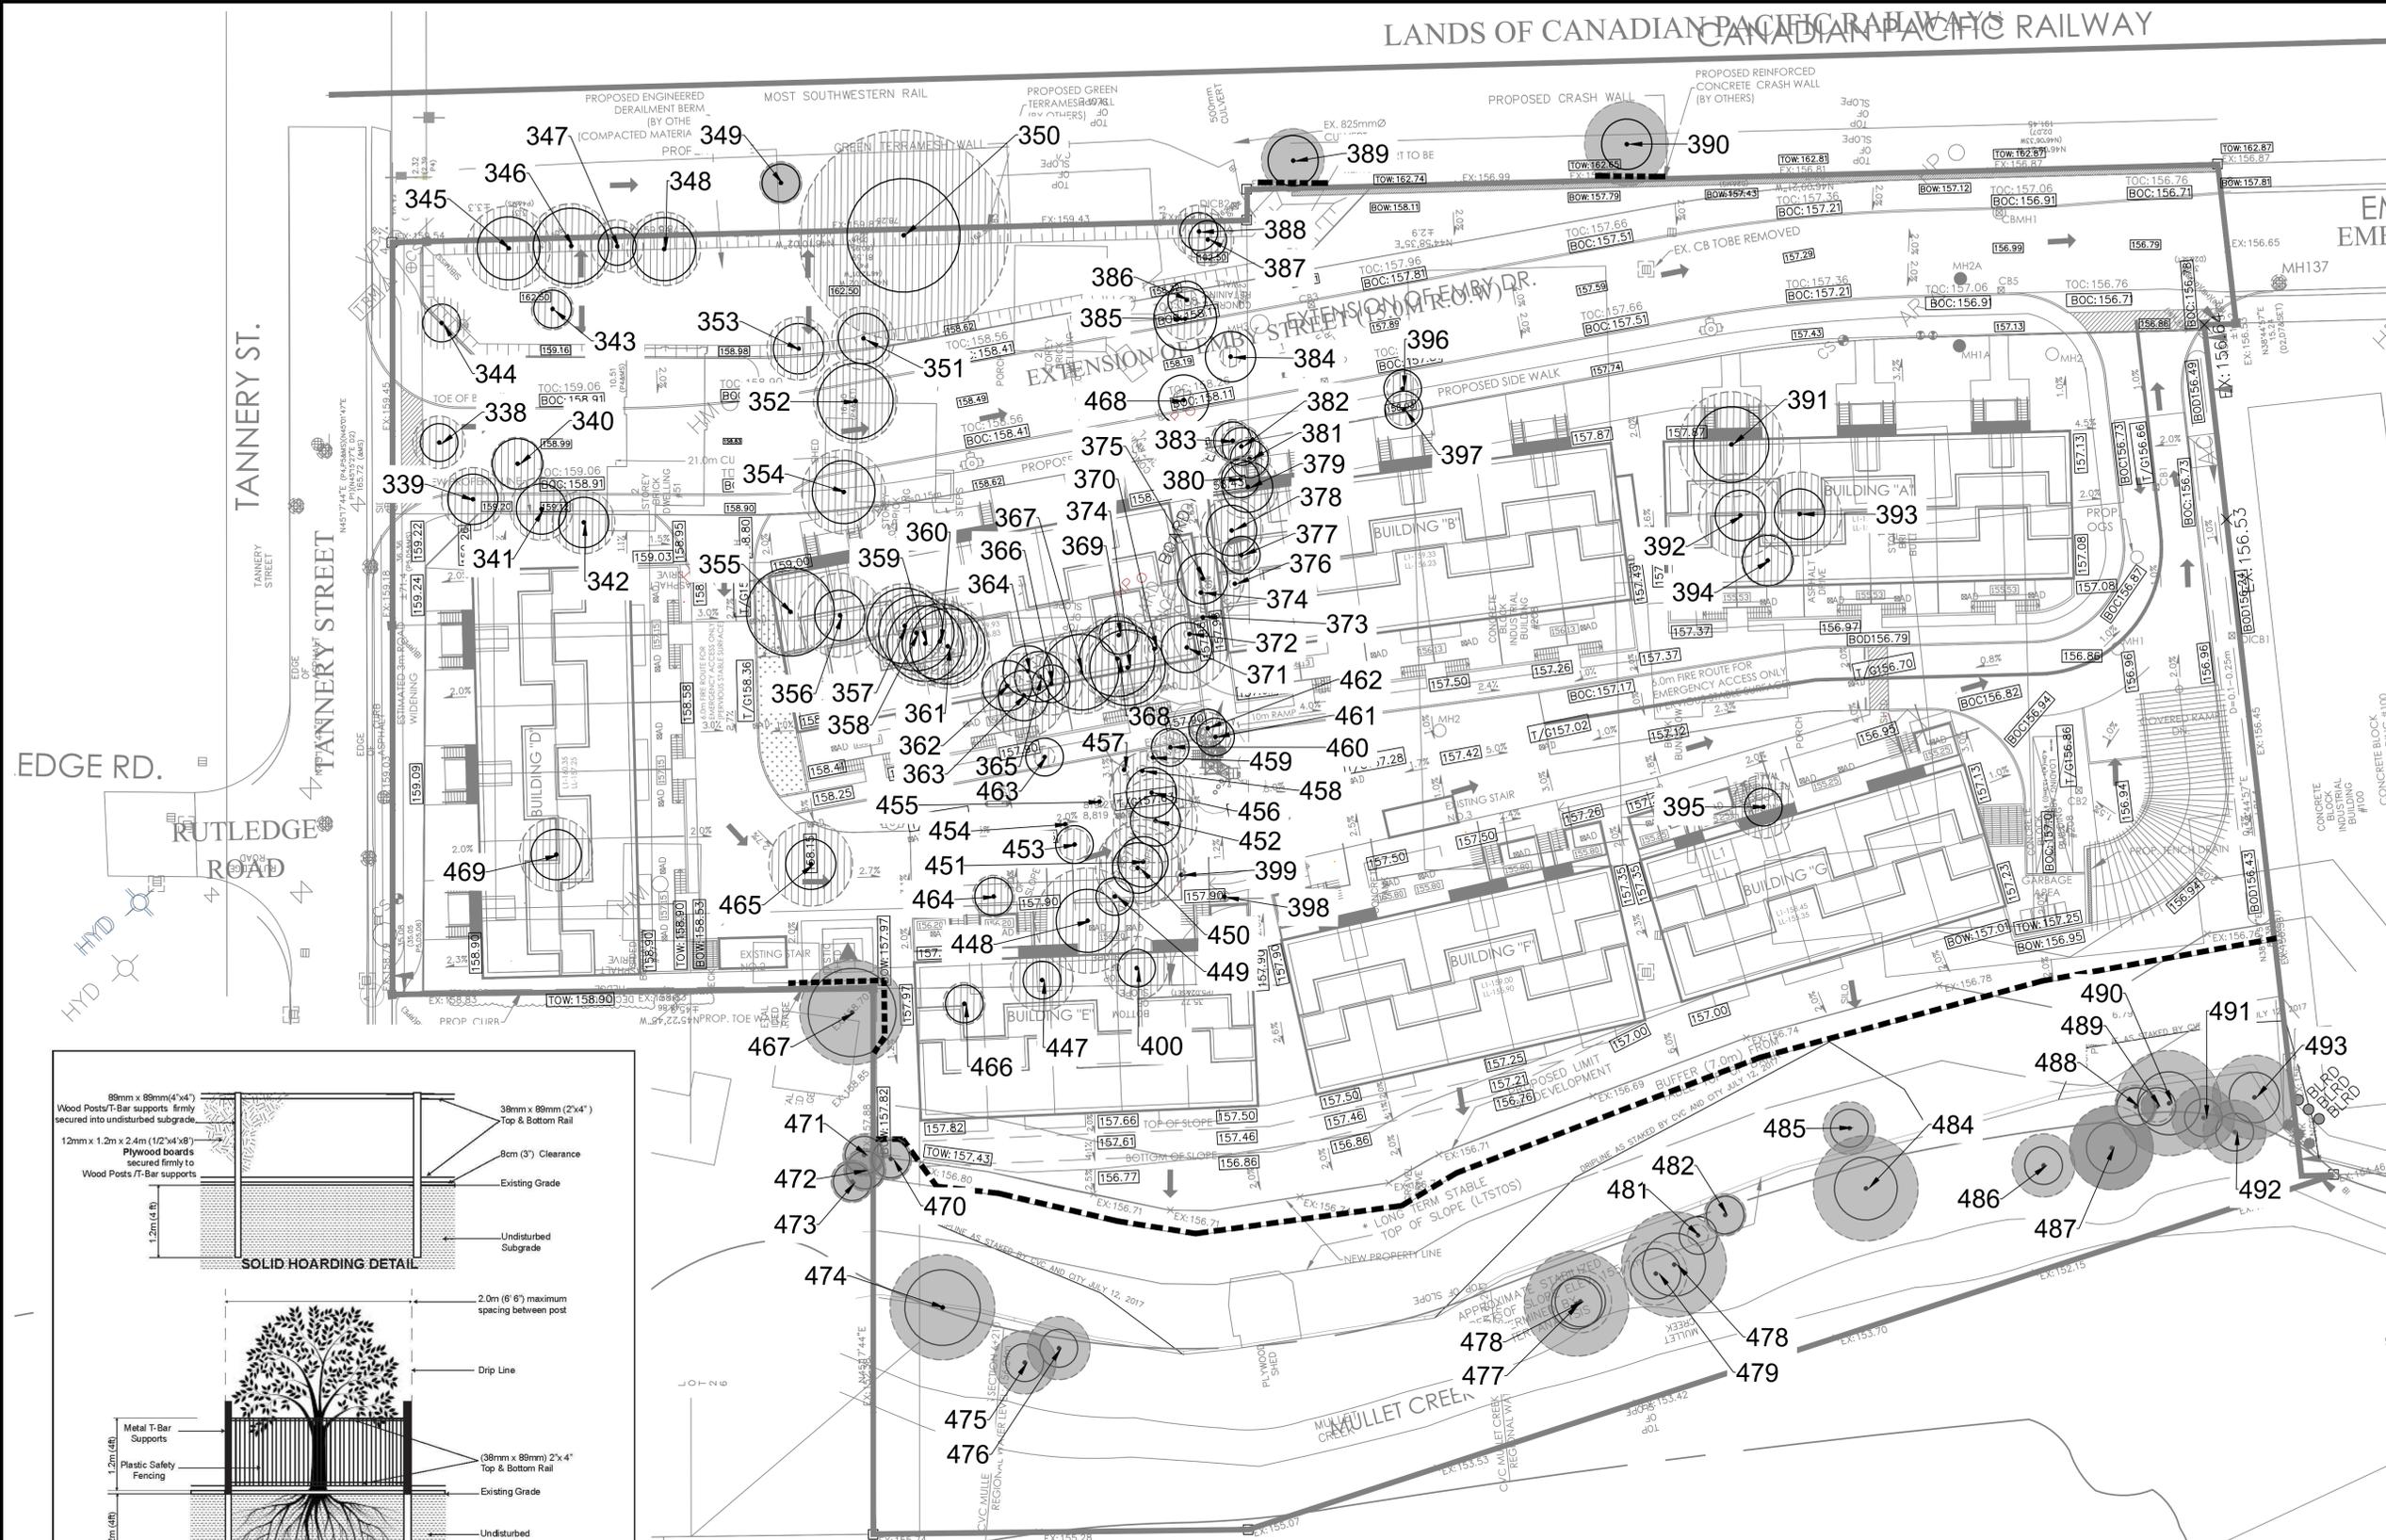
DRAWN BY: NC FIGURE NO: 1

A total of 110 trees were inventoried on and adjacent to the subject property. A complete list of trees is provided in **Appendix A**. Tree locations are illustrated in **Figure 1**. Trees range in size from 10 to 95 cm DBH, with a median DBH of 22 cm. The majority of the trees are Manitoba Maple. A summary of the species and size class distribution is provided in **Table 1**. Tree condition is summarized as follows:

A total of 82 trees are recommended for removal to accommodate the proposed development (see **Figure 1**), of which 35 are in fair or good condition, 27 are in poor condition, 10 are in fair-poor condition, and 10 are dead. The majority are Manitoba Maple.

A total of 28 trees are identified for preservation (see **Figure 1** and **Appendix A**), primarily along Mullet Creek.

Trees to be retained shall be protected through the establishment of a tree protection zone (TPZ). The minimum recommended TPZ's are based on the DBH of the tree as indicated in **Table 2** and illustrated on **Figure 1**. While not explicitly recognized by the City of Mississauga, comparable TPZs are accepted in other area municipalities, including the City of Toronto, City of Burlington, the Town of Richmond Hill, and the Town of Aurora.

The TPZ should be demarcated with tree protection hoarding consisting of 1.2 m orange plastic fencing framed with solid top and bottom rail, or 1.2 m plywood (see **Figure 1** for fence location and detail), or an alternative approved by the City. Fencing should be installed before any construction or site alteration takes place.
