**GEOTECHNICAL INVESTIGATION FOR
PERFORMING SLOPE STABILITY ANALYSIS
PROPOSED DEVELOPMENT
51 TANNERY STREET
MISSISSAUGA, ONTARIO**

Project 37105
May 21, 2019
March 24, 2017

**Geotechnical Investigation For
Performing Slope Stability Analysis
Proposed Development
51 Tannery Street
Mississauga, Ontario**

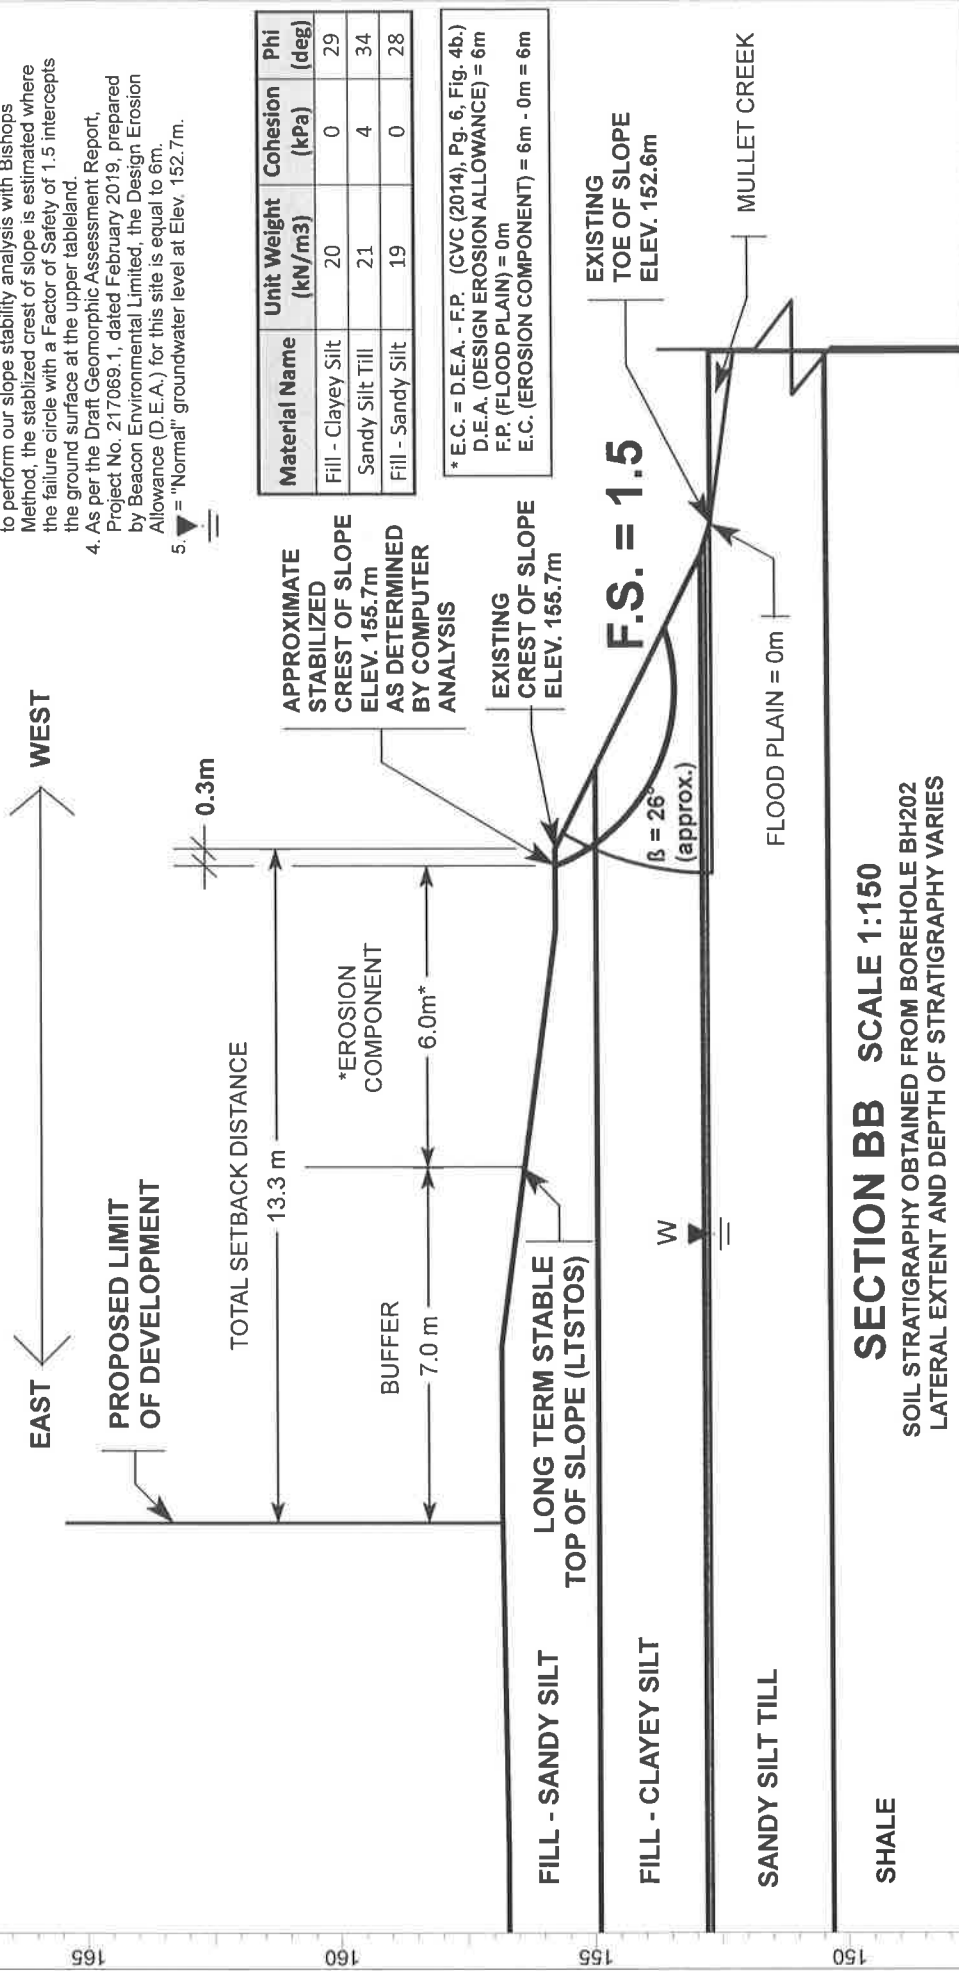
FIGURE 1B: "NORMAL" GROUNDWATER LEVELS PROPOSED DEVELOPMENT 51 TANNERY STREET, MISSISSAUGA, ONTARIO

The stabilized crest of the slope with a failure circle that has a minimum factor of safety of 1.5 which intercepts the ground surface at the upper tablelands is indicated on our Section AA (Figure 1A), Section BB (Figure 1B), Section CC (Figure 1C) and Section DD (Figure 1D). From the existing crest of the slope, it is located inward by a distance of 0.3m, 0.3m, 0.4m and 0.6m, for Section AA, Section BB, Section CC and Section DD, respectively. A standard precaution is to add the Erosion Component of Setback (E.C.) distance of 6m, 6m, 6m and 0.2m, for Section AA, Section BB, Section CC and Section DD, respectively, as discussed in Item 4.2 of this report. Furthermore, to add a 7m buffer distance at each section. Relative to the existing crest, the above results yield total combined setback distances of 13.3m, 13.3m, 13.4m and 7.8m for Section AA, Section BB, Section CC and Section DD, respectively. These total combined setback distances at each section, we referred to as the "Proposed Limit of Development". Development of the buildings can then take place inward of the "Proposed Limit of Development". This is illustrated in Figures 1A, 1B, 1C and 1D.

Project	37105 - Proposed Development - 51 Tannery Street, Mississauga, Ontario		
Analysis Description	SECTION BB - EXISTING SLOPE - "NORMAL" GROUNDWATER LEVELS - BISHOP'S METHOD		
Drawn By	S.B.	Scale	1:150
Date	2019-02-25		Company Patriot Engineering Ltd.
			File Name 37105-SectionBB.slim
			Figure: 1B

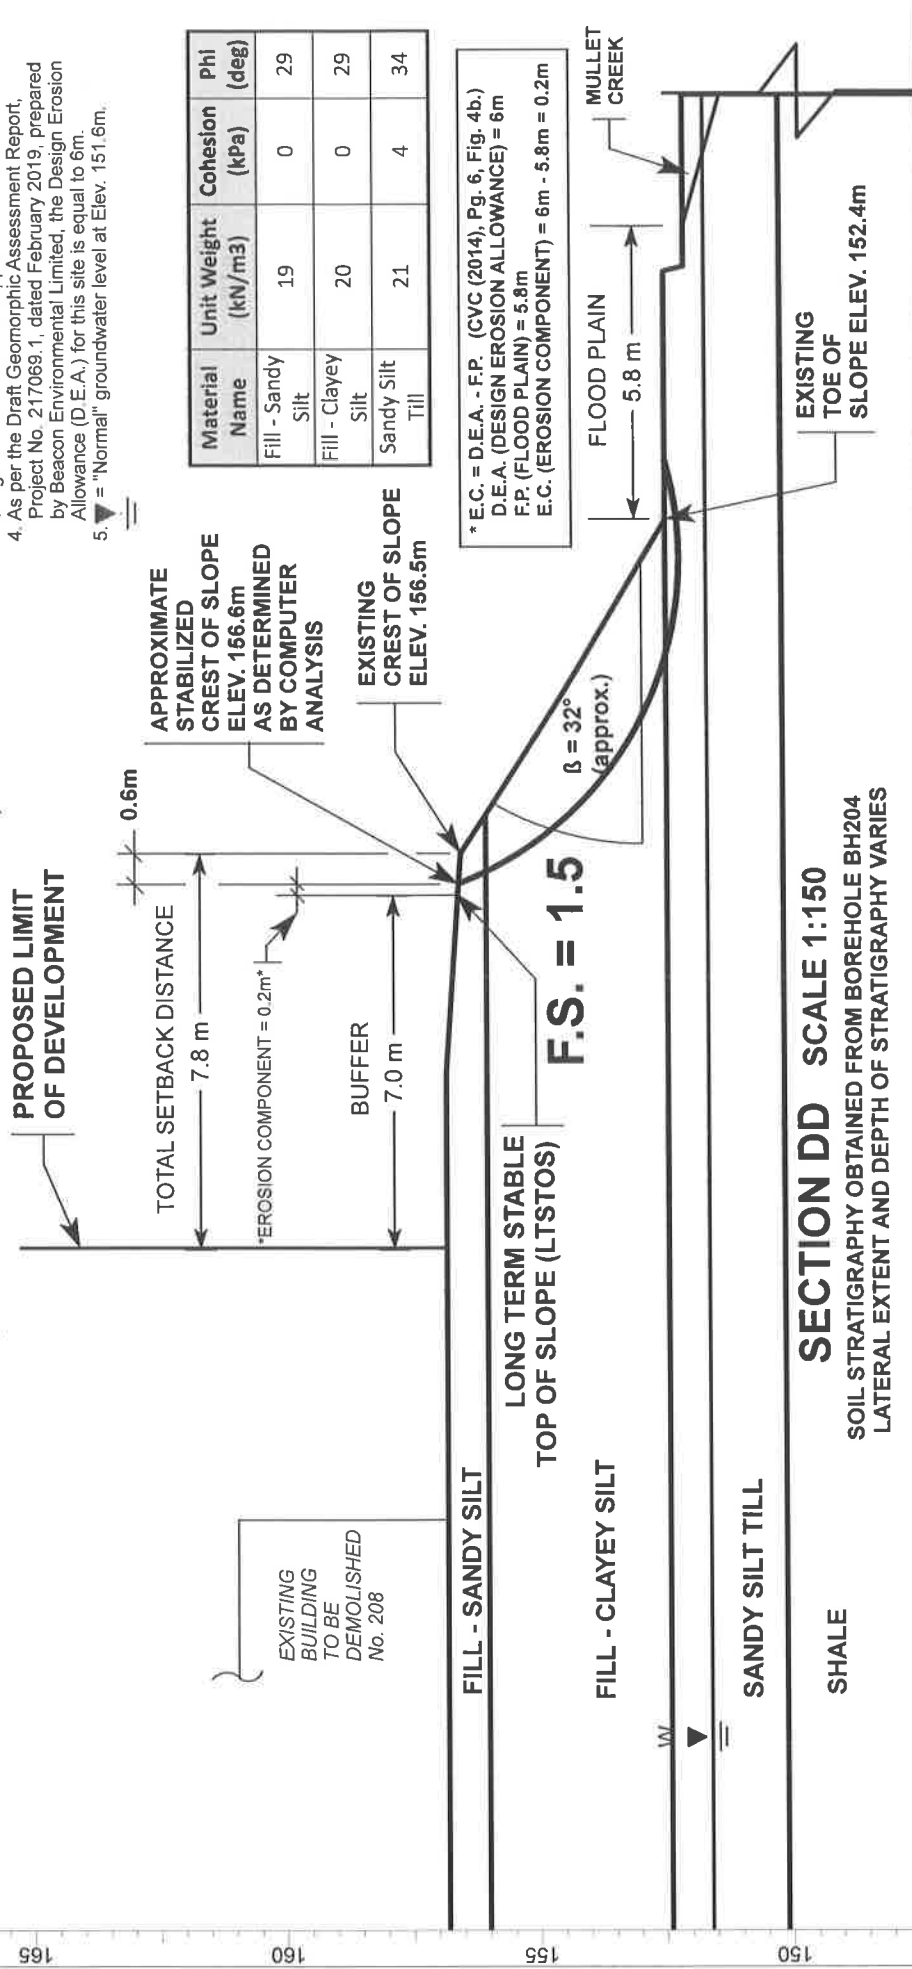
SECTION DD SCALE 1:150
SOIL STRATIGRAPHY OBTAINED FROM BOREHOLE BH204
LATERAL EXTENT AND DEPTH OF STRATIGRAPHY VARIES

<p>PATRIOT ENGINEERING LTD. Consulting Engineers</p>	Project 37105 - Proposed Development - 51 Tannery Street, Mississauga, Ontario	
	Analysis Description SECTION DD - EXISTING SLOPE - "NORMAL" GROUNDWATER LEVELS - BISHOP'S METHOD	
Drawn By S.B.	Scale 1:150	Company Patriot Engineering Ltd.
Date 2019-02-25	File Name 37105-SectionDD.slim	Figure: 1D

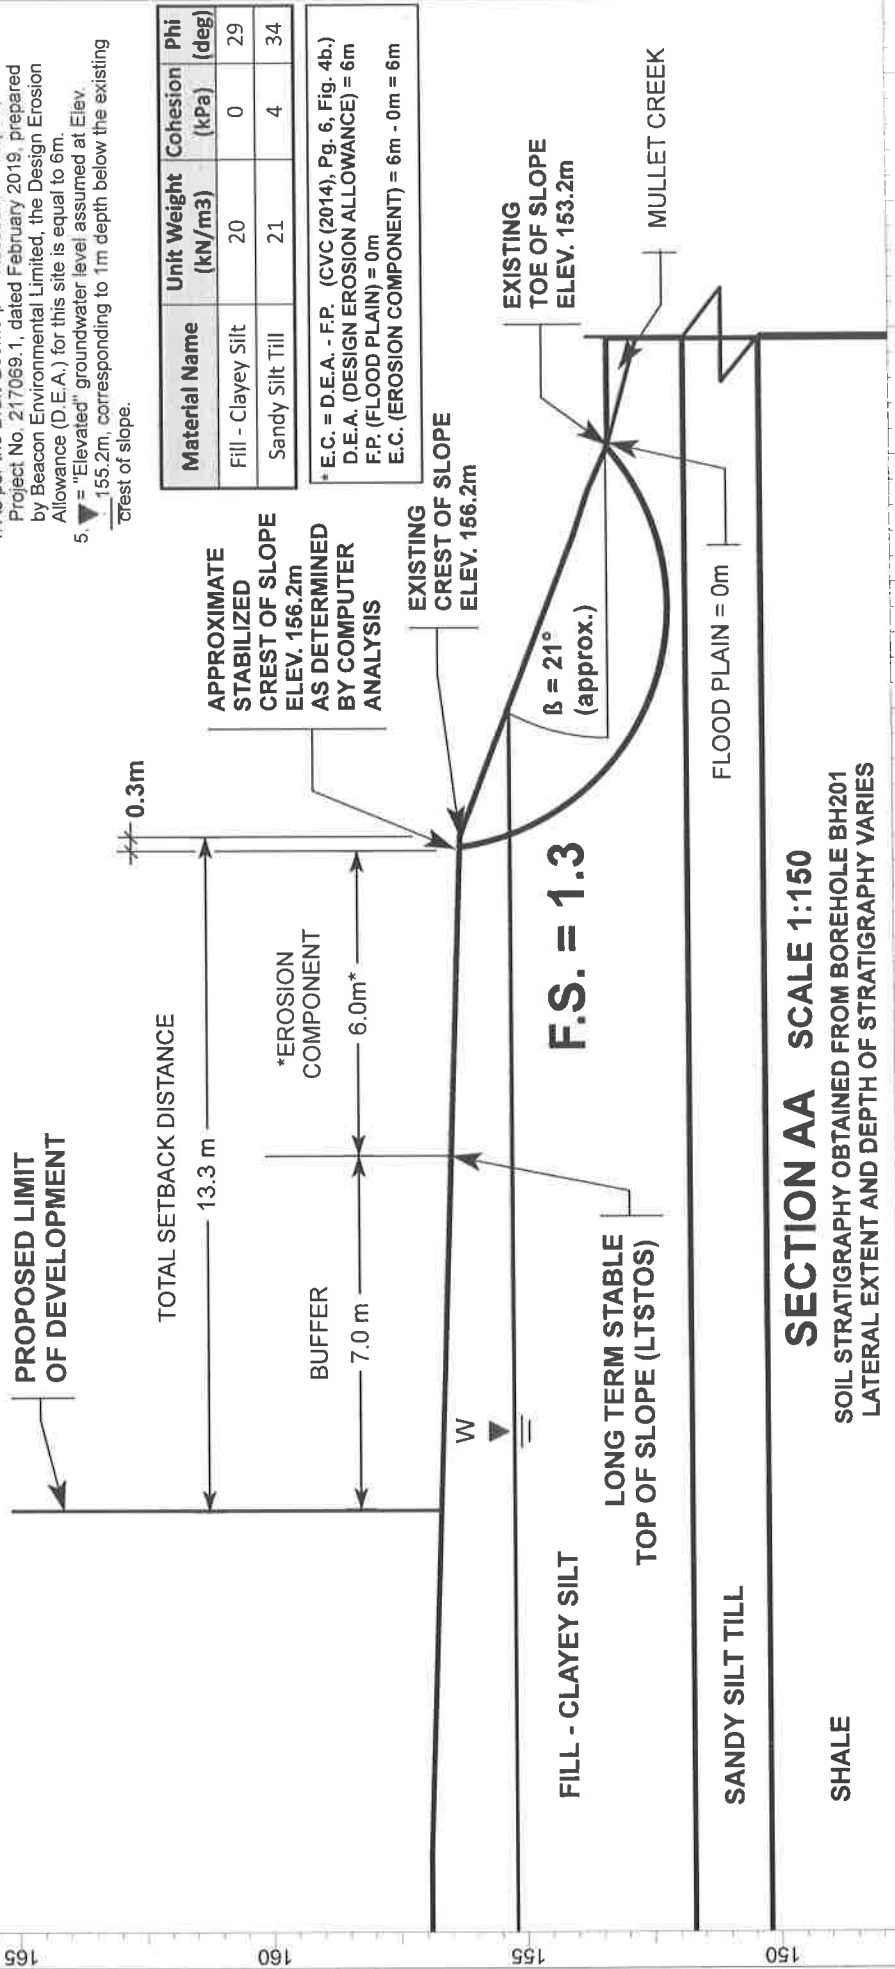
FIGURE 1E: "ELEVATED" GROUNDWATER LEVELS PROPOSED DEVELOPMENT 51 TANNERY STREET, MISSISSAUGA, ONTARIO

The stabilized crest of the slope with a failure circle that has a minimum factor of safety of 1.3 which intercepts the ground surface at the upper tablelands is indicated on our Section AA (Figure 1E), Section BB (Figure 1F), Section CC (Figure 1G) and Section DD (Figure 1H). From the existing crest of the slope, it is located inward by a distance of 0.3m, 0.2m, 0.4m and 0.5m, for Section AA, Section BB, Section CC and Section DD, respectively. A standard precaution is to add the Erosion Component of Setback (E.C.) distance of 6m, 6m, 6m and 0.2m, for Section AA, Section BB, Section CC and Section DD, respectively, as discussed in Item 4.2 of this report. Furthermore, to add a 7m buffer distance at each section. Relative to the existing crest, the above results yield total combined setback distances of 13.3m, 13.2m, 13.4m and 7.7m for Section AA, Section BB, Section CC and Section DD, respectively. These total combined setback distances at each section, we referred to as the "Proposed Limit of Development". Development of the buildings can then take

* E.C. = D.E.A. - F.P. (CVC (2014), Pg. 6, Fig. 4b.)
 D.E.A. (DESIGN EROSION ALLOWANCE) = 6m
 F.P. (FLOOD PLAIN) = 0m
 E.C. (EROSION COMPONENT) = 6m - 0m = 6m

- Notes:
- Slope geometry is derived and geodetically referenced from Topographical Plan prepared by Fiddes Clipsham Inc., Ontario Land Surveyor, dated January 23, 2019.
 - The average slope β of 21° is estimated.
 - For "Elevated" groundwater levels, using the computer software Slide (Version 7.0) developed by Rocscience, to perform our slope stability analysis with Bishop's Method, the stabilized crest of slope is estimated where the failure circle with a Factor of Safety of 1.3 intercepts the ground surface at the upper tableland.
 - As per the Draft Geomorphic Assessment Report, Project No. 217069.1, dated February 2019, prepared by Beacon Environmental Limited, the Design Erosion Allowance (D.E.A.) for this site is equal to 6m.
 - "Elevated" groundwater level assumed at Elev. 155.2m, corresponding to 1m depth below the existing Crest of slope.

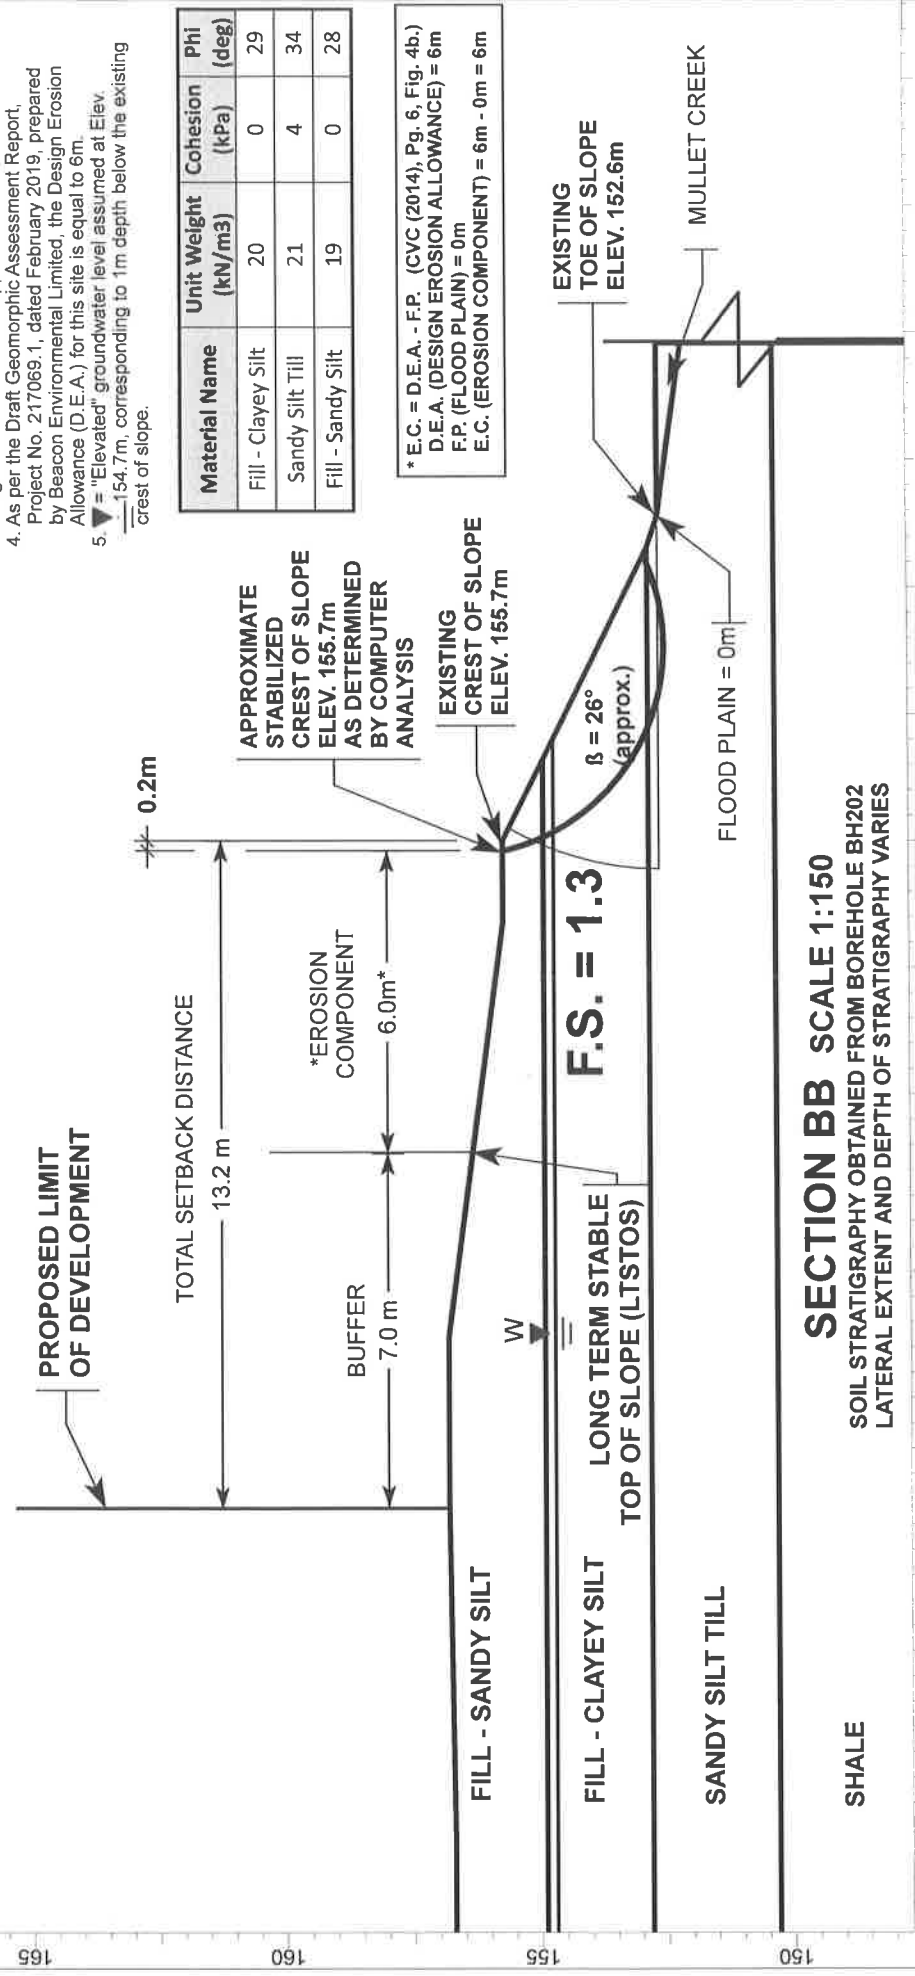
FIGURE 1F: "ELEVATED" GROUNDWATER LEVELS PROPOSED DEVELOPMENT 51 TANNERY STREET, MISSISSAUGA, ONTARIO

F.S. = 1.3

- Notes:
- Slope geometry is derived and geodetically referenced from Topographical Plan prepared by Fiddes Cliphsham Inc., Ontario Land Surveyor, dated January 23, 2019.
 - The average slope β of 26° is estimated.
 - For "Elevated" groundwater levels, using the computer software Slide (Version 7.0) developed by Rocscience, to perform our slope stability analysis with Bishop's Method, the stabilized crest of slope is estimated where the failure circle with a Factor of Safety of 1.3 intercepts the ground surface at the upper tableland.
 - As per the Draft Geomorphic Assessment Report, Project No. 217069.1, dated February 2019, prepared by Beacon Environmental Limited, the Design Erosion Allowance (D.E.A.) for this site is equal to 6m.
 - ▲ = "Elevated" groundwater level assumed at Elev. 154.7m, corresponding to 1m depth below the existing crest of slope.

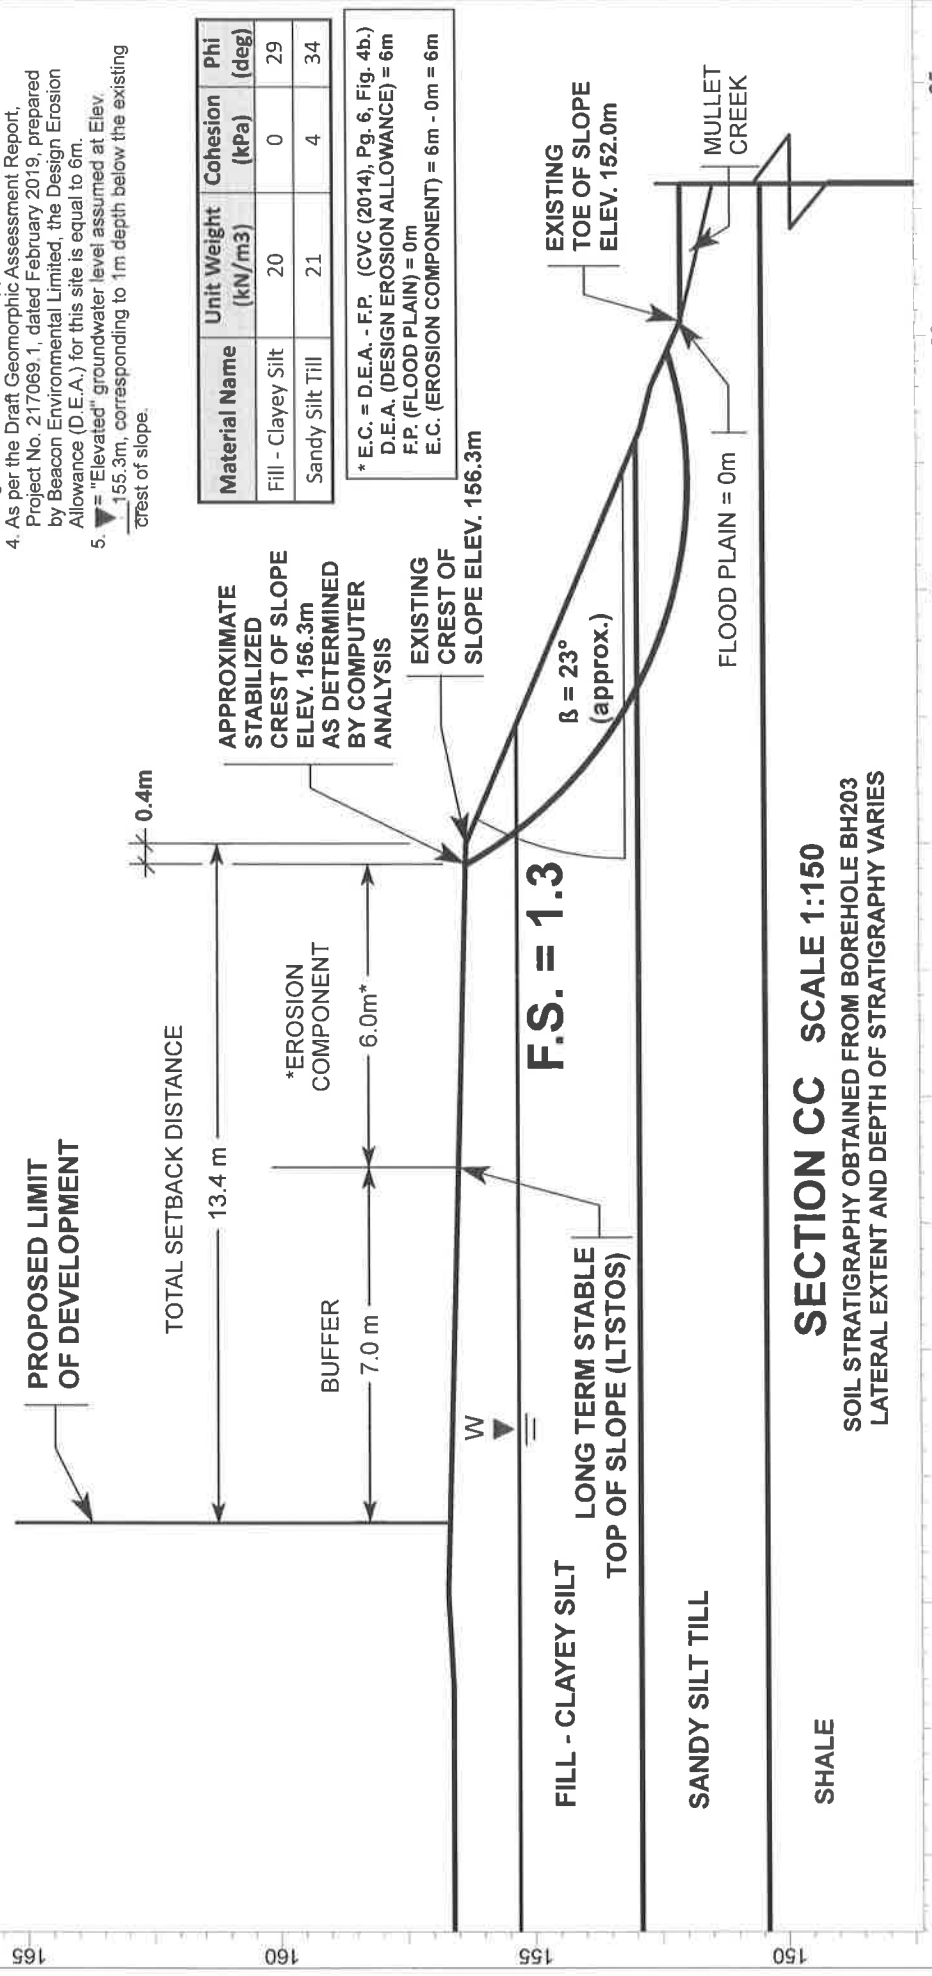
FIGURE 1G: "ELEVATED" GROUNDWATER LEVELS PROPOSED DEVELOPMENT

* E.C. = D.E.A. - F.P. (CVC (2014), Pg. 6, Fig. 4b.)
 D.E.A. (DESIGN EROSION ALLOWANCE) = 6m
 F.P. (FLOOD PLAIN) = 0m
 E.C. (EROSION COMPONENT) = 6m - 0m = 6m

- Notes:
- Slope geometry is derived and geodetically referenced from Topographical Plan prepared by Fiddes Cliphsham Inc., Ontario Land Surveyor, dated January 23, 2019.
 - The average slope β of 23° is estimated.
 - For "Elevated" groundwater levels, using the computer software Slide (Version 7.0) developed by Rocscience, to perform our slope stability analysis with Bishop's Method, the stabilized crest of slope is estimated where the failure circle with a Factor of Safety of 1.3 intercepts the ground surface at the upper tableland.
 - As per the Draft Geomorphic Assessment Report, Project No. 217069.1, dated February 2019, prepared by Beacon Environmental Limited, the Design Erosion Allowance (D.E.A.) for this site is equal to 6m.
 - "Elevated" groundwater level assumed at Elev. 155.3m, corresponding to 1m depth below the existing crest of slope.

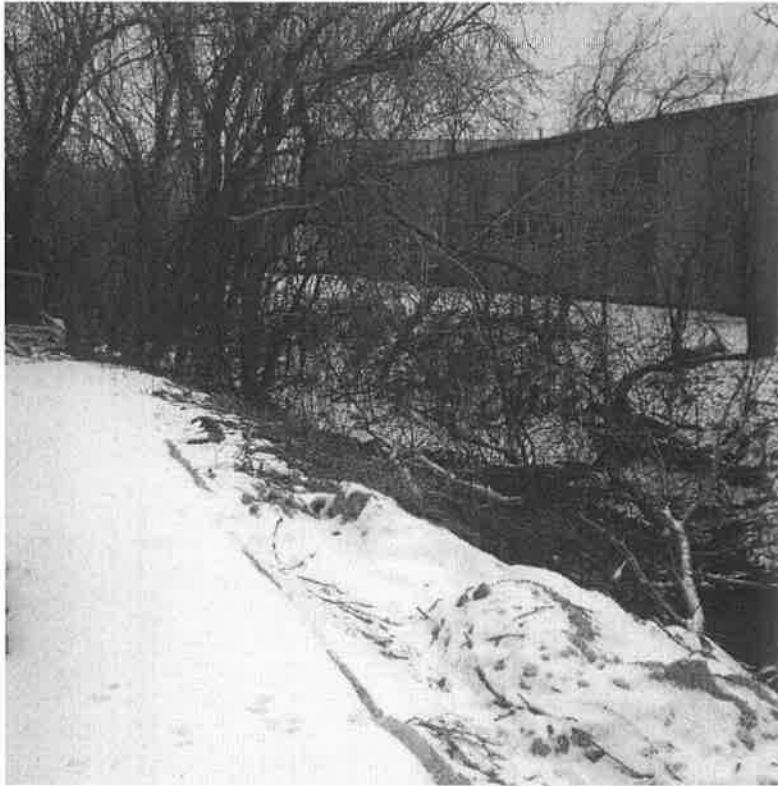
At the time of our visit, there was no evidence of surface erosion/gullies, nor any tension cracks nor any evidence of features that would be of concern regarding the slope and its stability.

Photograph 1: View of slope

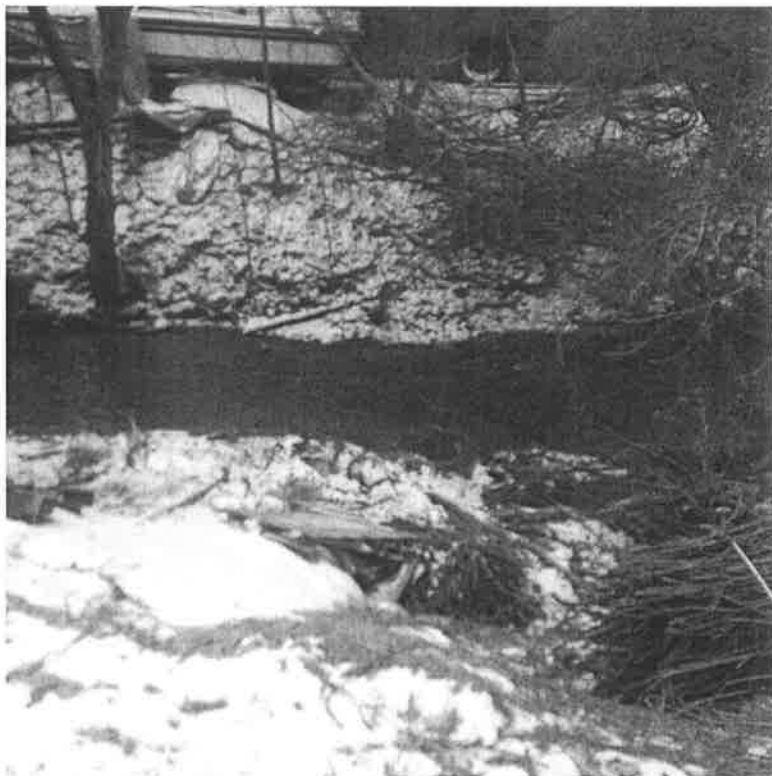
Photograph 2: View of well preserved slope

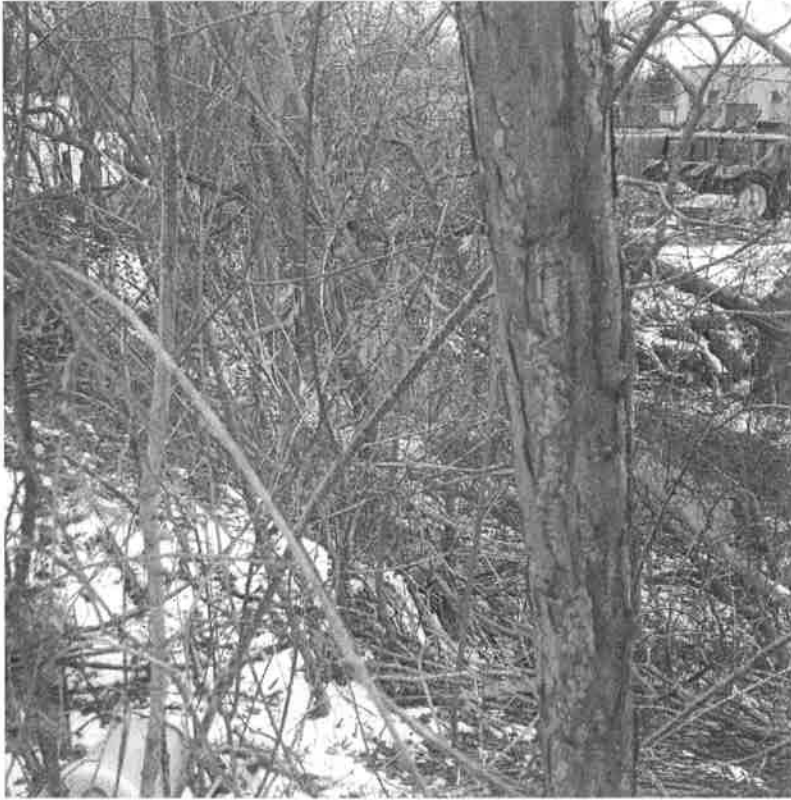
The upper tablelands leading to the crest of the slope are generally covered with grass and are sufficiently vegetated. Currently, the slope face contains a sufficient amount of mature trees and is adequately covered with vegetation. The toe of the slope is generally dry and is also covered with vegetation. The flat limited lands beyond the toe are also vegetated and lead to Mullet Creek, which is at or in close proximity to the slope. Photographs of the slope are shown in the attached Appendix A.

Photograph 3: View of well vegetated slope
