Lakeview Village Shoreline Hazard Assessment

Mississauga

January 14 2019 | 13012.101

Baird.
Innovation Engineered.

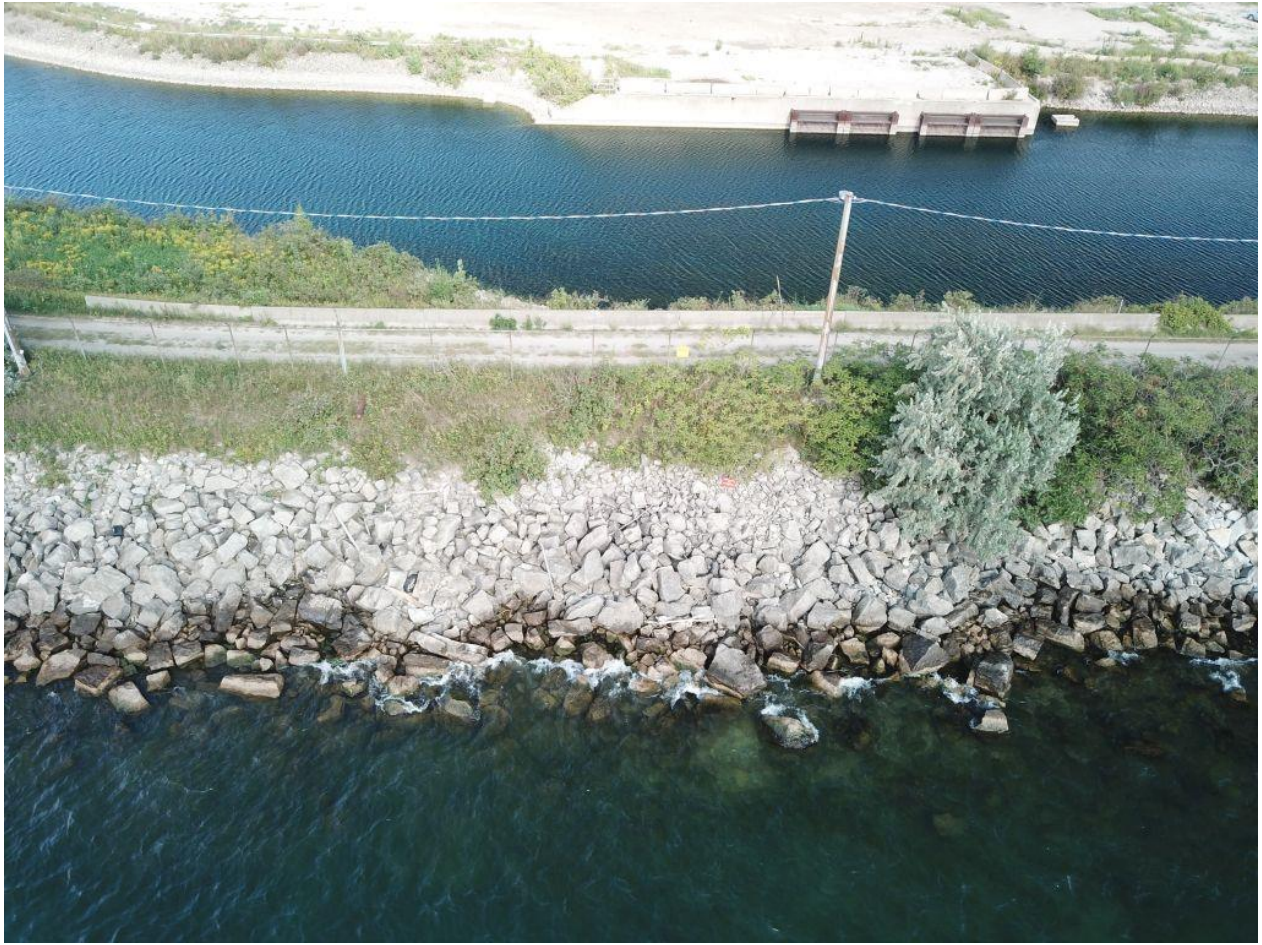
The stone protection appears to be in satisfactory condition and functional. The top elevation of the protection has been adequate for wave uprush and overtopping, as it has experienced nearly 60 years of exposure, including high water levels in 2017, with an acceptable level of damage. Regardless, the existing protection work will be upgraded and incorporated into the new shoreline design in accordance with accepted engineering practice. The design life of the new protection will be 60 years. The works will be designed by a professional engineer with experience and qualifications in coastal engineering.

Figure 2.24: Example of stone protection at easterly portion of Outer Shore (this view around OS500)

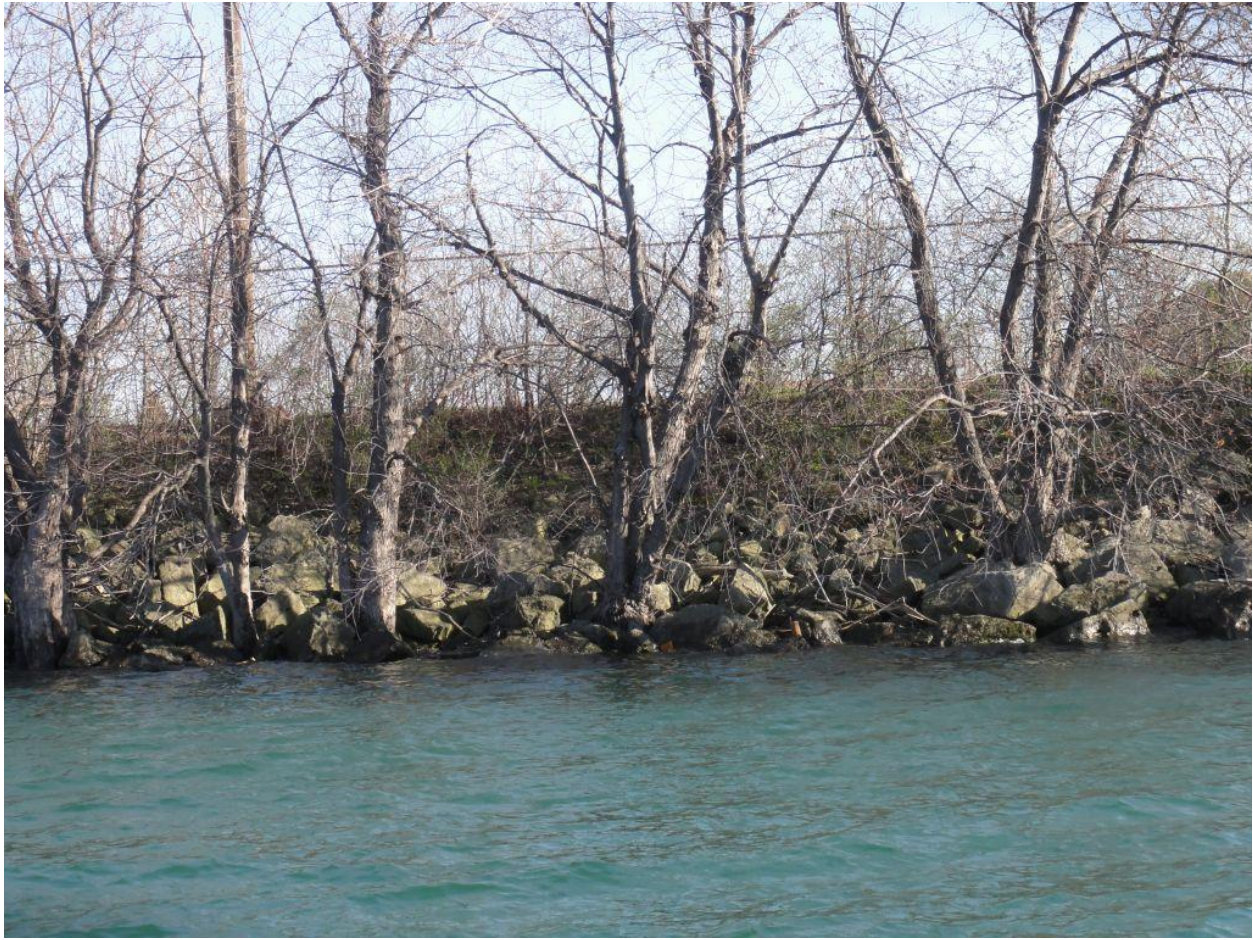
Figure 2.28: Example of established vegetation at Outer Shore (OS190 to OS330)

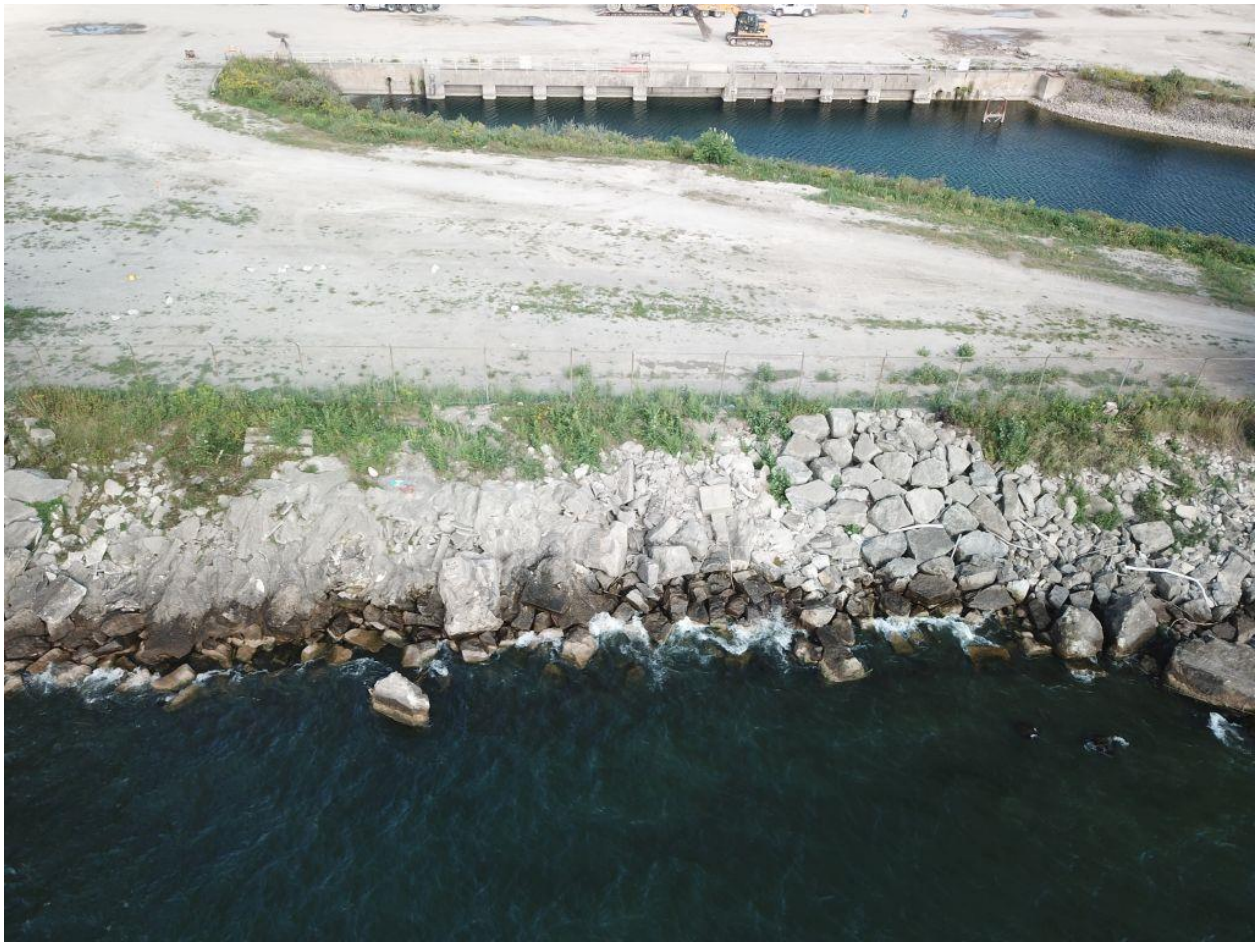
Figure 2.29: Mixture of armouring at westerly portion of Outer Shore (near OS610 to OS640)

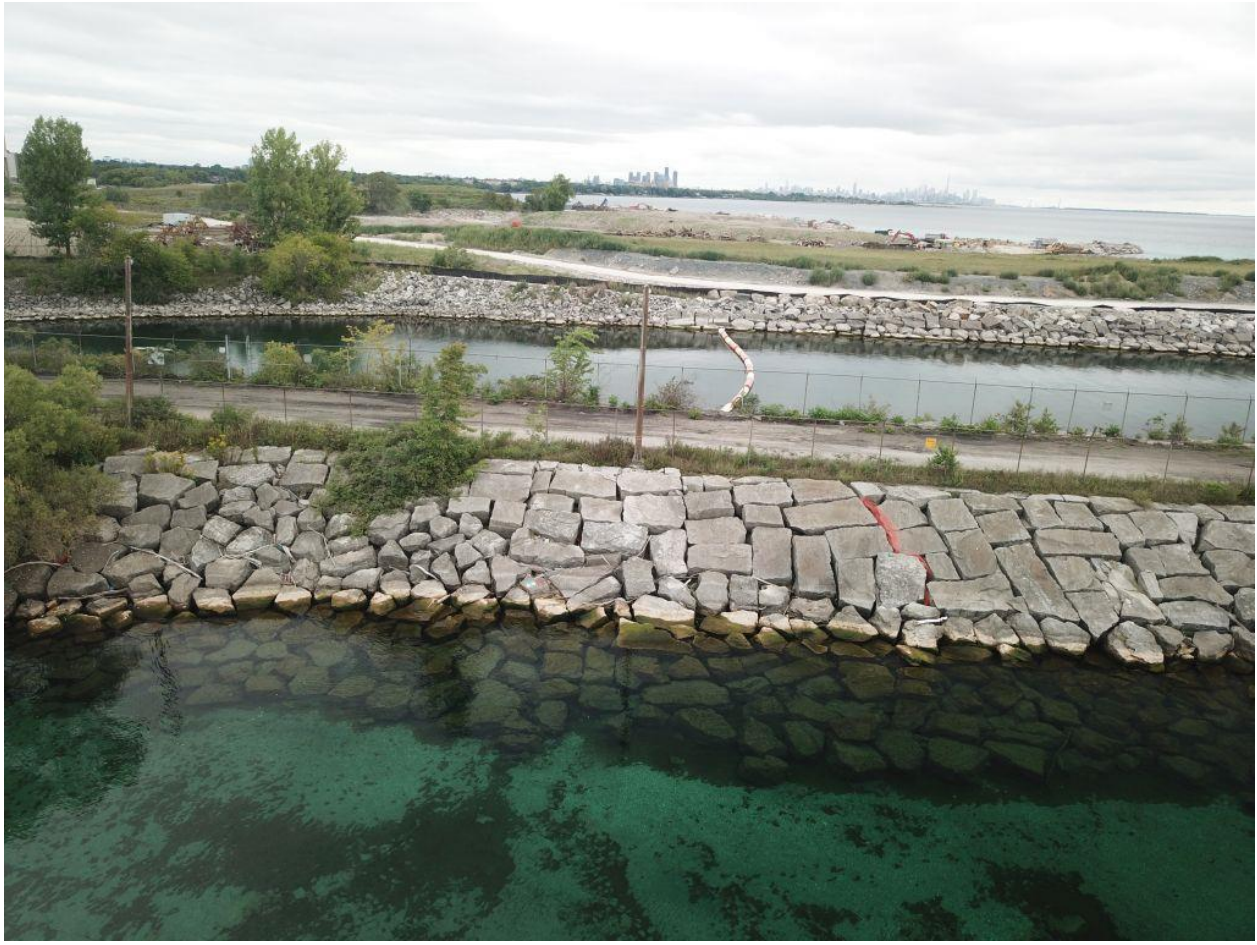
At the easterly end of the Outer Shore, the shoreline transitions to the rubble mound mole portion of the Western Pier (Figure 2.3). The rubble mound mole is protected with large, tightly placed armour stone in good condition (Figure 2.35 and Figure 2.36). The rubble-mound mole was reviewed as part of the Level I and Level II Investigation for the Western Pier. No repairs or upgrades are required for this shoreline.

Figure 2.35: Tightly placed armour stone on west side of shore-end of Western Pier rubble mound mole

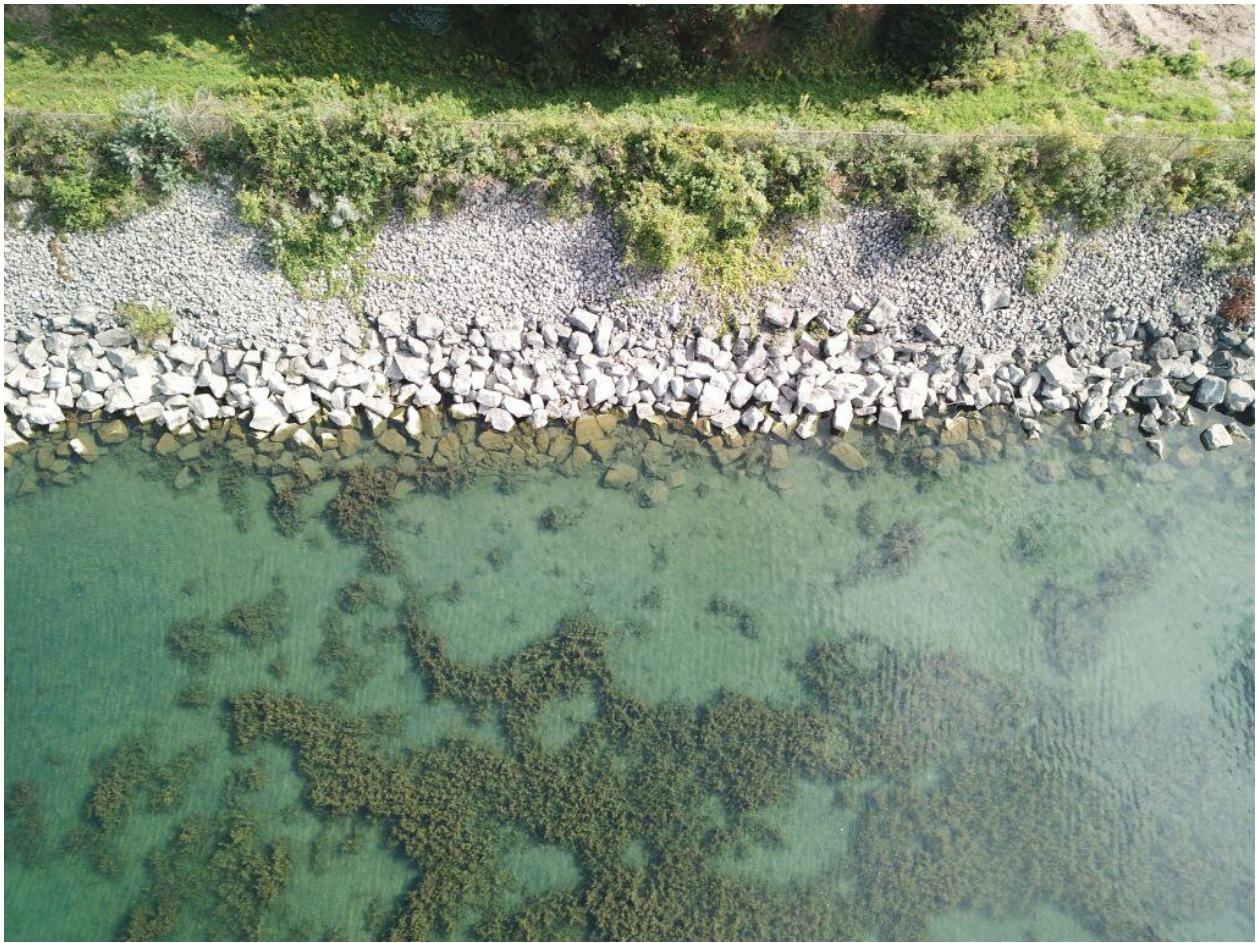
The West Shoreline protection appears to be in good condition and can readily be repurposed and integrated into the Masterplan. Primarily, future work required at the West Shoreline facing the marina basin will be guided by consideration of public use and landscape design, to bring the public closer to the water's edge and dealing with the miscellaneous structures to make them safe for the public (e.g., removal, closing off, adding railings). Naturalization features and aquatic habitat elements will be incorporated into the protection works where appropriate. The existing shoreline protection structure will be incorporated into the new shoreline design in accordance with accepted engineering practice. The works will be designed by a professional engineer with experience and qualifications in coastal engineering. The design life of the new protection will be 60 years.

Figure 2.37: West Shoreline armour stone and riprap shore protection

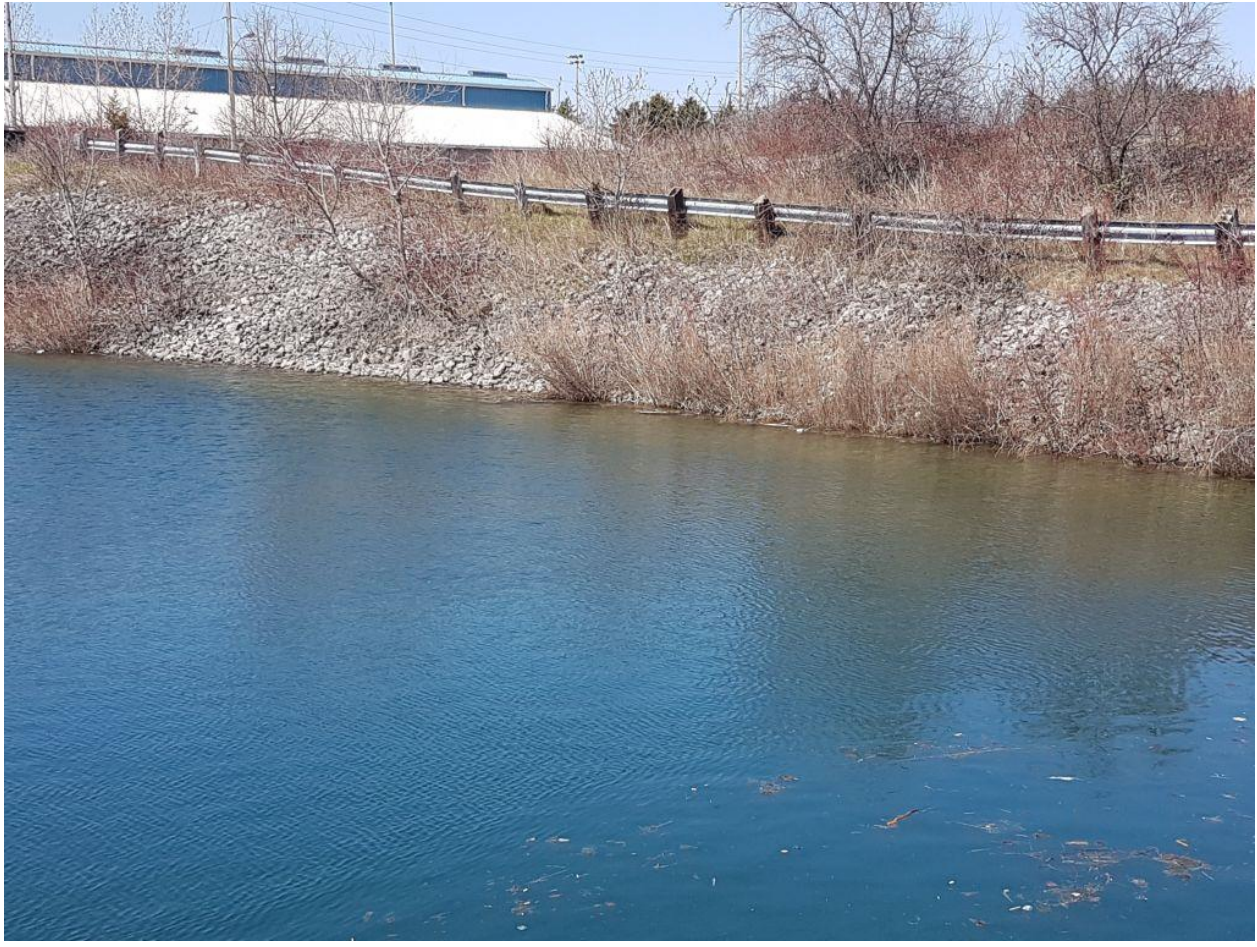
Figure 2.46: Discharge Channel West – vegetated riprap slope

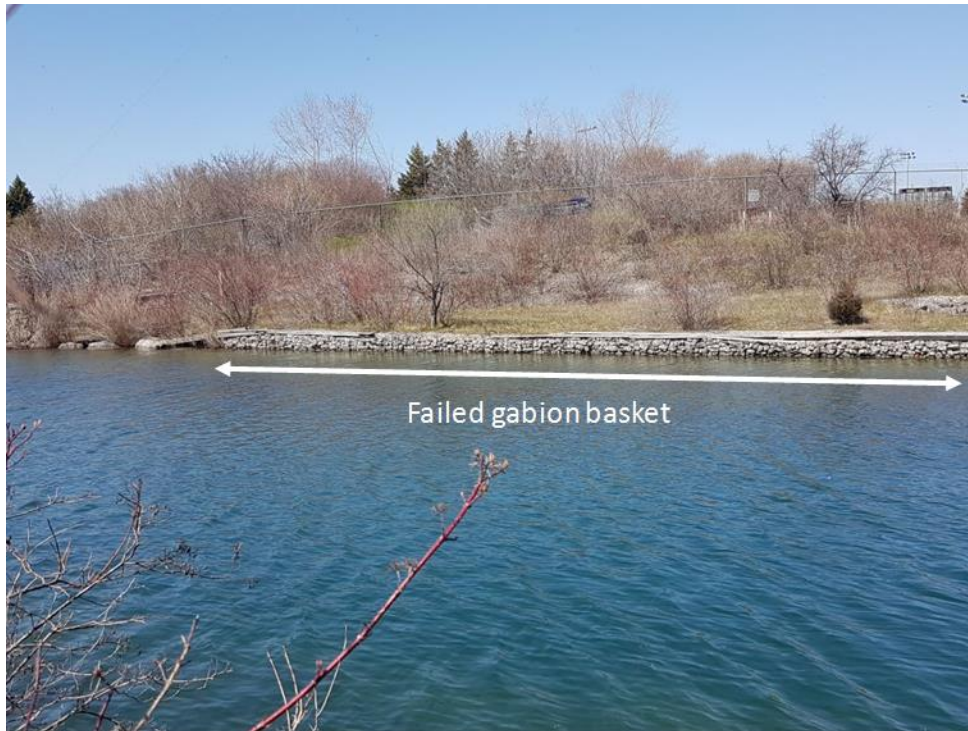
Figure 2.47: Discharge Channel West – failed gabion basket protection and gradual backshore slope

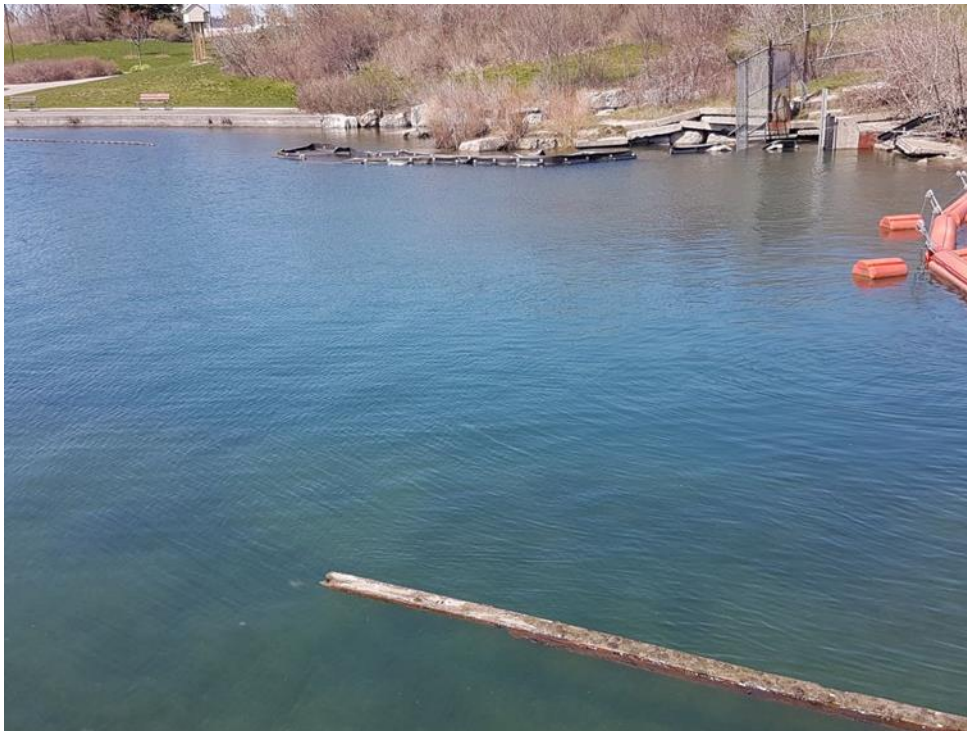
The section of shoreline from DW130 to DW180 is comprised of various structures and ad hoc protection (e.g., concrete slabs; see Figure 2.48) and will need to be addressed to make it suitable for public use.

Figure 2.48: Discharge Channel West Side between DW130 to DW180 with rubble and miscellaneous structures

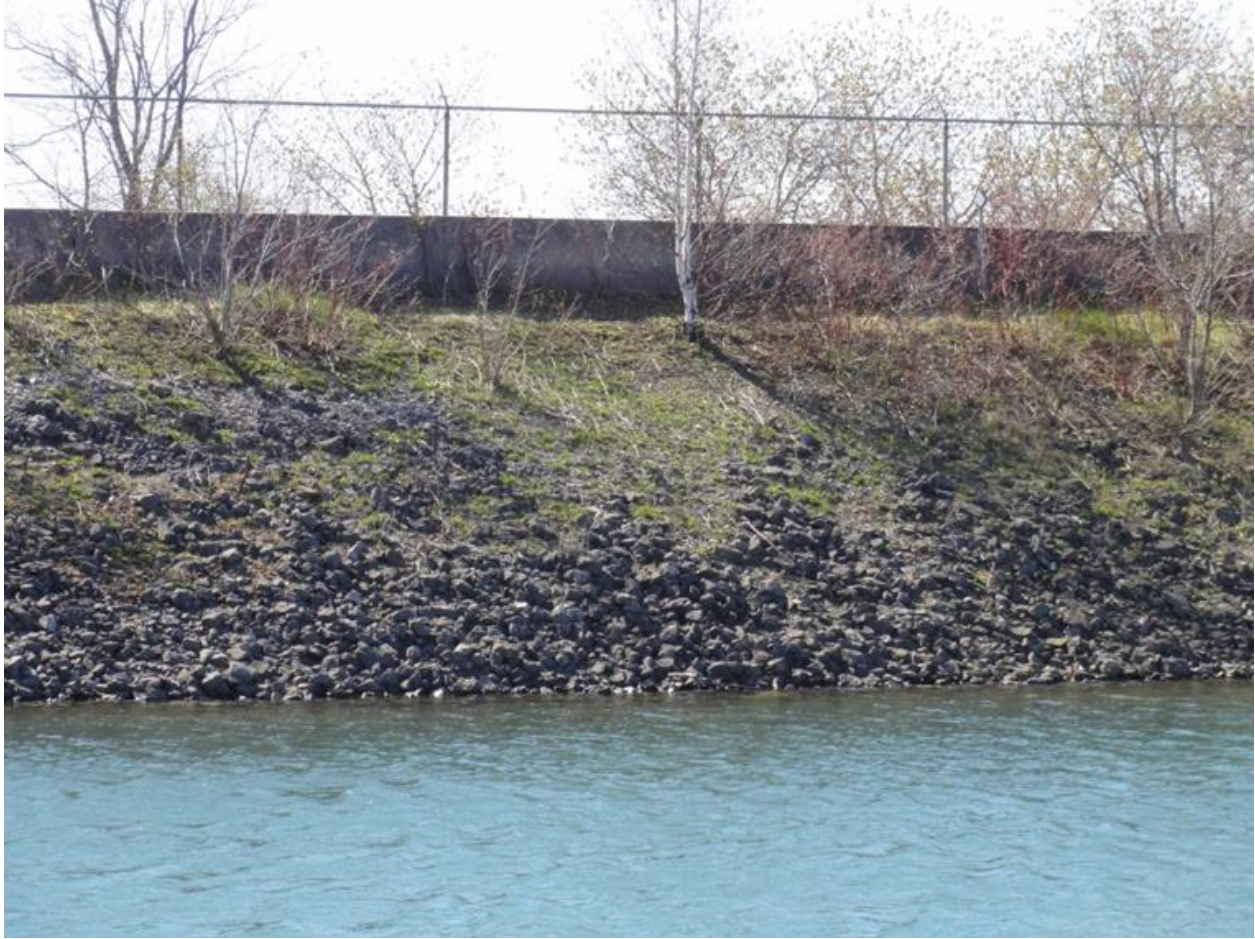
The riprap revetment is in good condition with well-established vegetation (see Figure 2.58 and Figure 2.60). The top elevation of the stone protection is adequate.

Figure 2.58: Example of riprap slope protection with some vegetation at Intake Forebay/Channel South

The existing protection work will be upgraded and incorporated into the shoreline Masterplan in accordance with accepted engineering practice. The design life of the new protection will be 60 years. Naturalization features and aquatic habitat elements will be incorporated into the protection works where appropriate.

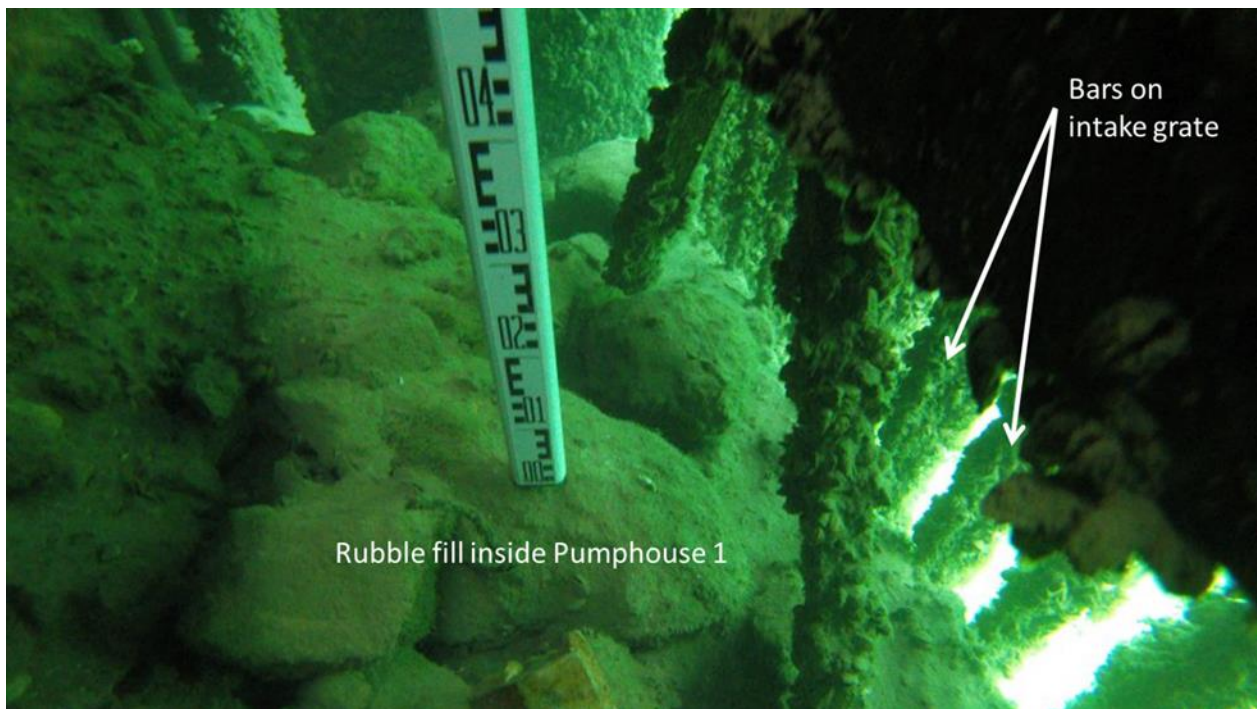
Figure 2.71: Rubble fill behind intake grate/screen inside Pumphouse 1
