FINAL **Phase I Environmental** **Site Assessment**

91 Eglinton Avenue East,
Mississauga, Ontario

August 8, 2017

Pinchin File: 0208402

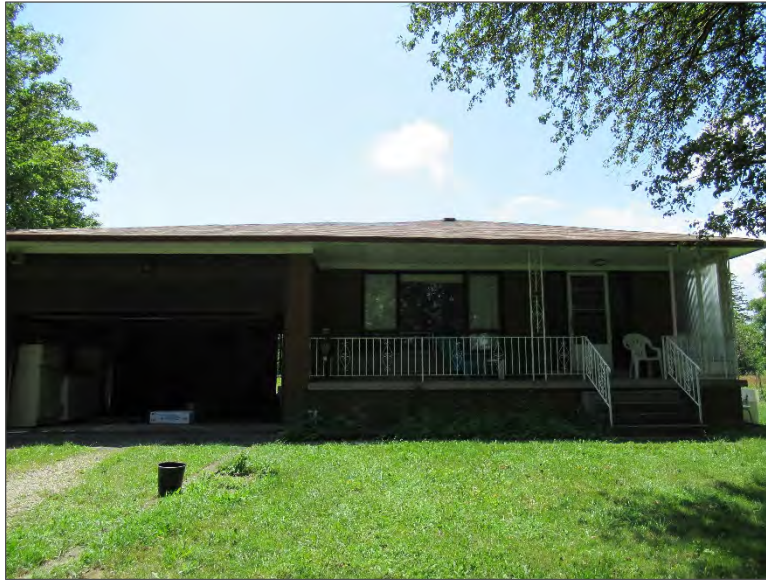
Photo 1 – Site Building A (northeast elevation).

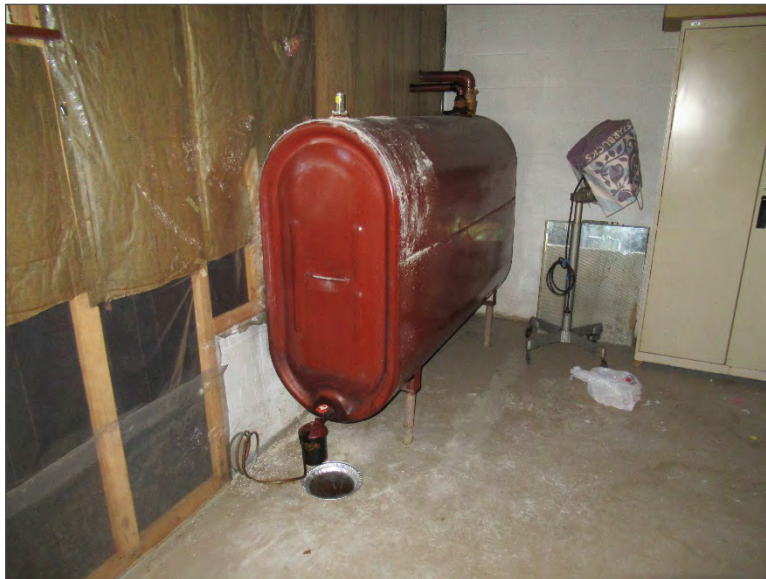
The ground floor condition in the vicinity of the above-listed ASTs was inspected and was noted in good condition with no signs of deterioration (i.e. cracks) or staining.

Photo 6 – Fuel oil AST located in the basement of Site Building A.

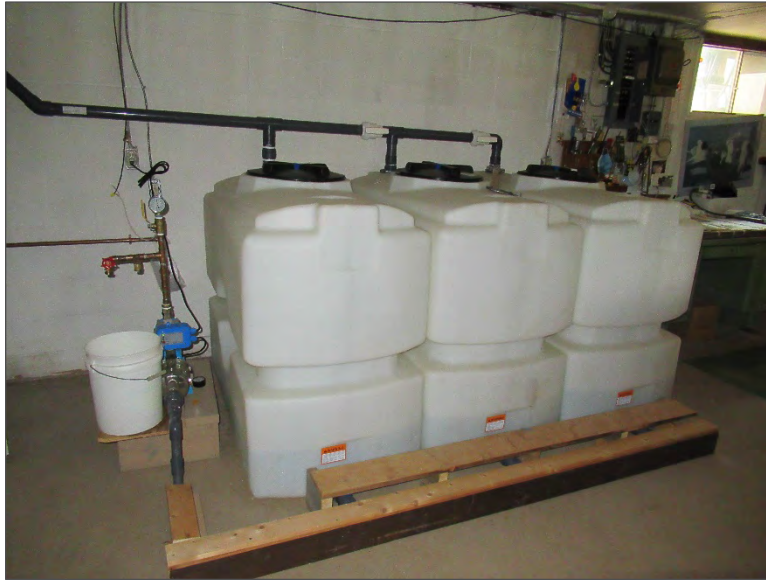
Photo 7 – Plastic domestic water totes located in the basement of Site Building A.

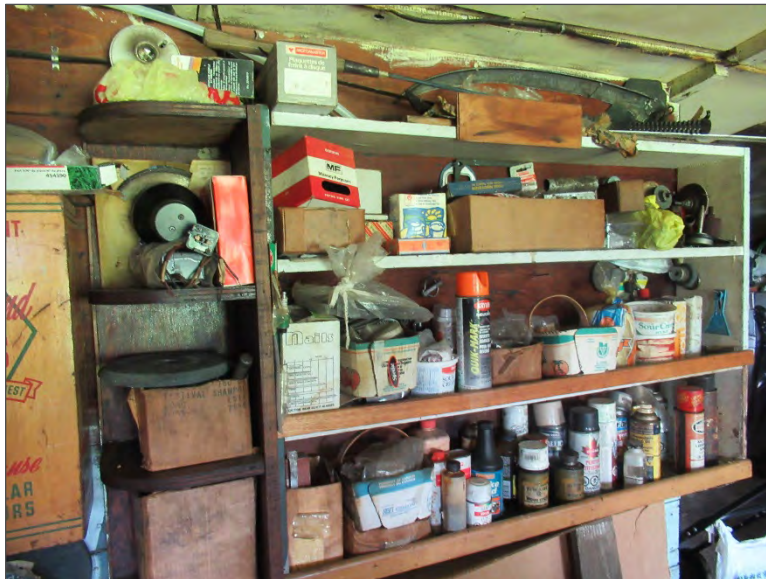
No spills or evidence of historical spills (i.e., staining) were observed in the chemical storage areas noted above. The interior floor slabs were observed to be in good condition (i.e., no cracking or pitting) and the chemicals appeared to be stored in an orderly fashion. No floor drains or catch basins were present in the vicinity of the chemical storage areas.

Photo 8 – Storage of small quantities of household chemicals formerly located in Site Building B.

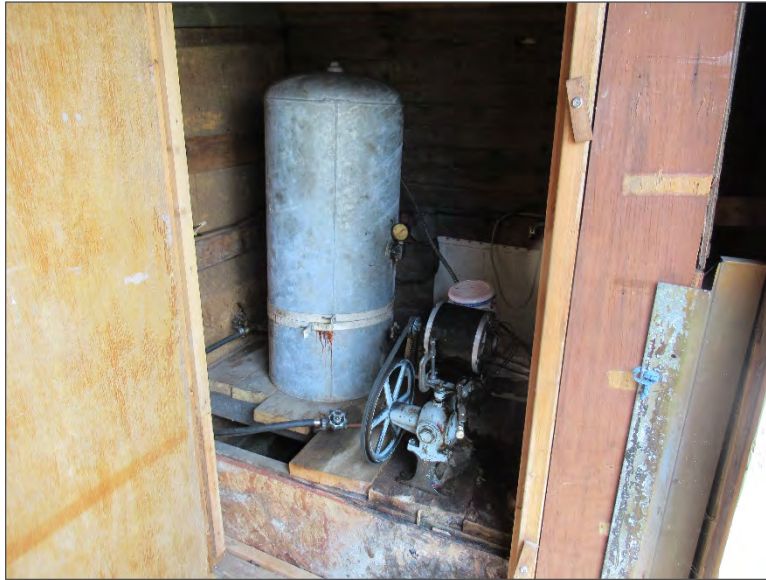
Photo 9 – Abandoned drinking water well in Site Building B.

Pinchin recommends that the potable well observed on-Site be decommissioned in accordance with Ontario Regulation (O. Reg.) 903/90 (as amended) during any future development activities.

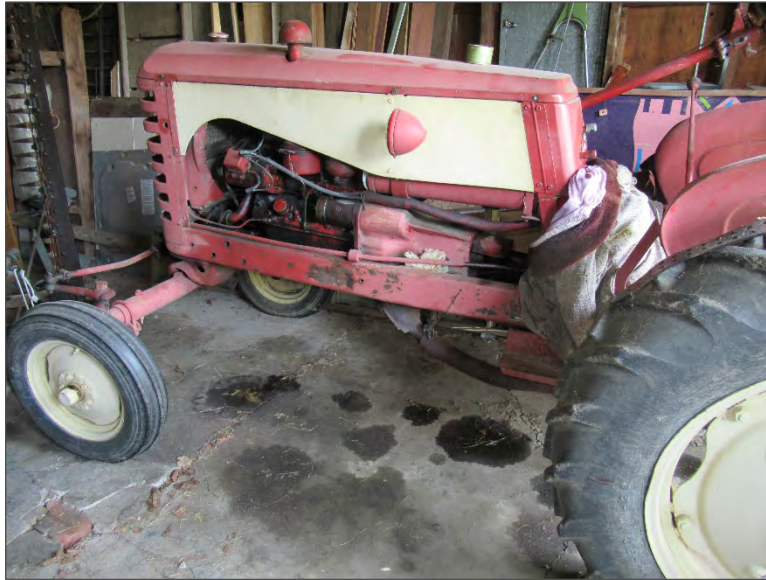
Black (likely petroleum hydrocarbon) staining (measuring less than 1 m²) was initially observed under the tractors on the concrete floor of Site Building C. The concrete floor was observed to be in fair condition with minor cracking and pitting. No floor drains were observed in the vicinity of the staining. No other

Pinchin notes that Site Building C was demolished subsequent to the initial Site reconnaissance on July 17, 2017. A supplementary Site reconnaissance was conducted on August 3, 2017 and found no stained soils or odours in the location of the former concrete slab of Site Building C where the staining was previously noted. It is Pinchin's opinion that the observed staining is not considered a potential issue of environmental concern.

Photo 11 – Surficial staining under a tractor in Site Building D prior to demolition.

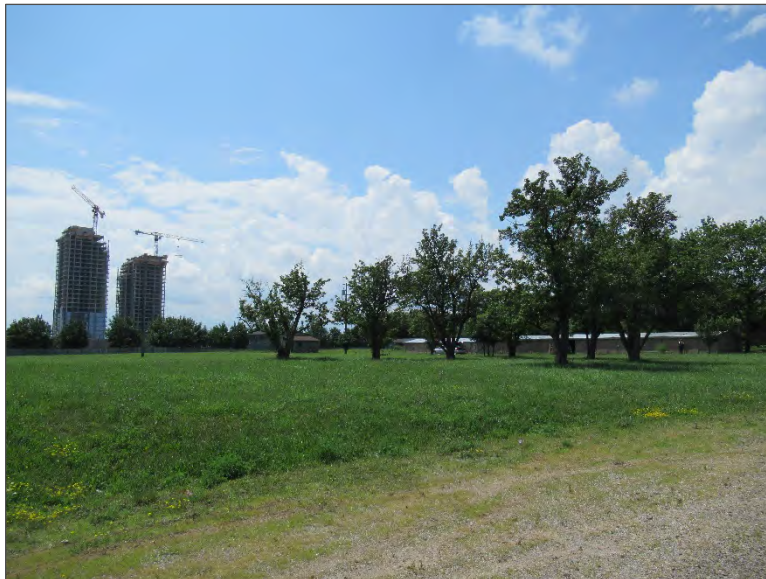
- An orchard was formerly present on the central portion of the Site. Pesticides and herbicides were typically applied to orchards. Based on the age of the orchard (from at least 1954 to at least 1975), the potential use of pesticides and/or herbicides could result in potential subsurface impacts at the Site; and
- A former Speedy Auto Service repair facility was located adjacent to the southwest of the Site. Based on the suspected age of the operations (from at least 1997 to 2003), this off-Site activity could result in potential subsurface impacts at the Site.

Photo 16 – Pear trees located near the central portion of the Site.

Based on the findings noted above, Pinchin recommends completing a Phase II ESA at the Site.
