**RE: LETTER OF RELIANCE
UPTOWN MISSISSAUGA
BLOCK 16, BLOCK 17 & PART BLOCKS 1 AND 2
MISSISSAUGA, ONTARIO**

**PHASE I
ENVIRONMENTAL SITE ASSESSMENT
PART OF LOT 1 CONCESSION 1, WHS
DESIGNATED AS PARTS 2 TO 6 ON PLAN 43R-24436
AND PART 1 ON PLAN 43R-24983
CITY OF MISSISSAUGA, ONTARIO**

File No. 1-08-3160
© **Terraprobe Limited**
August 18, 2008

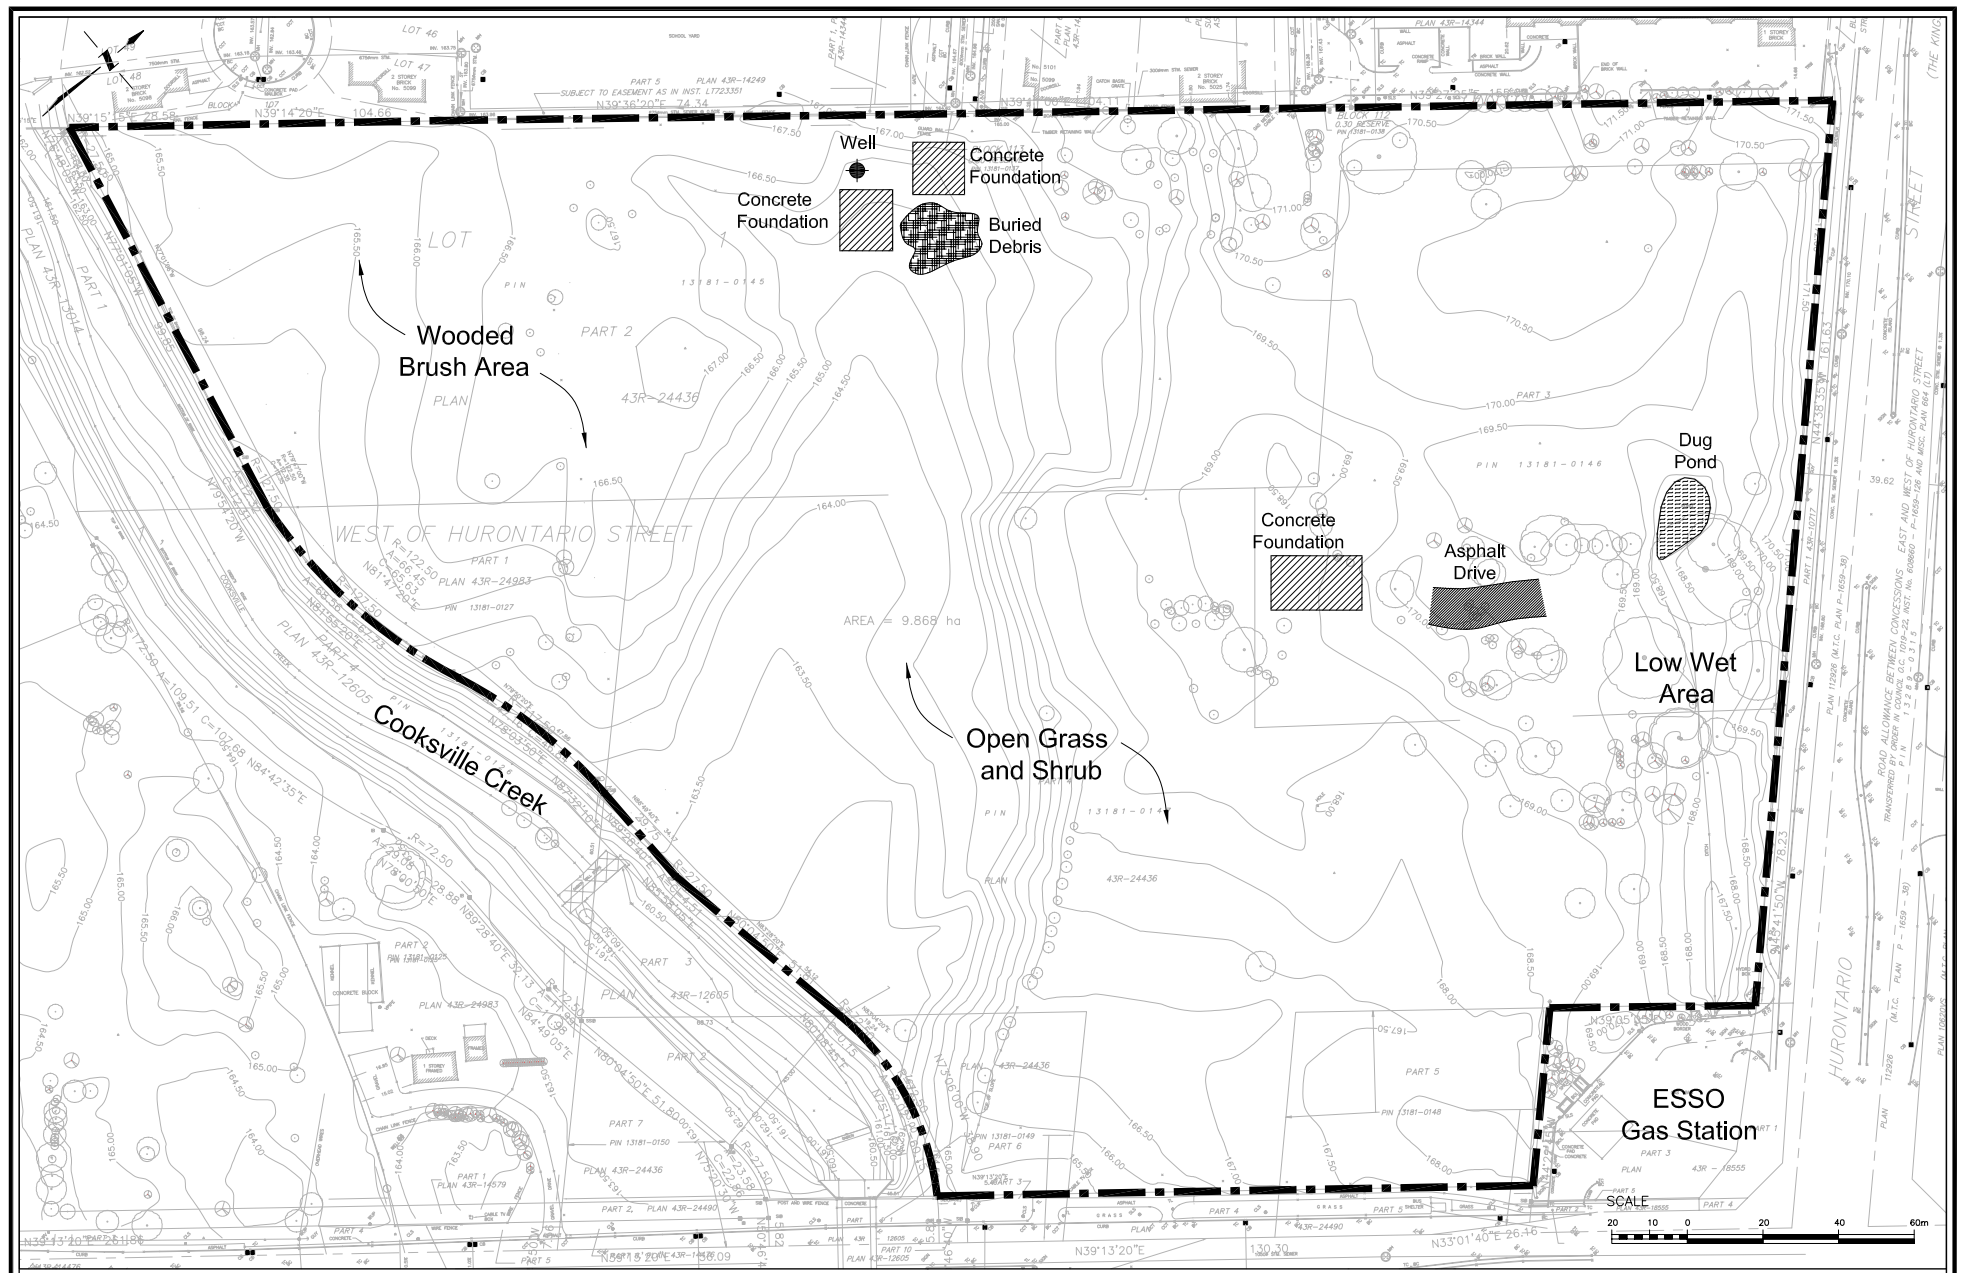
SITE PLAN

No buildings were located on the subject property at the time of site inspection. There were the remains of two buildings found. One near the northern edge of the property and one in the east central portion of the property. All that remains of these buildings are foundations and slabs. There is a remnant of an asphaltic concrete drive way associated with the east central foundation slab. The approximate locations of these features are shown on Figure No. 2.

A well was observed in the north central portion of the site (as shown on Figure 2). The well was open and debris had been discarded down the well. Two concrete foundations and buried construction debris were observed in the vicinity of this well. Although not directly observed, buried foundations and construction materials can be expected in the east central portion of the site, where the former farm buildings were located.

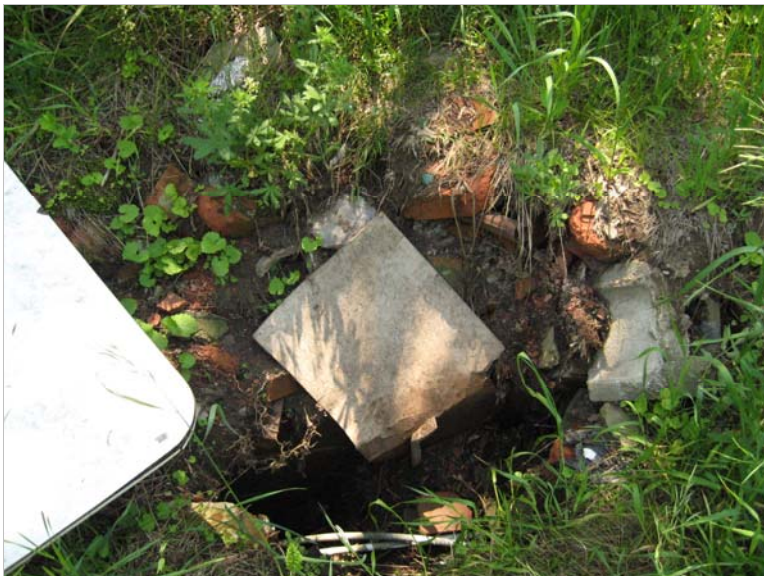
Photograph #3

No buildings were located on the subject property. There are concrete slabs and foundations in evidence of former building locations as shown on Figure No. 2.

Buried brick foundation located at the north end of the site.

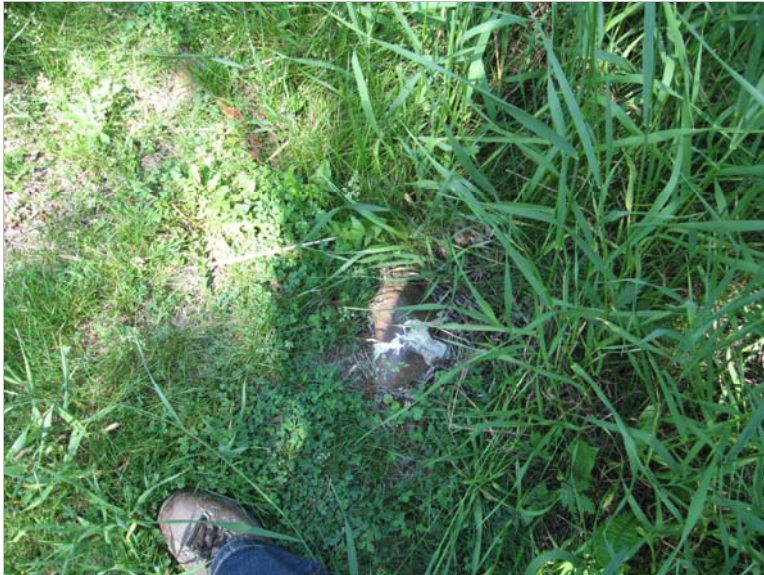
Photograph #4

Buried metal debris at the north end of the site.

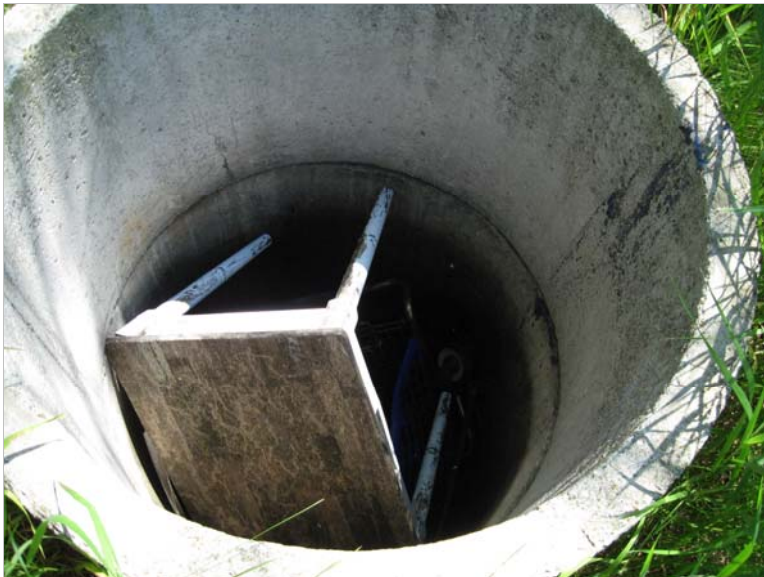
Photograph #5

A large diameter shallow dug well was found in the north central portion of the property, as shown on Figure No. 2. The well was open and debris had been discarded down the well. This well is a hazard and potential liability and it should be abandoned in accordance with O.Reg. 903 without delay.

Well located at the north end of the site.

- Fill materials are present on the site. A subsurface investigation should be conducted to determine the composition and quality of these fill materials.
- A gas station is located at the southeast corner of the property. A subsurface investigation should be conducted to determine if the soil and/or ground water on the subject site adjacent to the gas station has been impacted by petroleum hydrocarbons.
- All buried debris and foundations should be excavated and properly disposed of prior to development of the property.
- The well identified on the property is a hazard which should be addressed without delay. Since this is an identifiable well, even though no well record exists, the well should be abandoned by a licensed well driller in accordance with Ontario Reg. 903.

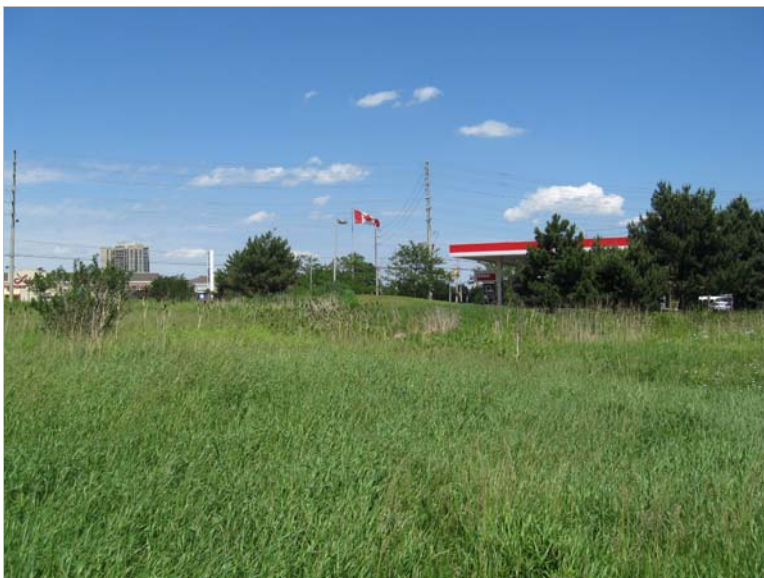
Photograph #6

- A gas station is located adjacent to the southeast corner of the property, which contains underground fuel storage tanks. The potential exists that the soil and/or ground water on the subject site adjacent to the gas station has been impacted by petroleum hydrocarbons.
- There was a large diameter shallow well found in the north central portion of the site. This open well casing about a metre in diameter is a hazard which should be addressed without delay. Since this is an identifiable well, even though no well record exists, the well should be abandoned by a licensed well driller in accordance with Ontario Reg. 903.

ESSO station located southeast of the subject site.
