**REPORT ON
SLOPE STABILITY STUDY
1345 LAKESHORE ROAD EAST
MISSISSAUGA, ONTARIO**

**REPORT NO.: 4738-17-G-VAN-A
REPORT DATE: MAY 11, 2018**

**PREPARED FOR
VANDYK GROUP OF COMPANIES
1944 FOWLER DRIVE
MISSISSAUGA, ONTARIO
L5K 0A1**

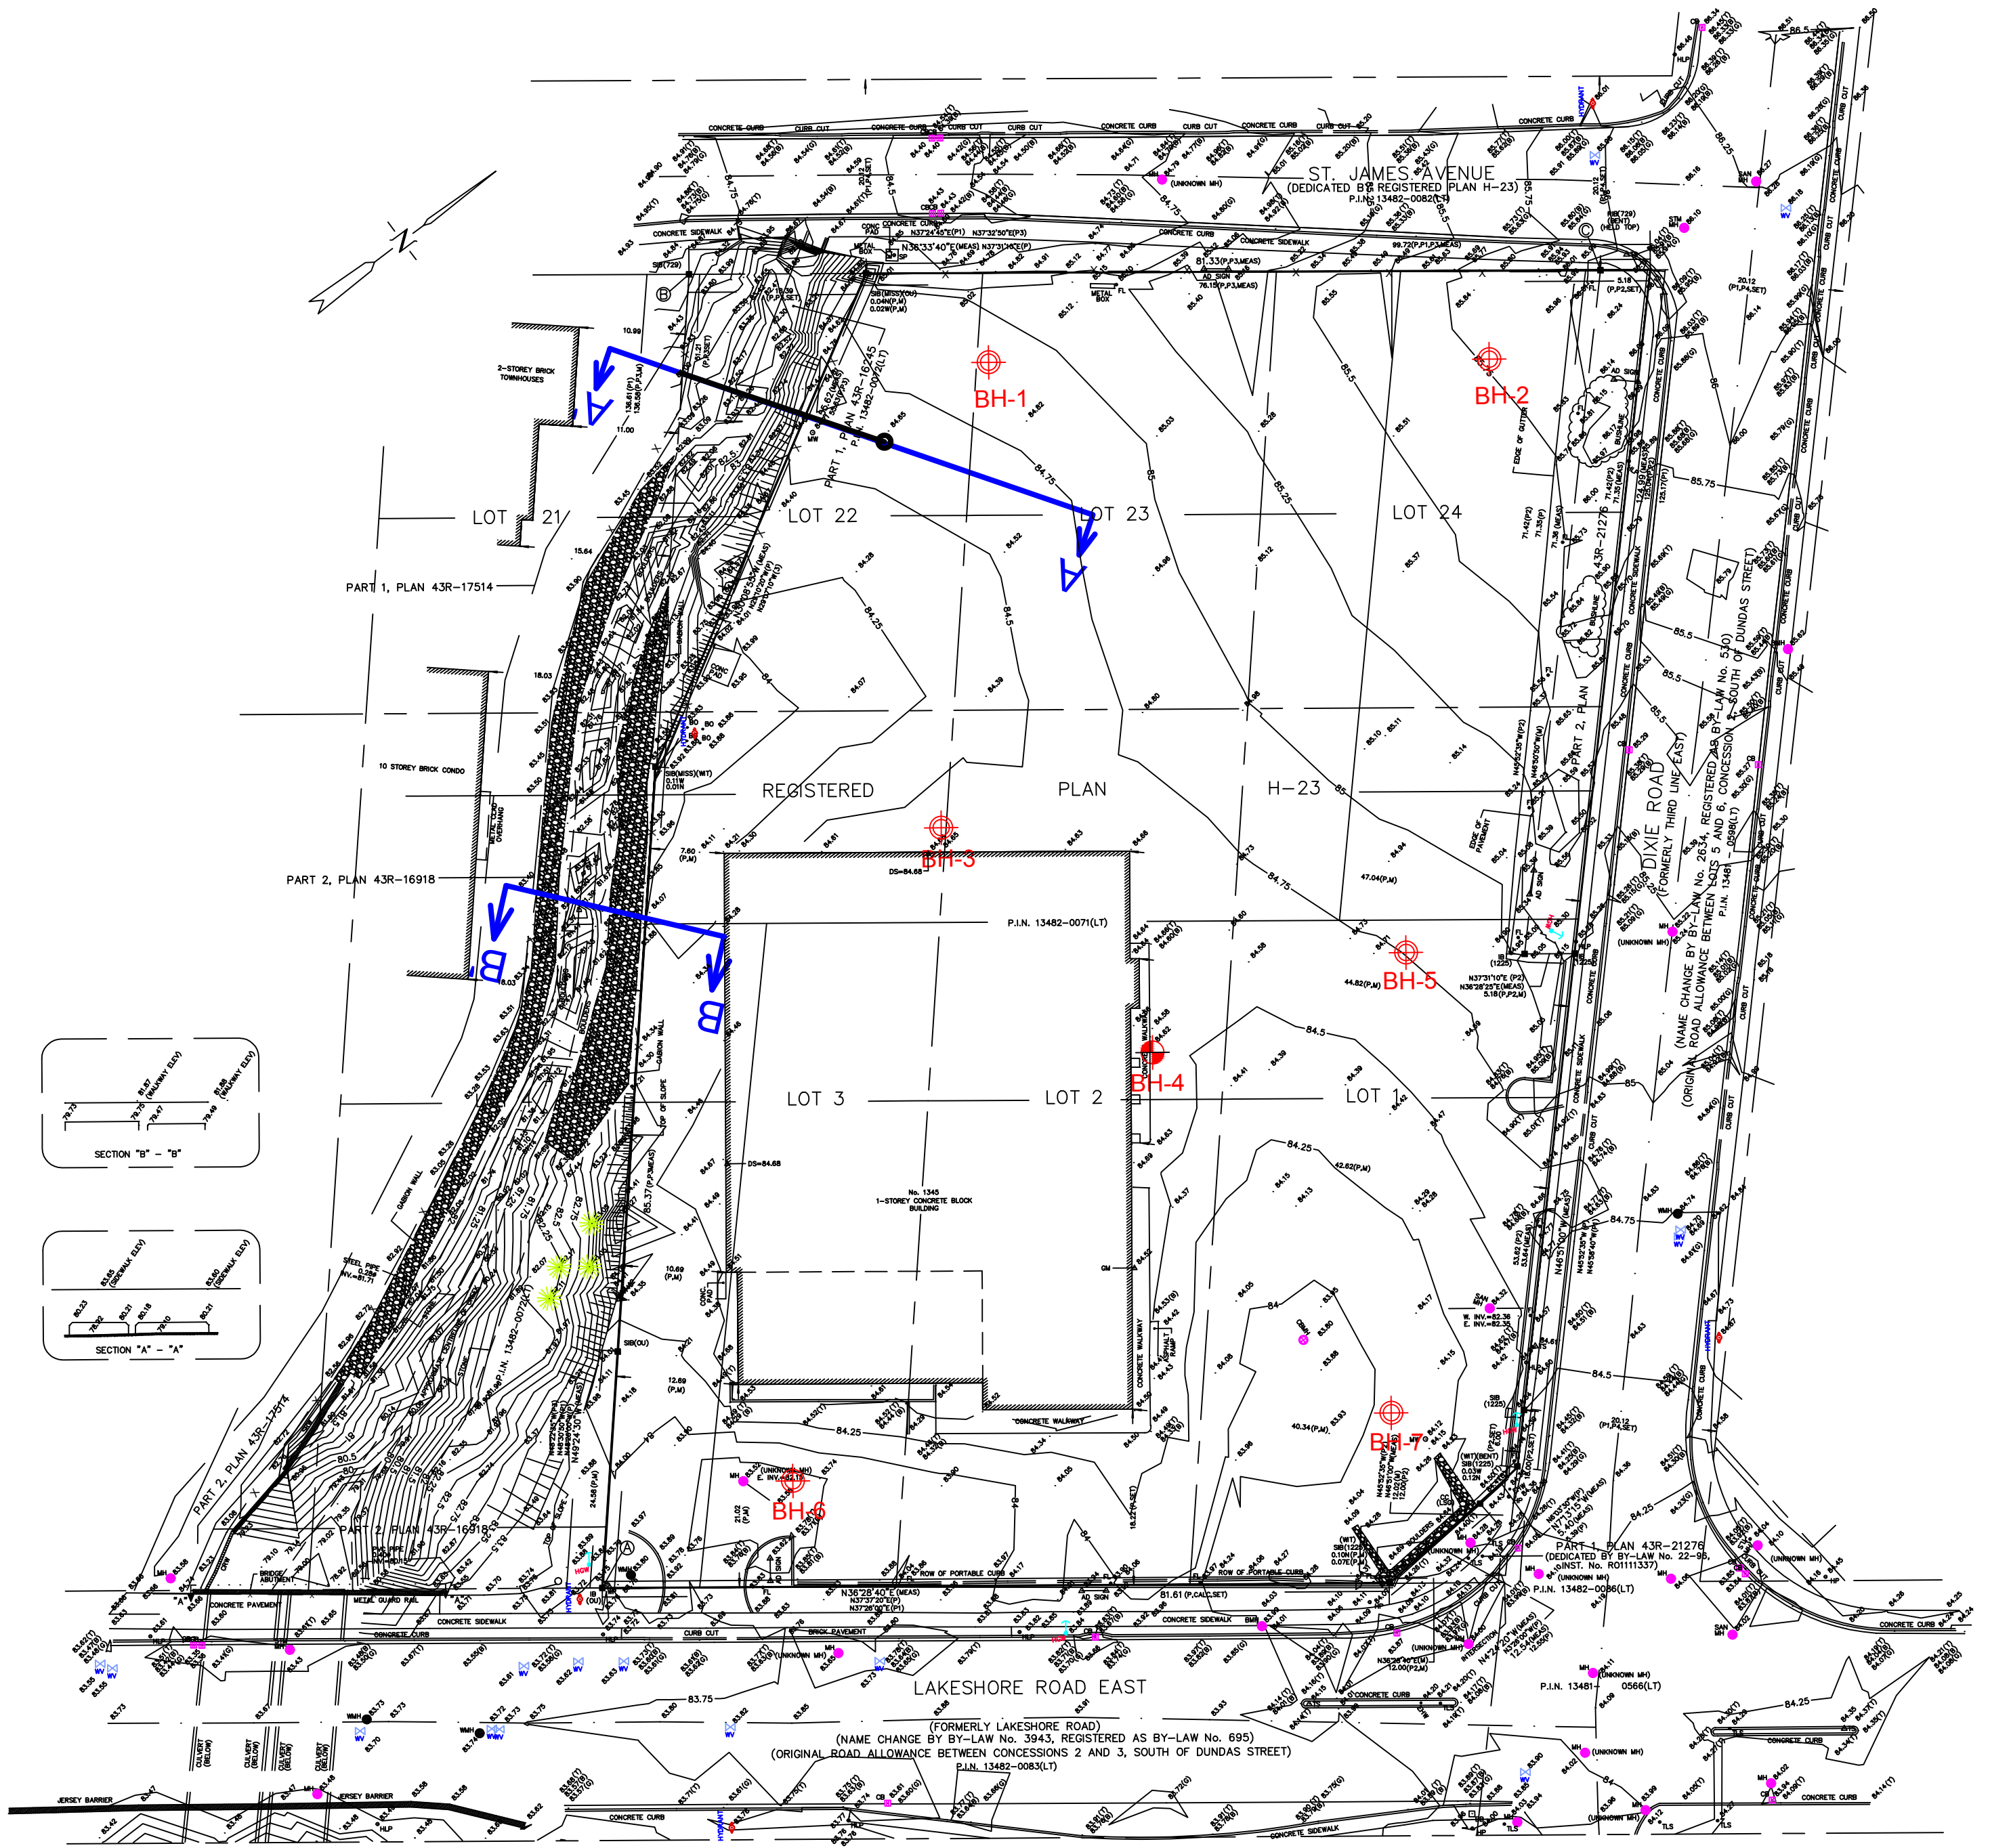
TITLE:	Borehole / Monitoring Well Location Plan / Slope Stability Study - Sections		
LOCATION:	1345 Lakeshore Road East, Mississauga, Ontario		
PROJECT NO.	4738-17-G-VAN-A	DATE :	May 2018
DRAWING NO.			1

The fieldwork for the slope stability study was carried out in the tableland, during the period of December 15 to 20, 2017, which consisted of drilling seven sampled boreholes, BH-1 to BH-7, having BH-1, BH-3 and BH-6 located close to the top of slope at the north, middle and south. The borehole locations are shown on the appended Borehole Location Plan, Drawing No. 1.

The borehole locations, established in the field by our site personnel, are shown on the appended Borehole Location Plan, Drawing No. 1. The ground elevations, at the borehole locations, were determined using “TOP OF MH”, located to the southwest of the existing building of the Site, as the temporary benchmark (TBM).

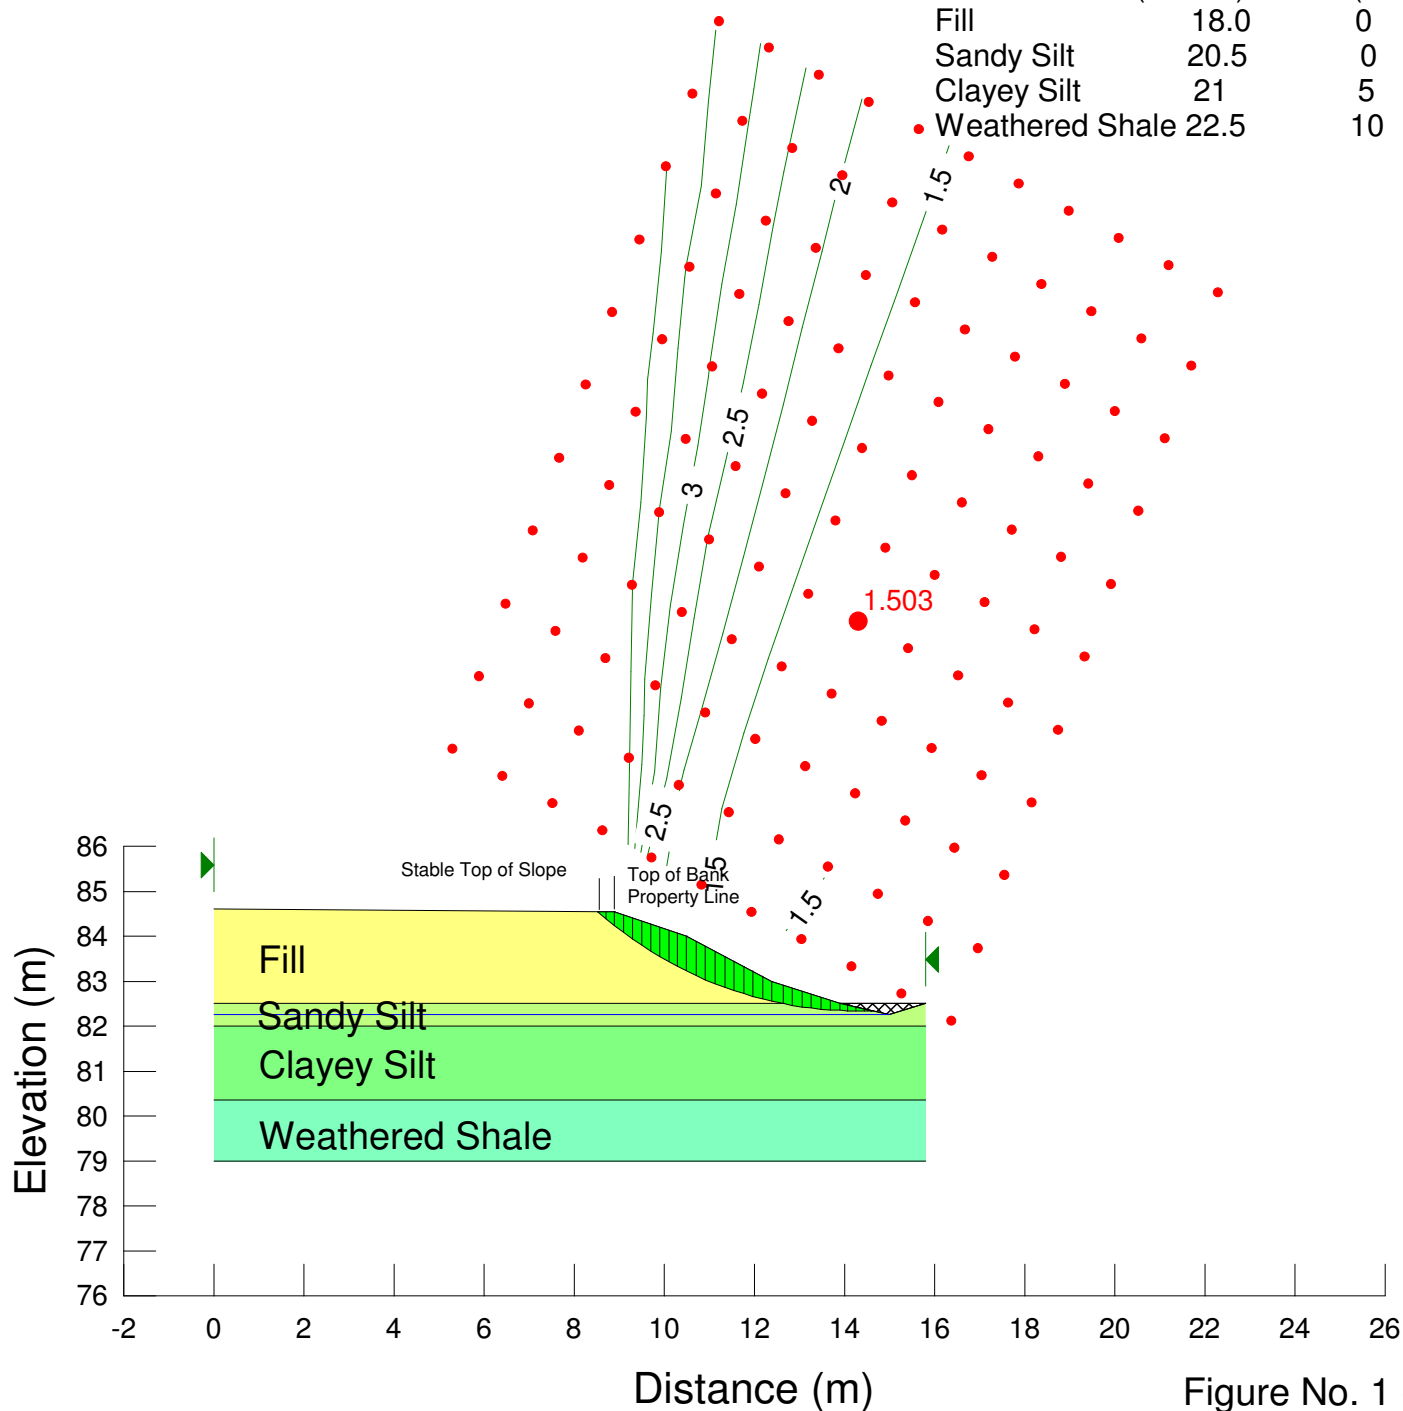
Figure No. 1 - Section A1

The analysis indicates that at Section A, the intercept at the tableland for the slip surface, with a factor of safety of 1.503, is at a distance of approximately 0.4m from the existing top of bank / property line. (Figure No. 1 – Section A1)

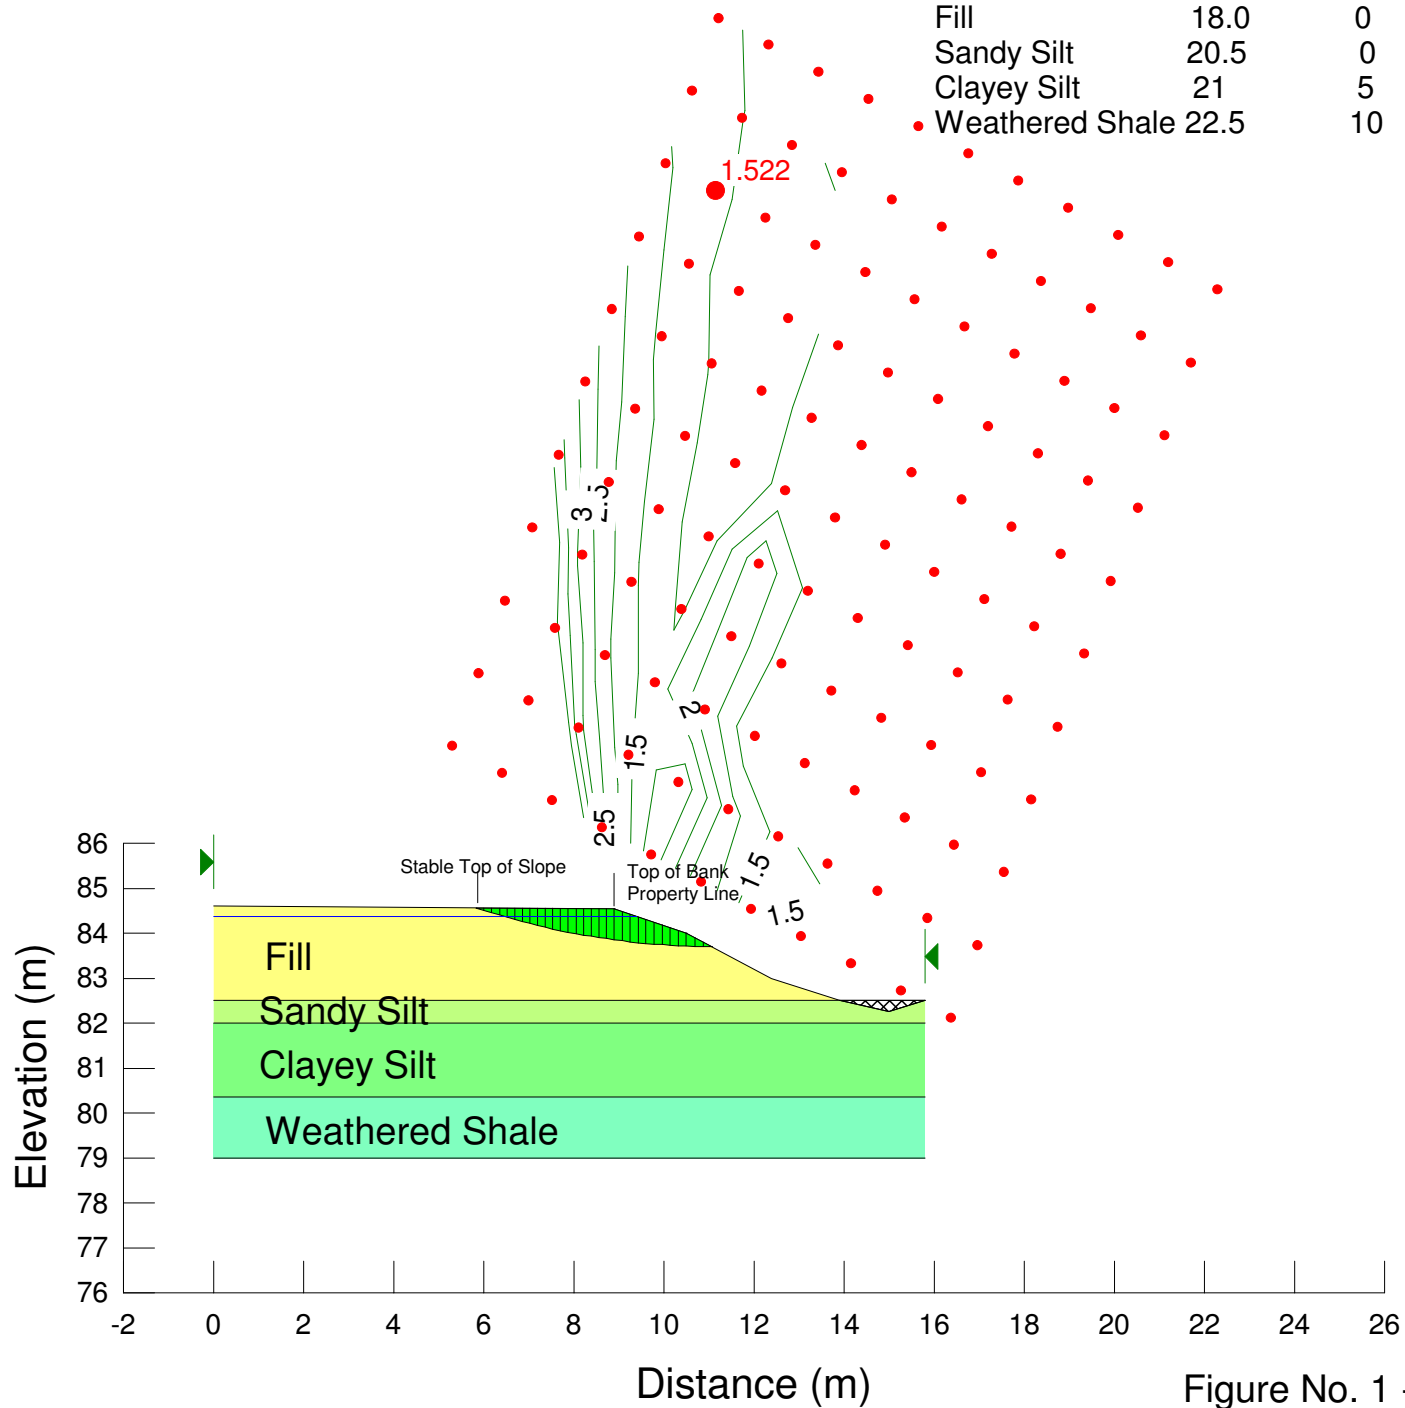
Figure No. 1 - Section A1-1

The analysis indicates that the failure plane, with the a factor of safety of 1.522 at Section A, has shifted into the tableland by about 3.0m from the existing top of bank / property line. (Figure No. 1 – Section A1-1)

The critical slip surface, with the factor of safety of 1.522 at Section A, has shifted into the tableland by about 3.0m from the existing top of bank / property line (Figure No. 1 – Section A1-1). This represents the Long Term Stable top of slope at 3.0m from the existing Top of Slope.

It is our opinion that a Toe Erosion Allowance of 1m should be considered at the north part (Section A).

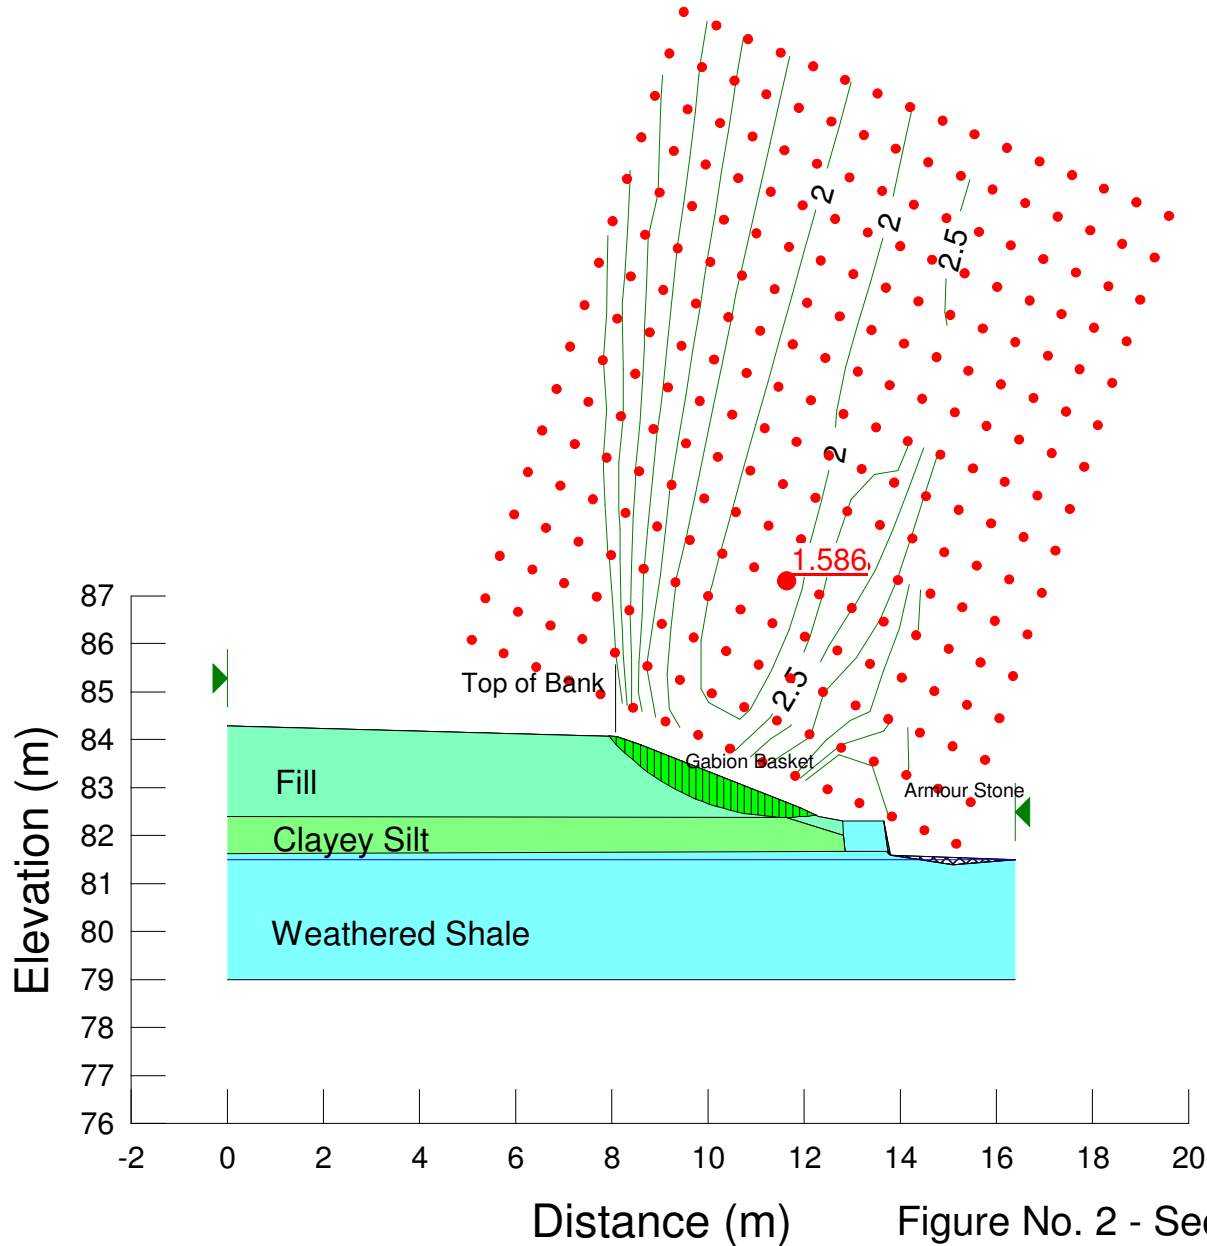
Figure No. 2 - Section B1

The analysis indicates that at Section B, the intercept at the tableland for the slip surface, with a factor of safety of 1.586, is very close to the existing top of bank / property line. (Figure No. 2 – Section B1)

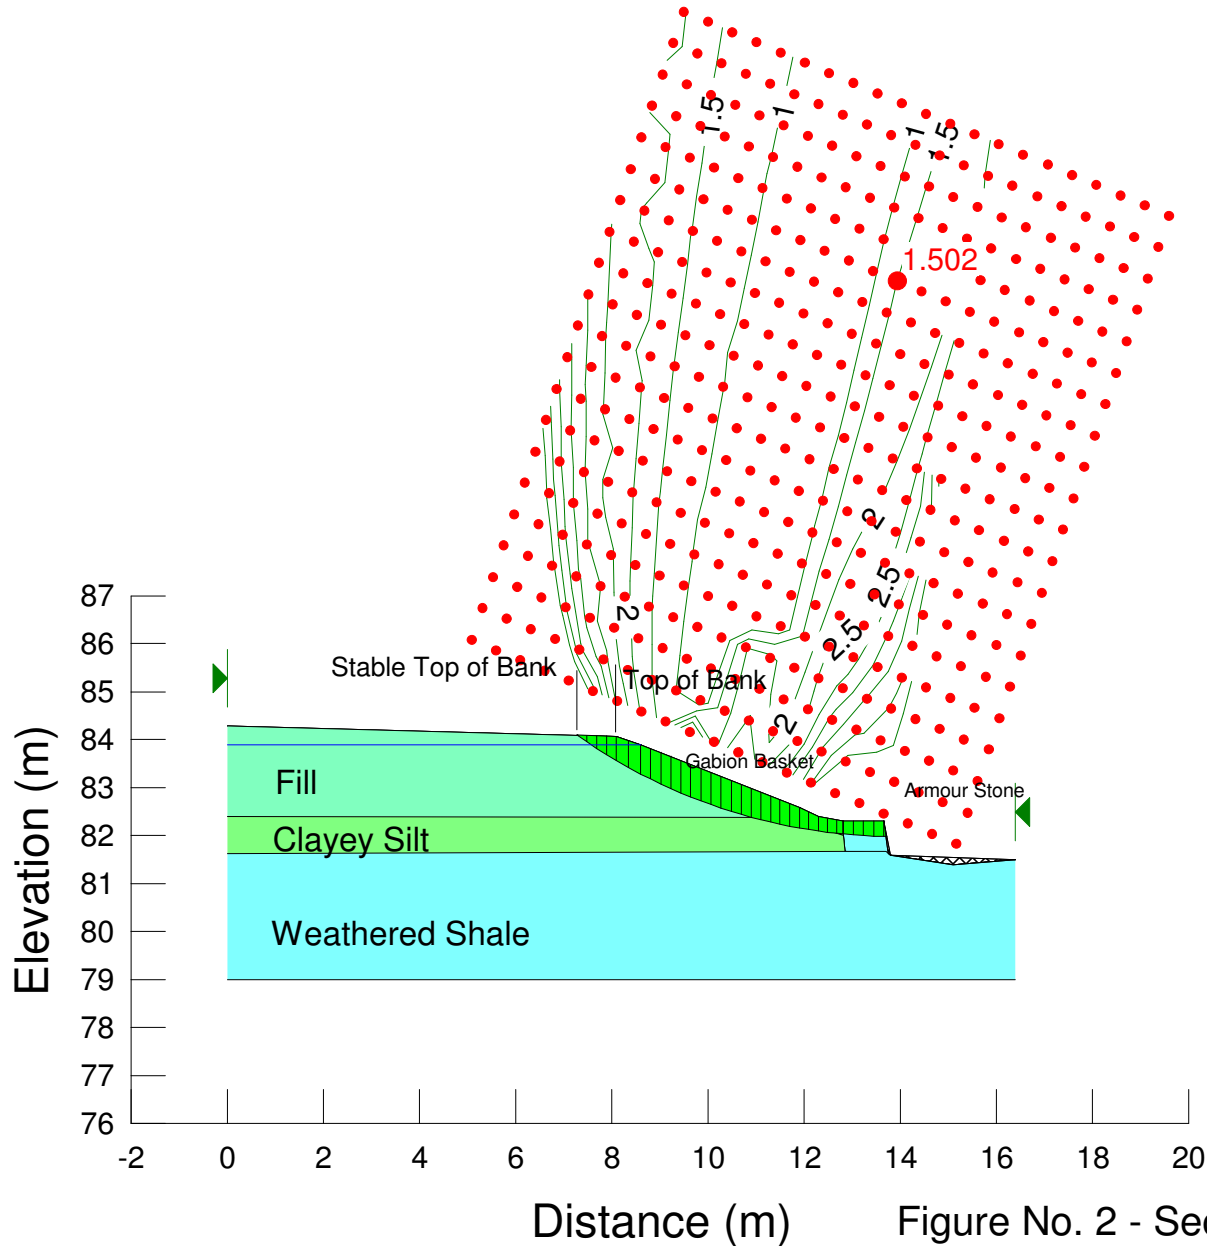
Figure No. 2 - Section B1-1

The analysis indicates that the failure plane, with the a factor of safety of 1.502 at Section B, has shifted into the tableland by about 0.7m from the existing top of bank / property line. (Figure No. 2 – Section B1-1)

The critical slip surface, with the factor of safety of 1.502 at Section B, has shifted into the tableland by about 0.7m from the existing top of bank / property line (Figure No. 2 – Section B1-1).

The existing top of bank at the middle part represents the stable of slope. During and after regulatory flooding, the stable top of bank may shift 0.7m at the middle part. (0.7m for stable slope allowance).

Toe Erosion along the creek, under normal circumstances, is unlikely due to the presence of the Armour stone wall at the middle and south parts (at Section B); therefore, a Toe Erosion Allowance is not required.
