**GEOTECHNICAL INVESTIGATION FOR
PERFORMING SLOPE STABILITY ANALYSIS
PROPOSED DEVELOPMENT
51 TANNERY STREET
MISSISSAUGA, ONTARIO**

**PATRIOT ENGINEERING LTD.
Consulting Engineers**

Project 37105
March 24, 2017

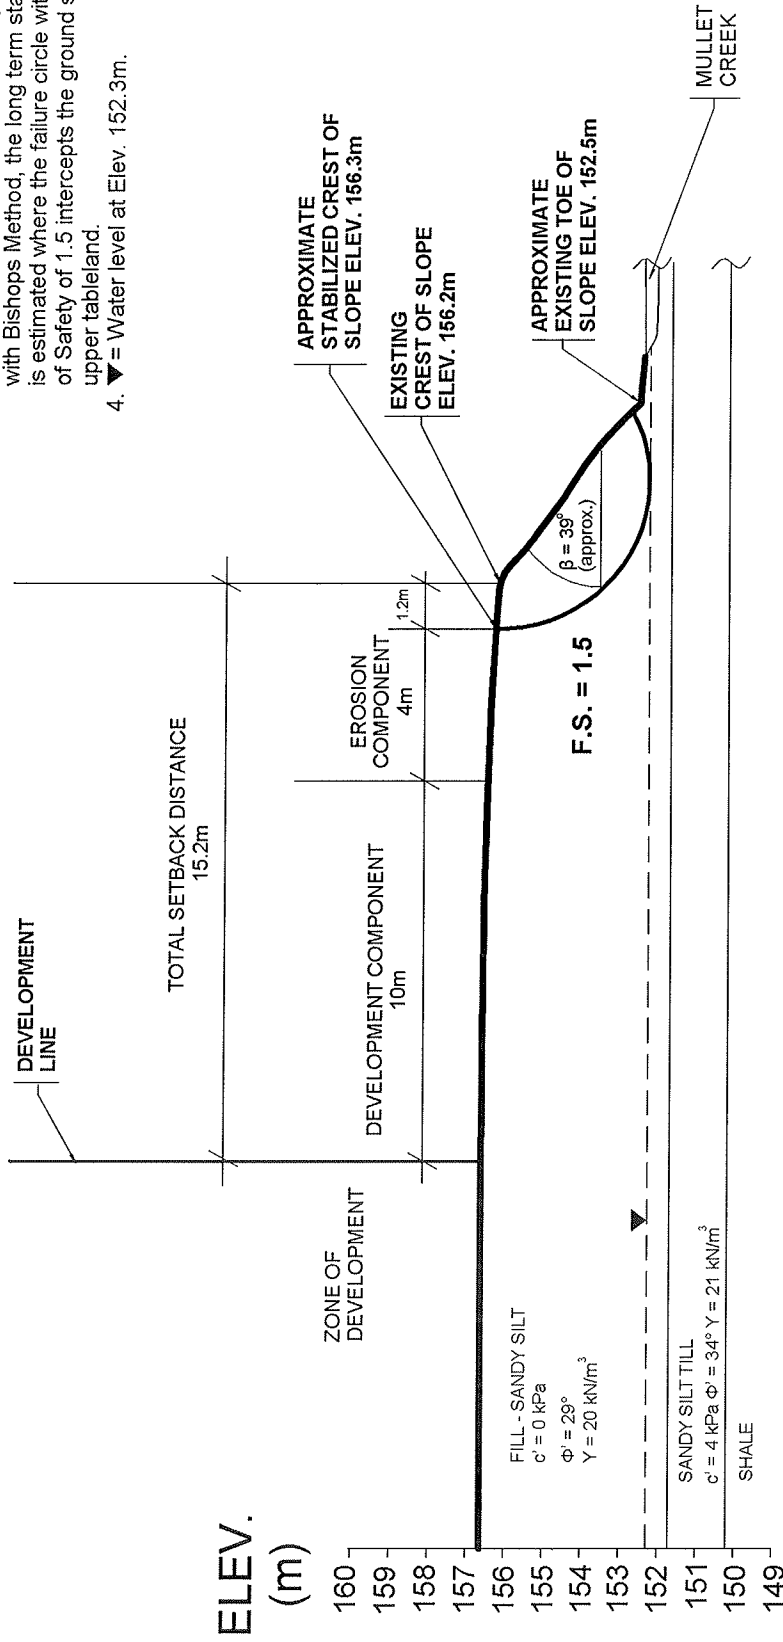
SECTION AA SCALE 1:200

Section AA, $\beta = 39$ degrees
Section BB, $\beta = 33$ degrees
Section CC, $\beta = 30$ degrees
Section DD, $\beta = 29$ degrees

The stabilized crest of the slope with a failure circle that has a minimum factor of safety of 1.5 which intercepts the ground surface at the upper tableland is indicated on our Section AA, Section BB and Section DD. From the existing crest of the slope, it is located inward by a distance of 1.2m, 0.4m and 0.8m, for Section AA, Section BB and Section DD, respectively. A standard precaution is to add a minimum 4m toe erosion component setback distance plus a 10m development setback distance, for a combined total of 14m, behind this stabilized crest of slope which is represented with the imaginary circle that has a factor of safety of 1.5. We referred this as the "Development Line". Development of the structures can then take place inward of the Development Line at the area that we designated as the "Zone of Development". This is illustrated in Figures 1A, 1B and 1D.

1. Slope geometry is approximate and based on tape and level measurements.
2. The average slope β of 39° is estimated.
3. Using the computerized slope stability analysis with Bishop's Method, the long term stable slope is estimated where the failure circle with a factor of Safety of 1.5 intercepts the ground surface at upper tableland.
4. \blacktriangledown = Water level at Elev. 152.3m.

SOIL STRATIGRAPHY OBTAINED FROM BOREHOLE BH201
LATERAL EXTENT AND DEPTH OF STRATIGRAPHY VARIES

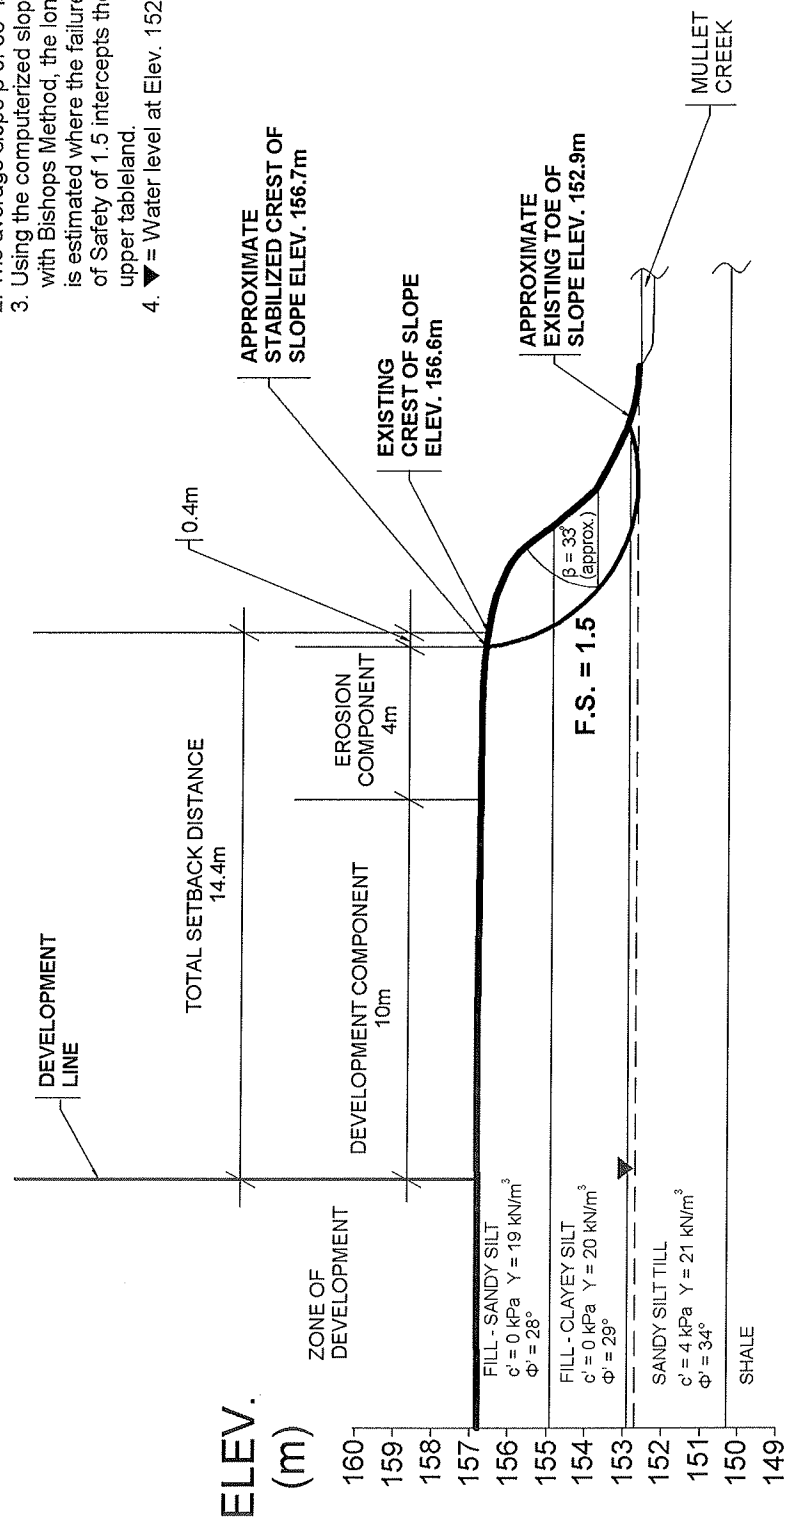
SECTION BB SCALE 1:200

1. Slope geometry is approximate and based on tape and level measurements.
2. The average slope β of 33° is estimated.
3. Using the computerized slope stability analysis with Bishop's Method, the long term stable slope is estimated where the failure circle with a factor of Safety of 1.5 intercepts the ground surface at upper tableland.
4. ▼ = Water level at Elev. 152.7m.

SOIL STRATIGRAPHY OBTAINED FROM BOREHOLE BH202
LATERAL EXTENT AND DEPTH OF STRATIGRAPHY VARIES

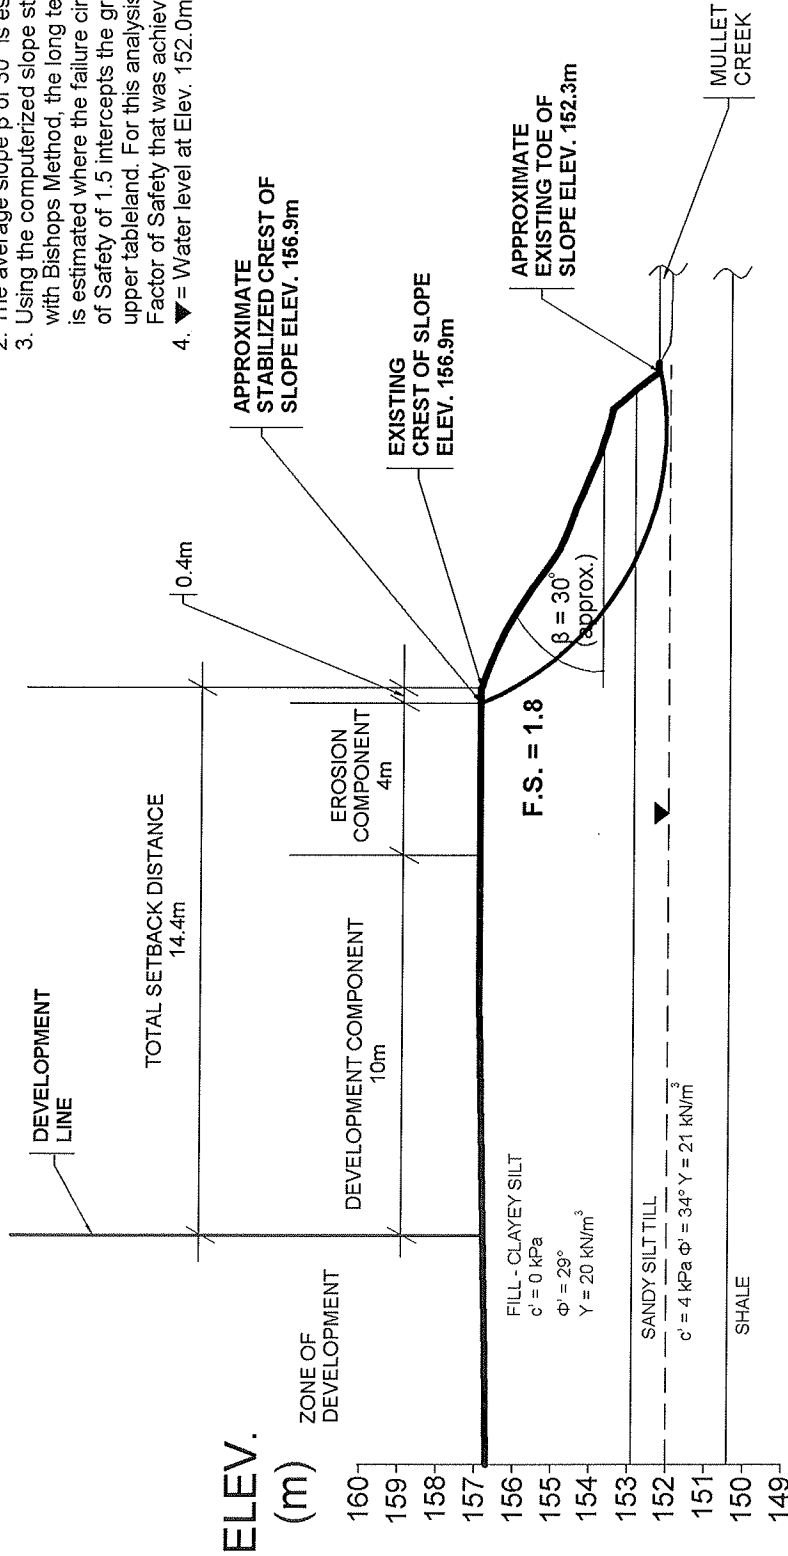
SECTION CC SCALE 1:200

For the above Section CC, our analysis assisted us to identify the location of the most critical circle which recorded the lowest available factor of safety, which was 1.8. From the existing crest of the slope, it is located inward by a distance of 0.4m. Considering that this was the lowest attainable value, it still exceeds the minimum criteria of 1.5. Again at these section, a standard precaution is to add a minimum 4m erosion component setback distance plus a 10m development setback distance for a combined total of 14m, behind this stabilized crest of slope. Typically, this 14m distance should be added inward from the point where the imaginary circle with a factor of safety of 1.5 meets the ground surface. However, we have used a conservative approach and added a 14m setback distance from the imaginary circles with factors of safety of 1.8, and this new point is identified as the Development Line. As indicated above, development of the structures can take place within the area described as Zone of Development, which is inward of the Development Line, as illustrated in Figure 1C.

1. Slope geometry is approximate and based on tape and level measurements.
2. The average slope β of 30° is estimated.
3. Using the computerized slope stability analysis with Bishop's Method, the long term stable slope is estimated where the failure circle with a factor of Safety of 1.5 intercepts the ground surface at upper tableland. For this analysis, the minimum Factor of Safety that was achieved was 1.8.
4. ▼ = Water level at Elev. 152.0m.

SOIL STRATIGRAPHY OBTAINED FROM BOREHOLE BH203
LATERAL EXTENT AND DEPTH OF STRATIGRAPHY VARIES

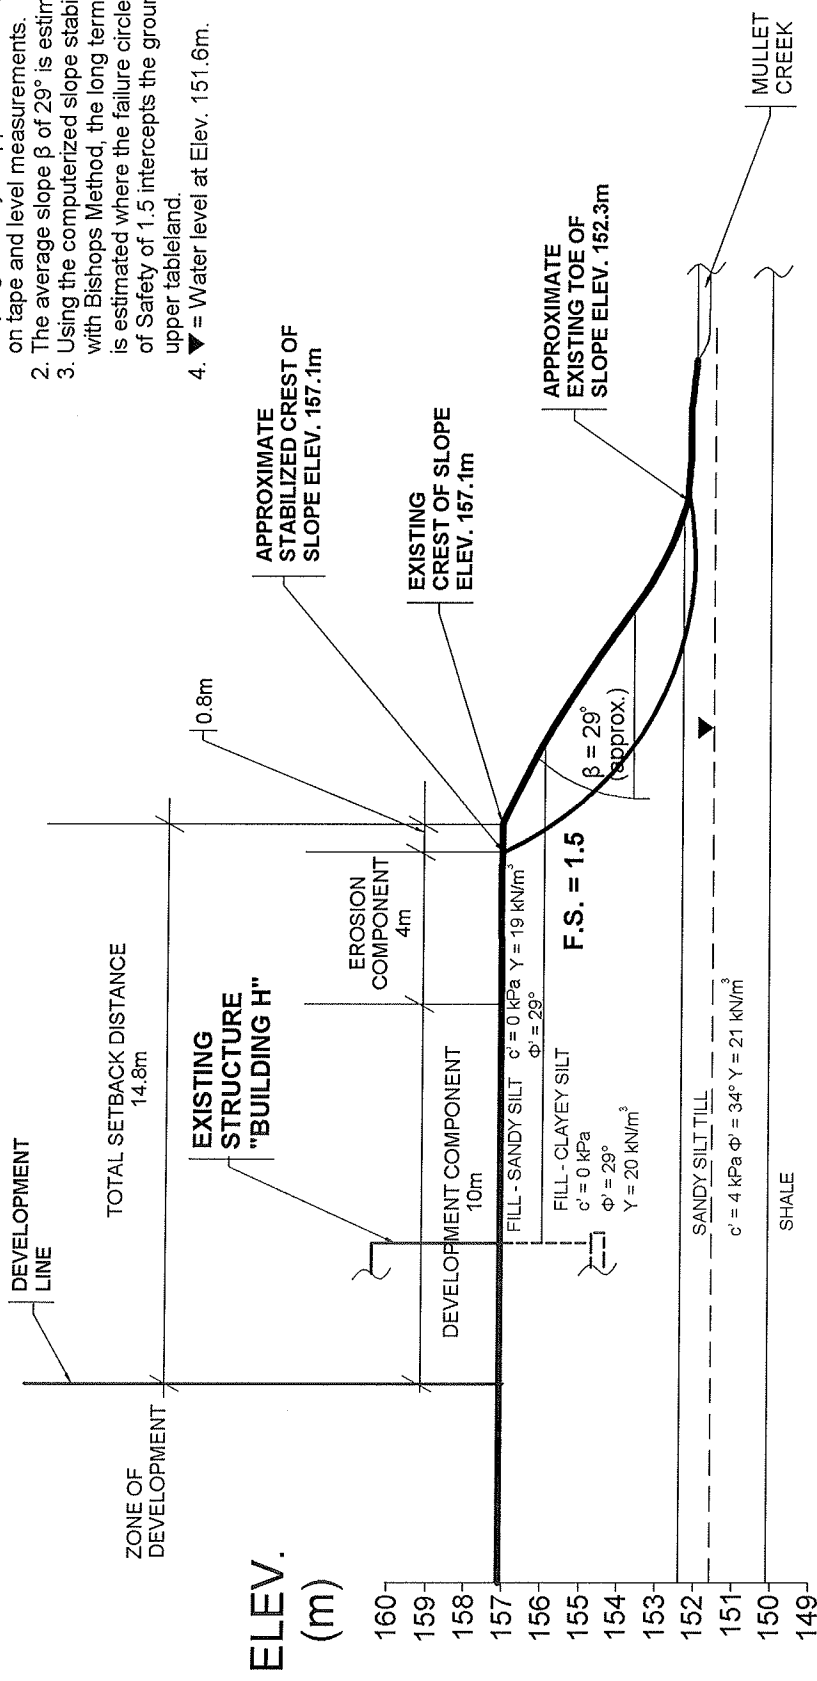
SECTION DD SCALE 1:200

1. Slope geometry is approximate and based on tape and level measurements.
2. The average slope β of 29° is estimated.
3. Using the computerized slope stability analysis with Bishops Method, the long term stable slope is estimated where the failure circle with a factor of Safety of 1.5 intercepts the ground surface at upper tableland.
4. ▼ = Water level at Elev. 151.6m.

SOIL STRATIGRAPHY OBTAINED FROM BOREHOLE BH204
LATERAL EXTENT AND DEPTH OF STRATIGRAPHY VARIES

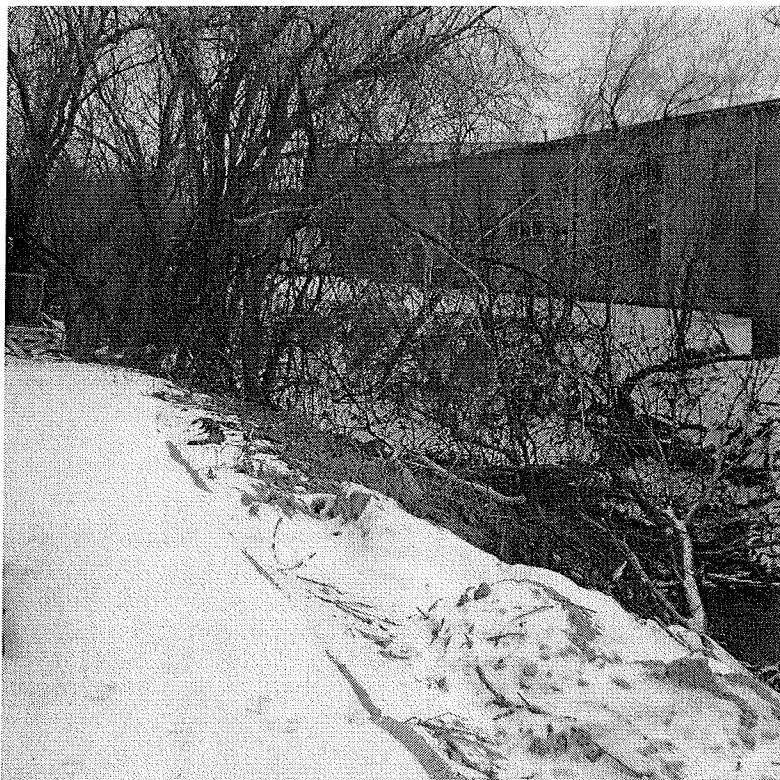
At the time of our visit, there was no evidence of surface erosion/gullies, nor any tension cracks nor any evidence of features that would be of concern regarding the slope and its stability.

Photograph 1: View of slope

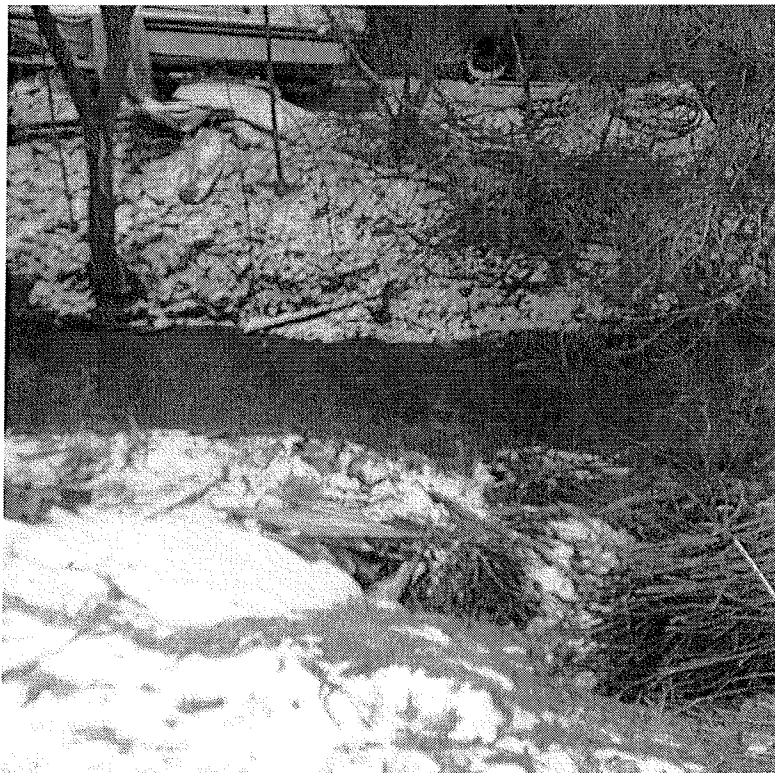
Photograph 2: View of well preserved slope

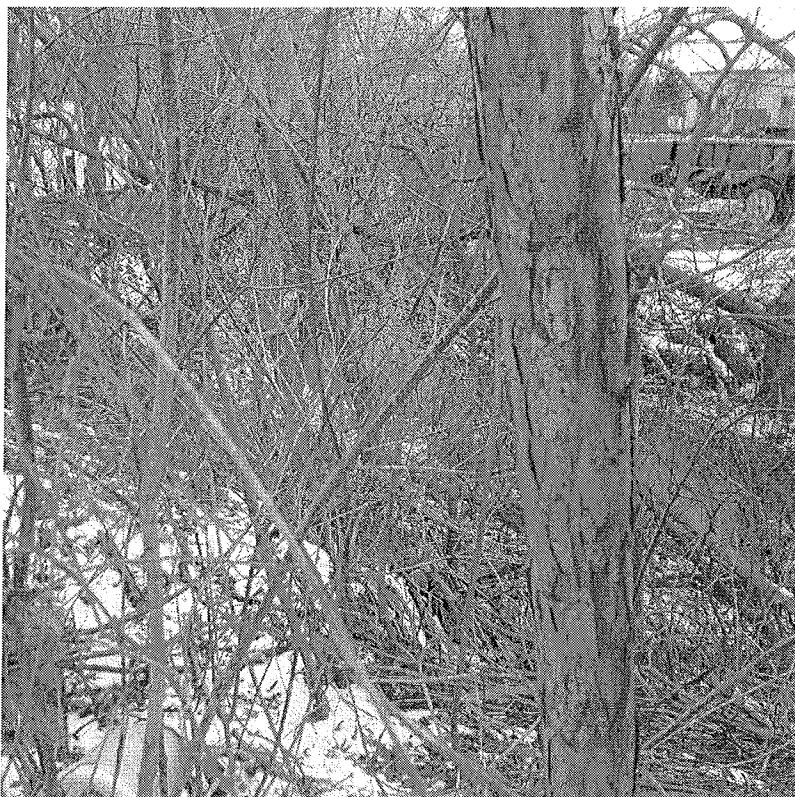
Photograph 3: View of well vegetated slope
