Soil Engineers Ltd.

February 9, 2017

Reference No. 1512-S086

**Re: Slope Stability Study Addendum
Proposed Residential Development
6611 Harmony Hill
City of Mississauga**

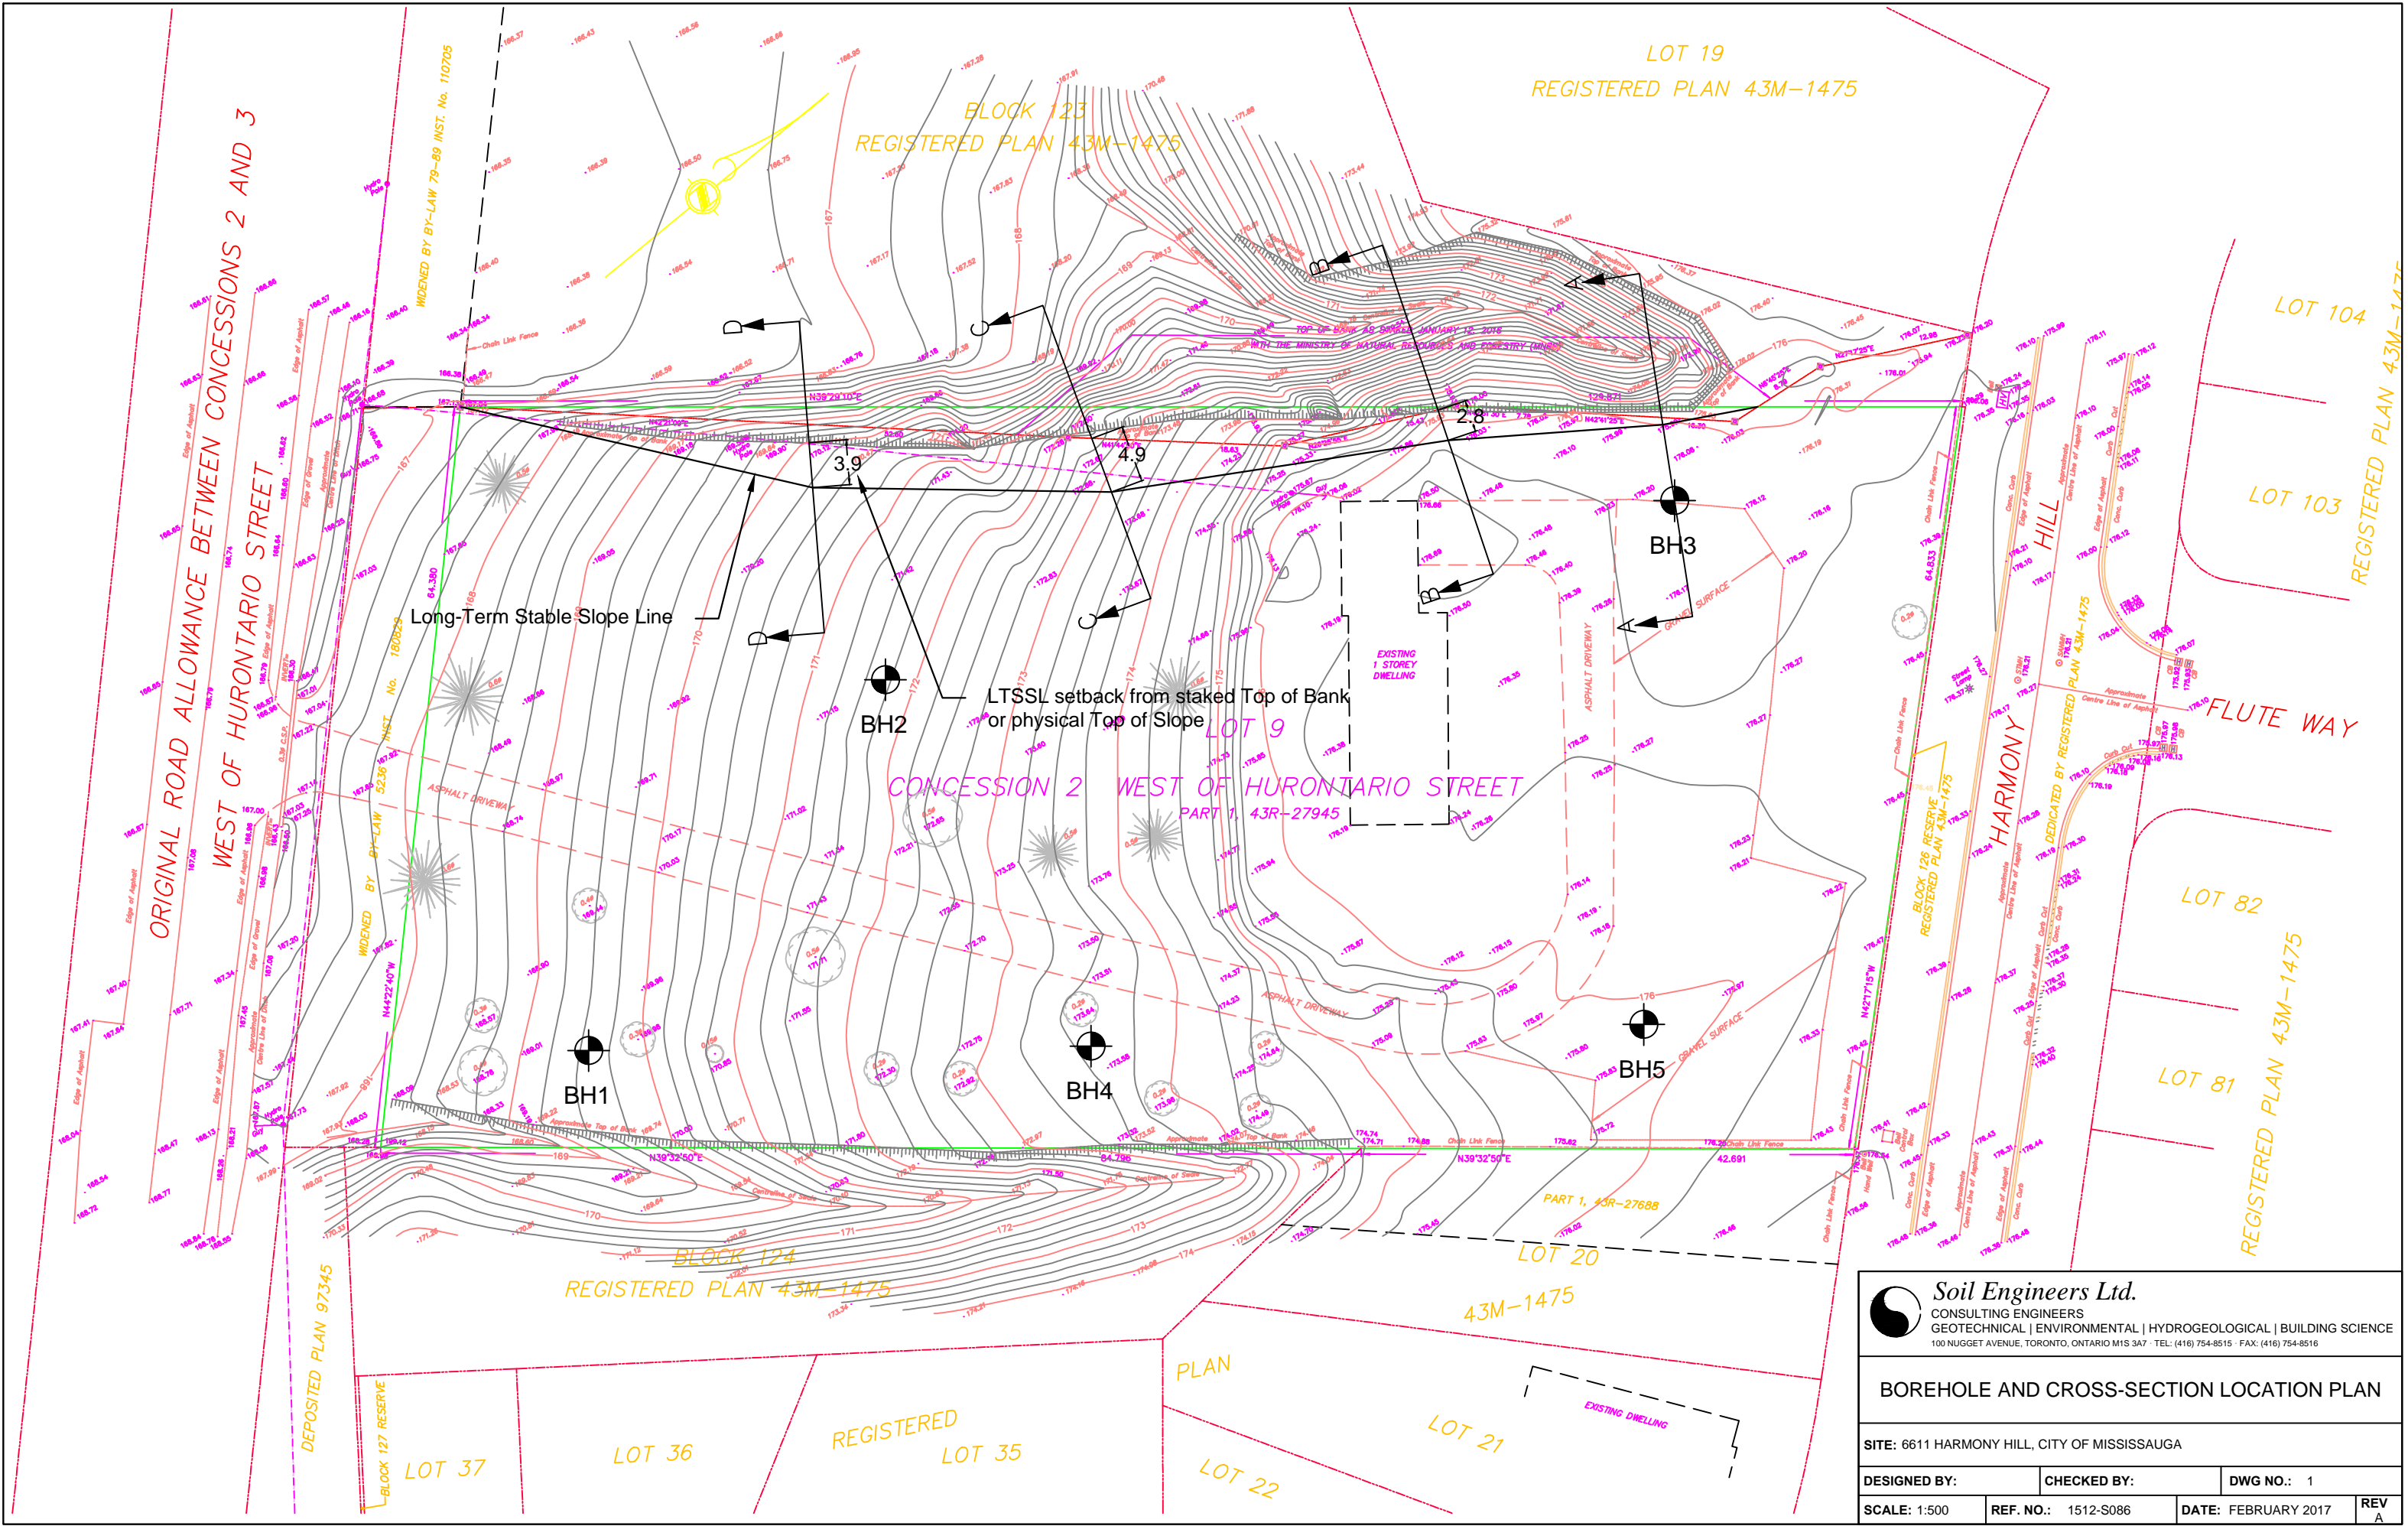
DWG NO.: 1

In the absence of a watercourse at the bottom of slope, toe erosion allowance is thus not required. The long-term stable slope line (LTSSL), incorporating the geotechnically stable gradients is established on the Borehole and Cross-Section Location Plan, Drawing No. 1.

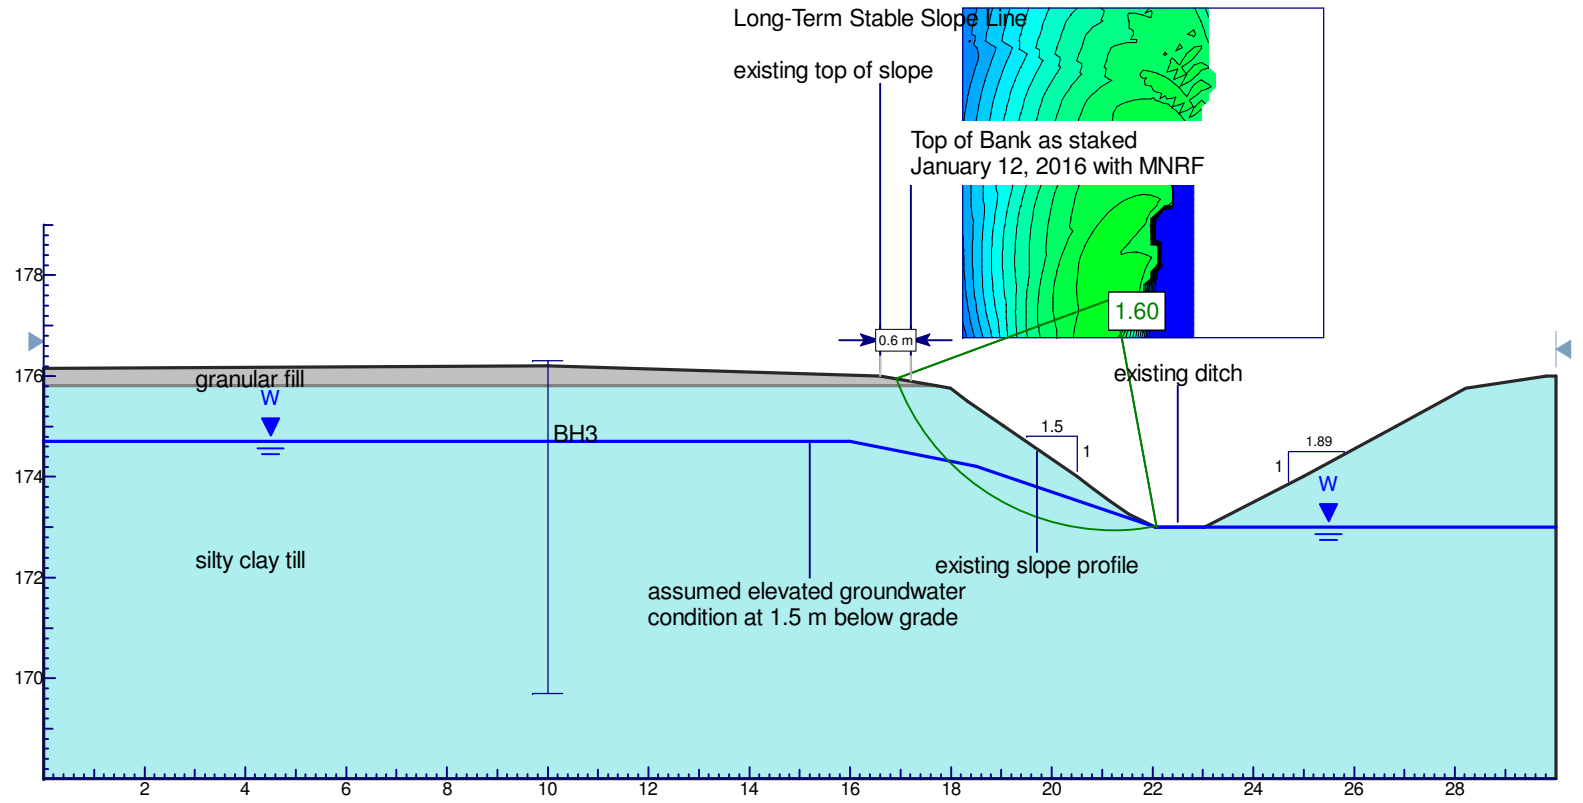
Project Title			Cross-Section A-A - Existing Condition		Load Case	
					Elevated Groundwater Condition	
Location			6611 Harmony Hill, Mississauga			
Drawn By		HWY	Checked By		BL	Scale
						1:150
Date			February 2017		Reference No.	
					1512-S086	
					Revision	
					A	
					Drawing No.	
					2B

The result from the analysis indicates that the slope at Cross-Sections A-A has FOS of 1.5+ under both NGC and EGC, which satisfies the CVC's Slope Stability Definition and Determination Guideline, 2011. The result of analyses is presented on Drawing Nos. 2A and 2B. The slope is therefore considered geotechnically stable at Cross-Section A-A.

Minimum Factor of Safety = 1.60

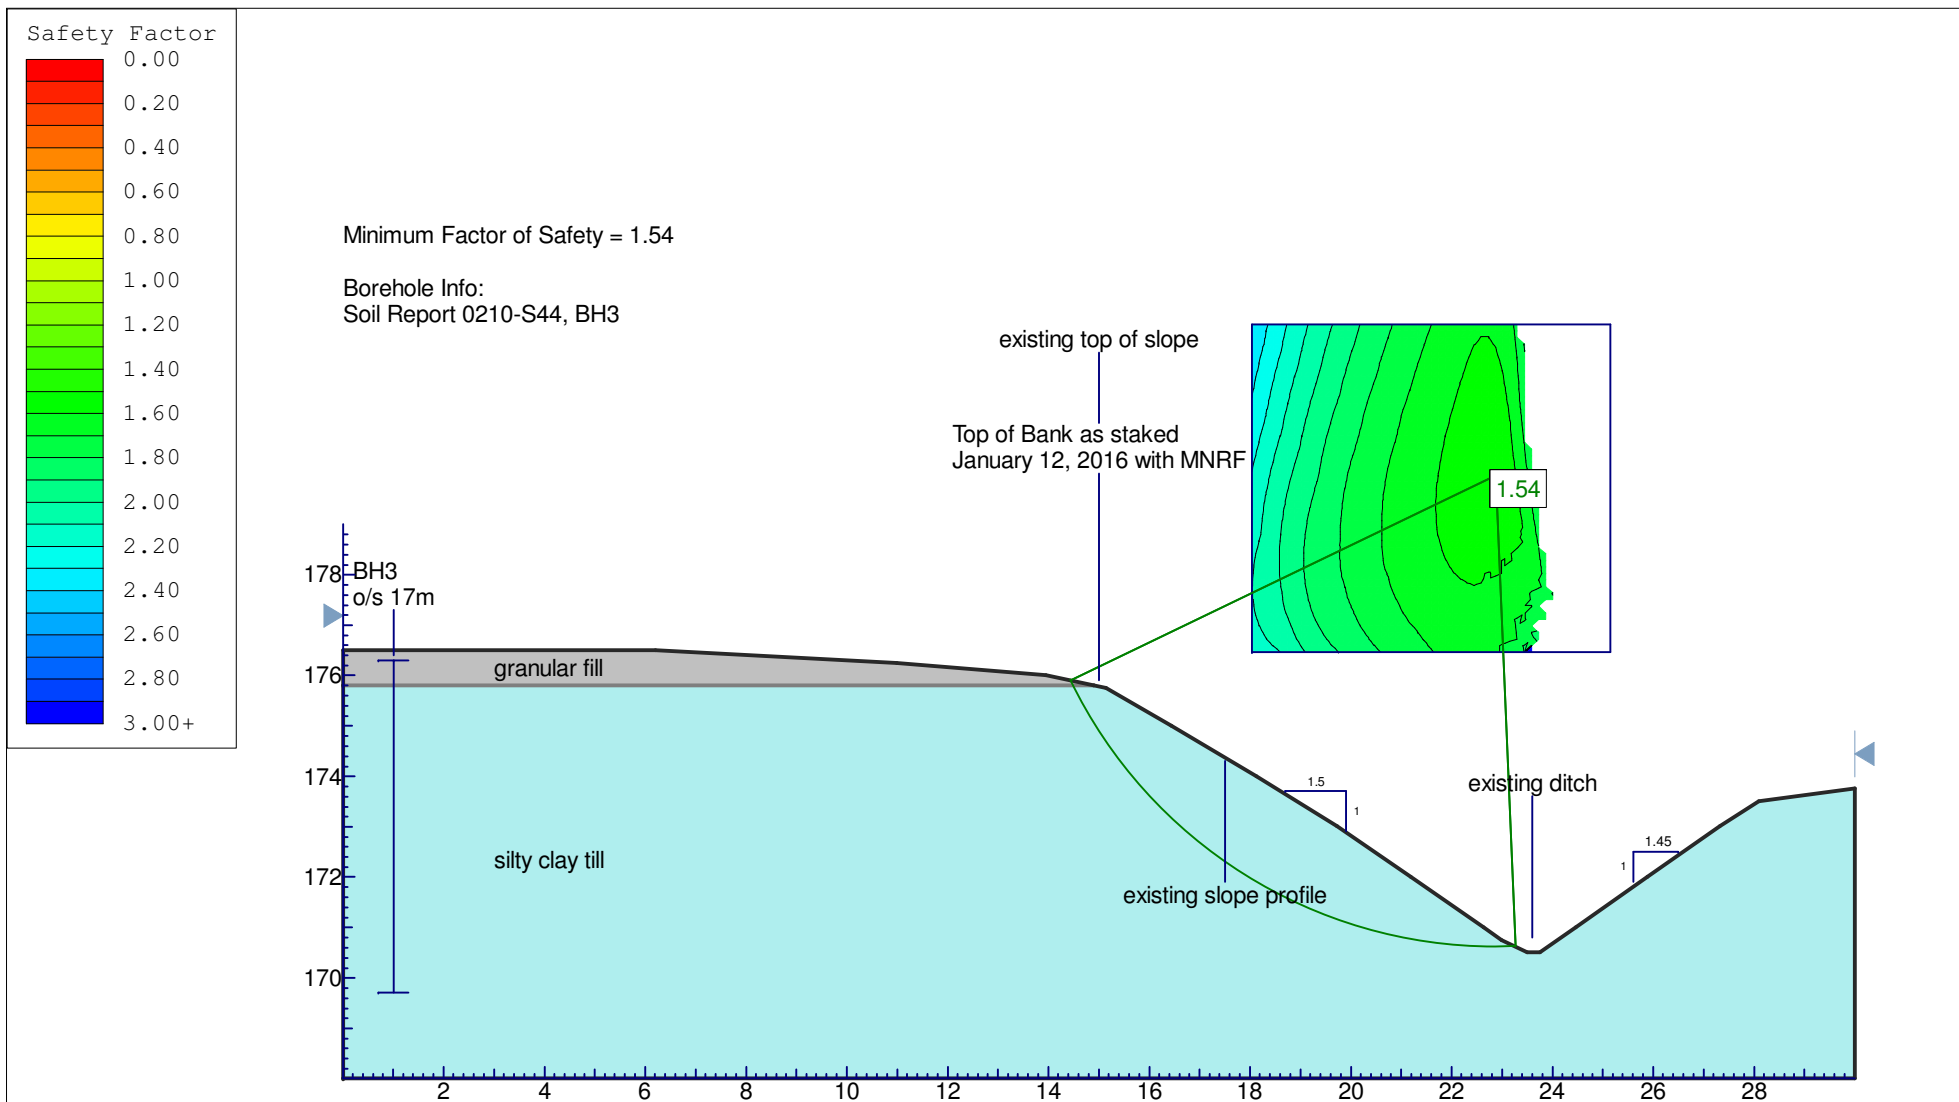
For Cross-Sections B-B, C-C and D-D, the results show that the existing slopes have FOS of 0.93 to 1.24, which fails to meet the CVC requirements under either NGC or EGC except for Cross-Section B-B under the NGC where a FOS of 1.54 is achieved. The results of analyses are presented on Drawing Nos. 3A, 3B, 4A, and 5A. Therefore, the existing valley slope at these locations is considered to be geotechnically unacceptable for the proposed residential development. A stable gradient of 1V:2.0H and 1V:3.0H is recommended for use in sound native soils and earth fill, respectively. The remodelled slopes, yielding a FOS of 1.5+ or 1.3+ under NGC or EGC, respectively, which meets the CVC requirements, are presented on Drawing Nos. 3C, 4B, 4C, 5B and 5C.

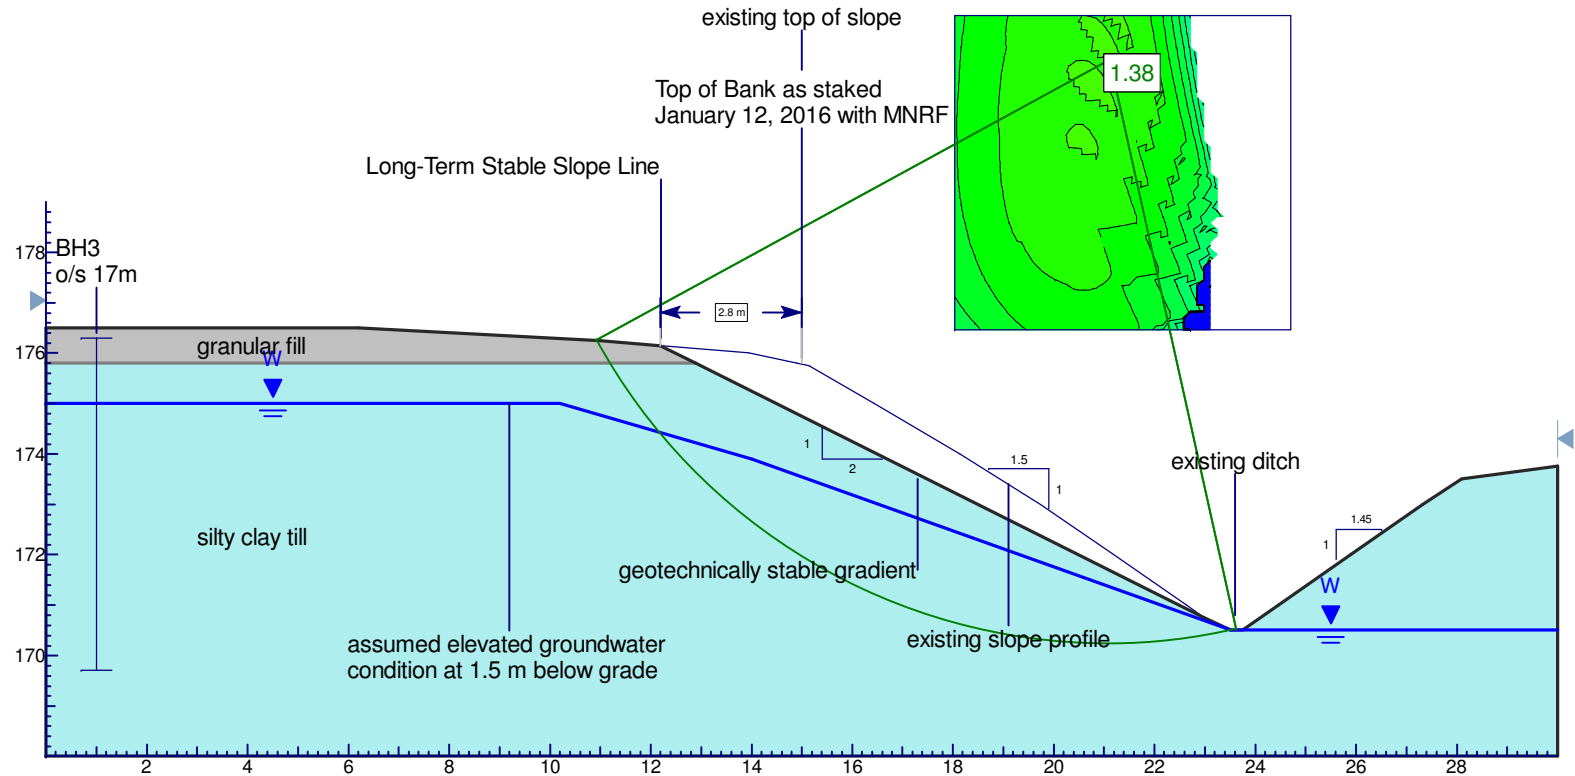
Project Title		Cross-Section B-B - Geotechnically Stable Condition		Load Case
				Elevated Groundwater Condition
Location		6611 Harmony Hill, Mississauga		
Drawn By	HWY	Checked By	BL	Revision
Date		February 2017		A
		Reference No.	1512-S086	Drawing No.
				3C

Minimum Factor of Safety = 1.38

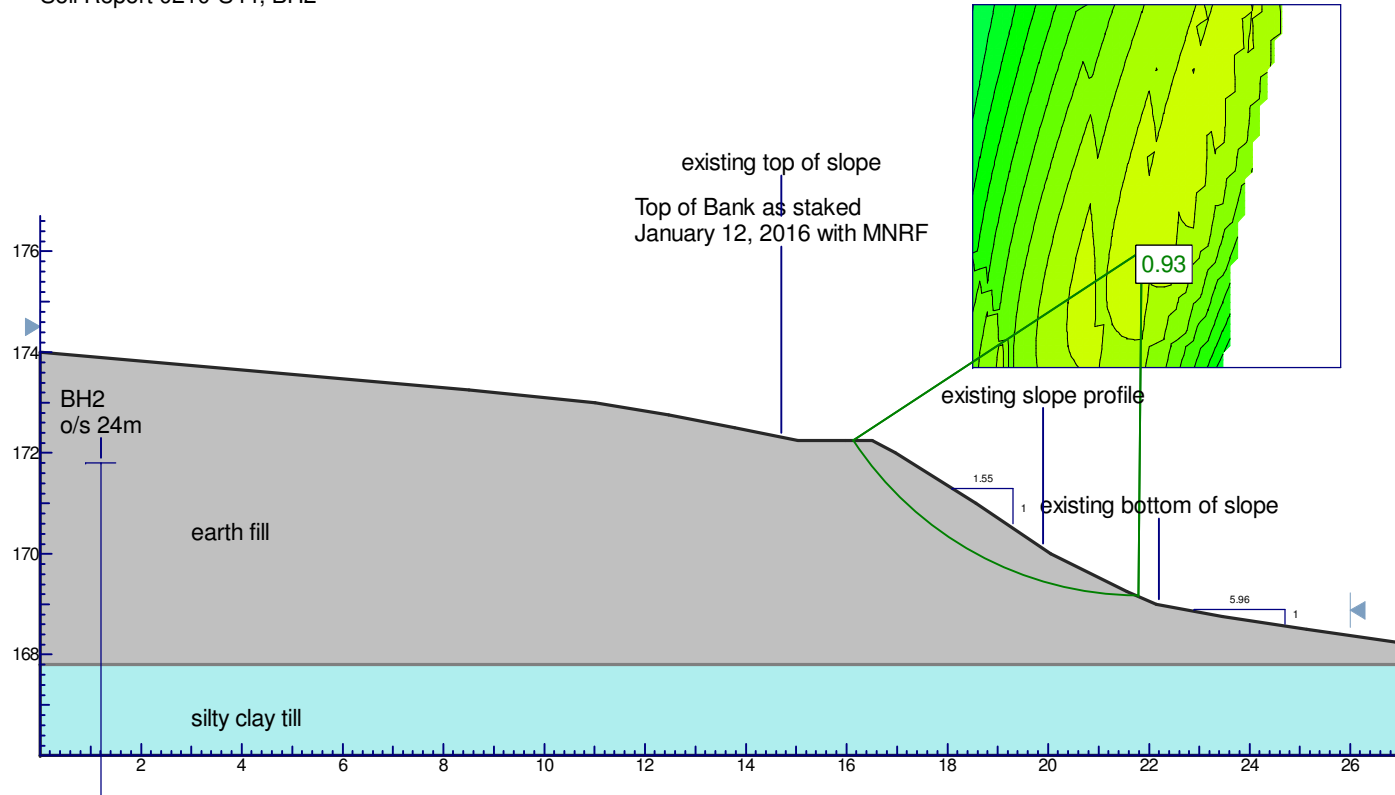
4A

Minimum Factor of Safety = 0.93

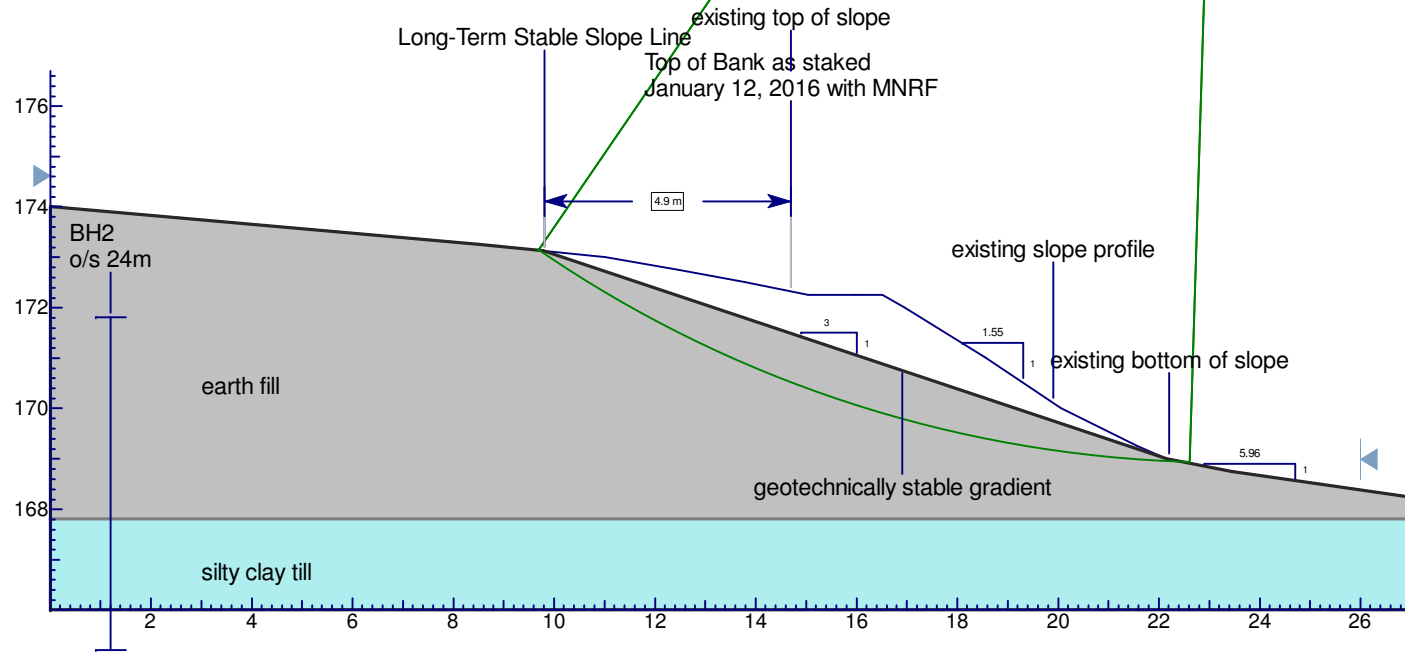
4B

Minimum Factor of Safety = 1.52

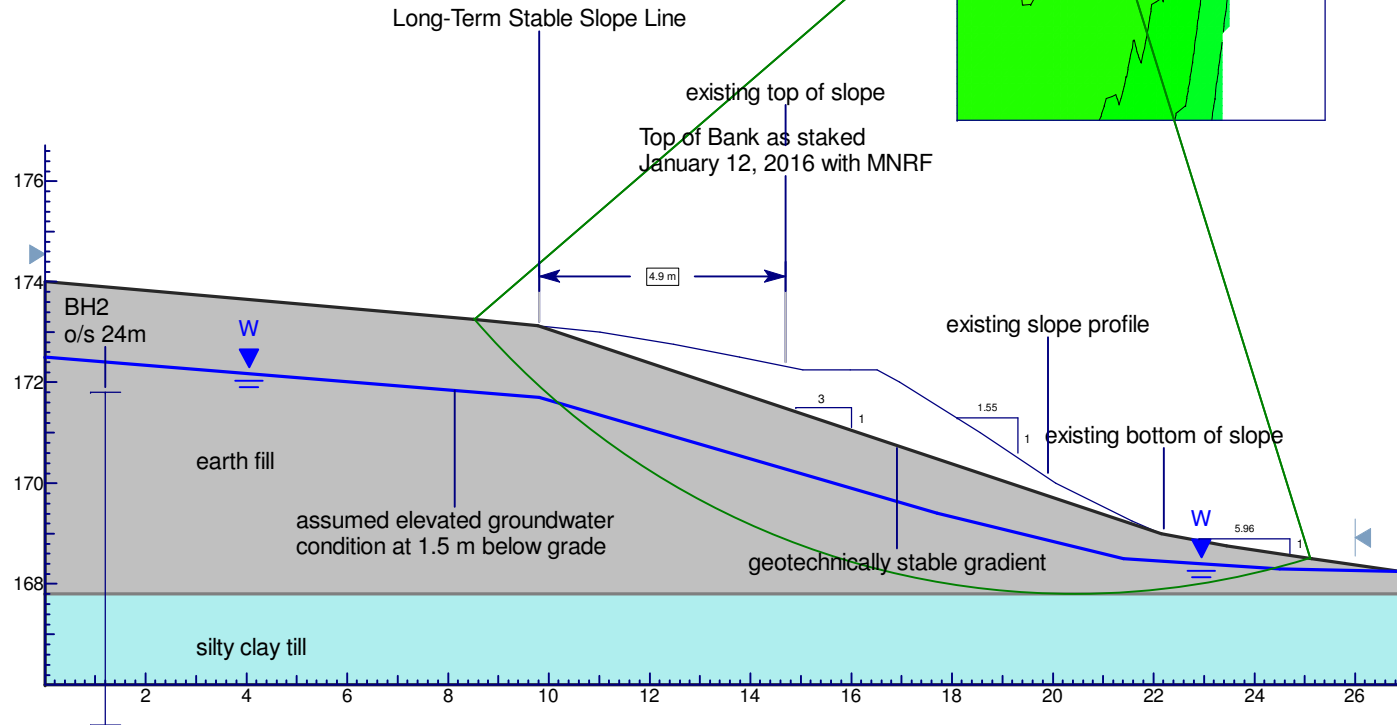
Project Title		Cross-Section C-C - Geotechnically Stable Condition		Load Case
Location		6611 Harmony Hill, Mississauga		Elevated Groundwater Condition
Drawn By	HWY	Checked By	BL	Revision
Date	February 2017	Reference No.	1512-S086	A
				Drawing No.
				4C

Minimum Factor of Safety = 1.36

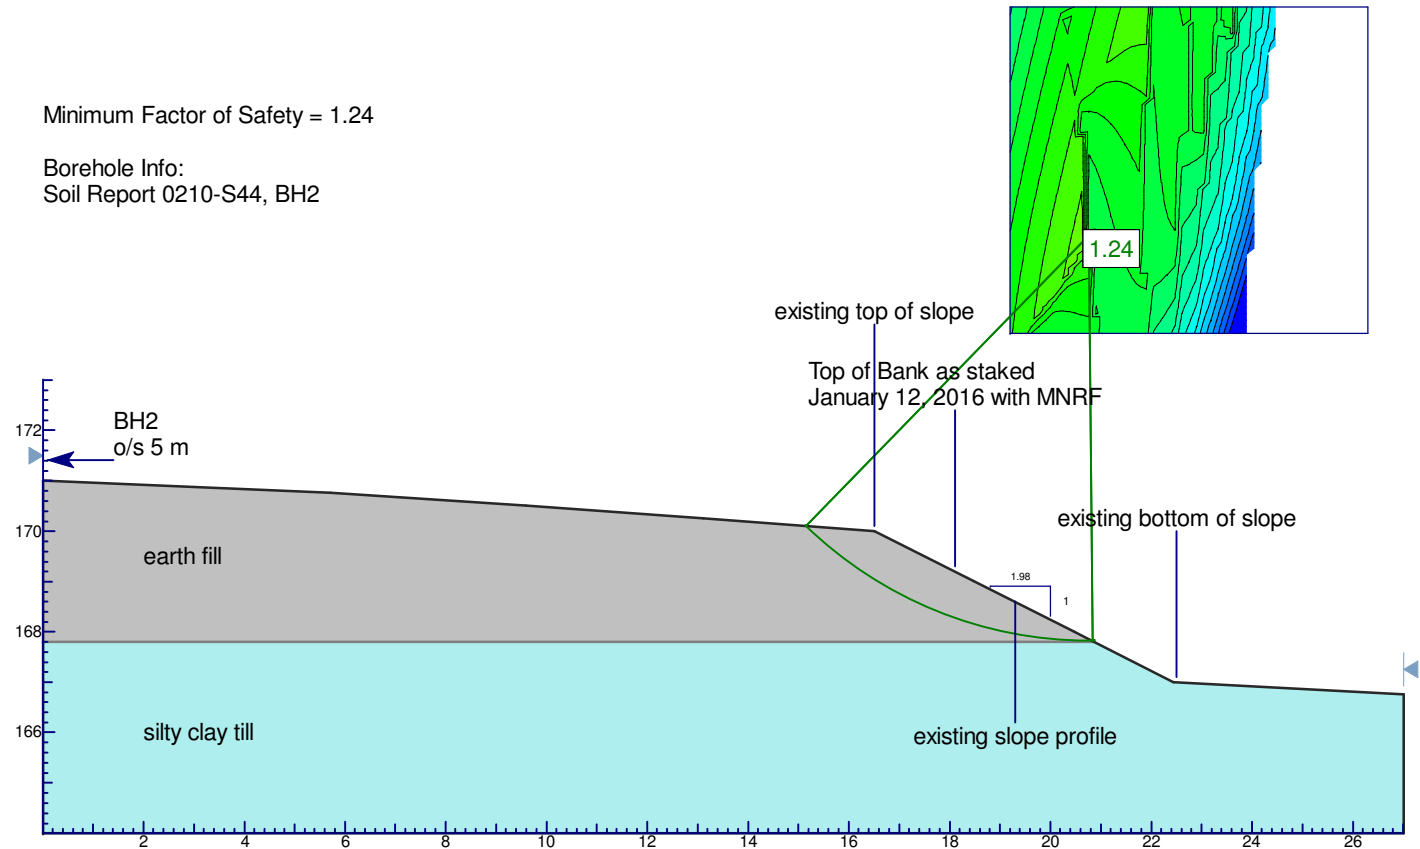
Project Title		Cross-Section D-D - Existing Condition		Load Case	Normal Groundwater Condition (Dry)
Location		6611 Harmony Hill, Mississauga			
Drawn By	HWY	Checked By	BL	Scale	1:150
Date	February 2017	Reference No.	1512-S086	Revision	-
				Drawing No.	5A

Minimum Factor of Safety = 1.24

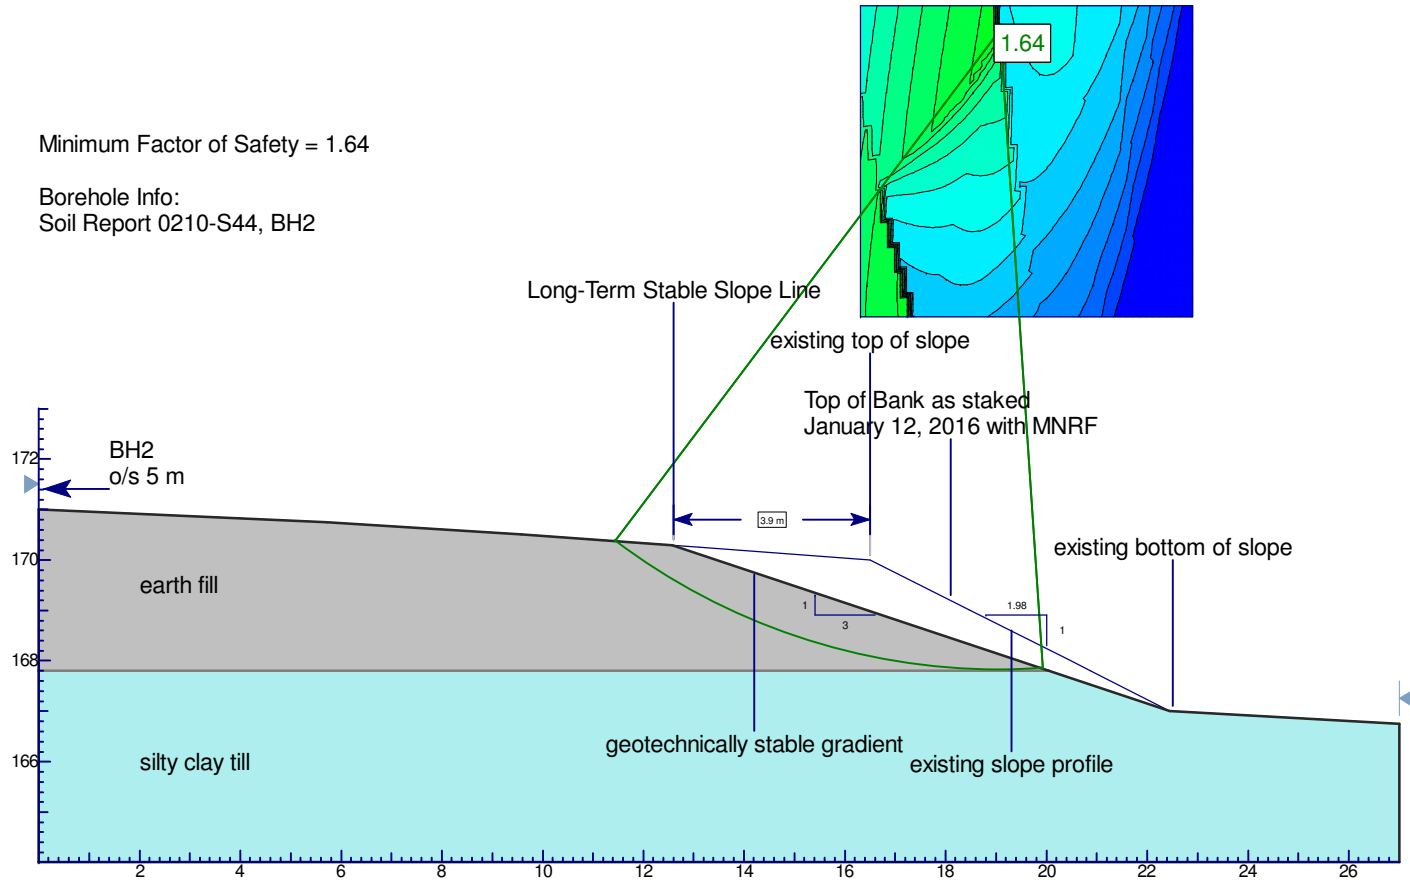
Project Title		Cross-Section D-D - Geotechnically Stable Condition		Load Case	Normal Groundwater Condition (Dry)
Location		6611 Harmony Hill, Mississauga			
Drawn By	HWY	Checked By	BL	Scale	1:150
Date	February 2017	Reference No.	1512-S086	Revision	-
				Drawing No.	5B

Minimum Factor of Safety = 1.64

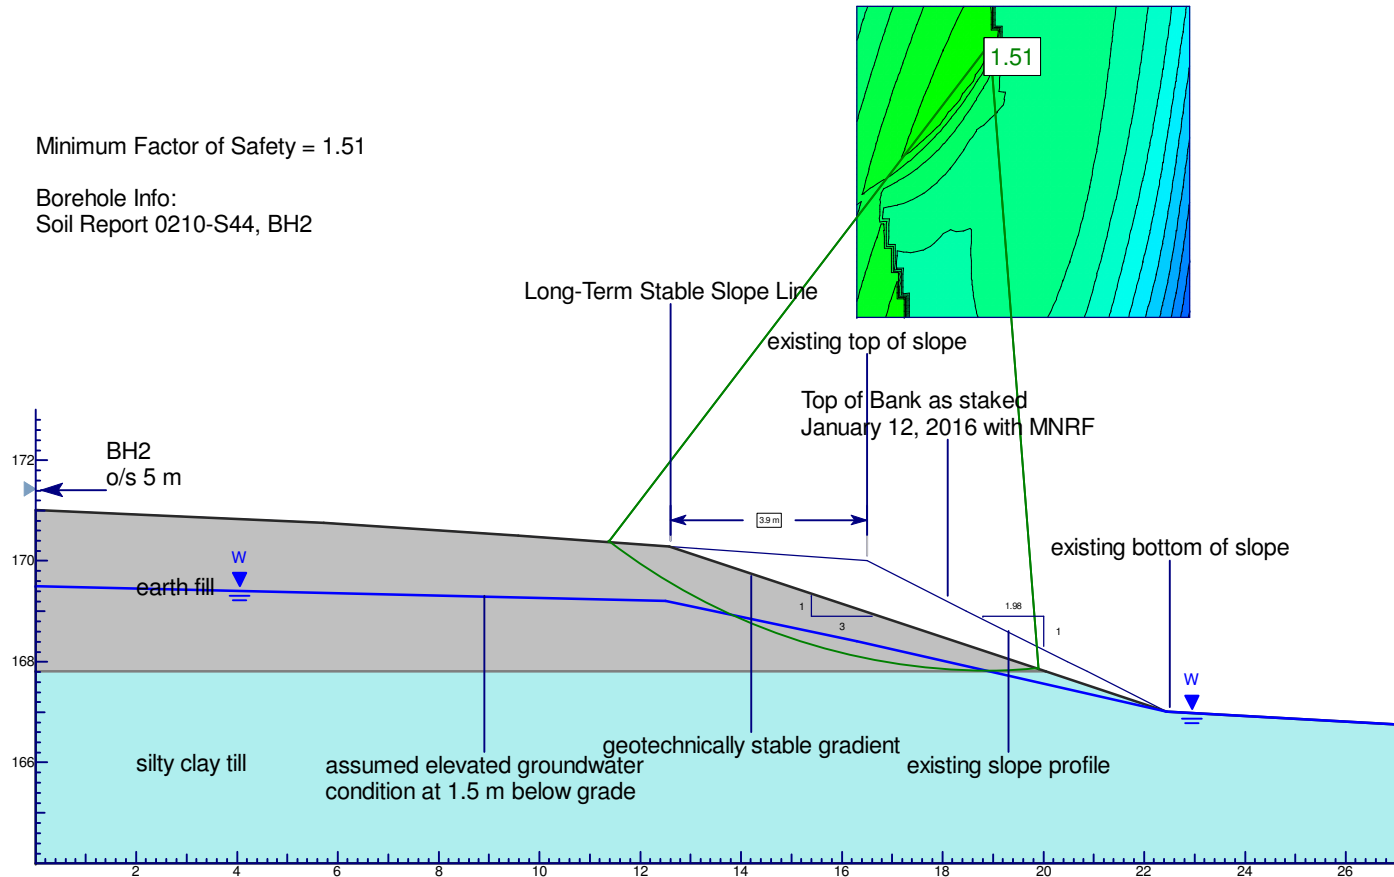
Project Title		Cross-Section D-D - Geotechnically Stable Condition		Load Case	Elevated Groundwater Condition
Location		6611 Harmony Hill, Mississauga			
Drawn By	HWY	Checked By	BL	Scale	1:150
Date	February 2017	Reference No.	1512-S086	Revision	-
				Drawing No.	5C

Minimum Factor of Safety = 1.51
