June 11, 2019
MTE File No.: C40602-300

**Re: Aboveground Storage Tank Decommissioning
2132 Dundas Street West, Mississauga, Ontario ("Site")**

**Photographic Log for Aboveground Storage Tank Decommissioning
2132 Dundas Street West, Mississauga, ON**

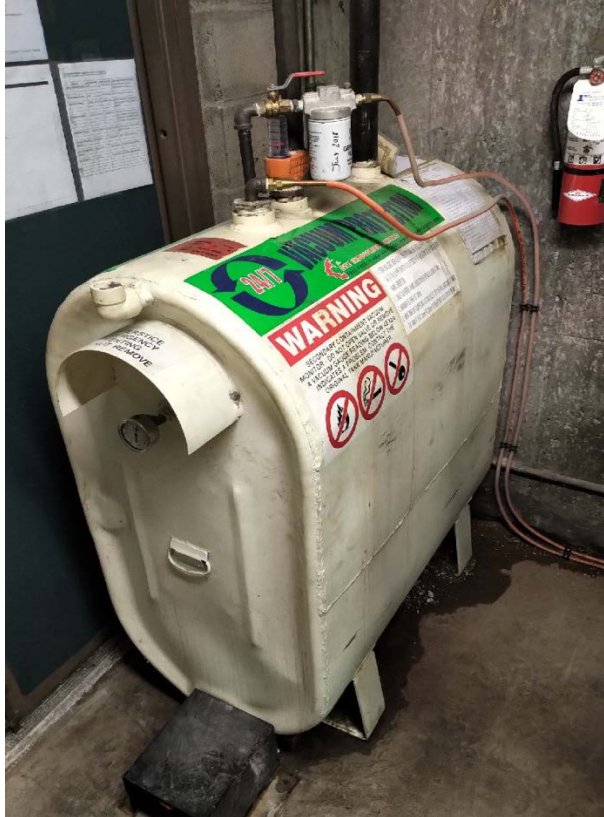
Photograph No. 1 –View of 450 L double-walled steel aboveground storage tank

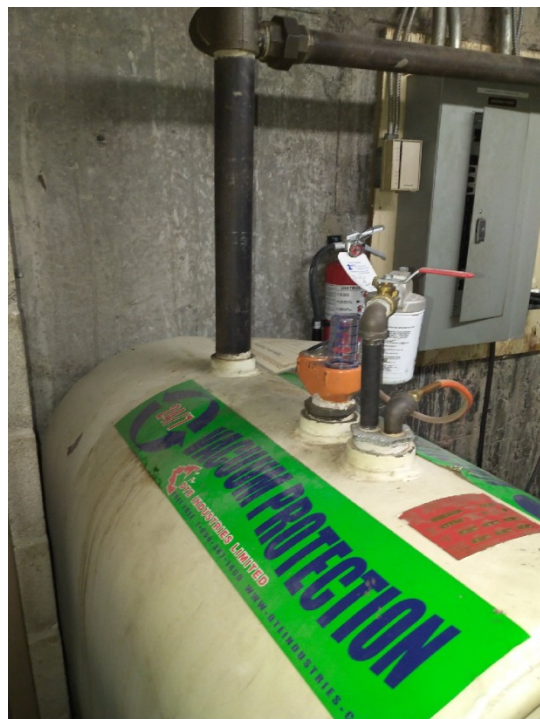
Photograph No. 2 – View of associated transfer piping and equipment

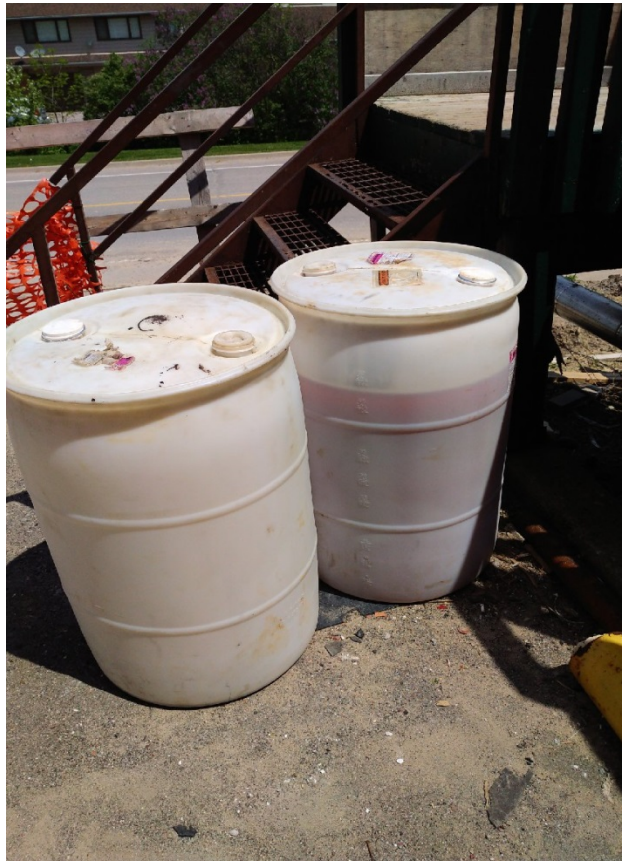
Photograph No. 3 – View of diesel fuel removed from aboveground tank

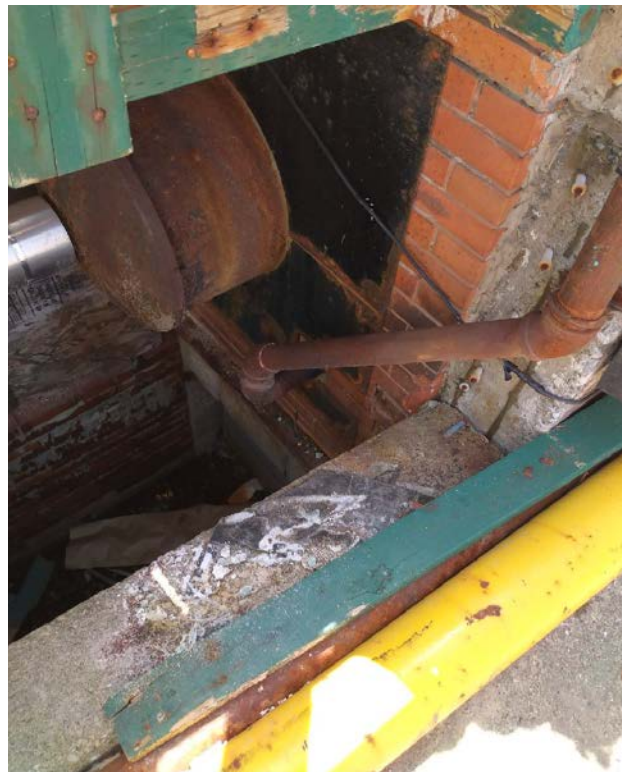
Photograph No. 4 – View of fill line from exterior of building to AST in the basement

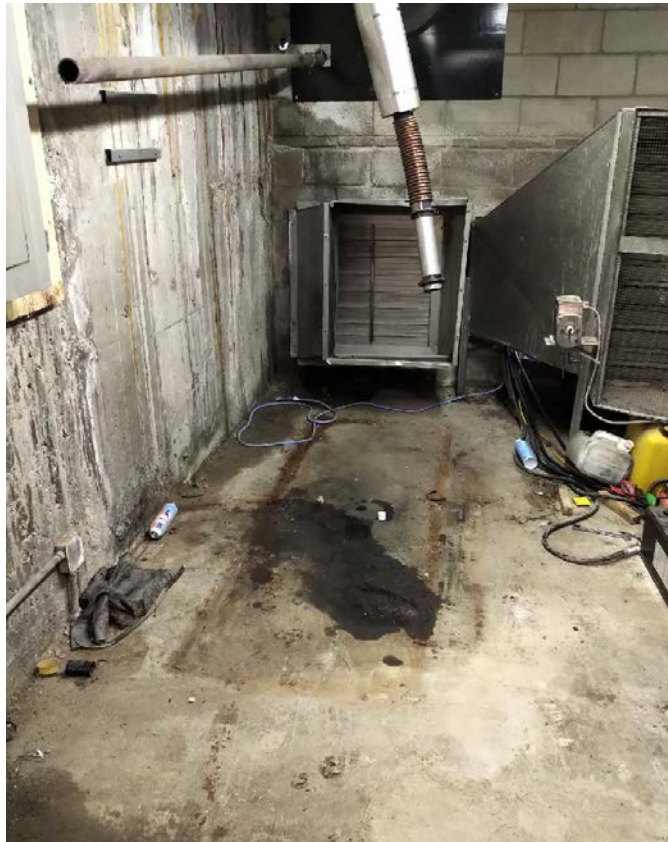
Minor staining was noted beneath the former location of the AST; however, the concrete floor appeared in good condition.

Photograph No. 5 – View of former aboveground tank location. Minor concrete staining visible

No further action is recommended at this time with respect to the removal of the AST and associated piping from 2132 Dundas Street West, Mississauga, Ontario.

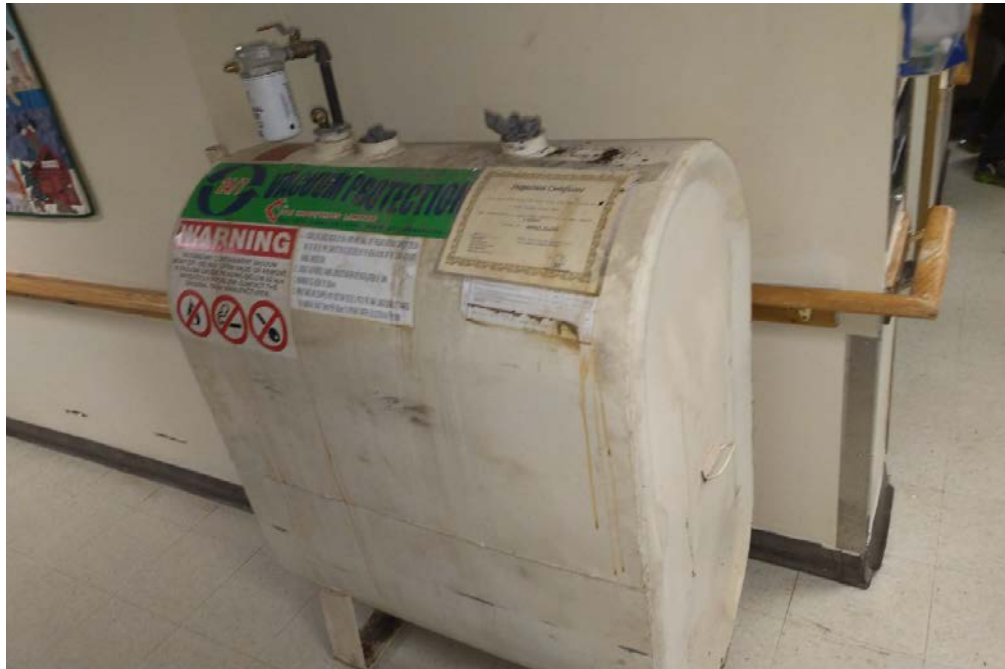
Photograph No. 6 – View of aboveground tank following removal
