Serson Creek Geomorphic Assessment and Rehabilitation Design Lakeview Village City of Mississauga

Date: Project:

July 2020 217424

Serson Creek Geomorphic Assessment and Rehabilitation Design Lakeview Village, City of Mississauga

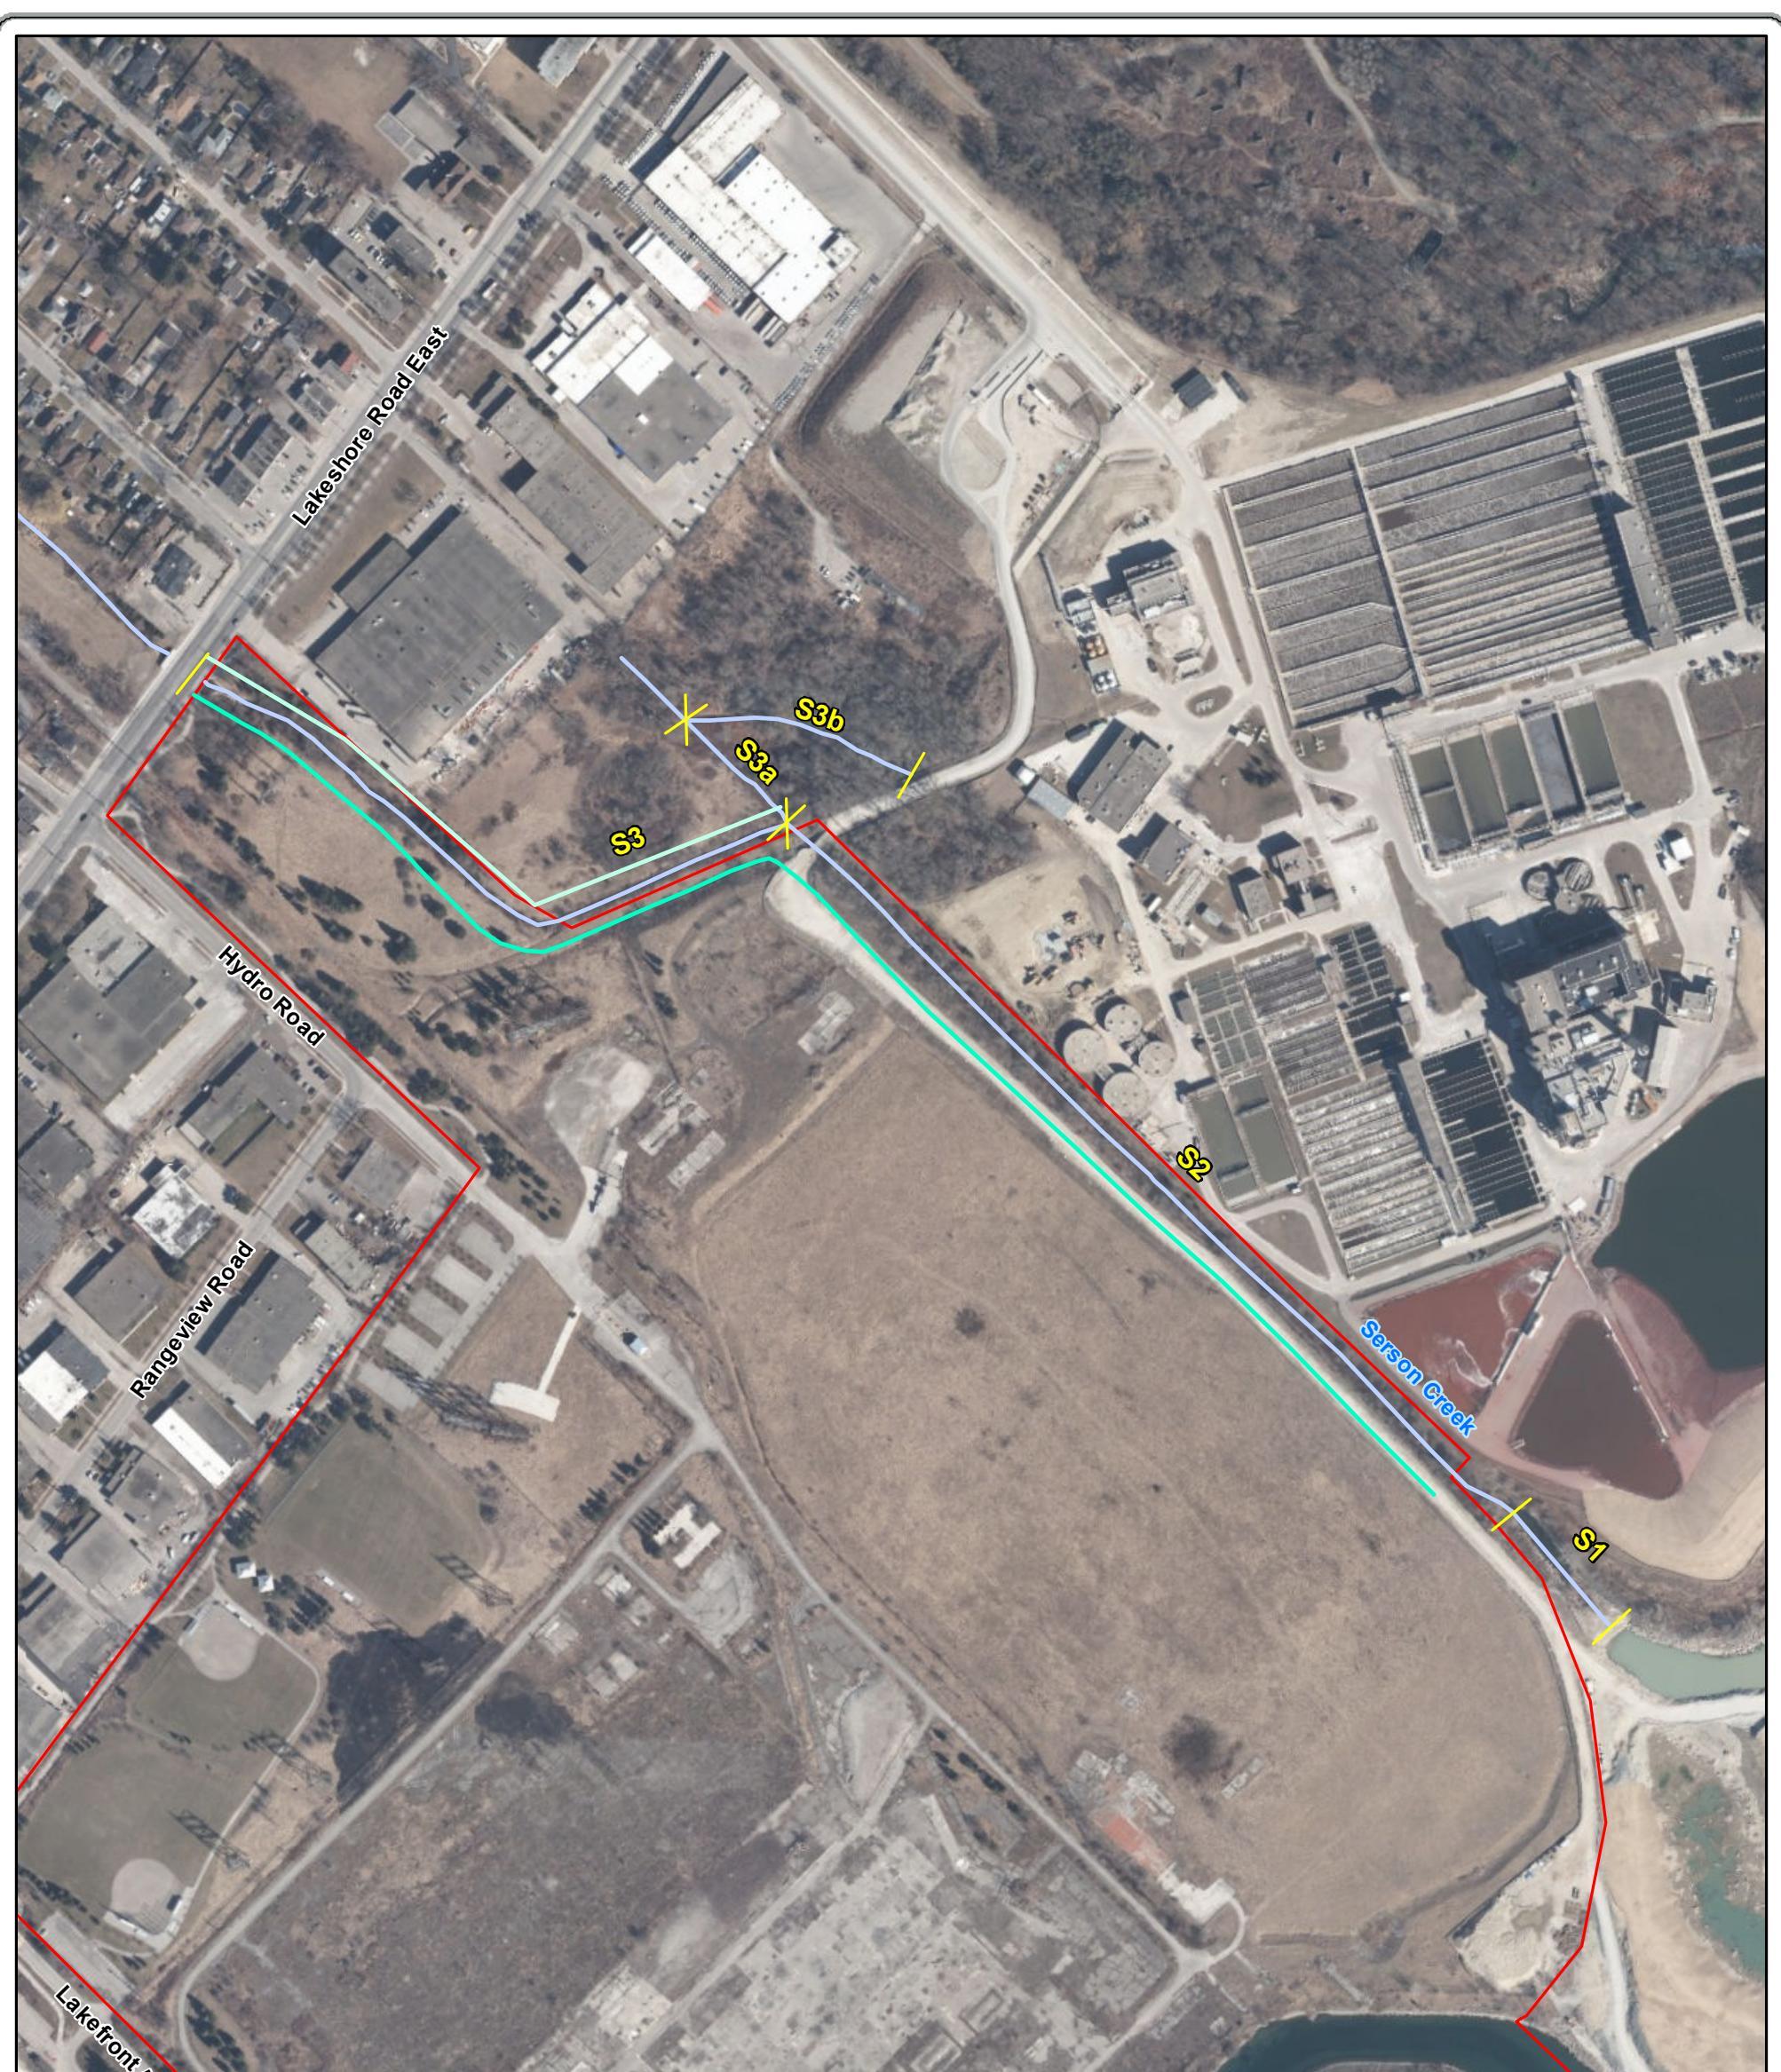
The results of the empirical analysis are summarized in **Table 5**. An illustration of the recommended meander belt limit for Reach S3 as shown on **Figure 3**. Note that the meander belt limit along the confined (right bank) of the valley slope was adjusted to illustrate the long-term stable top of slope as discussed in **Section 6.2**.

meander belt limit for Reach S3 of Serson Creek was adjusted to reflect the recommended long-term stable top of slope along the right bank of the valley slope. The recommended watercourse erosion hazard components (meander belt limit and long-term stable top of slope), are illustrated in **Figure 3**.

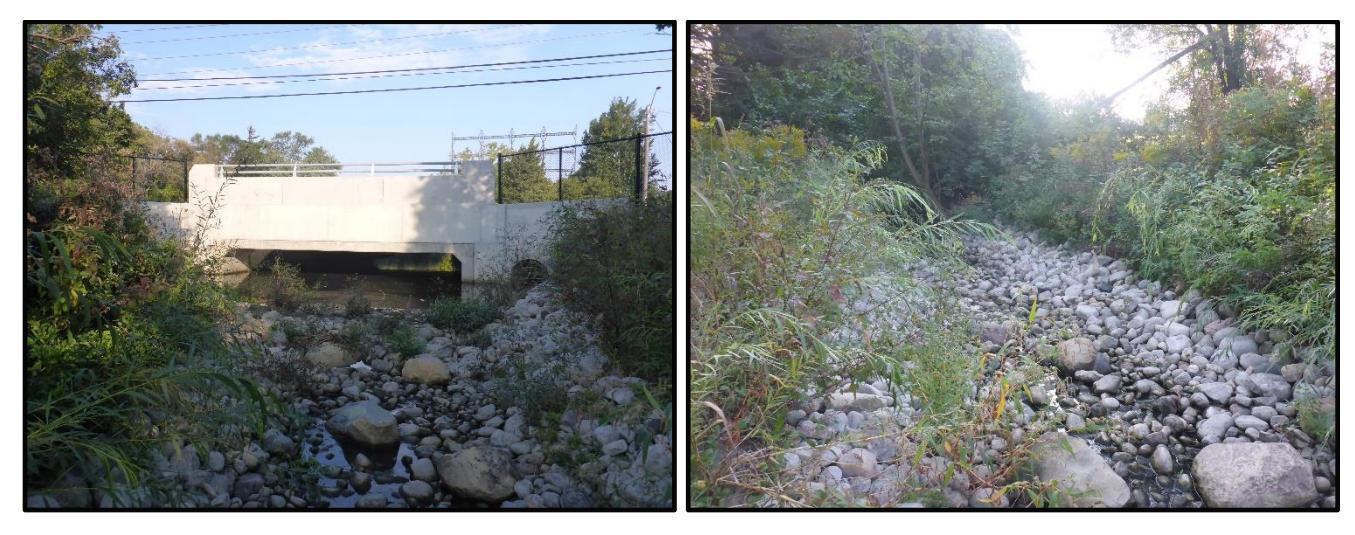
Photo 1. Location 1. Reach S3. Upstream view of designed cobble lined channel and Lakeshore Road E culvert. September 21, 2018.

Reach S3. Downstream view of designed cobble lined channel. September 21, 2018.

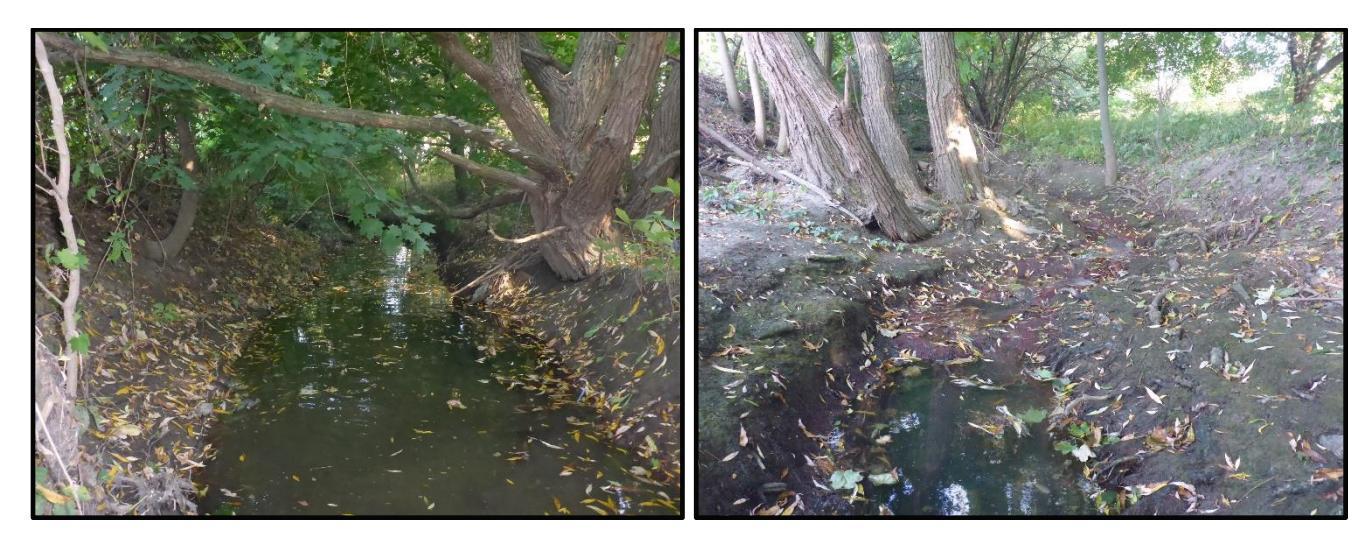
Upstream view of Reach S3 general conditions. September 21, 2018.

Photo 4. Location 3. Reach S3. Upstream view of rooted knickpoint leading into pool. September 21, 2018.

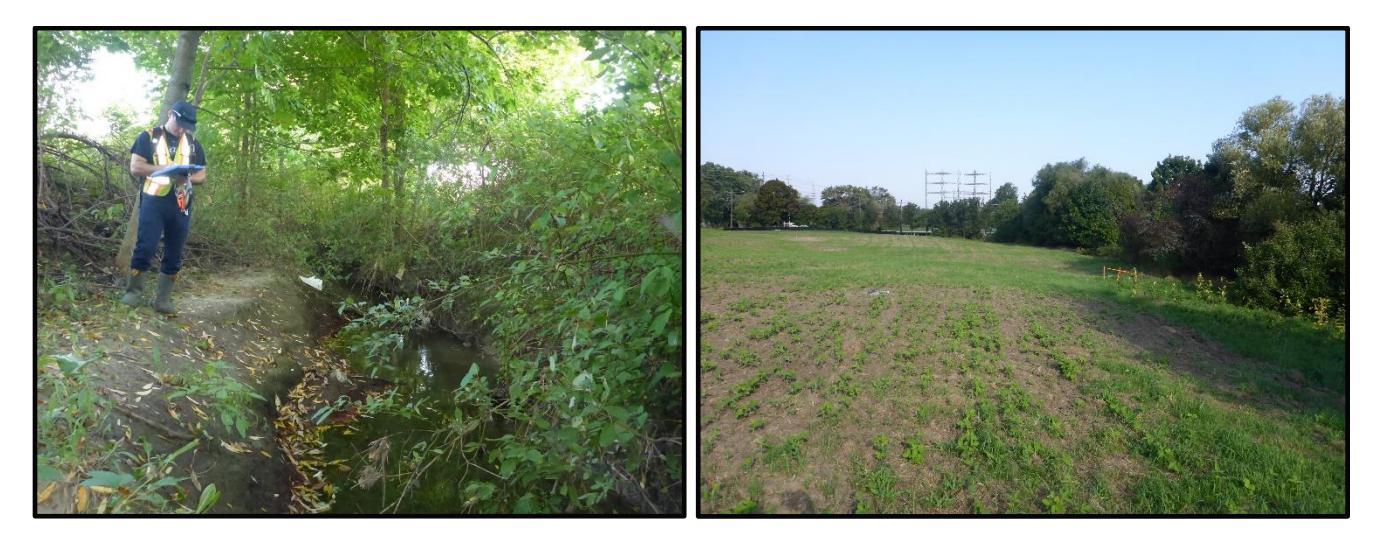
Photo 5. Location 4. Reach S3. Upstream view of pool with terracing on right bank. September 21, 2018.

Reach S3. Floodplain along top of right bank, view towards Lakeshore Road E. September 21, 2018.

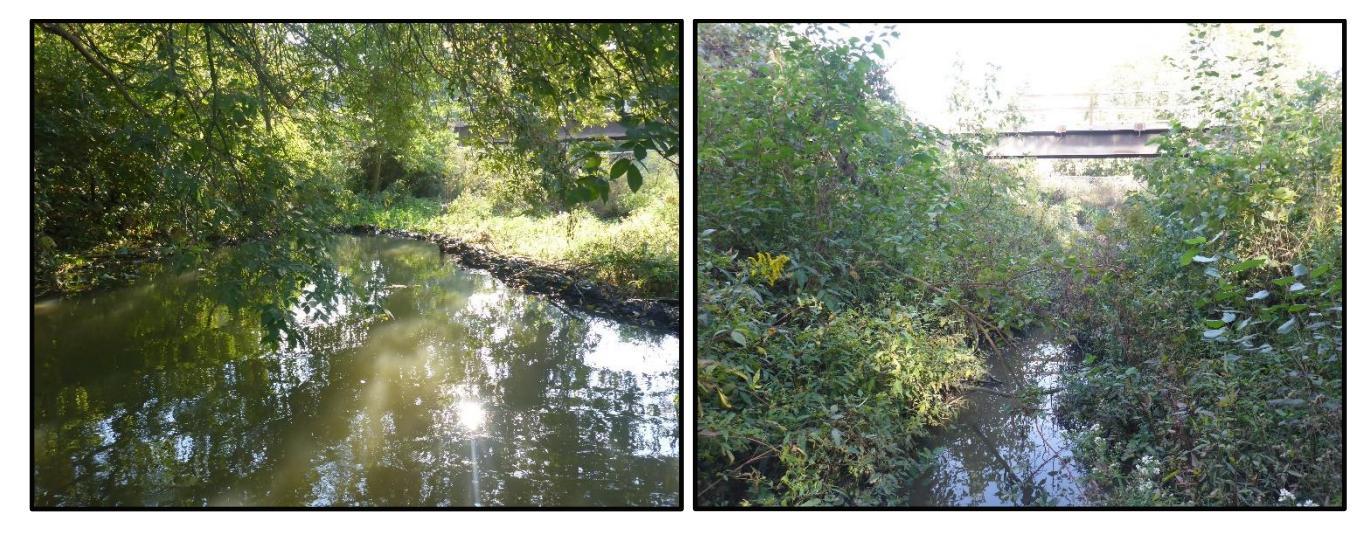
Photo 7. Location 6. Reach S3. Downstream view of backwatering from beaver activity at channel confluence. September 21, 2018.

Photo 8. Location 7. Reach S2. Upstream view towards property line at top end of reach. September 28, 2018.

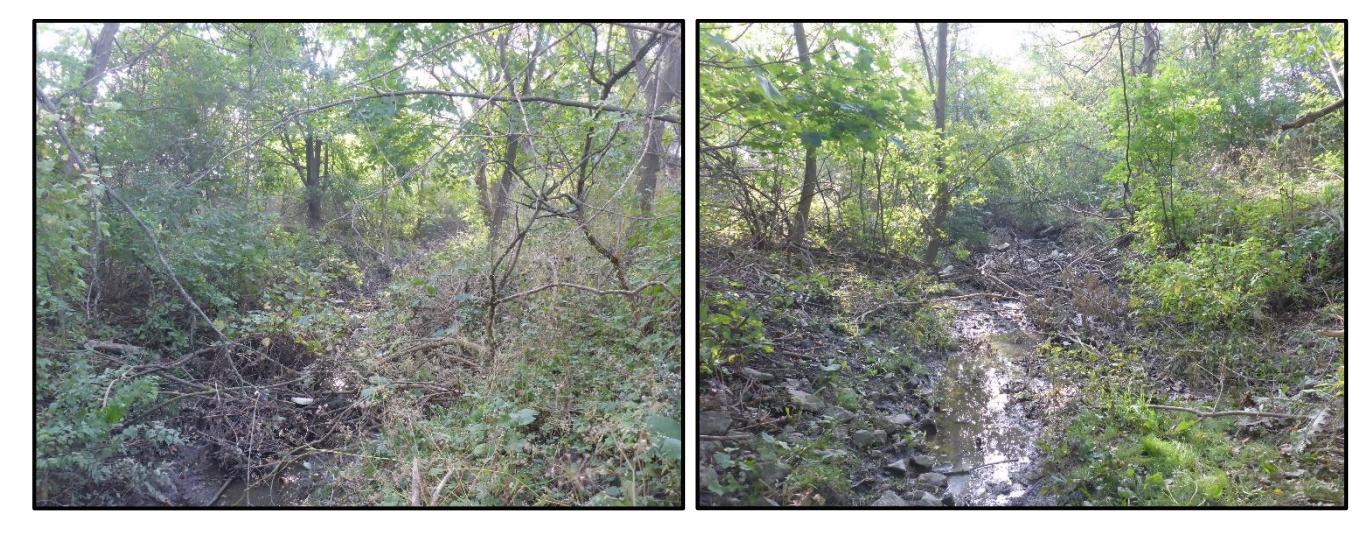
Photo 9. Location 8. Reach S2. Downstream view of woody debris jam. September 28, 2018.

Photo 10. Location 9. Reach S2. Downstream view of typical valley section: confined slope on right bank. September 28, 2018.

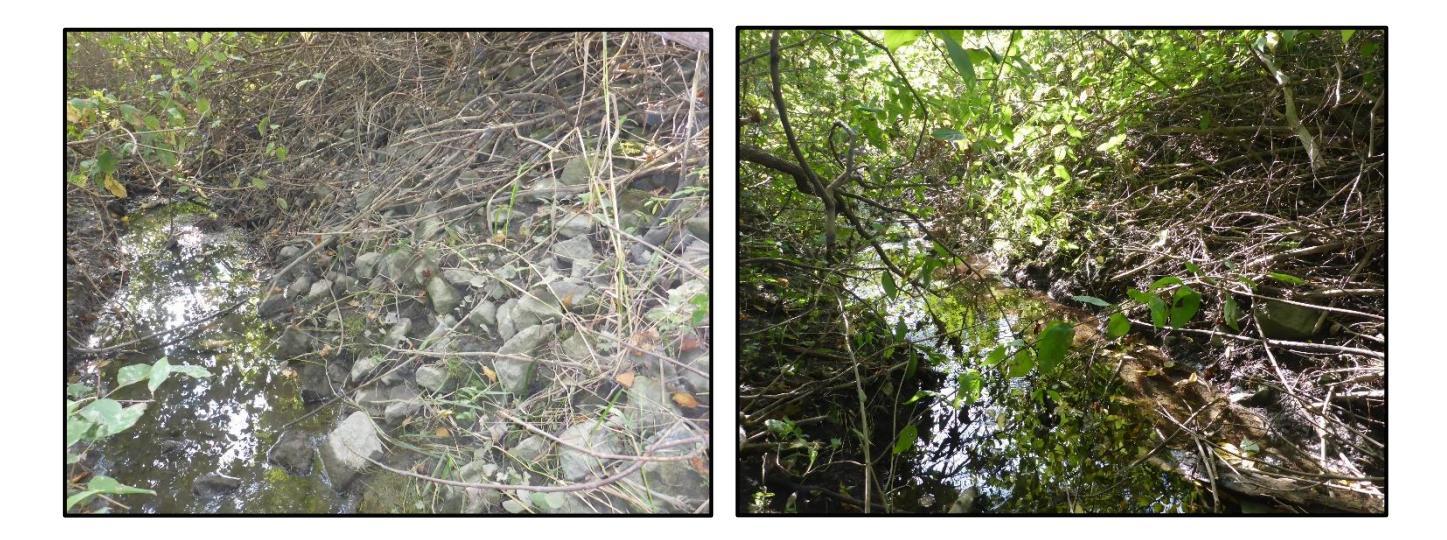
Photo 11. Location 10. Reach S2. Rip-rap protection along lower bank. September 28, 2018.

Photo 12. Location 11. General conditions downstream in Reach S2. September 28, 2018.

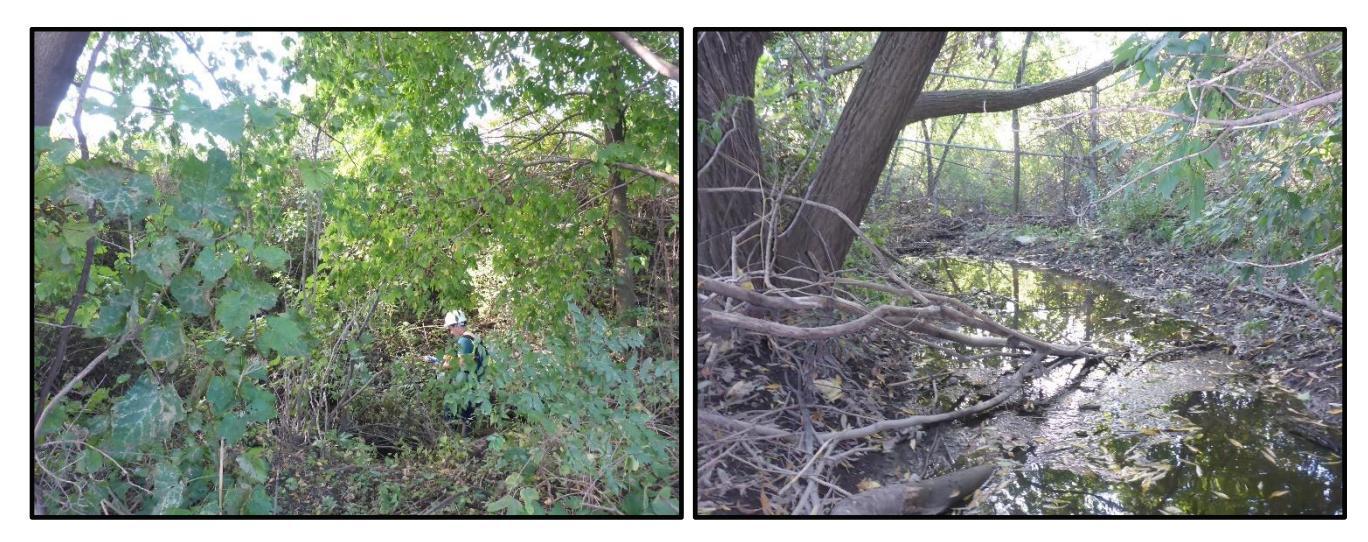
Photo 13. Location 12. Reach S2. General wooded valley and channel location. September 28, 2018.
