## **Report on**

Geotechnical Slope Stability Assessment Serson Creek Lakeview Village, 800 Hydro Road Mississauga, Ontario

**Prepared For:** Lakeview Community Partners Limited

**Project No.** 18-519-102 July 19, 2019

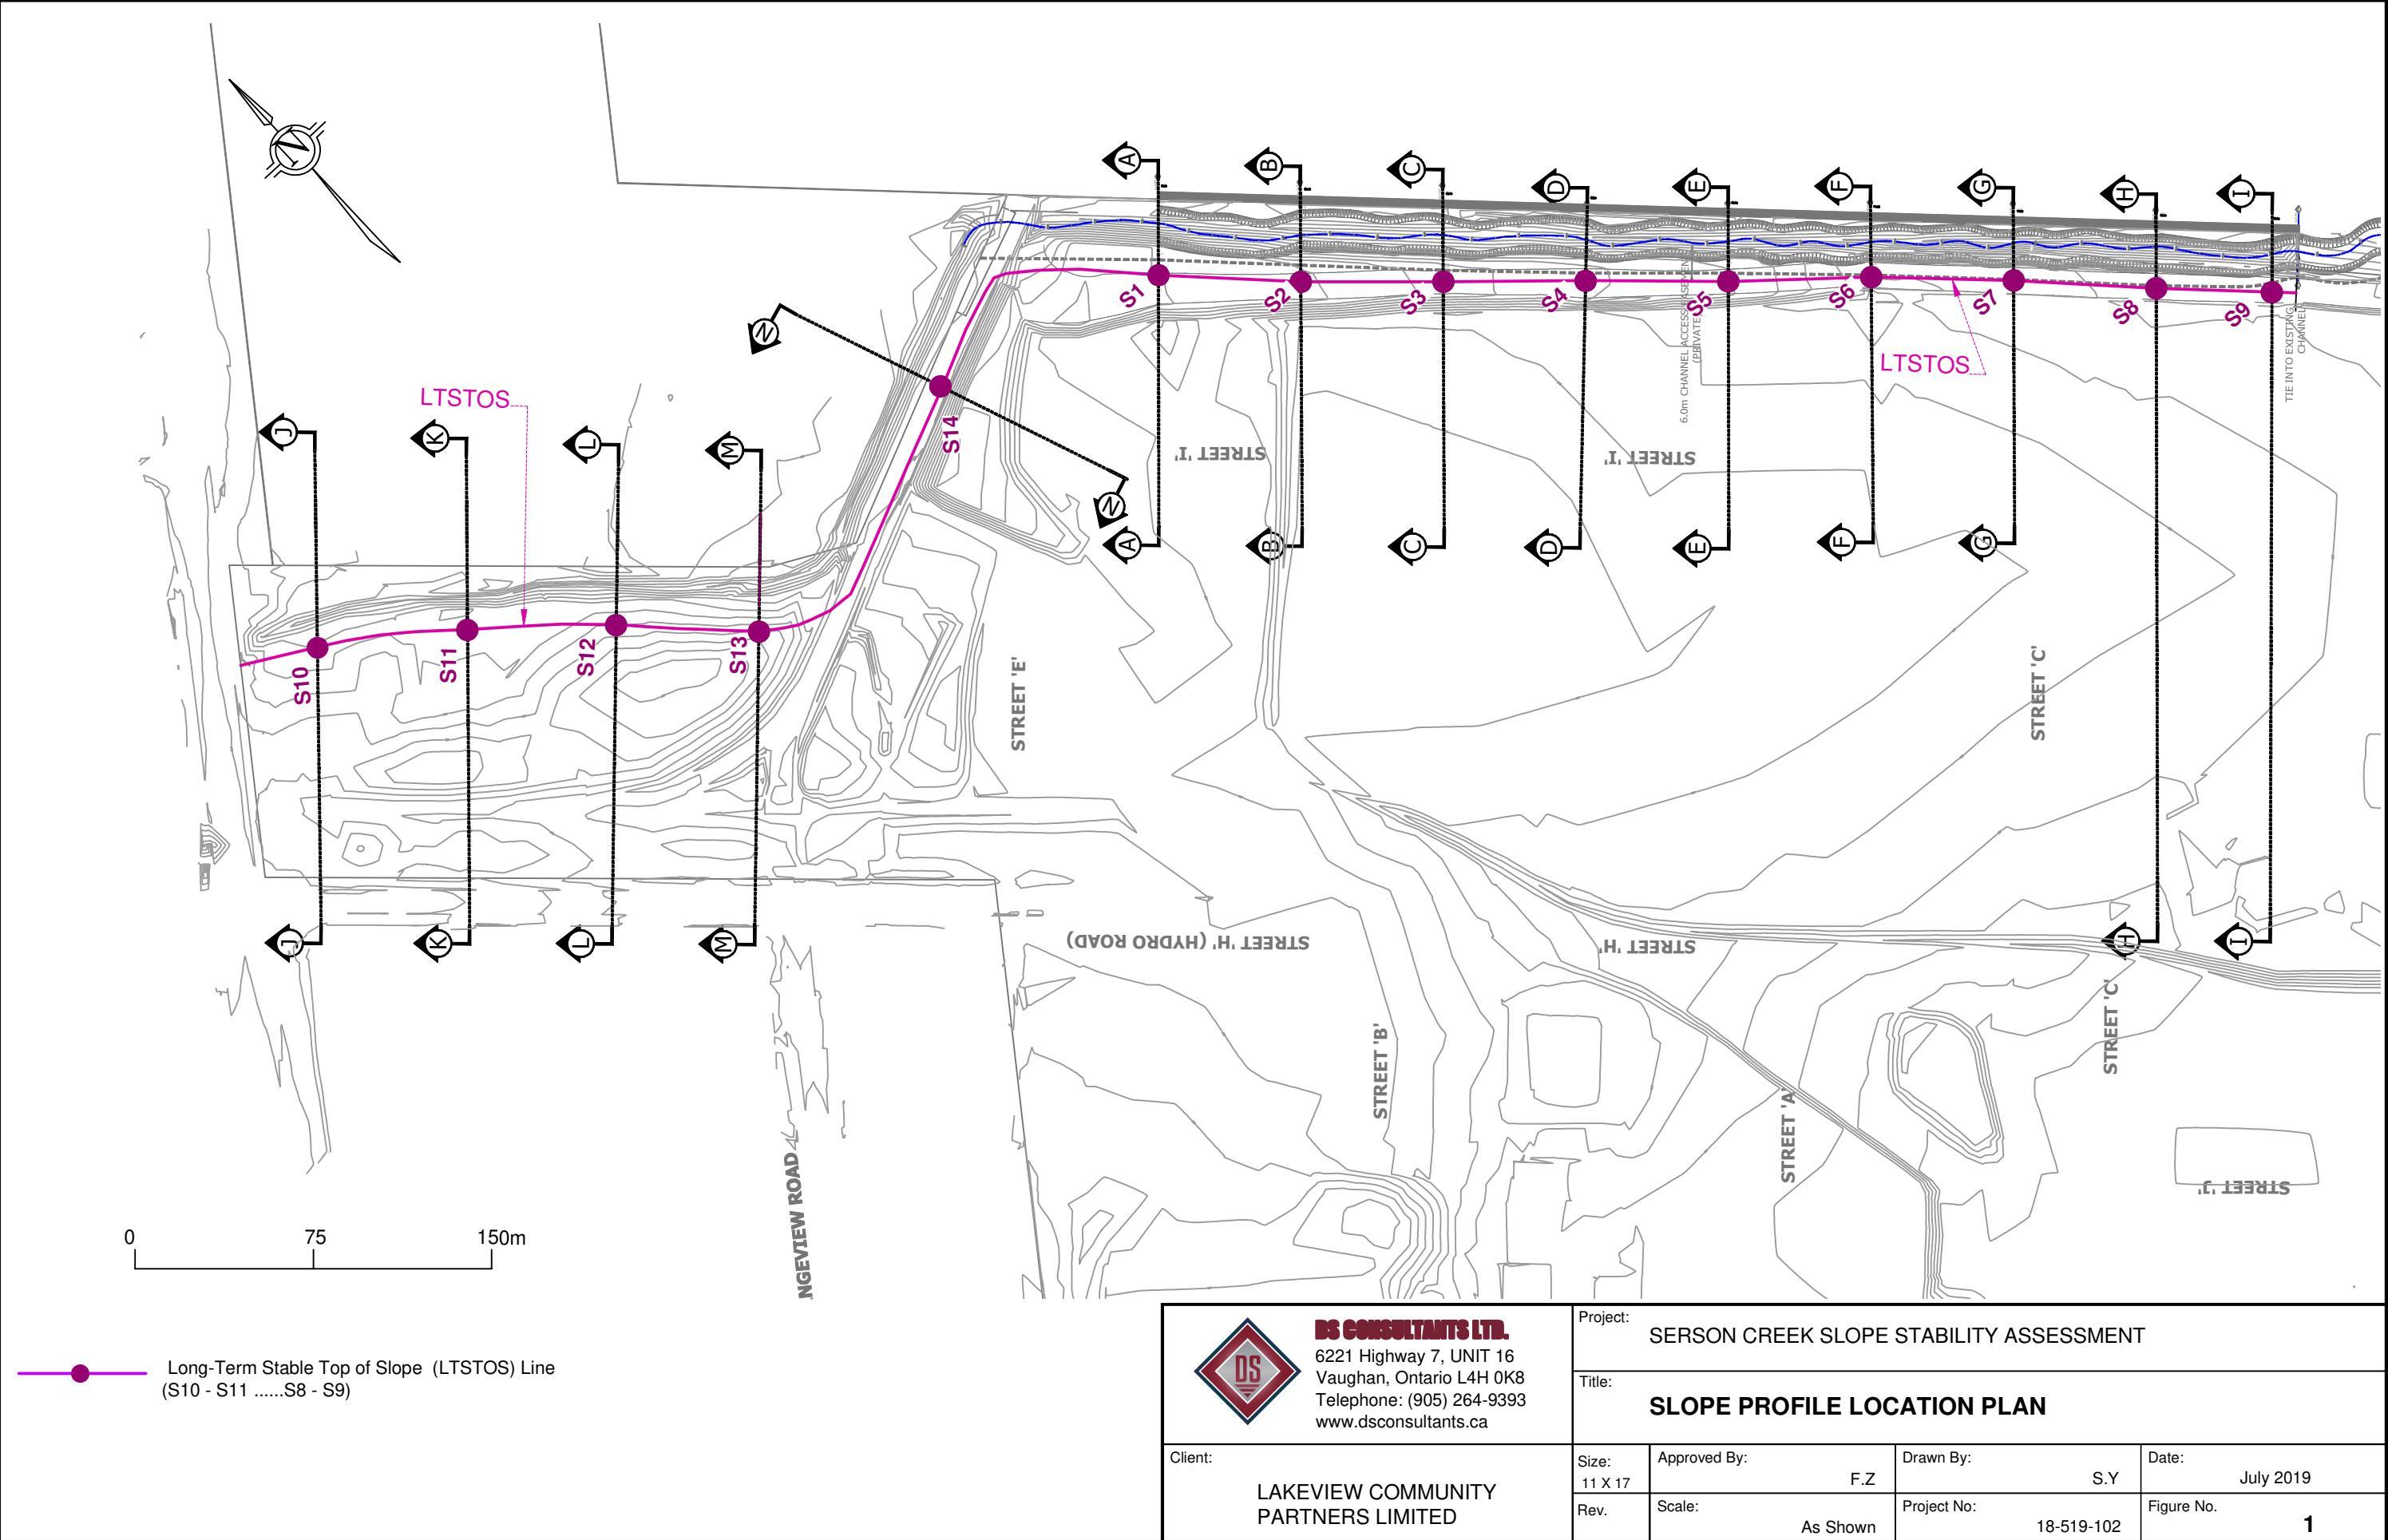
Drawn By:		Date:	
F.Z		S.Y		July 2019
	Project No:		Figure No.	
As Shown		18-519-102		1

Based on the long-term stable top of slope (LTSTOS) at Sections A-A to N-N, and our field observations, the recommended long-term stable top of slope line (Line S10-S11 ... S8-S9) is shown on Figure 1.

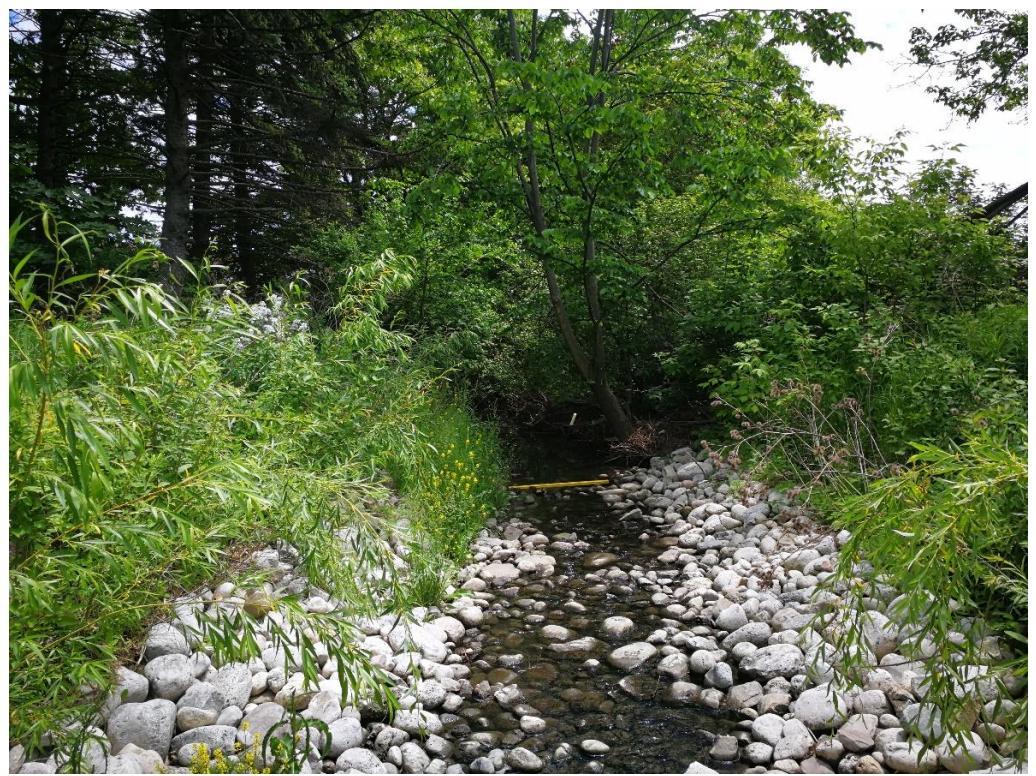
Photo B1: Creek and Concrete Culvert at Lakeshore Blvd (looking north - upstream)

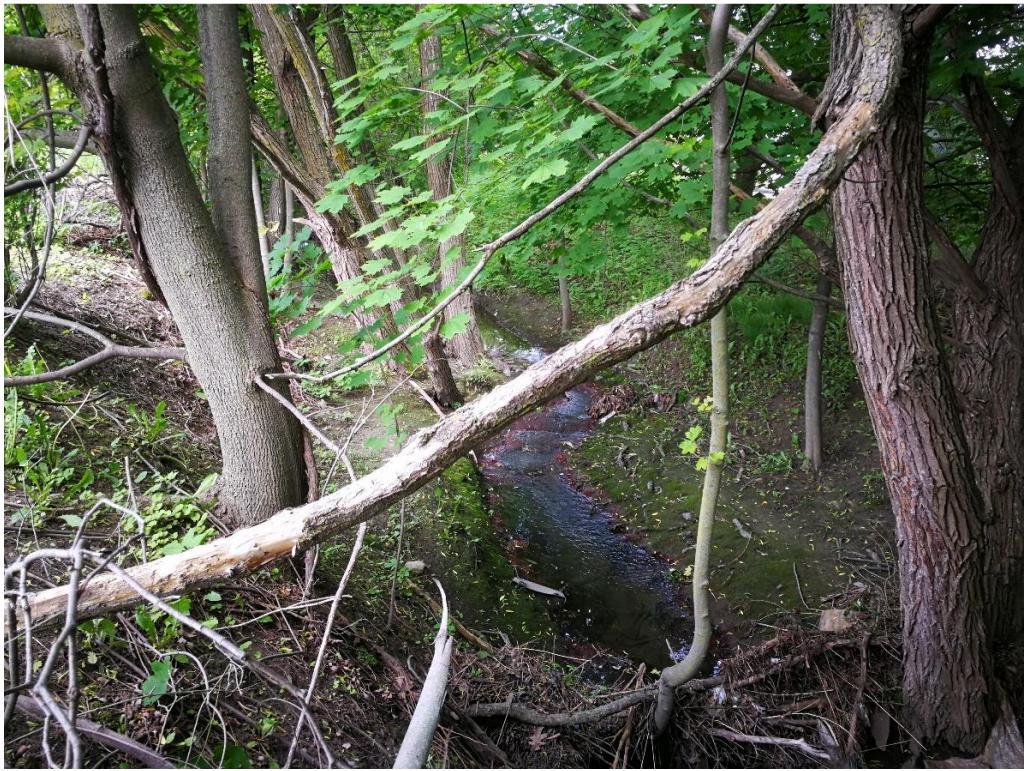
Photo B2: Creek conditions at south of Lakeshore Blvd (looking south - downstream)

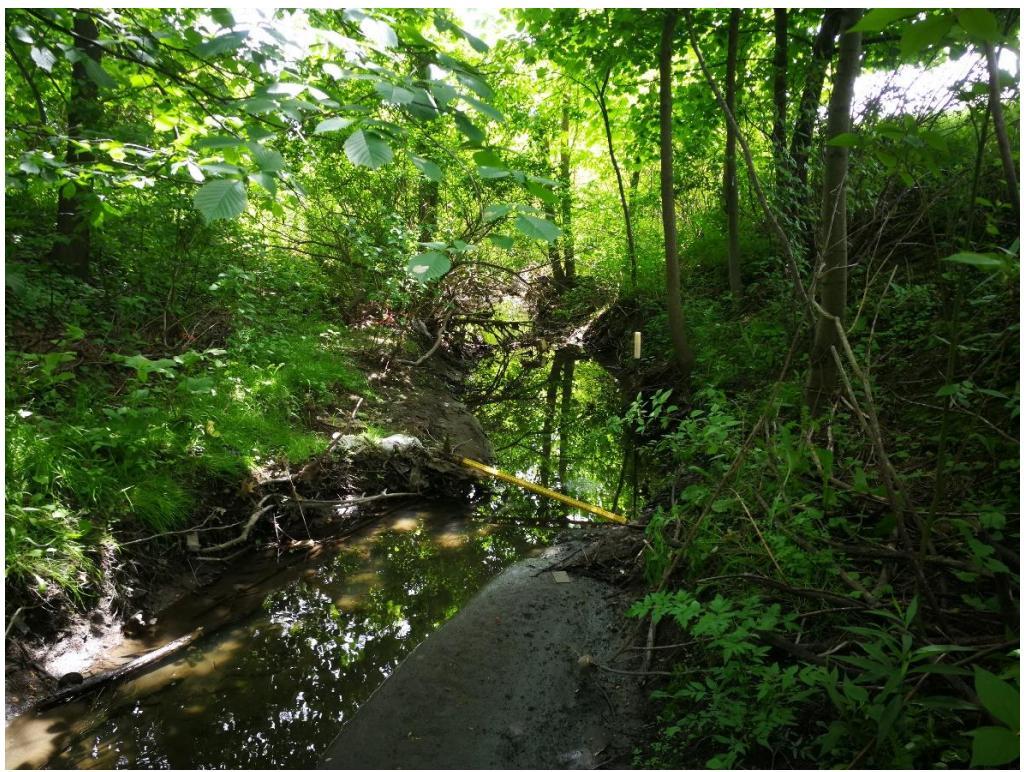
Photo B3: Creek conditions at north of Section L-L (looking north - upstream)

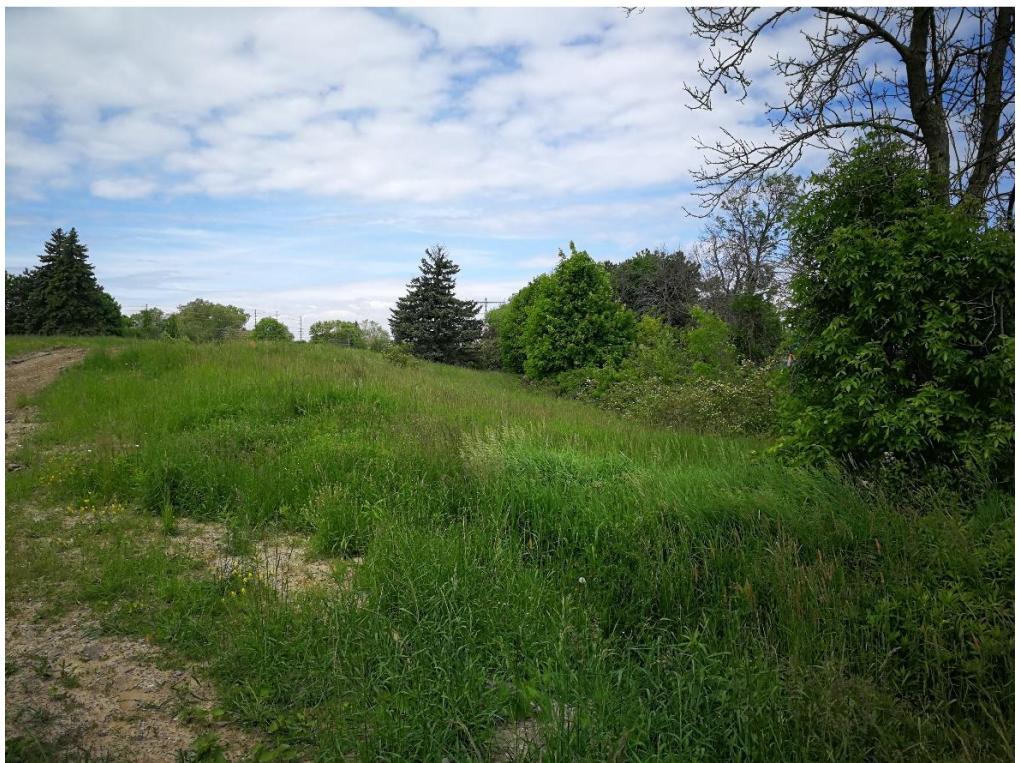
Photo B4: Creek conditions at north of Section L-L (looking south - downstream)

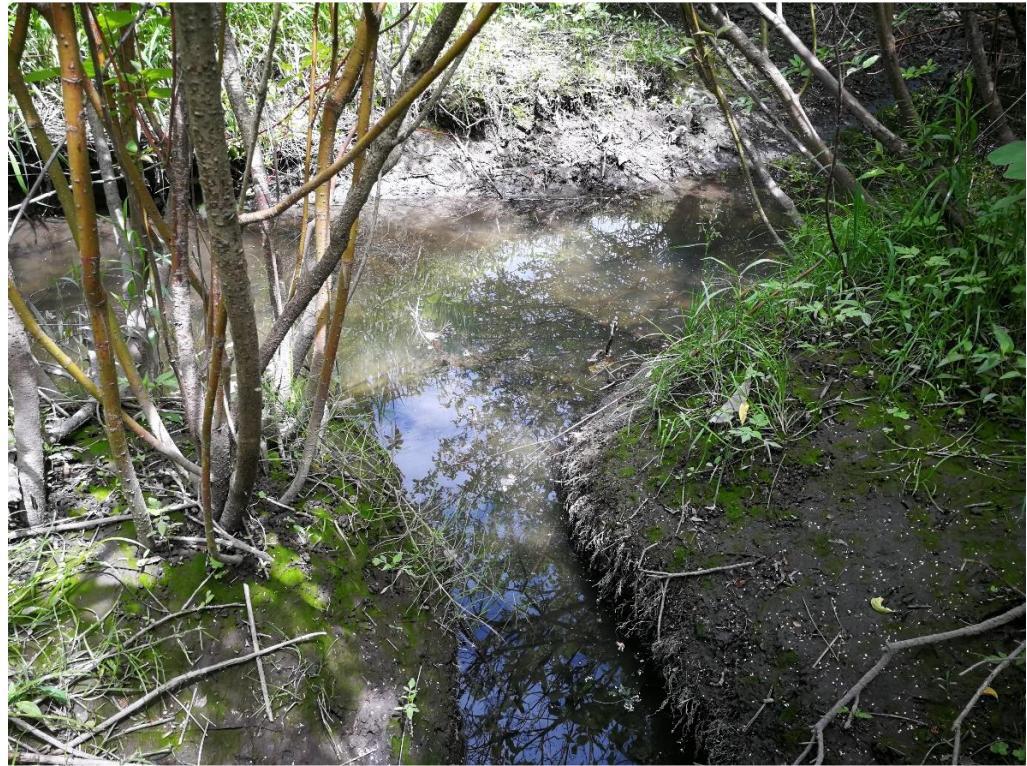
Photo B5: Top of slope conditions to north of Section M-M (looking north toward Lakeshore Blvd)

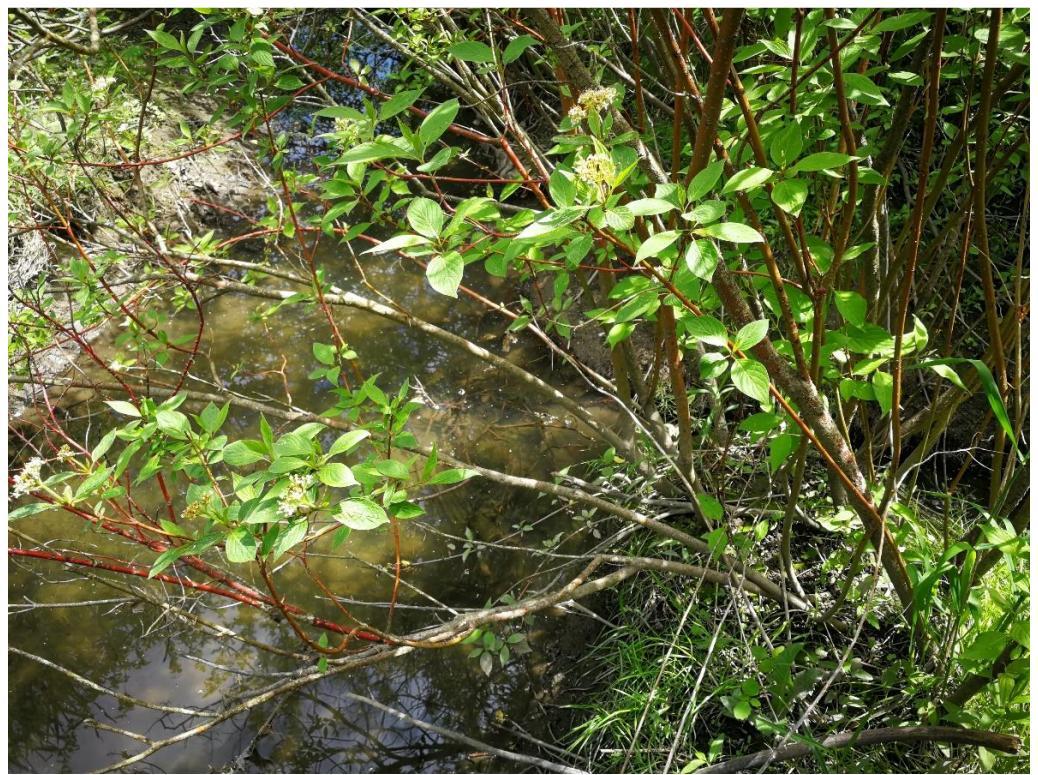
Photo B6: Creek conditions at the turning point to south of Section M-M (looking northeast)

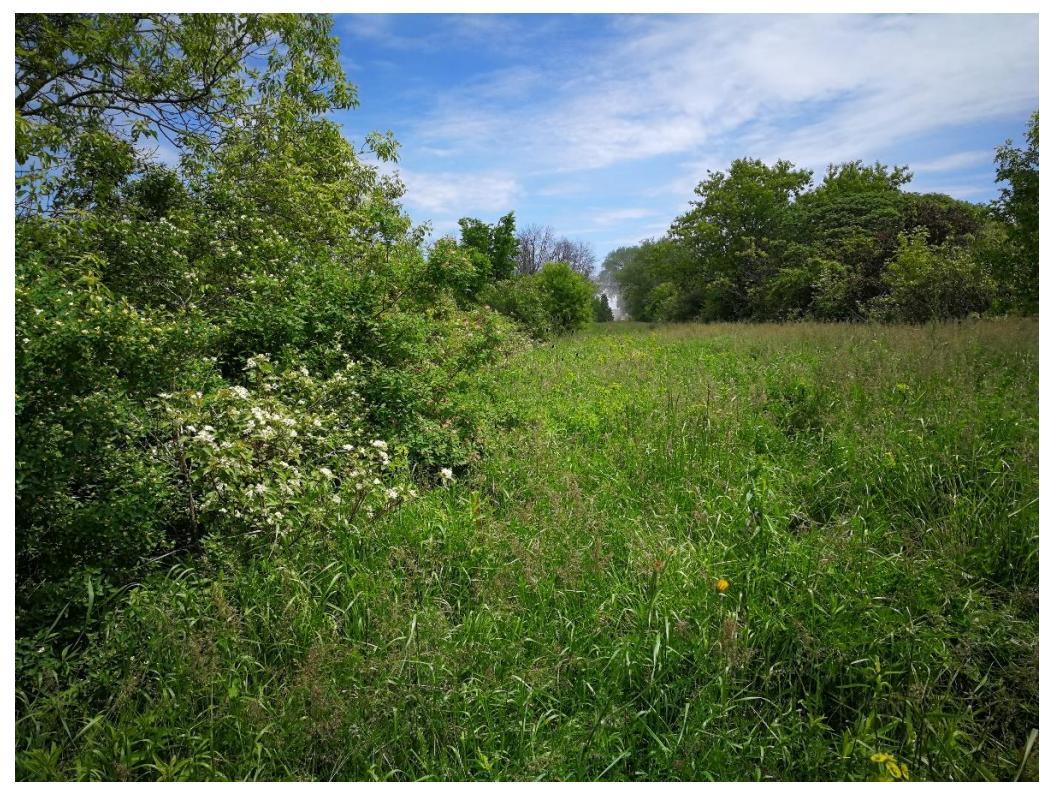
Photo B7: Creek conditions at west of Section N-N (looking east)

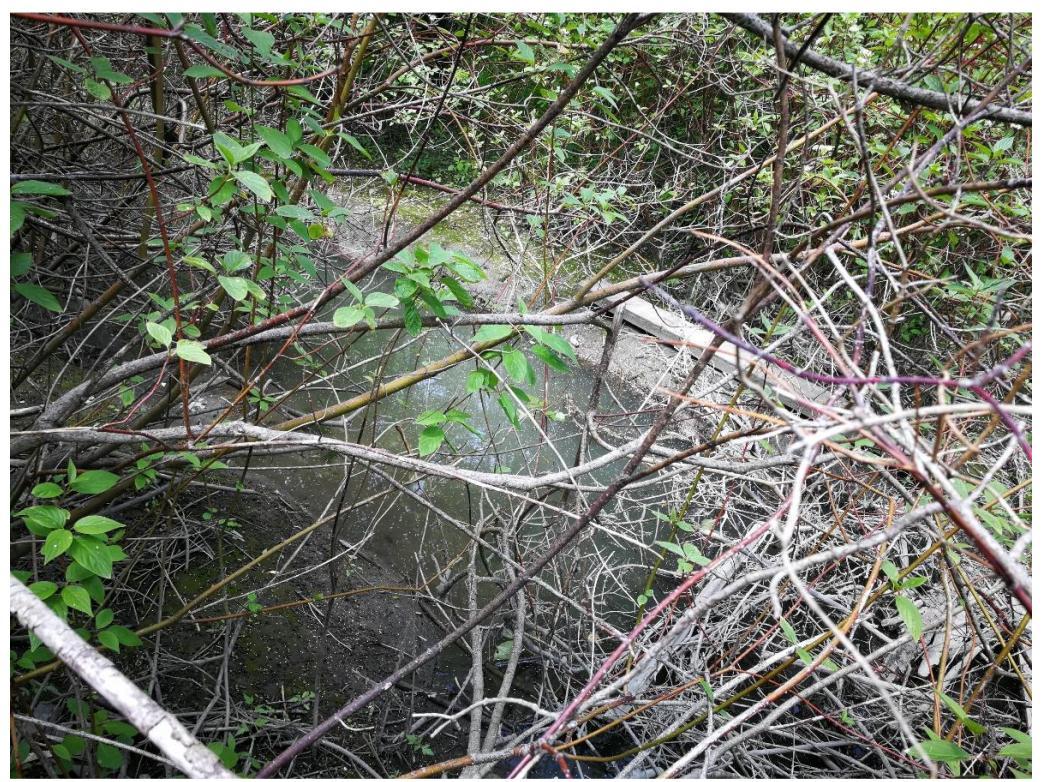
Photo B8: Top of slope conditions in area of and to west of Section N-N (looking east from Borehole BH18-41 area – See Appendix A)

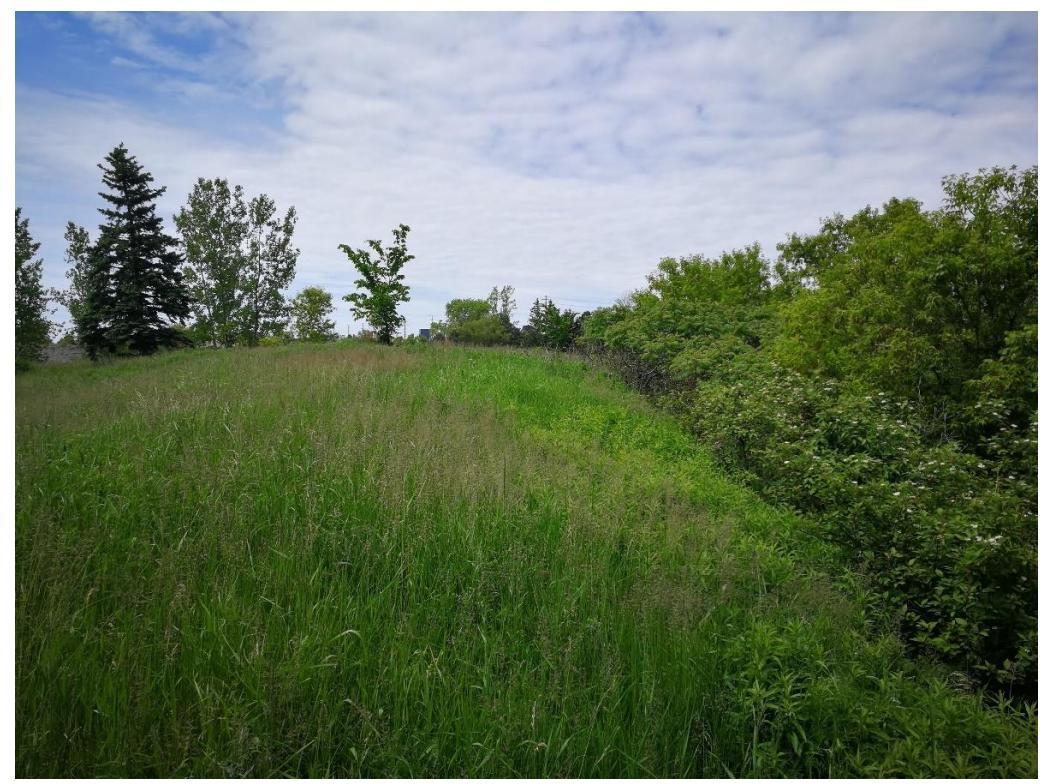
Photo B9: Creek conditions at west of Section N-N (looking northwest)

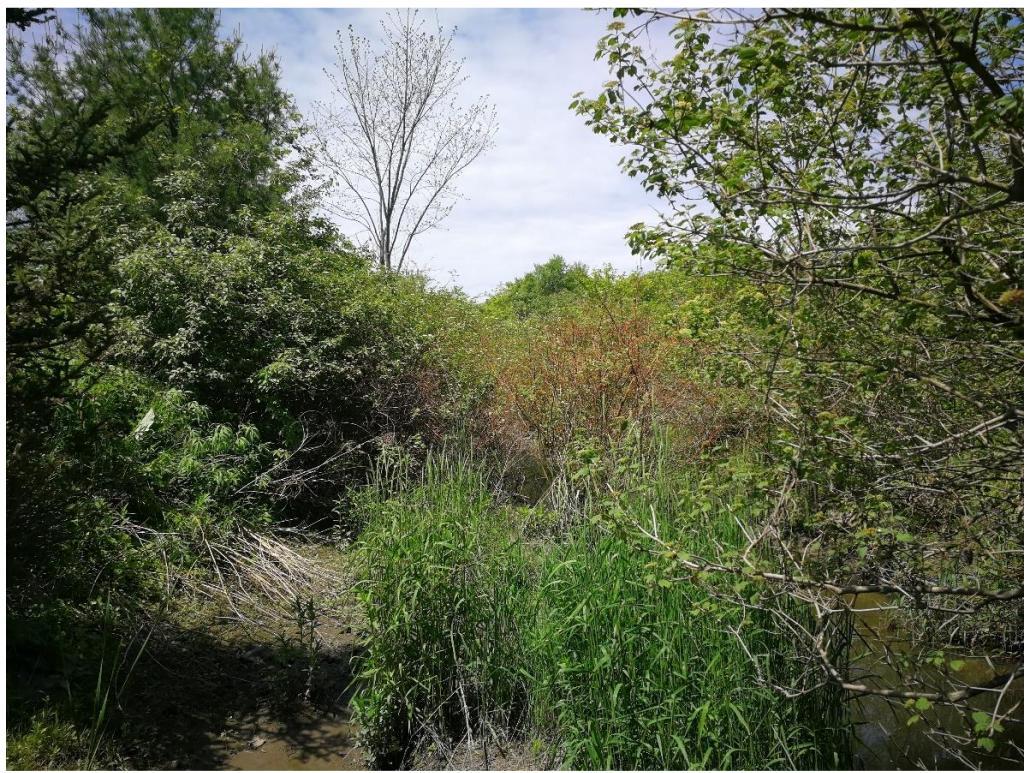
Photo B10: Top of slope conditions to west of Section N-N (looking west)

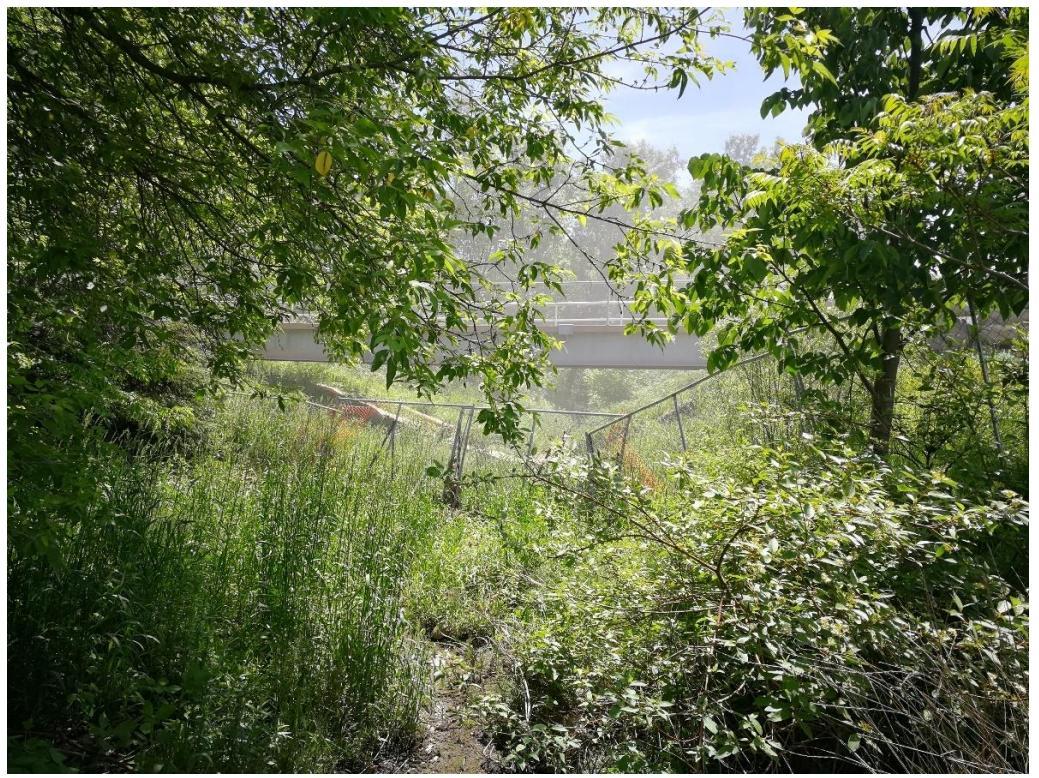
Photo B11: Slope conditions to east of Section N-N near road bridge (looking west)

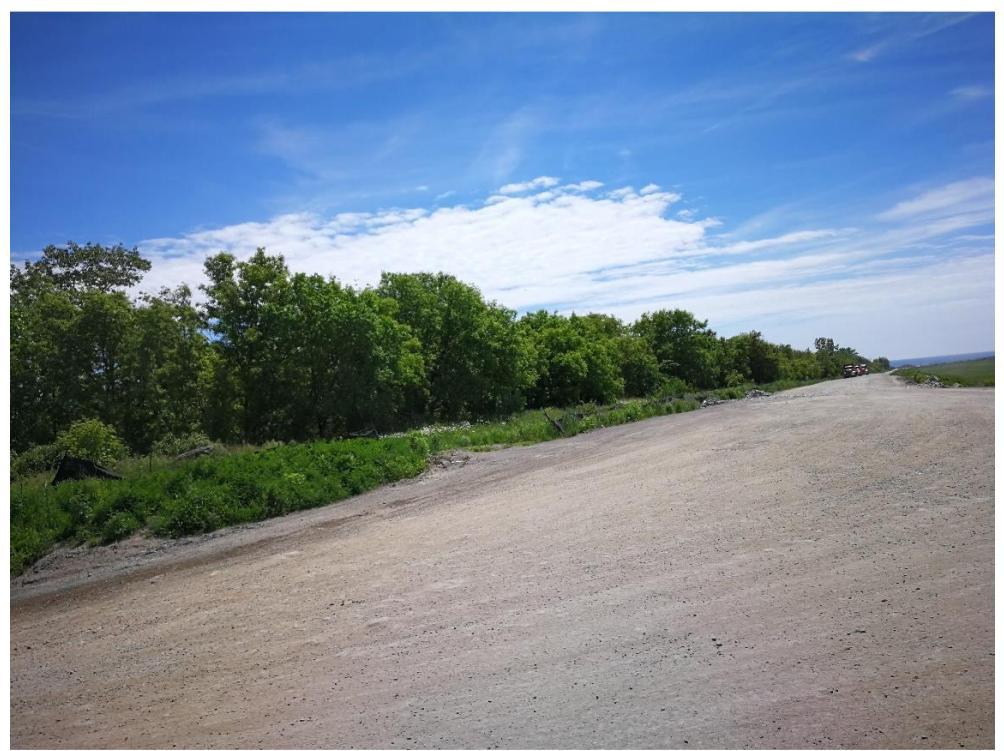
Photo B13: Road Bridge area (looking east)

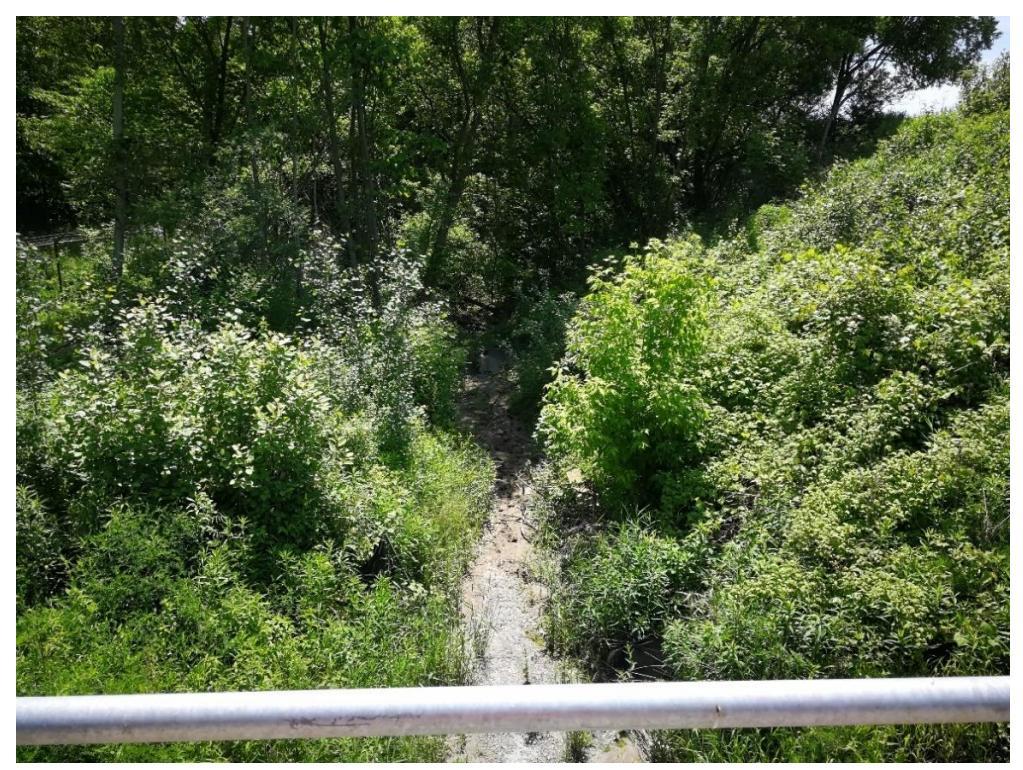
Photo B15: Creek conditions to south of bridge (looking north - upstream)

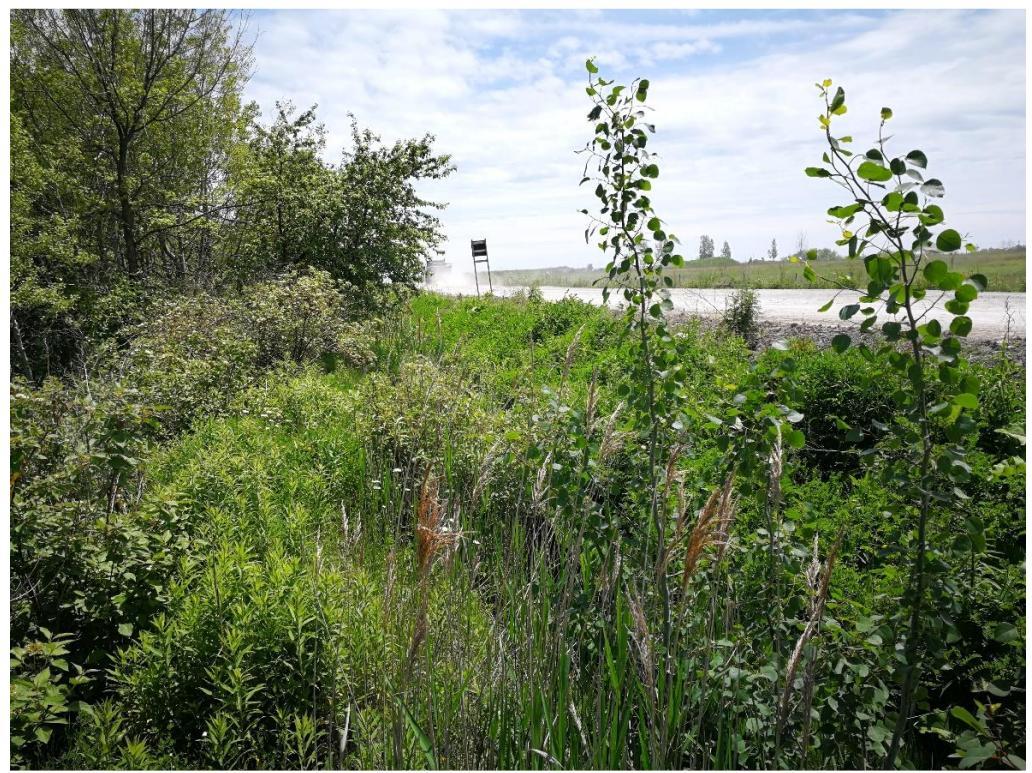
Photo B16: Creek and slope conditions to south of bridge (looking south from bridge – looking downstream)

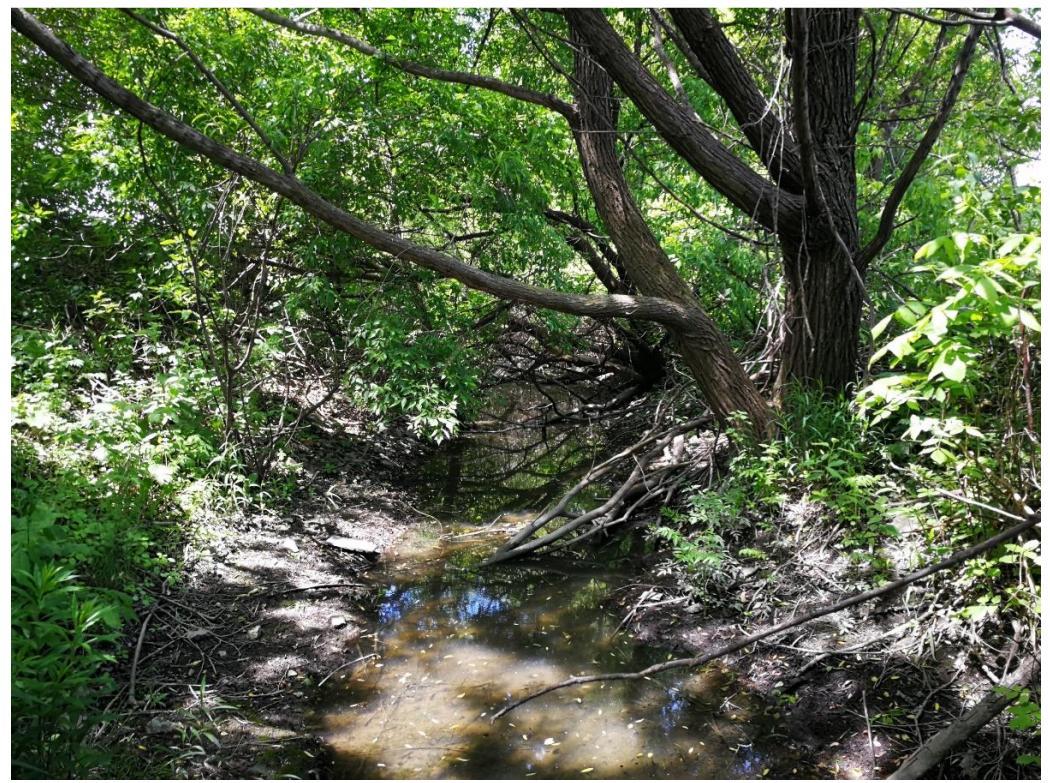
Photo B18: Ditch between Creek and Road at south part of Reach S2 area (looing north - upstream)

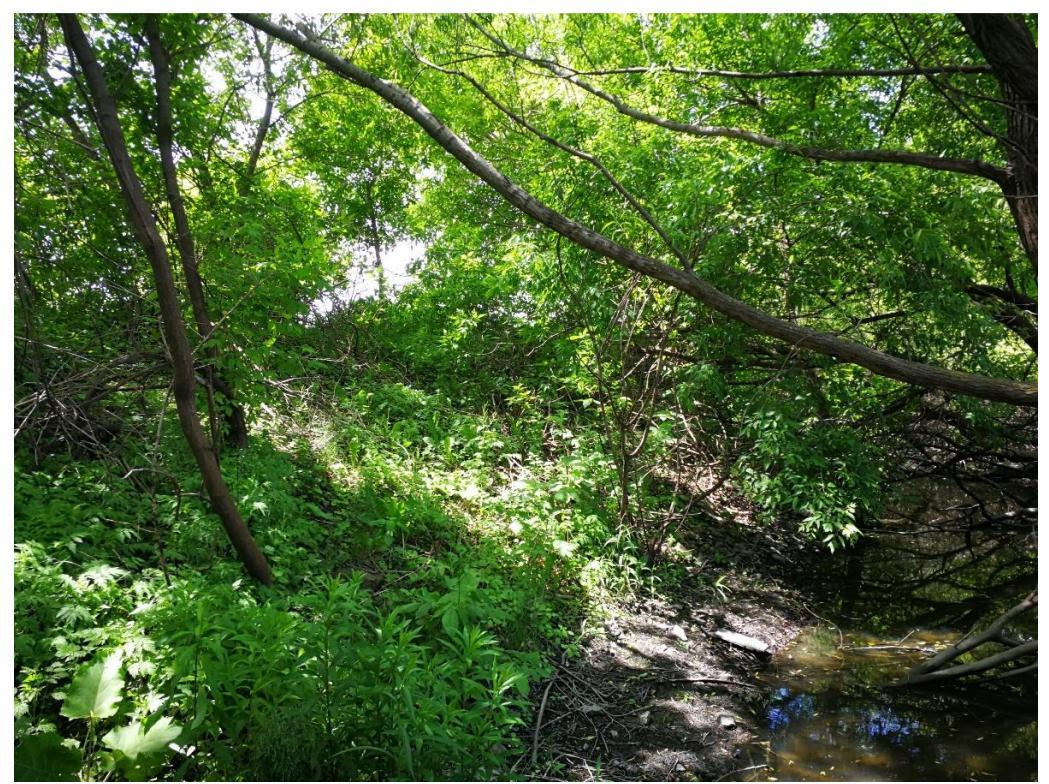
Photo B19: Creek Conditions to South of Steel Wire Fence at south end of Each S2 (looking north - upstream)

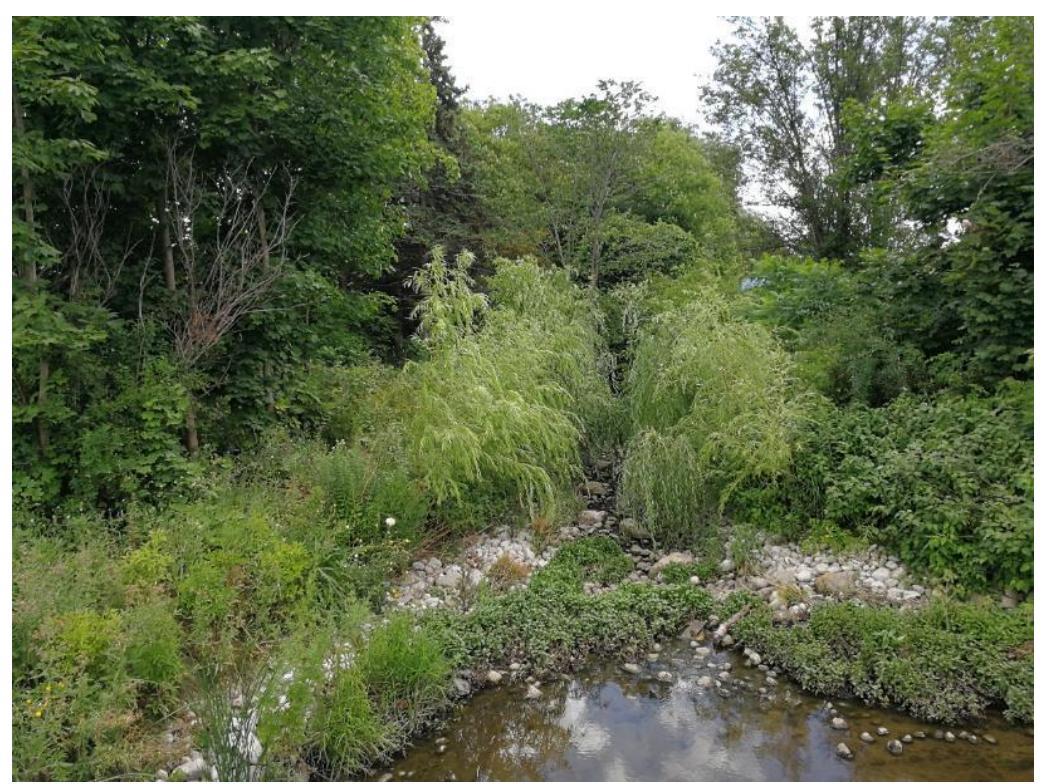
Photo 1: Creek and concrete culvert at Lakeshore Blvd (looking north - upstream)

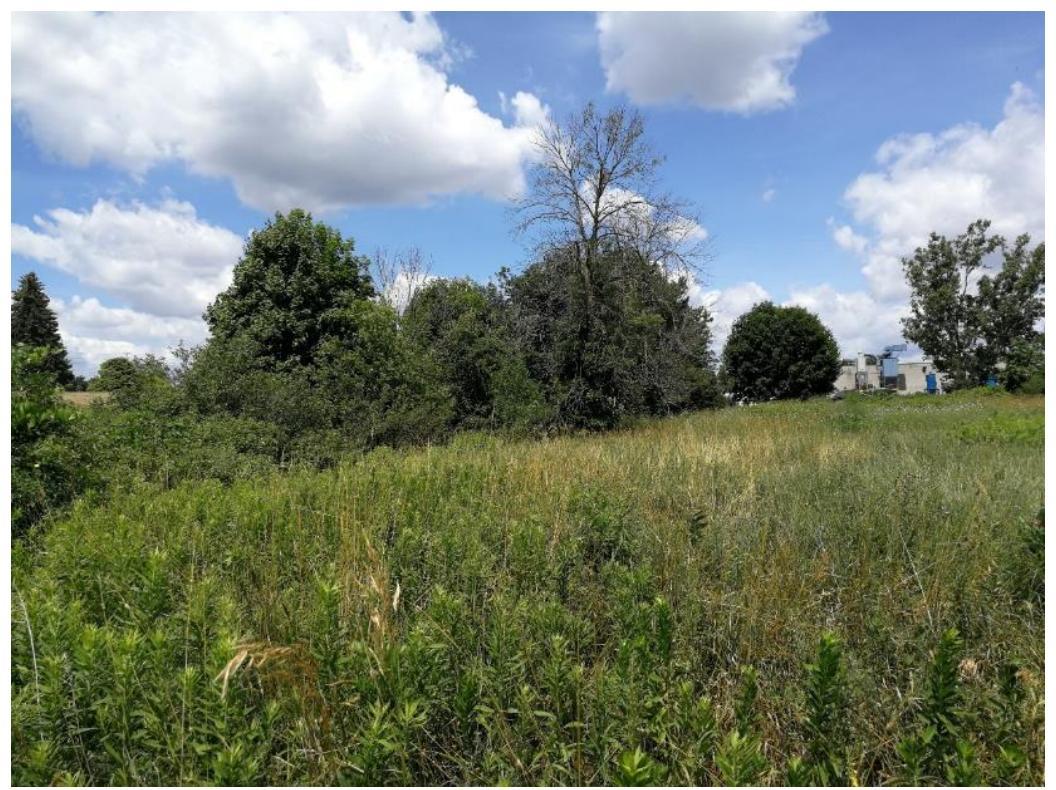
Photo 6: Creek conditions to north of Section L-L (looking northeast)

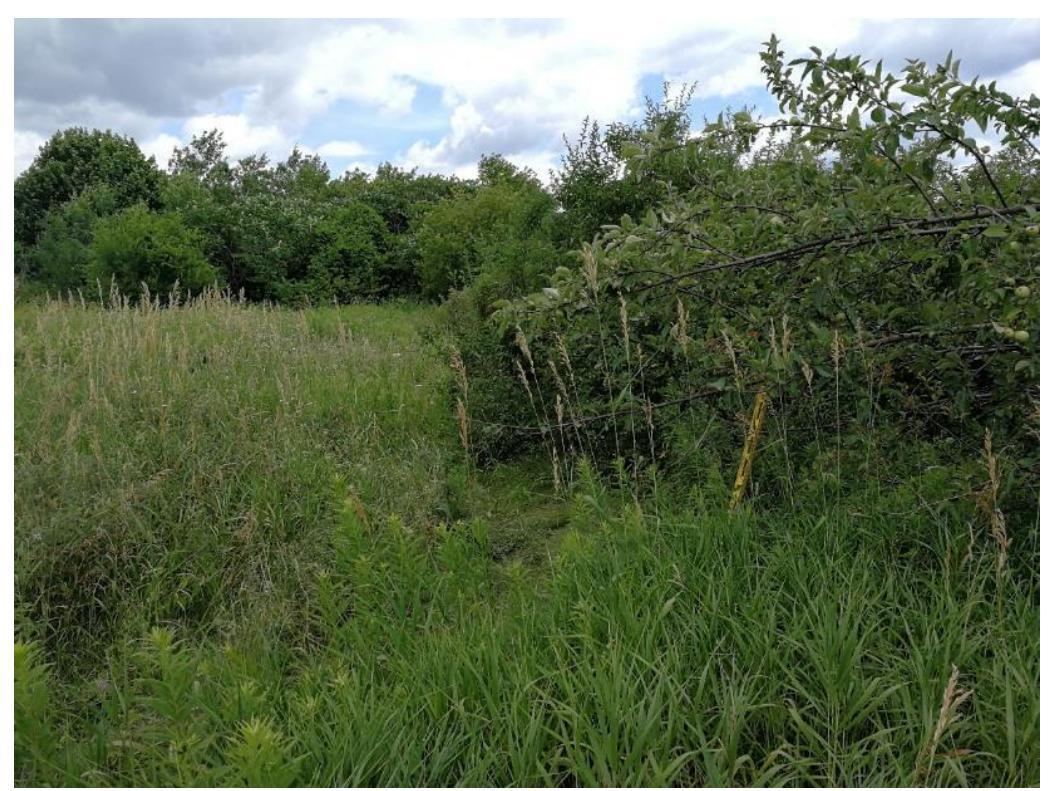
Photo 7: Top of slope area to north of Section M-M (looking northwest)

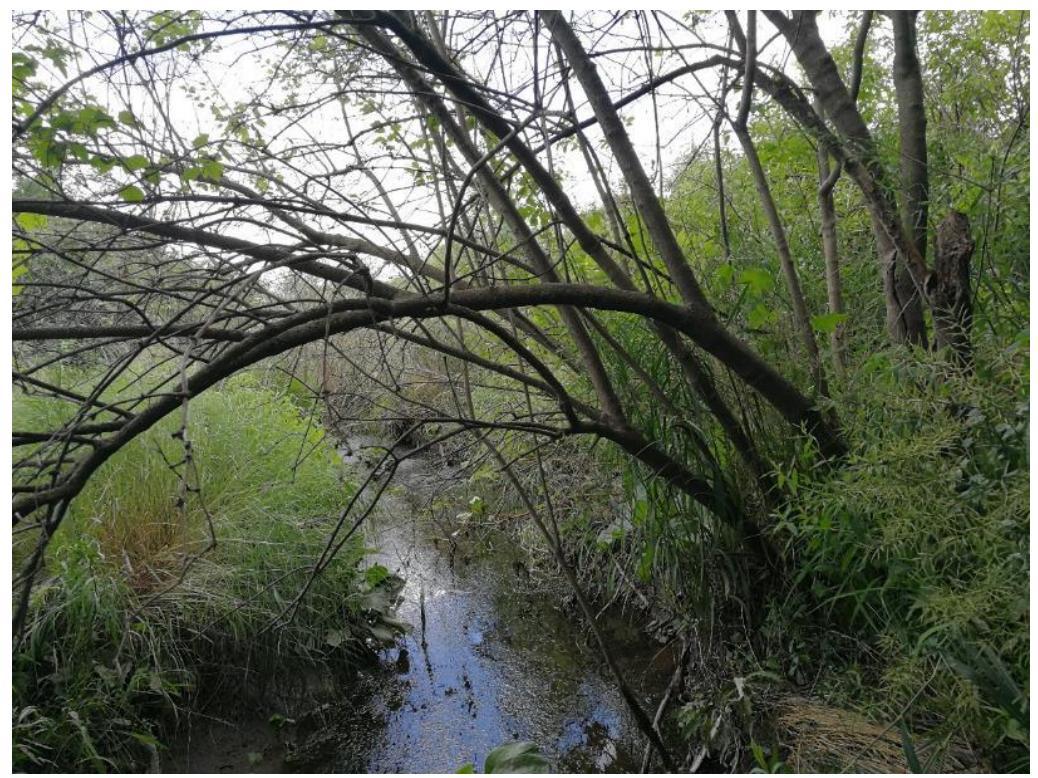
Photo 9: Creek conditions at west of Section N-N (looking west)

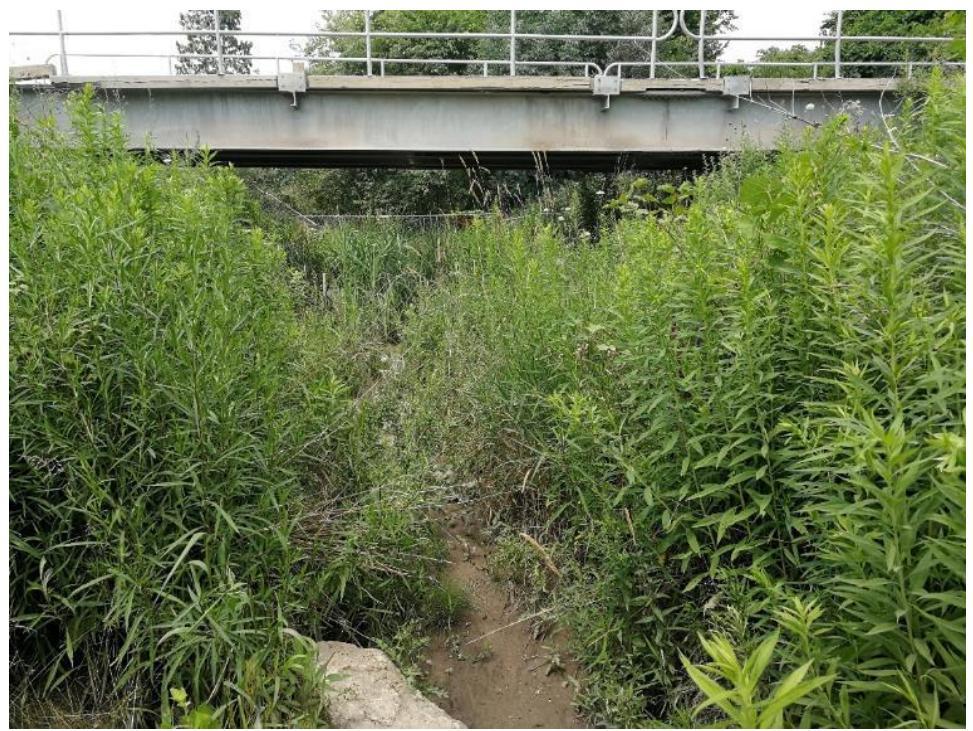
Photo 12: Creek and east slope conditions in Reach S2 (looking south from road bridge)

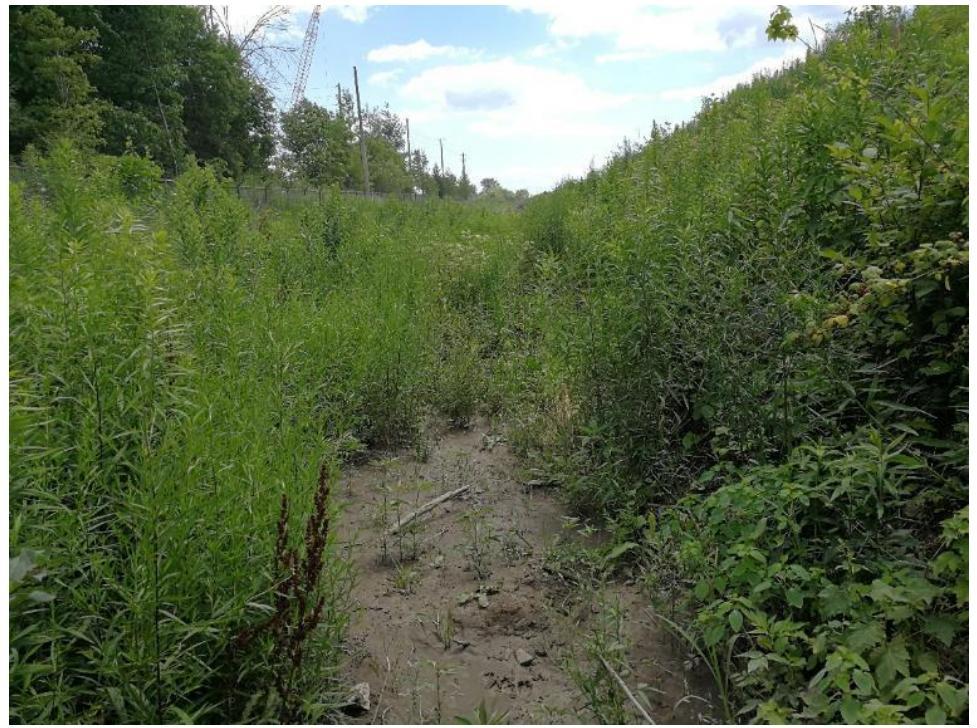
Photo 13: Creek conditions to south of road bridge (looking north - upstream)

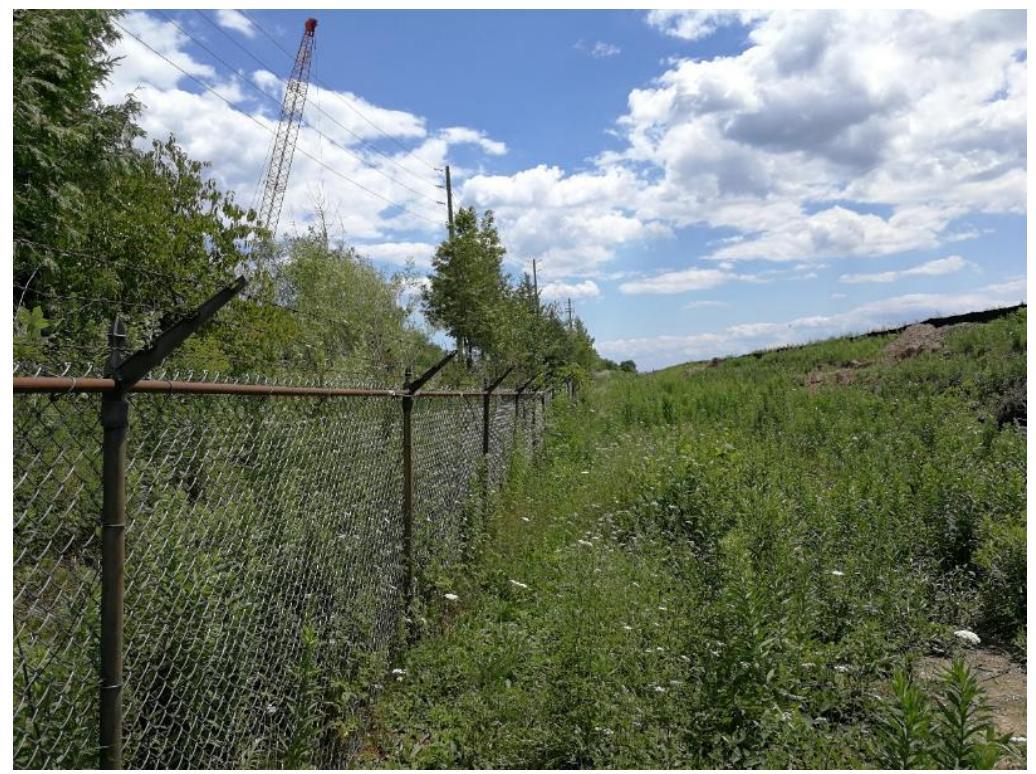
Photo 14: Creek and slope conditions to south of road bridge (looking south – downstream)
