## **Report on**

Geotechnical Slope Stability Assessment Serson Creek Lakeview Village, 800 Hydro Road Mississauga, Ontario

**Prepared For:** Lakeview Community Partners Limited

**Project No.** 18-519-102 July 19, 2019

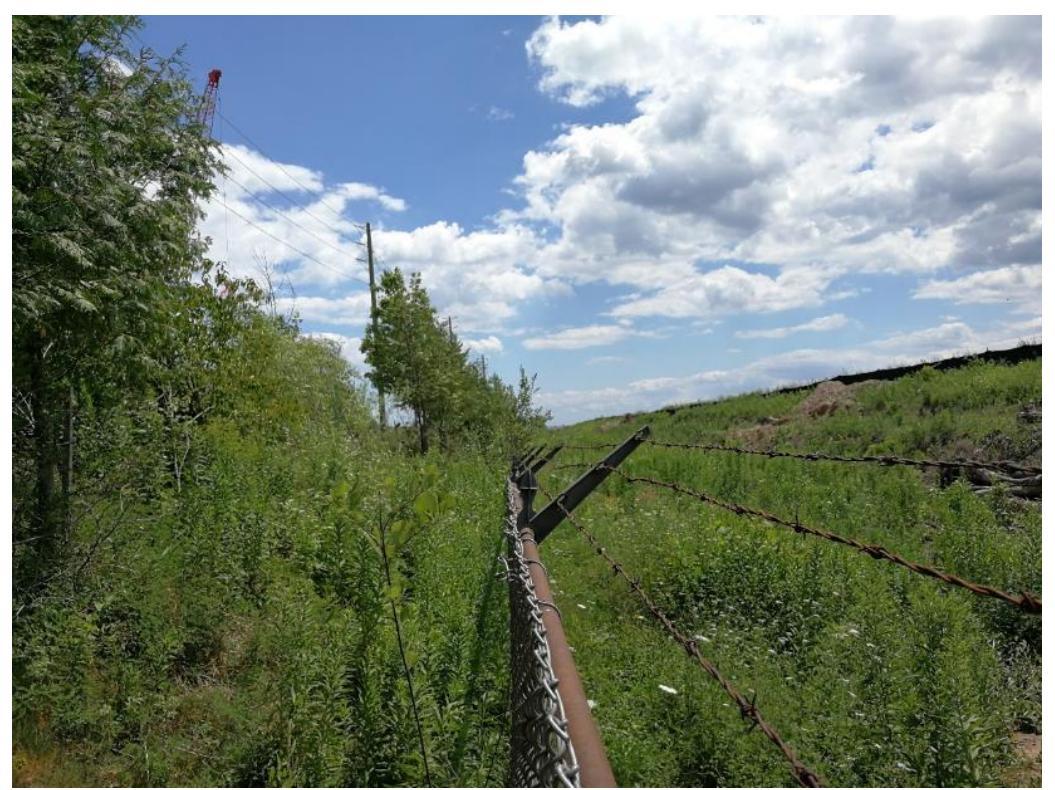
Photo 15: East slope near fence at north part of Reach S2 area (looing south - downstream)

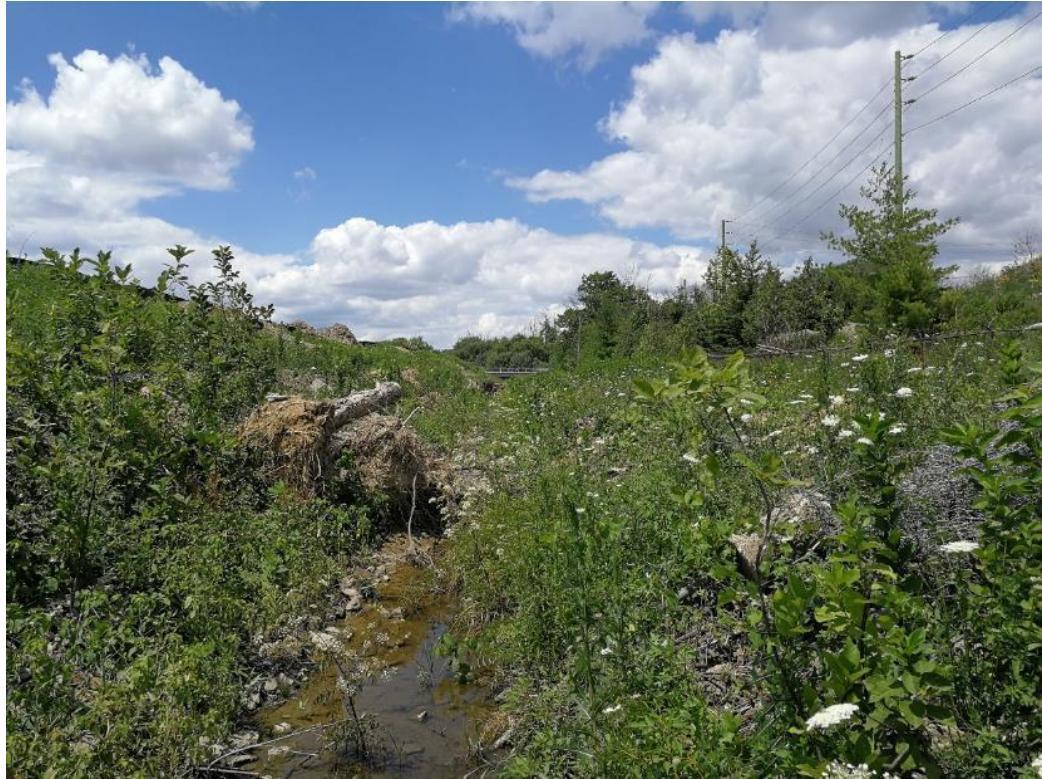
Photo 16: Conditions to east of fence at north part of Reach S2 area (looing south)

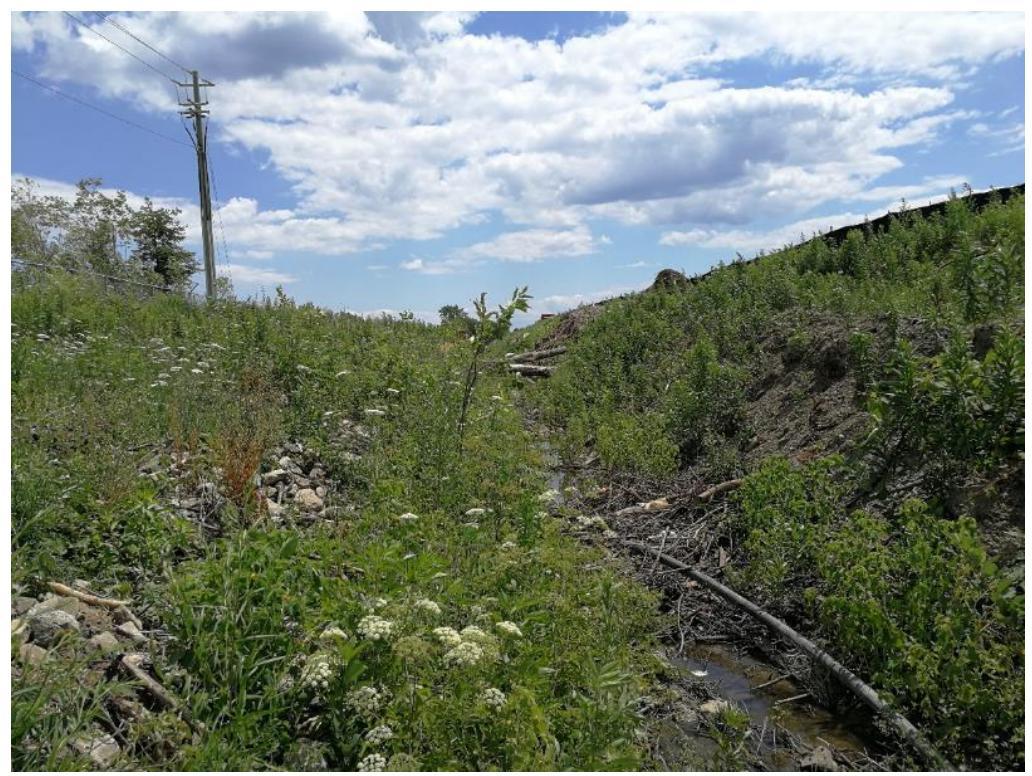
Photo 17: Creek conditions at middle-north part of Reach S2 (looking north - upstream)

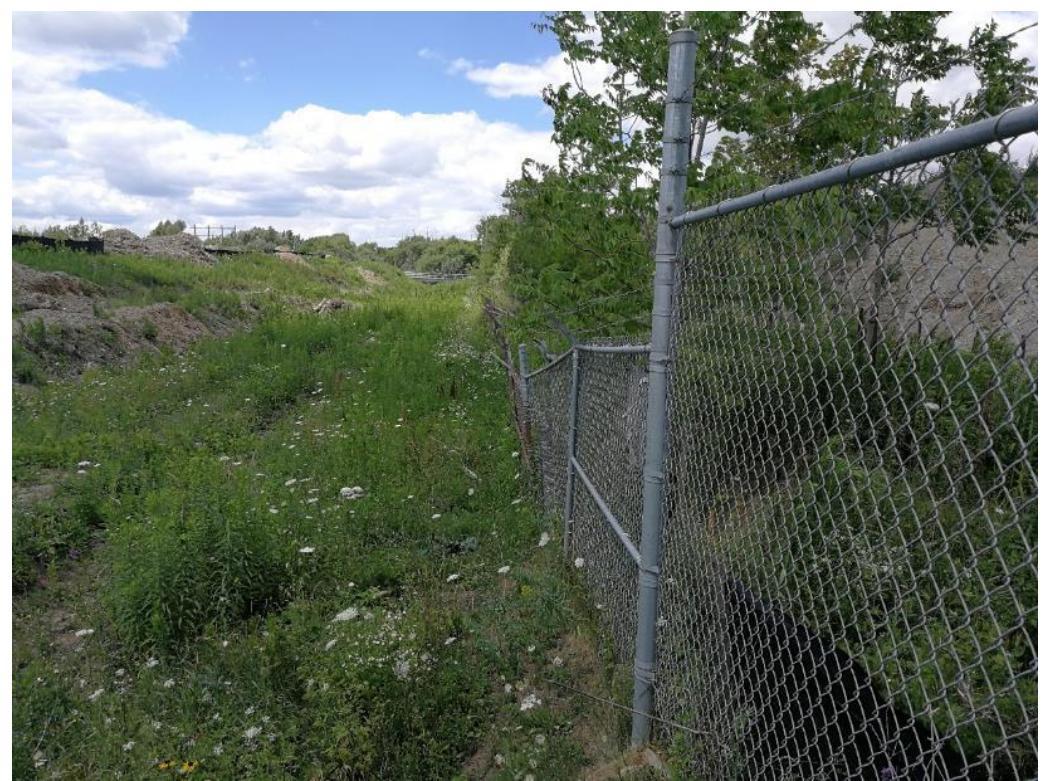
Photo 18: Creek conditions at middle-north part of Reach S2 (looking south - downstream)

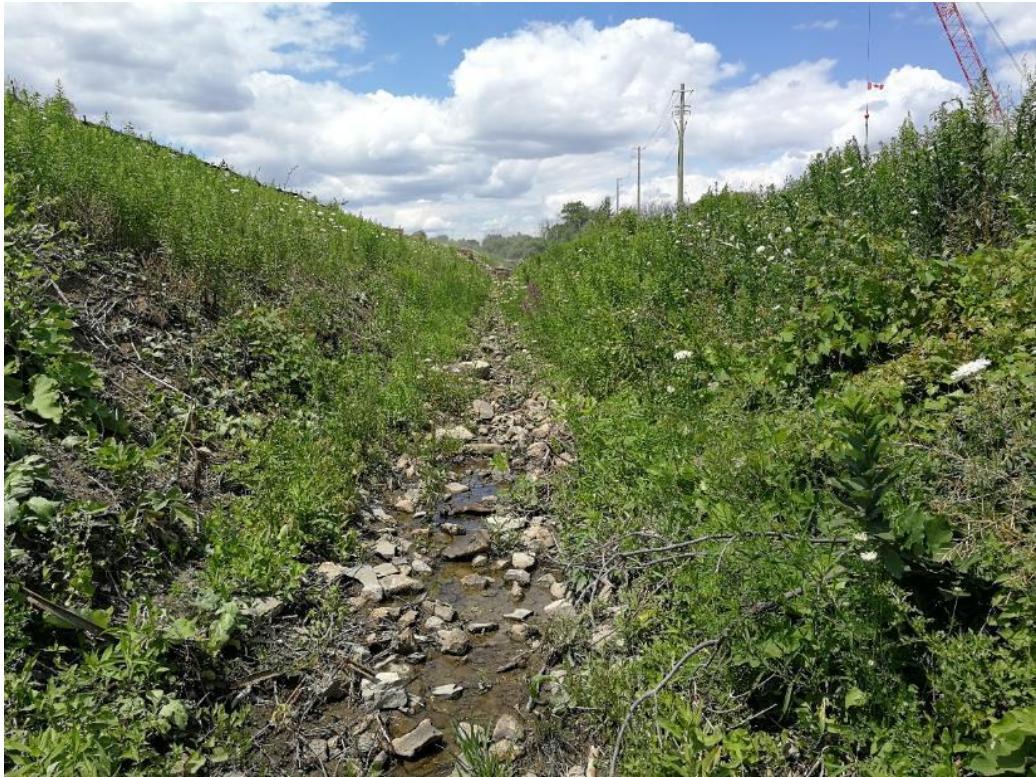
Photo 22: East slope near fence at middle-south part of Reach S2 (looking south - downstream)

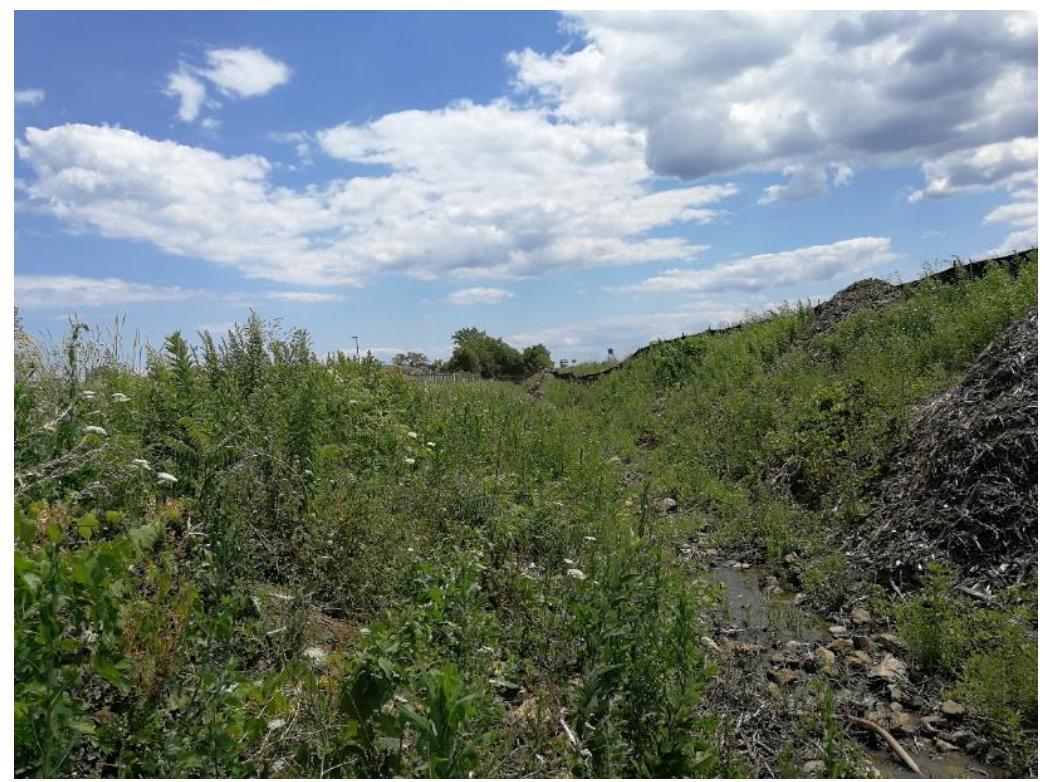
Photo 23: Creek conditions at middle-south part of Reach S2 (looking north - upstream)

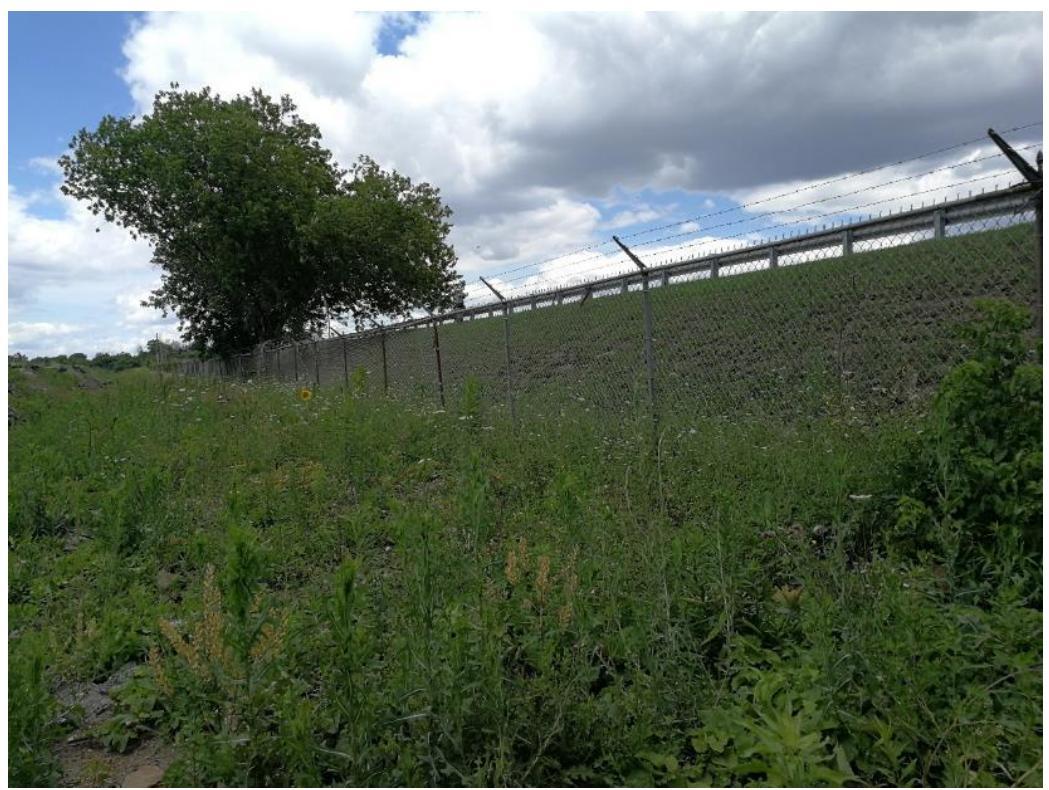
Photo 24: Creek conditions at middle-south part of Reach S2 (looking south - downstream)

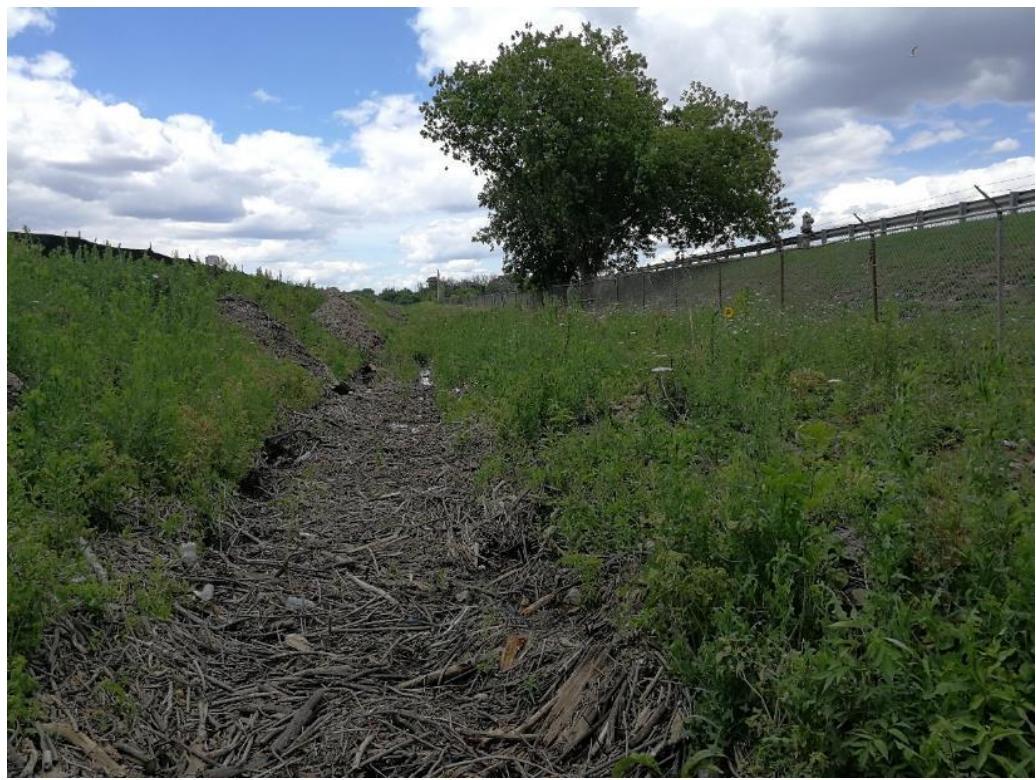
Photo 25: East slope near fence at south part of Reach S2 (looking northeast)

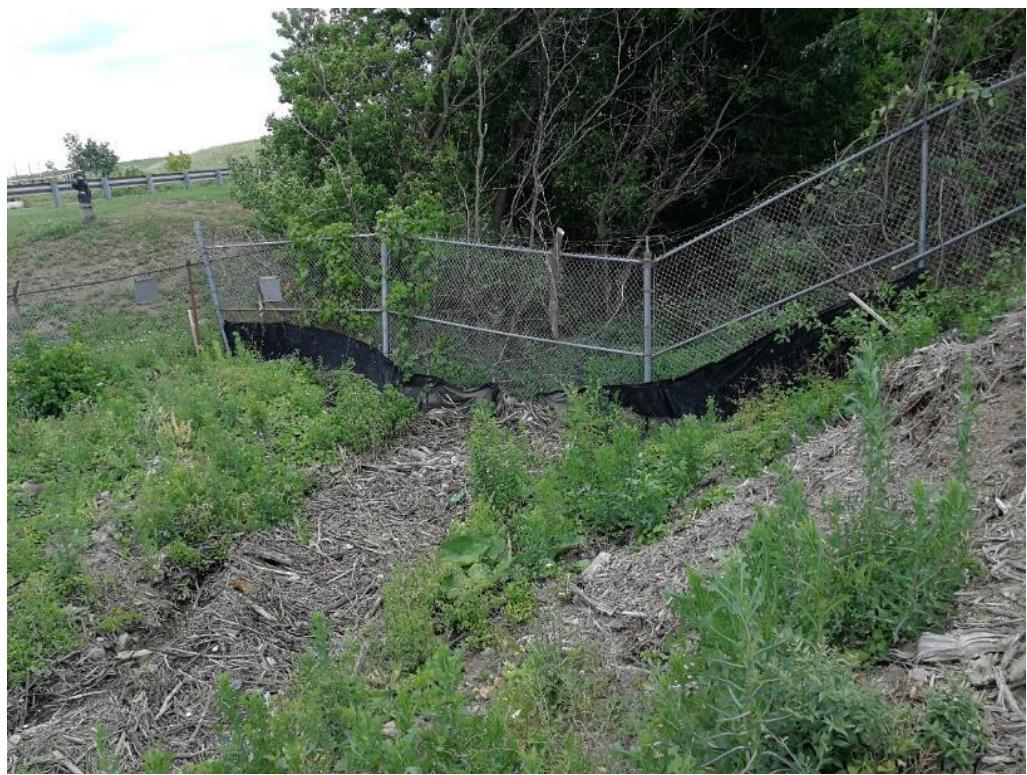
Photo 26: Creek conditions at south part of Reach S2 (looking north - upstream)
