ARBORIST REPORT

PROPOSED RESIDENTIAL DEVELOPMENT CITY OF MISSISSAUGA

SITE LOCATION:
2207 DIXIE ROAD
MISSISSAUGA, ONTARIO

November 11, 2019

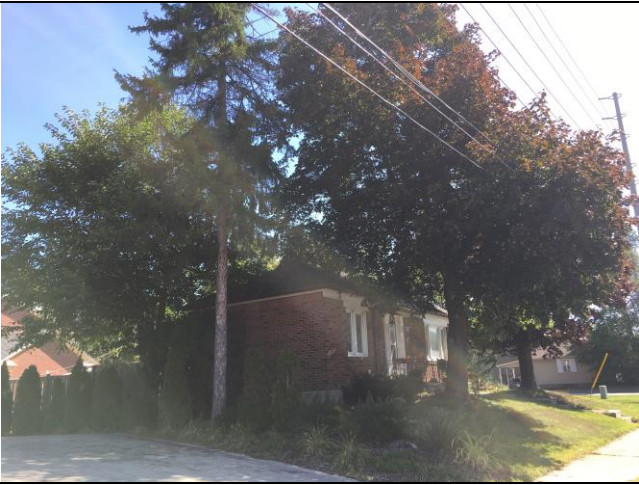
EXISTING TREE INVENTORY									
KEY	SPECIES	CALIPER	CROWN	HEALTH	STRUCTURE	COMMENTS	PRESERVATION	MIN. TPZ	KEY
		IN (cm)	IN (m)	G/F/P			DIRECTION		
1	NORWAY SPRUCE	32	5.0	POOR-FAIR	GOOD FORM	ELEVATED CROWN, DEADWOOD AND DECLINE IN LEADER AND LOWER CROWN	REMOVE	2.4	1
2	DEBORAH NORWAY MAPLE	63	12.0	GOOD	GOOD FORM	OLD PRUNING WOUNDS ON STEM, UNBALANCED CROWN DUE TO OVERHEAD WIRES	REMOVE	4.2	2
3	CRIMSON KING NORWAY MAPLE	49	8.0	POOR	IRREGULAR FORM	DECLINING CROWN, EPICORMIC GROWTH THROUGHOUT	REMOVE	3	3
4	NORWAY MAPLE	46	12.0	GOOD	GOOD FORM	MINOR INTERNAL EPICORMIC GROWTH, SOME INTERNAL TWIG TIP DIEBACK	PRESERVE	3	4
5	NORWAY MAPLE	48	15.0	POOR-FAIR	BROAD FORM	GIRDLED ROOTS, WEST SIDE OF CROWN IN DECLINE, EPICORMIC GROWTH THROUGHOUT CROWN	REMOVE	3	5
6	WHITE MULBERRY	34	9.0	GOOD	DOUBLE STEM	ONE SIDED FORM, CROWDED BY ADJACENT TREE, INCLUDED BARK	REMOVE	2.4	6
7	NORWAY SPRUCE	40	8.0	GOOD	GOOD FORM	CROWN ELEVATED	PRESERVE	2.4	7

Tree #s 1-3 view looking southeast (to be removed)

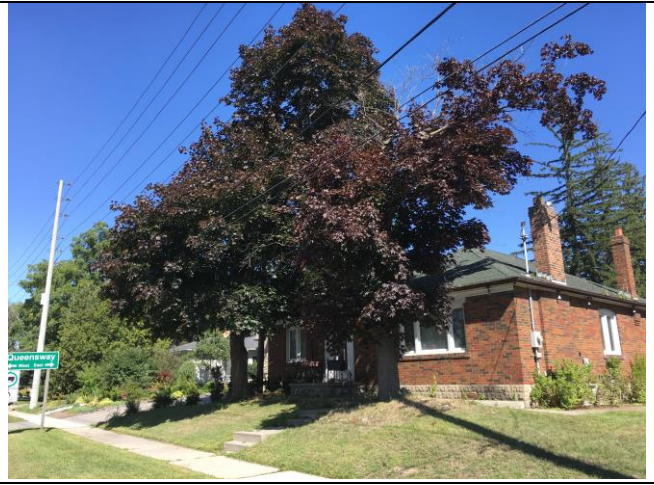
Tree #s 2 & 3 view looking northeast (to be removed)

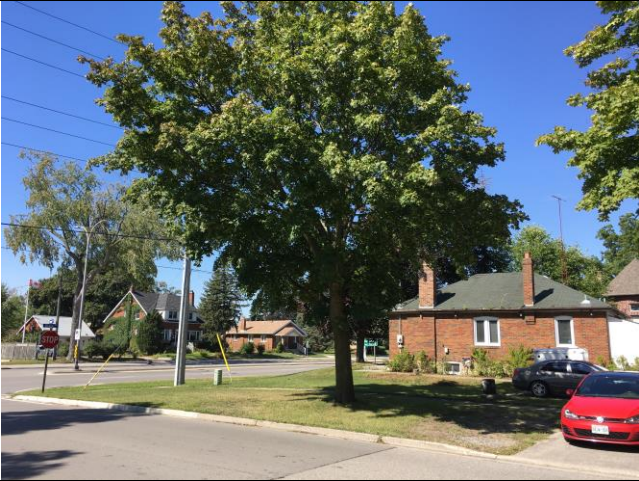
Tree# 4 view looking northwest (to be preserved)

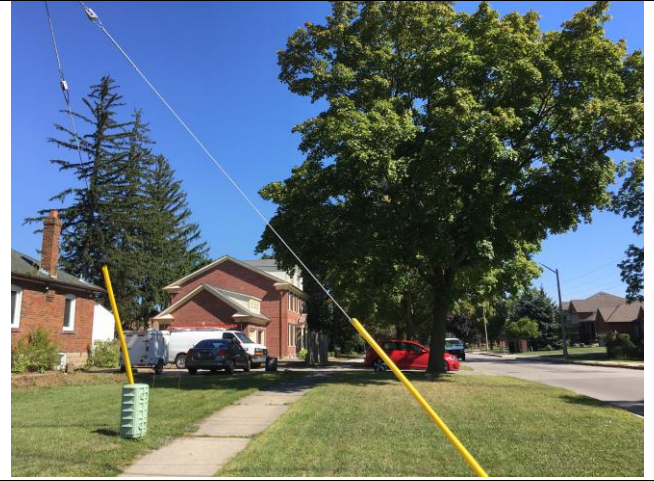
Tree # 4 view looking east (to be preserved)

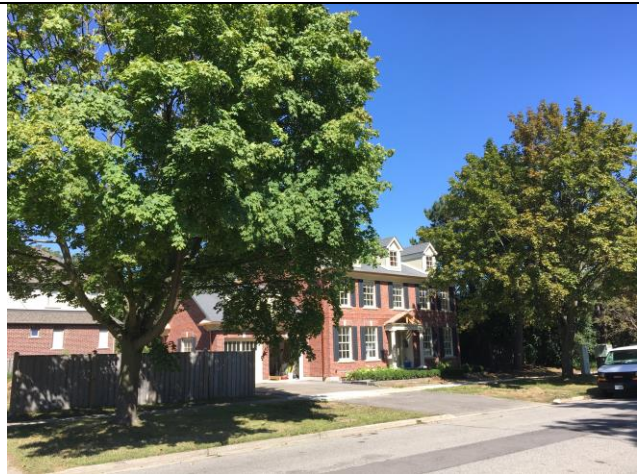
Tree# 5 view looking northeast (to be removed)

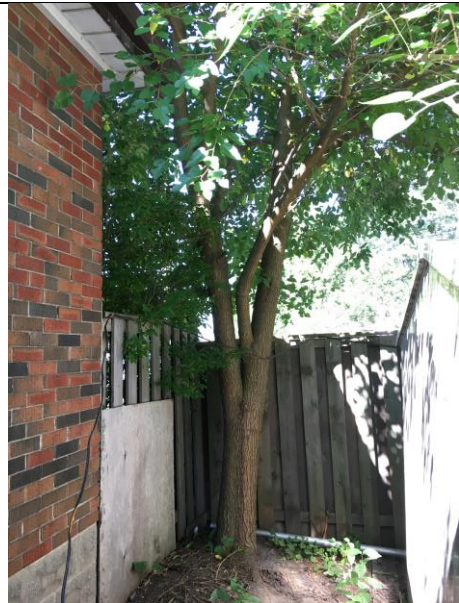
Tree#s 6 view looking north (to be removed)
