ARBORIST REPORT

PROPOSED TOWNHOUSE DEVELOPMENT 1110 LORNE PARK ROAD **CITY OF MISSISSAUGA**

> **PROJECT NO:** 18-5255

Revised January 14, 2020 As Per Updated Site Plan

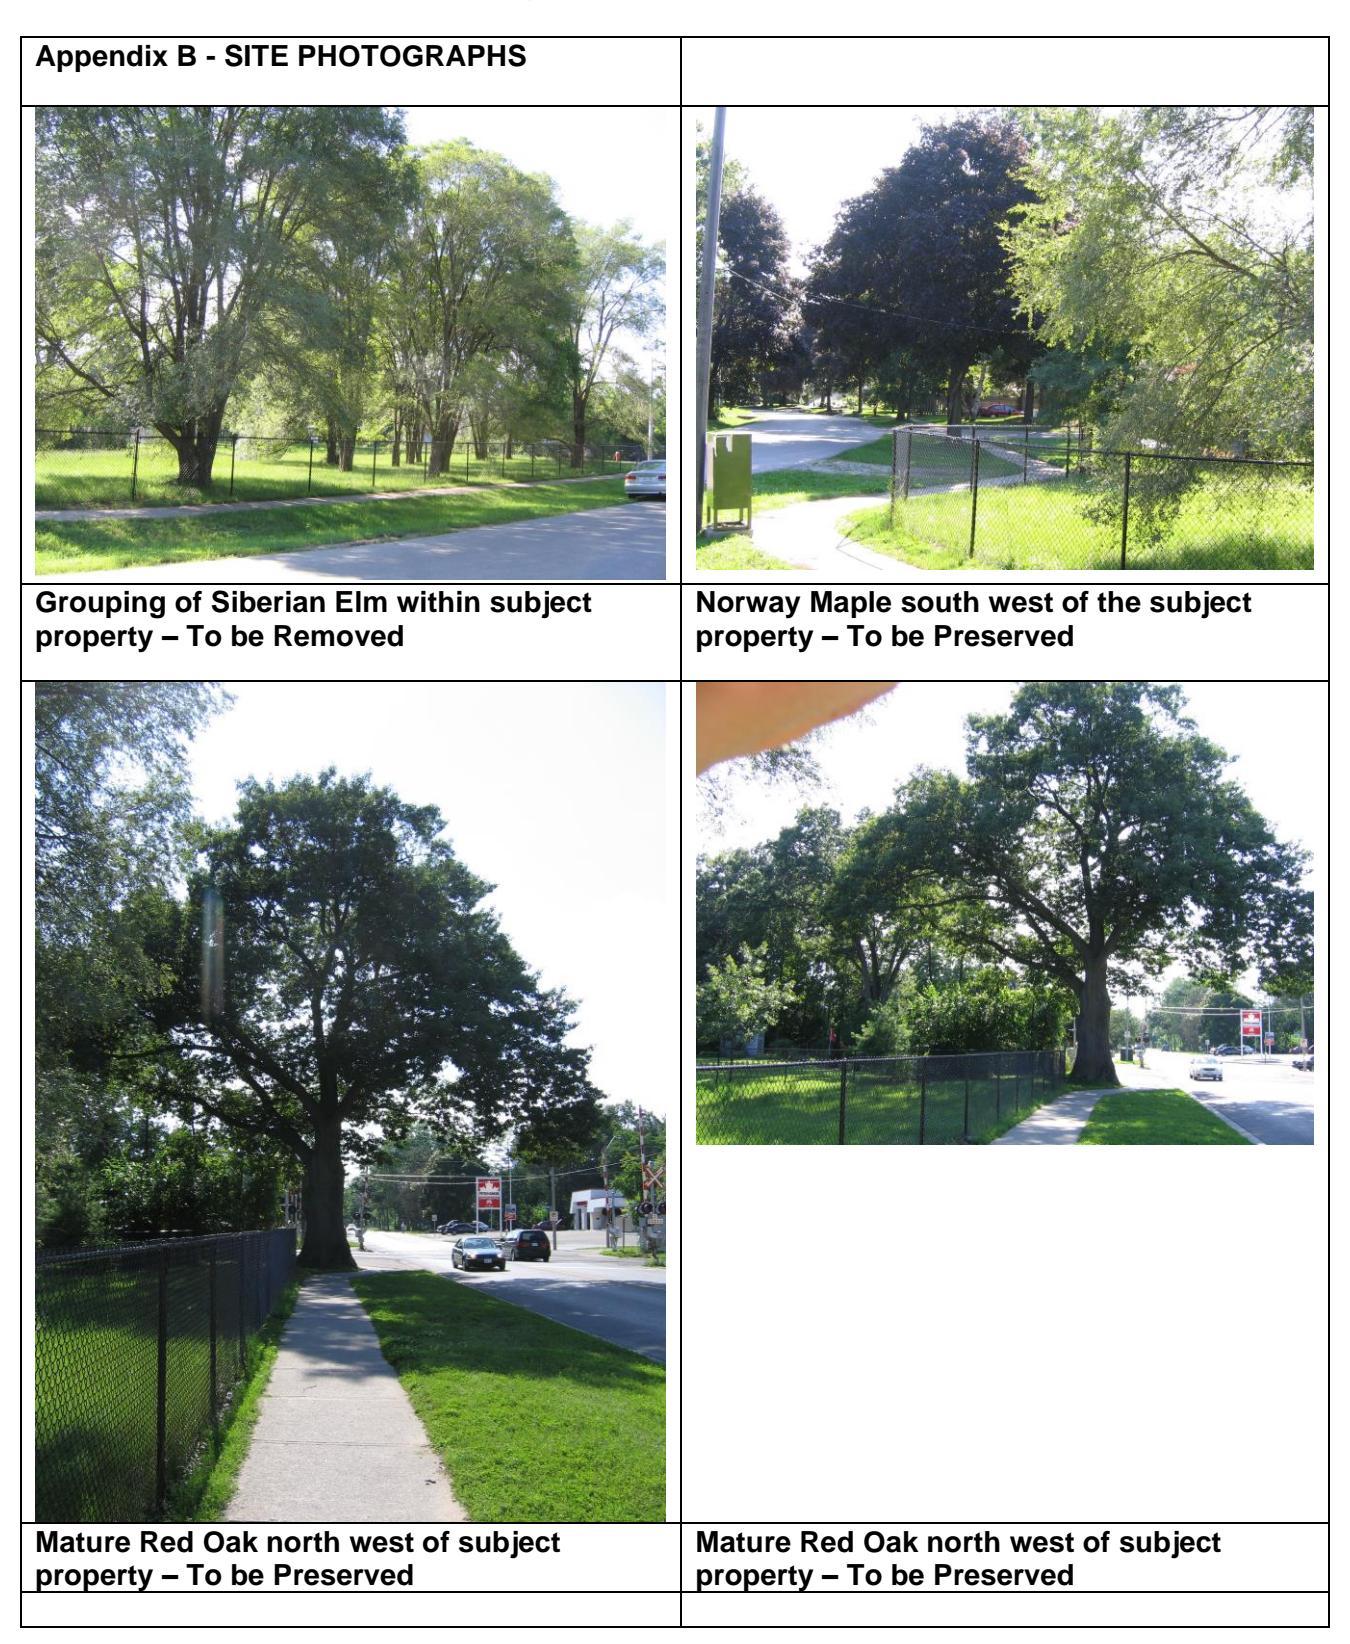
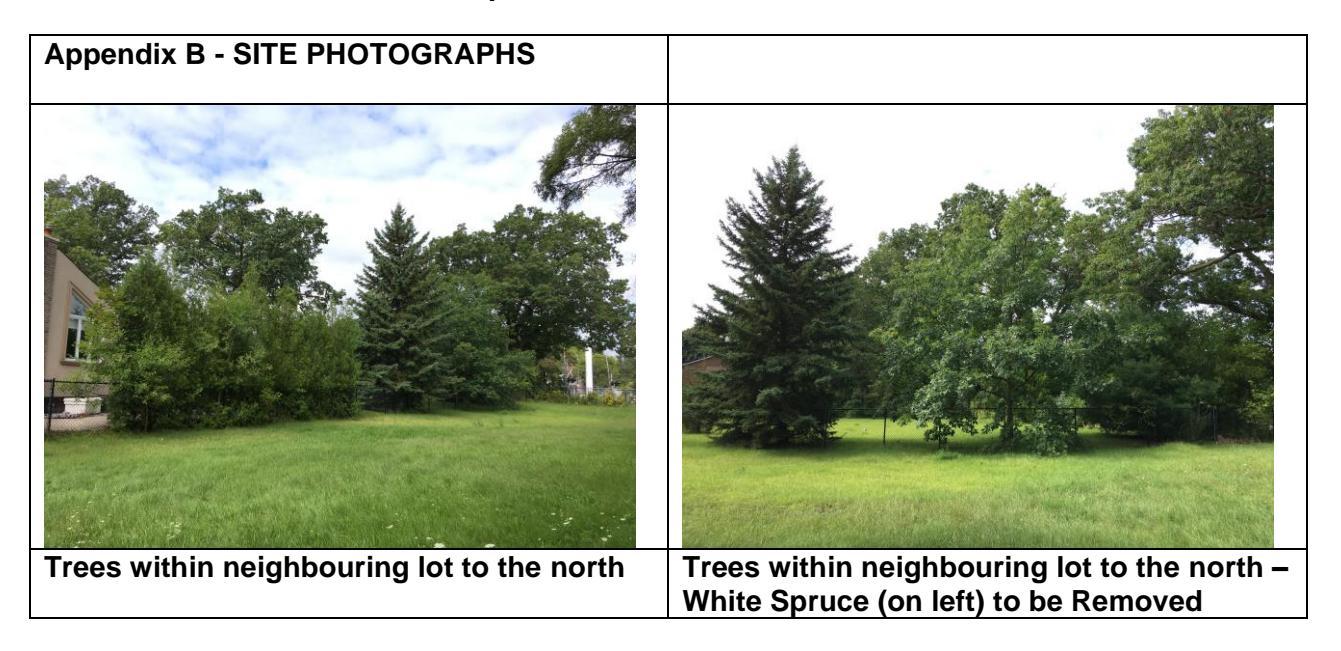
There are several semi-mature to mature Siberian Elm trees which comprise a naturalized grouping within the central area of the subject property. These trees are of generally poor to fair health and condition. Most of these trees have multiple stems and several weak branch unions are present. There is evidence of structural failure within some trees. Dieback and deadwood within several crowns have been observed as well. These generally weak wooded trees are invasive and are assessed a low preservation priority.

A mature Red Oak tree (159cm DBH) is located within the municipal right of way north west of the property. This tree exhibits a broad form and is an important feature of the streetscape along Lorne Park Road. There is a cavity on the north side of the stem that has been filled with a synthetic fill material.
