# Arborist Report & Tree Preservation Plan

## 16 Elm Drive West, Mississauga

*DATE: AUGUST 4, 2020*

*FILE #: TA-20-028*

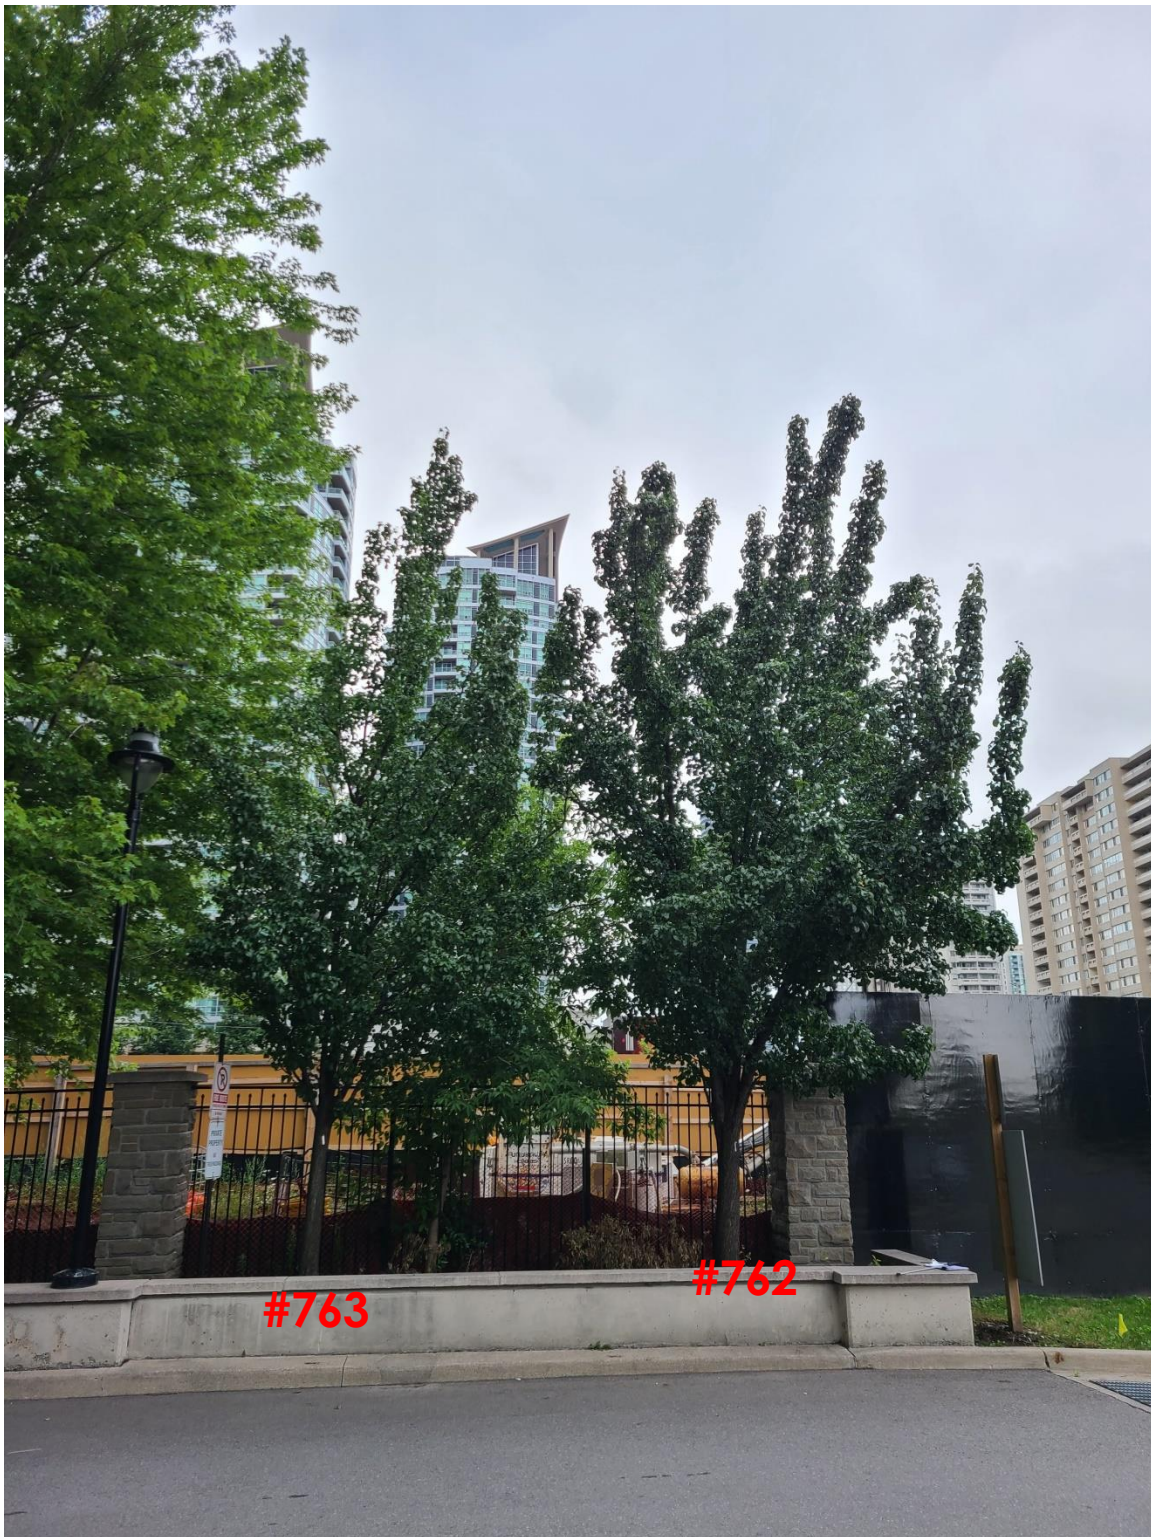
Tag #	Species	DBH (cm)	Condition	Category	Remarks	Rationale & Mitigation
762	Callery Pear <i>Pyrus calleryana</i> cv	21	Very Good	PP	Some epicormic branching at base; siltation fence installed along property boundary; excavation within close proximity to tree; located within planting bed along southern boundary of subject site on adjacent condominium property	<p>A total of approximately 17% of the tree's minimum TPZ will be impacted due to the required excavation along the southern boundary line</p> <p>This tree is in Very Good condition and, if the following recommendations are adhered to, it is not expected for the tree to succumb to the anticipated impacts of the proposed construction:</p> <ul style="list-style-type: none"> <li>- No tree protection fencing will be required to be installed; the existing sedimentation fencing and iron fence shall act as TPZ fencing</li> <li>- Any exposed roots shall be pruned by a qualified arborist</li> <li>- Provide a low-nitrogen fertilizer (i.e. 10-52-10) upon the completion of construction</li> </ul>

Tag #	Species	DBH (cm)	Condition	Category	Remarks	Rationale & Mitigation
763	Callery Pear <i>Pyrus calleryana</i> cv	21	Good	PP	Some epicormic branching at base; siltation fence installed along property boundary; excavation within close proximity to tree; located within planting bed along southern boundary of subject site on adjacent condominium property	<p>A total of approximately 18% of the tree's minimum TPZ will be impacted due to the required excavation along the southern boundary line</p> <p>This tree is in Good condition and, if the following recommendations are adhered to, it is not expected for the tree to succumb to the anticipated impacts of the proposed construction:</p> <ul style="list-style-type: none"> <li>- No tree protection fencing will be required to be installed; the existing sedimentation fencing and iron fence shall act as TPZ fencing</li> <li>- Any exposed roots shall be pruned by a qualified arborist</li> <li>- Provide a low-nitrogen fertilizer (i.e. 10-52-10) upon the completion of construction</li> </ul>

Figure 2. Trees #762 and #763 located on adjacent private property. Small Manitoba Maple growing between trees (not inventoried)

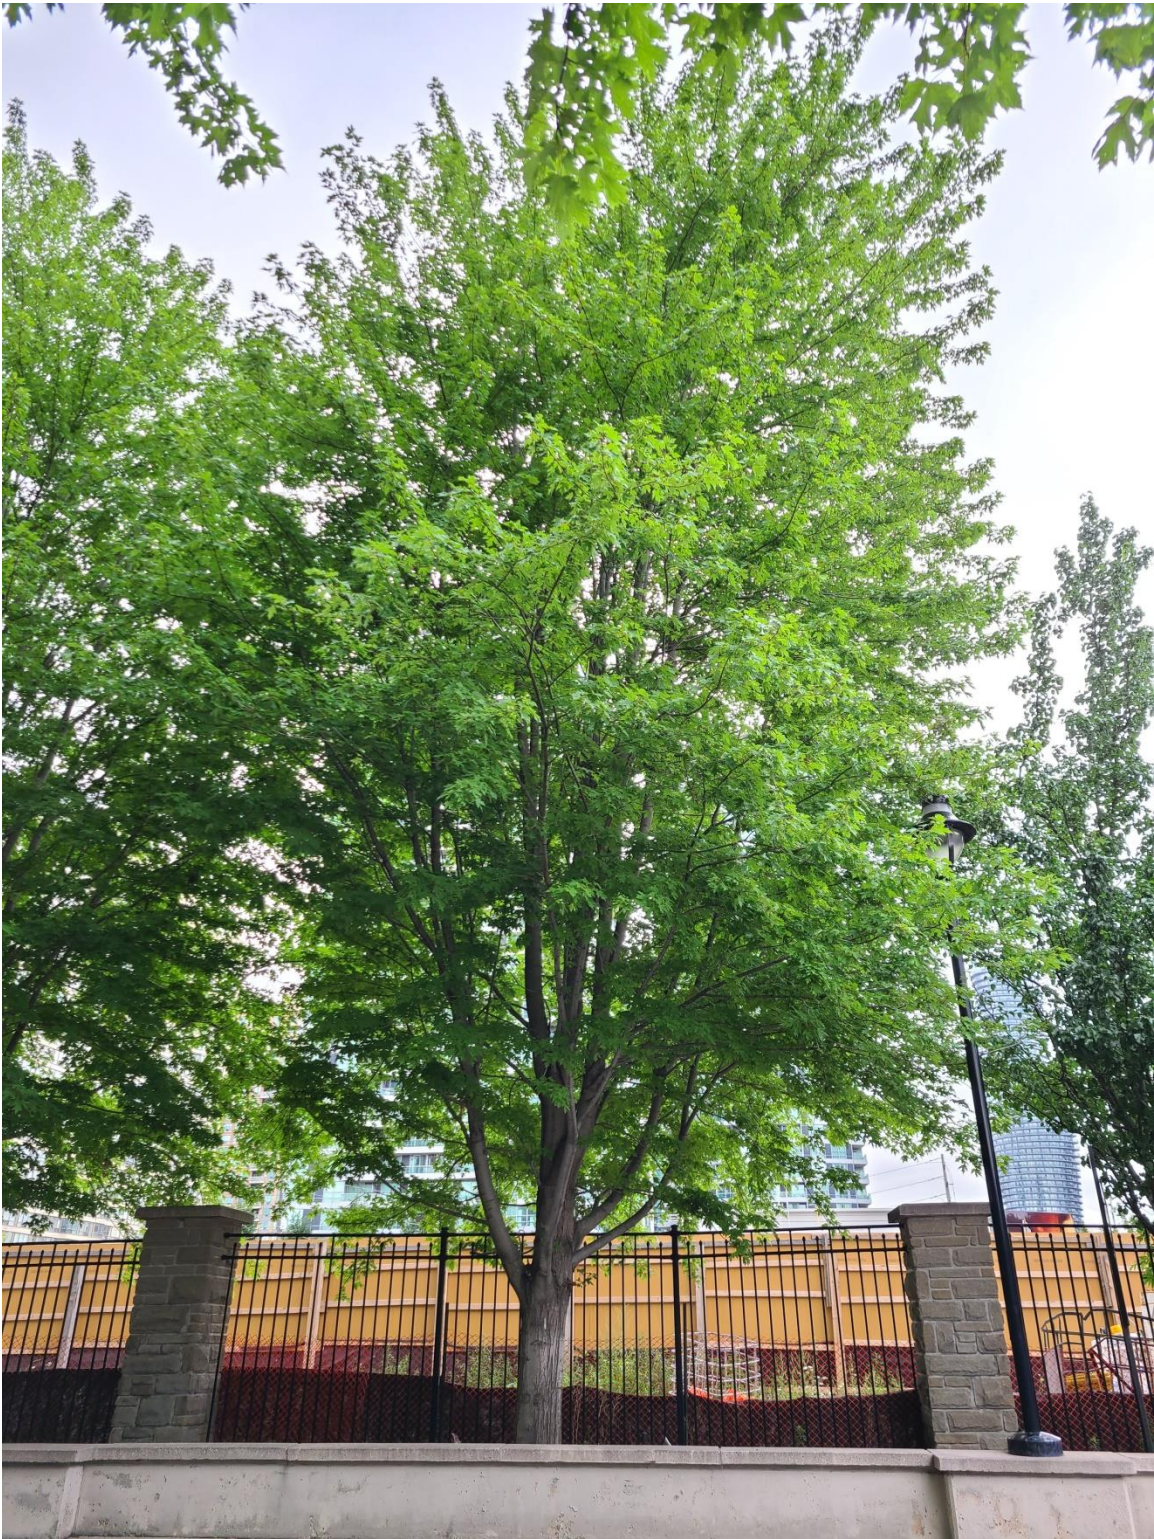
764	Silver Maple <i>Acer saccharinum</i> cv.	33	Very Good	PP	Siltation fence installed along property boundary; excavation within approximately 2.0m of tree; located within planting bed along southern boundary of subject site on adjacent condominium property	<p>A total of approximately 24% of the tree's minimum TPZ will be impacted due to the required excavation along the southern boundary line</p> <p>This tree is in Very Good condition and, if the following recommendations are adhered to, it is not expected for the tree to succumb to the anticipated impacts of the proposed construction:</p> <ul style="list-style-type: none"> <li>- No tree protection fencing will be required to be installed; the existing sedimentation fencing and iron fence shall act as TPZ fencing</li> <li>- Any exposed roots shall be pruned by a qualified arborist</li> <li>- Provide a low-nitrogen fertilizer (i.e. 10-52-10) upon the completion of construction</li> </ul>

Figure 3. Tree #764 located on adjacent private property to the south

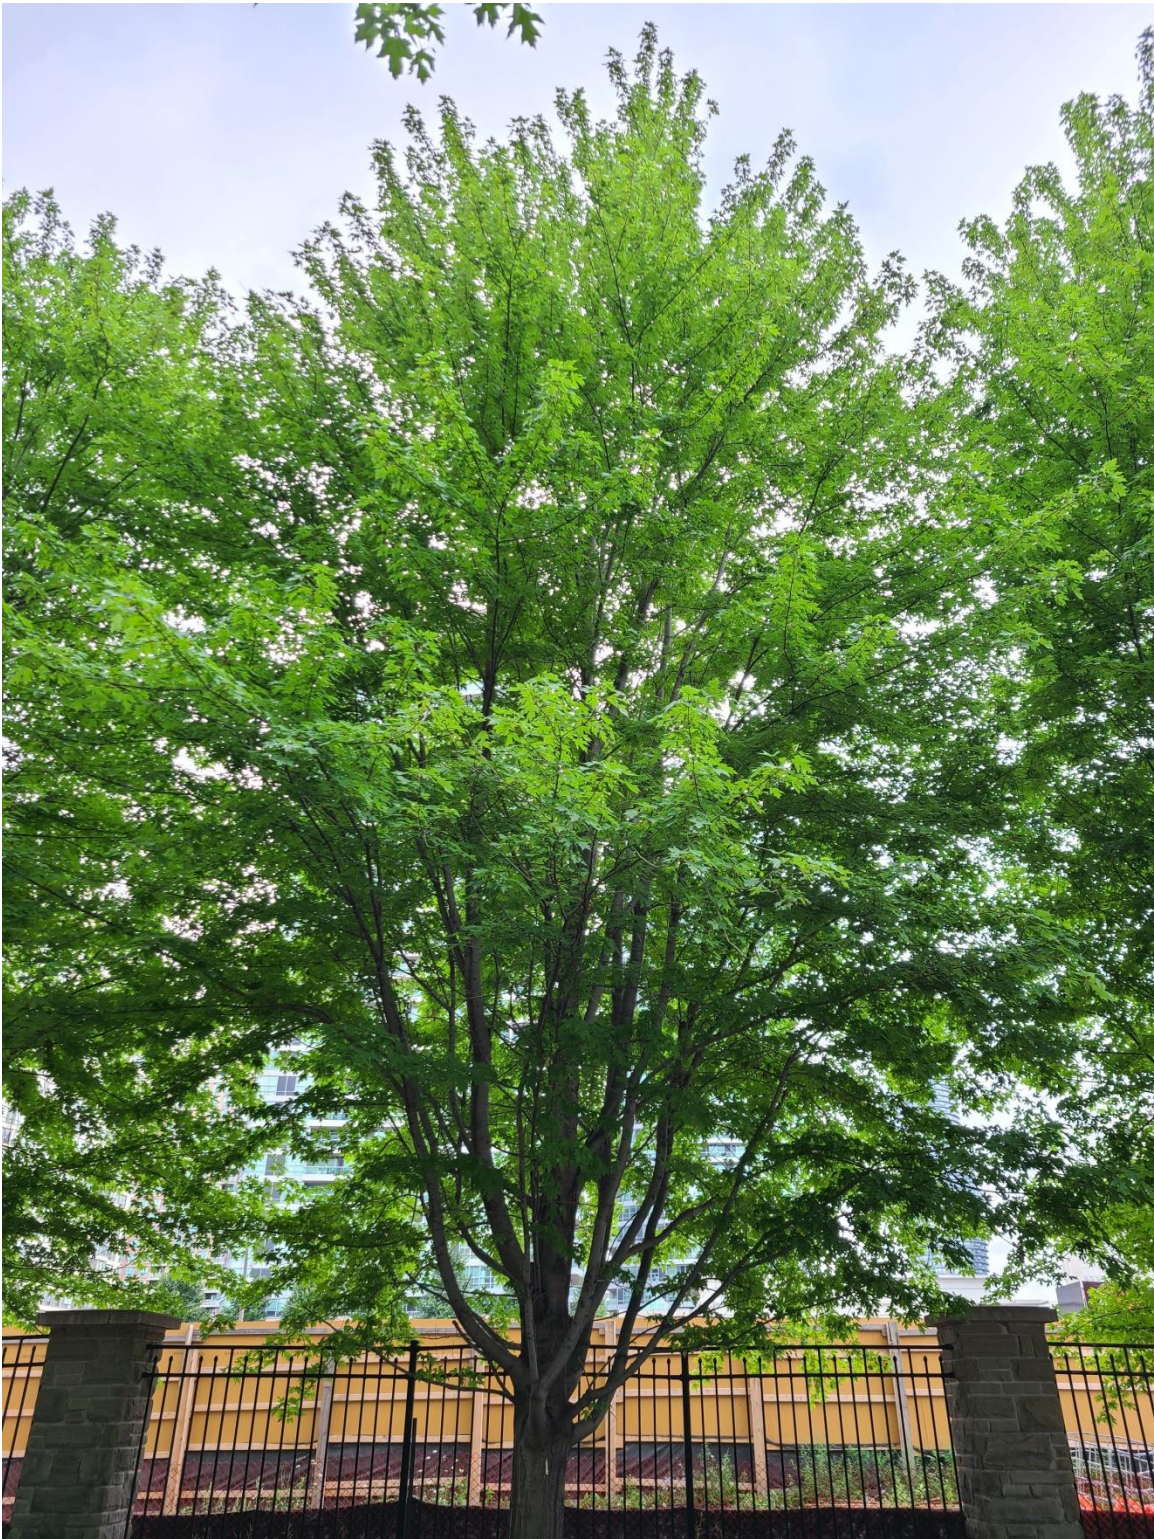
765	Silver Maple <i>Acer saccharinum</i> cv.	32	Very Good	PP	Siltation fence installed along property boundary; excavation within approximately 2.0m of tree; located within planting bed along southern boundary of subject site on adjacent condominium property	<p>A total of approximately 22% of the tree's minimum TPZ will be impacted due to the required excavation along the southern boundary line</p> <p>This tree is in Very Good condition and, if the following recommendations are adhered to, it is not expected for the tree to succumb to the anticipated impacts of the proposed construction:</p> <ul style="list-style-type: none"> <li>- No tree protection fencing will be required to be installed; the existing sedimentation fencing and iron fence shall act as TPZ fencing</li> <li>- Any exposed roots shall be pruned by a qualified arborist</li> <li>- Provide a low-nitrogen fertilizer (i.e. 10-52-10) upon the completion of construction</li> </ul>

Figure 4. Tree #765 located on adjacent private property to the south.

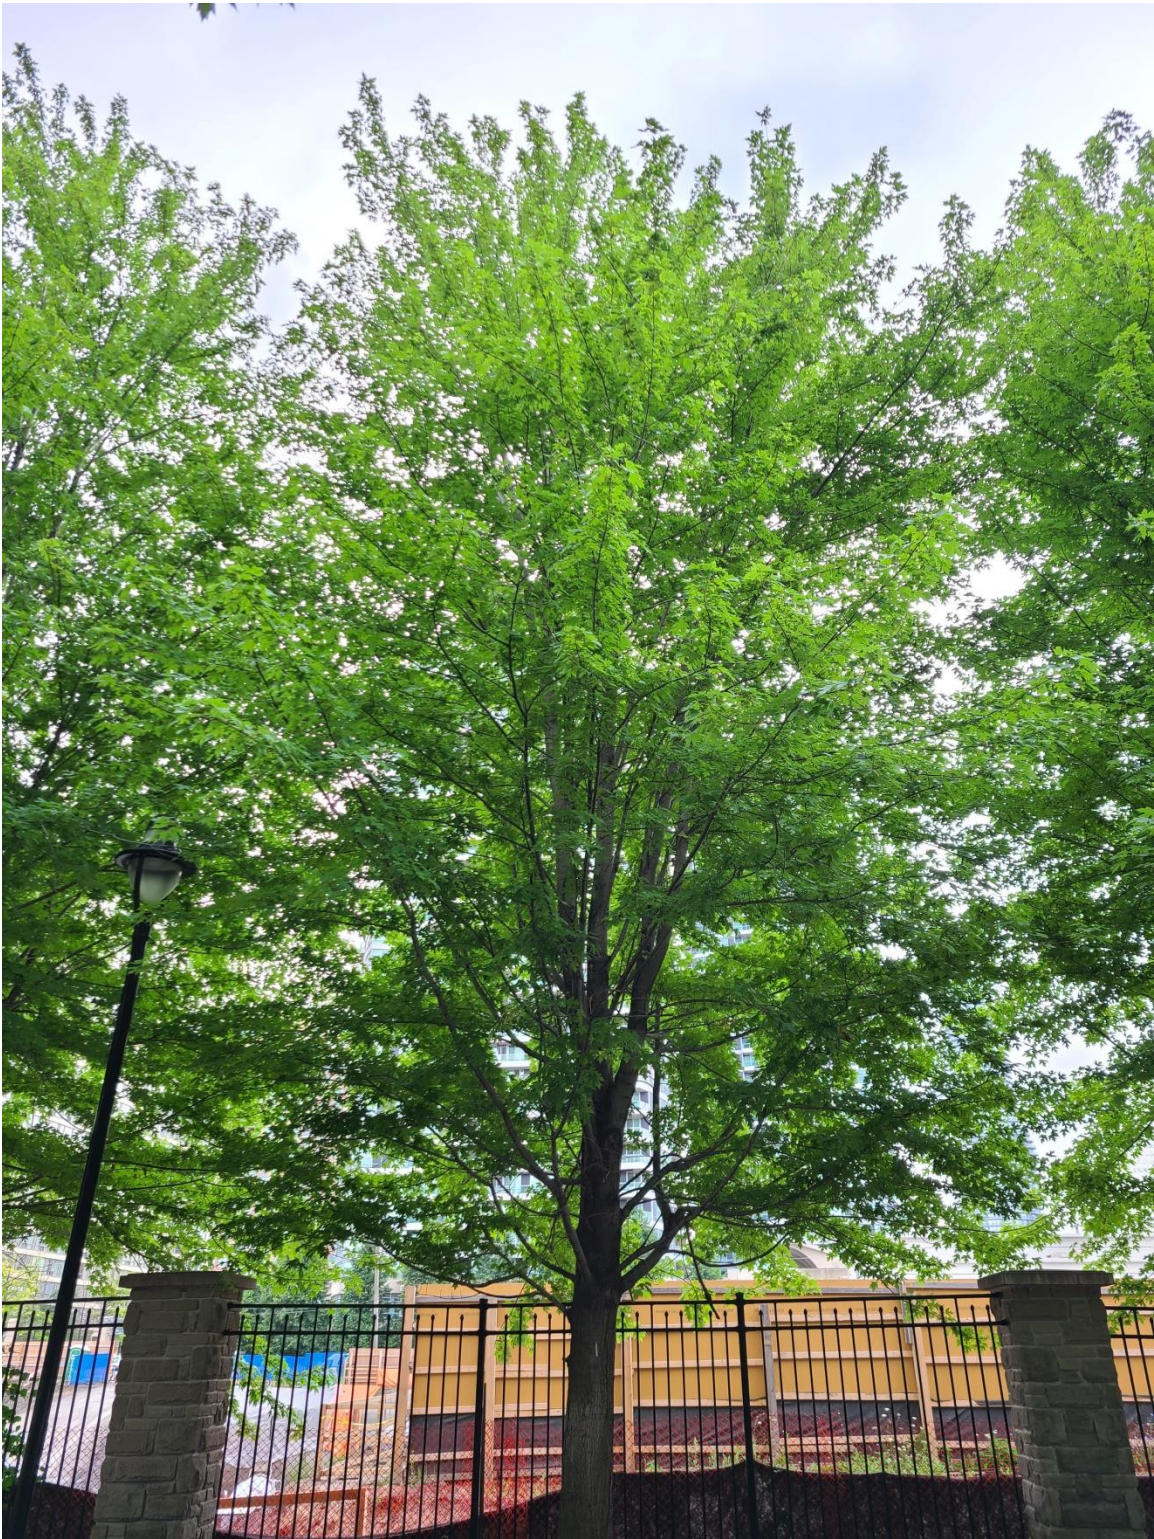
Tag #	Species	DBH (cm)	Condition	Category	Remarks	Rationale & Mitigation
766	Silver Maple <i>Acer saccharinum</i> cv.	28	Very Good	PP	Siltation fence installed along property boundary; excavation within approximately 2.0m of tree; located within planting bed along southern boundary of subject site on adjacent condominium property	A total of approximately 11% of the tree's minimum TPZ will be impacted due to the required excavation along the southern boundary line This tree is in Very Good condition and, if the following recommendations are adhered to, it is not expected for the tree to succumb to the anticipated impacts of the proposed construction: <ul style="list-style-type: none"> <li>- No tree protection fencing will be required to be installed; the existing sedimentation fencing and iron fence shall act as TPZ fencing</li> <li>- Any exposed roots shall be pruned by a qualified arborist</li> <li>- Provide a low-nitrogen fertilizer (i.e. 10-52-10) upon the completion of construction</li> </ul>

Figure 5. Tree #766 located on adjacent private property to the south

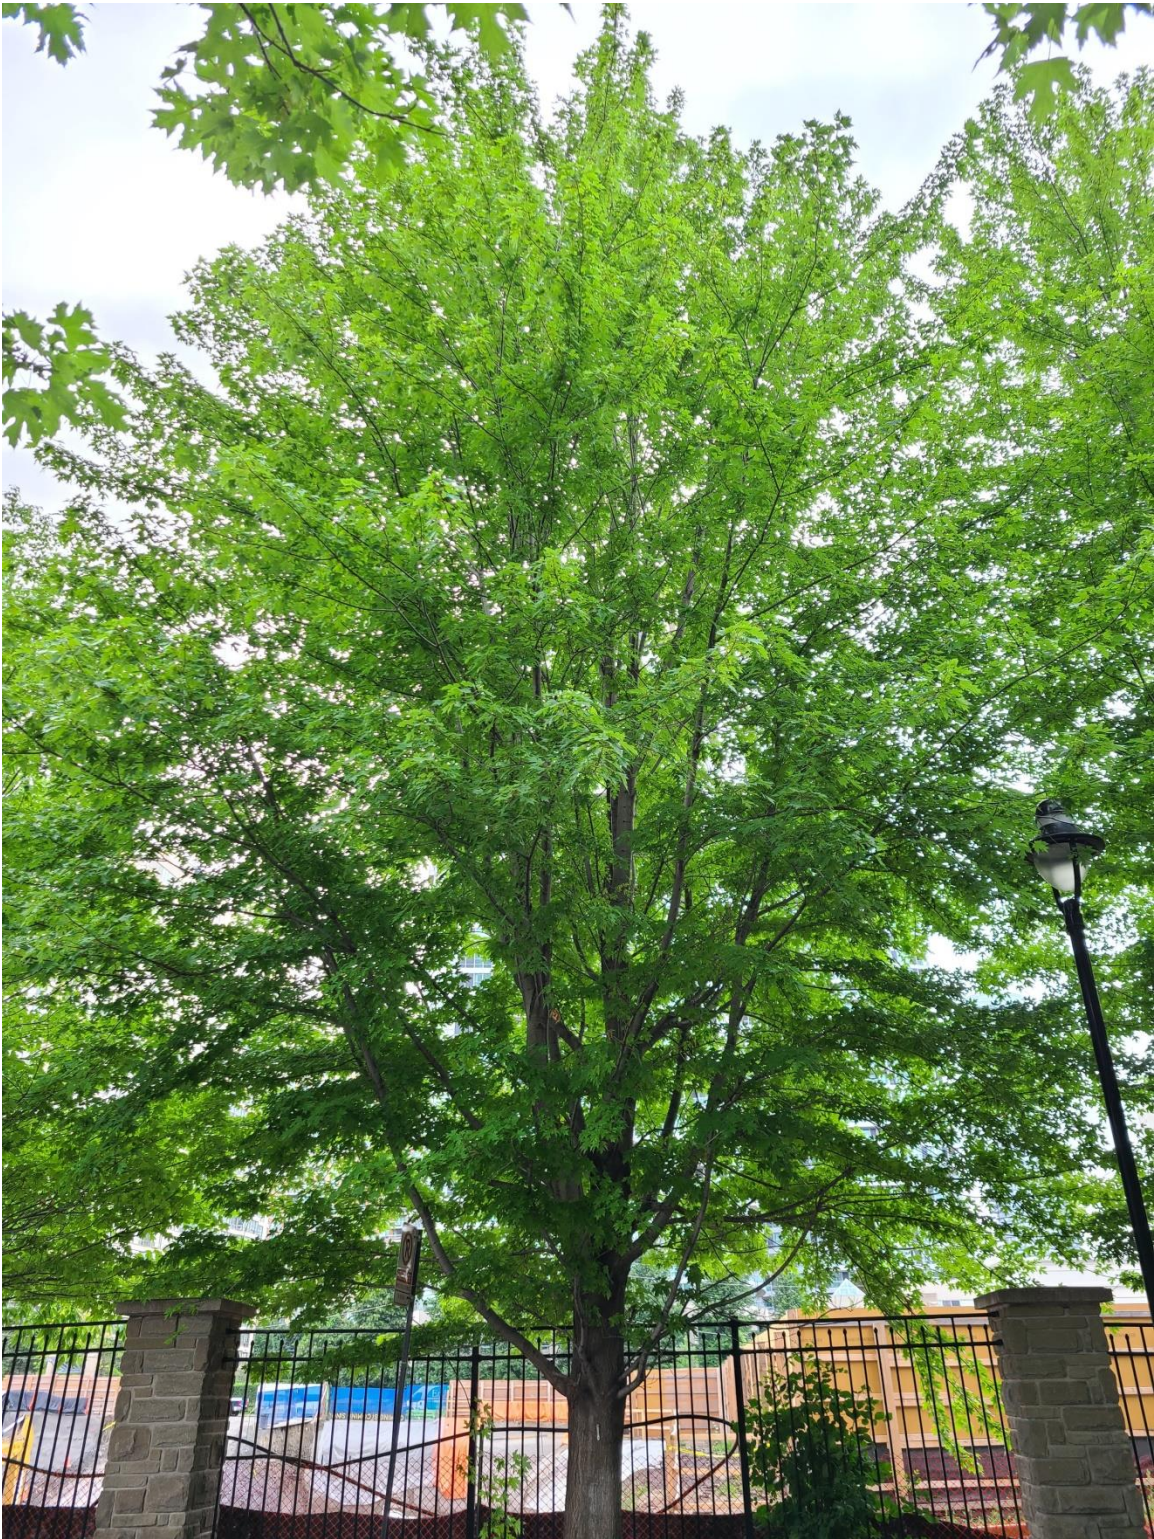
767	Silver Maple <i>Acer saccharinum</i> cv.	32	Very Good	PP	Siltation fence installed along property boundary; excavation within approximately 2.0m of tree; located within planting bed along southern boundary of subject site on adjacent condominium property	A total of approximately 20% of the tree's minimum TPZ will be impacted due to the required excavation along the southern boundary line This tree is in Very Good condition and, if the following recommendations are adhered to, it is not expected for the tree to succumb to the anticipated impacts of the proposed construction: <ul style="list-style-type: none"> <li>- No tree protection fencing will be required to be installed; the existing sedimentation fencing and iron fence shall act as TPZ fencing</li> <li>- Any exposed roots shall be pruned by a qualified arborist</li> <li>- Provide a low-nitrogen fertilizer (i.e. 10-52-10) upon the completion of construction</li> </ul>

Figure 6. Tree #767 located on adjacent private property to the south

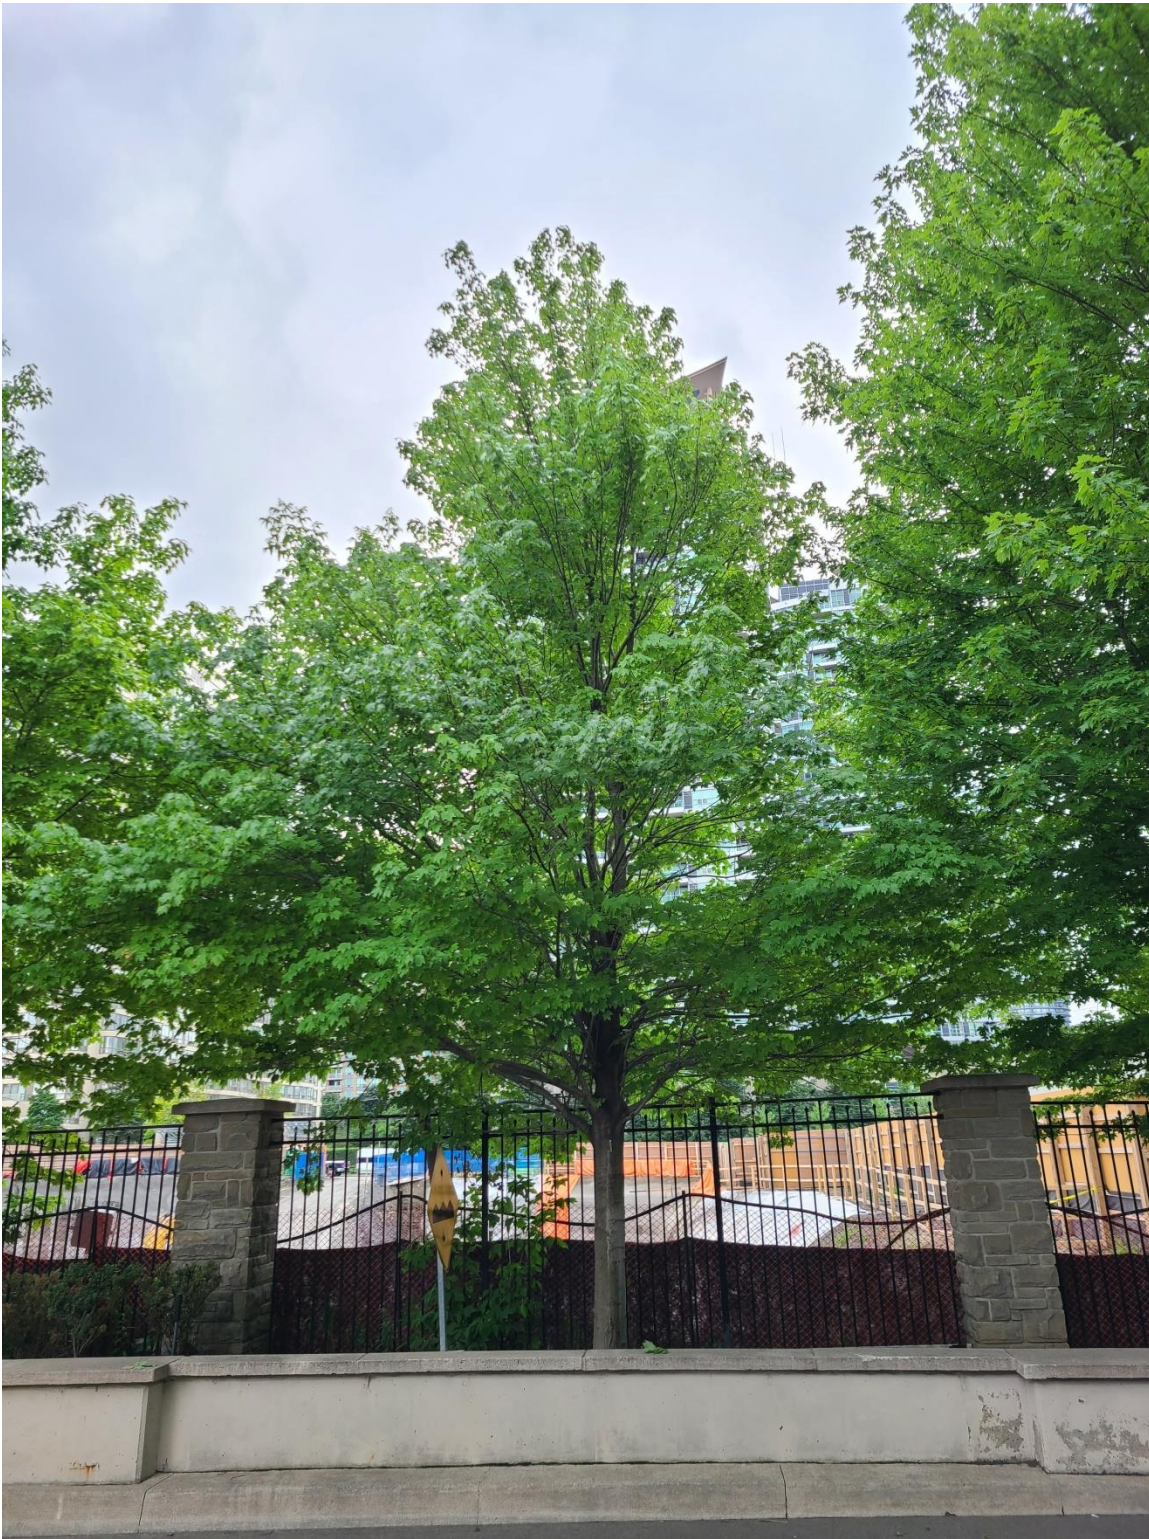
768	Red Maple <i>Acer rubrum</i> cv.	22	Good	PP	Potential girdling root condition on north side of root flare; chlorotic leaves; siltation fence installed along property boundary; excavation within approximately 2.0m of tree; located within planting bed along southern boundary of subject site on adjacent condominium property	A total of approximately 8% of the tree's minimum TPZ will be impacted due to the required excavation along the southern boundary line This tree is in Very Good condition and, if the following recommendations are adhered to, it is not expected for the tree to succumb to the anticipated impacts of the proposed construction: <ul style="list-style-type: none"> <li>- No tree protection fencing will be required to be installed; the existing sedimentation fencing and iron fence shall act as TPZ fencing</li> <li>- Any exposed roots shall be pruned by a qualified arborist</li> <li>- Provide a low-nitrogen fertilizer (i.e. 10-52-10) upon the completion of construction</li> </ul>

768	Red Maple	<i>Acer rubrum</i> cv.	22	1.8	PP	Good	Potential girdling root condition on north side of root flare; chlorotic leaves; siltation fence installed along property boundary; excavation within approximately 2.0m of tree; located within planting bed along southern boundary of subject site on adjacent condominium property	<b>PRESERVE &amp; PROTECT</b> No TPZ fencing required Ensure any exposed roots are pruned back to the soil surface Provide low nitrogen fertilization upon completion of construction.
769	Red Maple	<i>Acer rubrum</i> cv.	23	1.8	PP	Good	Potential girdling root condition on north side of root flare; chlorotic leaves; siltation fence installed along property boundary; excavation within approximately 2.0m of tree; located within planting bed along southern boundary of subject site on adjacent condominium property	<b>PRESERVE &amp; PROTECT</b> No TPZ fencing required Ensure any exposed roots are pruned back to the soil surface Provide low nitrogen fertilization upon completion of construction.

Figure 7. Tree #768 located on adjacent private property to the south

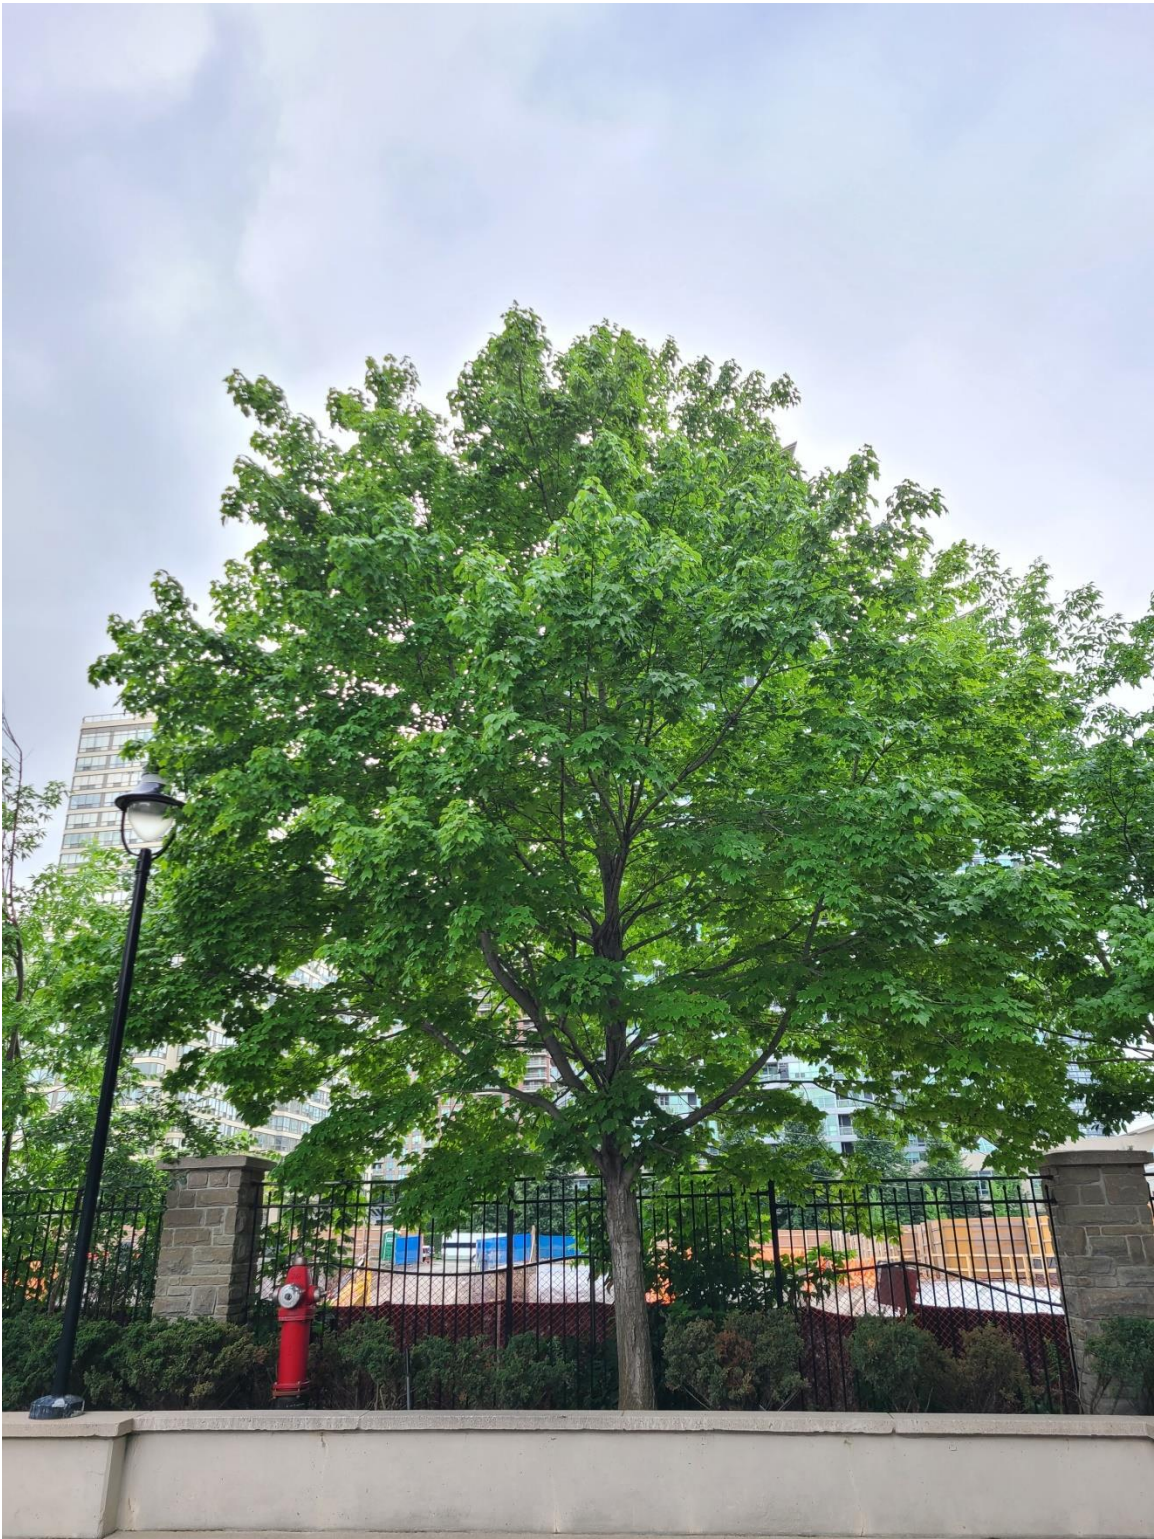
Tag #	Species	DBH (cm)	Condition	Category	Remarks	Rationale & Mitigation
769	Red Maple <i>Acer rubrum</i> cv.	23	Good	PP	Potential girdling root condition on north side of root flare; chlorotic leaves; siltation fence installed along property boundary; excavation within approximately 2.0m of tree; located within planting bed along southern boundary of subject site on adjacent condominium property	<p>A total of approximately 7% of the tree's minimum TPZ will be impacted due to the required excavation along the southern boundary line</p> <p>This tree is in Very Good condition and, if the following recommendations are adhered to, it is not expected for the tree to succumb to the anticipated impacts of the proposed construction:</p> <ul style="list-style-type: none"> <li>- No tree protection fencing will be required to be installed; the existing sedimentation fencing and iron fence shall act as TPZ fencing</li> <li>- Any exposed roots shall be pruned by a qualified arborist</li> <li>- Provide a low-nitrogen fertilizer (i.e. 10-52-10) upon the completion of construction</li> </ul>

Figure 8. Tree #769 located on adjacent private property to the south

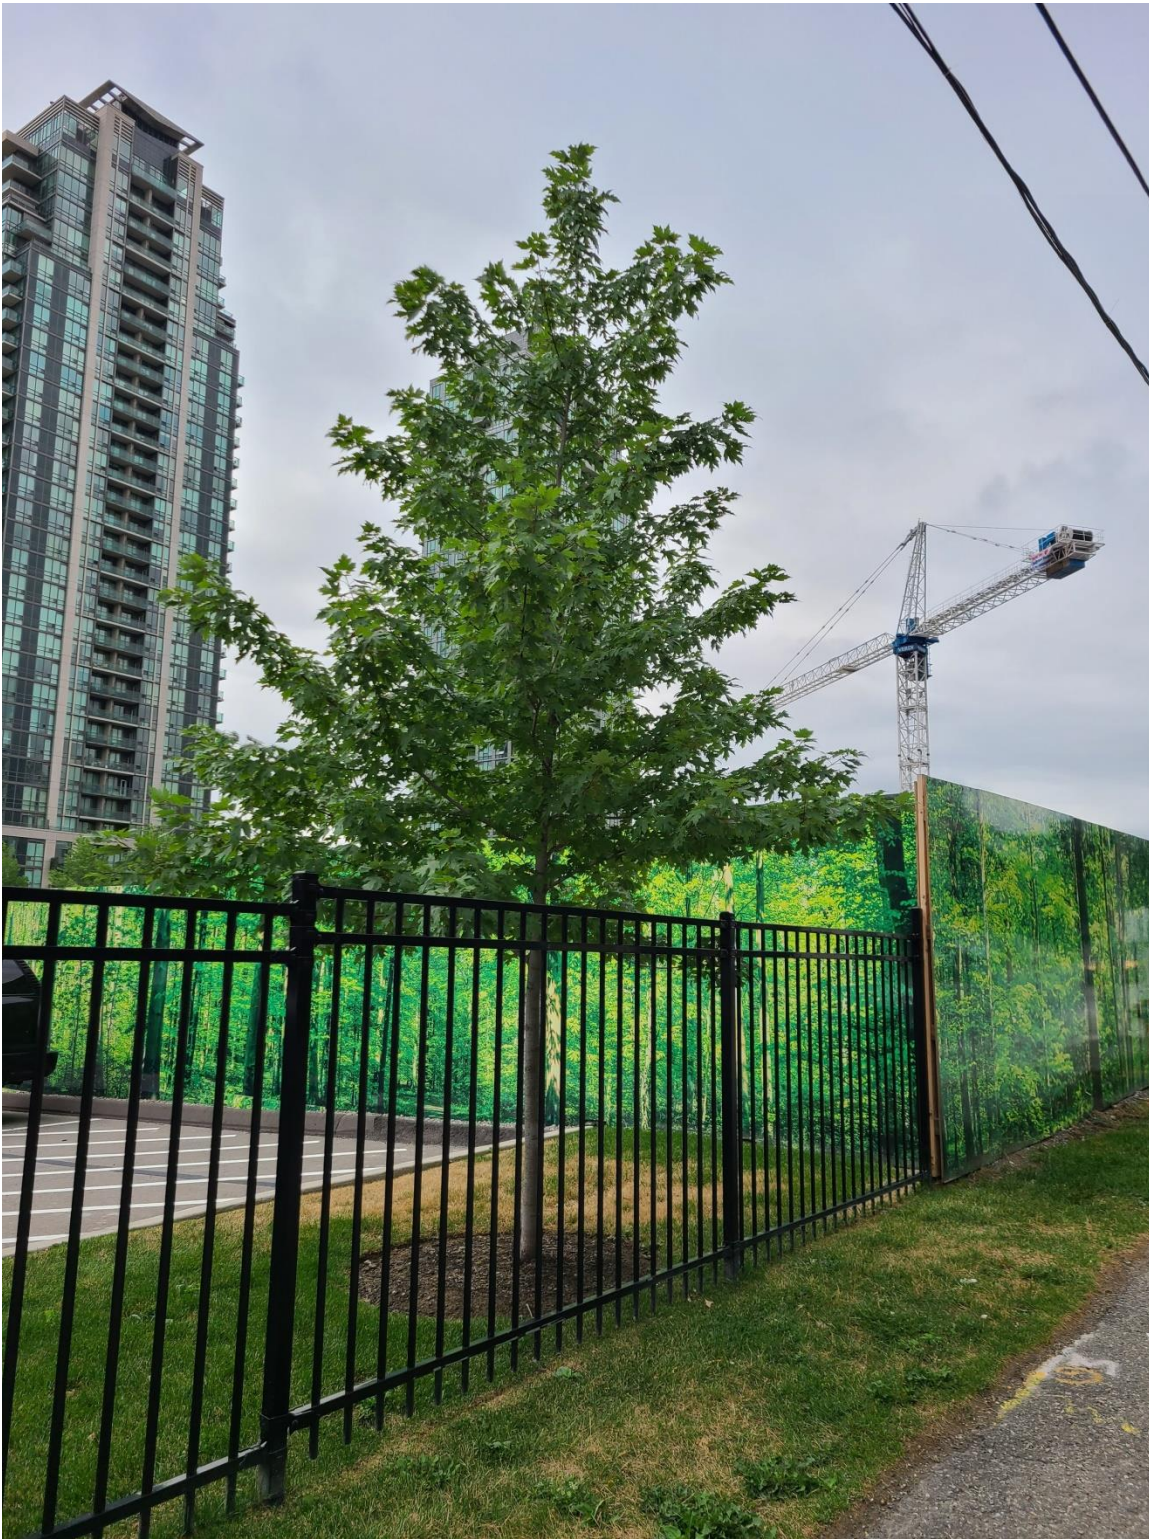
Tag #	Species	DBH (cm)	Condition	Category	Remarks	Rationale
770	Freeman Maple <i>Acer x fremanii</i>	6	Very Good	MT	Recently planted	Tree is located within the proposed sidewalk
771	Freeman Maple <i>Acer x fremanii</i>	7	Very Good	MT	Recently planted	Tree is located within the proposed sidewalk
772	Freeman Maple <i>Acer x fremanii</i>	7	Very Good	MT	Recently planted	Tree is located within the proposed sidewalk
773	Freeman Maple <i>Acer x fremanii</i>	7	Very Good	MT	Recently planted	Tree is located within proposed underground parking
774	Freeman Maple <i>Acer x fremanii</i>	7	Very Good	MT	Recently planted	Tree conflicts with proposed landscape plan
775	Freeman Maple <i>Acer x fremanii</i>	7	Very Good	MT	Recently planted	Tree conflicts with proposed landscape plan
776	Freeman Maple <i>Acer x fremanii</i>	7	Very Good	MT	Recently planted	Tree conflicts with proposed landscape plan

Figure 9. Tree #770 located on adjacent municipal right of way

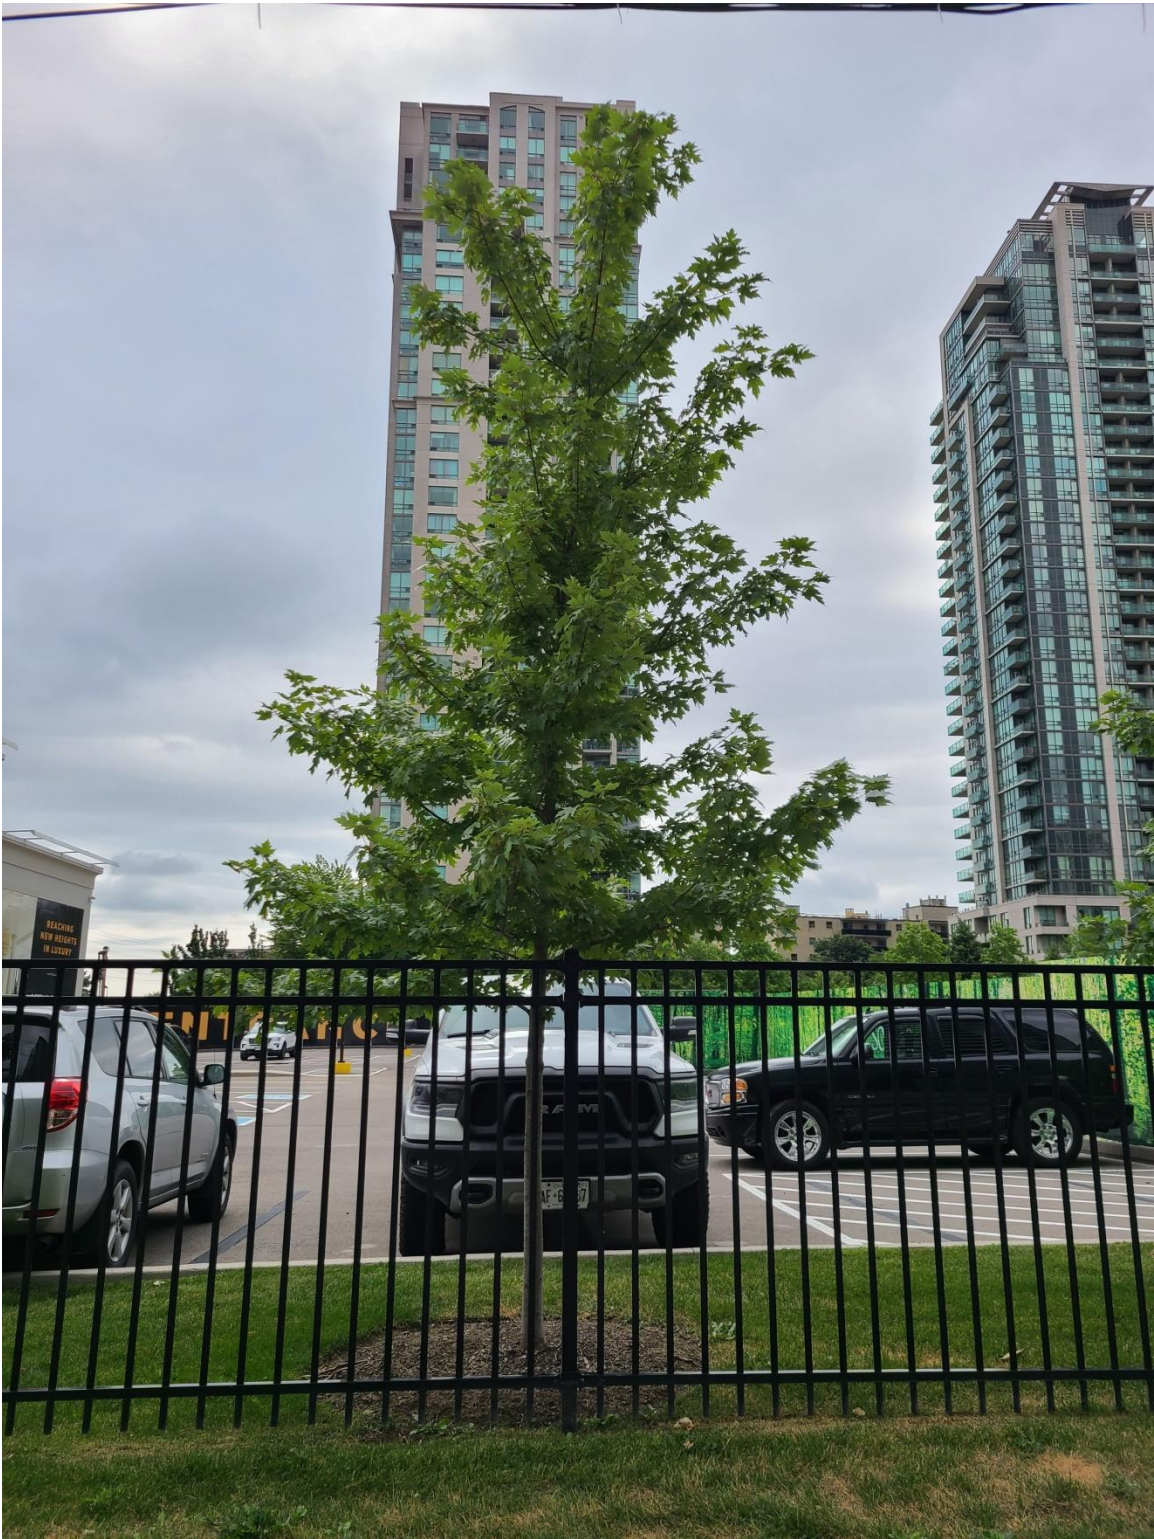
Figure 10. Tree #771 located on adjacent municipal right of way

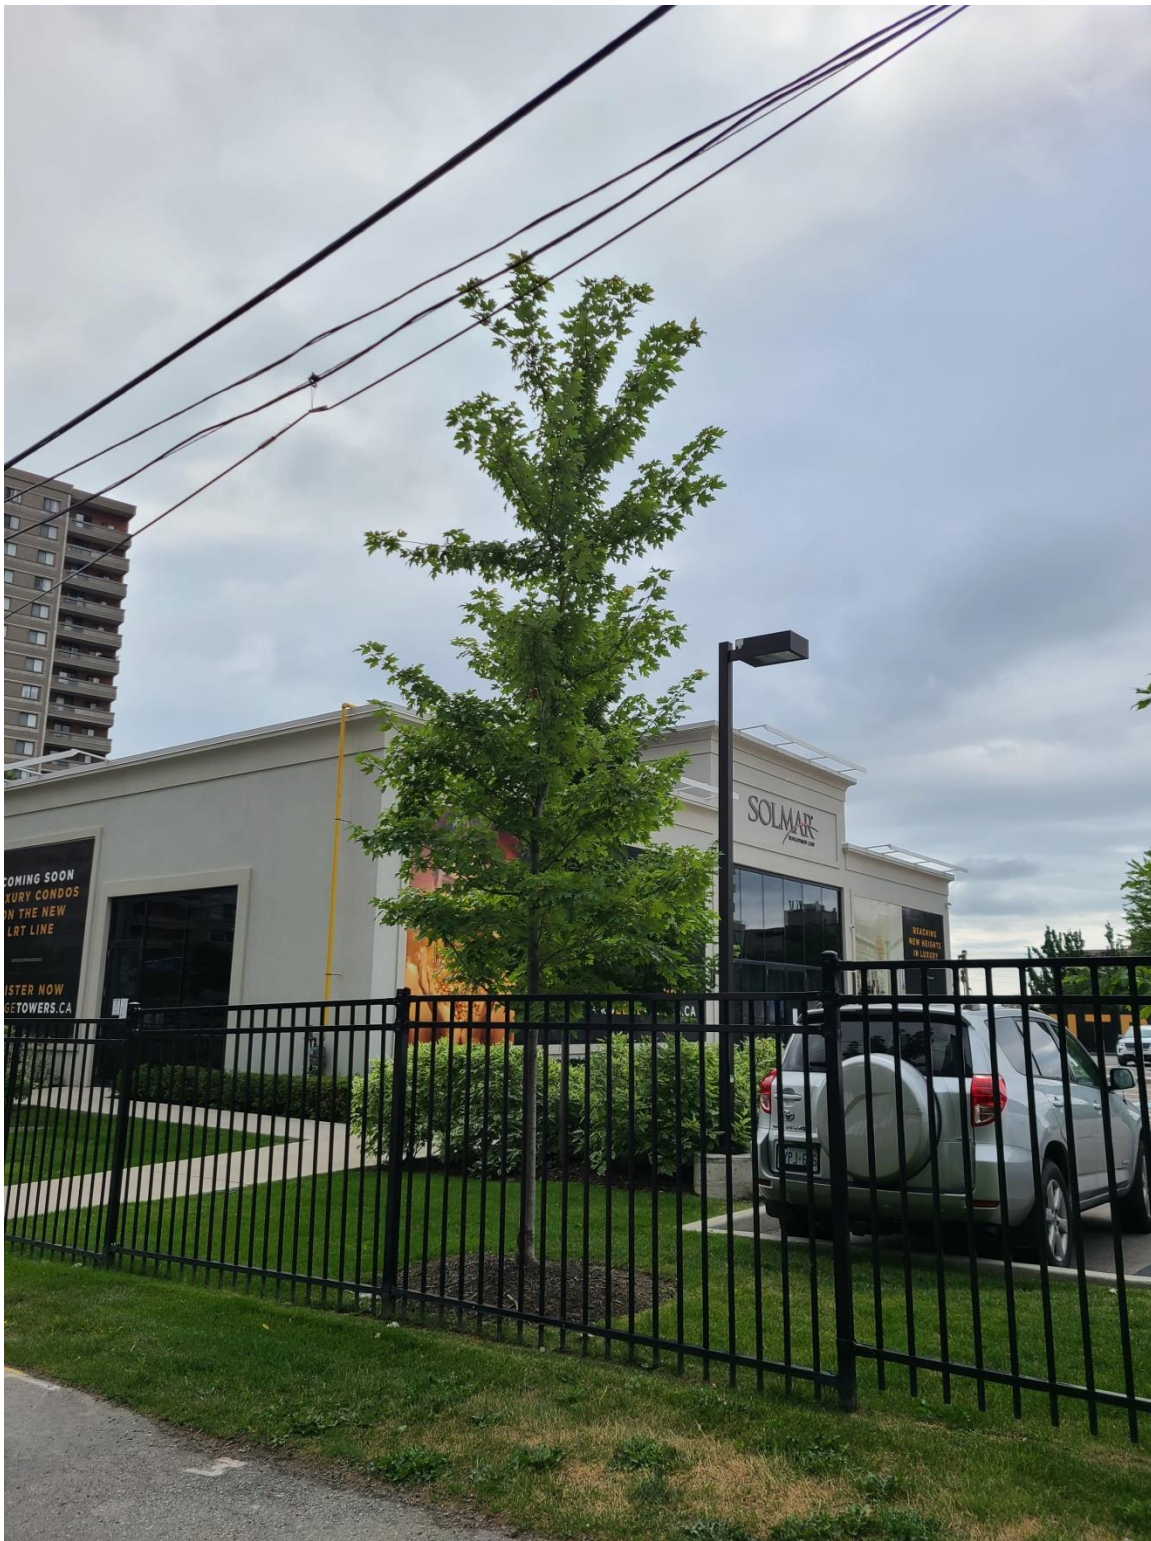
Figure 11. Tree #772 located on adjacent municipal right of way

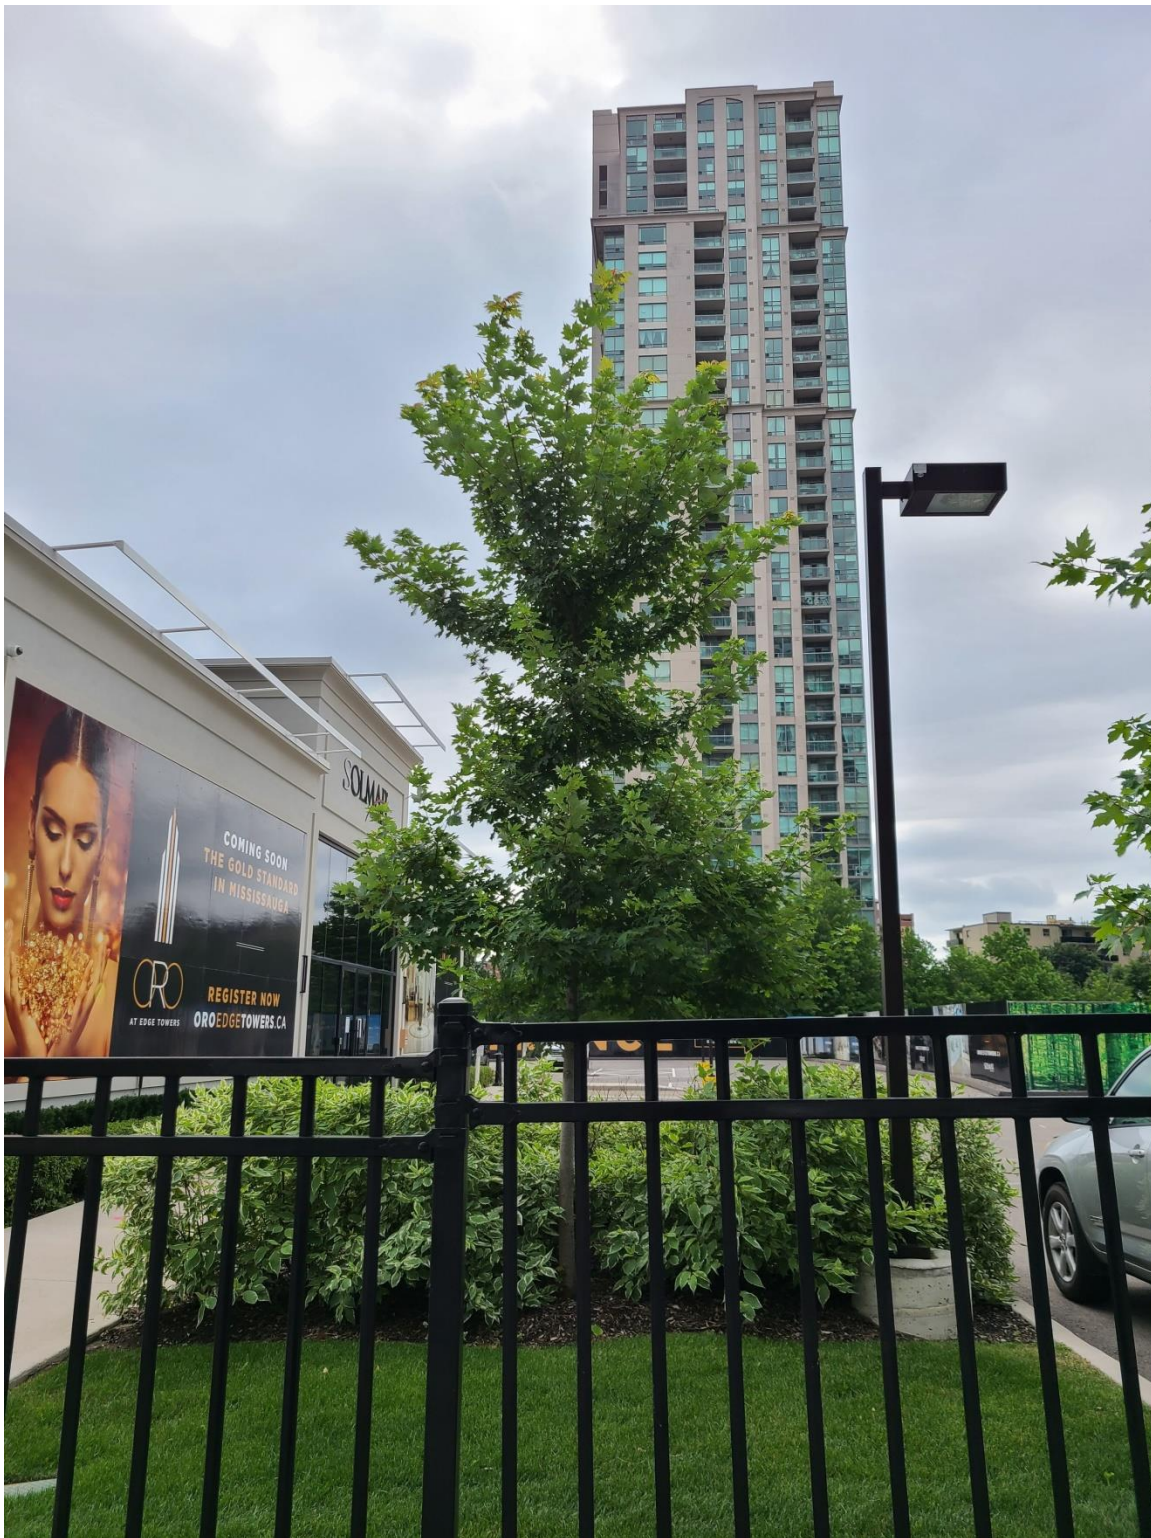
TAG #	COMMON NAME	LATIN BINOMIAL	DBH (cm)	Min. TPZ (m)	Cat.	CONDITION	REMARKS	RECOMMENDATIONS
773	Freeman Maple	<i>Acer x fremanii</i>	7	1.2	SL	Very Good	Newly planted	<b>REMOVE</b> Tree conflicts with proposed underground parking
774	Freeman Maple	<i>Acer x fremanii</i>	7	1.2	SL	Very Good	Newly planted	<b>REMOVE</b> Tree conflicts with proposed landscape plan
775	Freeman Maple	<i>Acer x fremanii</i>	7	1.2	SL	Very Good	Newly planted	<b>REMOVE</b> Tree conflicts with proposed landscape plan
776	Freeman Maple	<i>Acer x fremanii</i>	7	1.2	SL	Very Good	Newly planted	<b>REMOVE</b> Tree conflicts with proposed landscape plan
<b>Tree A</b>	Silver Maple	<i>Acer saccharinum</i> cv.	10	1.8	PP	Very Good	Siltation fence installed along property boundary; excavation within approximately 2.0m of tree; located within planting bed along southern boundary of subject site on adjacent condominium property	<b>PRESERVE &amp; PROTECT</b> No TPZ fencing required Ensure any exposed roots are pruned back to the soil surface Provide low nitrogen fertilization upon completion of construction

Figure 12. Tree #773 located on adjacent municipal right of way
