# Arborist Report & Tree Preservation Plan

## 16 Elm Drive West, Mississauga

*DATE: AUGUST 4, 2020*

*FILE #: TA-20-028*

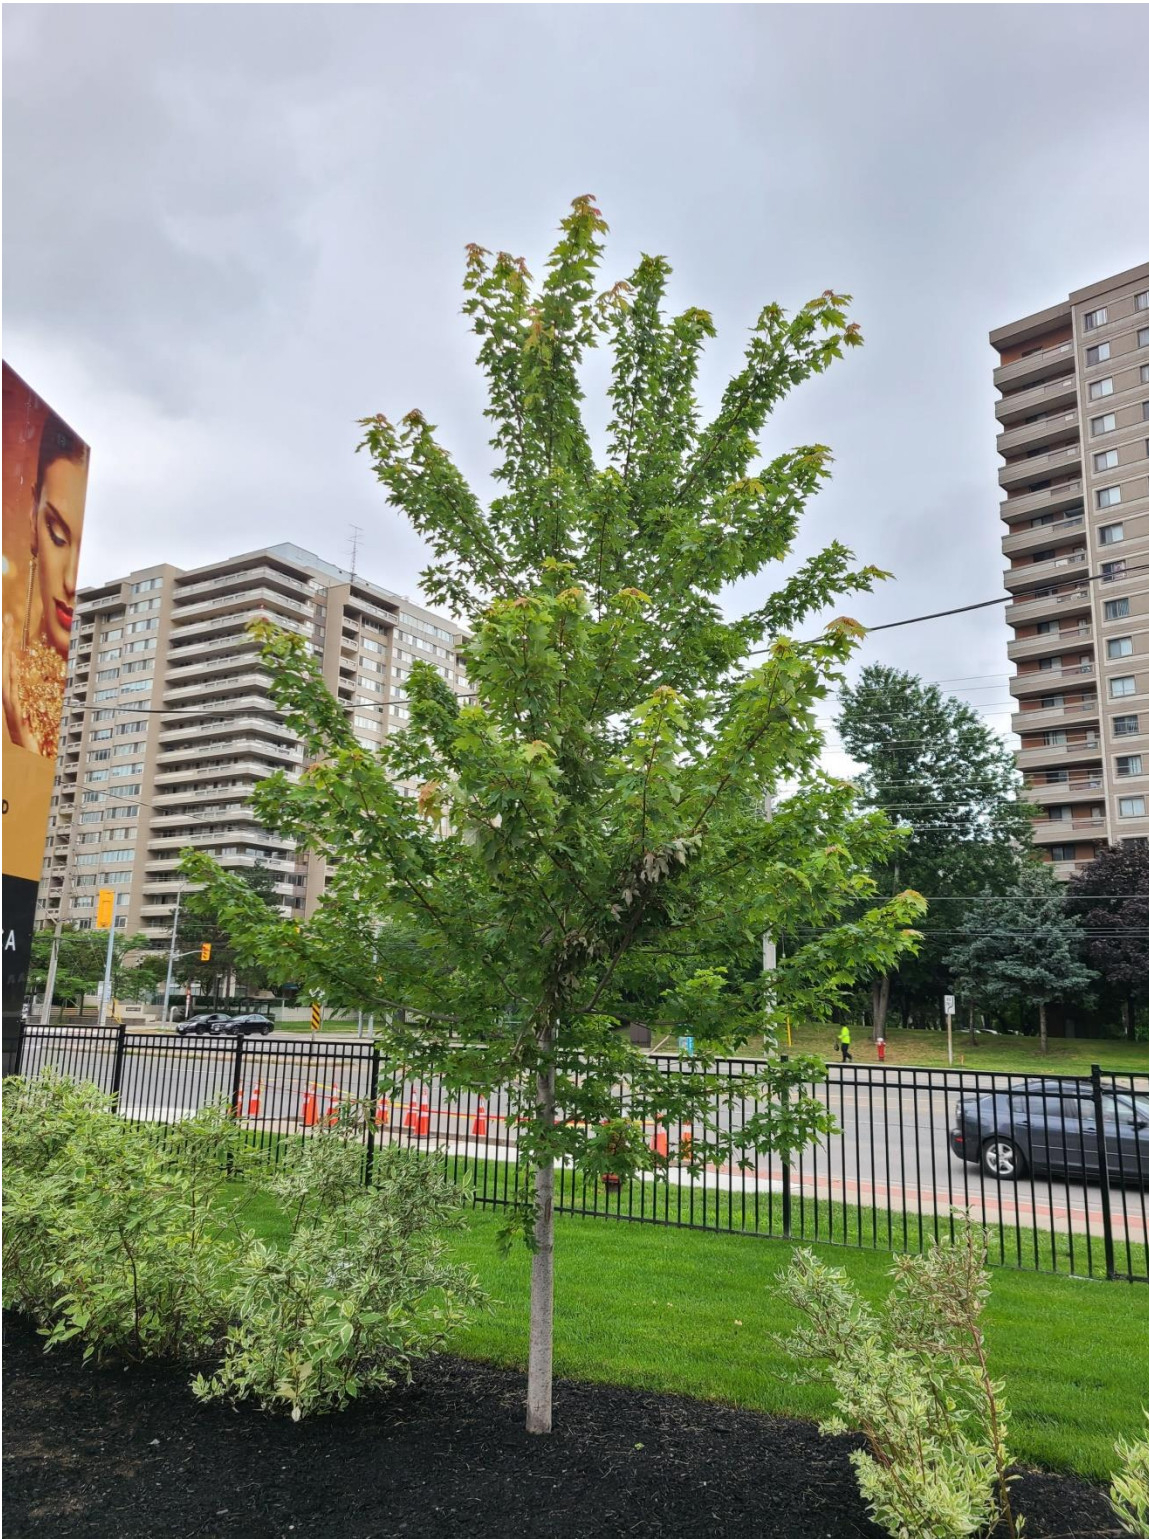
Figure 13. Tree #774 located on adjacent municipal right of way

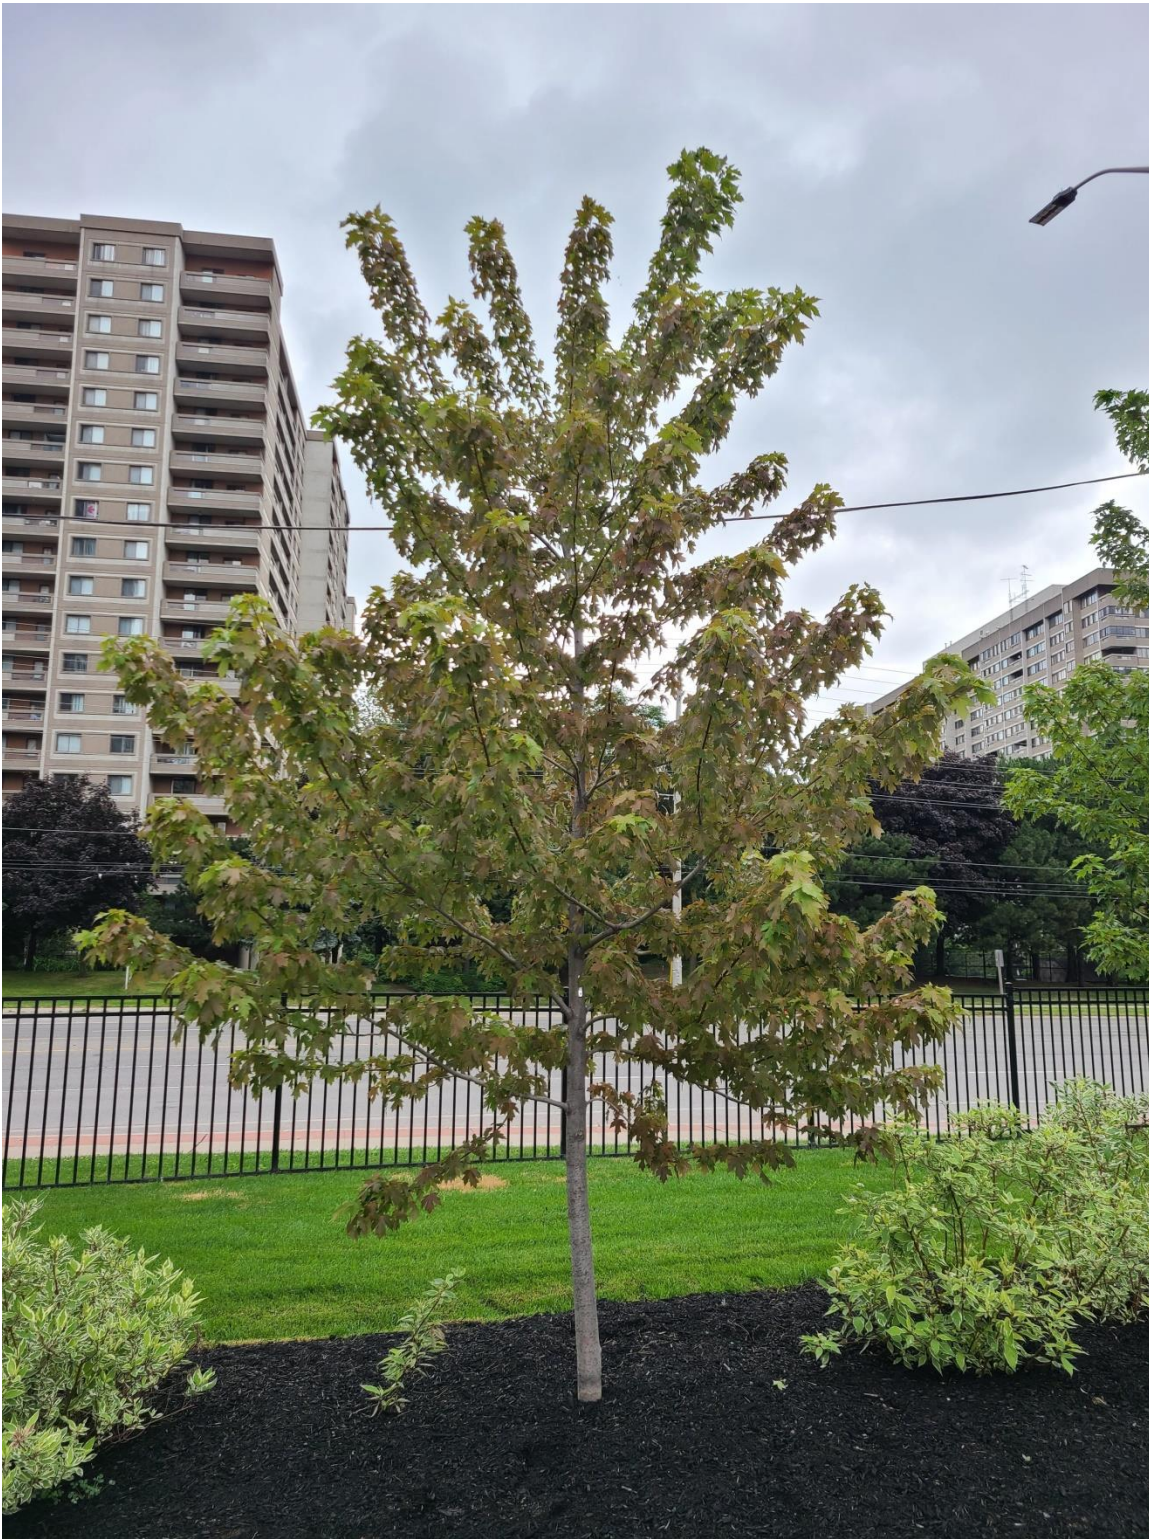
Figure 14. Tree #775 located on adjacent municipal right of way

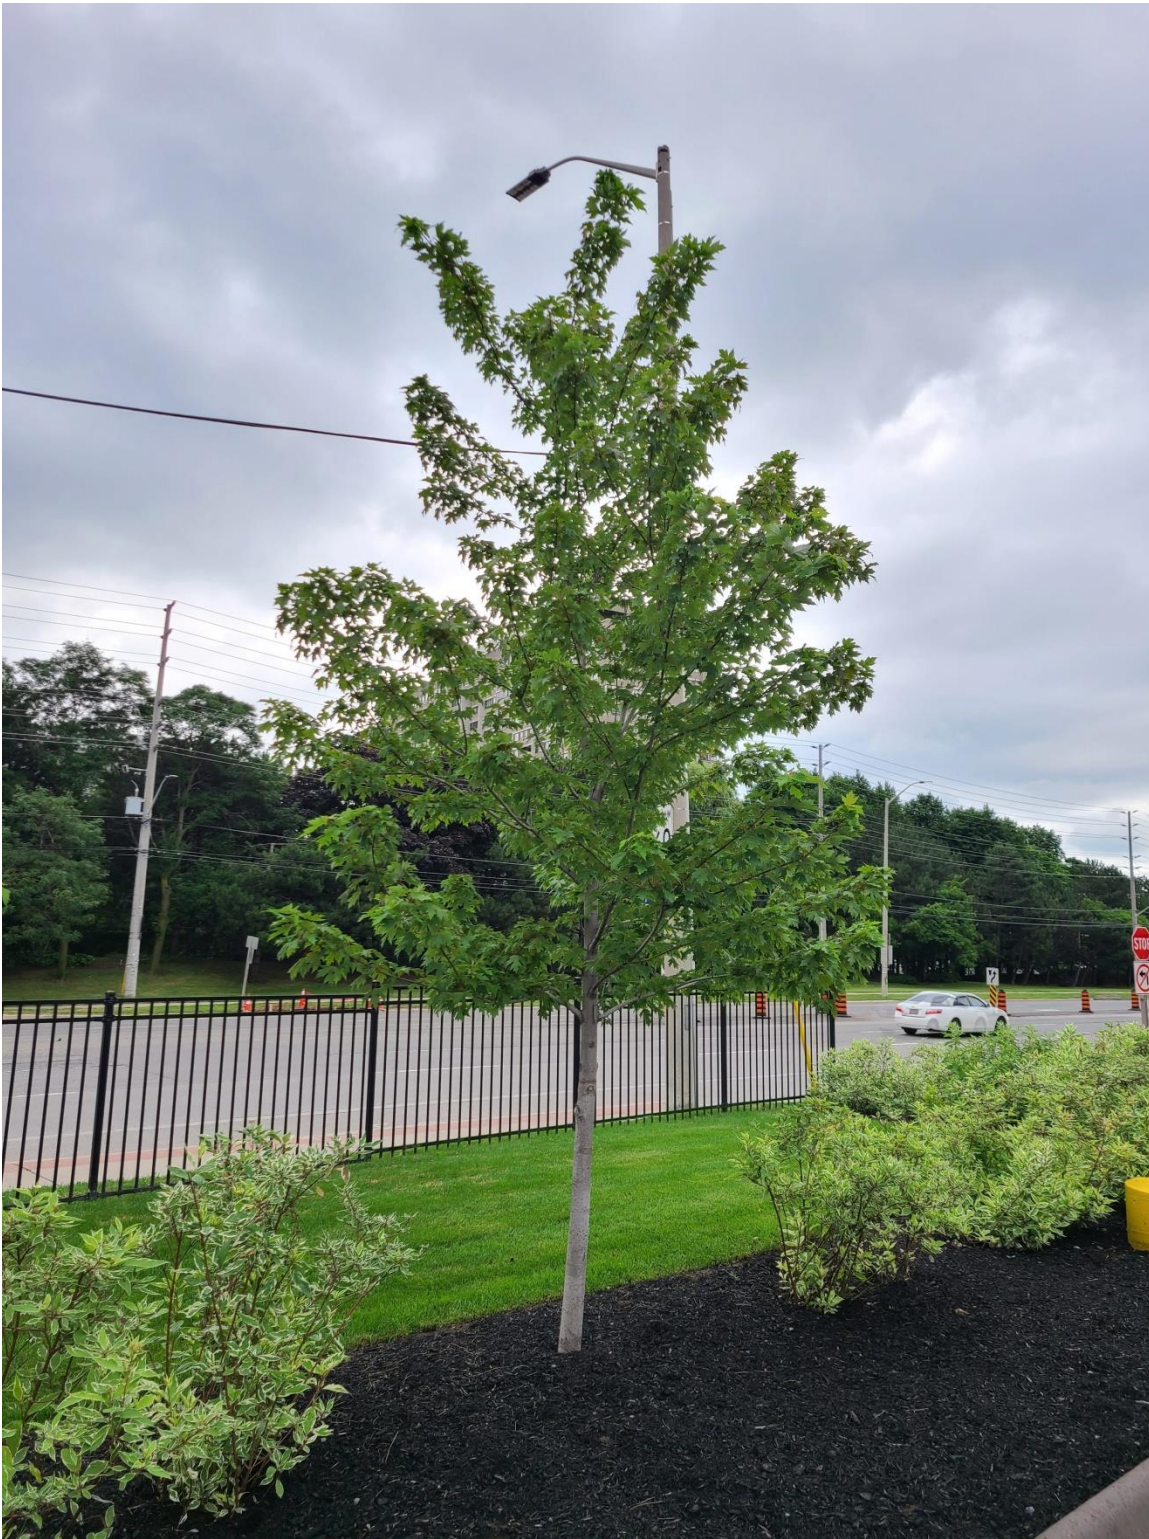
Figure 15. Tree #776 located on adjacent municipal right of way
