Arborist Report and Tree Protection Plan for 1750 Bloor Street and 3315 Fieldgate Drive (Mississauga, Ontario)

Prepared for: Forred Ltd.

October 31, 2017

Revised: April 18, 2018

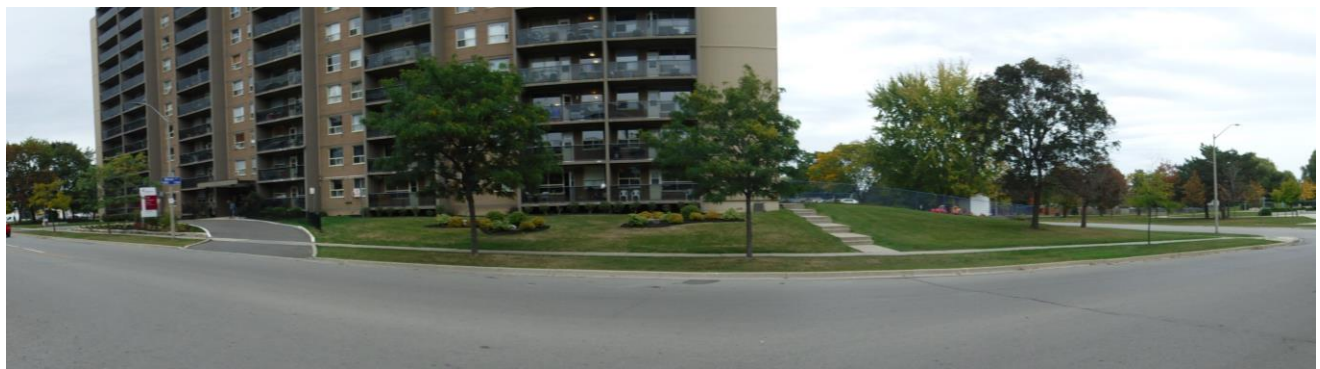
Figure 1: Northeast-facing panorama of 3315 Fieldgate Drive from the west side of the street. Honey locust trees have been planted along the boulevard in this area.

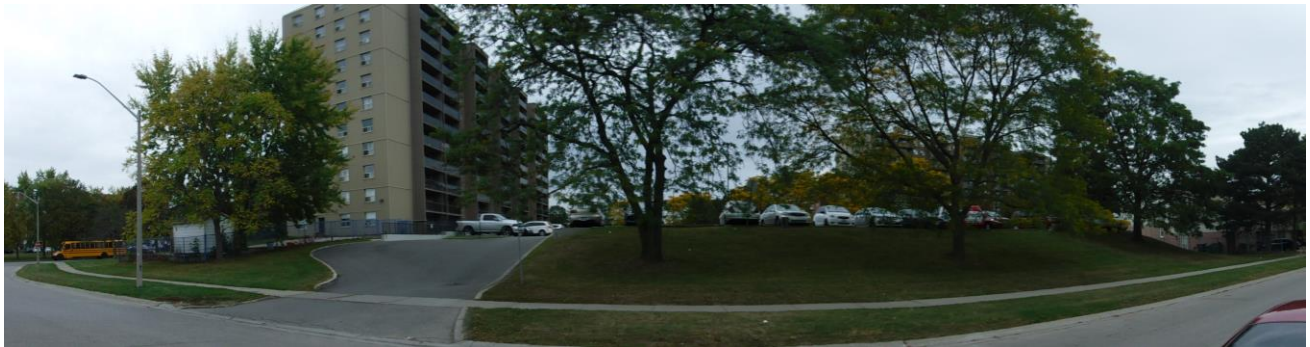
Figure 2: North-facing panorama of the southern property boundary from Kirkwall Crescent. Mature honey locusts, with a large Kentucky coffee-tree and silver maple are present in this area.

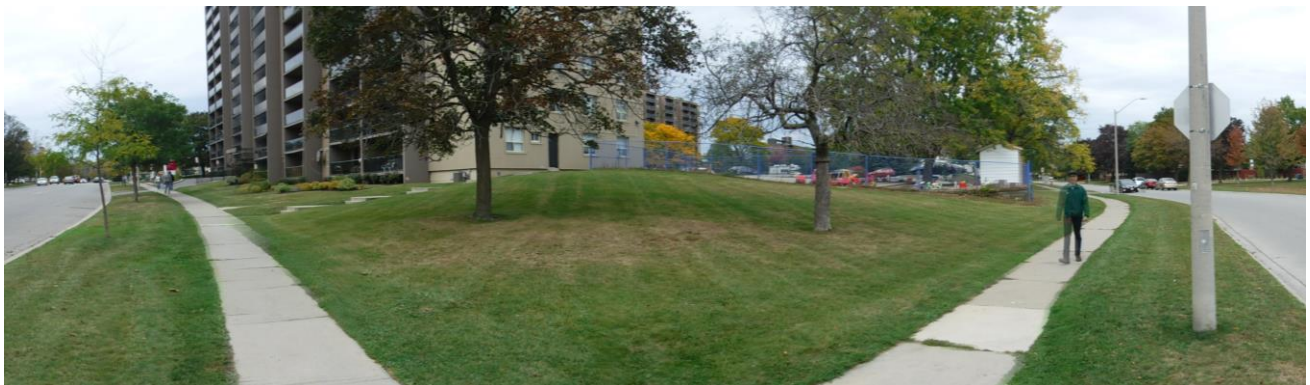
Figure 3: Northeast-facing panorama of the properties from the corner of Kirkwall Crescent and Fieldgate Drive. Scattered trees are surrounded by grass lawn in this area on the subject property and boulevard.

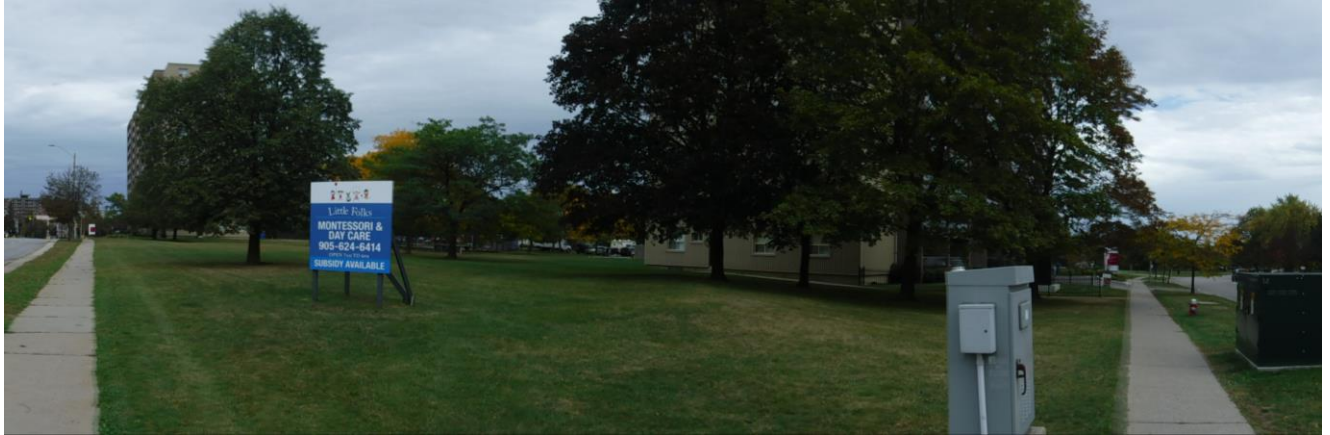
Figure 4: Southeast-facing panorama of the properties from the corner of Fieldgate Drive and Bloor Street. A grove of four Norway maples and one little-leaved linden is present in this area.

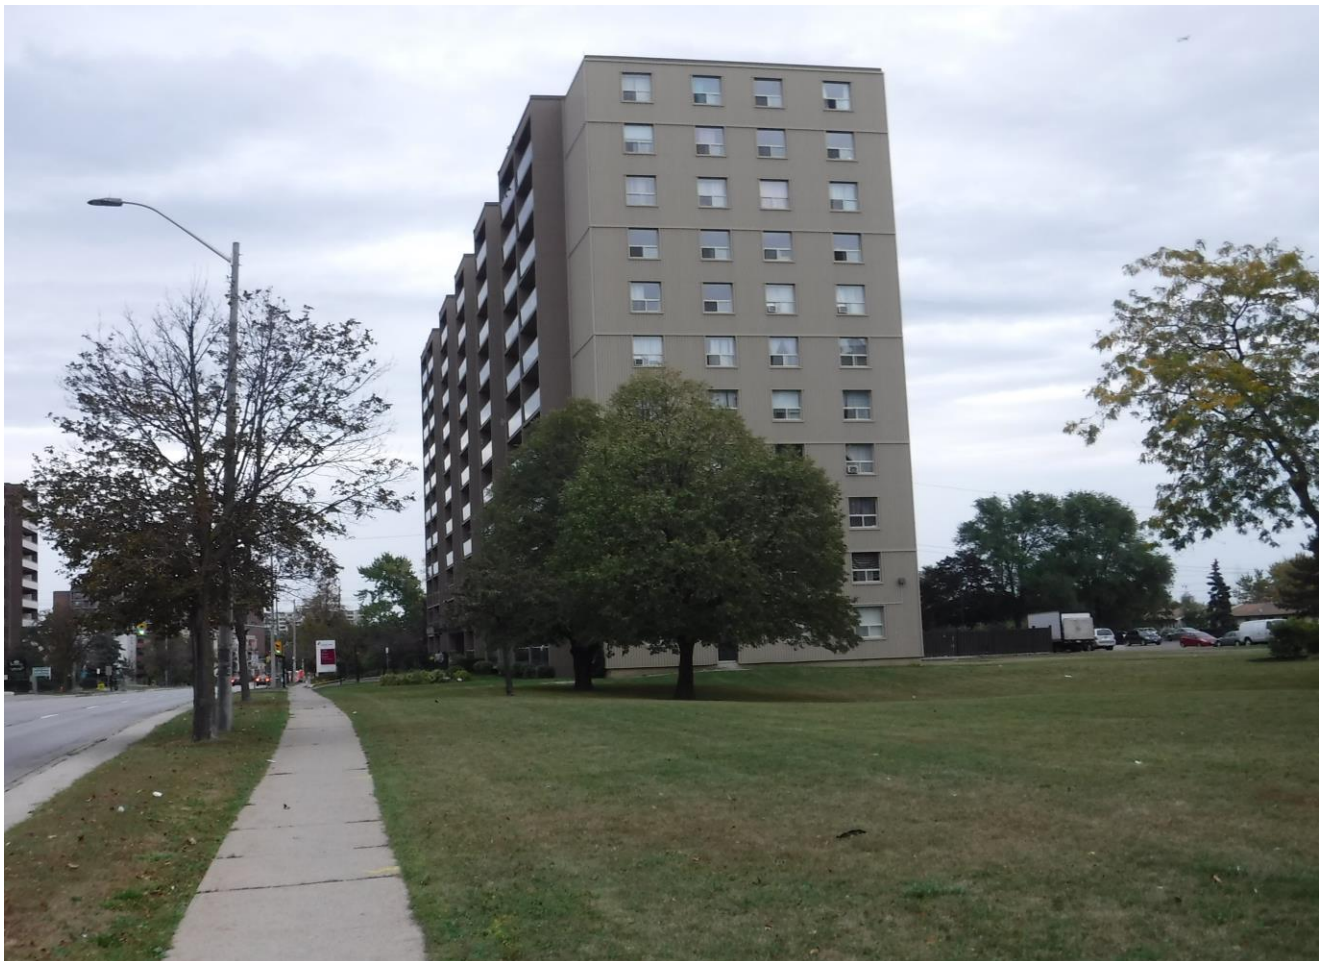
Figure 5: East-facing view of the northeast corner of the property and the existing apartment at 1750 Bloor Street. Two Norway maples in poor condition are present along the boulevard, while little-leaved linden and honey locust trees are present further south.

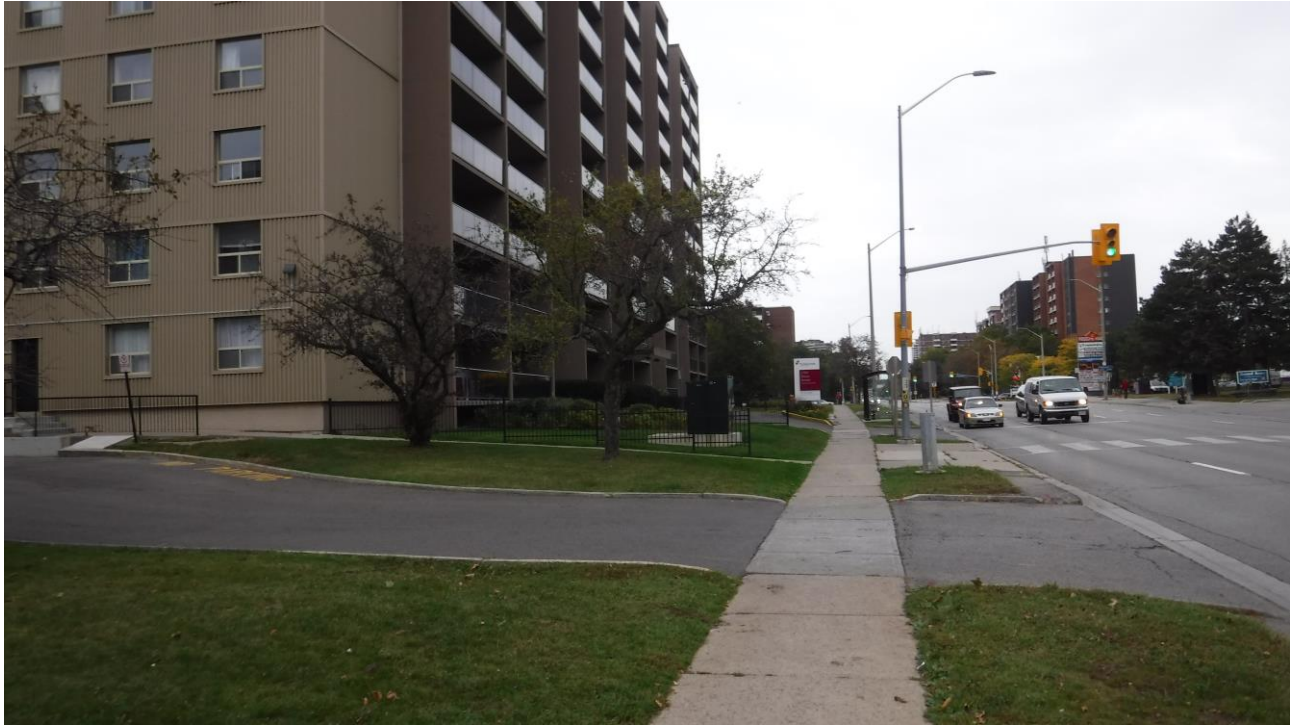
Figure 6: West-facing view of the northeast corner of the property and the front of 1750 Bloor Street from the northeast property corner. Small crabapple trees are present west of the entrance.

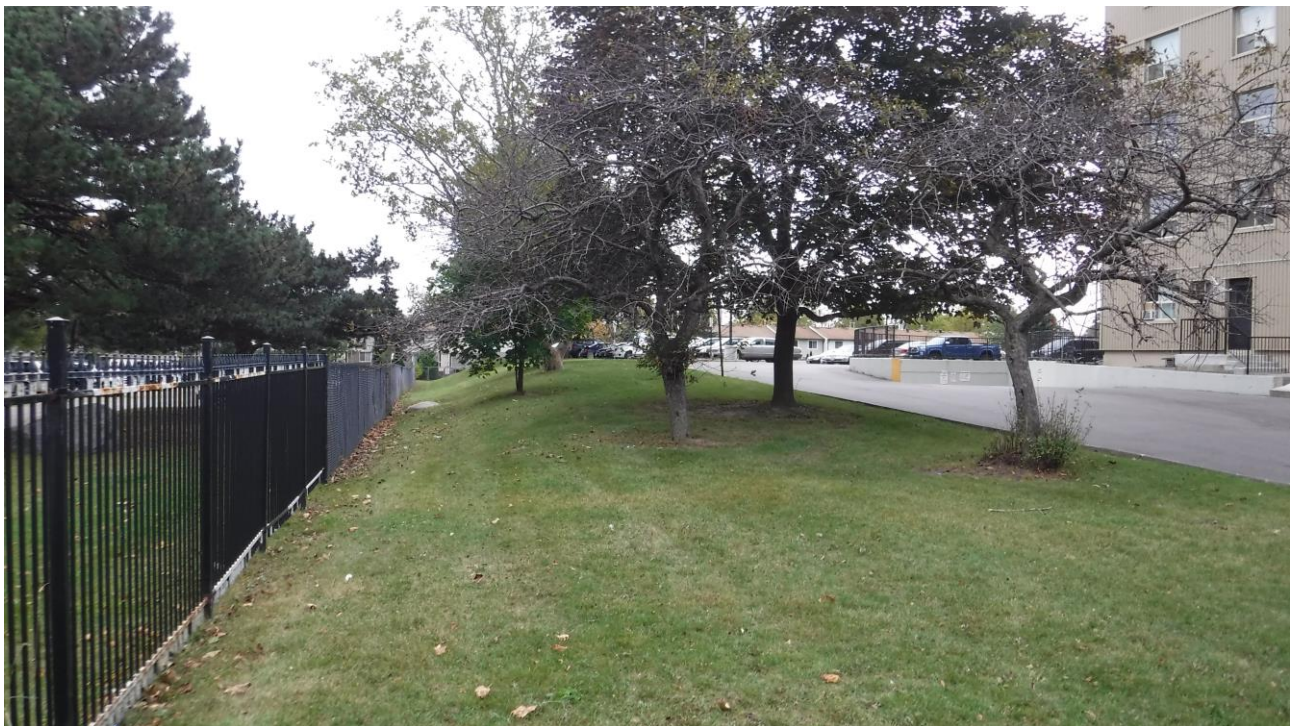
Figure 7: South-facing view of the north side of the east property line from the northeast corner, east of the site entrance. Trees in this area include crabapple, Norway maple, and London plane.

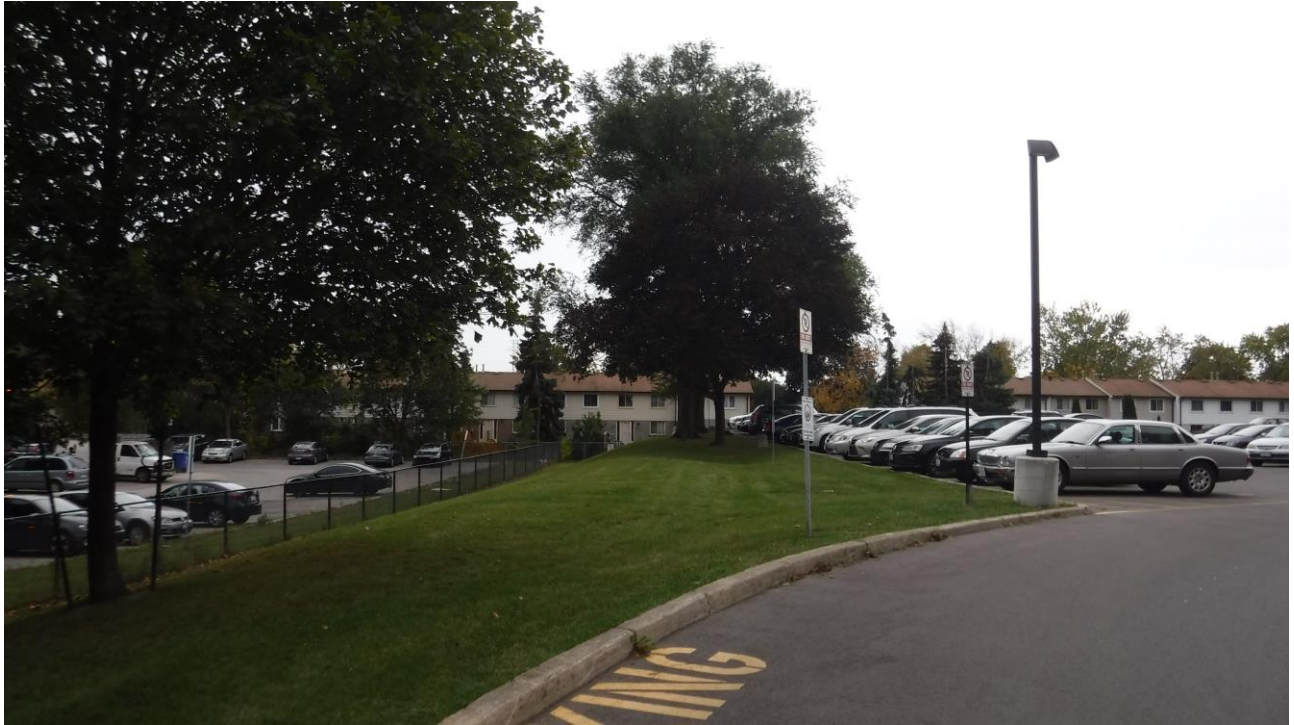
Figure 8: South-facing view of the southern end of the east property line. Two large Siberian elms and one Norway maple are present east of the east parking lot.

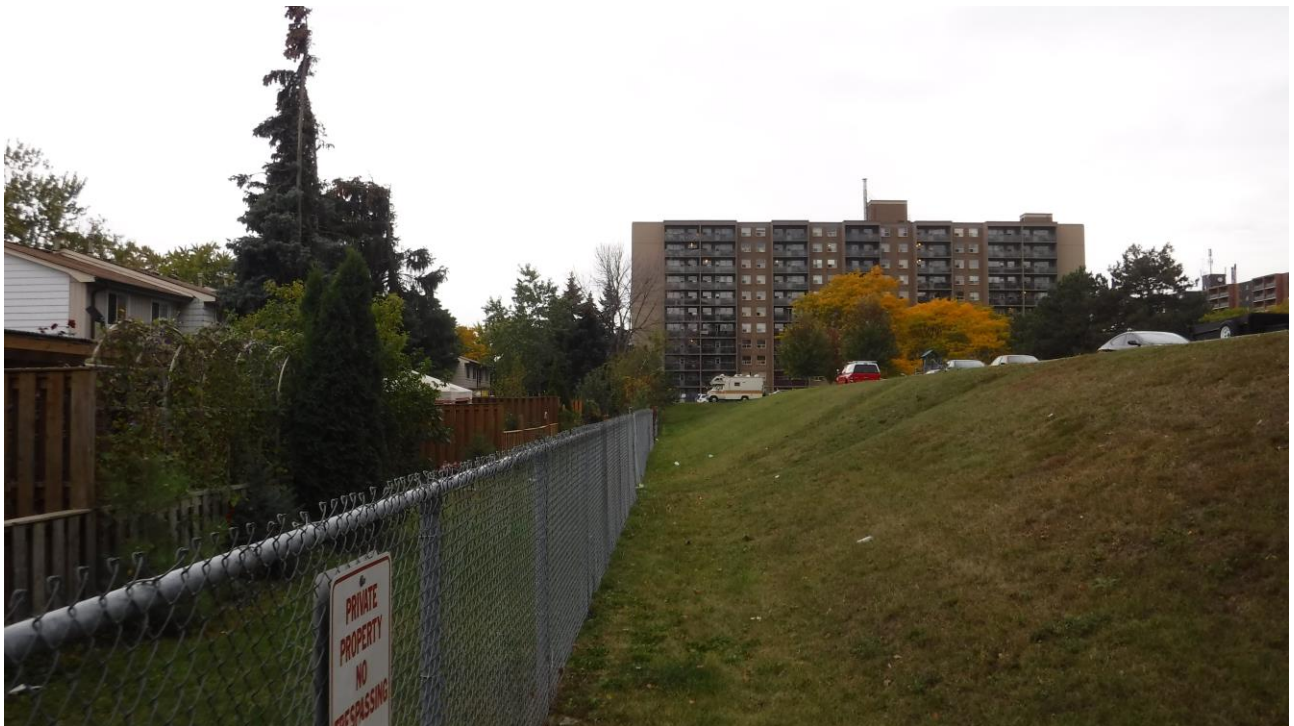
Figure 9: West-facing view of the south property line, south of the east parking lot. No trees are present in this area, with a variety of spruces (mostly blue and Colorado) and saplings on neighbouring properties.

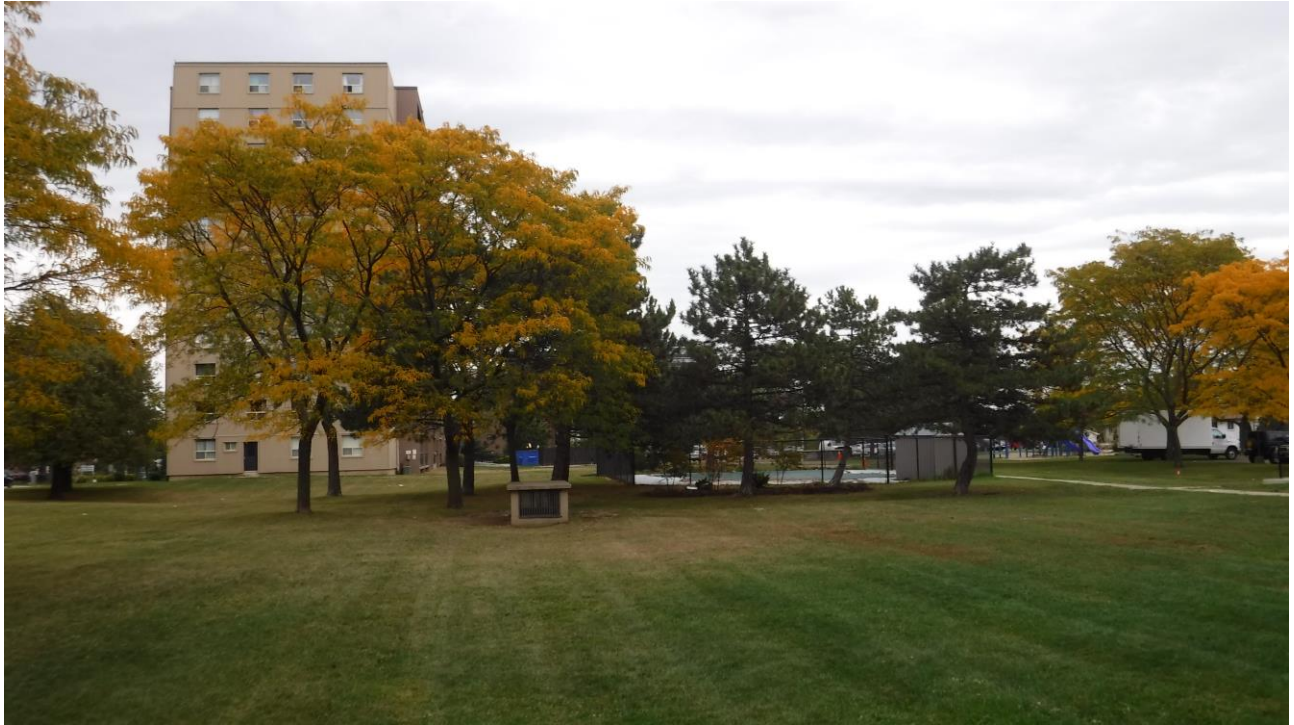
Figure 10: East-facing view of the existing pool from the east side of 3315 Fieldgate Drive, which is surrounded by Austrian pine and honey locust trees with beds of serviceberry shrubs.

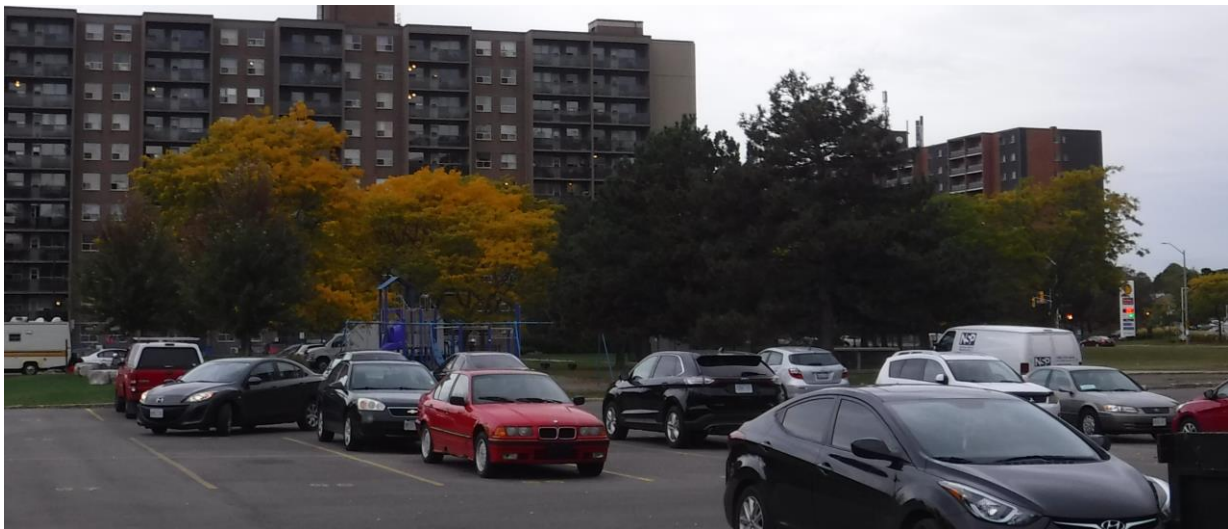
Figure 11: West-facing view of the west parking lot and playground from the east parking lot. Honey locusts surround the west parking lot at 3315 Fieldgate Drive, while Austrian pines and freeman maples surround a playground between the lots.

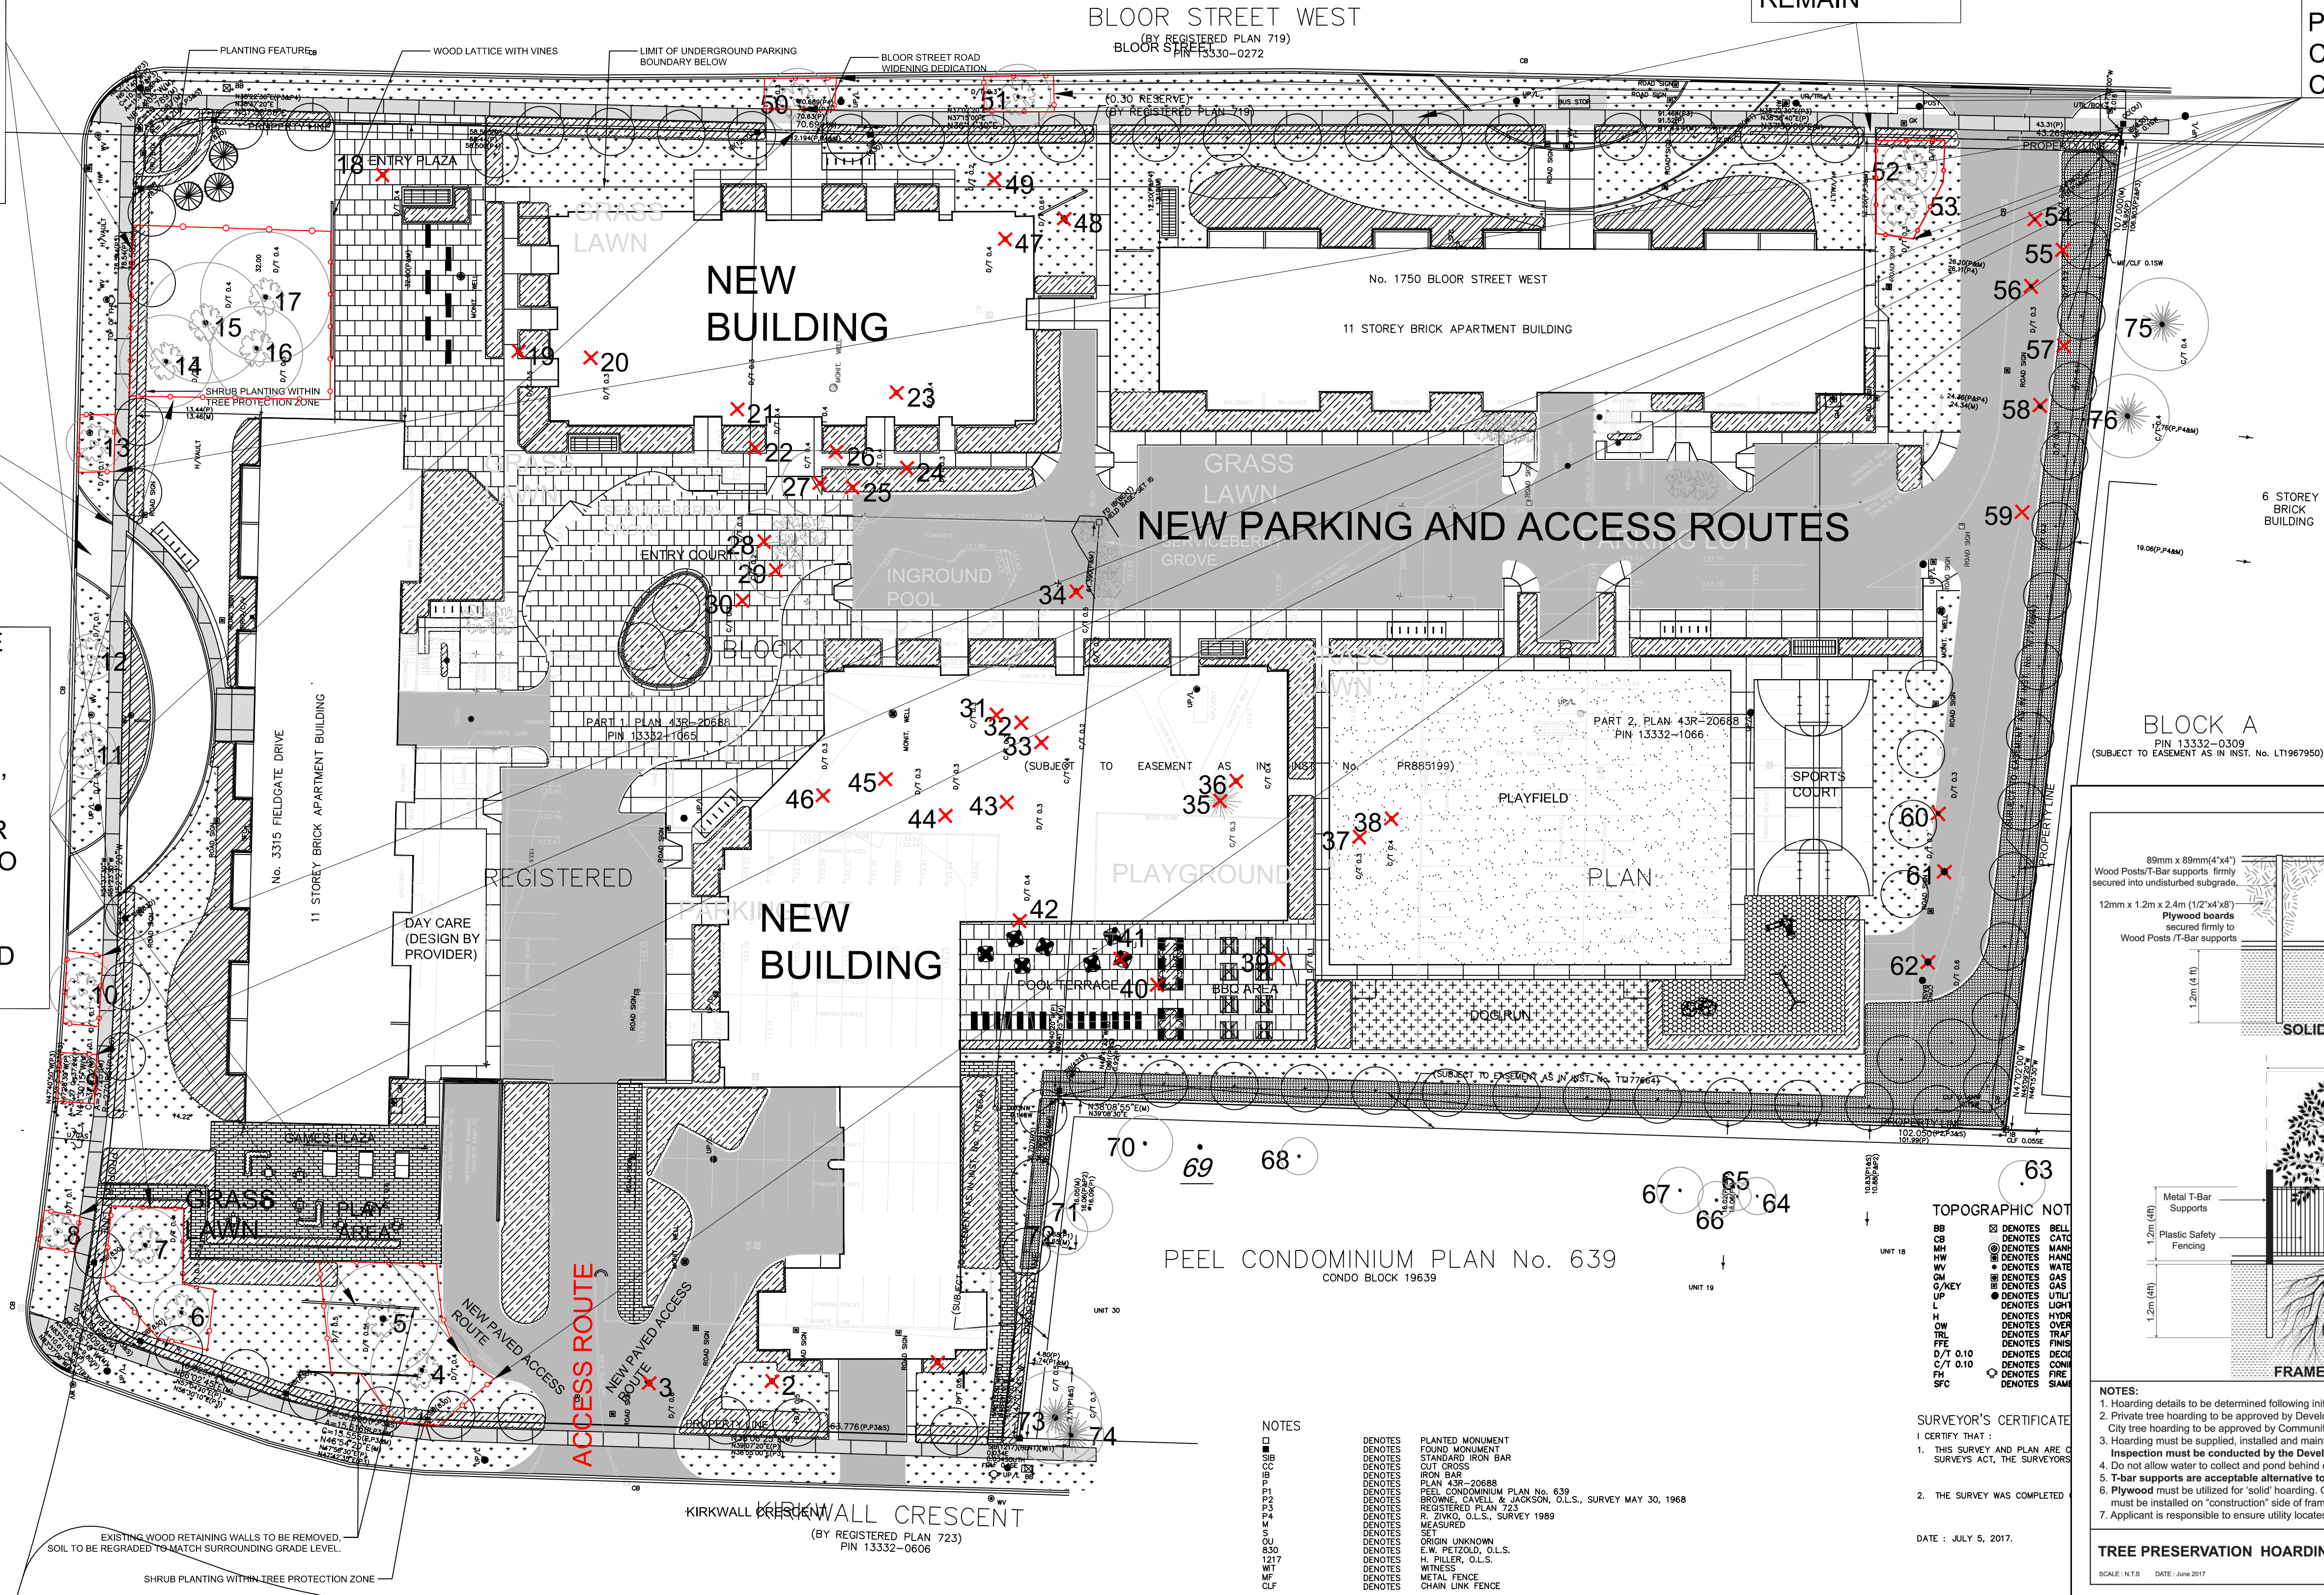
AR-02

THE SUPERVISING ARBORIST MUST BE PRESENT FOR HARDSCAPE AND RETAINING WALL REMOVAL, AS WELL AS ALL EXCAVATION, WITHIN THE PROTECTION ZONES OF TREES 4, 5, 14, AND 50. A NON-DESTRUCTIVE EXCAVATION BY HAND, AIR-SPADE, OR HYDRO-VAC MUST BE UNDERTAKEN TO A DEPTH OF 1.0M (OR MAXIMUM REQUIRED EXCAVATION) PRIOR TO CONSTRUCTION TO PRUNE ROOTS AND MINIMIZE DAMAGE.

WHERE SITE VISIBILITY ALLOWS, ESTABLISH 1.2M TALL SOLID BOARD PLYWOOD HOARDING AROUND RETAINED TREES PRIOR TO CONSTRUCTION, AND KEEP IN PLACE UNTIL CONSTRUCTION IS COMPLETE. REFER TO CITY OF MISSISSAUGA TREE PRESERVATION HOARDING DETAIL FOR MORE INFORMATION.

ESTABLISH SNOW FENCE ON A 2X4 OR T-BAR FRAME PRIOR TO CONSTRUCTION ALONG VEHICLE ACCESS ROUTES, AND KEEP IN PLACE UNTIL CONSTRUCTION IS COMPLETE.
