TREE INVENTORY

Project Title
Kaneff Crescent Residential
3575 KANEFF CRESCENT
MISSISSAUGA, ON

TREE INVENTORY & PRESERVATION PLAN

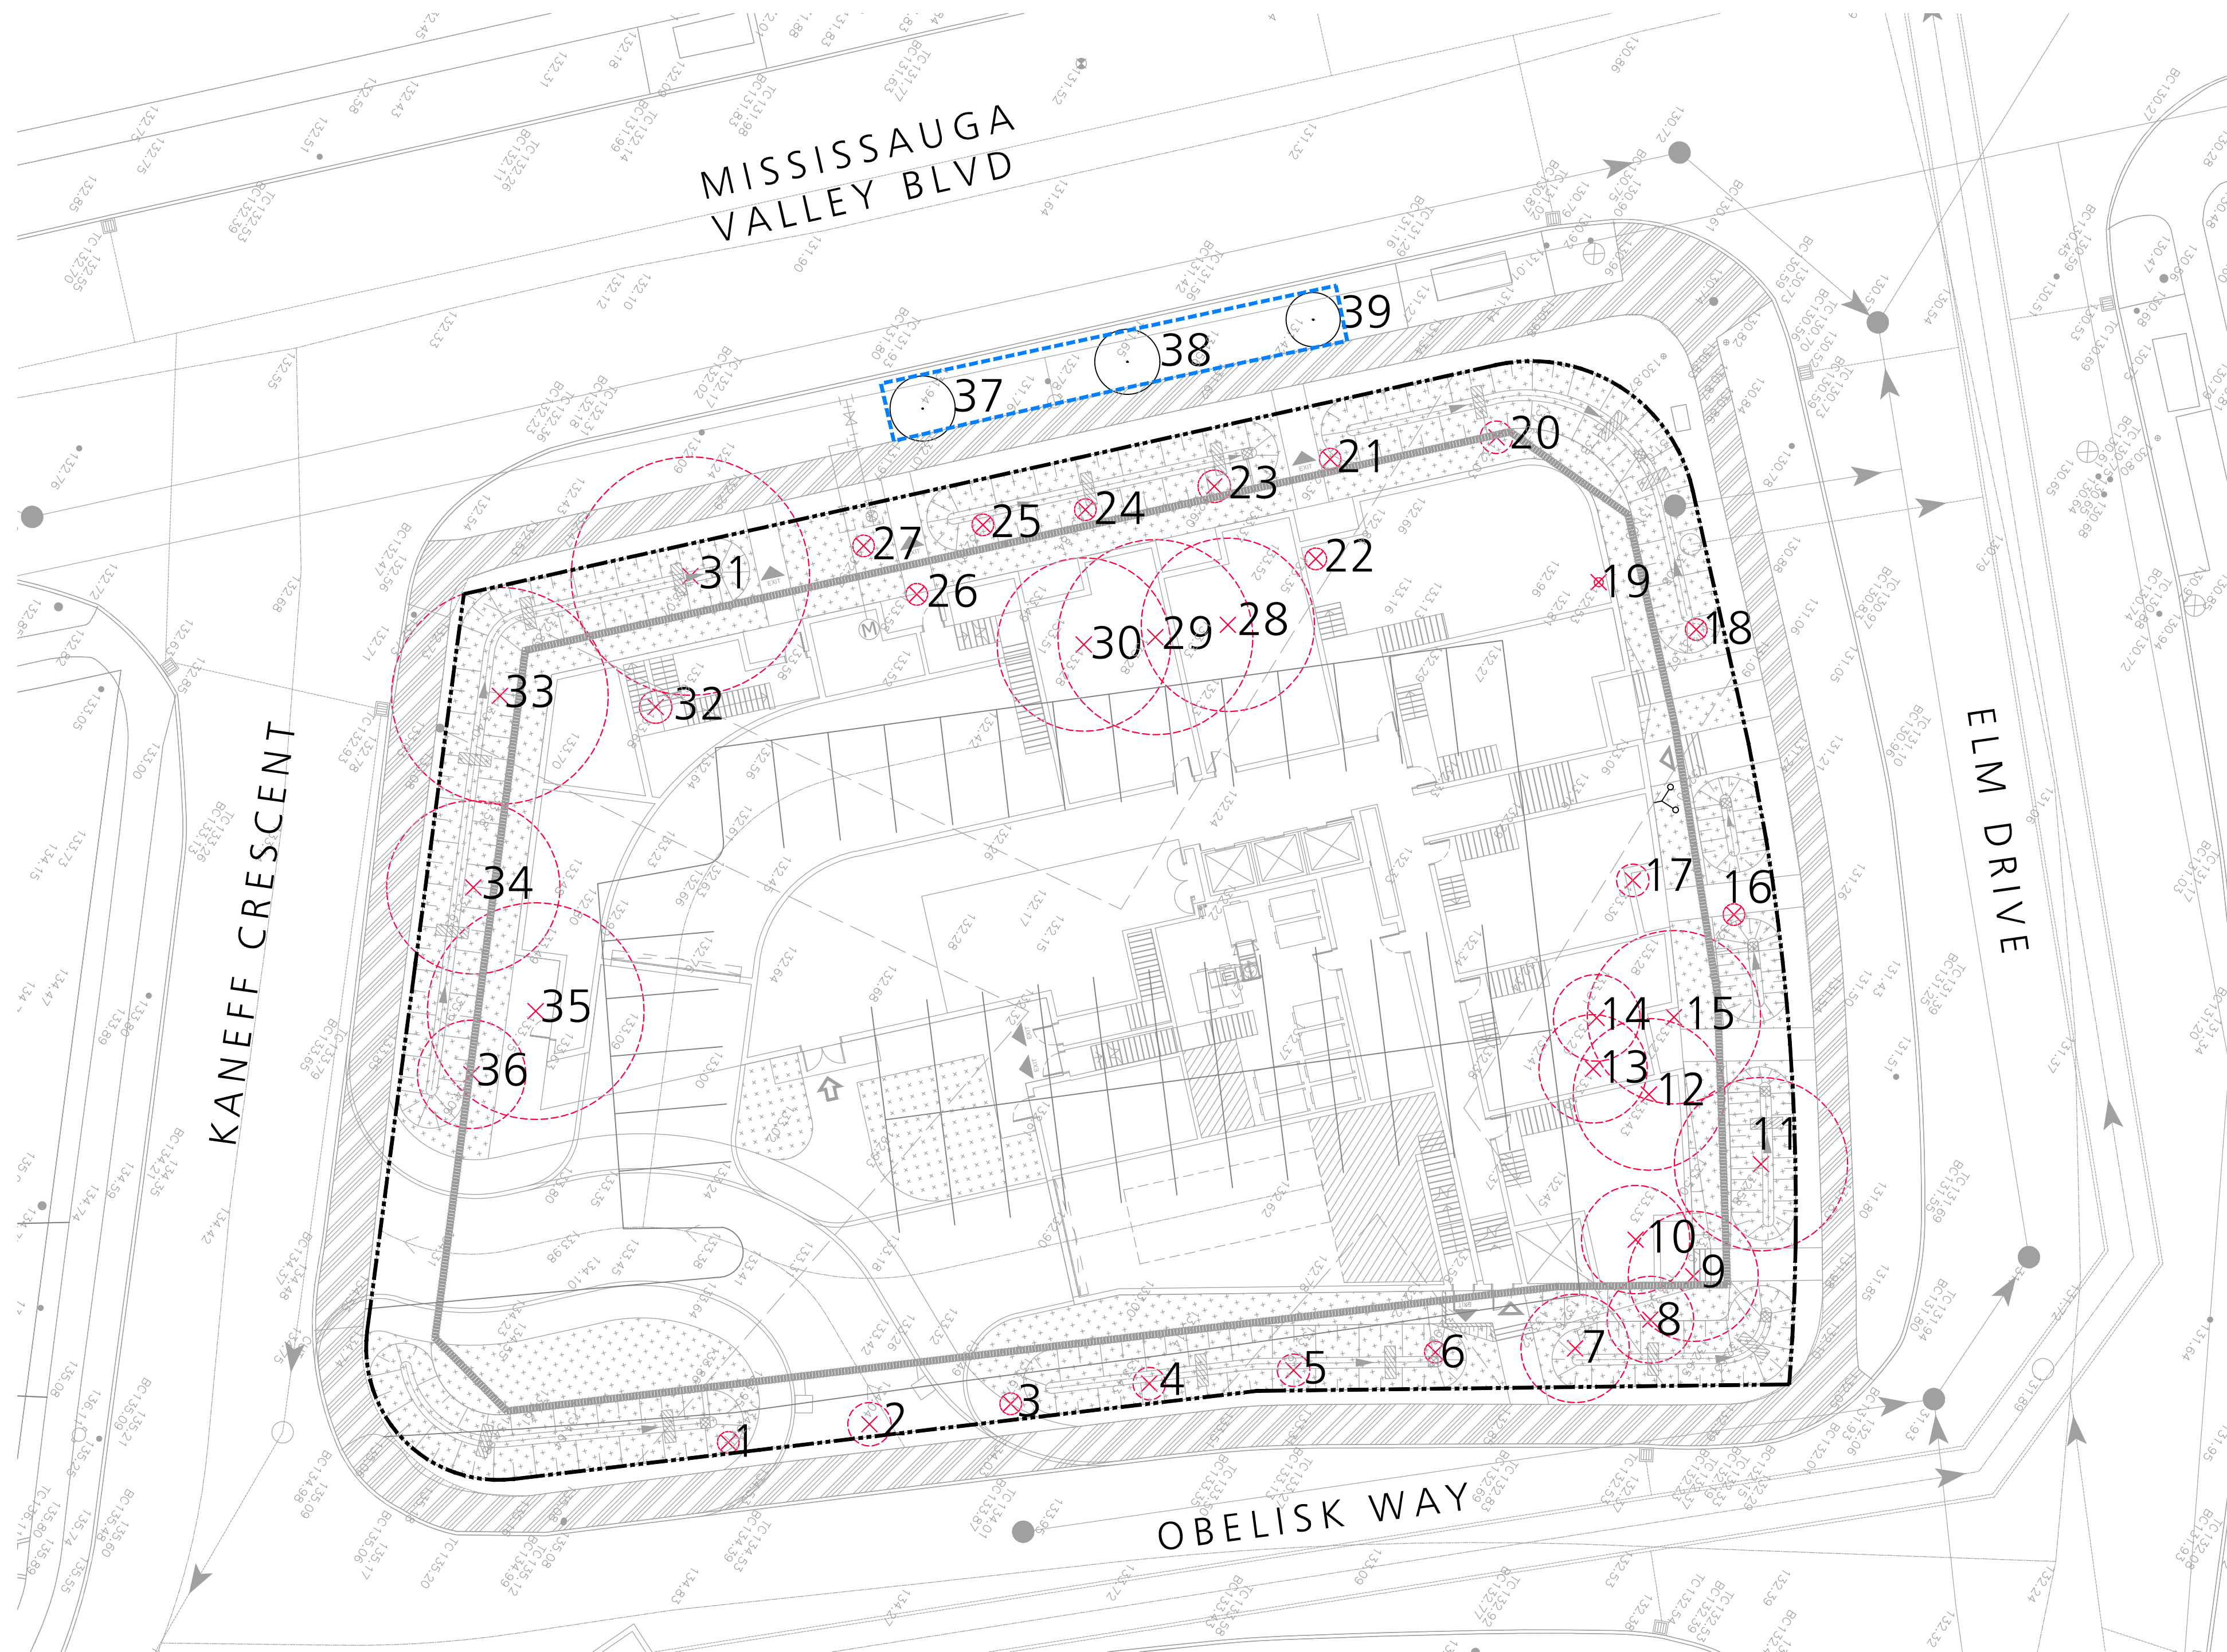
Tree No.	Species	dbh (cm)	Canopy diameter (m)	Biological Health	Structural Condition	Recommended Action	Comments
1	Celtis occidentalis (Common Hackberry)	4	1	H	H	R	OS, BF
2	Acer saccharum (Sugar Maple)	5.5	2	H	H	R	OS, crossing branches
3	Celtis occidentalis (Common Hackberry)	4	1	H	H	R	OS
4	Tilia americana (Basswood)	4	1.5	H	H	R	OS, 10°L(S)
5	Acer saccharum (Sugar Maple)	5.5	1.5	H	M	R	OS, epicormic sprouts, 50%TD @ base
6	Tilia americana (Basswood)	4	1	H	H	R	OS
7	Acer platanoides (Norway Maple)	22.5	5	ML	M	R	Many DBs (50% dieback)
8	Pinus nigra (Austrian Pine)	29.5	4	ML	M	R	20°L (NW to corner)
9	Acer platanoides (Norway Maple)	20	6	L	L	R	Top broken, 90% dieback
10	Pinus nigra (Austrian Pine)	29	5	M	M	R	Diplodea, G(root) 10°L (east)
11	Acer platanoides (Norway Maple)	30	8	H	MH	R	epi sprouts, BF, 1 medium sized DB

12	Pinus nigra (Austrian Pine)	23		D	D	R	leans to site (east) 10°
13	Pinus nigra (Austrian Pine)	26.5	5	M	M	R	20°L(east) 10%TD at 30cm ht.
14	Elaeagnus angustifolia (Russian Olive)	20.5	4	M	L	R	zig zag trunk, 45°L(east), 2 medium-sized branch stubs with tearing wound.
15	Acer platanoides (Norway Maple)	35	8	M	M	R	WSR, G (root), IB @ main union
16	Celtis occidentalis (Common Hackberry)	2.5	1	H	H	R	OS
17	Tilia americana (Basswood)	5	1.5	H	H	R	OS, IB on lowest branch union
18	Celtis occidentalis (Common Hackberry)	4	1	H	H	R	OS, IB on lowest branch
19				D	D	R	fallen, dead
20	Acer saccharum (Sugar Maple)	5	1.5	H	H	R	OS, BF
21	Quercus rubra (Red Oak)	3	1	M	M	R	OS, dieback on many small branches 10%
22	Picea pungens (Colorado Blue Spruce)	4	1	H	H	R	OS, dieback in lower branches on 15%
23	Quercus rubra (Red Oak)	5	1.5	H	H	R	OS, string tied around trunk, wound at base, 5% dieback
24	Acer saccharum (Sugar Maple)	5	1	M	M	R	OS, witches broom, BF, 10% dieback

25	Acer saccharum (Sugar Maple)	5	1	L	L	R	OS, 10%TD @ base, top died back, 75% dieback, crack at main union and down trunk.
26	Celtis occidentalis (Common Hackberry)	3	1	MH	M	R	OS, 30°L(N), 10% dieback

27	Celtis occidentalis (Common Hackberry)	3	1	H	H	R	OS, BF
28	Pinus nigra (Austrian Pine)	28.5	8	M	M	R	Diplodea, 3 large DBs, roots cut in past parking lot installation at surface.
29	Pinus nigra (Austrian Pine)	38.5	9	H	H	R	BF, possible G (root), 10%TD @ 1m.
30	Pinus nigra (Austrian Pine)	29	8	M	M	R	G(root), many medium-sized DBs, 25% canopy dieback
31	Acer platanoides (Norway Maple)	39.5	11	H	M	R	MB, WSR, G(root), crossing branches, Approx. 4 medium-sized DBs, 3 broken branch stubs.
32	Acer saccharum (Sugar Maple)	5	1.5	ML	H	R	BF, 50% dieback, OS
33	Acer platanoides (Norway Maple)	39	10	M	M	R	WSR, G(root), hole in branch with rot, 1 medium-sized DBs
34	Acer platanoides (Norway Maple)	28	8	ML	L	R	large splitting crack from base to 2m. Additional 10% TD @ base. 1 large DB, 4 large BB fallen, remaining canopy 10% dieback.
35	Acer platanoides (Norway Maple)	37.5	10	M	M	R	WSR, 15% dieback, >3 large DBs

36	Acer platanoides (Norway Maple)	20	5	M	H	R	BF, 3 medium-sized DBs, G(root)
37	Ulmus americana hybrid (American Elm hybrid)	10	3	H	H	P	BF, low branching in boulevard
38	Ulmus americana hybrid (American Elm hybrid)	10	3	H	H	P	BF, low branching in boulevard
39	Ulmus americana hybrid (American Elm hybrid)	8	2.5	H	H	P	BF, low branching in boulevard

- Install hoarding for subsequent municipal review/approval.
- Hoarding may be moved temporarily to provide access for tree removal only. These trees should be felled away from protected areas to avoid pulling and breaking of roots of trees to remain.

- Pruning, if required, should be done prior to construction and in accordance with current arboricultural practices.
- Storage of any materials, fill, vehicles/equipment, and disposal of liquids is not permitted within 1m of protected areas.

- Excavation in close proximity to protected areas are to be undertaken with a certified arborist present.
- Roots encountered due to excavation are to be cut with a clean sharp blade. Tearing and ripping of roots is not permitted.

- Hydrovac'ing is recommended as the preferred method for excavation, within 1m of protected areas.
- Exposed roots are to be covered immediately with mulch or topsoil and watered thoroughly. A light coloured tarpaulin may also be used to prevent root desiccation.

- Deep root fertilizer (3:1:1) following backfilling.
- Trees should be re-assessed periodically in order to maintain an up to date understanding of health and structure.
