**Tree Inventory and Preservation Plan Report
42 Park Street, 44 Park Street, 46 Park Street & 23 Elizabeth Street
Mississauga, Ontario**

15 April 2020
Revision 1: 17 April 2020

KUNTZ FORESTRY CONSULTING Inc. Project P2371

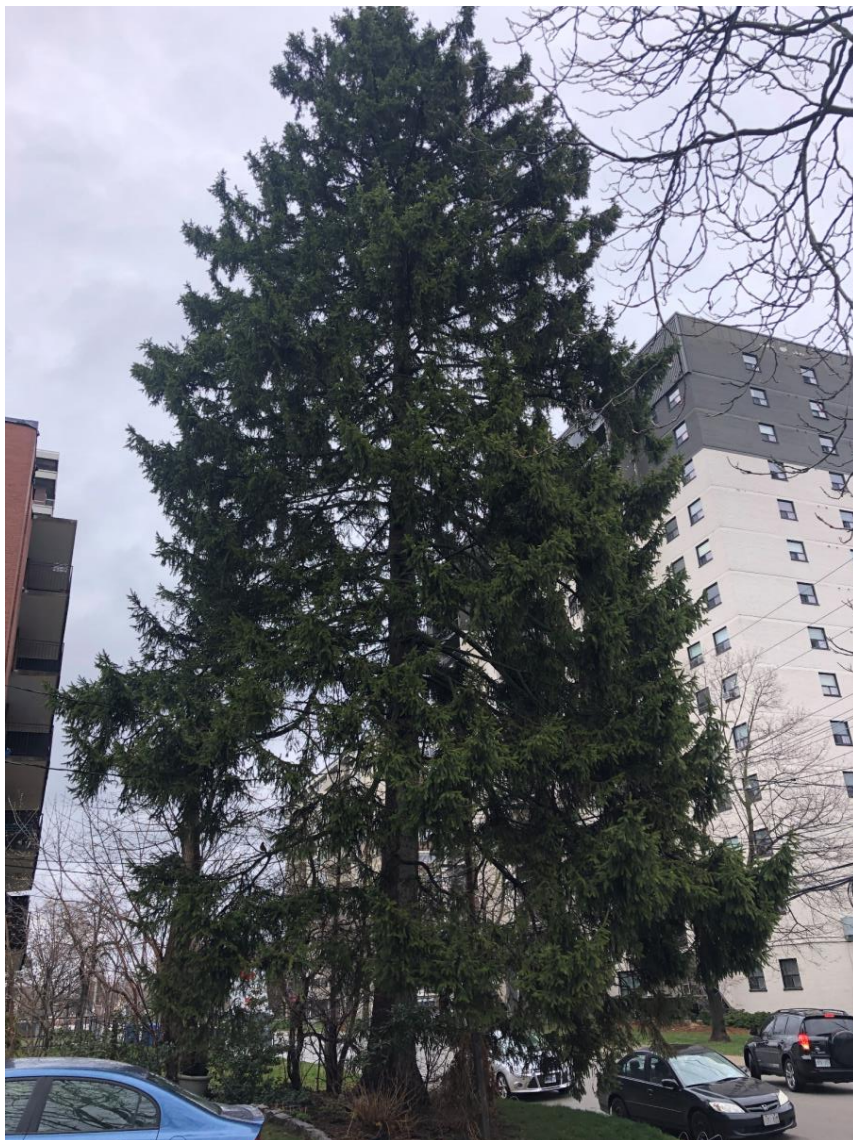
Image 1. Tree 673

Tree #	Common Name	Scientific Name	DBH	TI	CS	CV	RZE	CDB	DL	Comments	Action
673	White Spruce	<i>Picea glauca</i>	~65	G	G	G	F-G		6.0	Included fence, exposed roots (M)	Remove
674	Manitoba Maple	<i>Acer negundo</i>	~40	P	P	P	F		2.5	Topped at 6 metres, epicormic branching (H), cavity (H)	Remove (Condition)
675	Weeping White Mulberry	<i>Morus alba</i> 'Pendula'	13	G	G	G	F-G		1.5	Broken branches (L)	Remove
676	Manitoba Maple	<i>Acer negundo</i>	~30, ~20	P	P	P	F		4.0	Multiple stem failures, cavities (H), deadwood (H), epicormic branching (H), multi-stem at base, coppice growth (H), included fence, leaning on utility pole	Remove (Condition)
677	Manitoba Maple	<i>Acer negundo</i>	~75	P	F	P-F	P-F		4.5	Pruning wounds (H), coppice growth (H), epicormic branching (H), included fence	Remove (Condition)
678	Manitoba Maple	<i>Acer negundo</i>	13	F	F	F-G	P-F		4.5	Impervious surface in 50% of root zone	Remove
679	Siberian Elm	<i>Ulmus pumila</i>	~75, ~40	P-F	F	P-F	P-F		7.0	Co-dominant stems at 0.5 metres, included bark (M), broken branches (M), included fence, epicormic branching (H), cavity (M) at 0.5 metres, impervious surface in 50% of root zone	Remove

The removal of 25 trees is required to accommodate the proposed development. Trees 673, 674, 683, 693, and 696 have trunks that conflict directly with the proposed vehicle entrance ways. Trees 675, 676, 678, and 679 are located close to the proposed vehicle entrance ways such that their roots and / or crowns would be significantly impacted by construction. Trees 677 and 698 – 700 are located close to the proposed underground parking garage such that their roots and / or crowns would be significantly impacted by construction. Trees 680, 684, 686, 687, 692, and 697 conflict with the proposed landscaping upgrades. Trees 689 – 691 have trunks that conflict with the proposed building footprint. Tree 688 is located close to the proposed demolition of an existing house such that its roots and / or crown would be impacted by the demolition. Tree 695 is located close to the proposed transformer such that its roots and / or crown would be impacted by its construction. Trees 674, 676, 677, 682, 683, 695, and 697 are in poor or hazardous condition and their removal is advised regardless of the site plan.

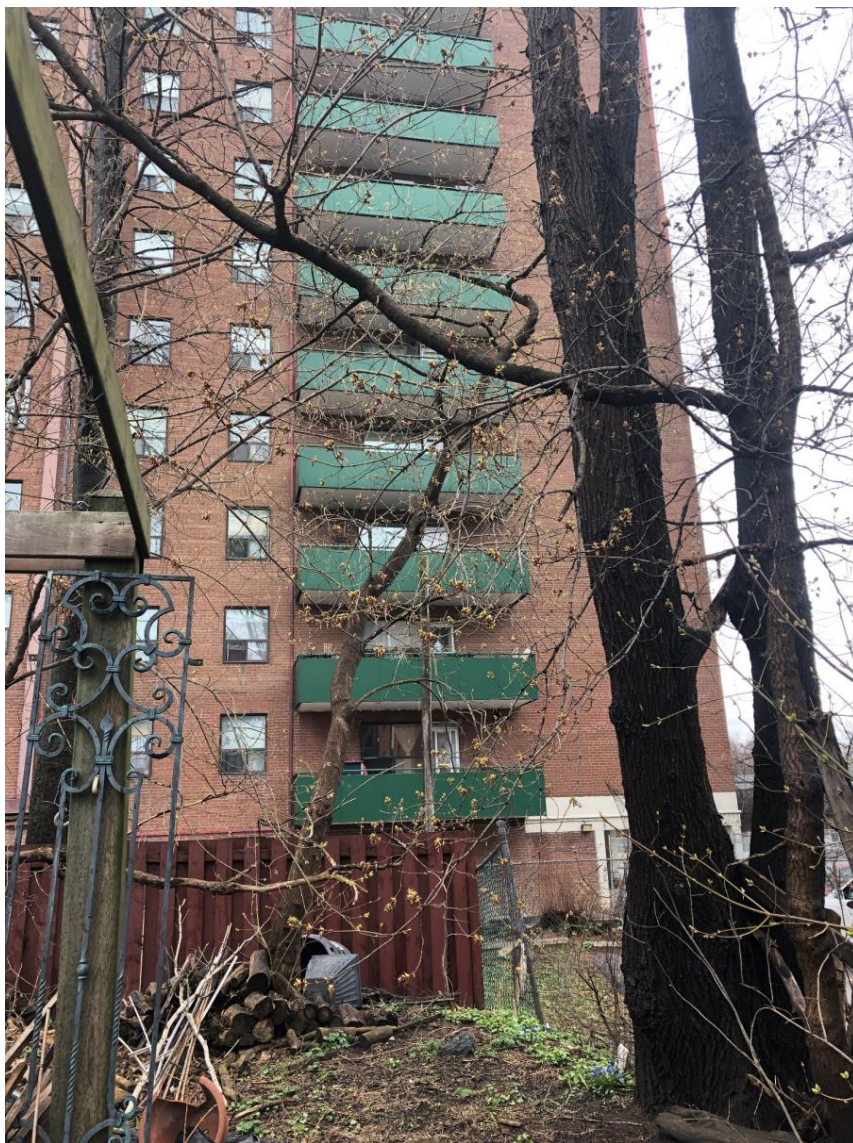
Image 7. Tree 680

680	Manitoba Maple	<i>Acer negundo</i>	20	F	P-F	F	F		5.0	Deadwood (M), pruning wounds (M), bow (M), debris in root zone, epicormic branching (L)	Remove
681	Little-leaf Linden	<i>Tilia cordata</i>	~45	F-G	G	F-G	P		4.0		Retain
682	Manitoba Maple	<i>Acer negundo</i>	~23, ~10	P	P	P-F	F		3.5	Debris in root zone, deadwood (H), one stem dead, multi-stem at base, pruning wounds (H), cavity (H) at base	Remove (Condition)
683	Black Walnut	<i>Juglans nigra</i>	12	F	P	P	F-G		0.5	Topped at 2.5 metres	Remove (Condition)
684	Siberian Elm	<i>Ulmus pumila</i>	35, 33, 16	P-F	F	F	P-F		8.0	Multi-stem at base, deadwood (L), epicormic branching (M), stem wound (M) at 1.5 metres, impervious surface in 50% of root zone	Remove
685	Manitoba Maple	<i>Acer negundo</i>	12	F	F	F-G	P-F		2.5	Pruning wounds (M), impervious surface in 50% of root zone, included fence	Retain
686	Manitoba Maple	<i>Acer negundo</i>	12, 6, 6	F	F	F	F		4.0	Coppice growth (H), lean (L), pruning wounds (H), deadwood (M)	Remove

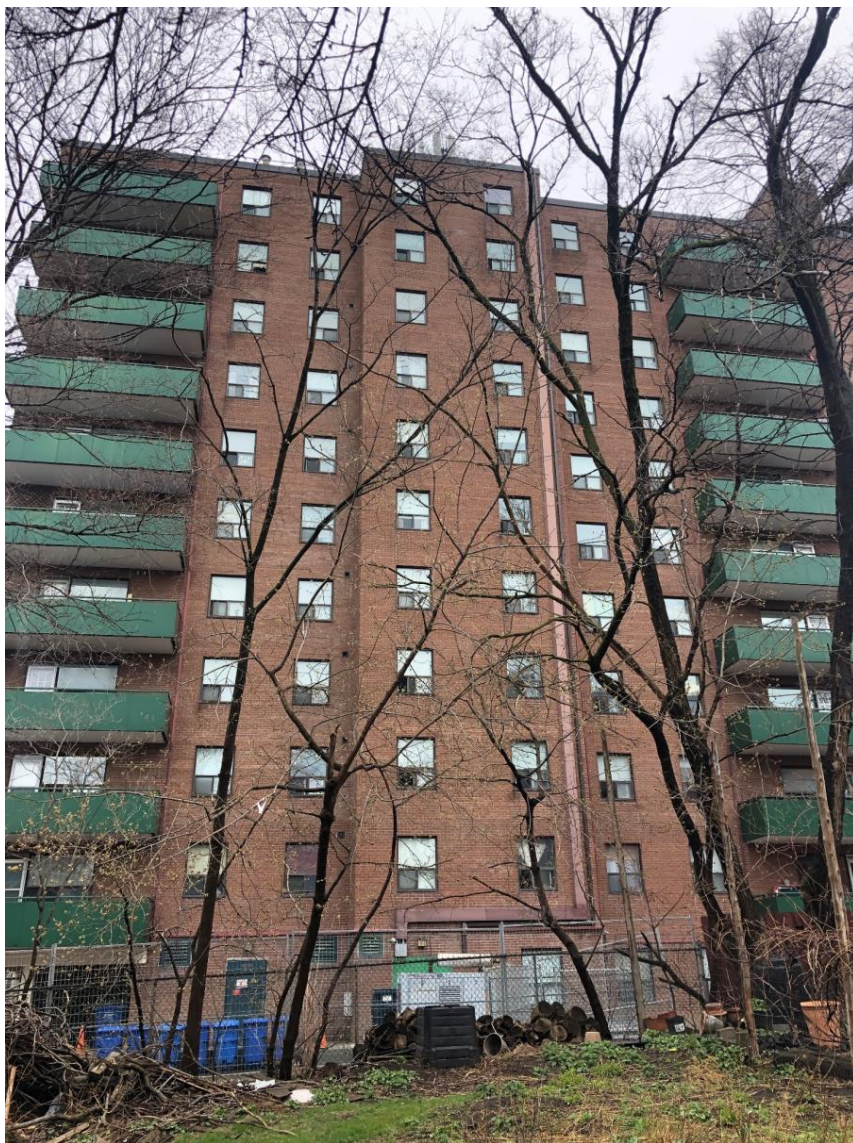
Image 11. Trees 685 – 687

687	Little-leaf Linden	<i>Tilia cordata</i>	16	G	G	F-G	F		4.0		Remove
688	Siberian Elm	<i>Ulmus pumila</i>	33	P-F	F	F-G	F		5.0	Co-dominant stems at 2 metres, broken branches (L), included fence, girdling trunk (H) from fence, epicormic branching (L)	Remove
689	Cherry species	<i>Prunus spp.</i>	32	F	P-F	F	F		6.0	Pruning wounds (H), sweep (L), debris in root zone, epicormic branching (M)	Remove
690	Cherry species	<i>Prunus spp.</i>	31	F	P-F	F	F-G		4.5	Pruning wounds (H), co-dominant stems at 1.5 metres, broken branches (L)	Remove
691	Tree-of-Heaven	<i>Ailanthus altissima</i>	~95	F	F-G	F-G	F		9.0	Seams (L), cavity (L) from pruning wound, pruning wounds (M), included fence, clothesline pulley inserted into trunk, vine competition (L)	Remove
692	Tree-of-Heaven	<i>Ailanthus altissima</i>	110	F	F	F	F		9.0	One stem dead, asymmetrical crown (M), pruning wounds (M), cavity (L)	Remove
693	Siberian Elm	<i>Ulmus pumila</i>	3	G	F-G	G	F		0.5		Remove

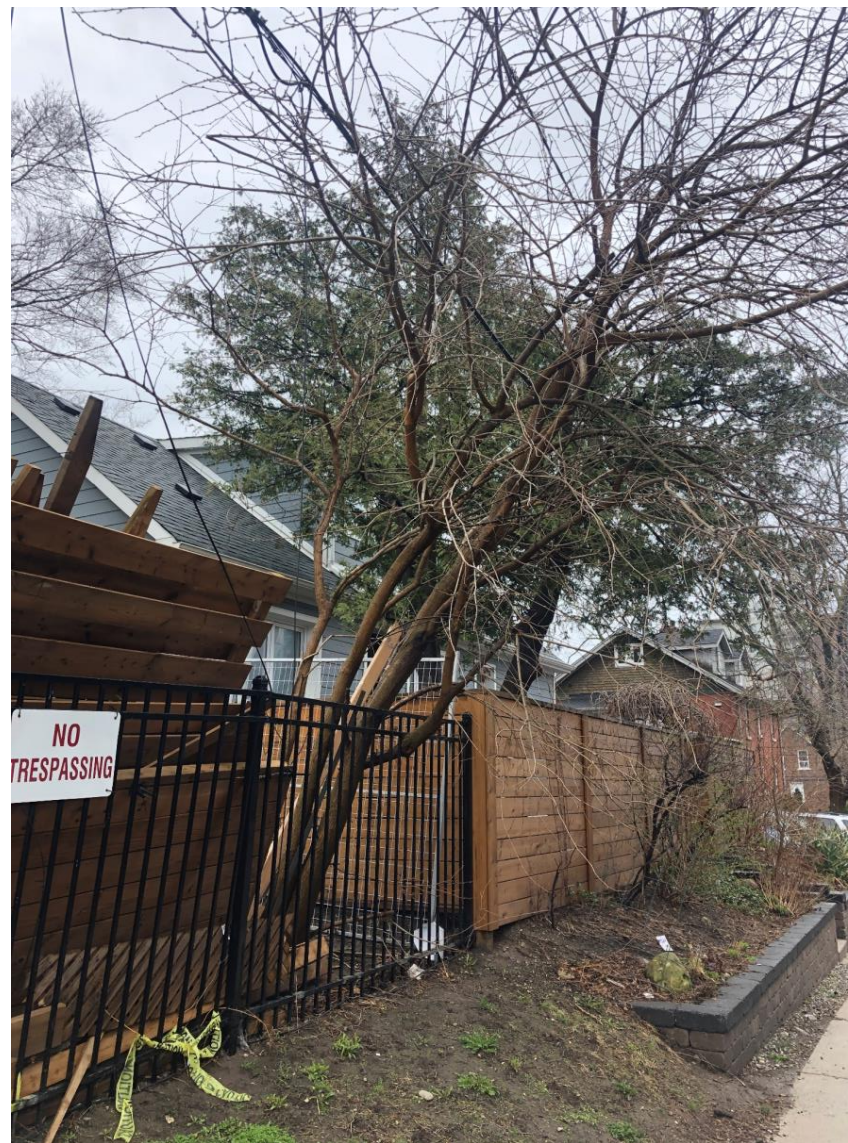
Image 18. Tree 694

694	White Mulberry	<i>Morus alba</i>	~15, ~8, ~8	F	F	F	F		2.5	Multi-stem at base, pruning wounds (M), included bark (M), epicormic branching (H), lean (L)	Retain
695	Eastern White Cedar	<i>Thuja occidentalis</i>	27, 27	P	P-F	F-G	P-F		3.5	Co-dominant stems at base, included bark (M), cavity (H) at union, one stem topped at 6 metres, pruning wounds (M)	Remove (Condition)
696	Weeping White Mulberry	<i>Morus alba</i> 'Pendula'	11	G	F-G	G	F		1.0	Broken branches (L), included bark (L)	Remove
697	Manitoba Maple	<i>Acer negundo</i>	64	P-F	P-F	P-F	F		6.0	Pruning wounds (H), epicormic branching (H), asymmetrical crown (M), seams (M), cavities (M), cavity (H) where large stem was previously pruned, broken branches (L)	Remove (Condition)
698	Manitoba Maple	<i>Acer negundo</i>	18, 15, 11	F	P-F	F	F-G		4.0	Multi-stem at base, one stem pruned at base, pruning wounds (M), broken branches (L)	Remove
699	Manitoba Maple	<i>Acer negundo</i>	15, 14	F	F	F-G	F-G		2.5	Pruning wounds (M), co-dominant stems at 0.25 metres, included bark (H), epicormic branching (M)	Remove

The preservation of the remaining three trees will be possible with the use of appropriate tree protection measures as indicated on Figure 1. As the drip line of Tree 694 does not encroach onto the subject property, tree protection fencing is not required for this tree. Tree protection measures must be implemented prior to the proposed work to ensure tree resources designated for retention are not impacted by the proposed development. Refer to Figure 1 for the location of required tree preservation fencing and general Tree Protection Plan Notes. Refer to Appendix B for tree preservation fencing details.

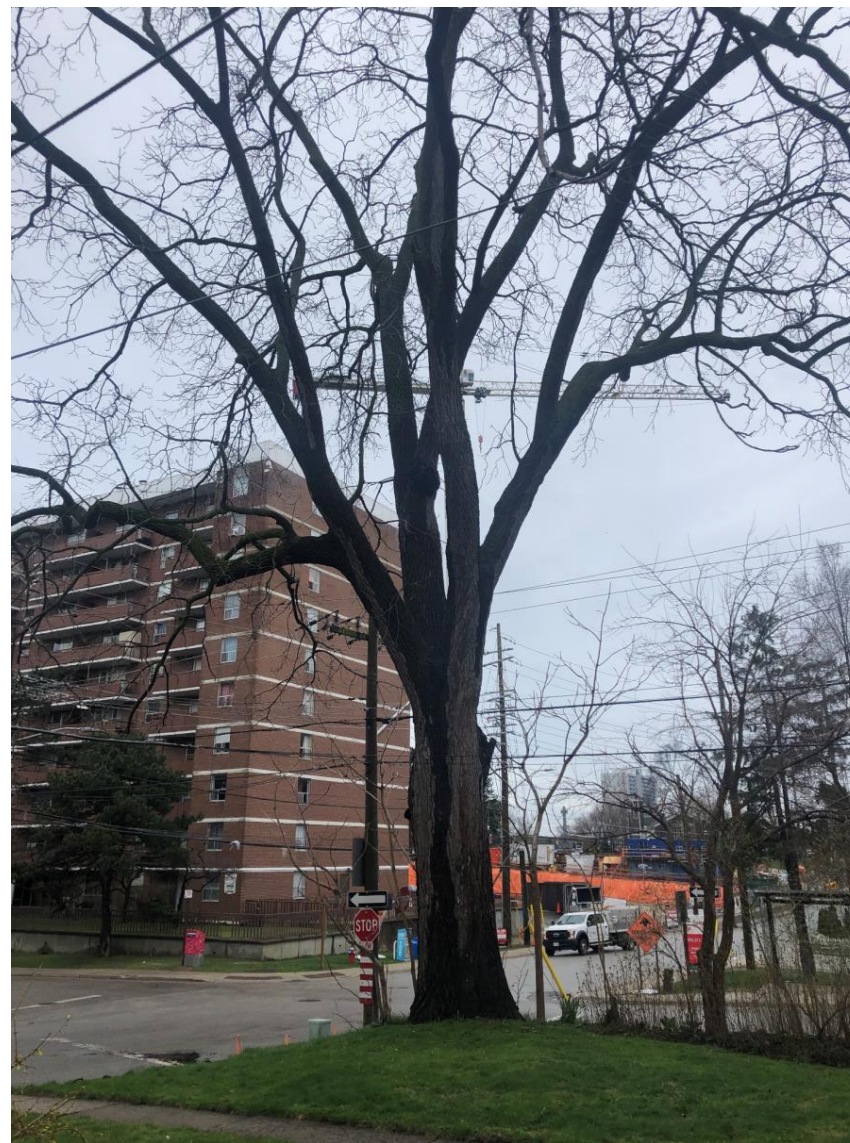
Image 24. Tree 700

700	Black Walnut	<i>Juglans nigra</i>	116	G	F-G	G	F		10.0	Co-dominant stems at 3 metres, pruning wounds (L)	Remove
