ARBORIST REPORT

**PROPOSED MIXED USE DEVELOPMENT
420 LAKESHORE ROAD EAST
MISSISSAUGA, ONTARIO**

**ISA CERTIFIED ARBORIST
MATTHEW GEHRES – ON1114A
OUR PROJECT NO:
20-5470**

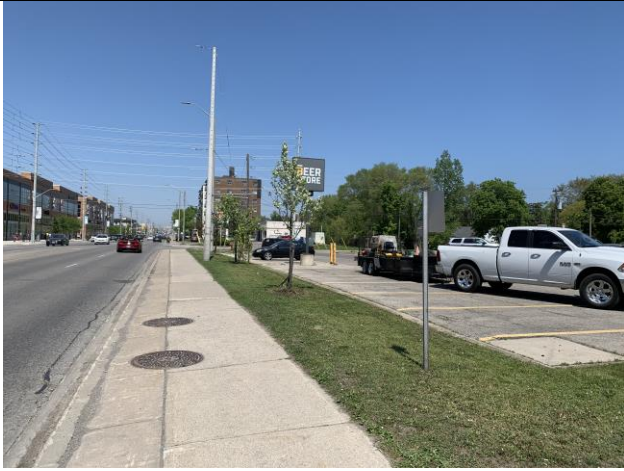
Lakeshore Rd. E., - View East (tree# 1-4)

With the exception of one, most of the boulevard trees along Lakeshore Rd. are in generally poor condition. The Austrian Pine trees that flank the west property limit are either dead or in a general state of decline. Of the two Norway Maple trees close to the existing building frontage, one is dead and the other is in good condition. The mature Siberian Elm trees occur south of the property limit along a naturalized area between the residential lots and the existing plaza. These trees are in generally fair condition and exhibit crown dieback and weak branch unions typical of this species and their size.

SUMMARY OF TREE REMOVALS						
KEY	SPECIES	CALIPER	HEALTH	COMMENTS	PRESERVATION	TREE CATEGORY
		IN (cm)	G/F/P		DIRECTION	
1	ORNAMENTAL PEAR	4.0	FAIR	MINOR DIEBACK THROUGHOUT	REMOVE	3
2	ORNAMENTAL PEAR	12.0	FAIR	SOME TWIG TIP DIEBACK THROUGHOUT	REMOVE	3
3	ORNAMENTAL PEAR	8.0	POOR-FAIR	SUCKER GROWTH THROUGHOUT	REMOVE	3
4	ORNAMENTAL PEAR	5.0	GOOD	MINOR CROWN DIEBACK	REMOVE	3
10	NORWAY MAPLE	20.0	GOOD	DENSE GLOBE STRUCTURE	REMOVE	1
11	NORWAY MAPLE	30.0	DEAD		REMOVE	1
12	NORWAY MAPLE	32.0	GOOD	CROWDED BY ADJACENT BUILDING	REMOVE	1

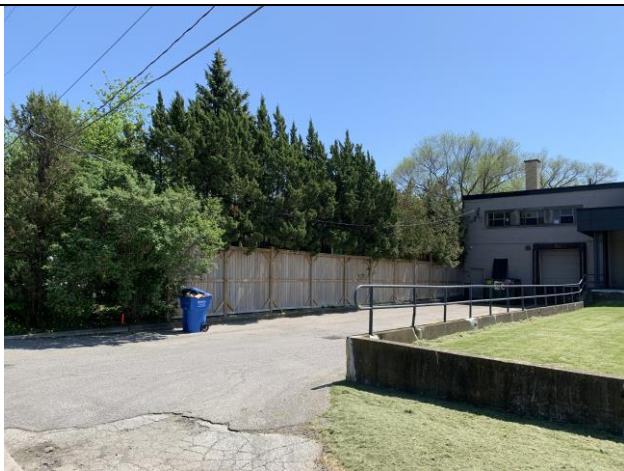
Southeast property limit (tree# 19 foreground & 20 Background)

20	SIBERIAN ELM	+/- 45	10.0	GOOD	GOOD FORM	LOCATED ADJACENT TO EXISTING BUILDING FOUNDATION ON SUBJECT SITE. STRUCTURAL ROOT MASS IS NOT ANTICIPATED TO HAVE GROWN BEYOND THE LIMIT OF THE EXISTING BUILDING FOUNDATION WALL.	PRESERVE	2.4	20

An existing hedgerow composed of White Cedar and Juniper flanks the southeast property line within the residential property to the south. This hedge is situated behind an existing concrete curb/toe wall as well as solid board privacy fence.

City approved tree protection hoarding shall be erected as shown on the approved Tree Inventory & Preservation Plans. The existing hedgerow flanking the southeast corner of the site is currently protected by a high, solid board privacy fence. This fence should provide adequate protection for this hedge. Tree protection fencing is to remain in place throughout the duration of construction and should be periodically reviewed by the Consulting Arborist to ensure that it remains in good working condition.

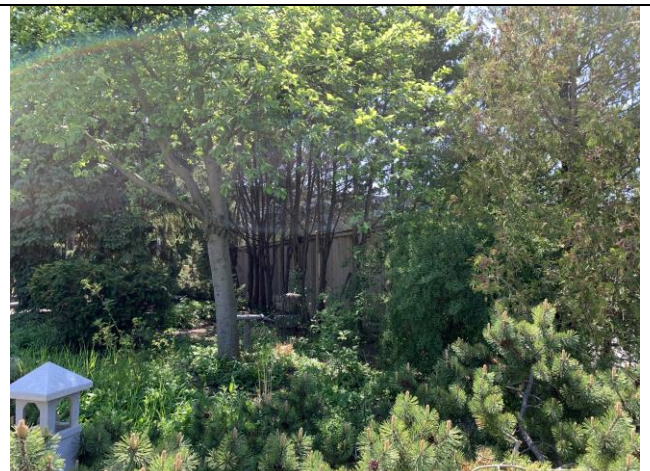
Adjacent Residential lot frontage (tree# 16-18)

There are multiple immature to semi-mature ornamental trees within the front yard of the lot to the south.

Based on the proposed development constraints including grading, servicing and construction requirements, all of the trees internal to the site are recommended for removal. Based on the location of the existing building, the adjacent trees' roots on the property to the south should not be adversely affected. All trees on the adjacent properties will be preserved and protected.
