HERITAGE ADVISORY COMMITTEE

2. <u>Request to Demolish a Structure on a Heritage Listed Property within a Cultural</u> Landscape – 6545 Creditview Road, the "Harris Farm" (Ward 11)

HARRIS FARM BRIDGE

Geniva**r** Limited Substructure Condition Survey Report Harris Farm Bridge over Credit River Mississauga, ON CONCETOB22821AA 21 November 2013

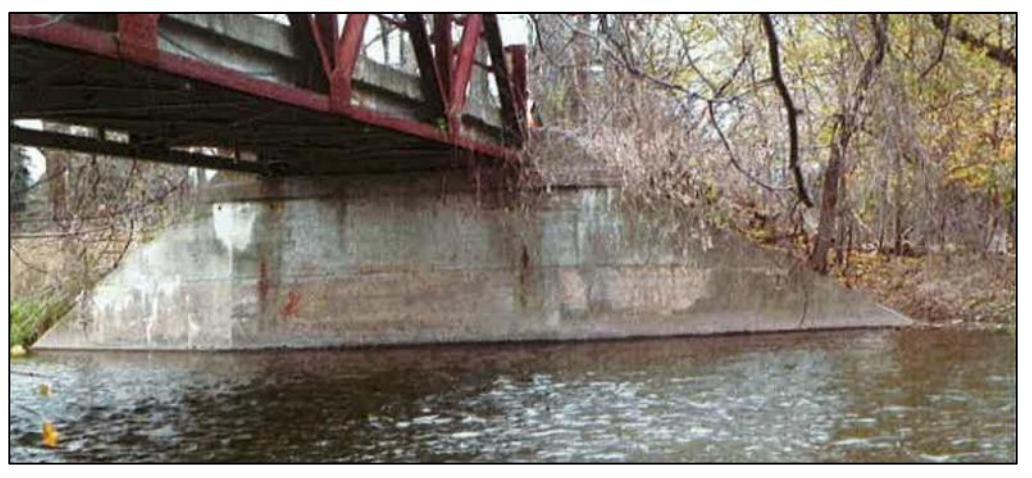
Figure 3: East Abutment

The abutments wall has a trapezoidal shape as shown in Figure 3 and Figure 5. The dimensions are 5.5 m wide at the top, 18.0 m wide at the bottom, and 3.5 m high.

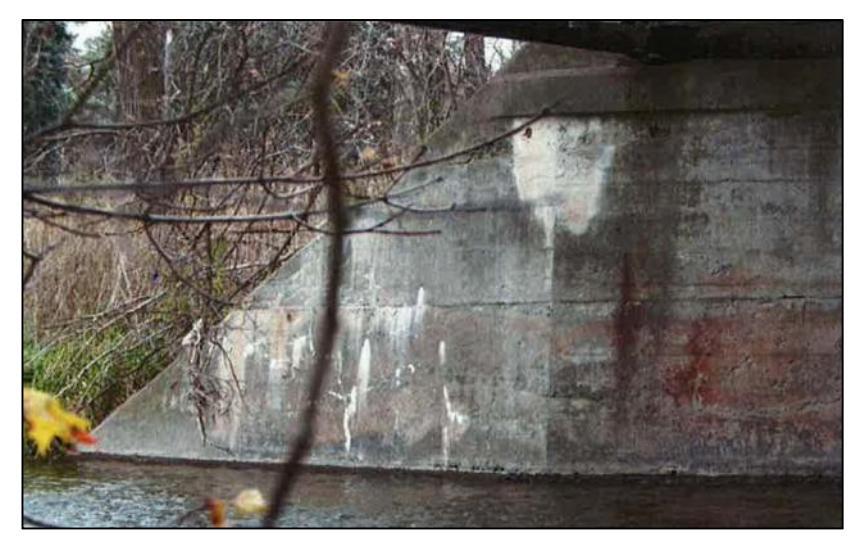
The east abutment was typically in good condition exhibiting evidence of stained cracking (8.0 m), isolated spall (0.2 m^2) and light scaling (0.5 m^2). Figure 4 shows these typical conditions. The concrete cover on the east abutment (at the limited locations inspected) ranged from 110 to 189 mm, with an average concrete cover of 145 mm.

Figure 4: Typical Condition - stained cracking, isolated spalls and light scaling

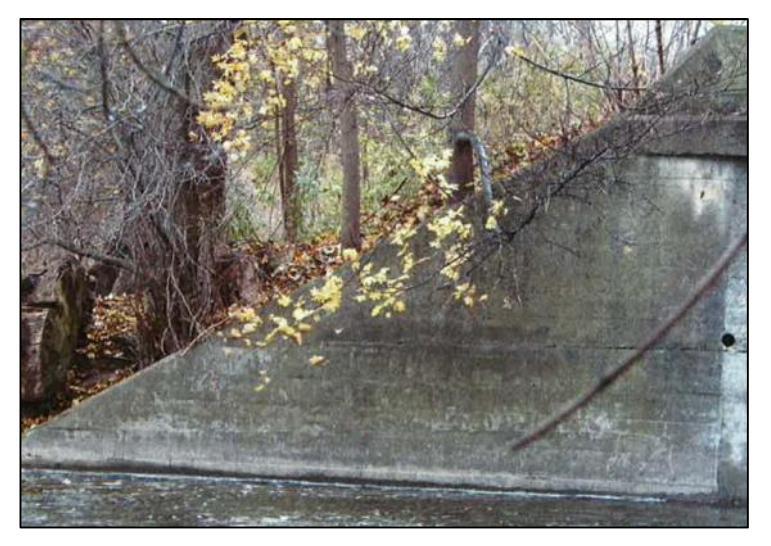
The west abutment was typically in good condition exhibiting evidence of isolated spalls (0.5 m^2) . Figure 6 shows this typical condition. The concrete cover of the west abutment (at the limited locations inspected) ranged from 126 to 190 mm, with an average concrete cover of 148 mm.

Figure 6: Typical Condition - localized spalling

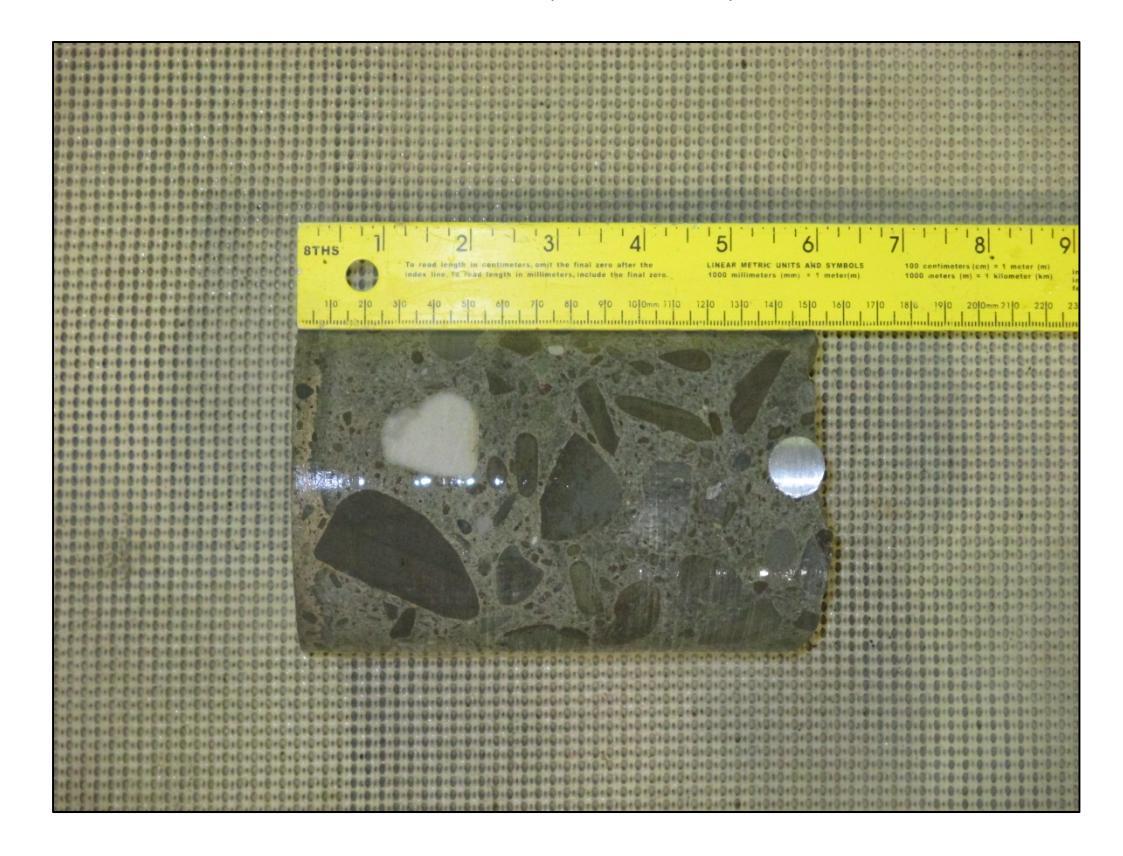
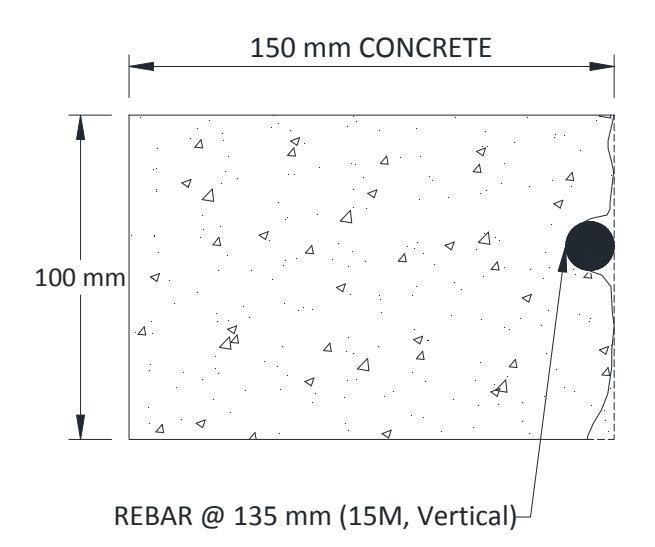
CORE C1 (west abutment)

Cores C1 and C2 were extracted from the west abutment, as shown in Photos C1 and C2, and the core locations are given on the accompanying drawing. The concrete in the cores was typically in good condition. The reinforcing steel exposed during the coring operation was in good condition with no evidence of surface corrosion. Cores C1 and C2 were tested for compressive strength in accordance with CSA A23.2-14C. The compressive strength of the west abutment concrete ranged from 37.7 to 38.3 MPa, with an average compressive strength of 38.0 MPa.

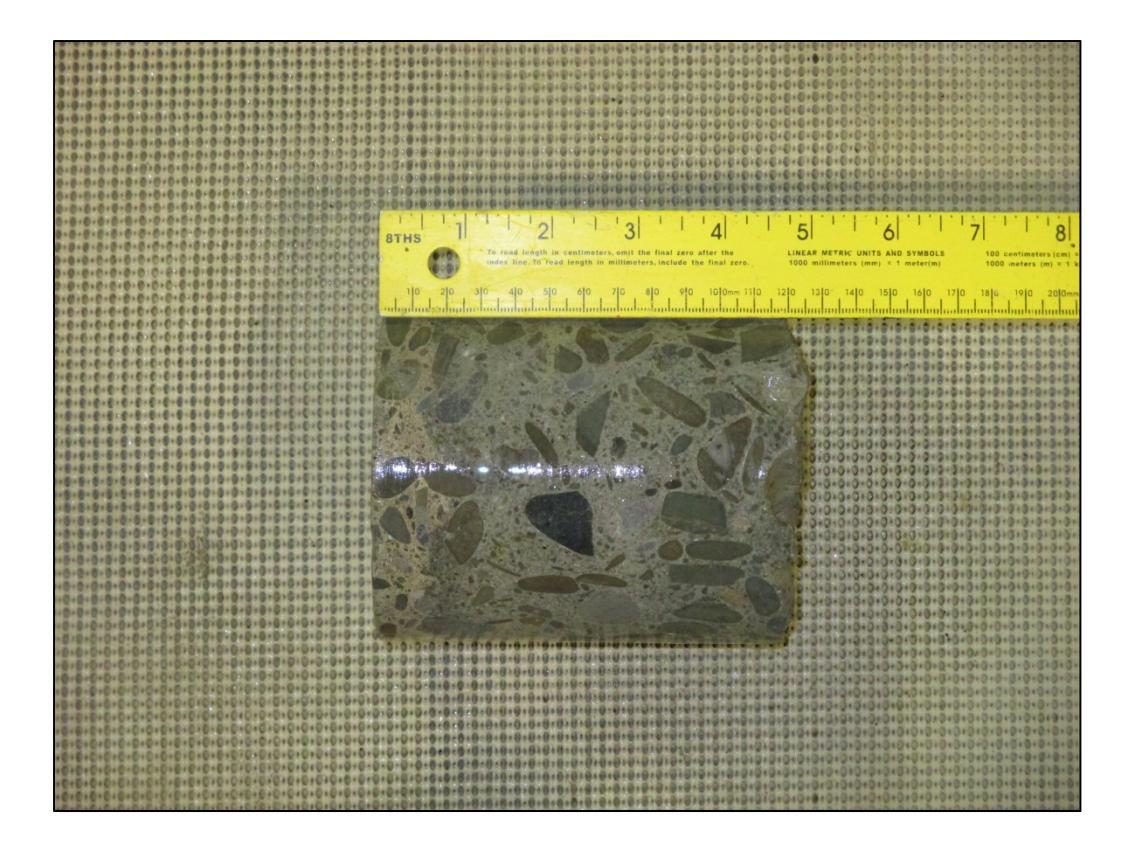
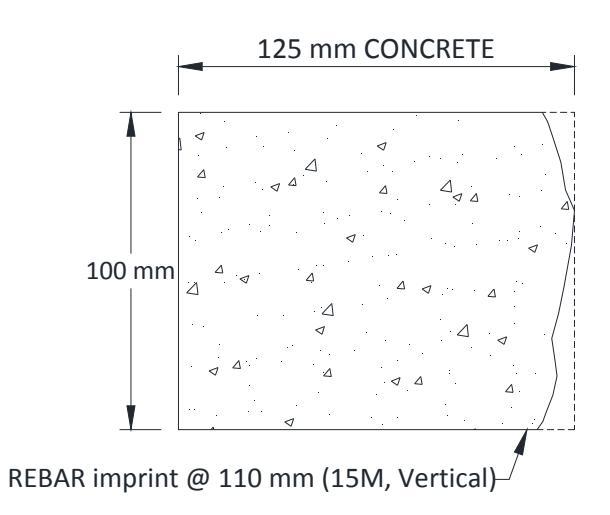
Coffey Geotechnics CONCETOB22821AA Harris Farm Bridge over Credit River Core Photographs & Sketches CORE C3 (east abutment)

Cores C3 and C4 were extracted from the east abutment, as shown in Photos C3 and C4, and the core locations are given on the accompanying drawing. The concrete in the cores was typically in good condition. The reinforcing steel exposed during the coring operation was in good condition with no evidence of surface corrosion. Cores C3 and C4 were tested for compressive strength in accordance with CSA A23.2-14C. The compressive strength of the east abutment concrete ranged from 34.0 to 37.6 MPa, with an average compressive strength of 35.8 MPa.

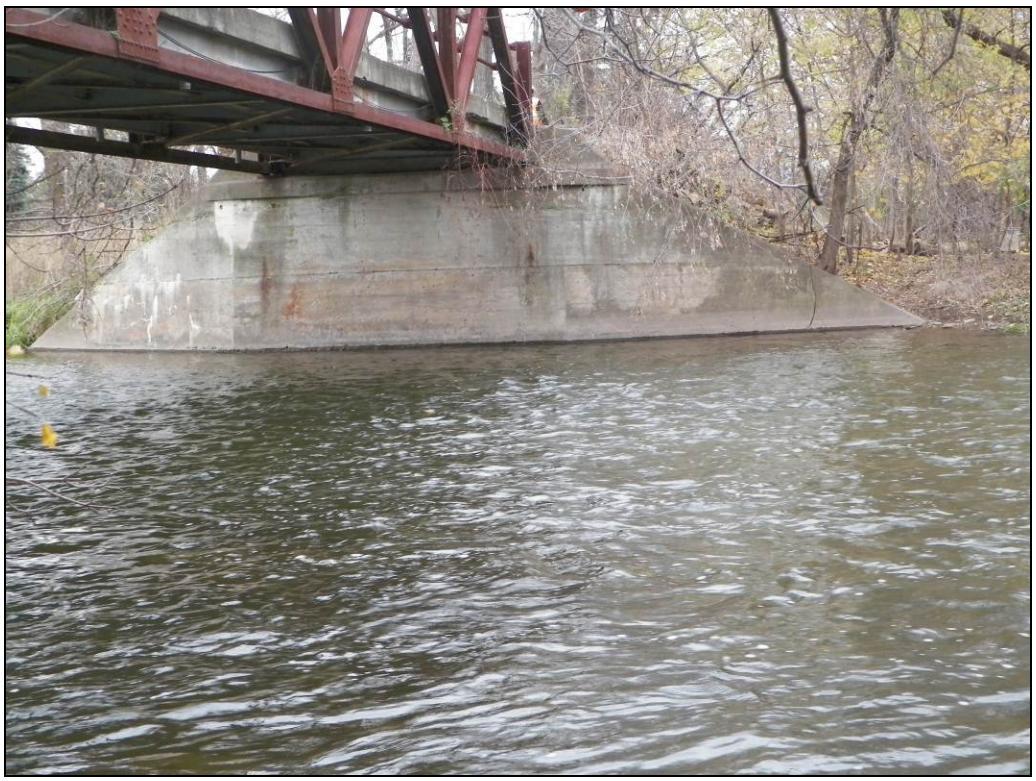
The east abutment was typically in good condition exhibiting evidence of stained cracking (8.0 m), isolated spalls (0.2 m²) and light scaling (0.5 m²), as shown in Photos P3 to P6. The concrete cover on the east abutment *(at the limited locations inspected)* ranged from 110 to 189 mm, with an average concrete cover of 145 mm. The average spacing of reinforcing steel (15M) in the east abutment was 300mm (horizontal) and 500mm (vertical).

Photo P3– Typical Condition of East Abutment (good condition – stained cracking, isolated spalls and light scaling)

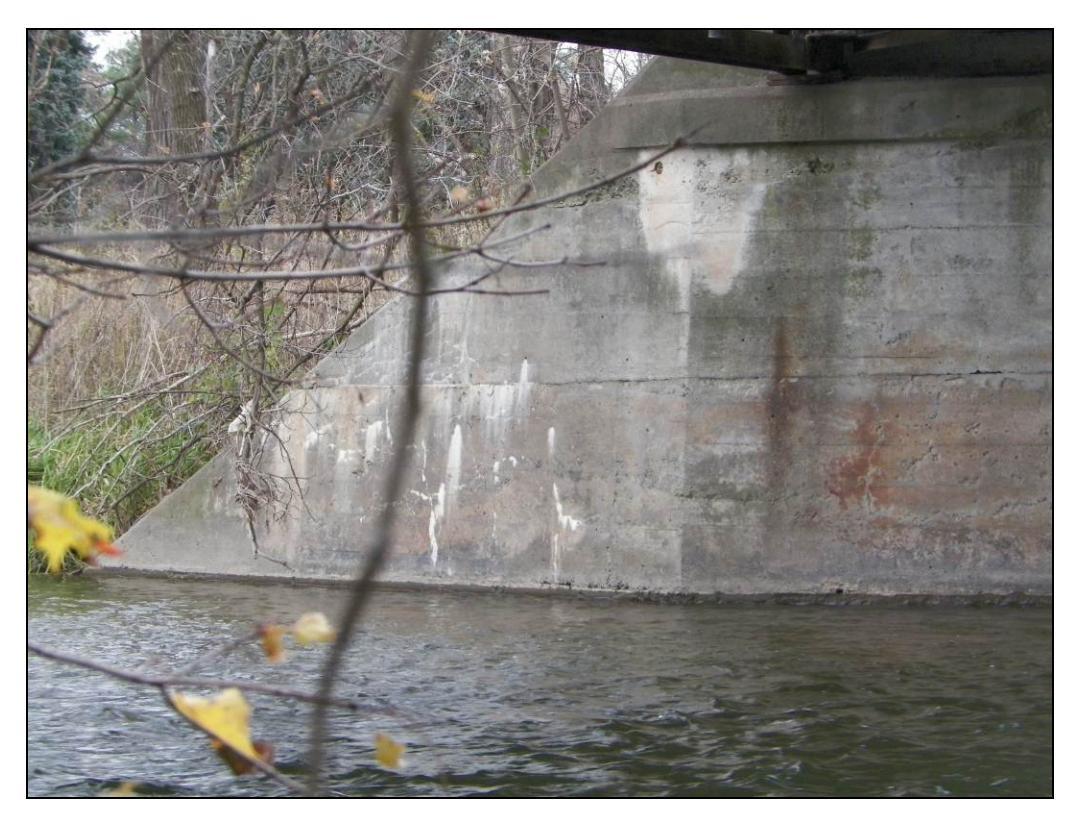
Photo P4– Typical Condition of East Abutment (good condition – stained cracking, isolated spalls and light scaling)

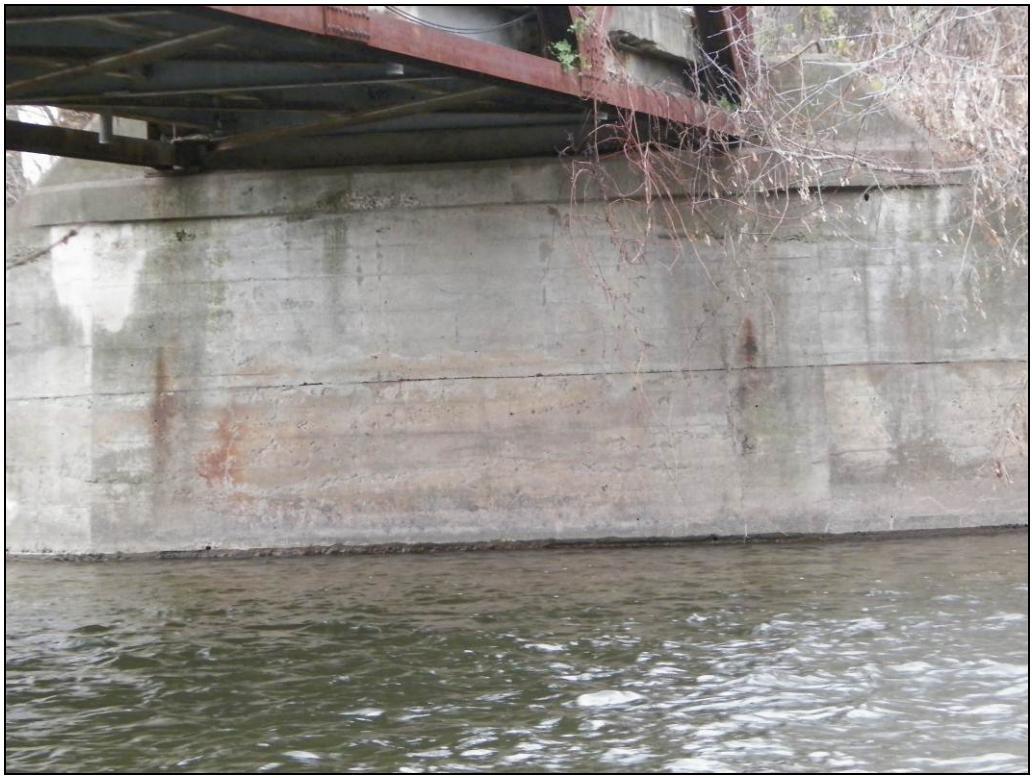
Photo P5– Typical Condition of East Abutment (good condition – stained cracking, isolated spalls and light scaling)

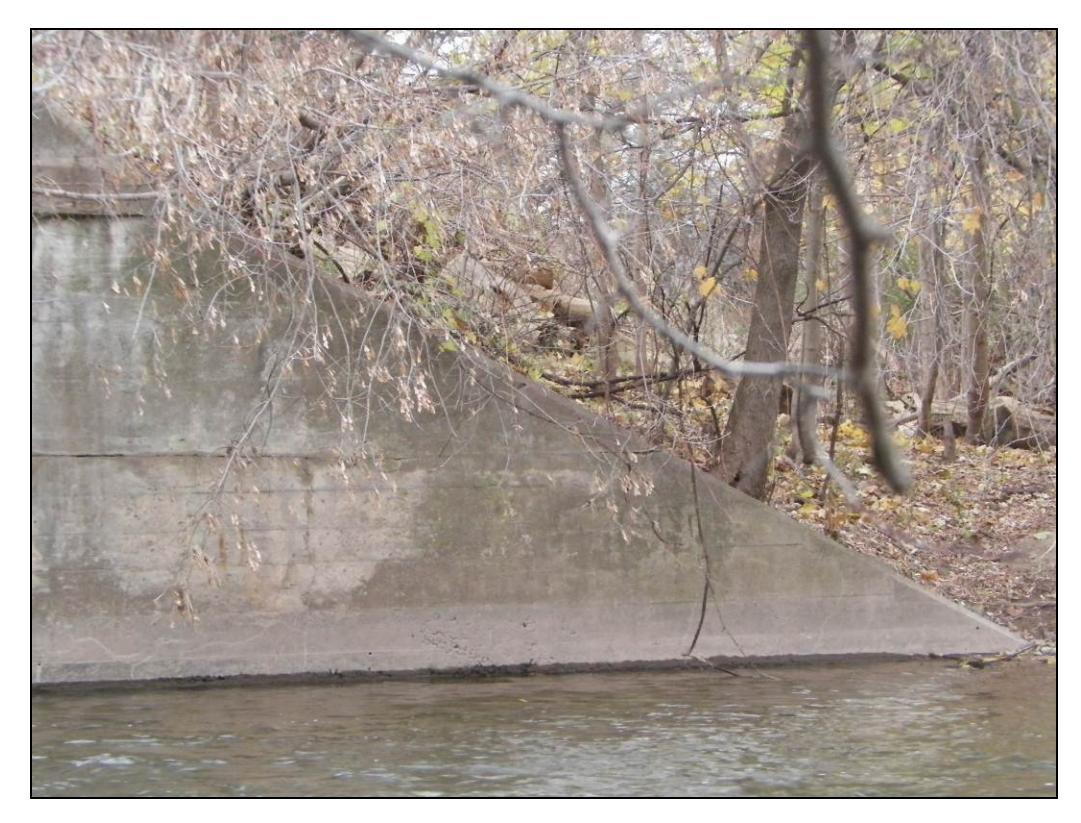
Photo P6– Typical Condition of East Abutment (good condition – stained cracking, isolated spalls and light scaling)

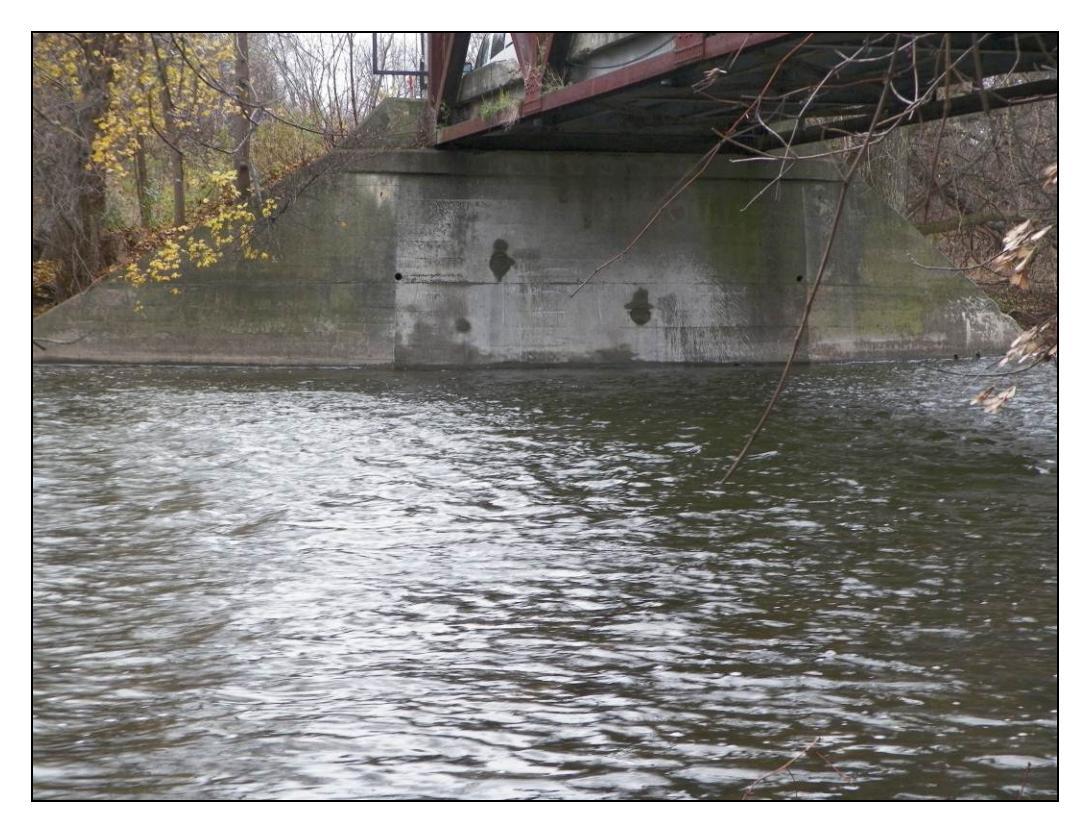
The west abutment was typically in good condition exhibiting evidence of isolated spalls (0.5 m²), as shown in Photos P7 to P10. The concrete cover of the west abutment *(at the limited locations inspected)* ranged from 126 to 190 mm, with an average concrete cover of 148 mm. The average spacing of reinforcing steel (15M) in the west abutment was 300mm (horizontal) and 500mm (vertical).

Photo P7- Typical Condition of West Abutment (good condition - localized spalling)

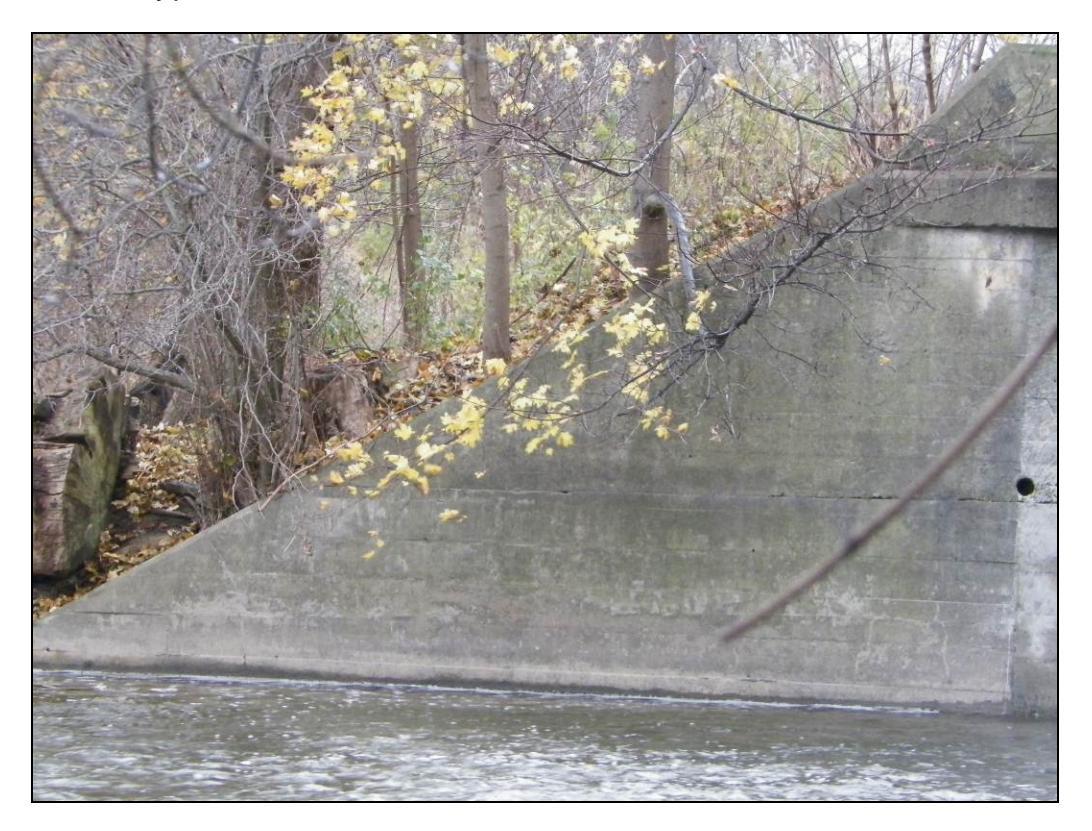
Photo P8- Typical Condition of West Abutment (good condition - localized spalling)

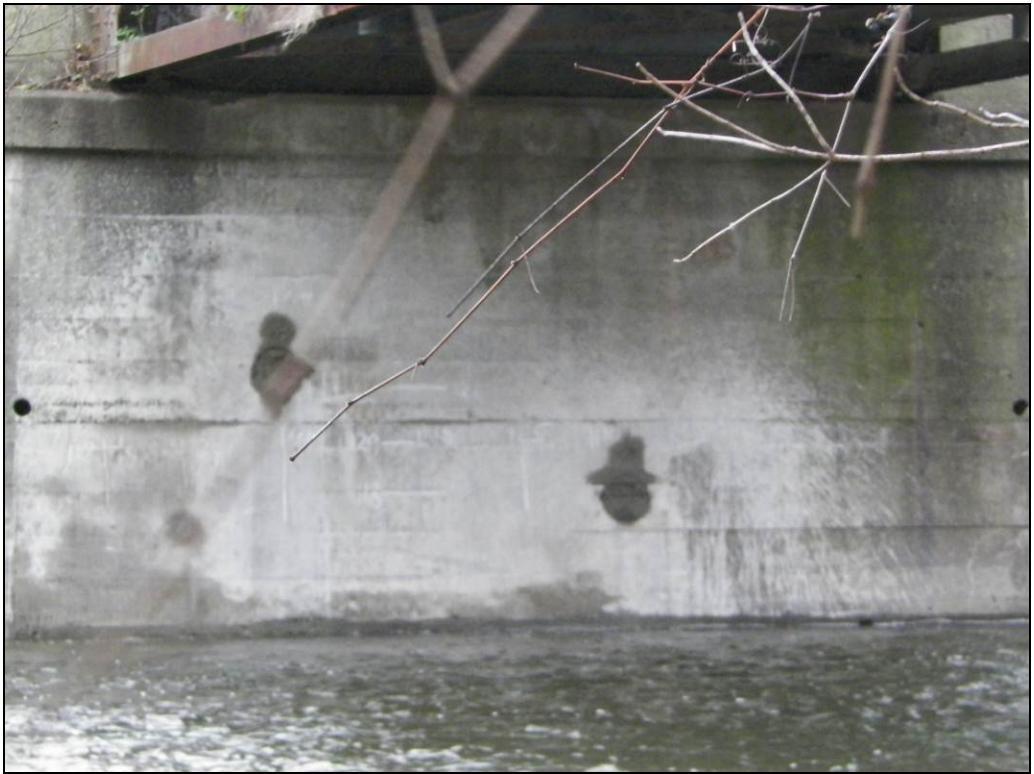
Photo P9- Typical Condition of West Abutment (good condition - localized spalling)

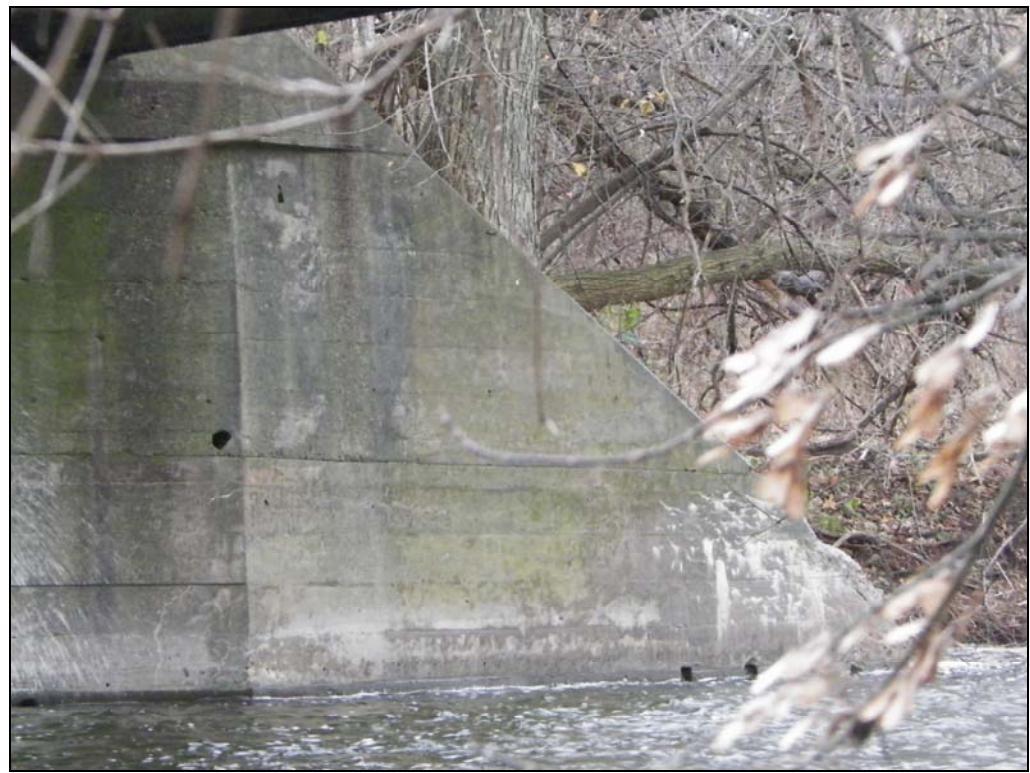
Photo P10– Typical Condition of West Abutment (good condition – localized spalling)

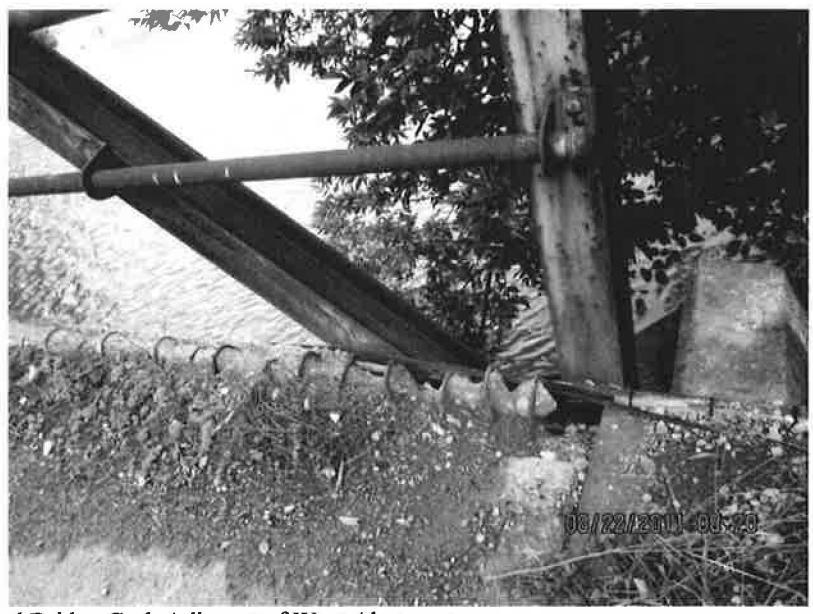
A4: Deteriorated Bridge Curb Adjacent of West Abutment

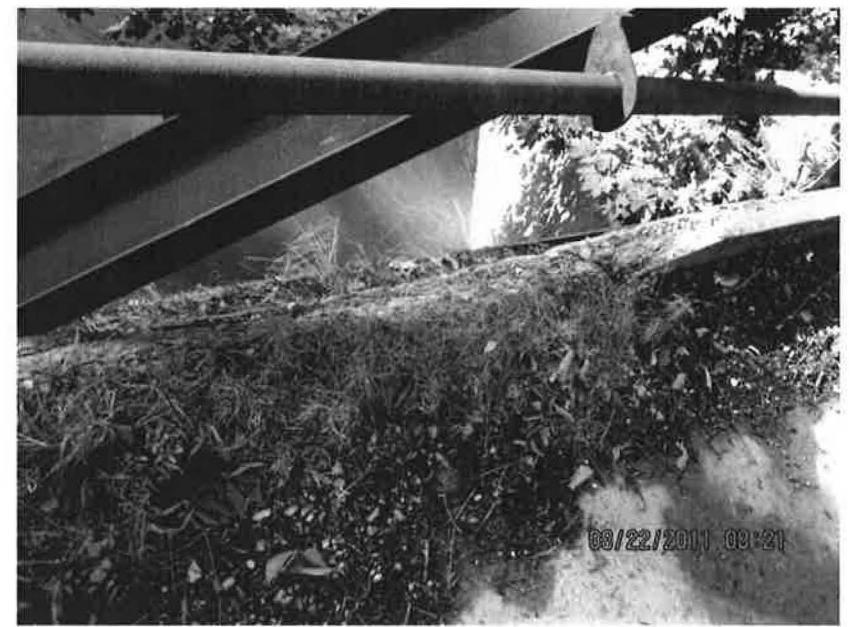
A5: Deteriorated Bridge Curb Near Middle Span
