Tree Inventory, Arborist Report, Tree Protection Plan

2476 & 2482 Confederation Parkway
Mississauga, Ontario
TPB188171 Preeminent Developments Inc.

April 29, 2020

Wood Environment and Infrastructure Solutions
3450 Harvester Road, Suite 100
Burlington, ON, N3H 4R7, Canada
T: 519-650-7100

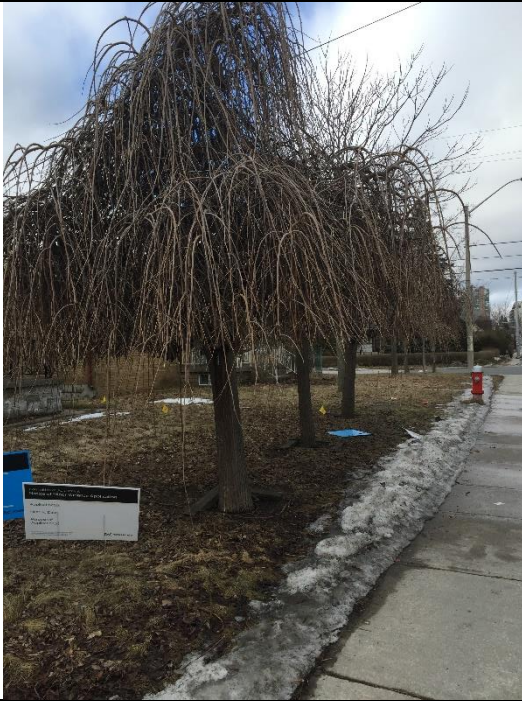
Structure	Health*	Hazard				Owner	Street No.	Street Name	City	Postal Code
179	<i>Morus alba</i>	White Mulberry	24.2	1	Good	Good	No	Remove	Yes	Tree will interfere with construction footprint and space necessary to facilitate construction work (i.e., grading, laydown, and equipment use/access.	Private	2476	Confederation Parkway	Mississauga	L5B
180	<i>Morus alba</i>	White Mulberry	17	1	Good	Good	No	Remove	Yes	Tree will interfere with construction footprint and space necessary to facilitate construction work (i.e., grading, laydown, and equipment use/access.	Private	2476	Confederation Parkway	Mississauga	L5B
181	<i>Morus alba</i>	White Mulberry	20.1	1	Good	Good	No	Remove	Yes	Tree will interfere with construction footprint and space necessary to facilitate construction work (i.e., grading, laydown, and equipment use/access.	Private	2476	Confederation Parkway	Mississauga	L5B
182	<i>Pyrus communis</i>	Common Pear	44.6	2.5	Good	Good	No	Remove	Yes	Previously pruned; tree will interfere with construction footprint and space necessary to facilitate construction work (i.e., grading, laydown, and equipment use/access.	Private	2476	Confederation Parkway	Mississauga	L5B

Photograph 1. Three (3) White Mulberry at the front of 2476 Confederation Parkway. (Tree Tag No. 179 to 181).

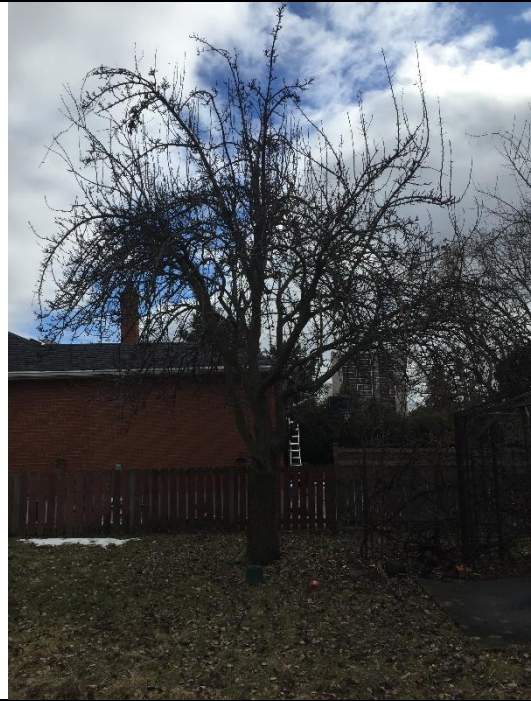
Photograph 2. Common Pear located in the rear yard of 2476 Confederation Parkway. (Tree Tag No. 182).

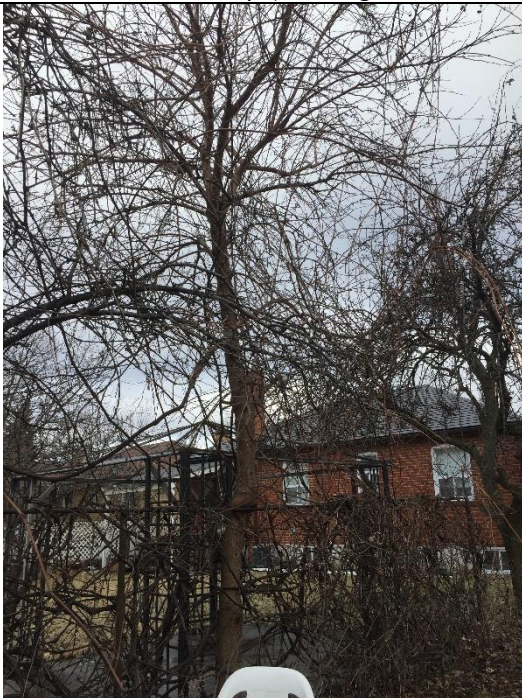
Photograph 3. White Mulberry located in rear yard of 2476 Confederation Parkway. (Tree Tag No. 183).

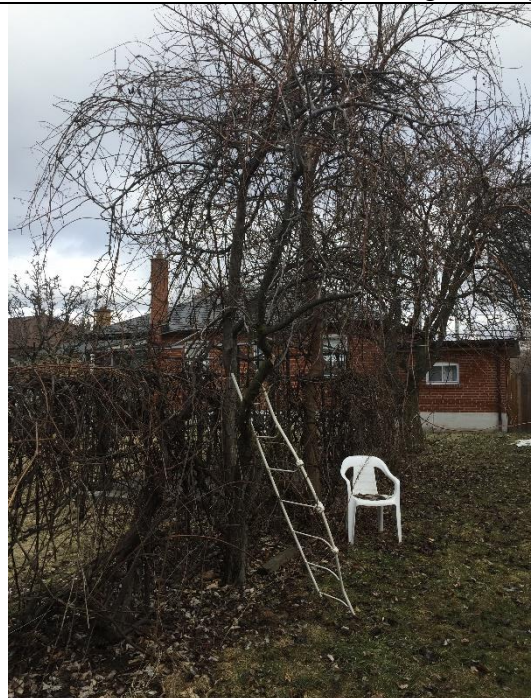
Photograph 4. Common Pear located in rear yard of 2476 Confederation Parkway (Tree Tag No. 184)

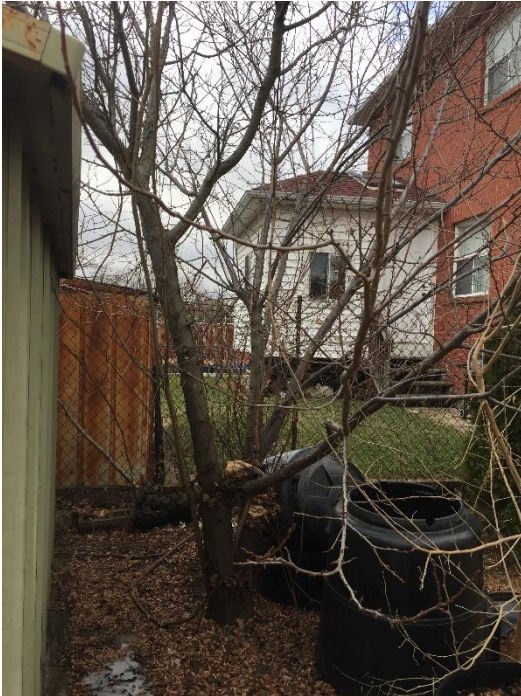
Photograph 5. Japanese cultivar located in the rear yard of 2476 Confederation Parkway (Tree Tag No. 185).

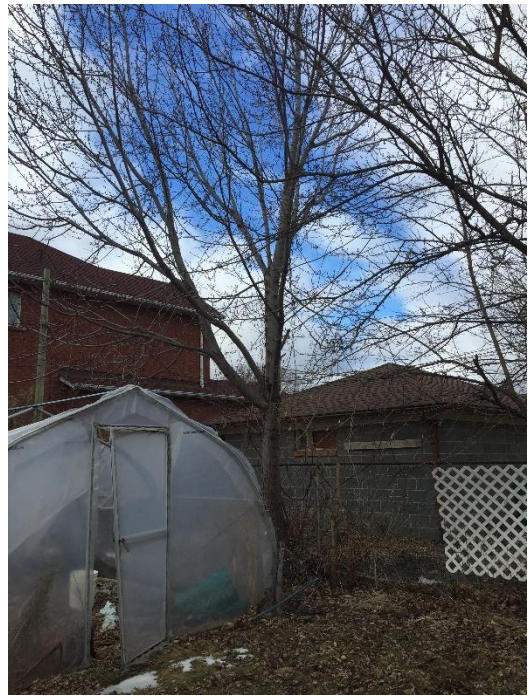
Structure	Health*	Hazard				Owner	Street No.	Street Name	City	Postal Code
186	<i>Acer saccharinum</i>	Silver Maple	26.5	2	Fair	Good	No	Remove	Yes	Tree will interfere with construction footprint and space necessary to facilitate construction work (i.e., grading, laydown, and equipment use/access.	Private	2476	Confederation Parkway	Mississauga	L5B
187	<i>Morus alba</i>	White Mulberry	22.8	2	Fair	Good	No	Remove	Yes	Co-dominant stem; tree will interfere with construction footprint and space necessary to facilitate construction work (i.e., grading, laydown, and equipment use/access.	Private	2476	Confederation Parkway	Mississauga	L5B
188	<i>Morus alba</i>	White Mulberry	11.7	2	Good	Good	No	Remove	No	Tree will interfere with construction footprint and space necessary to facilitate construction work (i.e., grading, laydown, and equipment use/access.	Private	2476	Confederation Parkway	Mississauga	L5B

Photograph 6. Silver Maple located along fence line in the rear yard of 2476 Confederation Parkway. (Tree Tag No.186).

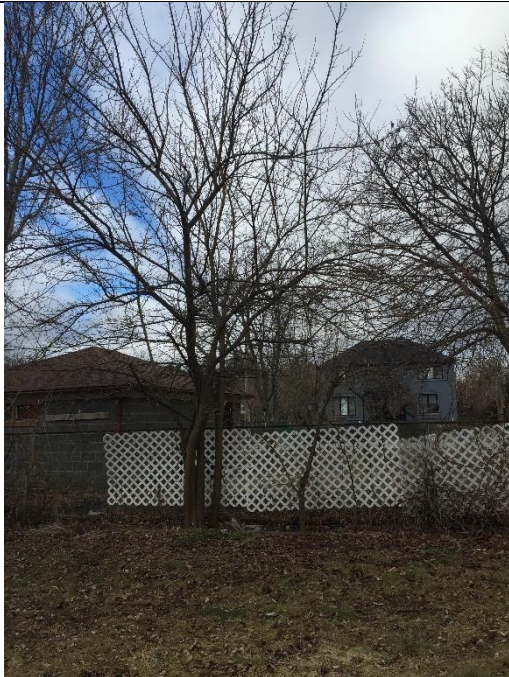
Photograph 7. Two White Mulberries along fence line in the rear yard of 2476 Confederation Parkway. (Tree Tag No.187 and 188).

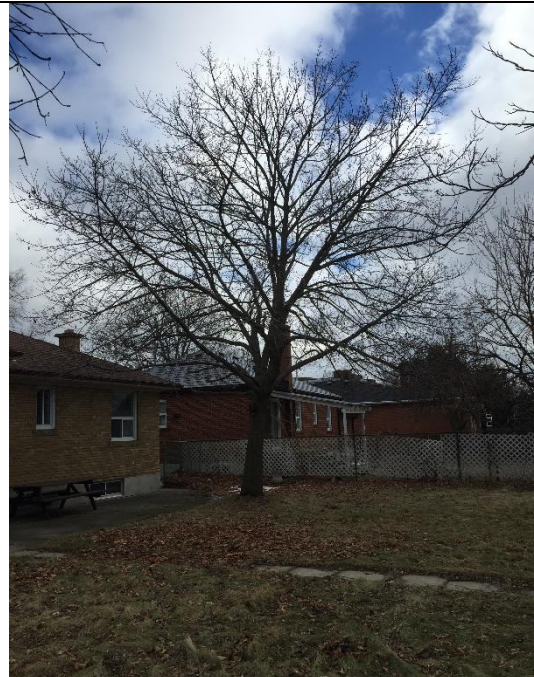
Photograph 8. Norway Maple in rear yard of 2482 Confederation Parkway. (Tree Tag no. 189).

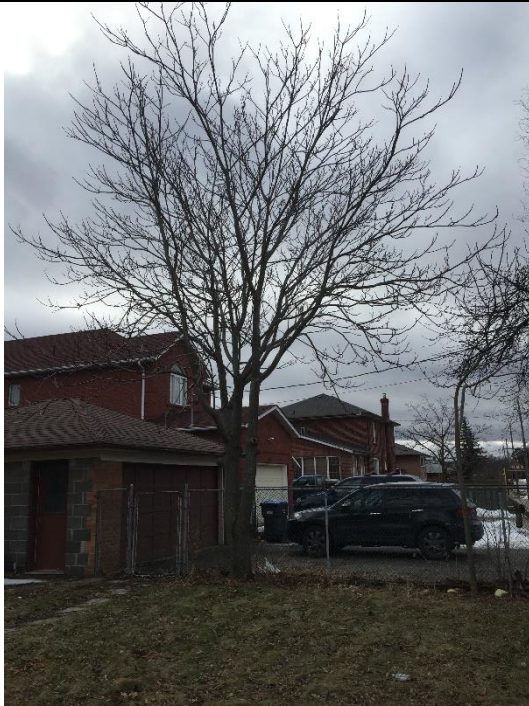
Photograph 9. Tree of Heaven located in the rear yard of 2482 Confederation Parkway. (Tree Tag No. 190).

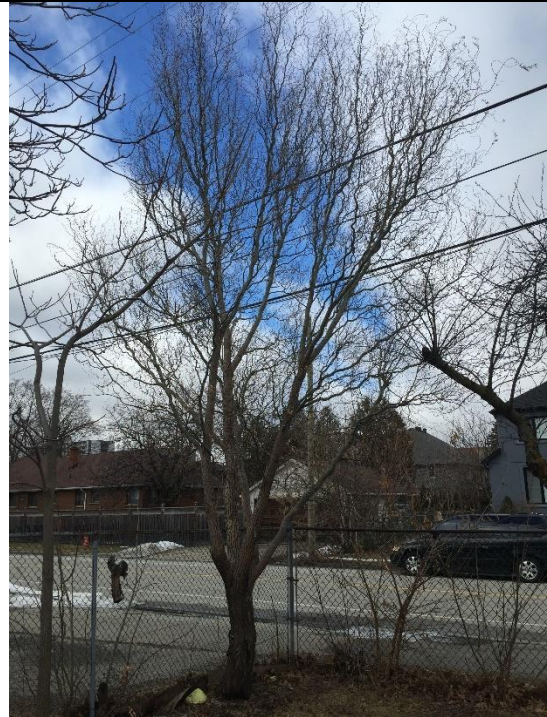
Photograph 10. Corkscrew Willow located in the rear yard of 2482 Confederation Parkway. (Tree Tag no. 191).

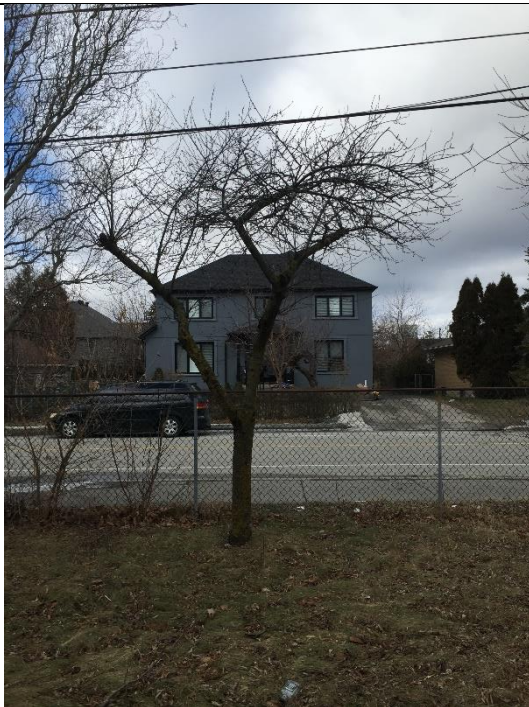
Photograph 11. Ornamental Cherry located in the rear yard of 2482 Confederation Parkway. (Tree Tag no. 192).

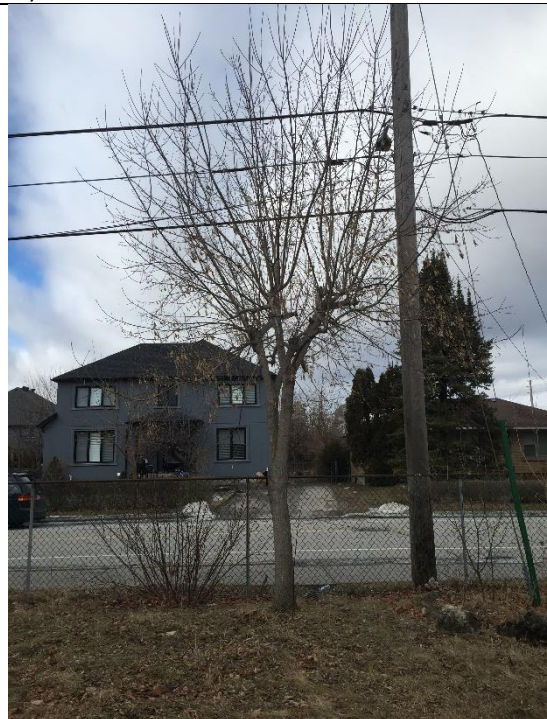
Structure	Health*	Hazard				Owner	Street No.	Street Name	City	Postal Code
193	<i>Acer negundo</i>	Manitoba Maple	22.2	1.5	Good	Good	No	Remove	Yes	Along fence-row; tree will interfere with construction footprint and space necessary to facilitate construction work (i.e., grading, laydown, and equipment use/access.	Private	2482	Confederation Parkway	Mississauga	L5B
194	<i>Acer negundo</i>	Manitoba Maple	33.3	2.5	Fair	Good	No	Remove	Yes	Multi-stem; along fence-row; part of trunk wrapped with wire; epicormic shoots; tree will interfere with construction footprint.	Private	2482	Confederation Parkway	Mississauga	L5B
195	<i>Ailanthus altissima</i>	Tree of Heaven	22.3	2	Good	Good	No	Remove	Yes	Tree will interfere with construction footprint and space necessary to facilitate construction work (i.e., grading, laydown, and equipment use/access.	Private	2482	Confederation Parkway	Mississauga	L5B
196	<i>Acer negundo</i>	Manitoba Maple	20.5	2	Good	Good	No	Remove	Yes	Tree will interfere with construction footprint and space necessary to facilitate construction work (i.e., grading, laydown, and equipment use/access.	Private	2482	Confederation Parkway	Mississauga	L5B

Photograph 12. Manitoba Maple located in the rear yard of 2482 Confederation Parkway. (Tree Tag no. 193).

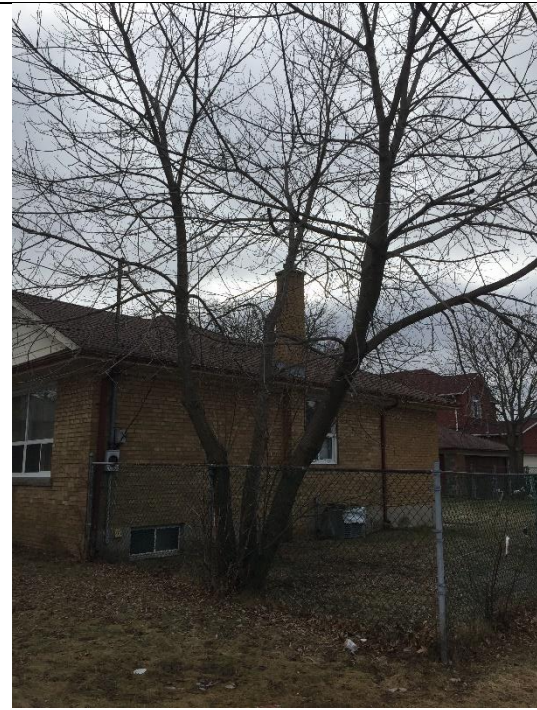
Photograph 13. Manitoba Maple located in the side yard of 2482 Confederation Parkway. (Tree Tag no. 194).

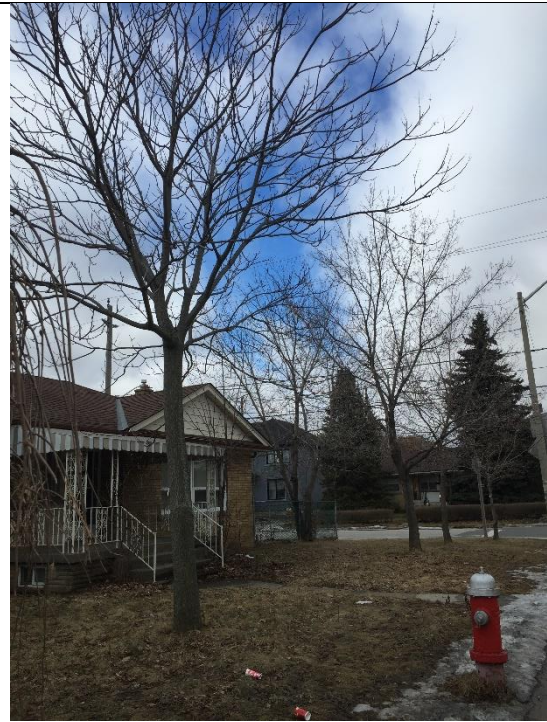
Photograph 14. Tree of Heaven located in the rear yard of 2482 Confederation Parkway. (Tree Tag no. 195).

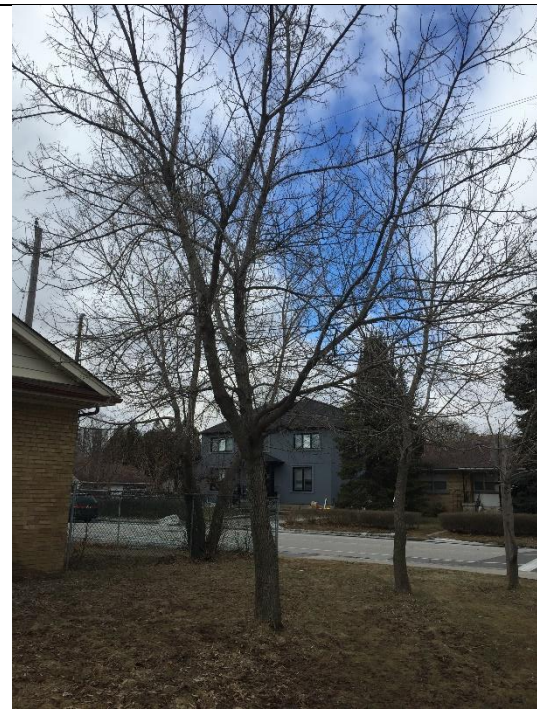
Photograph 15. Manitoba Maple located in the front yard of 2482 Confederation Parkway. (Tree Tag no. 196).

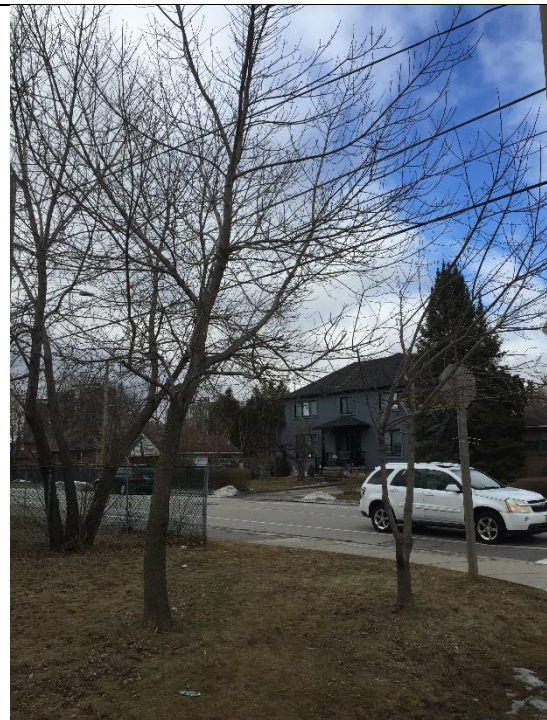
Photograph 16. Manitoba Maples located in the front yard of 2482 Confederation Parkway. (Tree Tag no. 197 and 198).

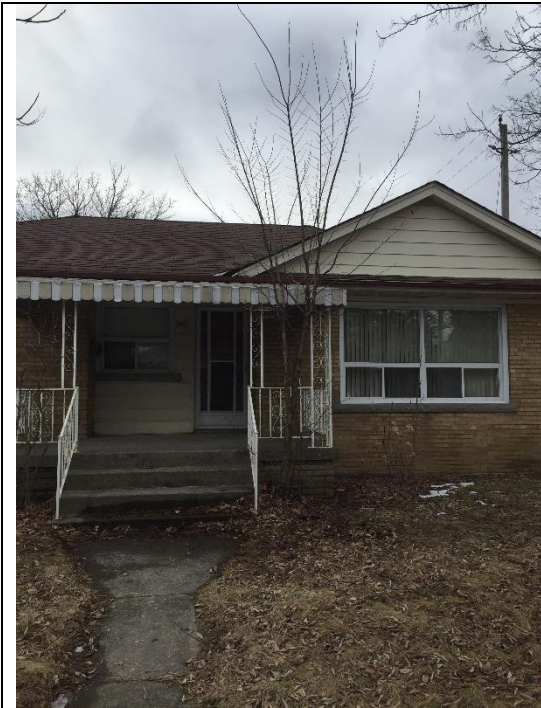
Photograph 17. Scotch Elm located in the front yard of 2482 Confederation Parkway. (Tree Tag no. 199).

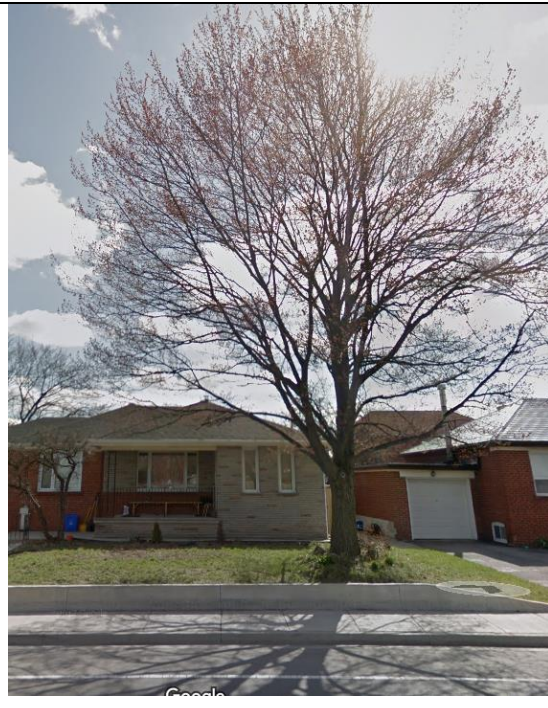
For the 22 trees inventoried, a total of one (1) tree will be preserved. Tree No. 200 is situated on the adjacent property at 2470 Confederation Parkway. This tree is within five (5) to 10 metres of proposed construction and has been included in this inventory as per the PSR. Based on the understanding of future construction requirements at this time, it is recommended this tree be avoided and protected as prescribed and illustrated in Appendix A.

Photograph 18. Silver Maple image taken from google imagery. Tree located in front yard of 2470 Confederation Parkway. No tag. Identified as Tree No. 200.
