ARBORIST REPORT

**PROPOSED TOWNHOUSE CONDOMINIUM DEVELOPMENT
1240 BRITANNIA ROAD WEST
CITY OF MISSISSAUGA**

ISA CERTIFIED ARBORIST
MATTHEW GEHRES – ON1114A
OUR PROJECT NO:
19-5406

March 20, 2020
Issued for Submission

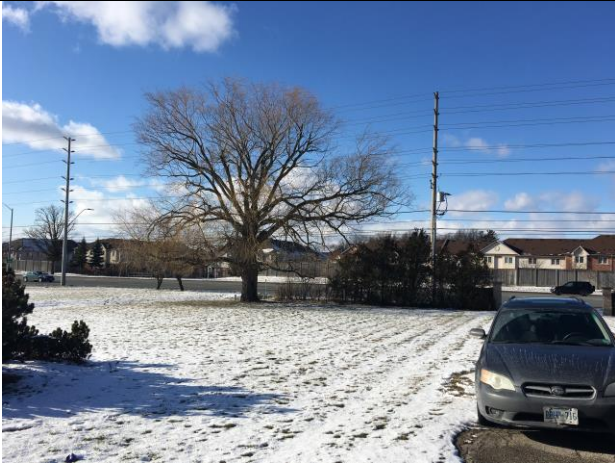
View north from existing dwelling

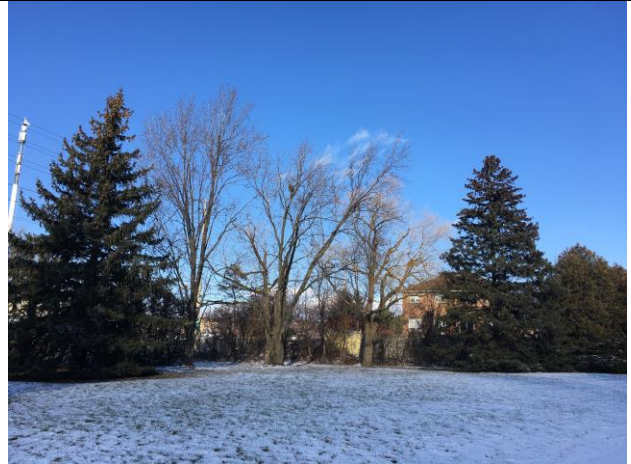
Northeast corner of property

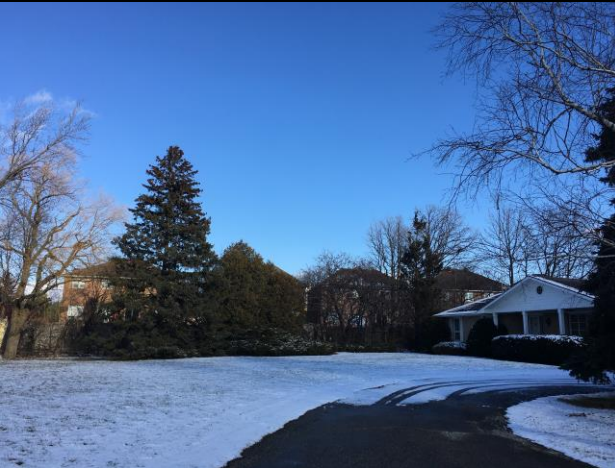
View southeast from driveway off of Britannia

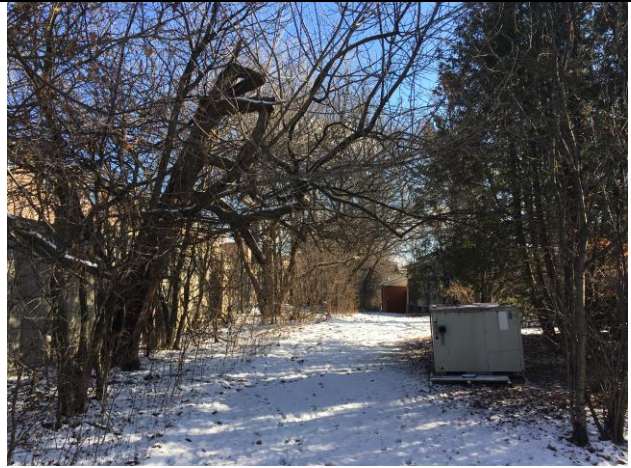
View south of naturalized grouping flanking east property limit

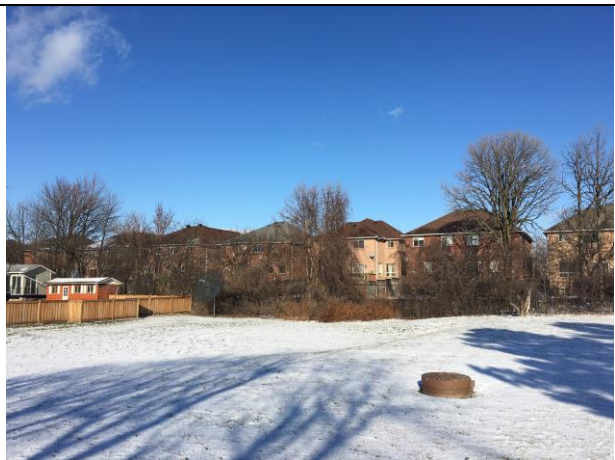
View east of east property limit

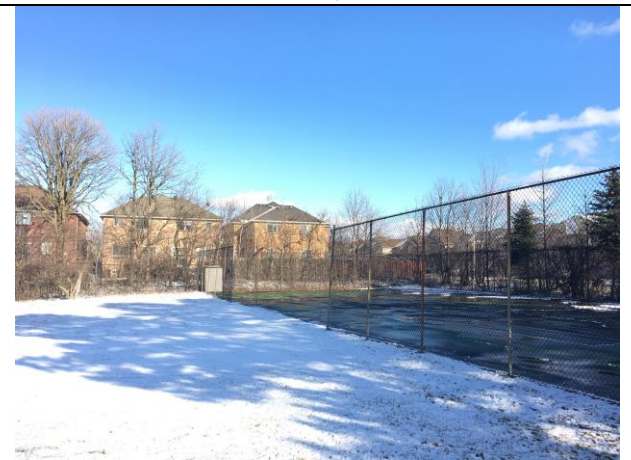
View southeast of east property limit

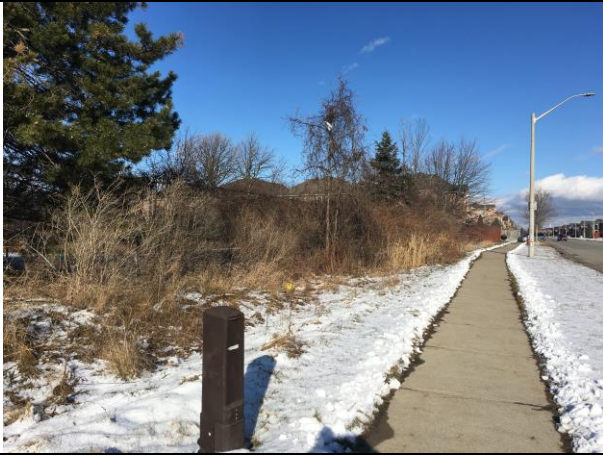
View east along south property limit

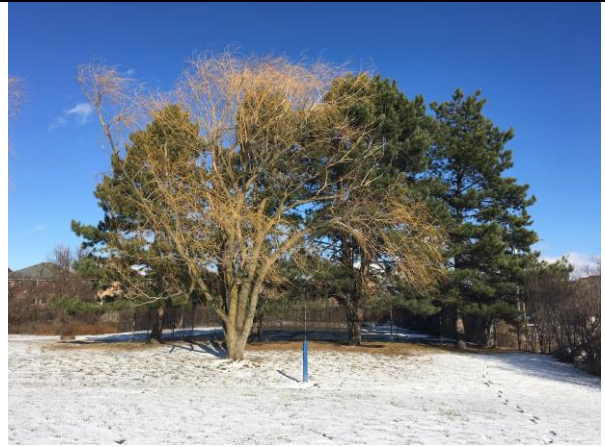
View east of west side of tennis court

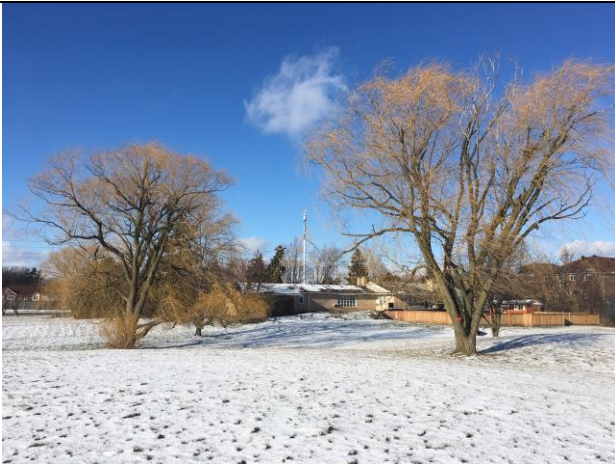
View north from tennis court

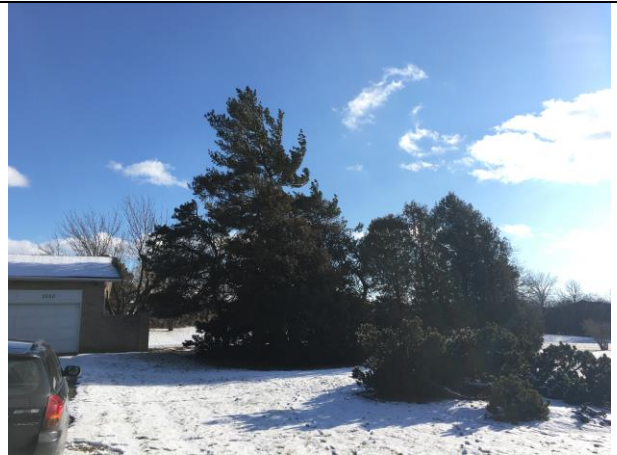
View south from west side of existing dwelling

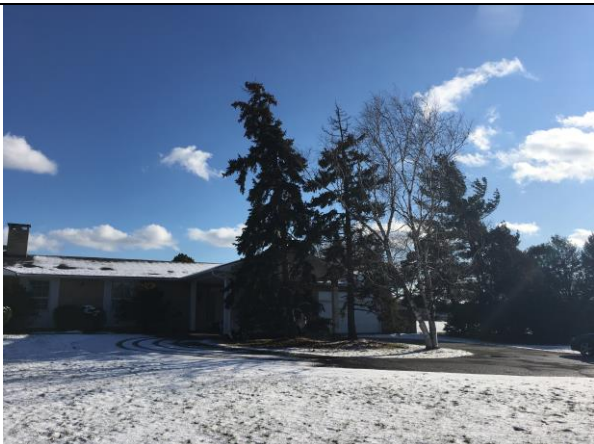
View south of tree grouping in front of existing dwelling

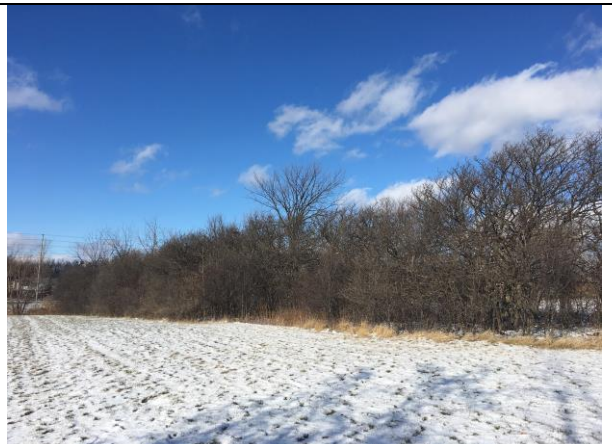
View north of west edge of naturalized grouping along west edge of property

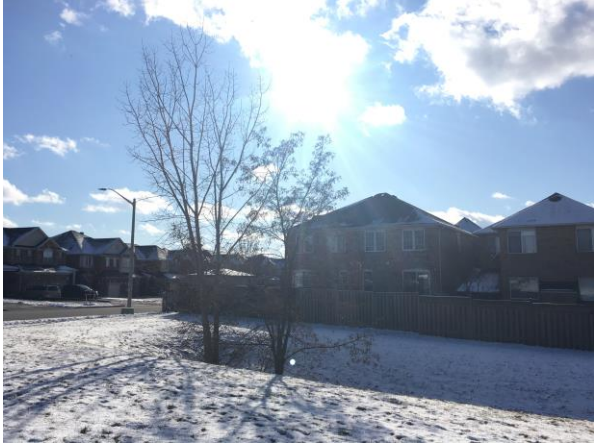
View southwest of southwest property limit

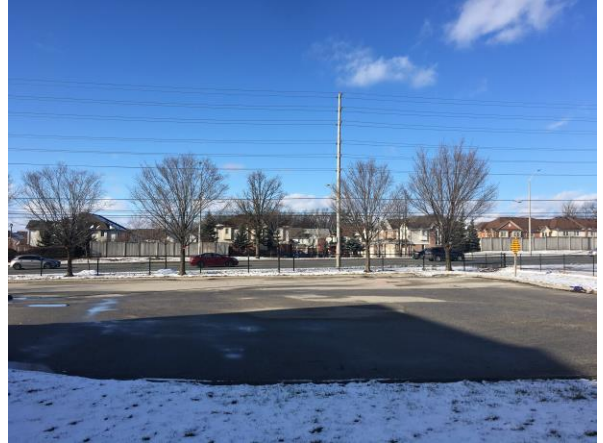
Existing Blvd. trees along north edge of cul de sac at northwest property I

The existing boulevard trees along the north side of the existing cul de sac at the end of Cabrera Crescent (north west corner of the site), tree#2 (located on an adjacent lot to the east of the site) and four trees flanking the east property limit are to be preserved and protected during the site development works. These trees shall be protected in accordance with City of Mississauga tree protection standards. Tree protection is to be installed along the limit of the minimum TPZ or as outlined on the V100 - Tree Inventory, Preservation & Removals Plan. Hoarding is to remain in place throughout the duration of construction and should be periodically reviewed by the Consulting Arborist to ensure that it remains in good working condition.

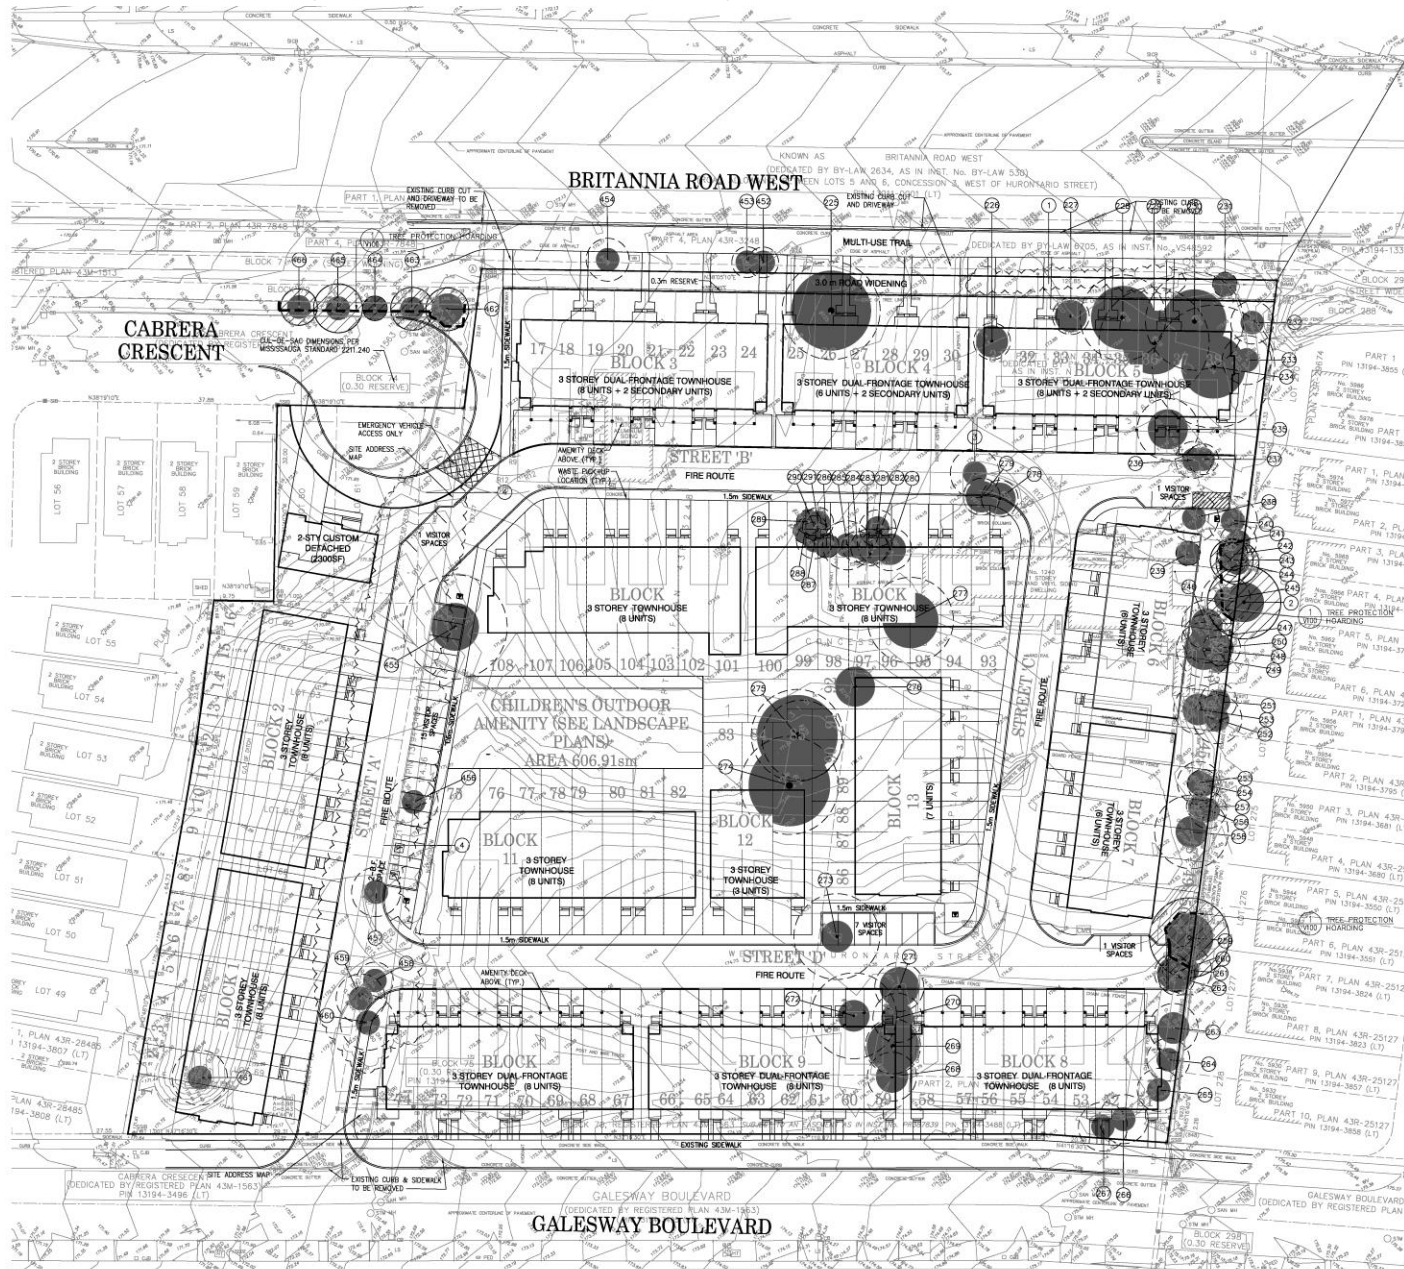
Appendix C – TREE INVENTORY PLAN
(for context only – refer to full size V100 Tree Inventory, Preservation and Removals Plan for details)

Based on the proposed development constraints including grading, servicing and construction requirements, all of the trees internal to the site are recommended for removal with the exception of four trees flanking the east property limit.
