Geomorphic Assessment 51 & 57 Tannery Street & 208 Emby Drive Mullet Creek Watershed City of Mississauga

Prepared For: Nyx Capital Corp.

Prepared By: Beacon Environmental Limited

> Date: Project: May 2019 217069.1

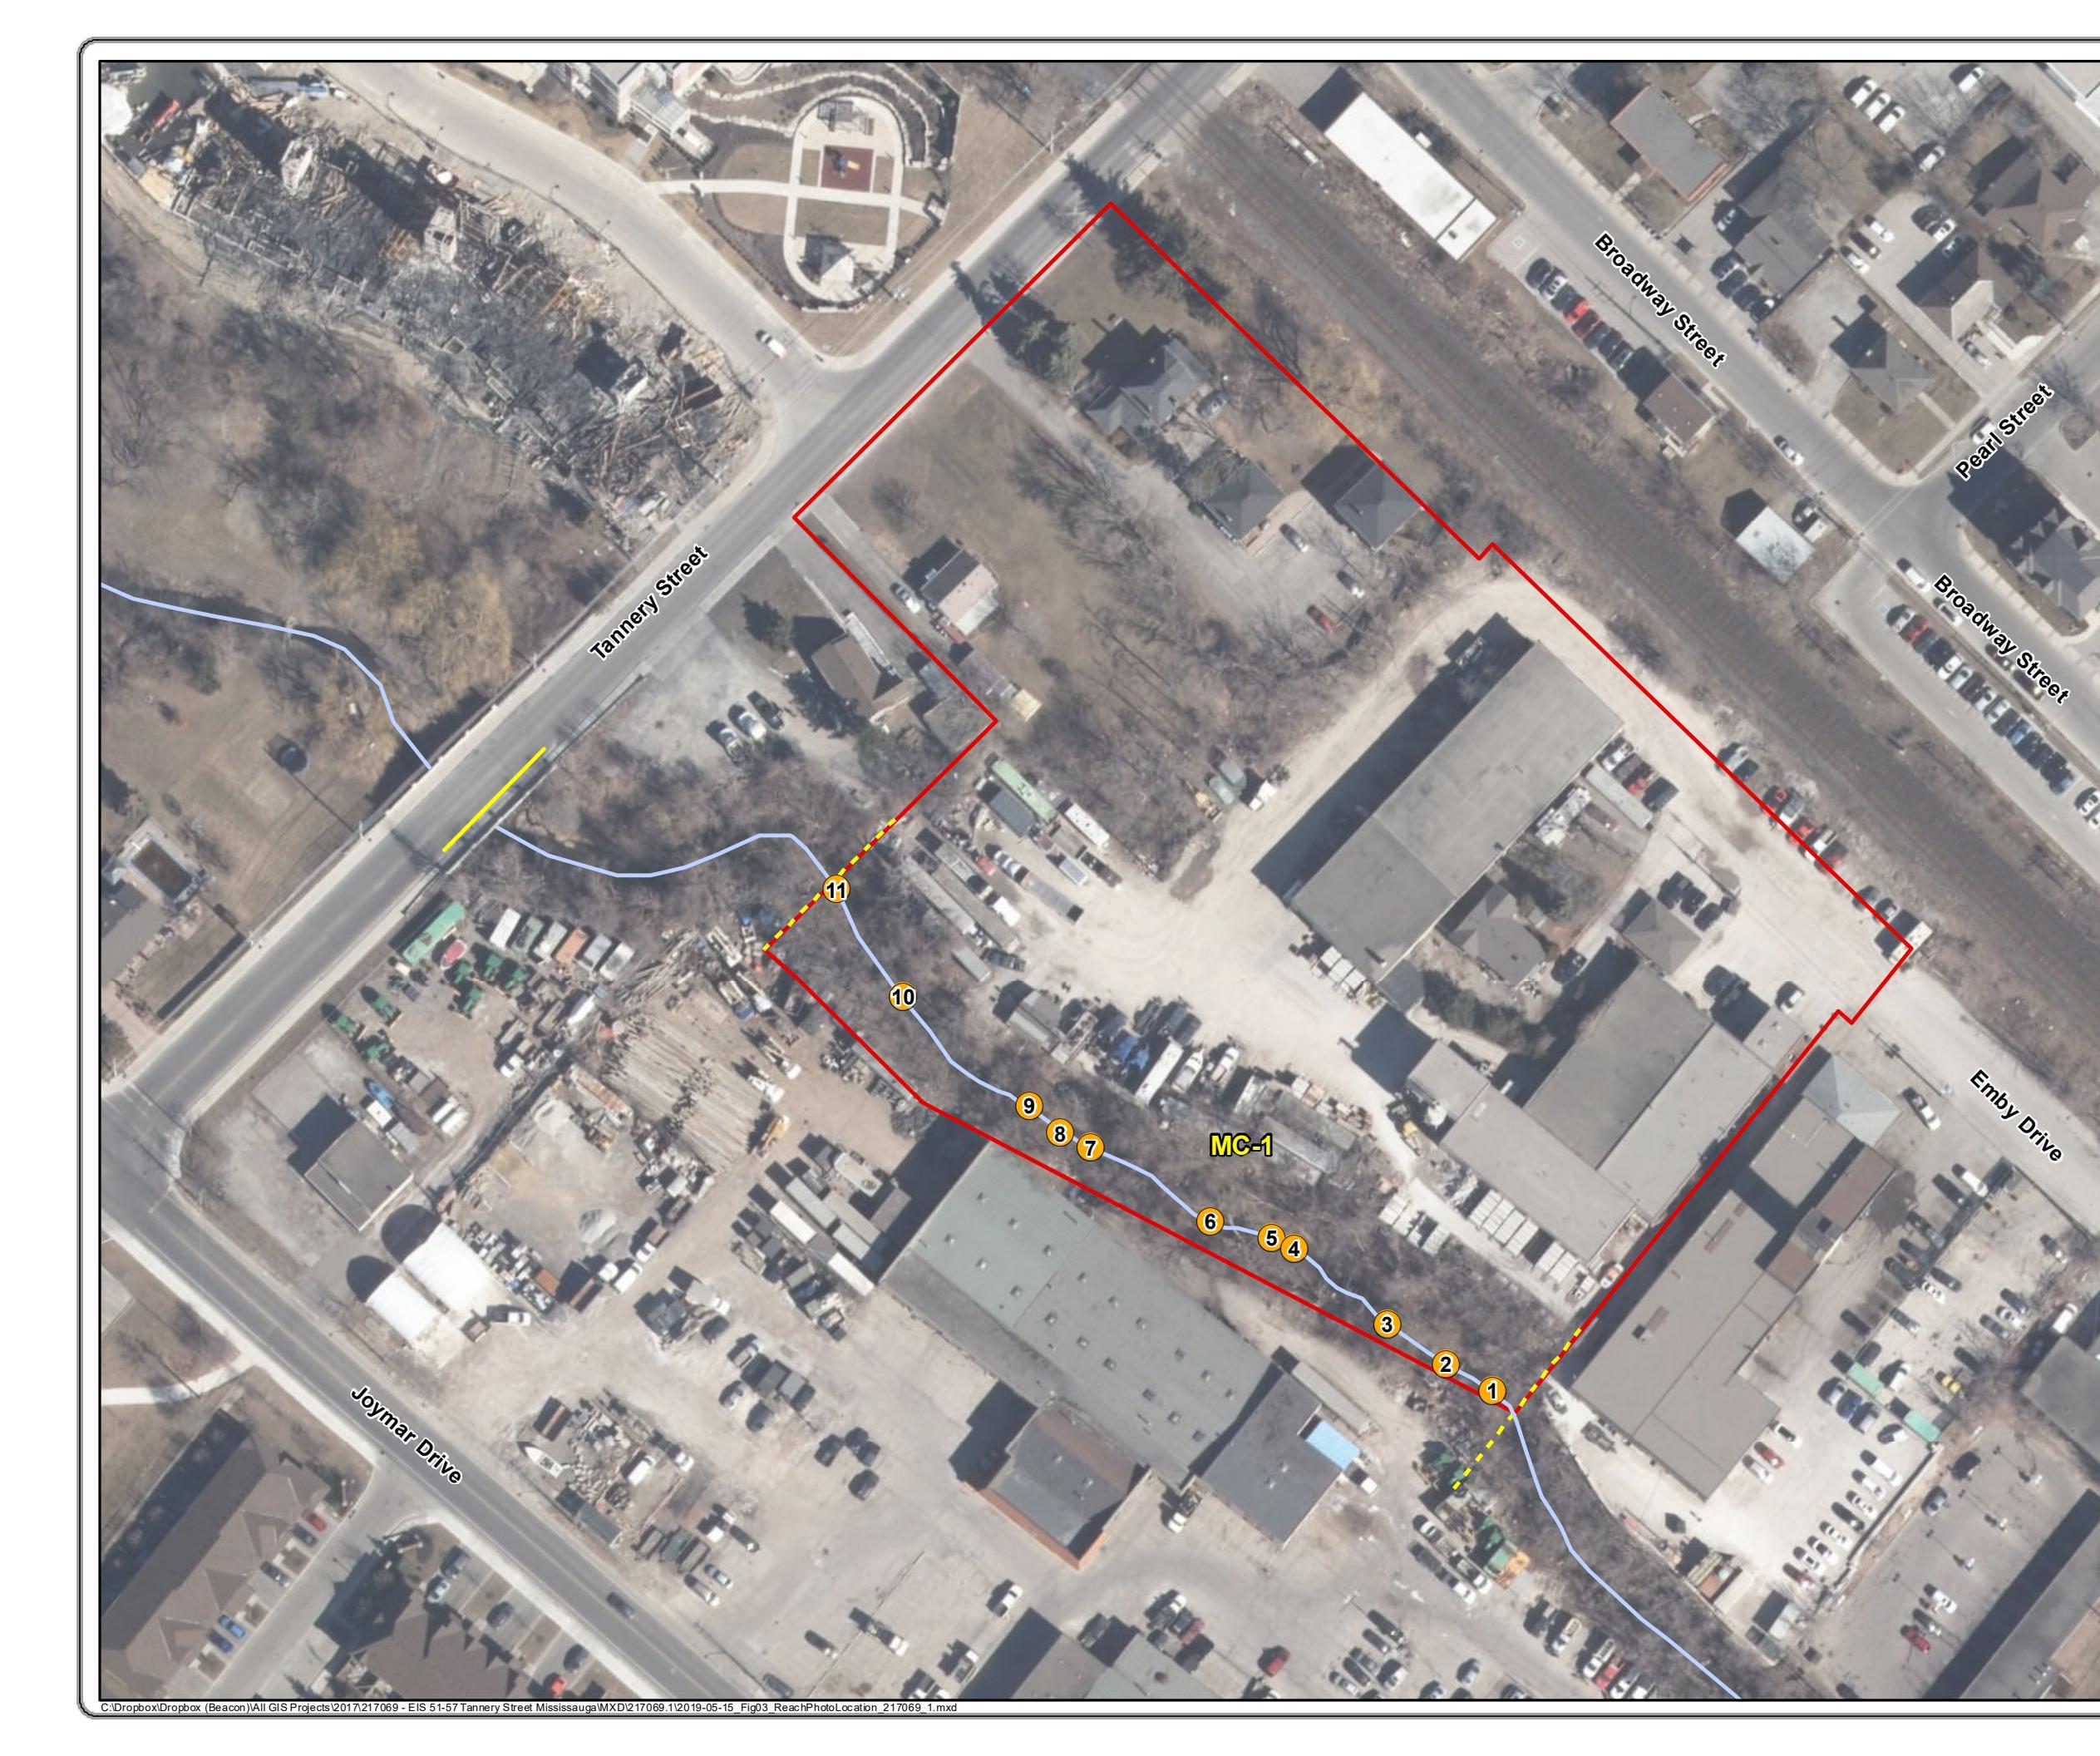
Figure 3

Results of the rapid assessments are summarized in **Table 4** and **Table 5** below. A photographic record of site conditions at the time of the assessment is provided in **Appendix B.** Photo locations and extent assessed through the field investigation are identified on **Figure 3**.

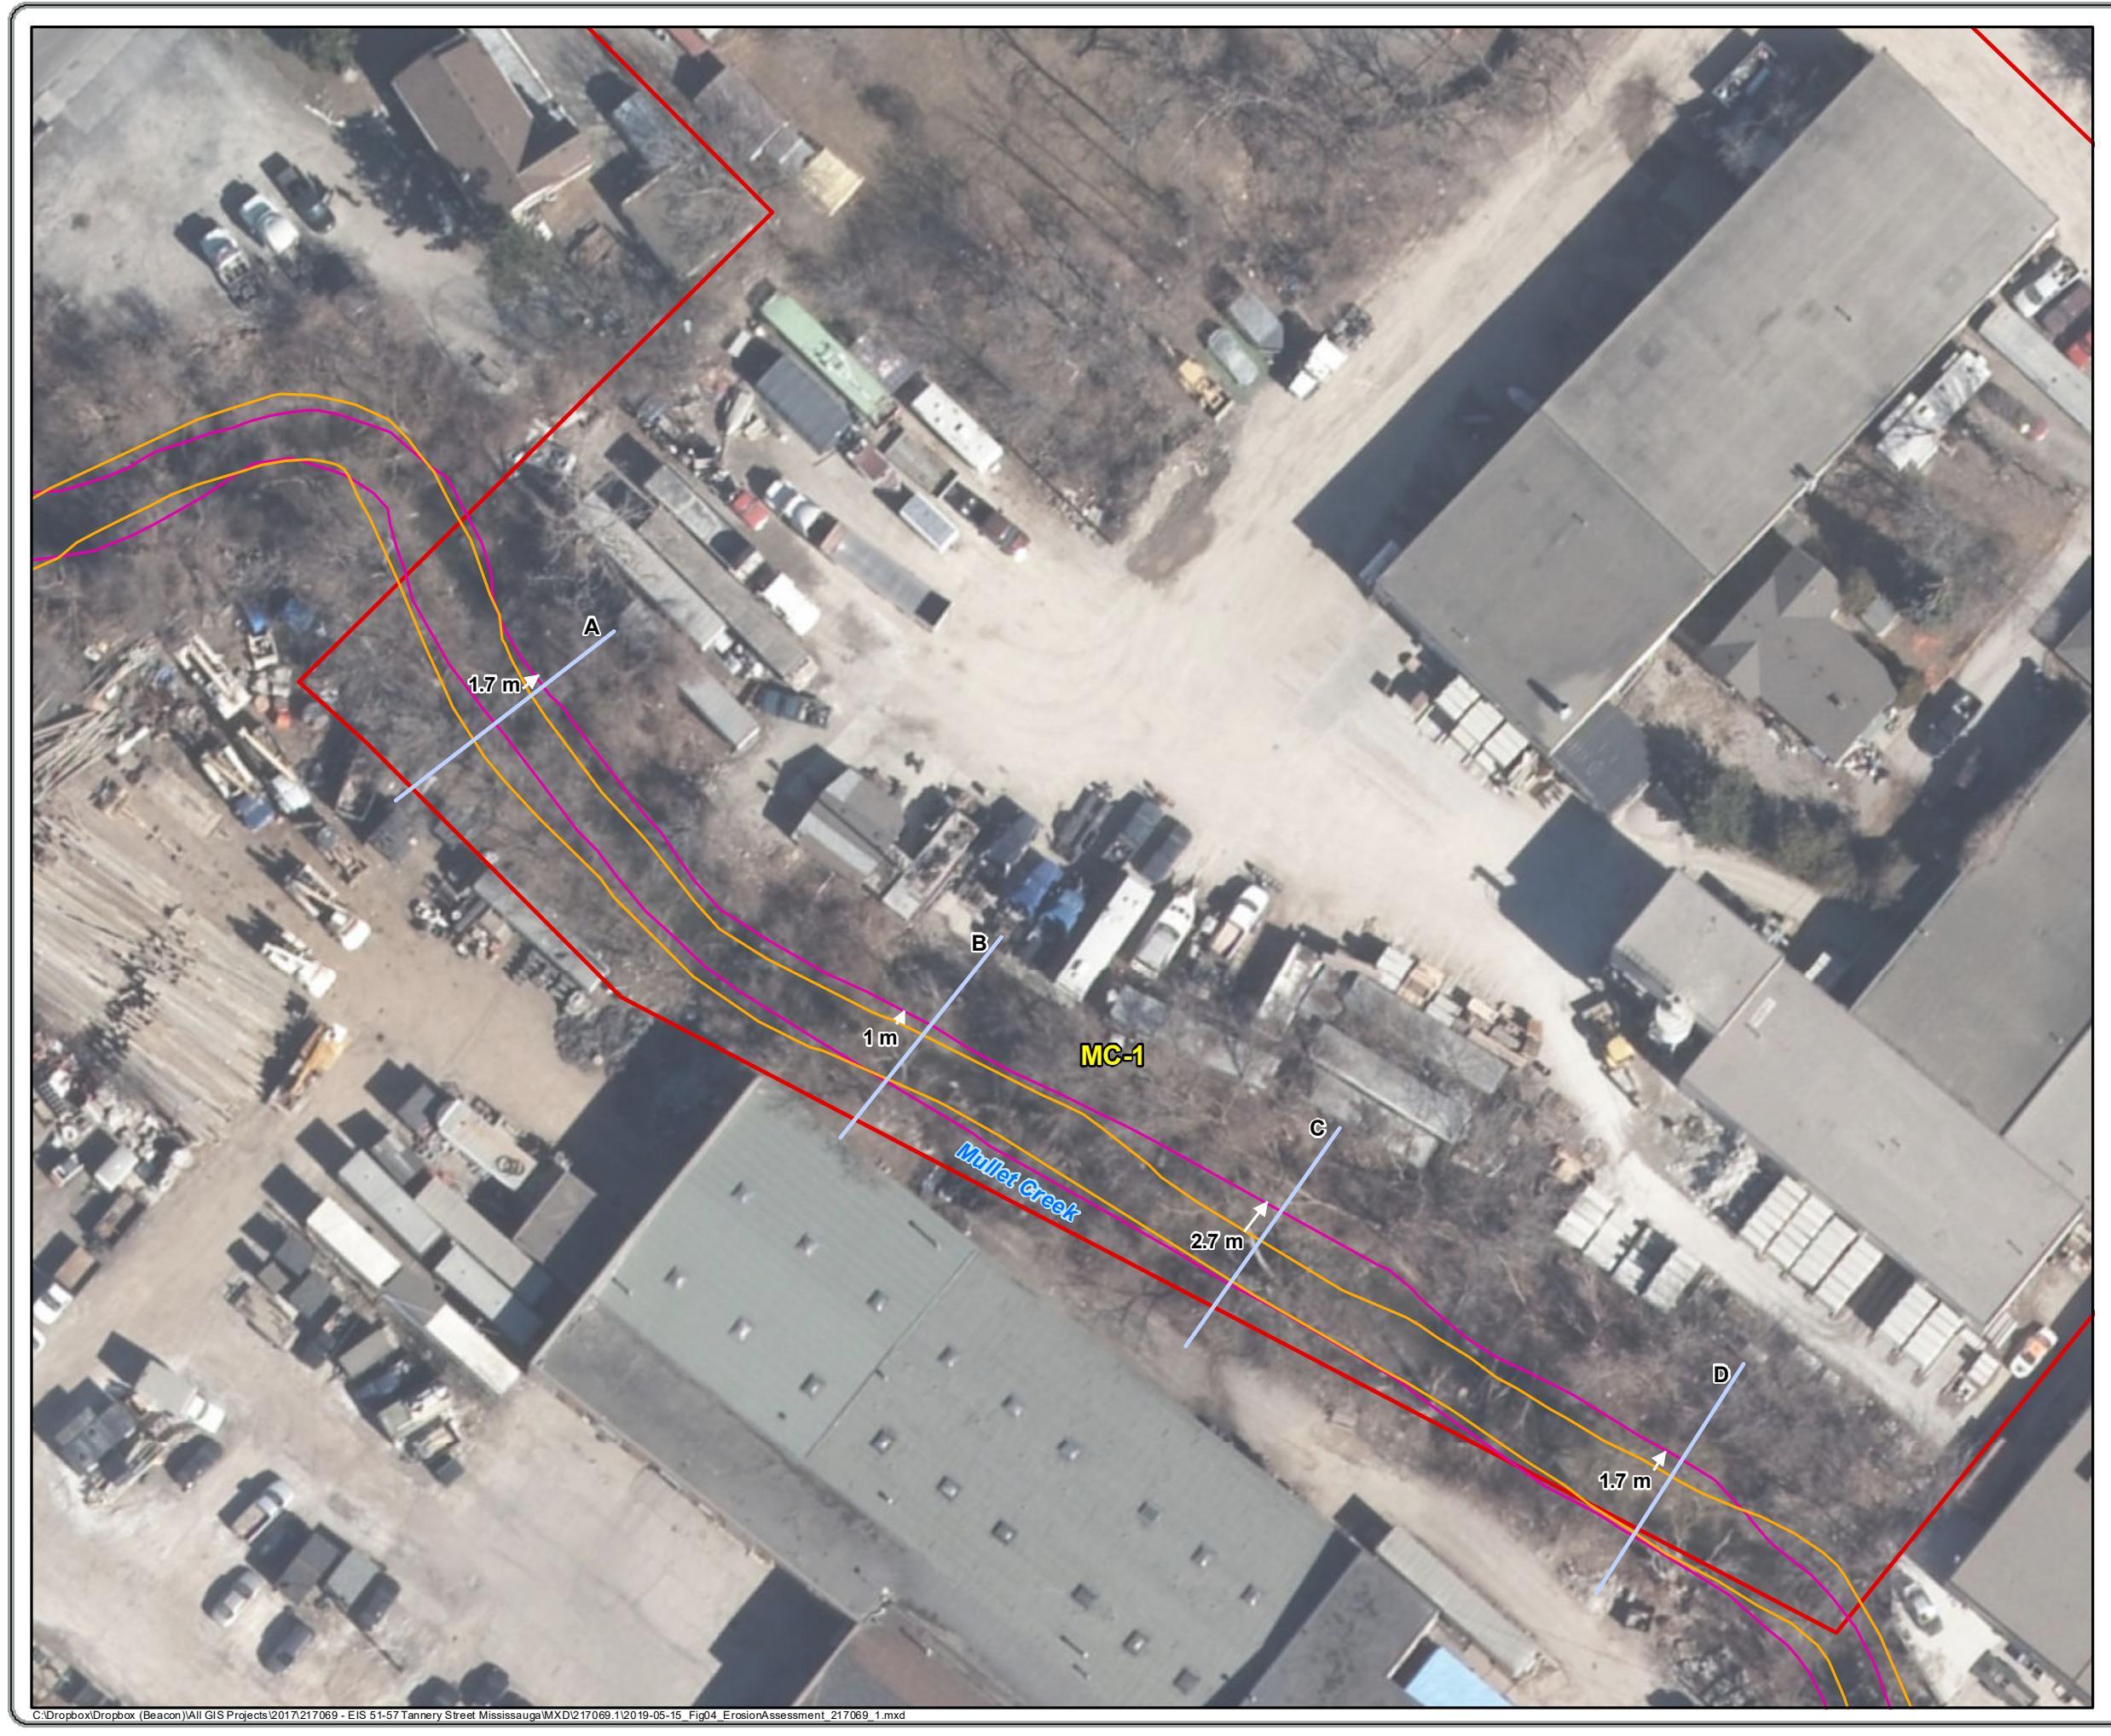
Figure 4

Within the extent assessed, the overall trend in migration was noted to be in the direction of the valley slope and subject property. These results are consistent with the findings of the field investigation.

Results of the geomorphic field investigation characterized the portion of Mullet Creek within the subject property as being in an active state of adjustment, with planform adjustment and widening flagged as the dominant modes of adjustment. Site-specific observations at the four slope profile locations referenced in the Geotechnical Investigation (Patriot Engineering Ltd. 2017) noted evidence of active bank erosion.

In consideration of the lateral migration analysis, a 6 m design toe erosion allowance is recommended. This allowance was calculated as follows (reference **Figure 4**):

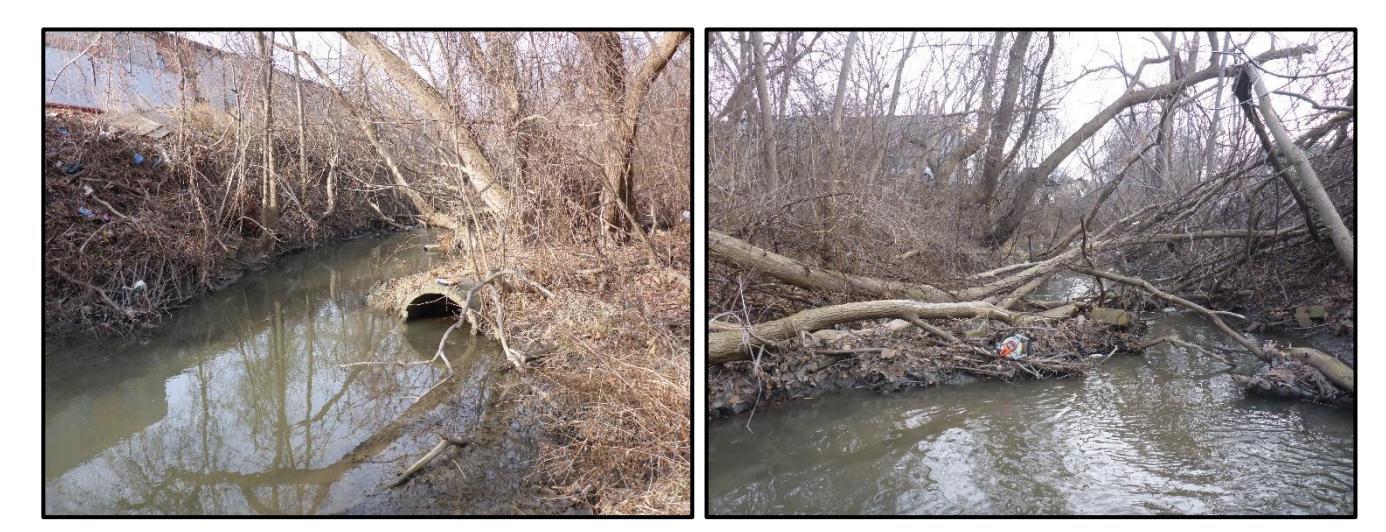
Photo 1 (Photo Location 1) Upstream view of Reach MC-1 from property limit.

Photo 2 (Photo Location 2) Upstream view of wood and urban debris within channel.

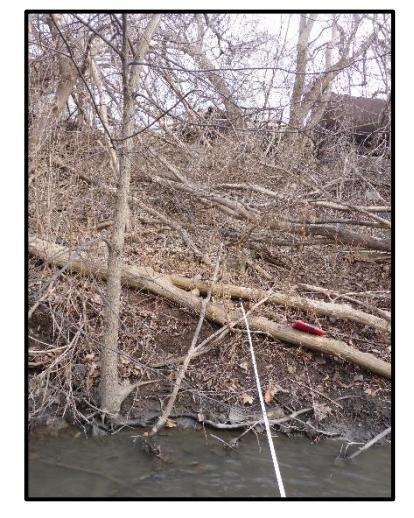
Photo 3 (Photo Location 3) Channel bank and toe of slope conditions at geotechnical section DD.

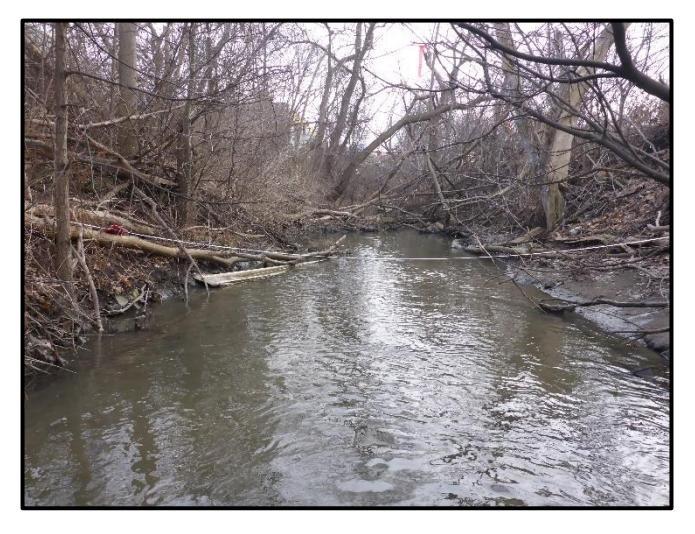
Photo 4 (Photo Location 3) Upstream view of general conditions at geotechnical section DD.

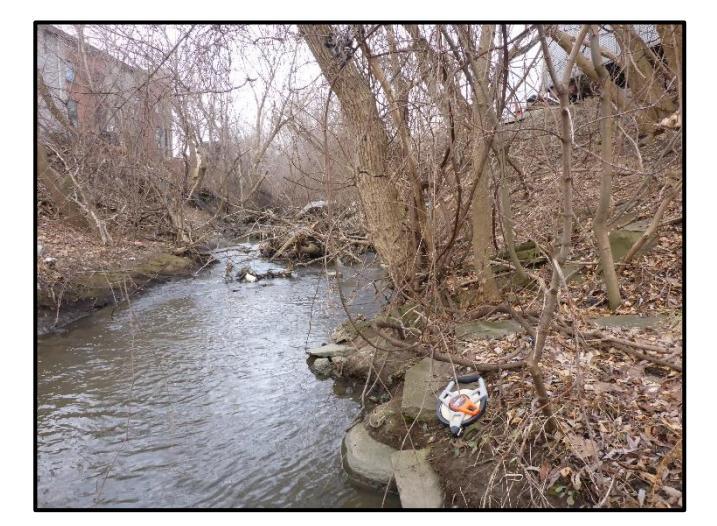
Photo 5 (Photo Location 4) Upstream view of wood debris jam.

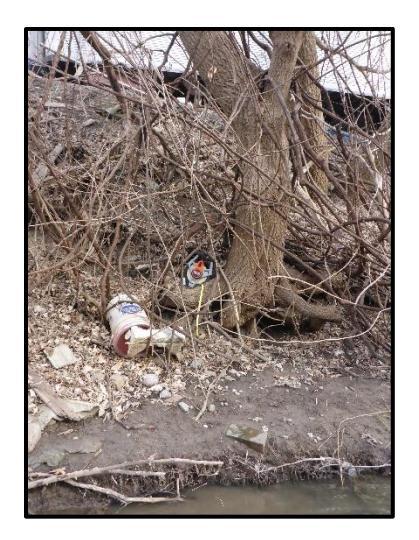
Photo 6 (Photo Location 5) Evidence of bank erosion and slope conditions along subject property.

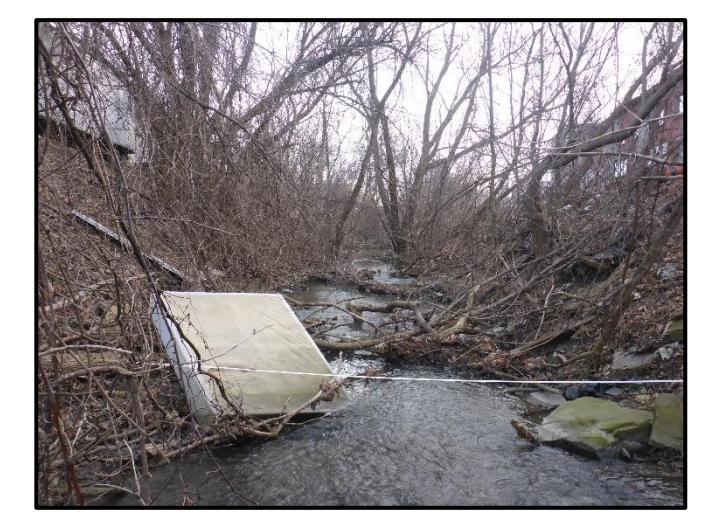
Photo 7 (Photo Location 6) Downstream view of general conditions at geotechnical section CC.

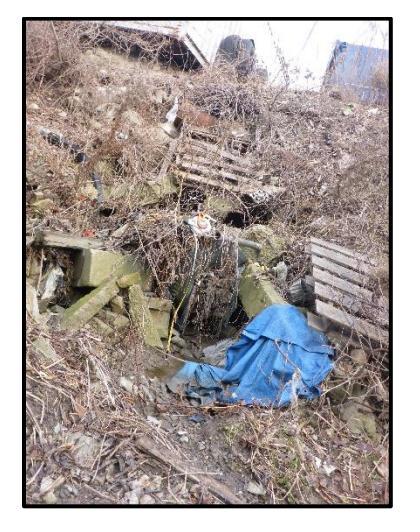
Photo 8 (Photo Location 7) Existing 1000 mm CSP outlet and debris along valley slope.

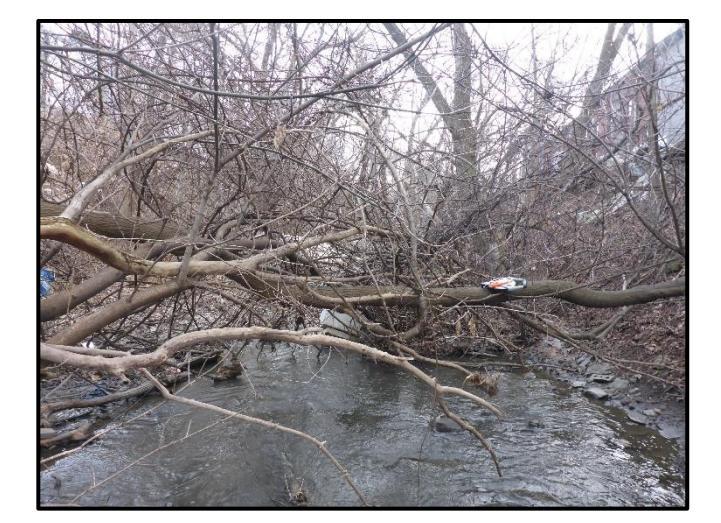
Photo 9 (Photo Location 7) Downstream view of general conditions and wood debris jam.

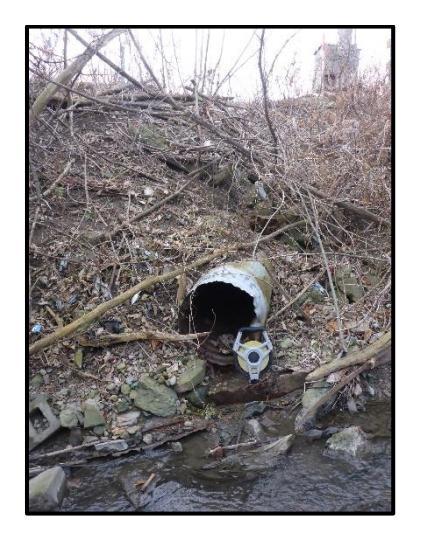
Photo 10 (Photo Location 8) Existing 500 mm CSP outlet to valley slope.

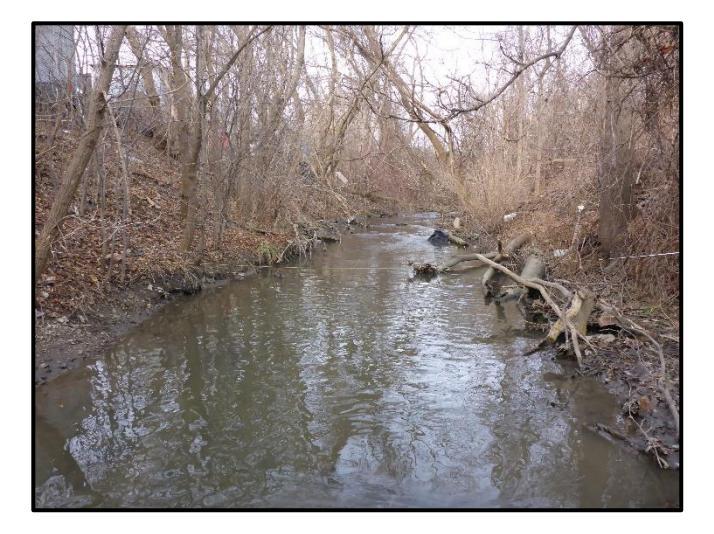
Photo 11 (Photo Location 9) Upstream view of channel conditions at geotechnical section BB.

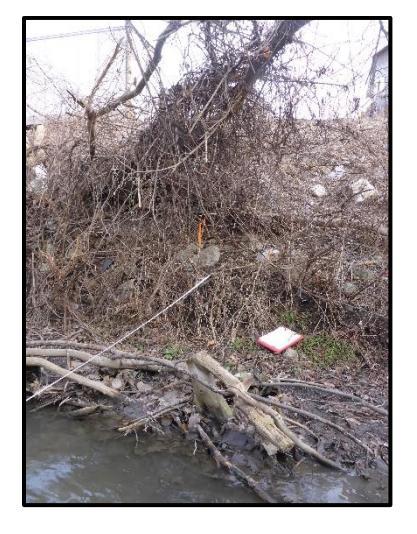
Photo 12 (Photo Location 9) Toe of slope at geotechnical section BB.

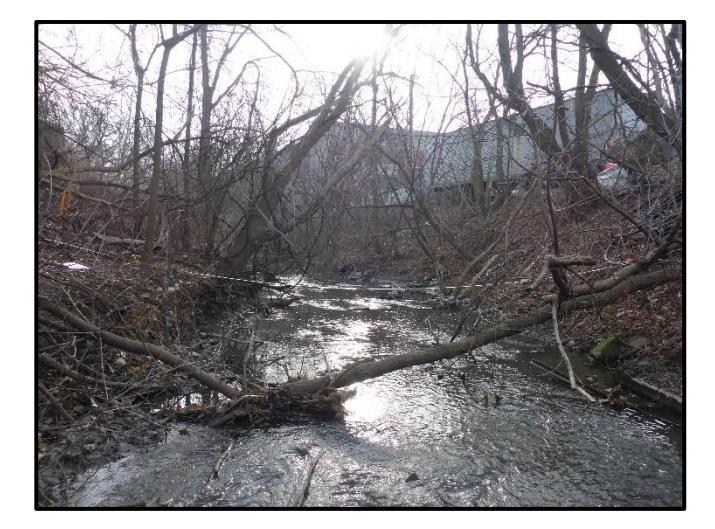
Photo 13 (Photo Location 10) Downstream view of channel conditions at geotechnical section AA.

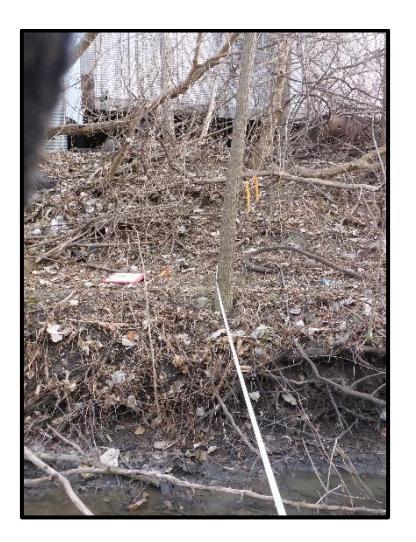
Photo 14 (Photo Location 10) Toe of slope at geotechnical section AA.

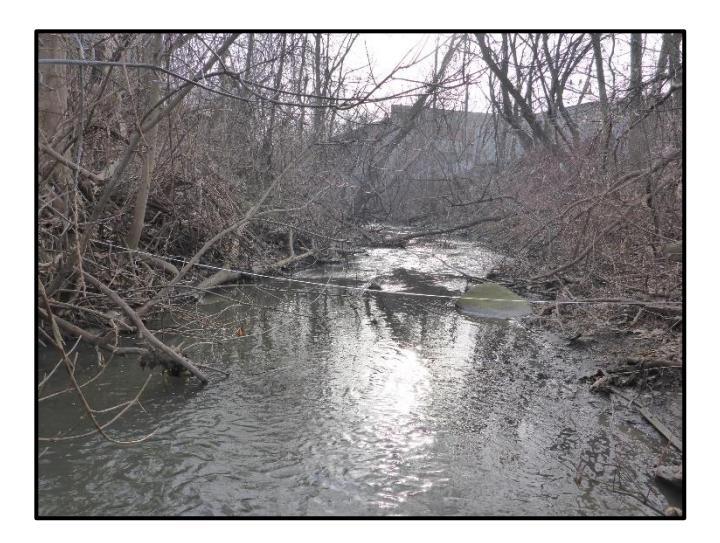
Photo 15 (Photo Location 11) Downstream view of general conditions at property limt.

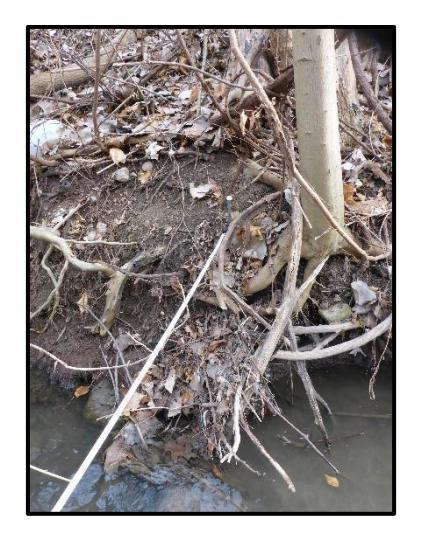
Photo 16 (Photo Location 11) Toe of slope at property boundary.
