# **Soil Engineers Ltd.**

March 20, 2019  
(Revision to Letter Report dated December 22, 2016)

**Re: Revised Slope Stability Study Addendum  
Proposed Residential Development  
1745, 1765 and 1775 Thorny Brae Place  
City of Mississauga**

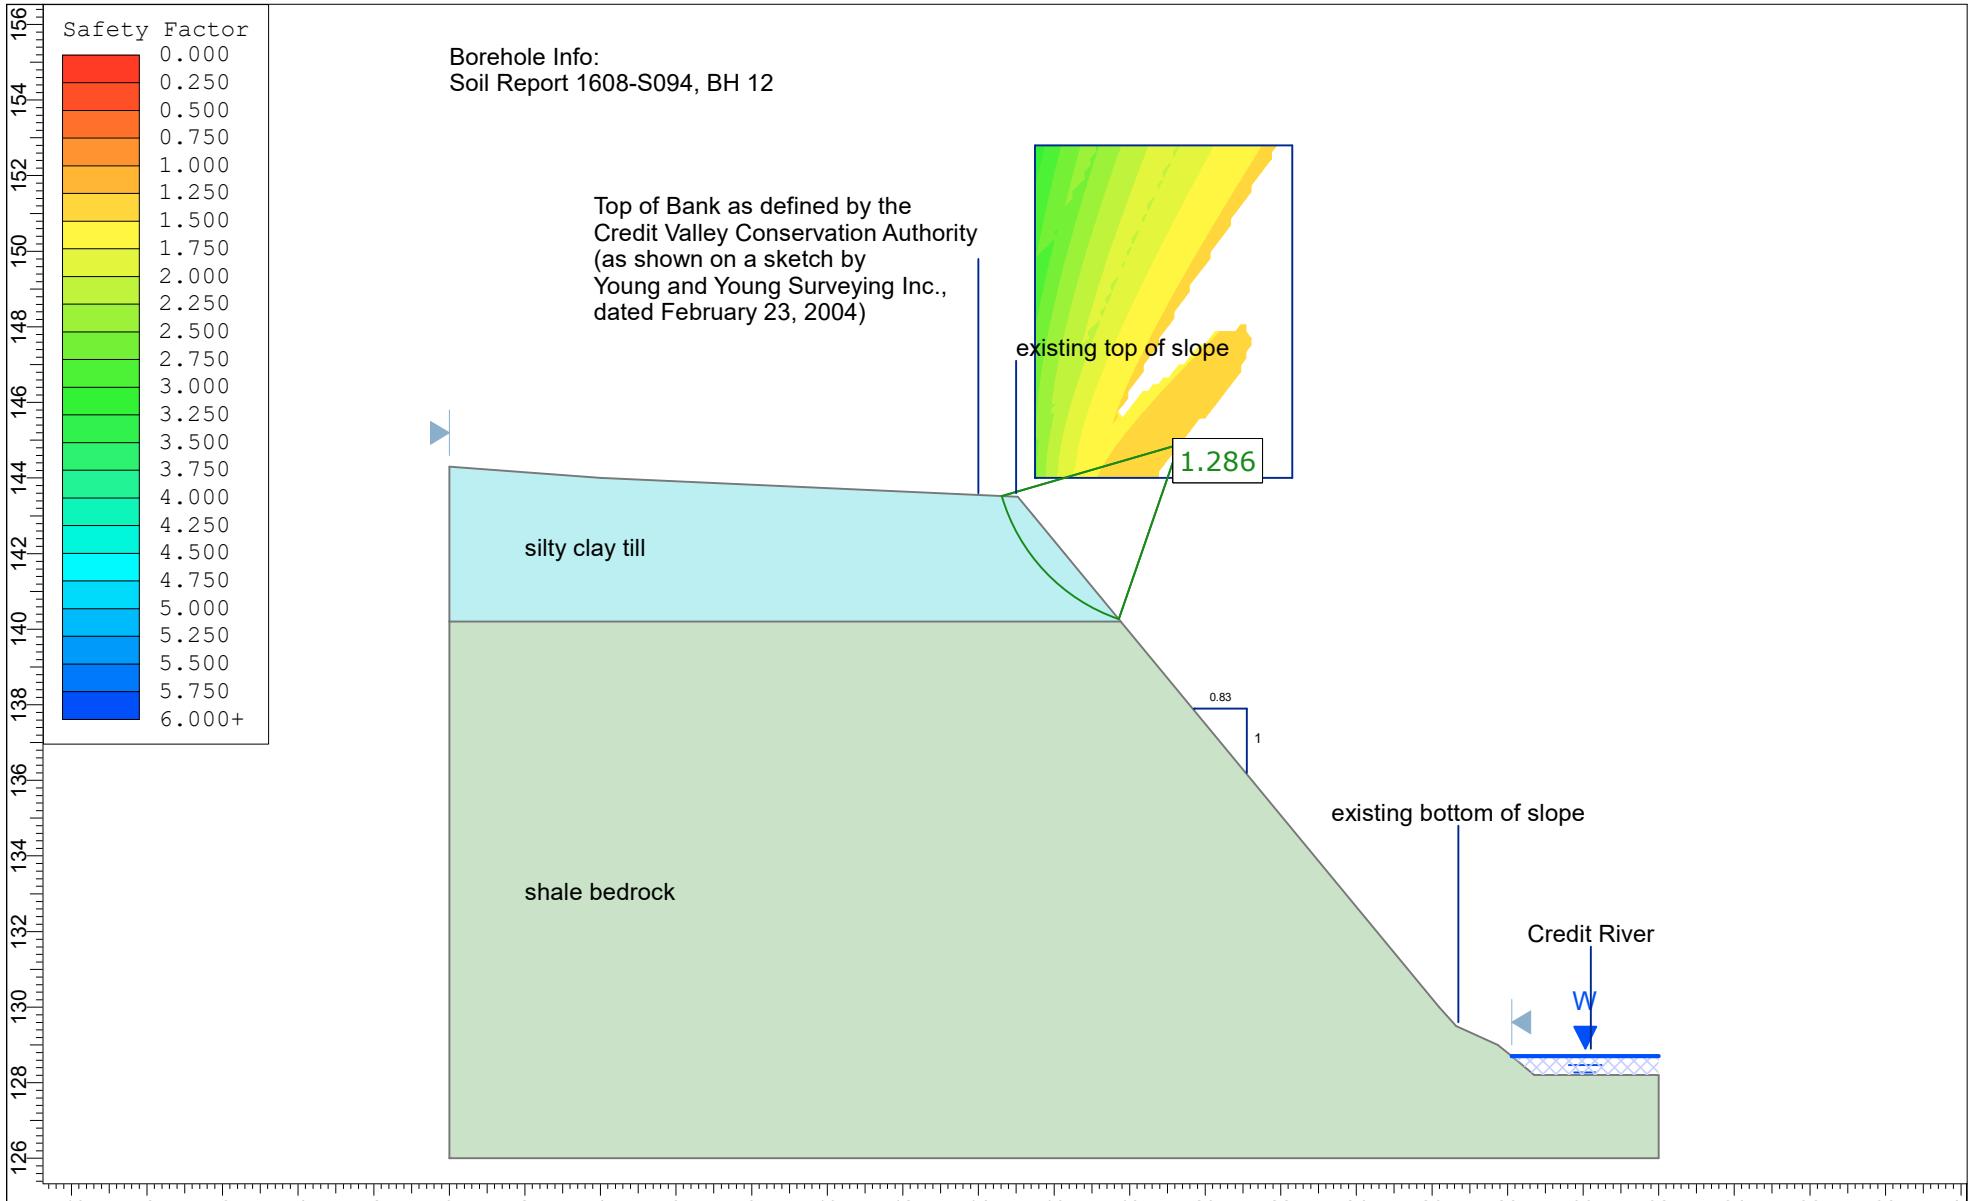
The results from the analyses indicate that the existing slope at Cross-Section A-A has a factor of safety (FOS) of 1.29 under both NGC and EGC, which does not meet the aforementioned minimum FOS. Therefore, the stability of the slope at Cross-Section A-A is considered to be geotechnically unacceptable. In order to achieve the required FOS, geotechnically stable gradients of 1V:1.4H and 1V:1.7H are recommended for use in the shale bedrock and silty clay till overburden, respectively. The remodeled slope, yielding a FOS of 1.834 which satisfies the OMNR and CVC requirements, is presented on Drawing No. 2C.

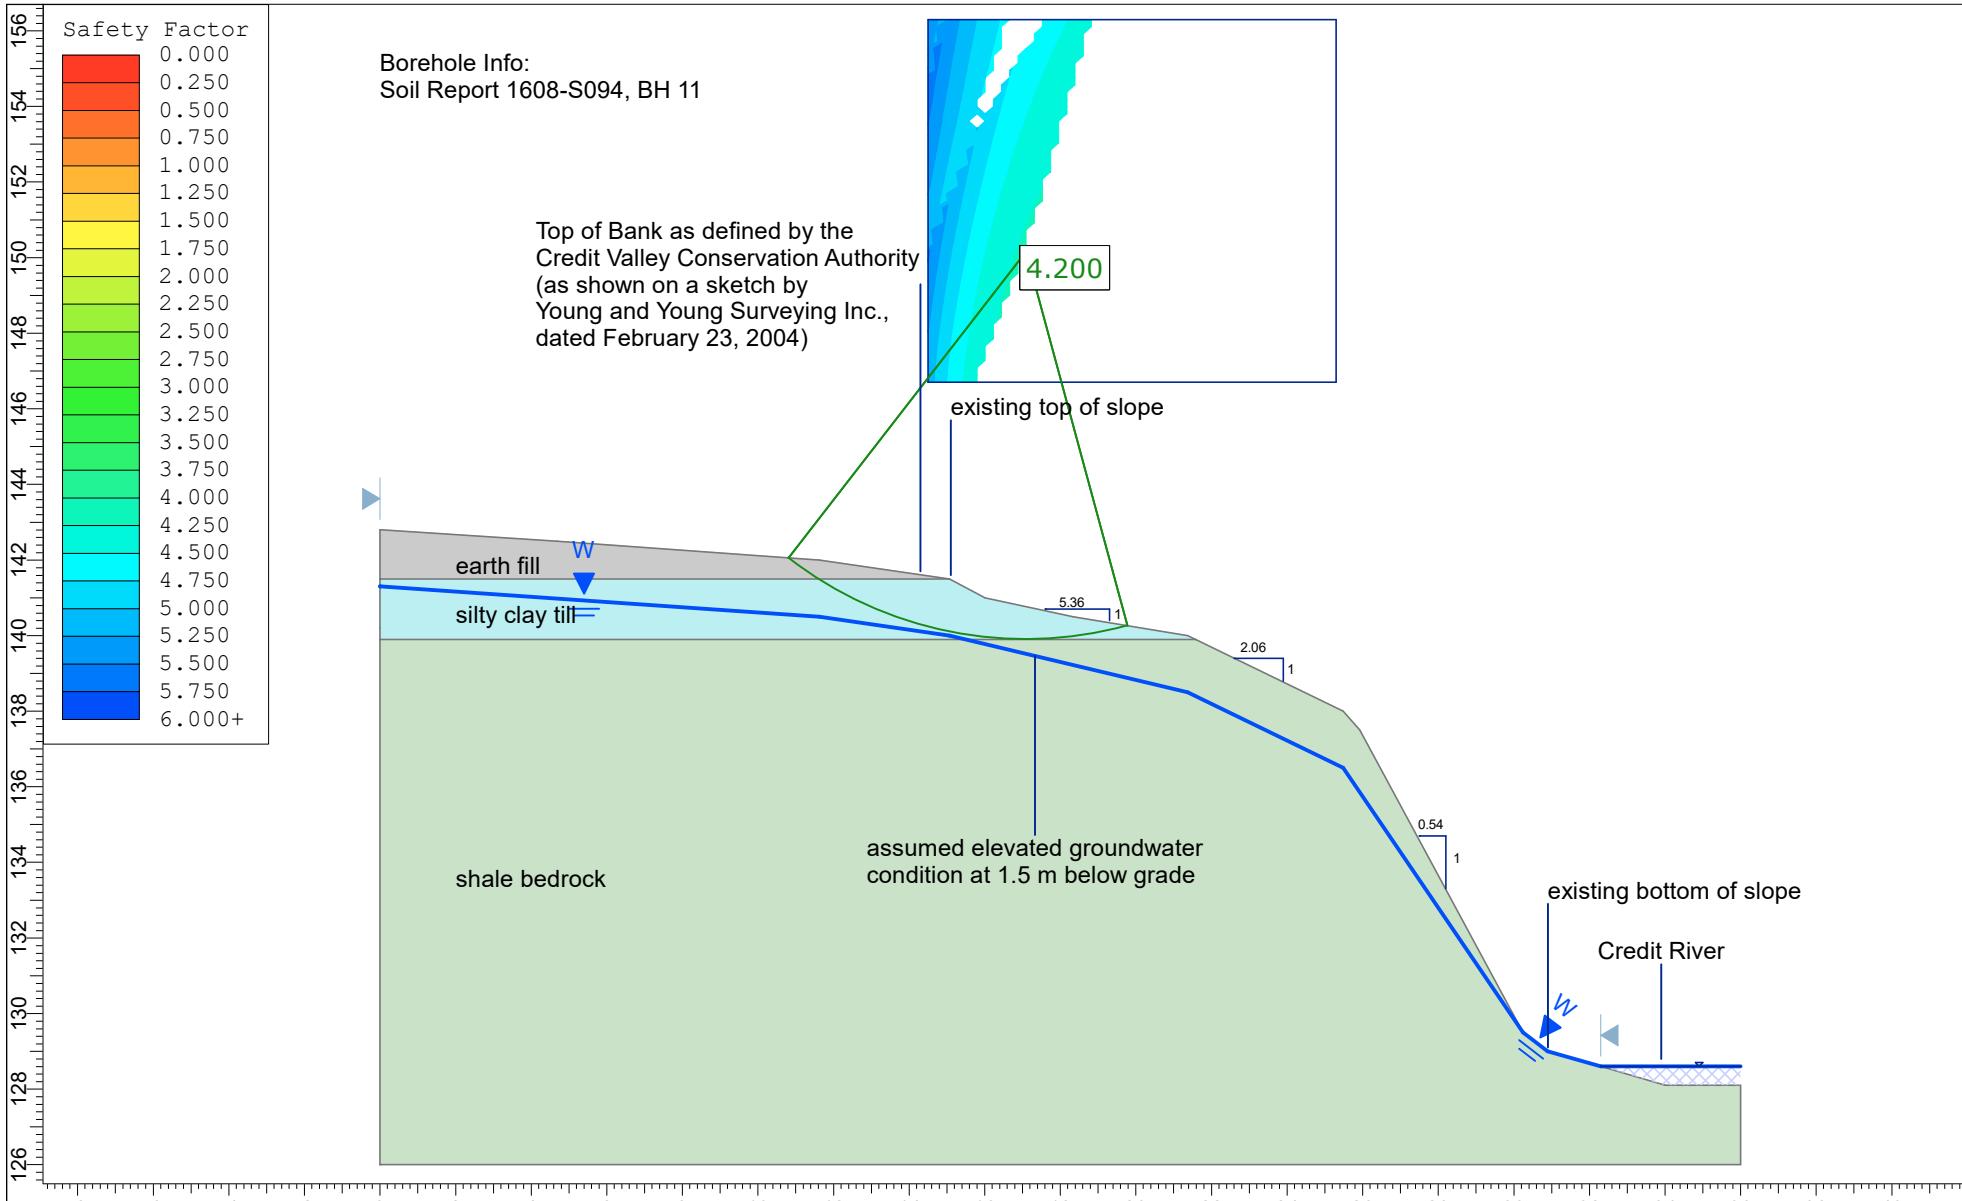
Project Title	Cross-Section B-B - Existing Condition		Load Case
		Location	1745, 1765 and 1775 Thorny Brae Place, Mississauga		Elevated Groundwater Condition
Drawn By	Checked By	Scale			Revision
HWY	BL	1:200			-
Date March 2019		Reference No.	1608-S094		Drawing No.
					3B

The existing slopes at the locations of Cross-Sections B-B, C-C, D-D and E-E have FOS of 1.5+ under both NGC and EGC, which satisfy the OMNR and CVC requirements for active land use. The result of analyses is presented on Drawing Nos. 3 to 6 (A and B), inclusive. Although the slopes at Cross-Sections B-B and C-C are considered to be geotechnically stable in their current condition, environmental degradation of the exposed shale bedrock should be anticipated and accounted for. Therefore, the geotechnically

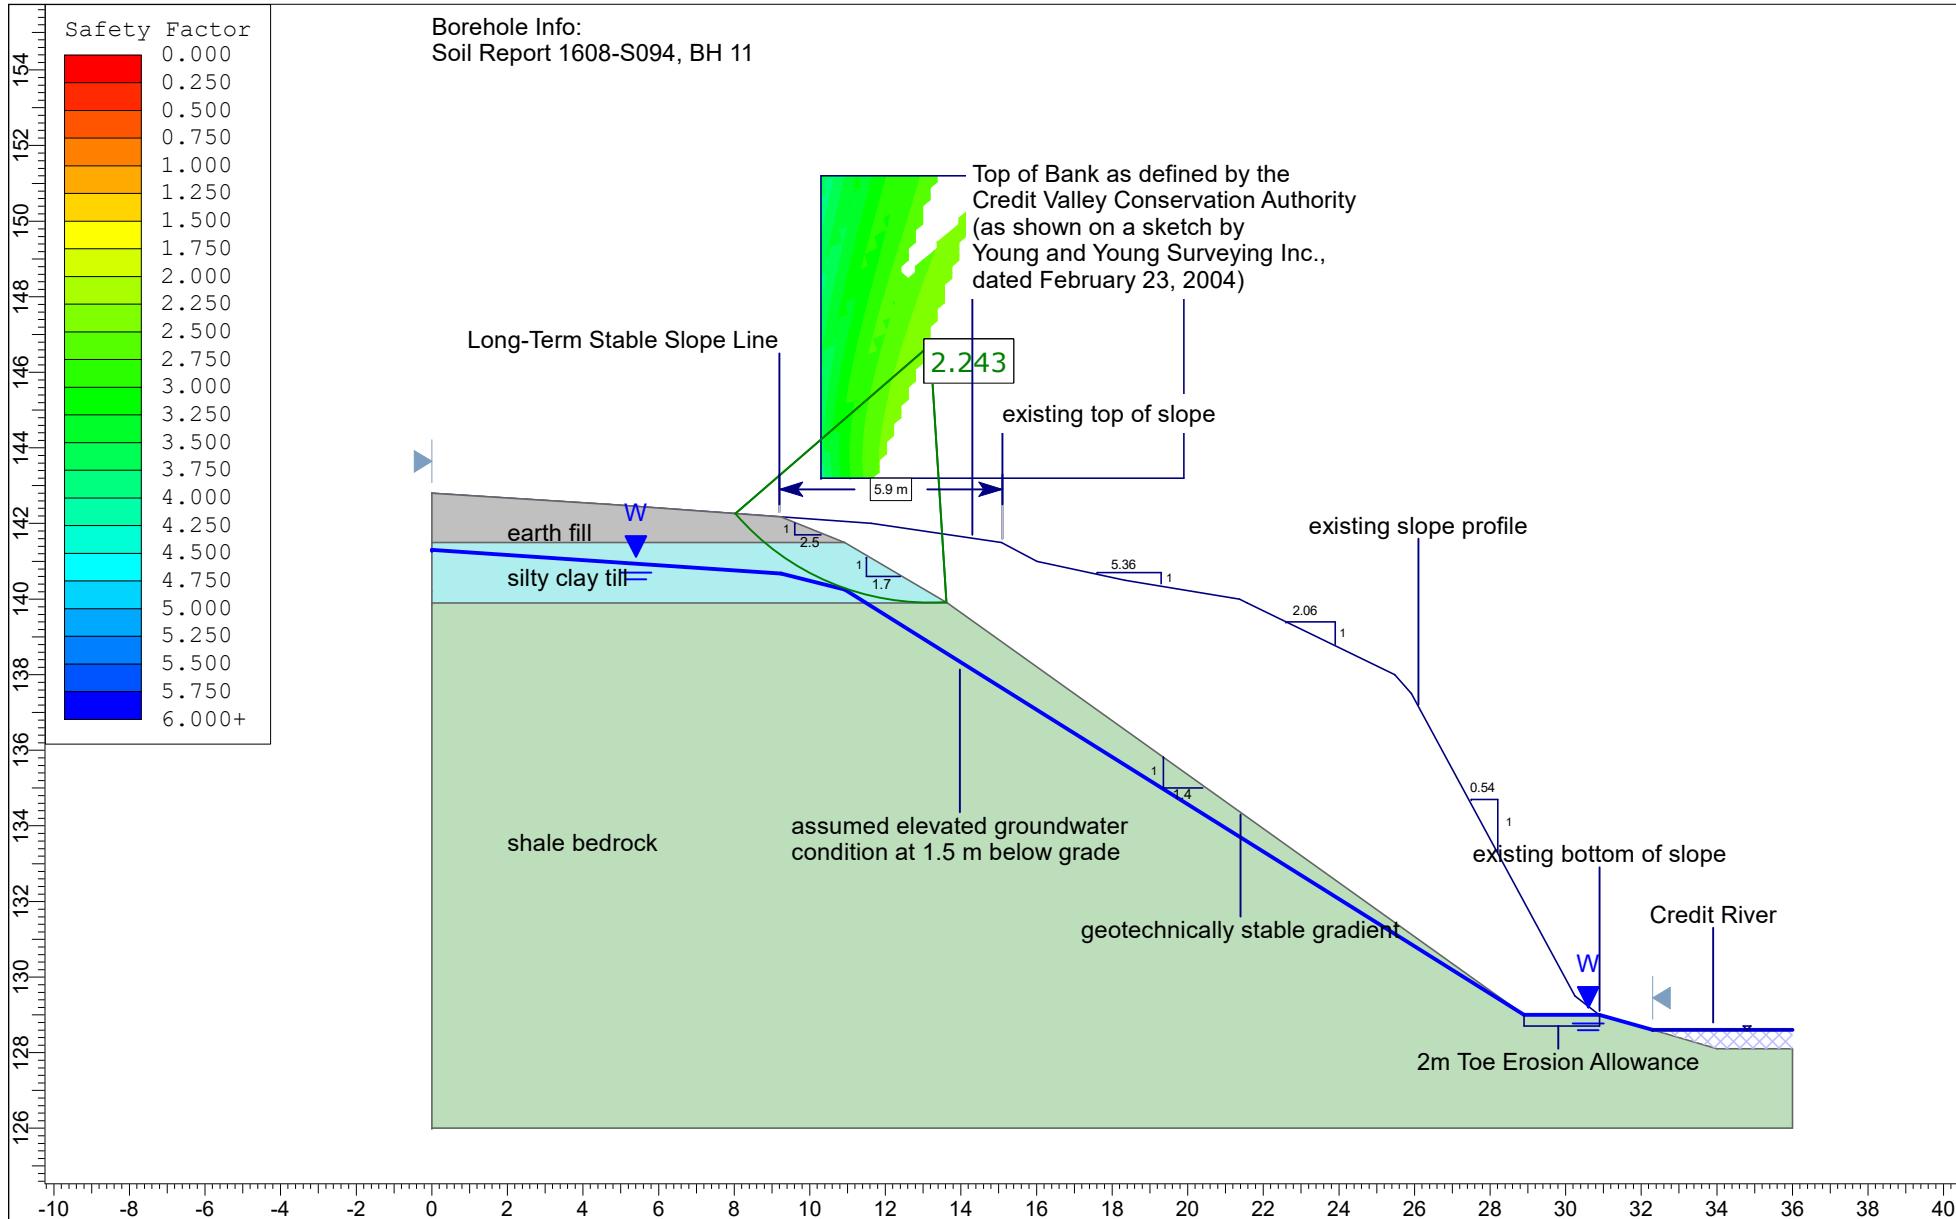
stable gradients listed in the above table are applied and the sections are remodeled. In earth fill, a stable gradient of 1V:2.5H is used. The remodeled slopes, yielding FOS of 2.243 and 2.622 for Cross-Sections B-B and C-C, respectively, are presented on Drawing Nos. 3C and 4C.
