Tree Inventory and Preservation Plan Report 200 South Service Road & 201 Radley Road Mississauga, Ontario

12 October 2017, revised 18 December 2017

KUNTZ FORESTRY CONSULTING INC Project P1645

# Table 1. Tree Inventory

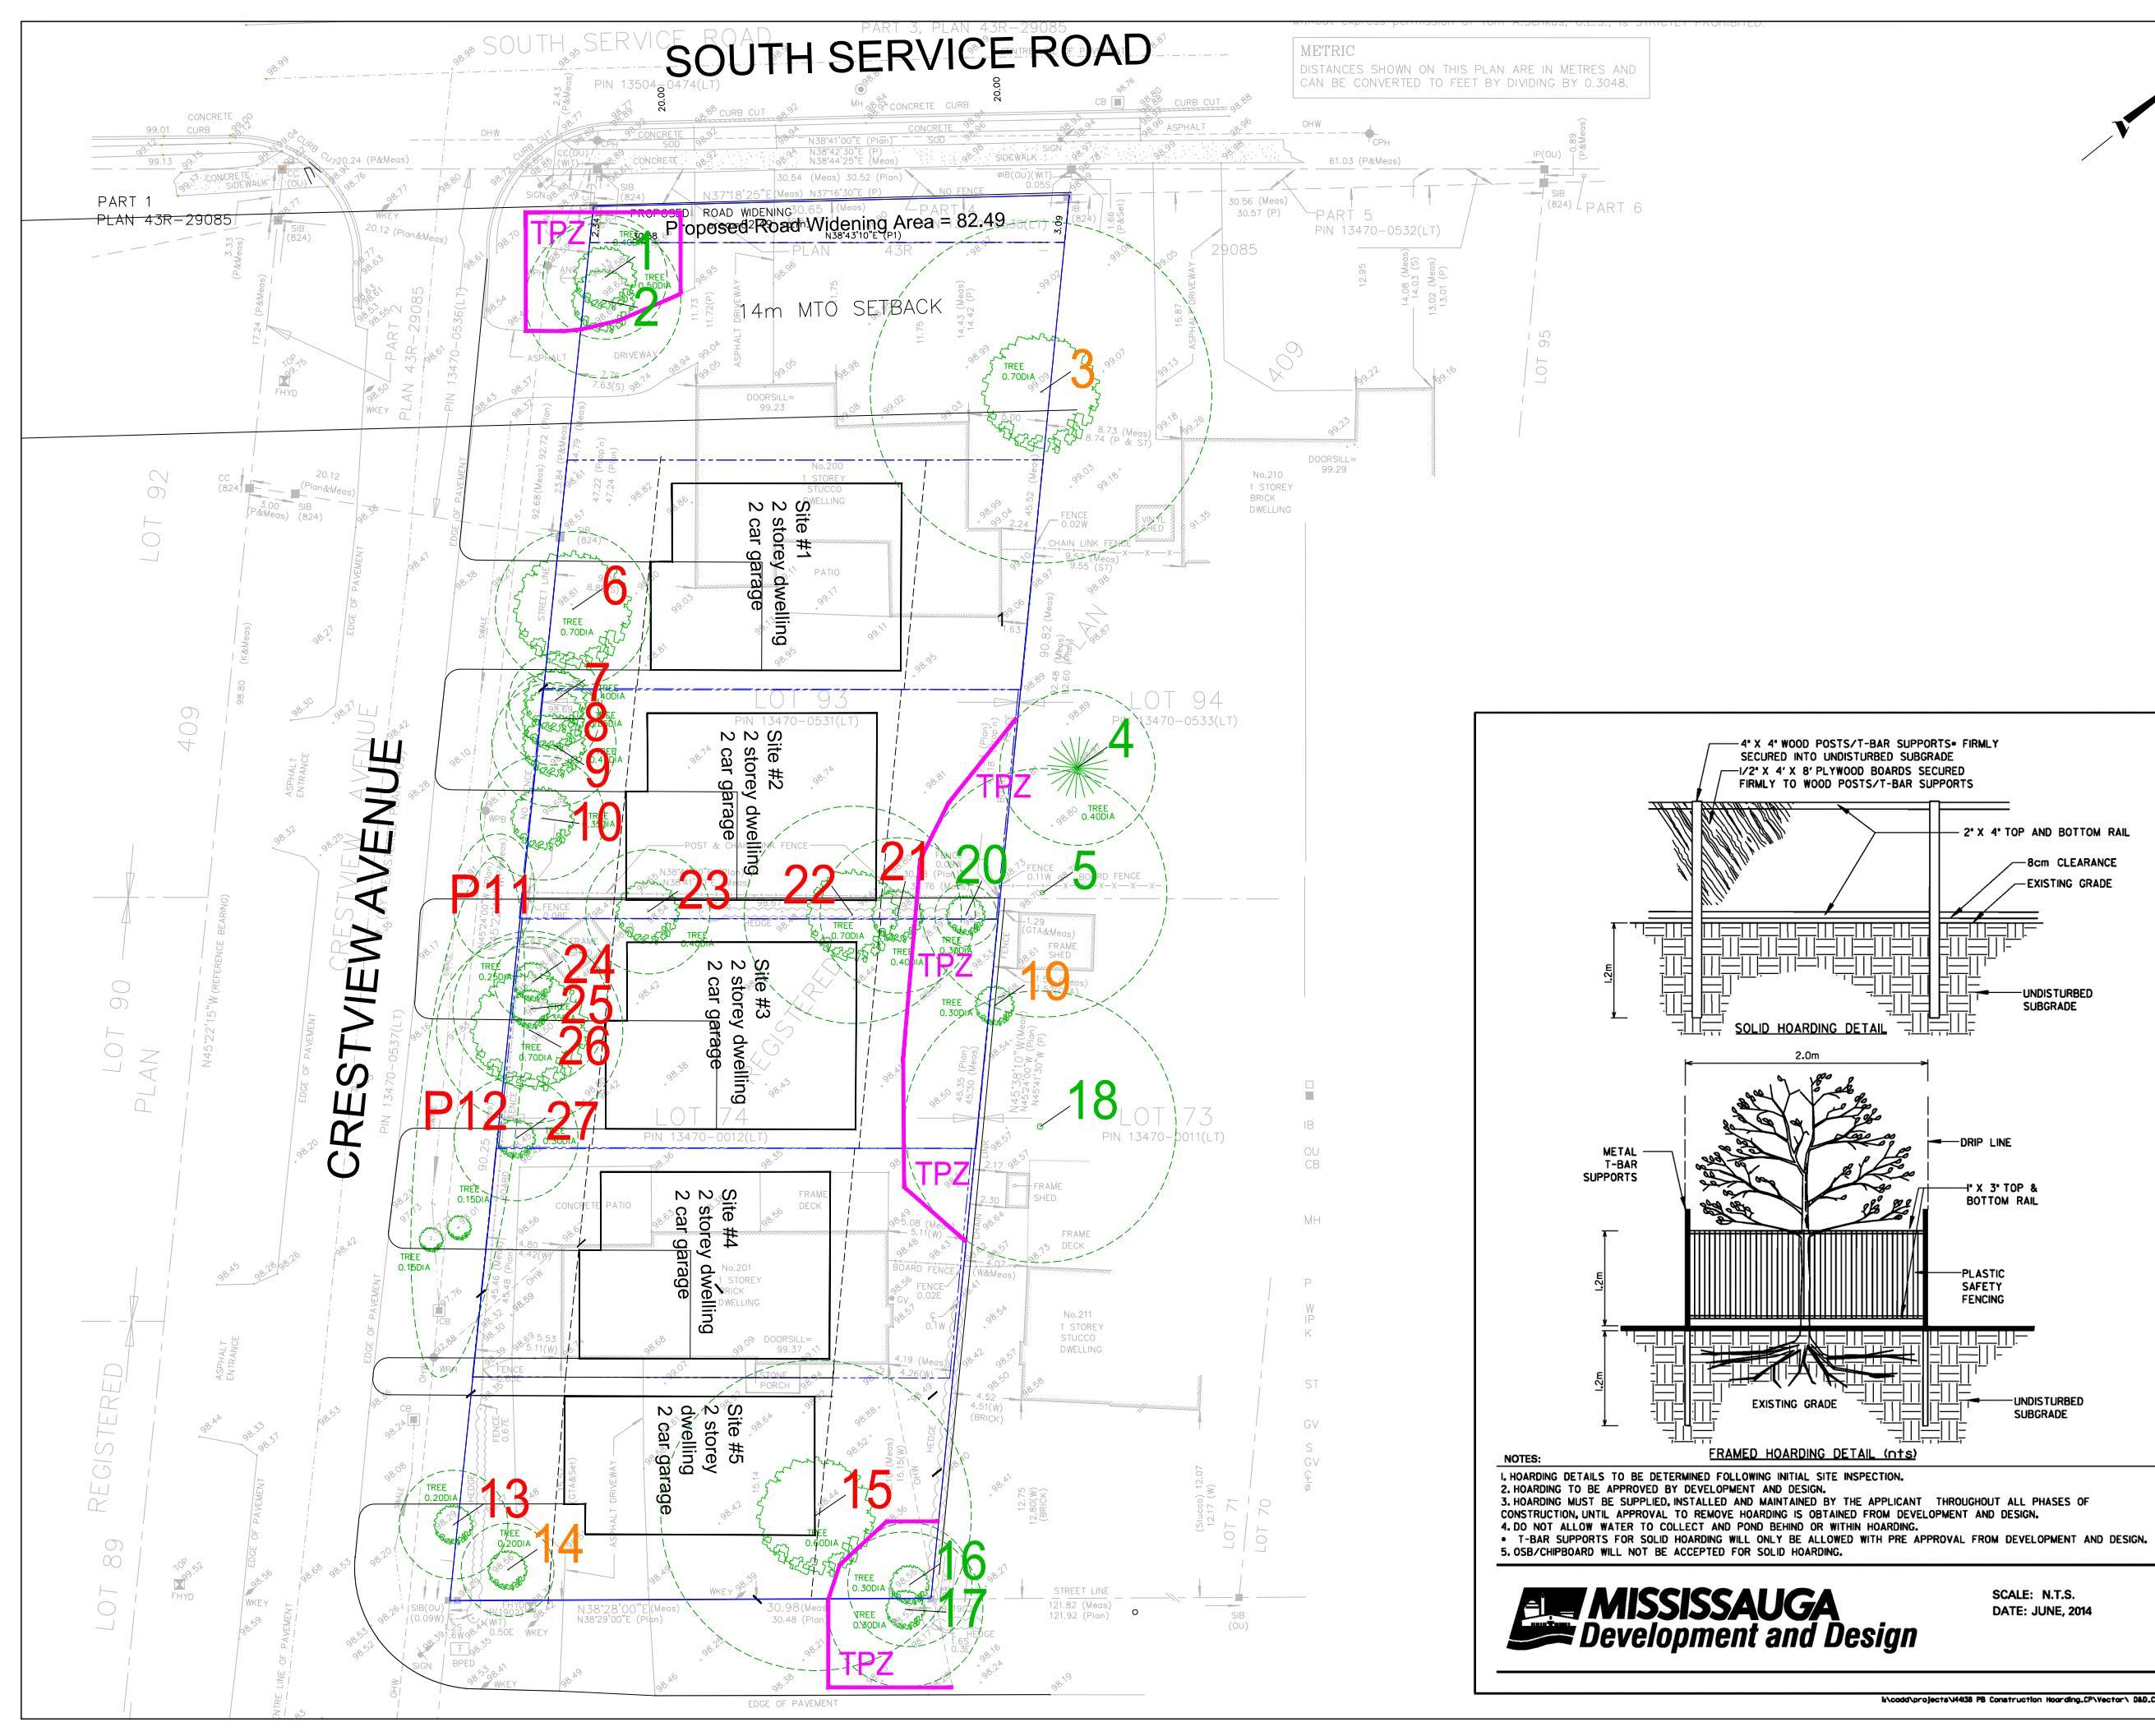
The removal of 17 trees and 2 tree polygons will be required to accommodate the proposed works or due to condition. Required tree removals are indicated with RED labels. Dead, dying and hazardous trees are indicated with ORANGE labels.

Preservation of all remaining tree resources will be possible with appropriate tree protection measures. Trees identified for preservation are indicated with GREEN labels. Required Tree Preservation Fencing is indicated in MAGENTA and approximate dripline of trees is shown with dashed GREEN circles. Refer to Tree Protection Plan Notes for eservation details

Any existing driveway is located within the driplines of Trees 1 and 2. The removal of the existing asphalt within the driplines of these trees should be removed carefully by hand. The area must then be amended with healthy topsoil and stabilized (seeded or sodded). The tree protection hoarding must then be extended to the full dripline of these trees for the remainder of the proposed development.

A portion of the tree protection hoarding for Trees 1, 2, 16 and 17 are located within the City road allowance. Tree protection hoarding on the subject property should consist of solid plywood hoarding and tree protection hoarding within the City road allowance should consist of plastic safety fencing. A portion of the mTPZs for Trees 1 and 2 are located within a proposed road widening. Preservation planning for these trees should be reassessed prior to the proposed road widening; however, these trees will be retained based on the proposed development.

- Tree protection barriers and fencing should be erected at locations prescribed on Figure 1.
- Tree protection measures will have to be implemented prior to demolition and construction to ensure the trees identified for preservation are not impacted by the development.

- No construction activity including surface treatments, excavations of any kind, storage of materials or vehicles, is permitted within the area identified on Figure 1 as a tree protection zone (TPZ) at anytime during or after construction.
