PROJECT: **PROPOSED STACKED TOWNHOUSE DEVELOPMENT**
 65-95 JOYMAR DRIVE
 MISSISSAUGA, ONTARIO

DRAWING TITLE: **EXISTING TREE INVENTORY AND PRESERVATION PLAN**

SCALE: AS SHOWN PROJECT No. 19-5173
 DATE: MAY 2019
 DRAWN BY: SS DRAWING No. V100
 CHECKED BY: MG

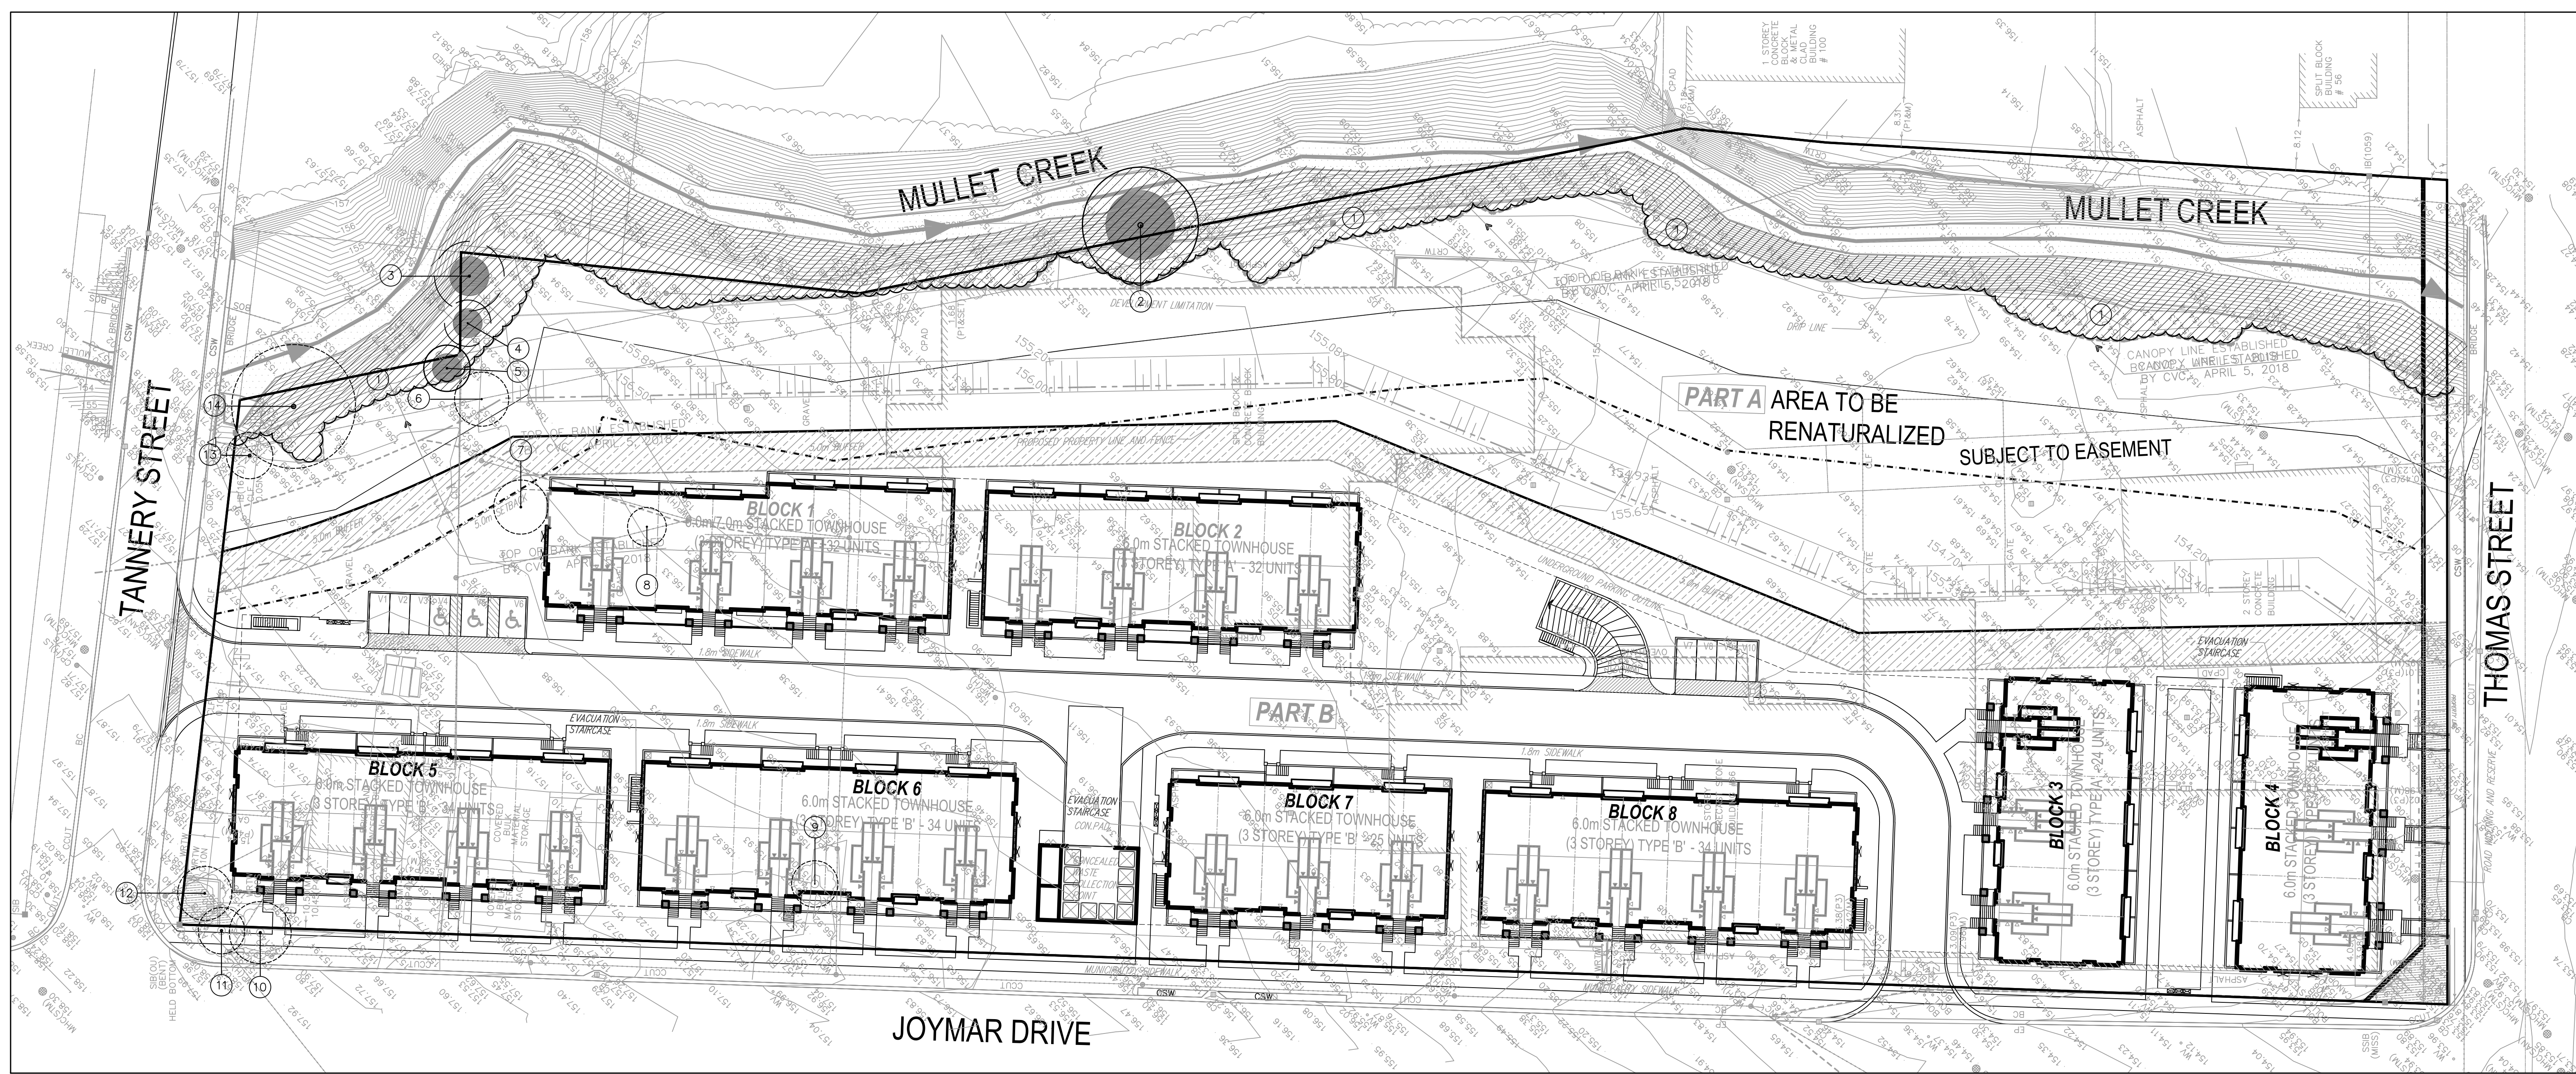
KEY	SPECIES	CALIPER (in cm)	CROWN (in m)	HEALTH	STRUCTURE	COMMENTS	PRESERVATION DIRECTION	MIN. TPZ	KEY
1	NATURALIZED GROUPING	WHIP-65	VARIES	VARIES		MIXED, NATURALIZED GROUPING OF TREES AND SHRUBS WHICH OCCURS ALONG THE TOP OF EXISTING BANK AND ALONG CREEK SLOPE. THIS GROUPING IS DOMINATED BY DECLINING ASH TREES AND SEVERAL MANTOBA MAPLES. A SMALLER NUMBER OF CRACK WILLOW MOSTLY ALONG THE EAST CREEK BANK ARE PRESENT. THE MAJORITY OF THE TREES EXHIBIT MULTIPLE STEMS AND ONE SIDED FORMS DUE TO CROWDING. OVERALL, THE VEGETATION ALONG THE WEST SIDE OF THE CREEK IS COMPOSED EITHER OF EXOTIC, INVASIVE SPECIES OR DEAD OR DECLINING ASH TREES. THIS GROUPING IS IN GENERALLY POOR CONDITION. THE EXISTING TOP OF BANK APPEARS TO BE FILL MATERIAL AND DEBRIS.	(SELECTIVE REMOVALS OF THE IMMATURE, NATURALIZED AND INVASIVE TREES ALONG THE STACKED TOP OF BANK MAY BE REQUIRED DUE TO THE PROPOSED GRADING TO RE-ESTABLISH THE TOP OF BANK)	NA	1

2	CRACK WILLOW	65.0	15.0	FAIR	MULTI-STEMMED	MATURE, MULTI-STEMMED TREE LOCATED ALONG THE EXISTING CREEK BANK. SOME DIEBACK THROUGHOUT IS NOTED AS WELL AS SEVERAL POTENTIALLY WEEK BRANCH UNIONS	PRESERVE	4.2	2
3	SIBERIAN ELM	15.30	9.0	POOR-FAIR	MULTI-STEMMED	ASYMMETRICAL FORM, CROWDED BY ADJACENT TREE. DIEBACK THROUGHOUT, INCLUDED BANK	REMOVE	2.4	3
4	MANTOBA MAPLE	16.0	6.0	FAIR	HORIZONTAL	LEANING, CROWDED BY ADJACENT TREE	REMOVE	1.8	4
5	SIBERIAN ELM	17.0	6.0	GOOD	MULTI-STEMMED	NARROW FORM, CROWDED BY ADJACENT TREE	PRESERVE	1.8	5
6	SIBERIAN ELM	18.0	6.0	GOOD	MULTI-STEMMED	FENCE INGROWN, DIEBACK ON LOWER BRANCHES	REMOVE	1.8	6
7	SIBERIAN ELM	25.0	6.0	GOOD	DOUBLE STEM	DAMAGE TO LOWER BRANCHES	REMOVE	1.8	7
8	SIBERIAN ELM	18.0	5.0	POOR	IRREGULAR FORM	FENCE INGROWN, DIEBACK THROUGHOUT	REMOVE	1.8	8
9	ASH	6.0	6.0	DEAD			REMOVE	NA	9
10	MANTOBA MAPLE	29.0	6.0	POOR-FAIR	ASYMMETRICAL FORM	CROWDED BY ADJACENT TREE; SOME DIEBACK THROUGHOUT	REMOVE	1.8	10

11	NORWAY MAPLE	32.0	6.0	FAIR	ASYMMETRICAL FORM	CROWDED BY ADJACENT TREE; SOME INTERNAL DIEBACK	REMOVE	2.4	11
12	NORWAY MAPLE	24.0	7.0	GOOD	GOOD FORM	MINOR INTERNAL DIEBACK	REMOVE	1.8	12
13	ASH	40.0	6.0	DEAD			REMOVE	2.4	13
14	MANTOBA MAPLE	60.0	18.0	DEAD			REMOVE	3.6	14
