Meadowvale Heritage Conservation District Advisory Sub-Committee

HERITAGE IMPACT STUDY
IMPACT OF PROPOSED RENOVATION
7004 SECOND LINE W., MISSISSAUGA

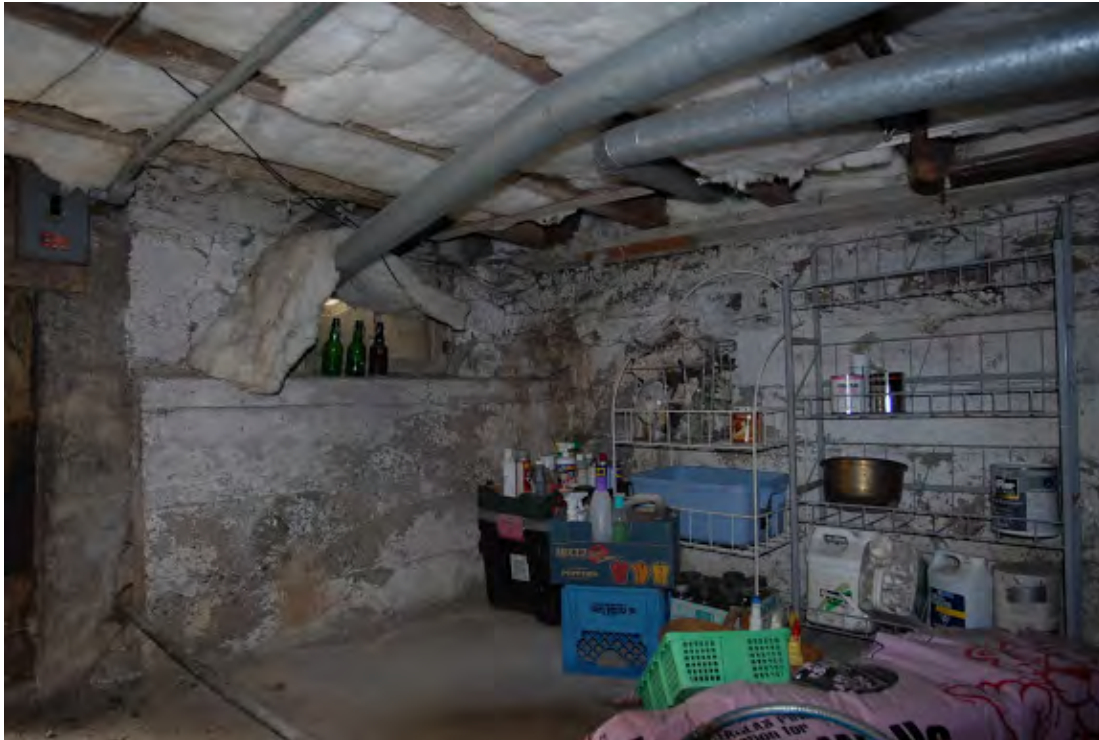
Existing Basement - note original stone wall at right, later underpinning at left

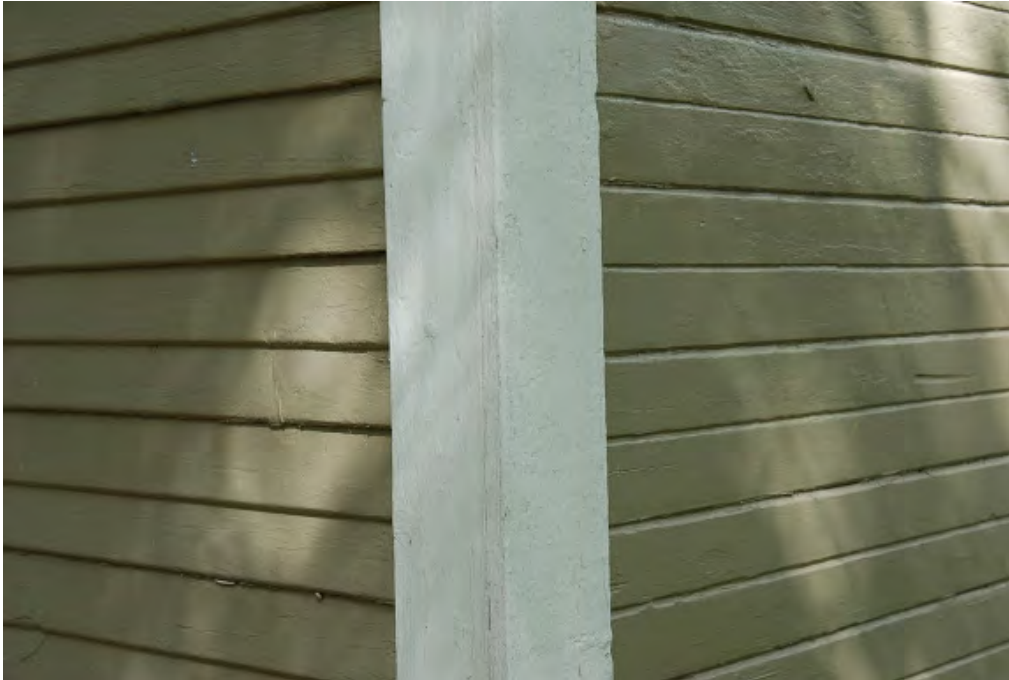
Corner detail showing differential siding materials. Material at left is horizontal clapboard with 4" exposure. Material at right is 8" shiplap with center dado detail to make it appear as 4" widths. Corner boards are all later replacements.

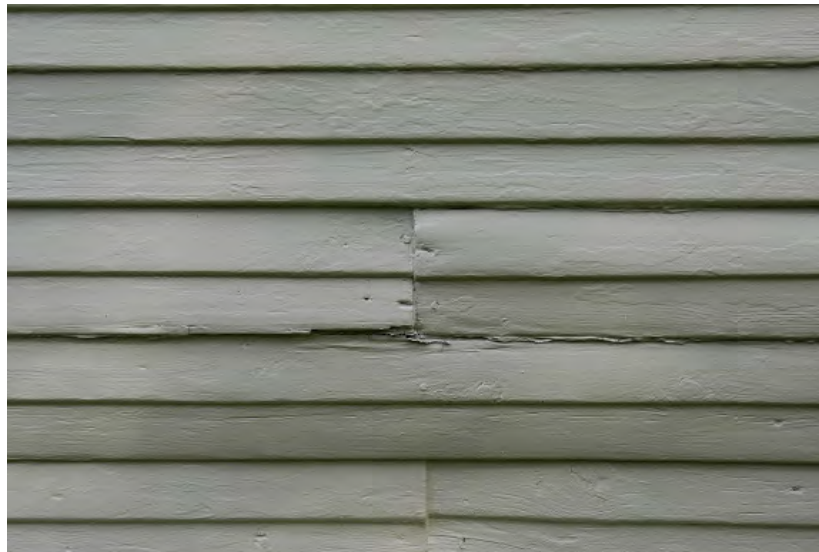
Weathered and deteriorated clapboard siding

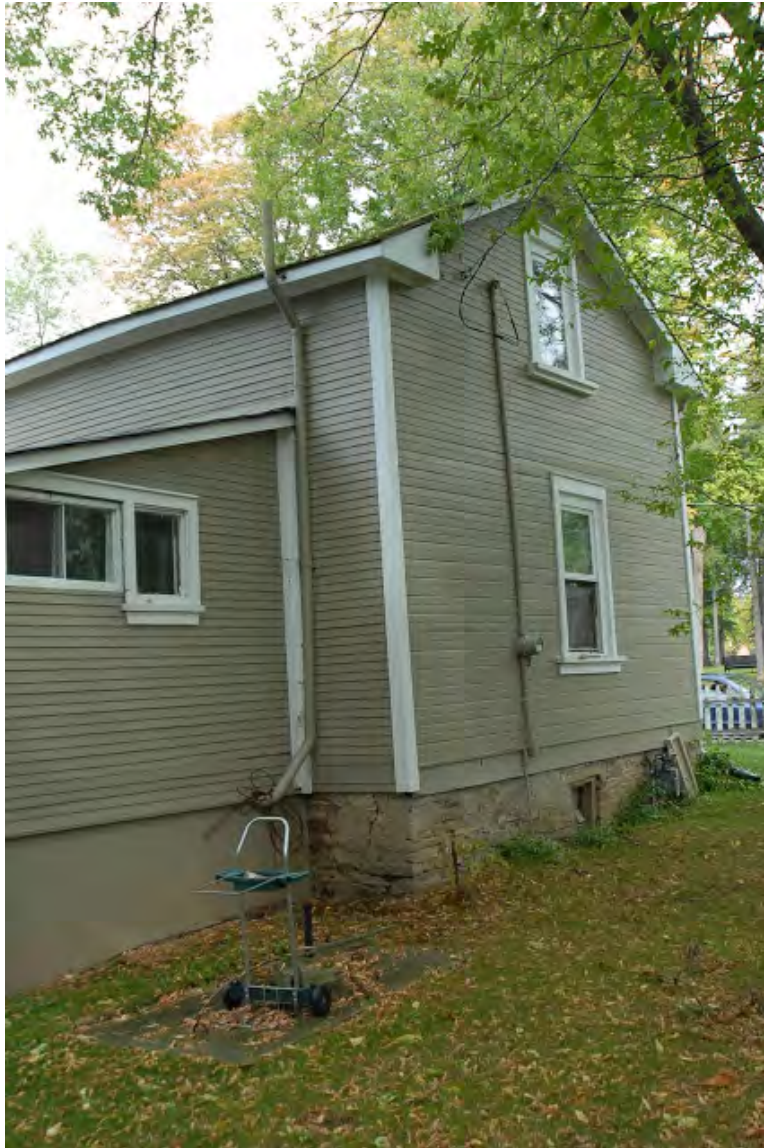
South-west oblique view showing rear addition. Note lack of foundation at addition.

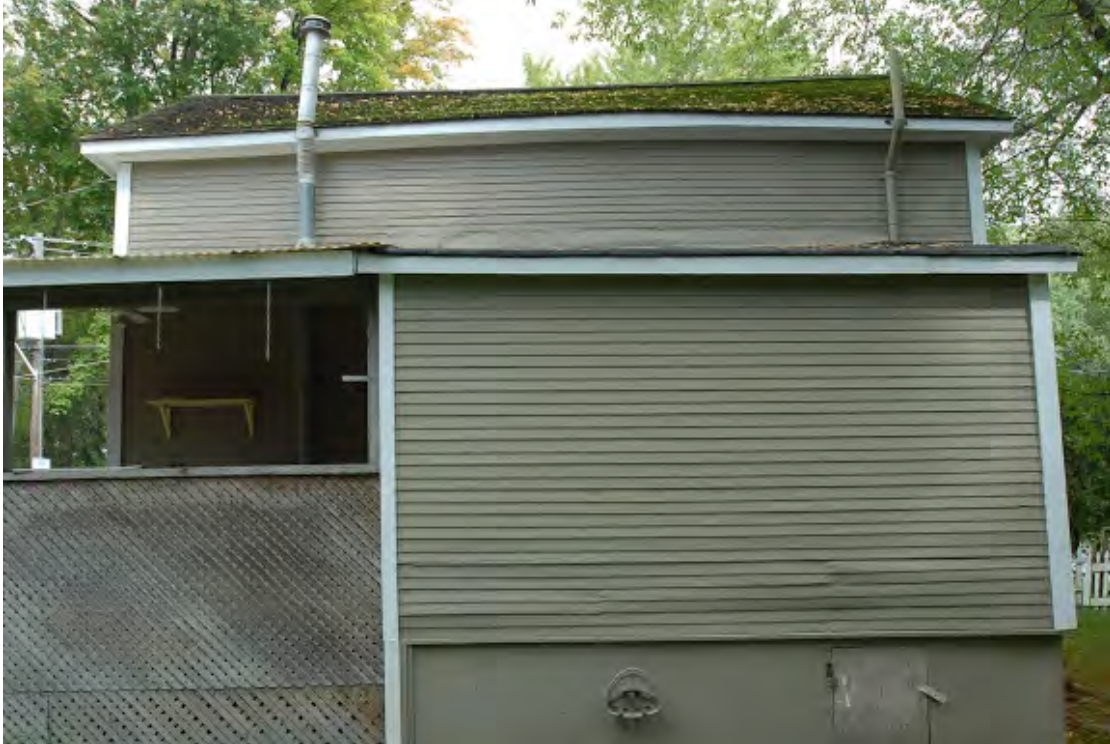
West elevation of rear addition and later covered porch. Note deformation of upper roof/rear wall on main building.

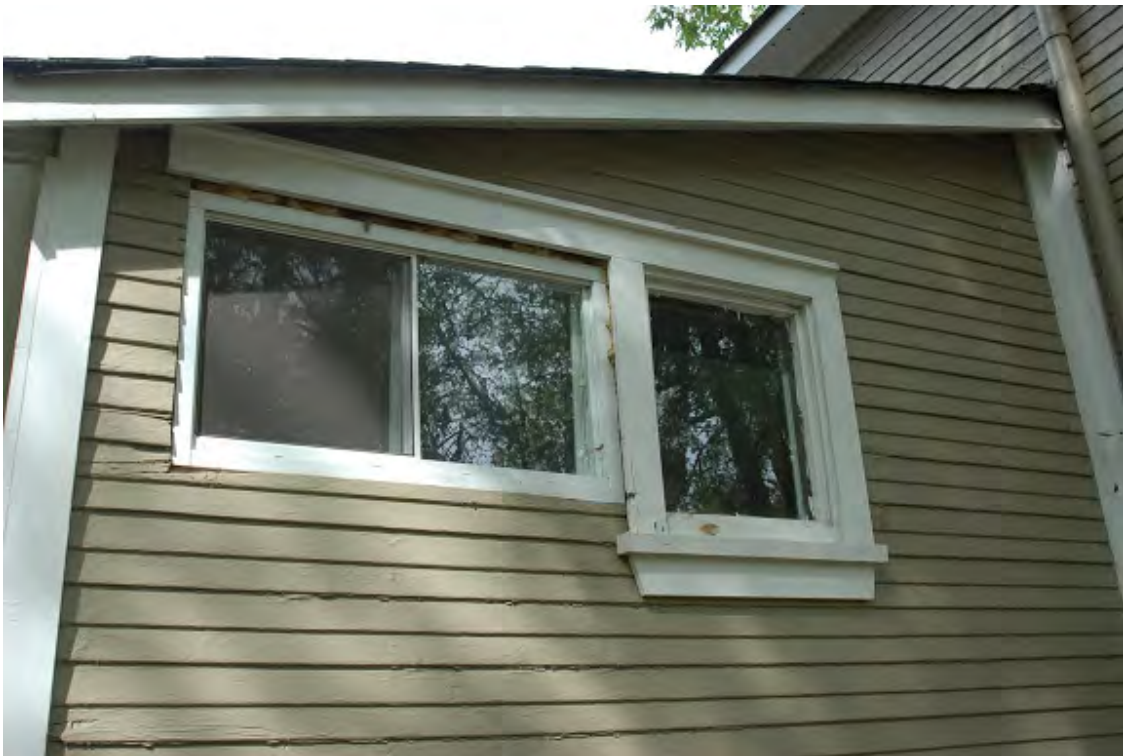
South elevation of rear addition showing newer windows, haphazard, poorly detailed trims, deteriorated siding.

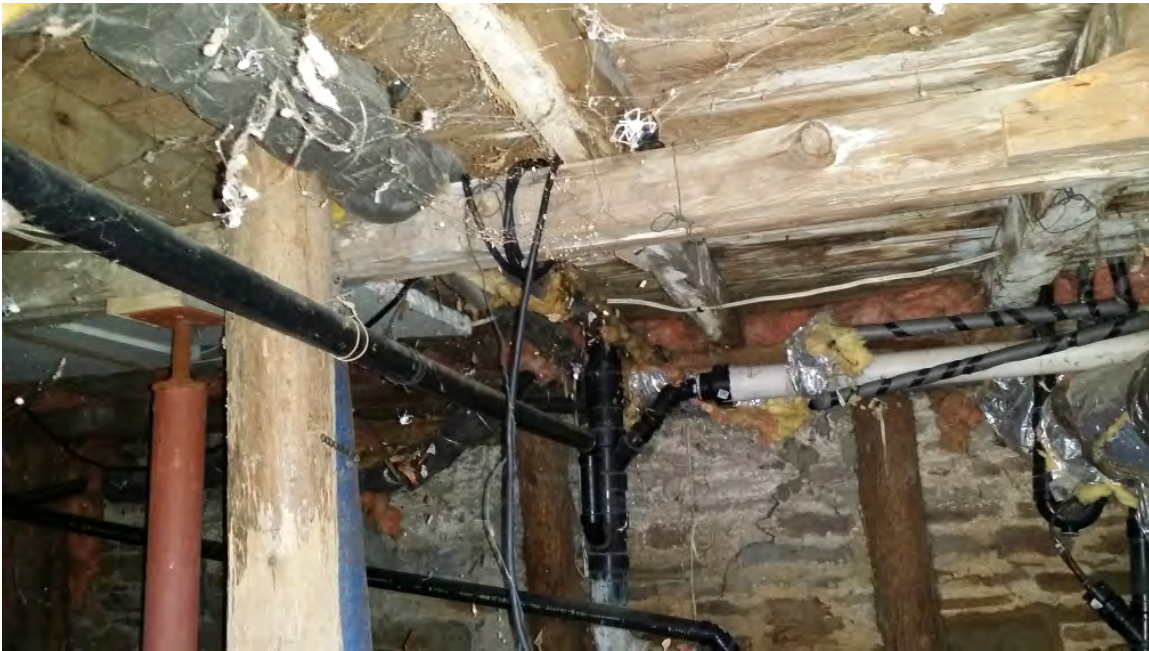
Rear addition under floor framing. House stone foundation is beyond. Note agglomeration of old and new posts, extensive deterioration, lack of insulation, haphazard construction

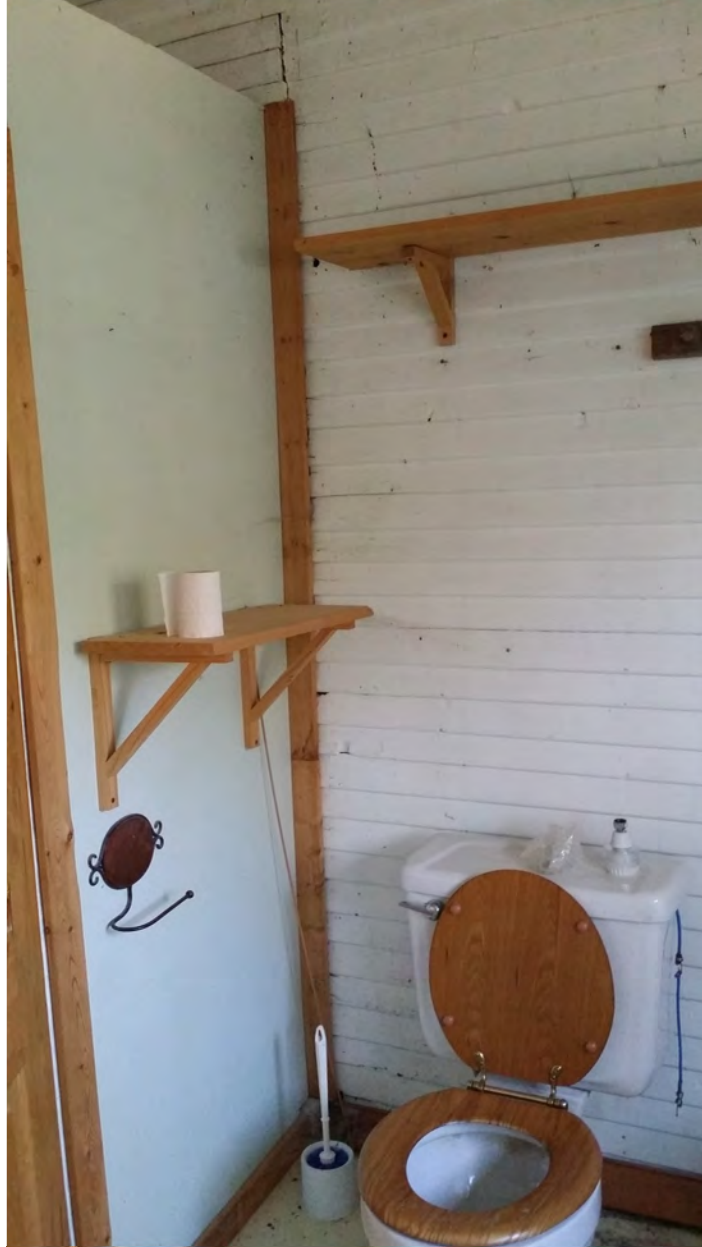
Bathroom interior showing older siding material as wall finish. Note patched siding material at upper left

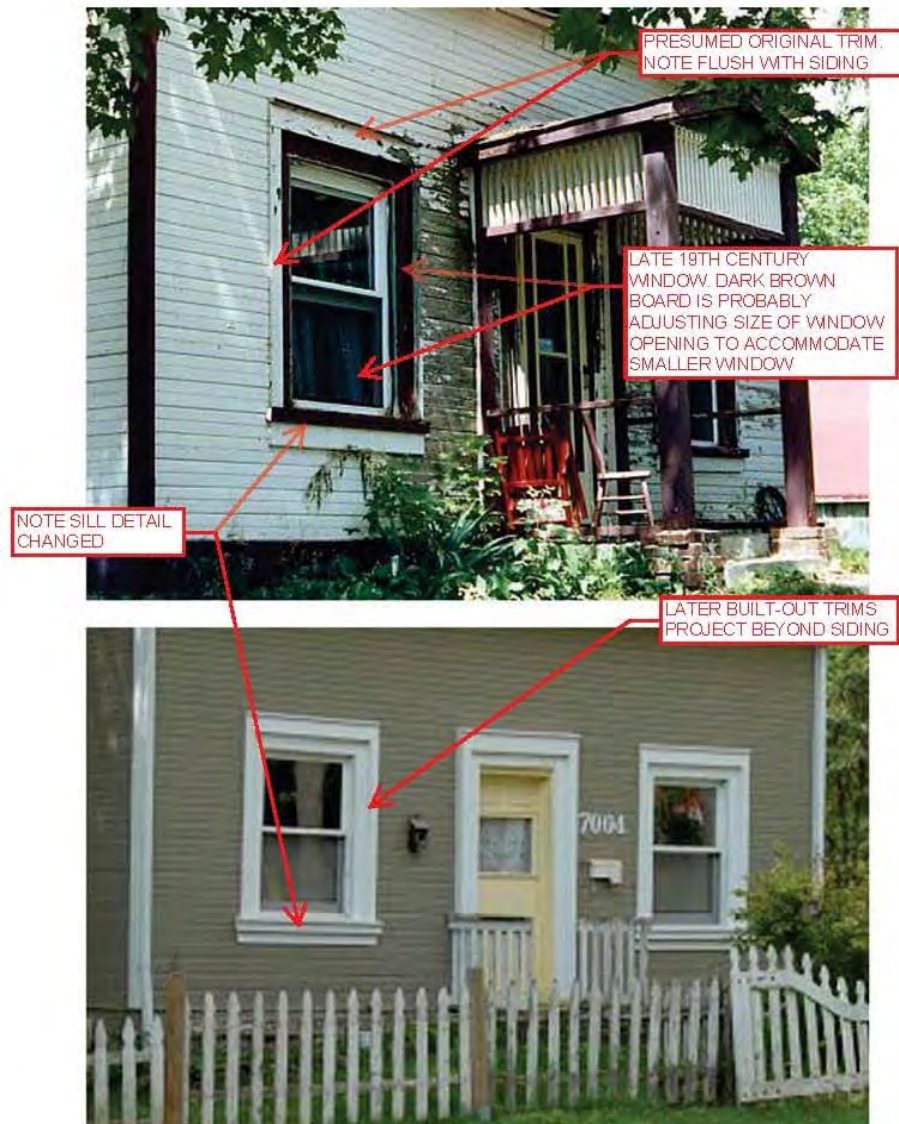
Front elevation comparing images from 1980's and present day showing non-original windows and trims

All of the windows on the existing building are inappropriate recent replacements and should be removed. The associated trims are also recent, poorly constructed and detailed and do not reflect typical 19th century methods or appearance. Their lack of flashing or proper installation to prevent water penetration is highly problematic. These should also be removed. In their place new double hung windows, either painted wood or vinyl with the appearance of painted wood should be installed. New trims, either painted wood or maintenance-free material painted to look like wood, should be installed as per the following detail.

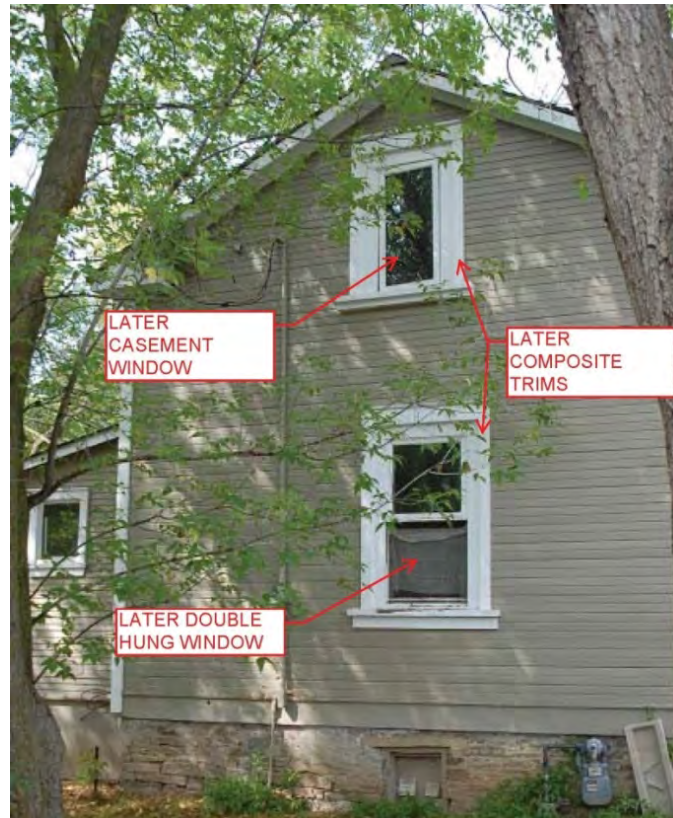
South elevation showing non-original windows and trims

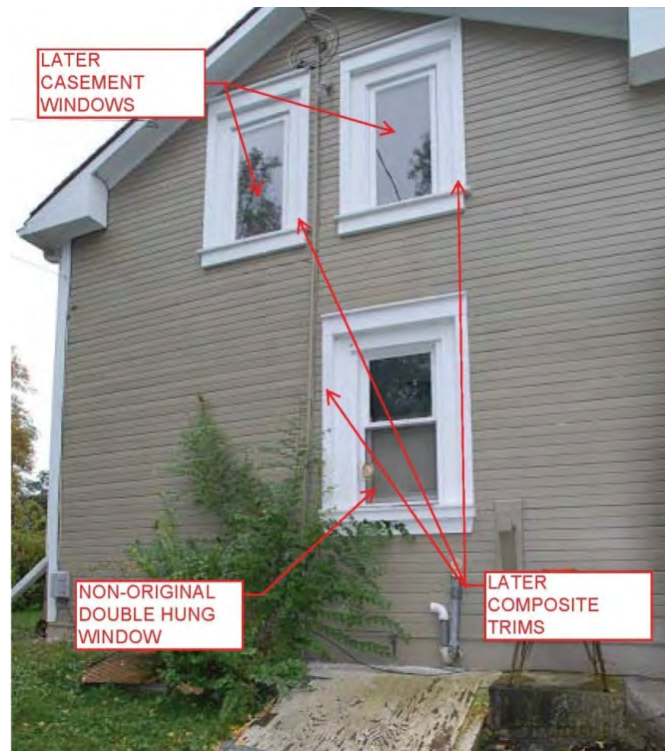
North elevation showing non-original windows and trims

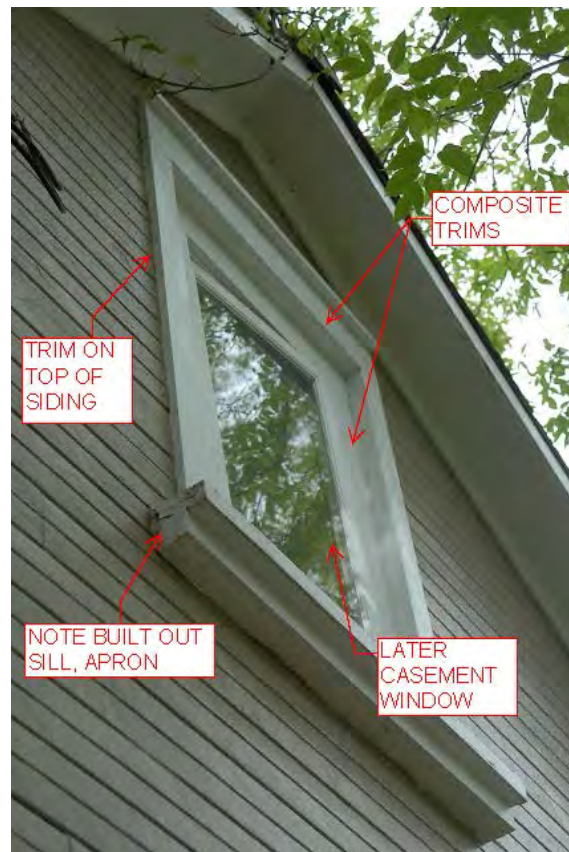
Detail of window on south elevation showing built out trims, poor detailing and workmanship

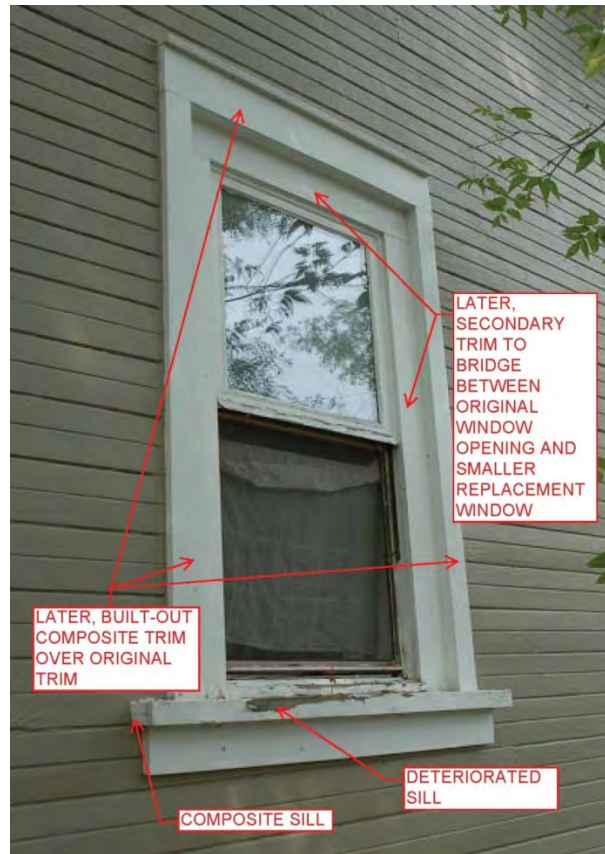
Detail of trims on south elevation showing composite trims, poor detailing and workmanship

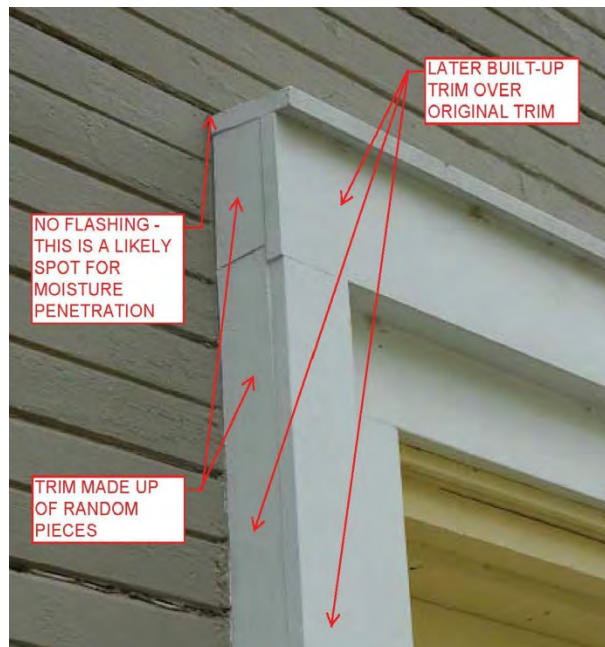
Detail of trims at front door showing composite trims, poor detailing and workmanship. The siding should lap over the trim at the top and be flashed. This is a very bad detail that will encourage moisture penetration into the building.

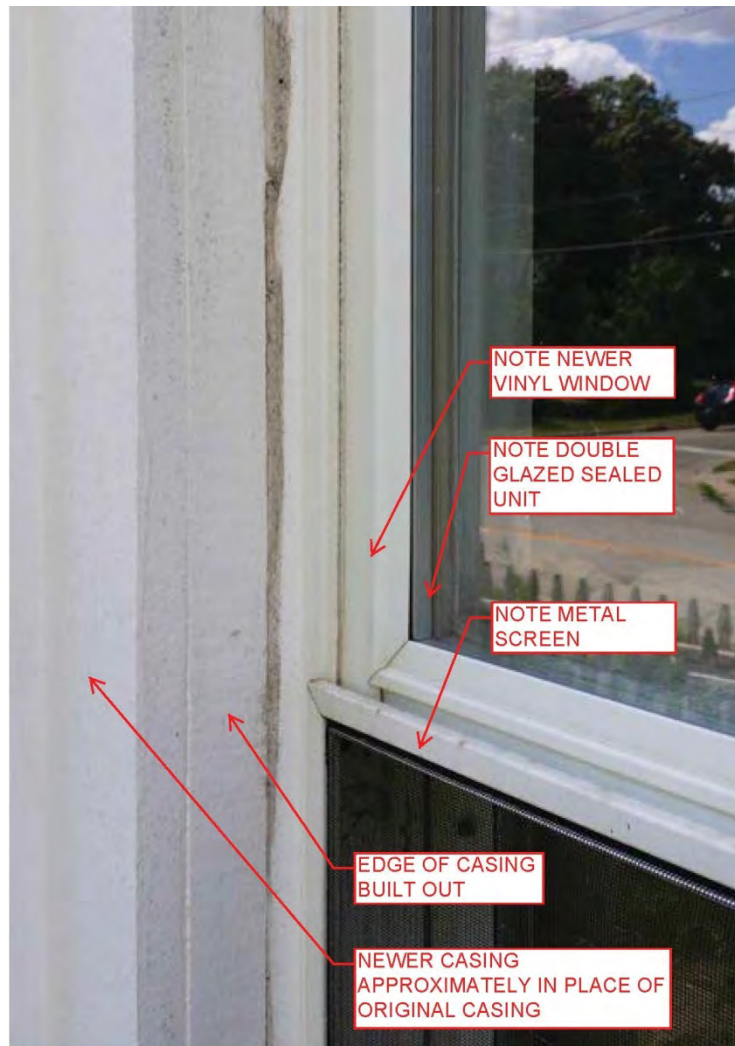
Detail of window on south elevation showing modern components, built out trims

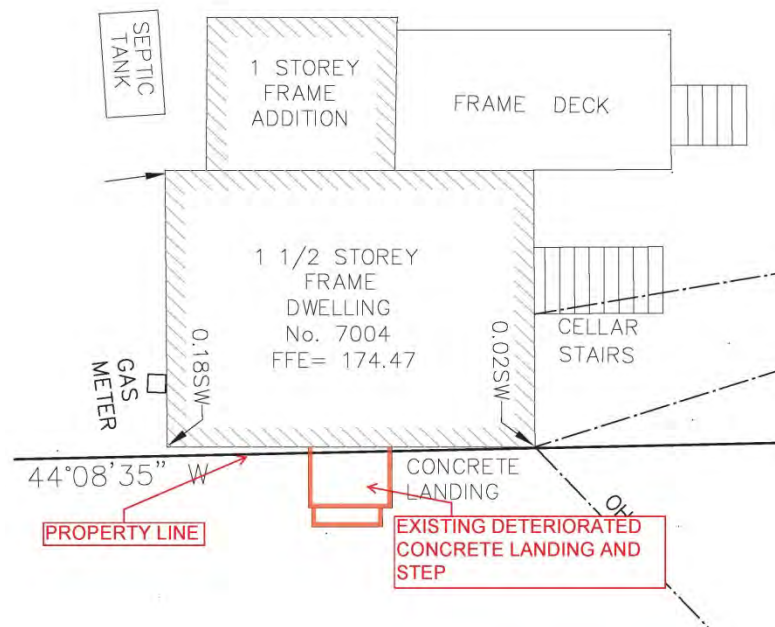
Detail from existing survey showing encroachment of front landing and step onto City property

The front wall of 7004 Second Line West is located virtually on the Second Line West property line with the result that an existing concrete front landing and step are located entirely on City of Mississauga property. This has not been an issue up until this point but because the renovation of this building is the subject of a Site Plan application, the City has asked that the encroachment be removed, subject to a consideration of its heritage value.

considered an encroachment by the City. This seems a reasonable and appropriate compromise, especially given that the present landing is not original to the home and because of its poor condition would need to be demolished and re-built in any scenario.

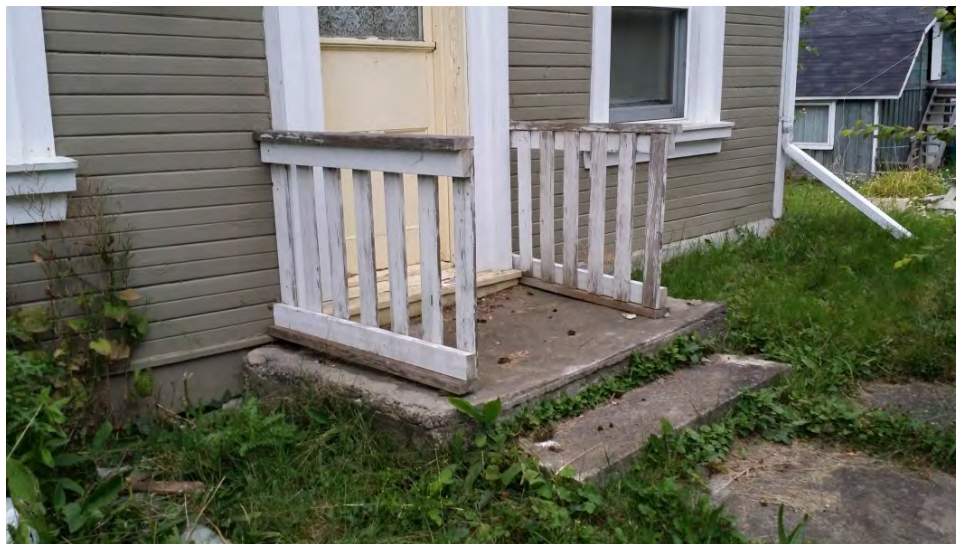
Present condition of encroaching front concrete landing and step

The concrete landing is approx. 4' x 6'. It appears to have been poured in place flat on the ground. There is no foundation. It is quite significantly deteriorated and uneven and would be impossible to repair without being broken up and re-built. The step is similar although may have been poured in a form and then placed on the ground. Poured landings and steps such as this became popular in the mid-20th century. It is definitely not original to the home. The landing and steps are unusual in that the step heights associated with them are very small. From grade to the step and from the step to the landing is about a 5" rise and from the landing to the finished floor level varies from a 2" to 5" rise. Typical rises in these situations would be about 7".

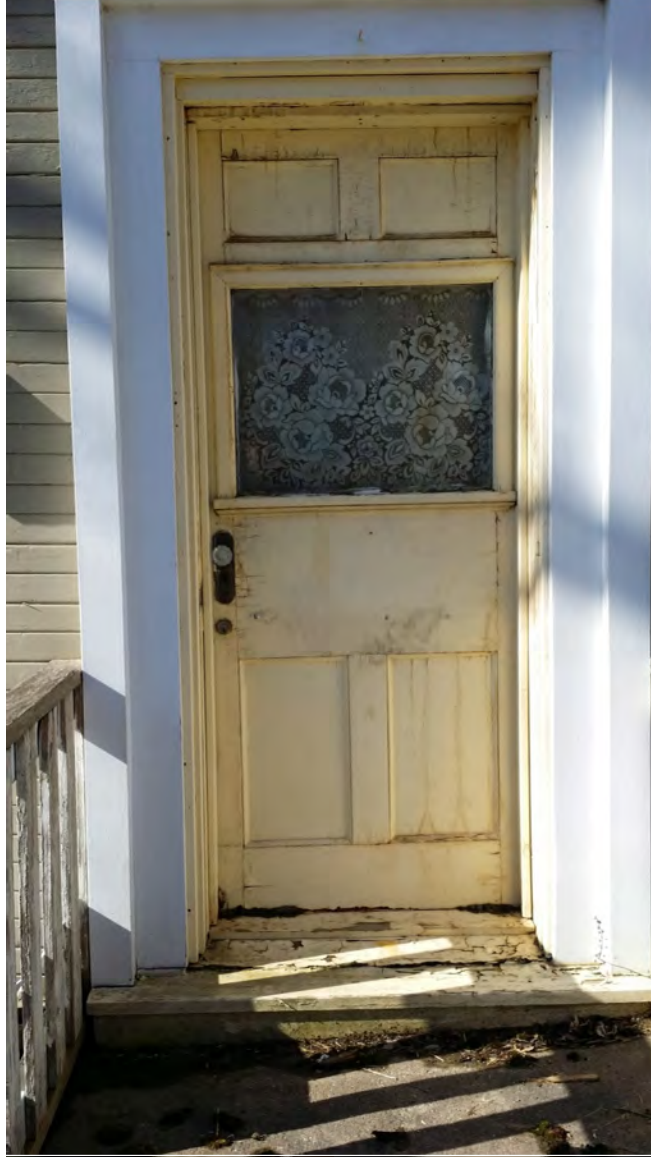
The existing front door to the home is older but likely not original to the home. It appears to have been sourced from elsewhere and the frame and trim modified to fit. Its integrity and appearance has also been compromised by a large rectangular glazed opening that has roughly been cut into it and inappropriately trimmed.

Front door from exterior. Note deterioration at bottom of door and sill. Note inappropriate opening cut for window and associated trimwork

The existing front door is very likely not original, unattractive and not in good condition. There would be insignificant heritage value in its retention. It's replacement with a new wood door (and associated jamb) as shown in the detail below be appropriate.

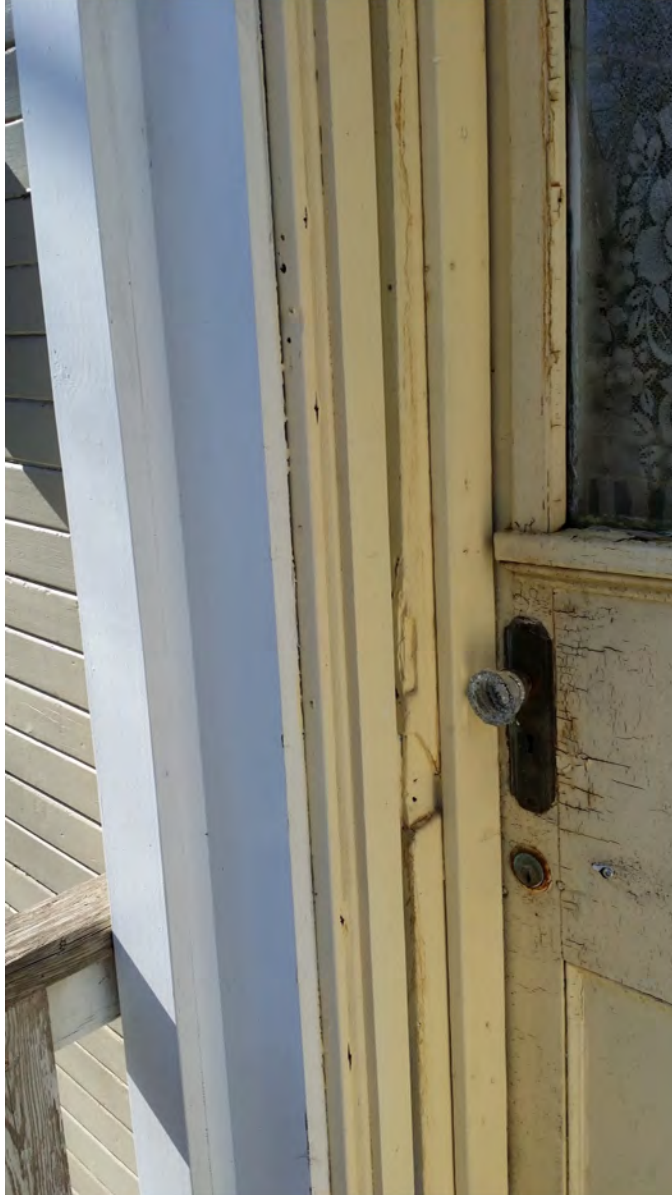
Detail at front door jamb. Note layers of built-up trimwork, deterioration of door

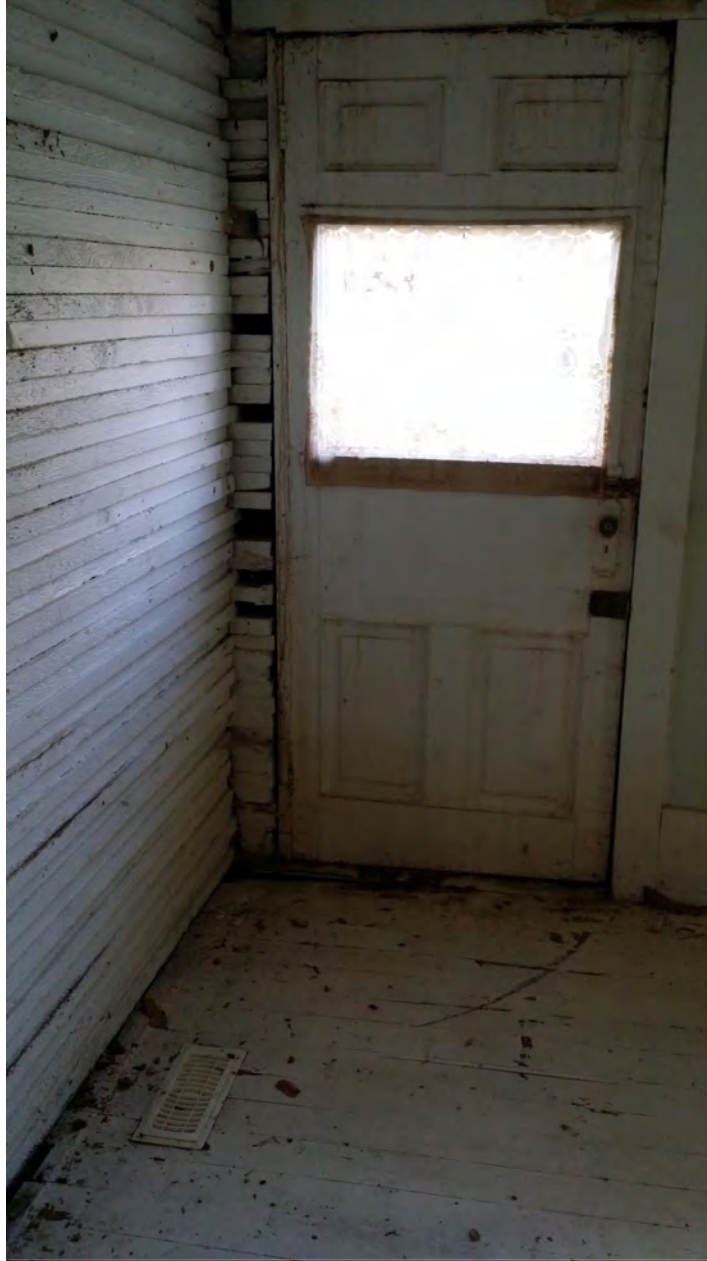
Front door from interior. Note general deterioration. Stacked plank construction can clearly be seen here

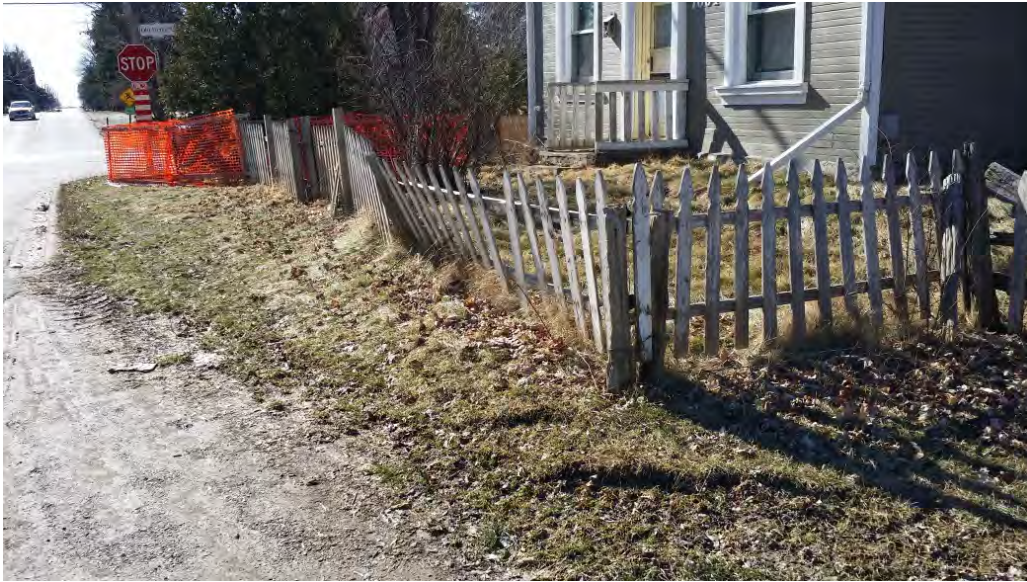
The fence is in poor condition. It is very haphazard in nature (the fence sections in some cases are attached to the posts by twisted wire only). It was clearly not designed for any significant length of use.

Deteriorated fencing along east and south side of property. Orange snow fence is tree protection hoarding. All of this fencing is on City property

The request by the City to remove this fencing is reasonable in this instance. Fencing, especially low picket fencing, is an appropriate way to define the limits of a property in a semi-rural context such as this and there are many similar examples in the village. If sufficient space were available between the front wall of the building and the street it would be advisable to replace the fencing. In this case, however, because the space is very limited the effect of the fence is to exaggerate the closeness of the existing building to the street. Typically a fence such as this would be located much closer to the street line than it would be to the house. In this case, because the distance between the edge of the street and the fence and that between the fence and the house is roughly the same it creates an awkward proportion and exaggerates the closeness of the building to the street. The various historic images available show that the type and extent of fencing around this property has changed multiple times and the fencing as it exists now is a relatively new element. The removal of this fence will not be a loss to the heritage value of the building.

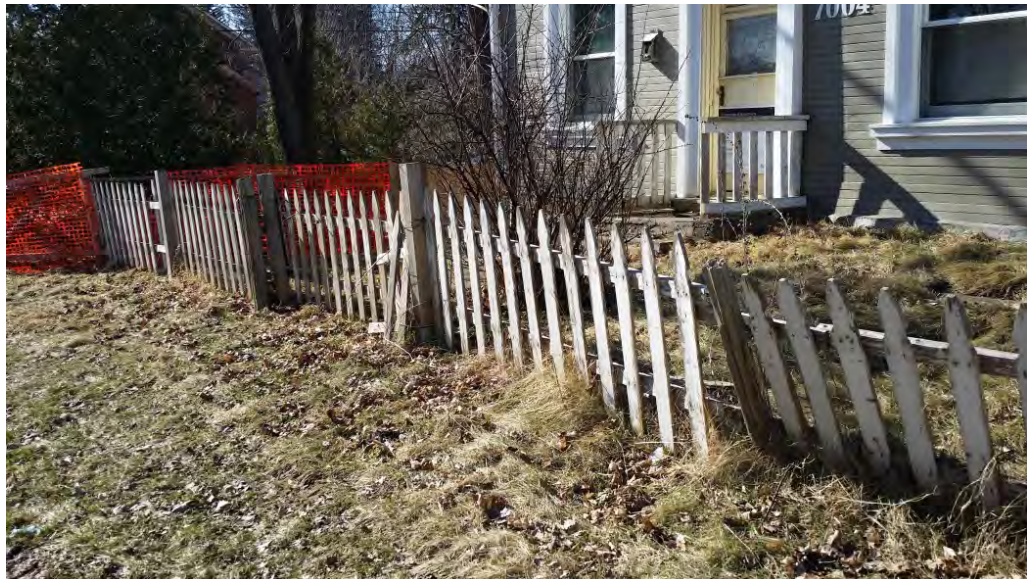
Detail of existing fence condition along east side of house

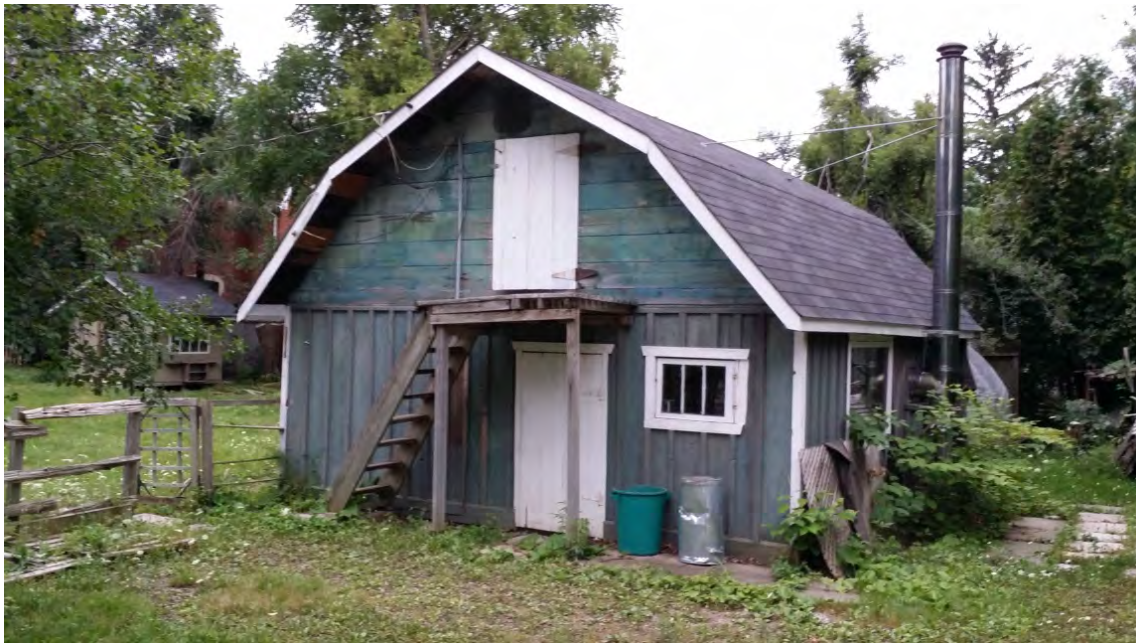
East and north barn elevations. Note metal chimney from wood stove within and stairs to second floor loft. These stairs and landing are in poor condition and missing handrails and guards. They are unsafe and should be removed

The barn building is in moderate to poor condition. The stairs to the loft are in very poor condition, a relatively new addition (as witnessed by their absence in the mid-1980's photo) and are unsafe and should be removed. The greenhouse on the west elevation is a home-made structure of pipe, wood and sheet plastic, was similarly absent in the mid-1980's and should be removed. Both are in danger of collapse from deterioration.

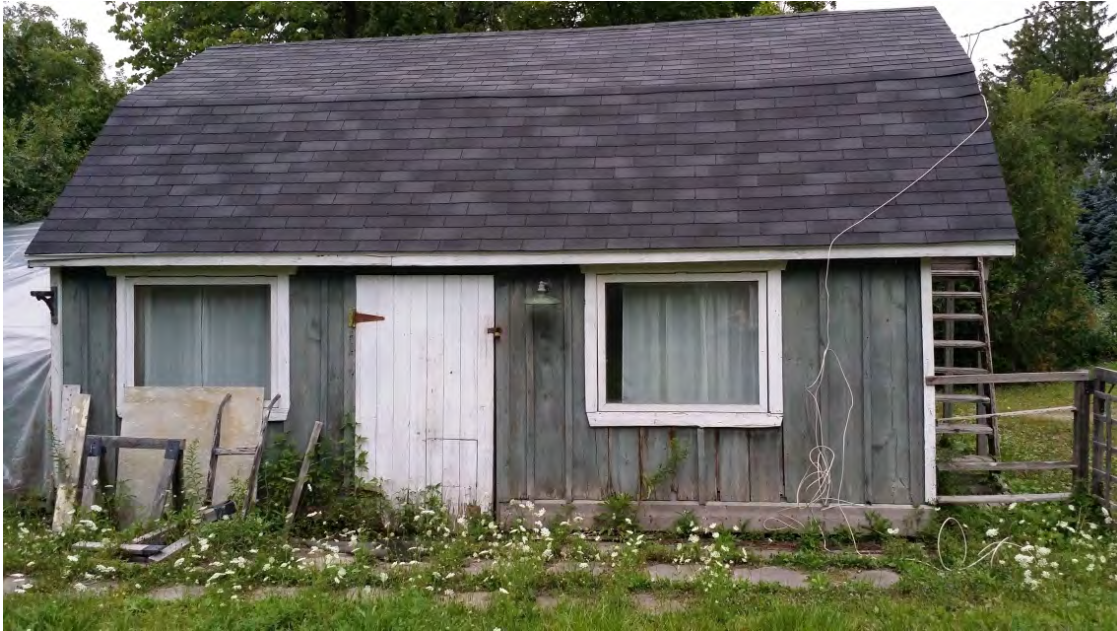
Barn south elevation. Note inappropriate newer windows, general lack of maintenance

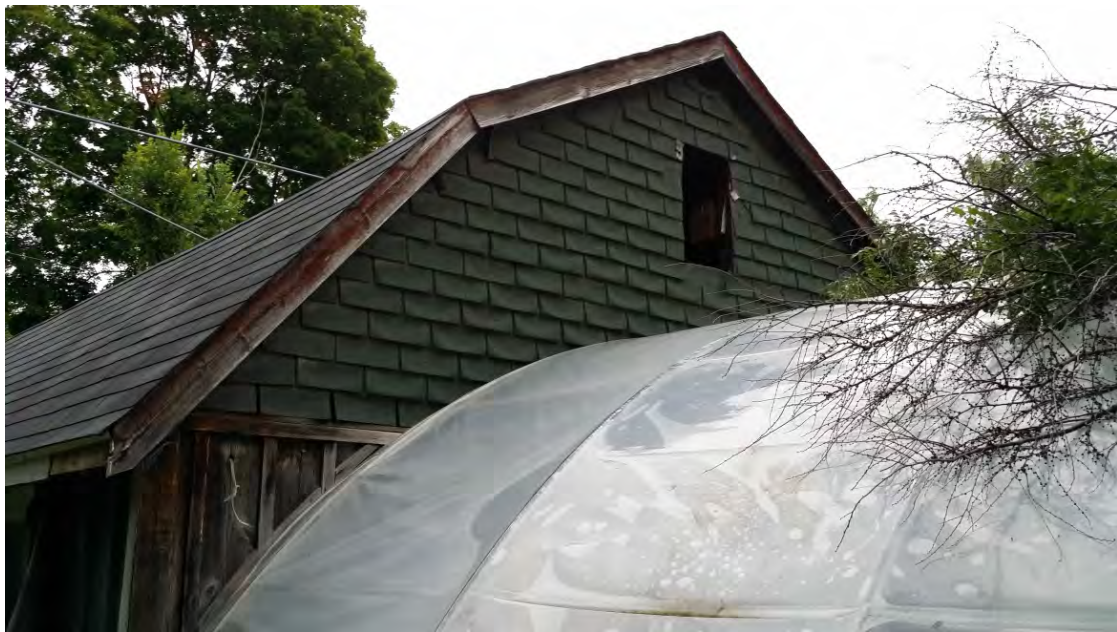
Barn west elevation. Later greenhouse structure in foreground. Note that trims and siding have not been painted here as they have on more visible east and south elevations

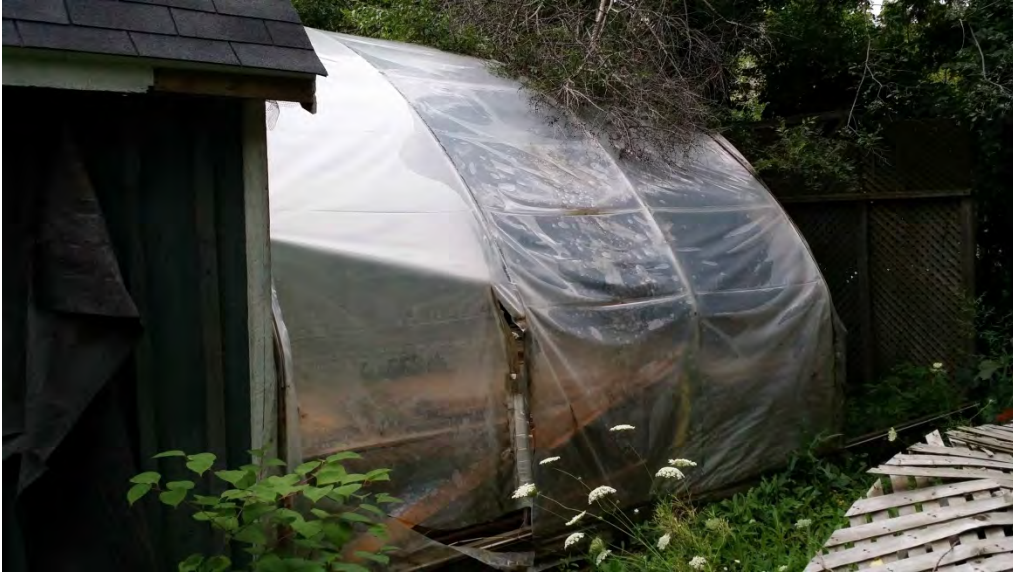
Greenhouse structure in poor repair
