**THURBER** ENGINEERING LTD.

**FINAL  
PHASE ONE ENVIRONMENTAL SITE ASSESSMENT  
PART OF BURNHAMTHORPE ROAD WEST  
CLASS ENVIRONMENTAL ASSESSMENT STUDY FOR BURNHAMTHORPE ROAD WEST  
MISSISSAUGA, ONTARIO**

**CIMA+**

Date: April 2, 2018  
File: 20337

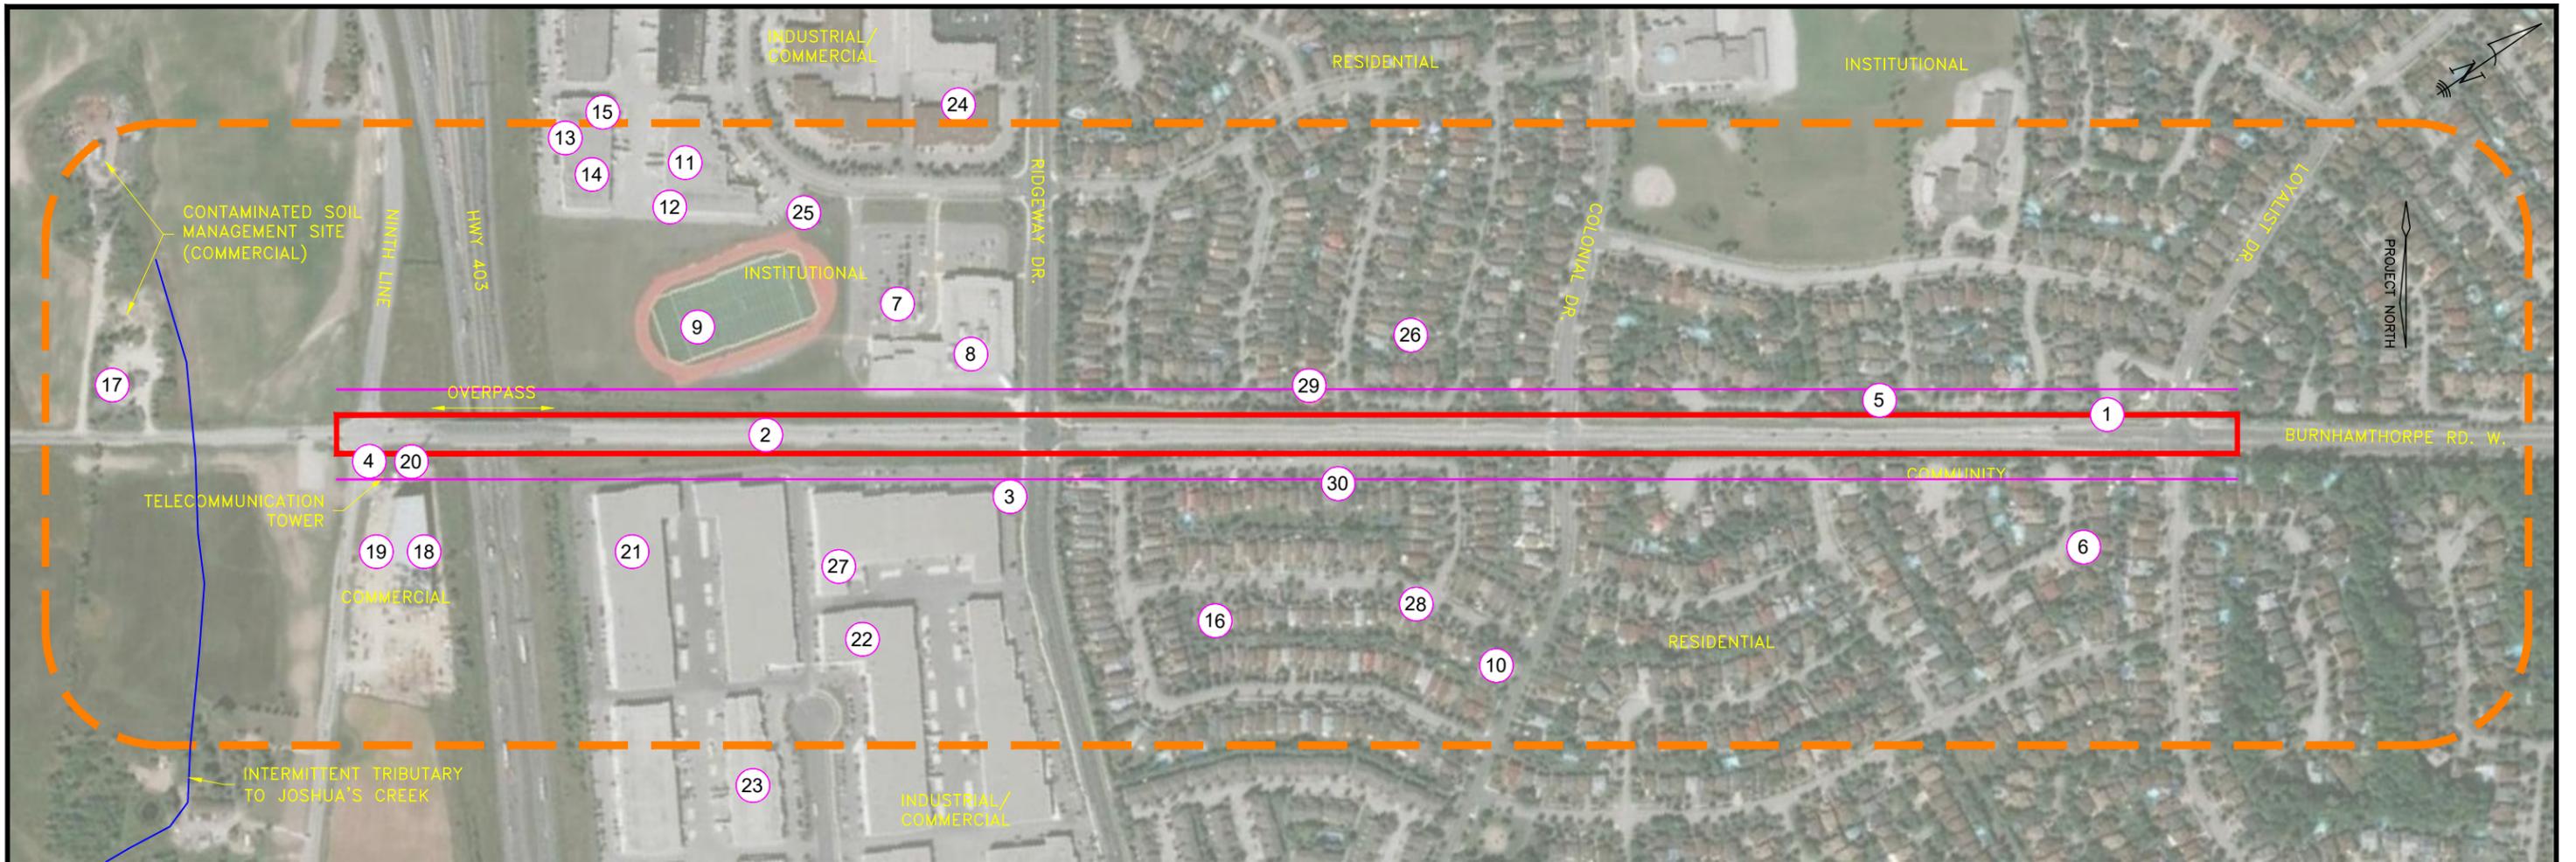
CONCEPTUAL SITE MODEL-POTENTIAL CONTAMINATING ACTIVITIES  
JOB# 20337

No.	Location/Address (distance (m) /direction from Phase One Property)	PCA # (Table 2, Schedule D, O. Reg. 153/04)	Description of PCA
<b>Phase One Property</b>			
1	North side of Burnhamthorpe Road West, west of Loyalist Drive, at Iglesia Ni Cristo (0 / -)	PCA #55 Transformer Manufacturing, Processing and Use	A pad-mounted transformer was located between the sidewalk and the church and may encroach on the Phase One Property.
2	Entire Phase One Property (0 / -)	PCA #30: Importation of Fill Material of Unknown Origin	Fill materials were likely used to construct the embankments for the Highway 403 overpass and may be present on the Phase One Property for grading during construction of the existing roadway, boulevards and sidewalks.
<b>Phase One Study Area (beyond the Phase One Property)</b>			
3	West side of Ridgeway Drive, 10 m north and south of Burnhamthorpe Road West (10 - 20 / North & South)	PCA #55 Transformer Manufacturing, Processing and Use	Three pad-mounted transformers were located to the west of the sidewalk along Ridgeway Drive to the north of Burnhamthorpe Road West, and two pad-mounted transformers were located to the south of Burnhamthorpe Road West.

4	3625 Ninth Line & Burnhamthorpe Road West, 20 m south of Burnhamthorpe Road West (20 / South)	PCA #55 Transformer Manufacturing, Processing and Use	A pad-mounted transformer was located between the Sentinel Storage facility and the telecommunications tower.
5	4006 Mellort Crescent (0 / North)	PCA #28 Gasoline and Associated Products Storage in Fixed Tanks	Potential former or current retail fuel tank(s)
6	3713 Price Court (32 / South)	PCA #8 Chemical Manufacturing, Processing and Bulk Storage	Potential former bulk storage of chemicals
7	4010 Sladeview Crescent (45 / North)	PCA #8 Chemical Manufacturing, Processing and Bulk Storage PCA #51 Solvent Manufacturing, Processing and Bulk Storage	Bulk storage, use and disposal of aliphatic solvents, and inorganic and organic laboratory chemicals at a school
8	4010 Sladeview Crescent (45 / North)	PCA #39 Paints Manufacturing, Processing and Bulk Storage	Bulk storage, use and disposal of paints at a school

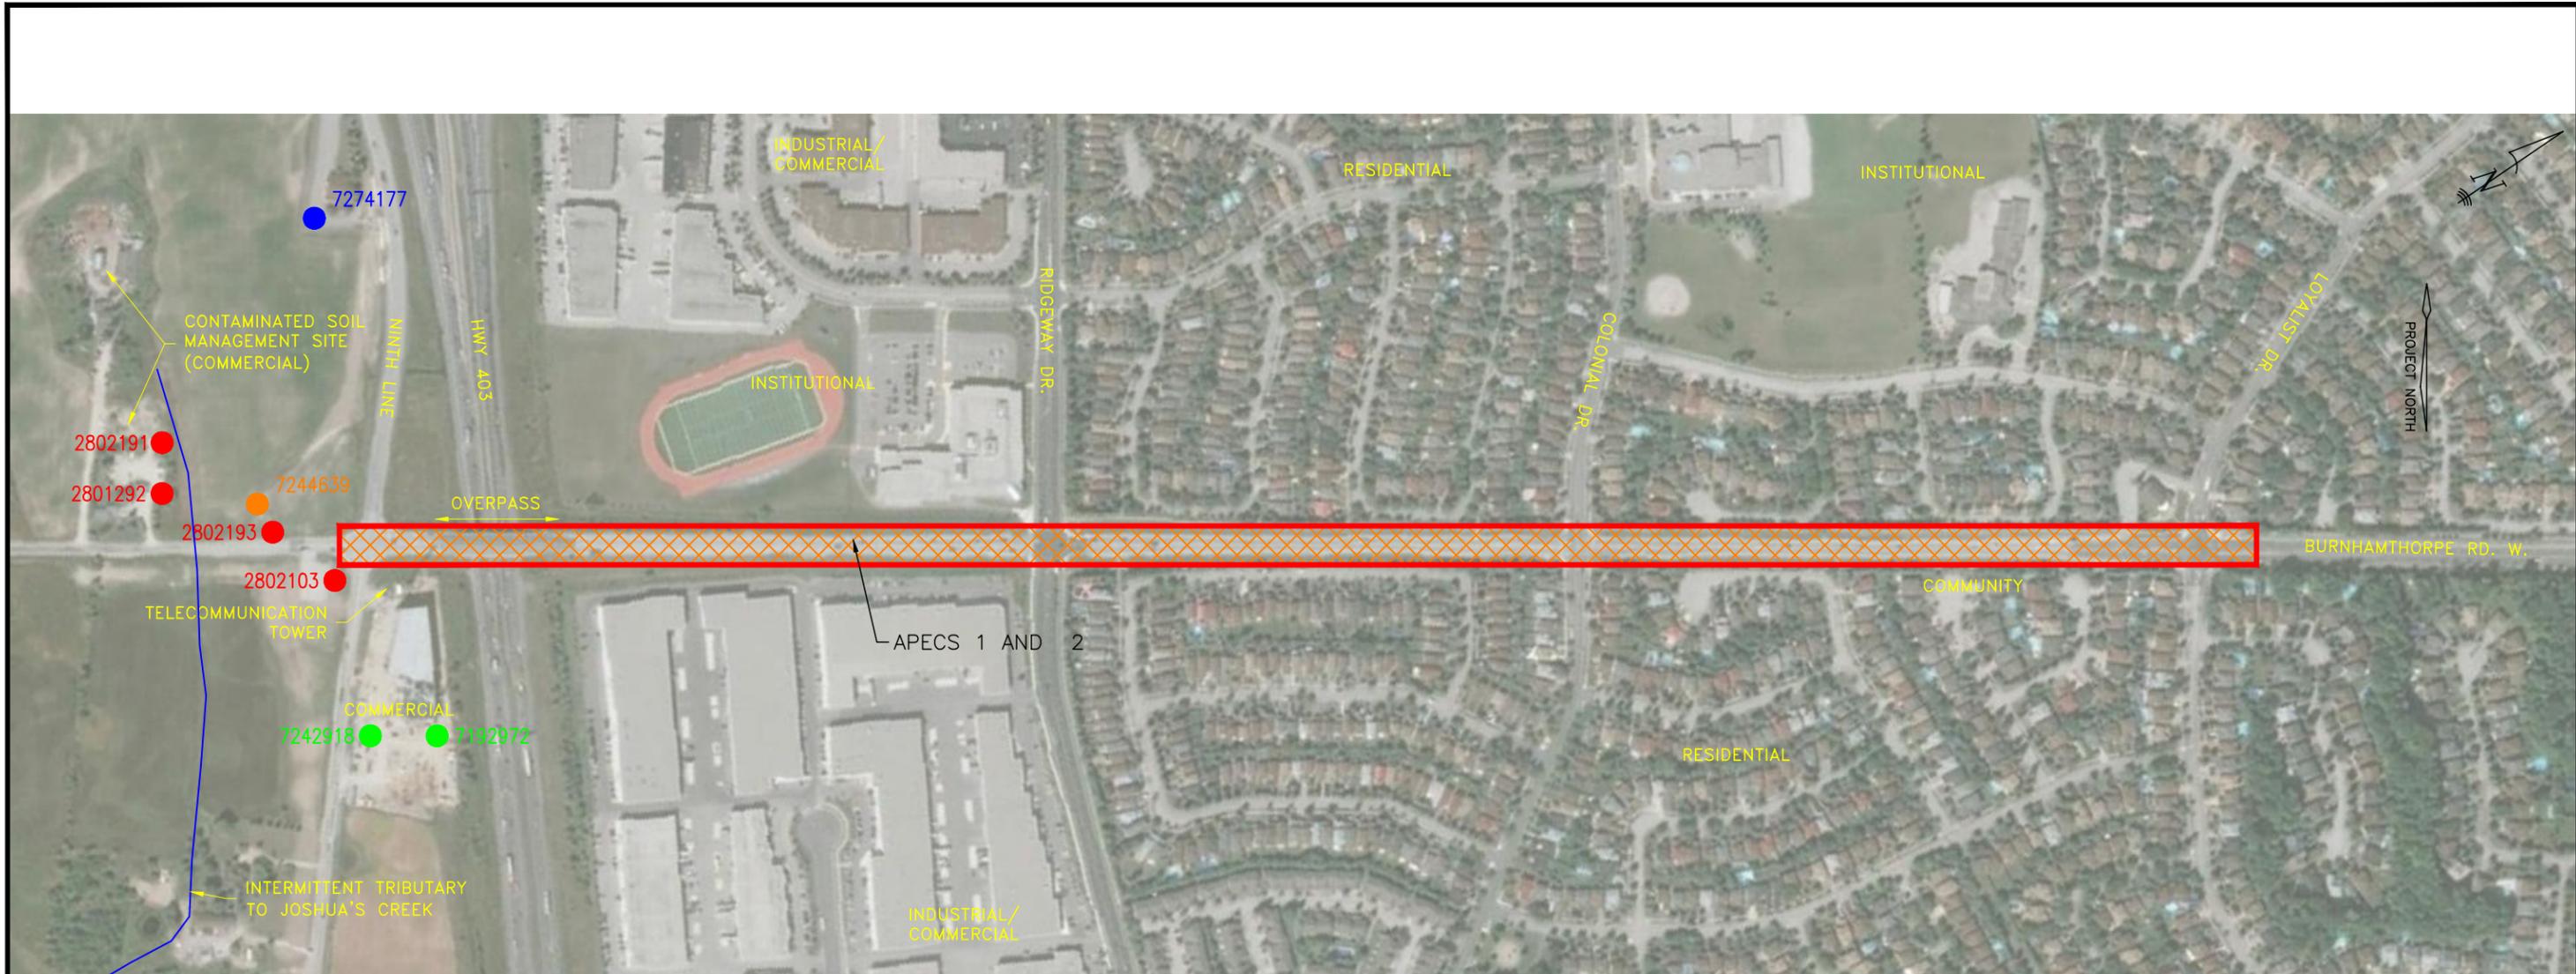
<b>THURBER ENGINEERING LTD.</b>		
ENGINEER :	DRAWN :	APPROVED :
YC	AN	DK
DATE :	SCALE :	DRAWING No. :
APRIL 2018	AS SHOWN	20337-2

- Phase One Property Boundary
- APEC 1 is due to PCA No. 2 (PCA#30)
- APEC 2 is due to PCA Nos. 9, 18, 29 and 30 (PCA#40)

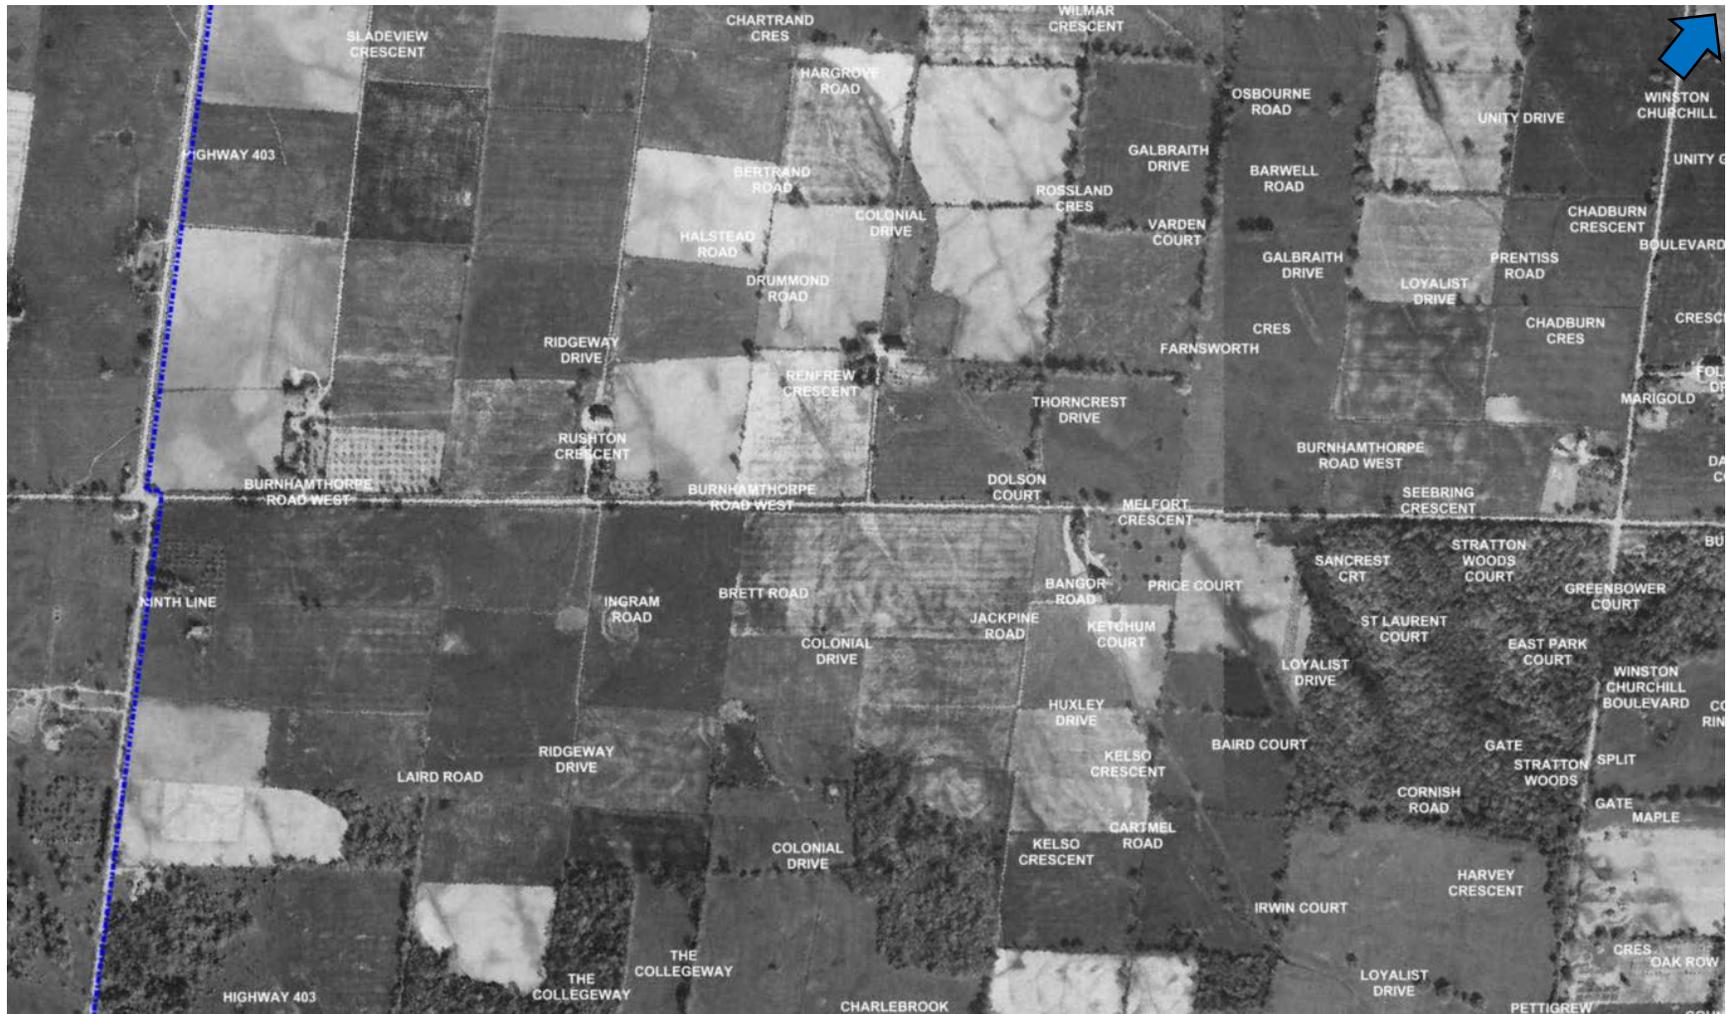
**1954 Aerial Photograph**  
Part of Burnhamthorpe Road West  
Mississauga, Ontario

Year	Phase One Property	Surrounding Properties in Phase One Study Area
1954	The Phase One Property appeared to be a gravel/dirt road sparsely lined with trees.	<p>The Phase One Study Area consists of agricultural and vacant land in all directions. Ninth Line and Burnhamthorpe Road West were developed in the Phase One Study Area.</p> <p>Forested land was observed southeast of the intersection of current Loyalist Drive and Burnhamthorpe Road West.</p> <p>Two orchards with associated farm buildings were observed north and south of the west end of Burnhamthorpe Road West: one orchard was located in the area of the current playing field of Loyola Catholic Secondary School at 4010 Sladeview Crescent, and the other was located in the area of the current Sentinel Storage facility, southeast of the intersection of Burnhamthorpe Road West and Ninth Line.</p> <p>Farm houses were observed north and south of Burnhamthorpe</p>

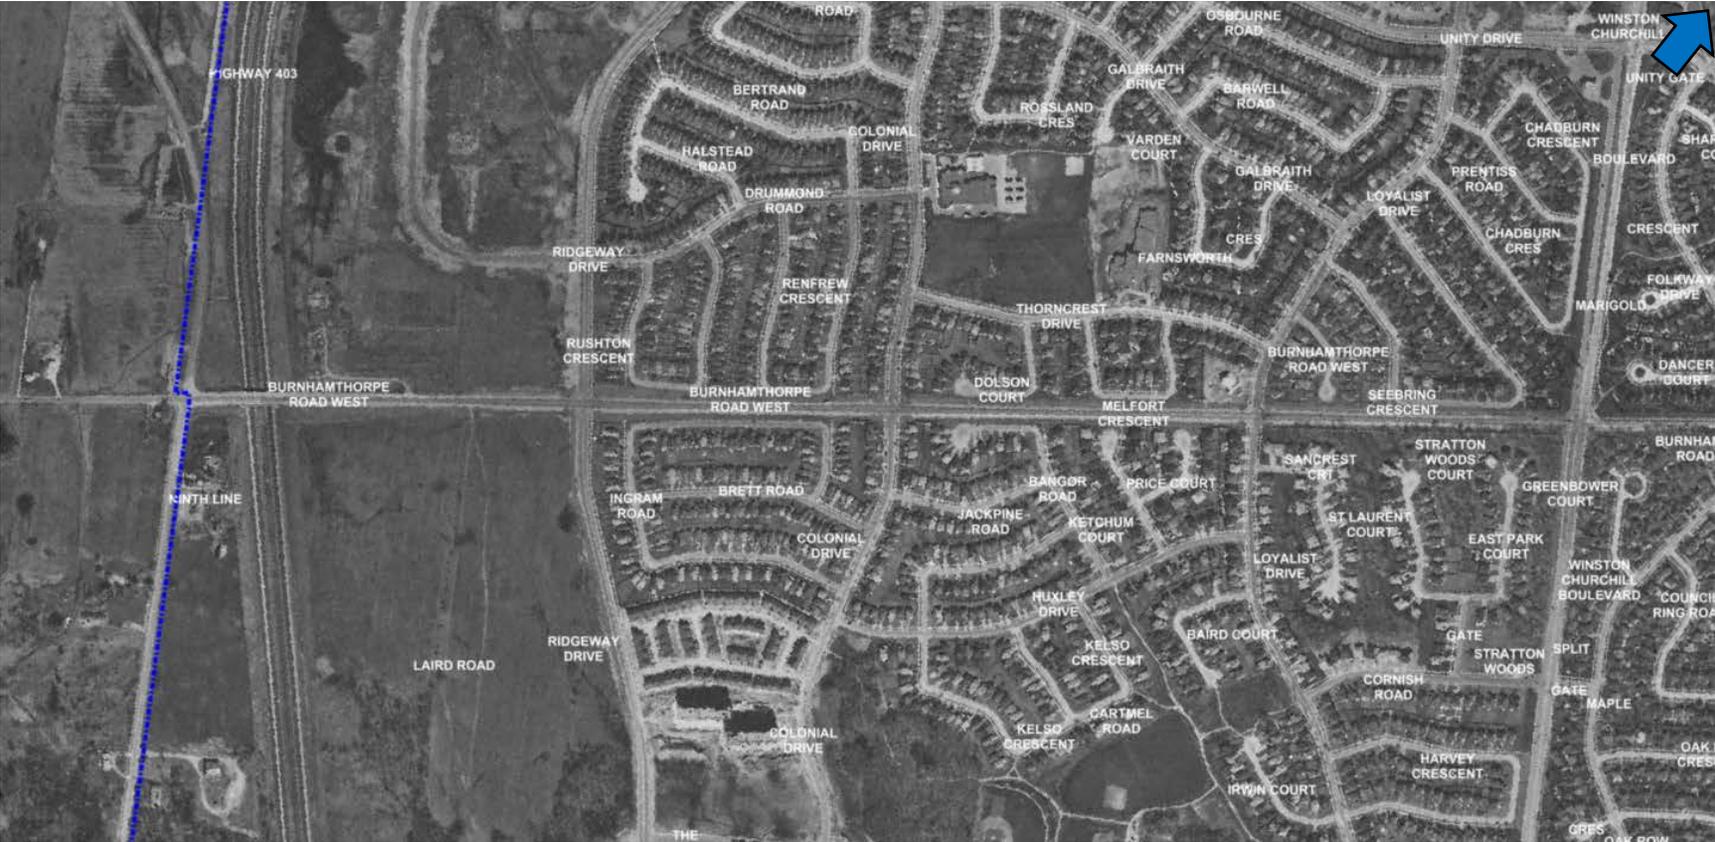
**1989 Aerial Photograph**

1989	Burnhamthorpe Road West appeared to be paved and improved.	The orchards were no longer visible. The area located southeast of the intersection of Burnhamthorpe Road West and Ninth Line appeared to be disturbed, potentially for the construction of the telecommunications tower.  Most areas east of the current Ridgeway Drive and to the north and south of Burnhamthorpe Road West were developed with residential subdivisions.  Indications of the above-referenced watercourses are barely noticeable in the developed area.  A portion of Ninth Line to the north of Burnhamthorpe Road West was re-routed to the west.
1997	No changes were observed from 1989.	The area northwest of the intersection of Ridgeway Drive and Sladeview Crescent has been developed with an industrial park.  Additional lanes have been constructed on Highway 403 north of Burnhamthorpe Road West.  The telecommunications tower was evident southeast of the intersection of Ninth Line and Burnhamthorpe Road West.

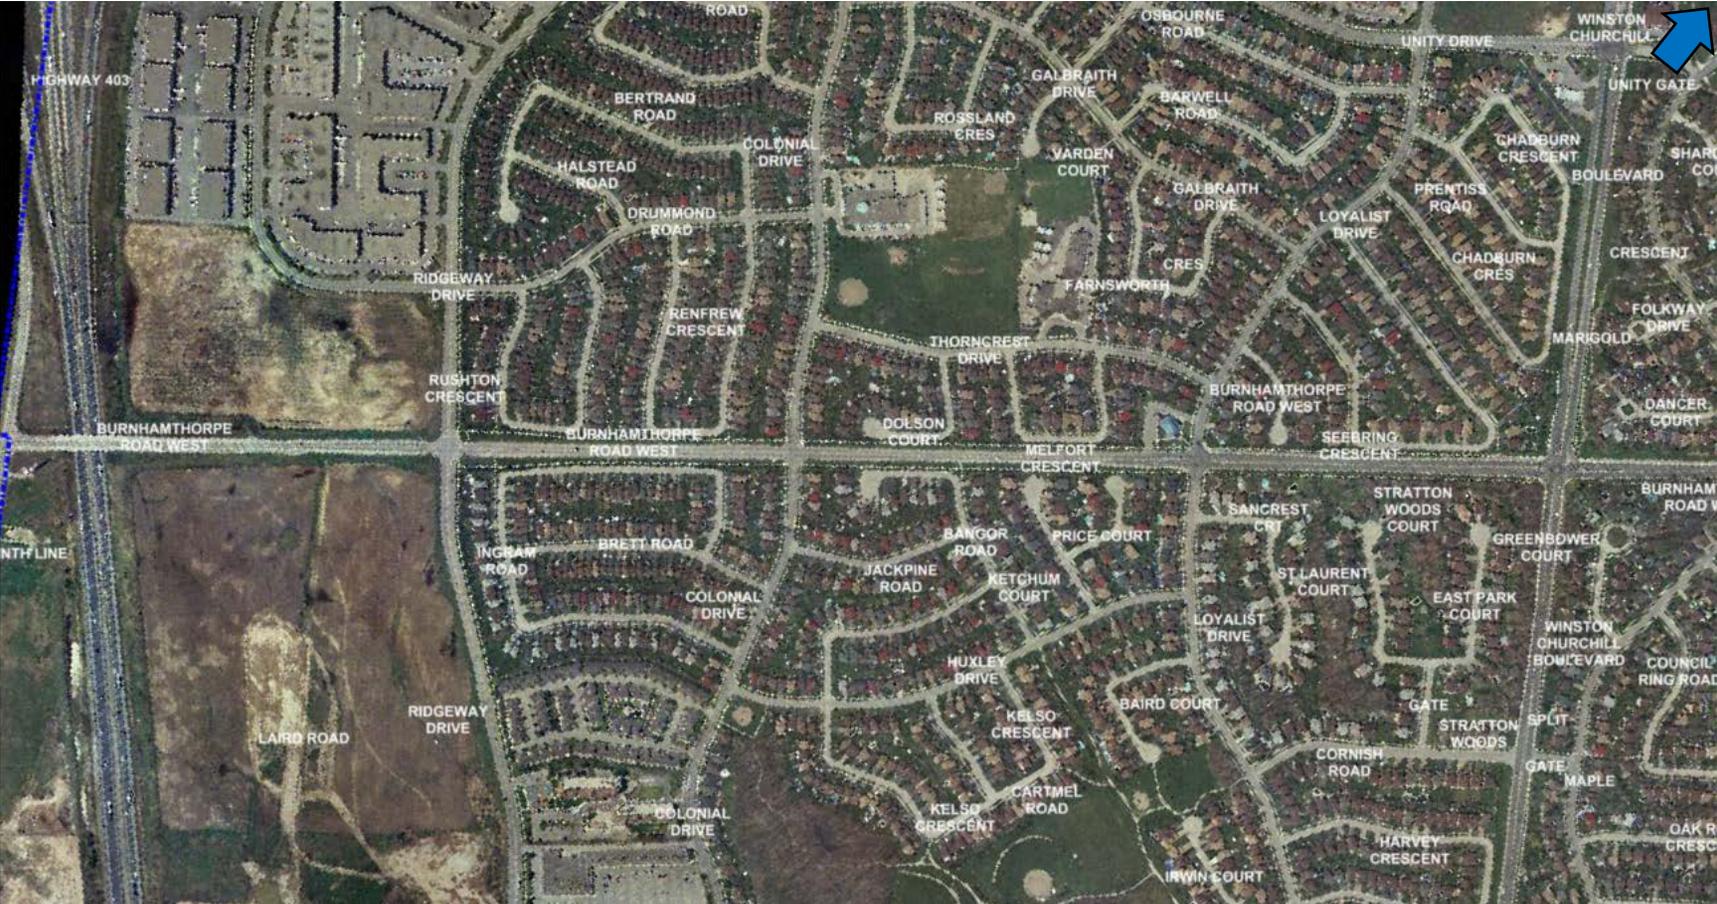
**2002 Aerial Photograph**

2002	No changes were observed from 1989.	Additional industrial development was evident in the area between Highway 403 and Sladeview Drive. Grading of the land southwest of the intersection of Ridgeway Drive and Burnhamthorpe Road West appears to have occurred.
2007	No changes were observed from 1989.	Two additional buildings (4020A and 4020B Sladeview Crescent) exist at the south end of the industrial park.  An area to the north of Burnhamthorpe Road West at the west end of Phase One Study Area appeared to be occupied by some

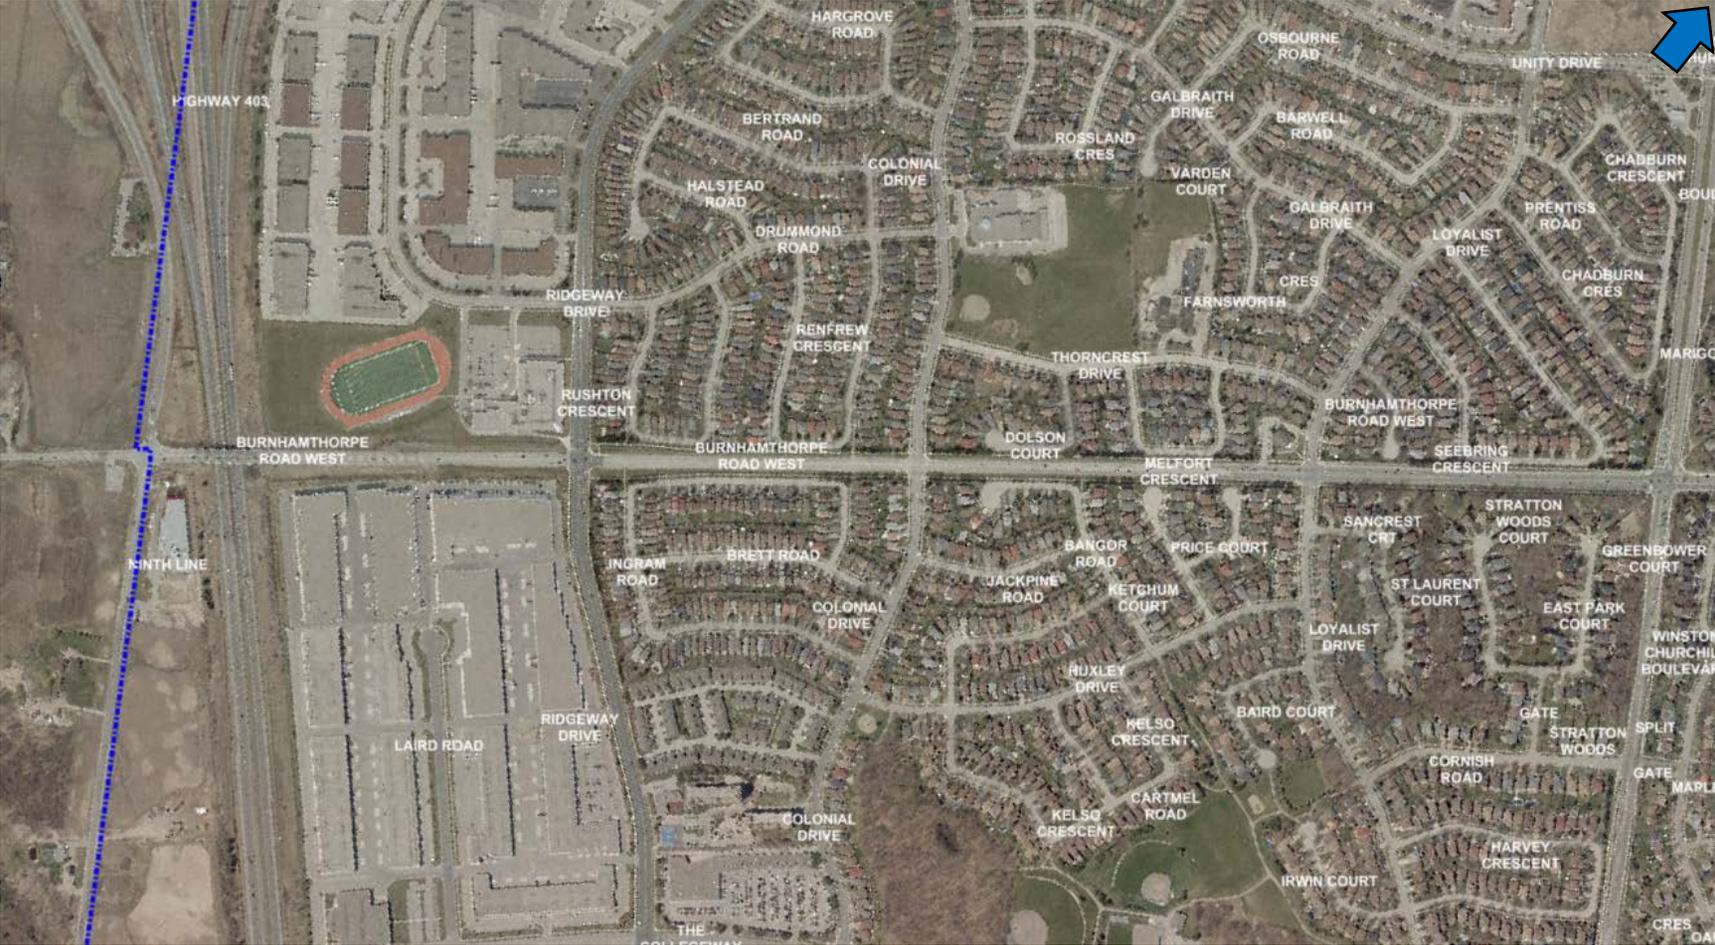
**2017 Aerial Photograph**

2017	No changes were observed from 2012.	<p>The adjacent areas were fully developed.</p> <p>The parcel to the south of Burnhamthorpe Road West between Highway 403 and Ridgeway Drive was developed with industrial buildings.</p> <p>The construction of Loyola Catholic Secondary School and playing field appeared to be completed to the north of Burnhamthorpe Road West between Highway 403 and Ridgeway Drive.</p> <p>A building has been constructed on the quadrant southeast of Ninth Line and Burnhamthorpe Road West, adjacent to the telecommunications tower.</p> <p>A graded area was evident on the quadrant west of Ninth Line and Burnhamthorpe Road West.</p>

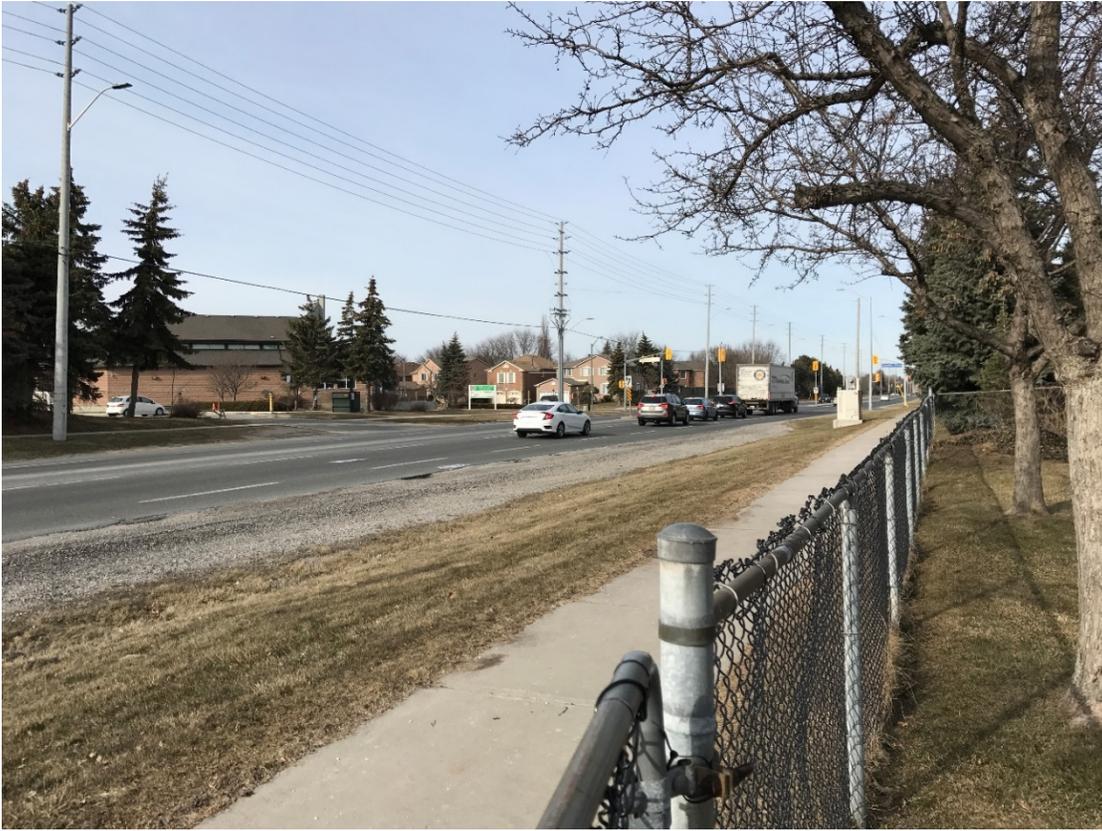
Photo 1: East end of the Phase One Property, facing northeast, showing the pad-mounted transformer in the foreground of Iglesia Ni Cristo church (PCA No. 1).

- The mineral insulating oil contained within the transformer located on the north side of the sidewalk and Burnhamthorpe Road West and west of Loyalist Drive may be located on the Phase One Property. There is a potential for the transformer to have leaked and impacted the soil and/or groundwater in the vicinity of the transformer.

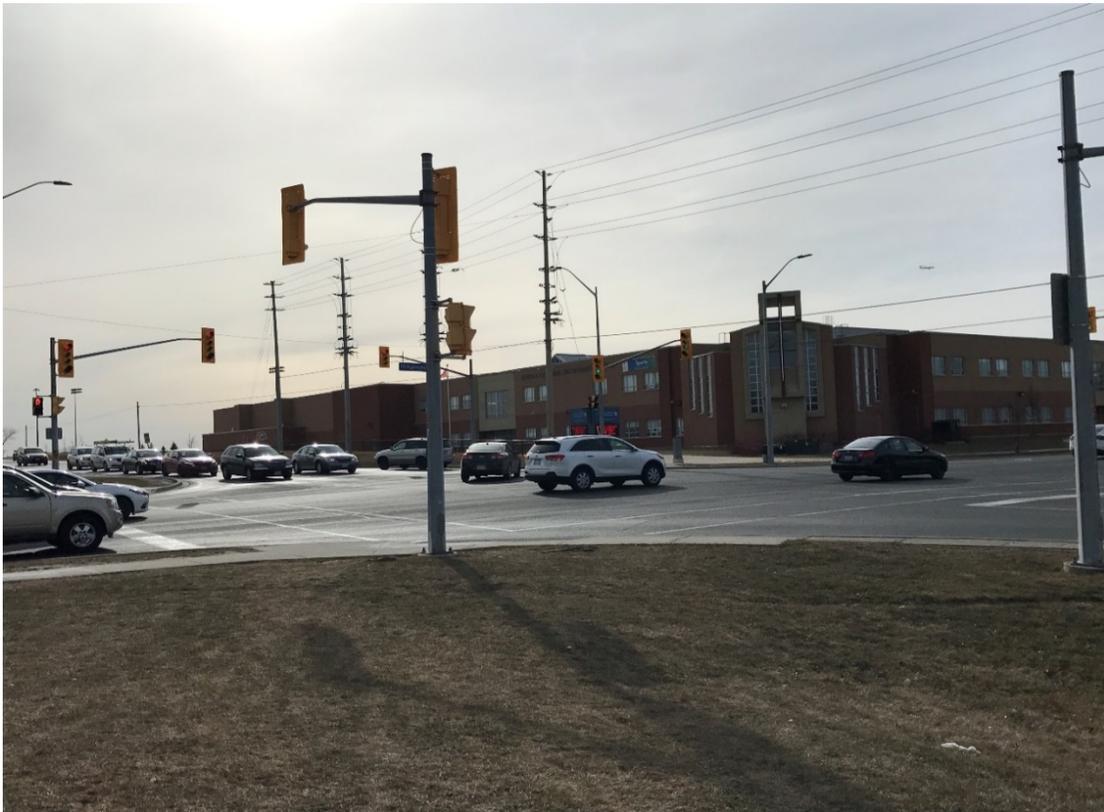
Photo 2: Facing southwest from the central portion of the Phase One Property.

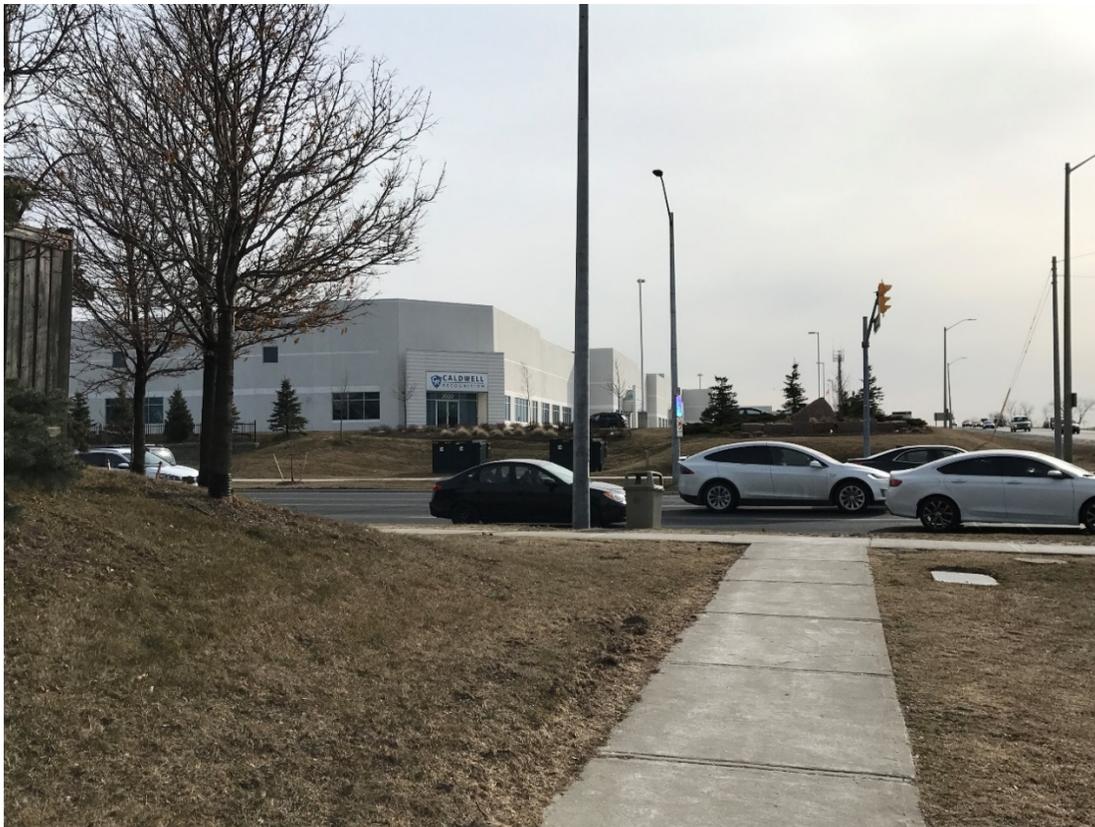
Photo 4: Ridgeway Drive just south of Burnhamthorpe Road West, facing west, showing pad-mounted transformers on the west side of Ridgeway Drive (PCA No. 3).

The transformers closest to the Phase One Property were observed at the following locations: 1) approximately 10 m to the north and south of Burnhamthorpe Road West, on the west side of Ridgeway Drive, and 2) approximately 20 m south of Burnhamthorpe Road West and east of Ninth Line. The transformers are relatively new and appeared to be in good condition with no evidence of staining on the ground surface in the areas surrounding the transformers.

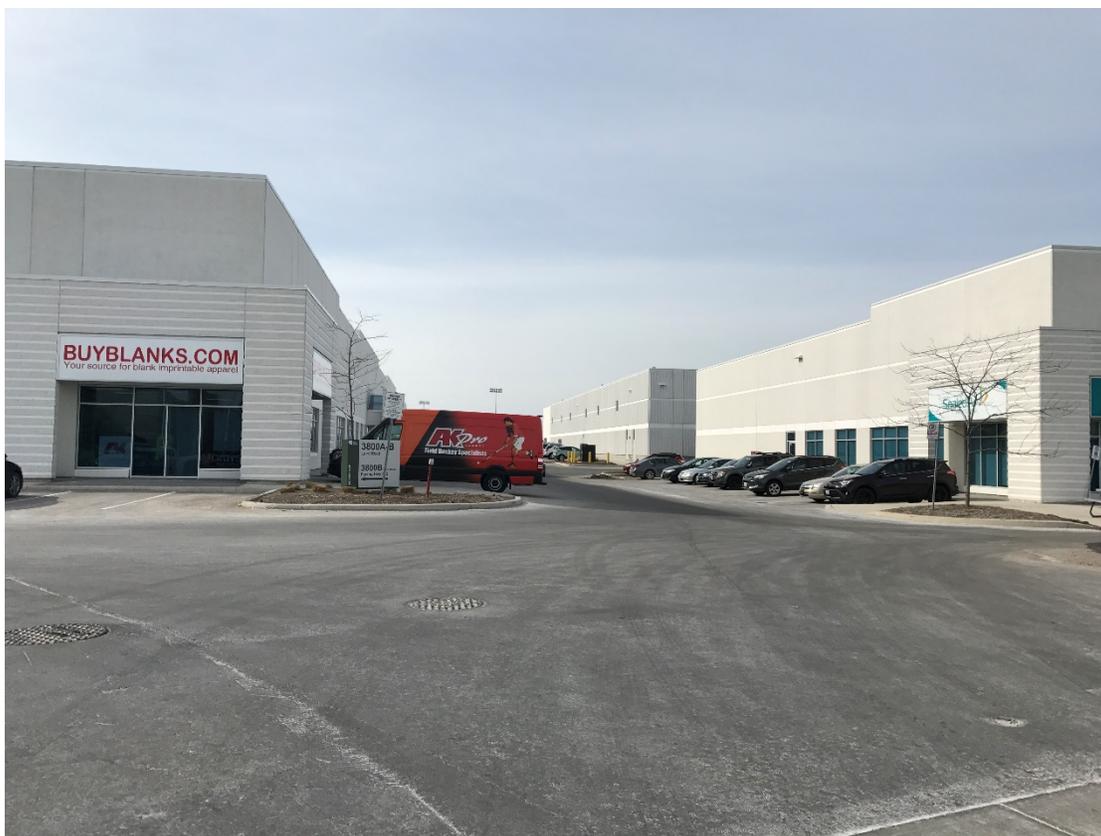
Photo 9: 3770A Laird Road (right) (PCA No. 23), facing south from the north end of Laird Road.

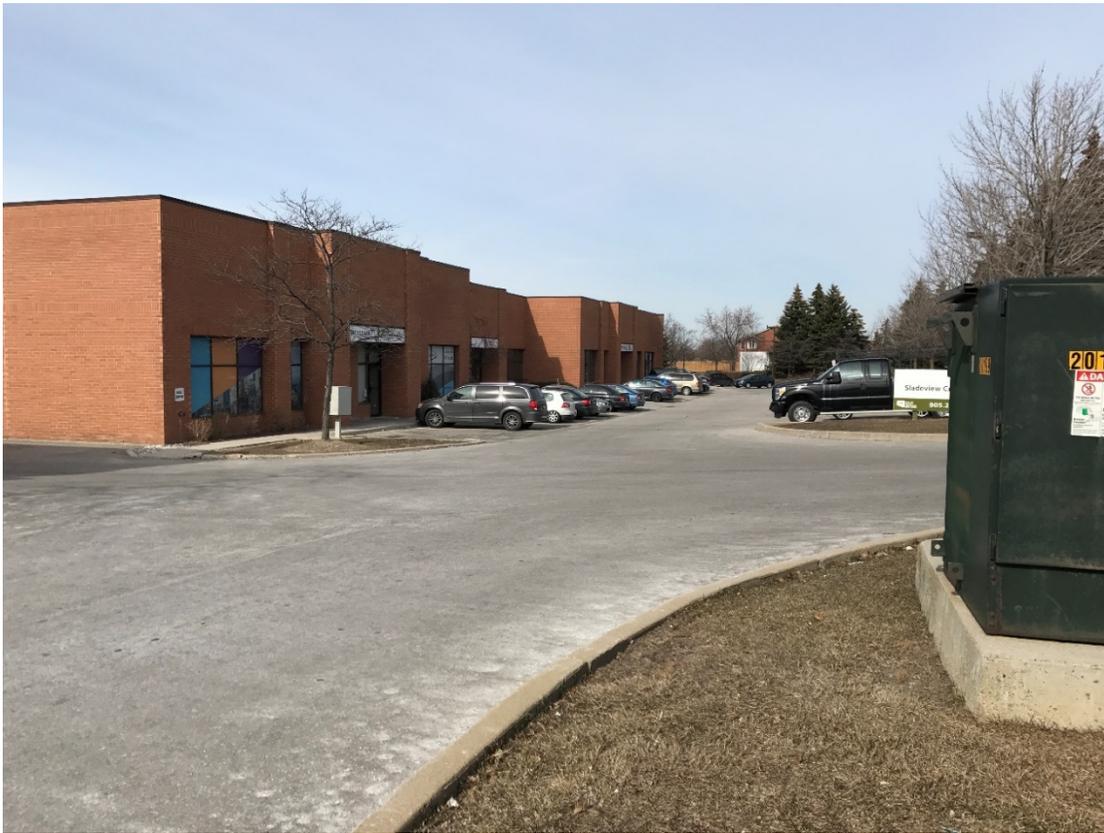
Photo 11: 3995 Sladeview Crescent (PCA No. 24), facing northeast from the entrance.

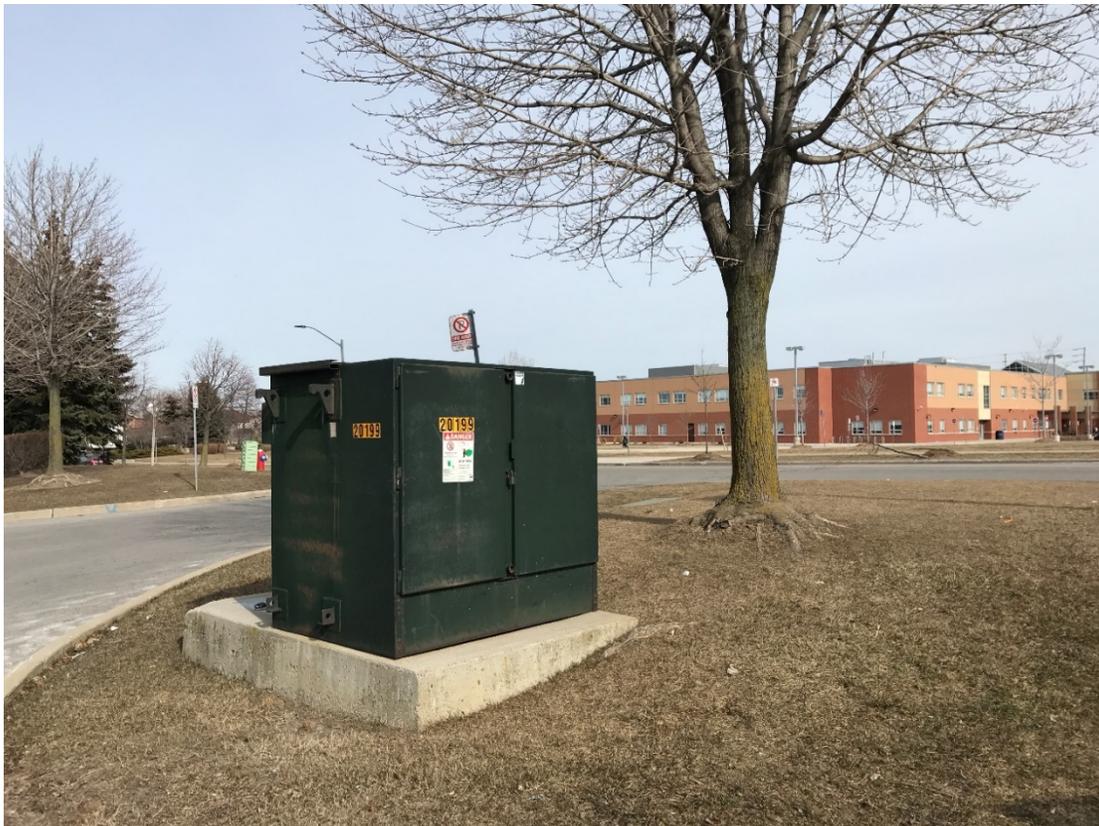
Photo 12: A transformer near the entrance of 3995 Sladeview Crescent, beyond which is Sladeview Crescent and Ignatius Catholic High School, facing southeast.

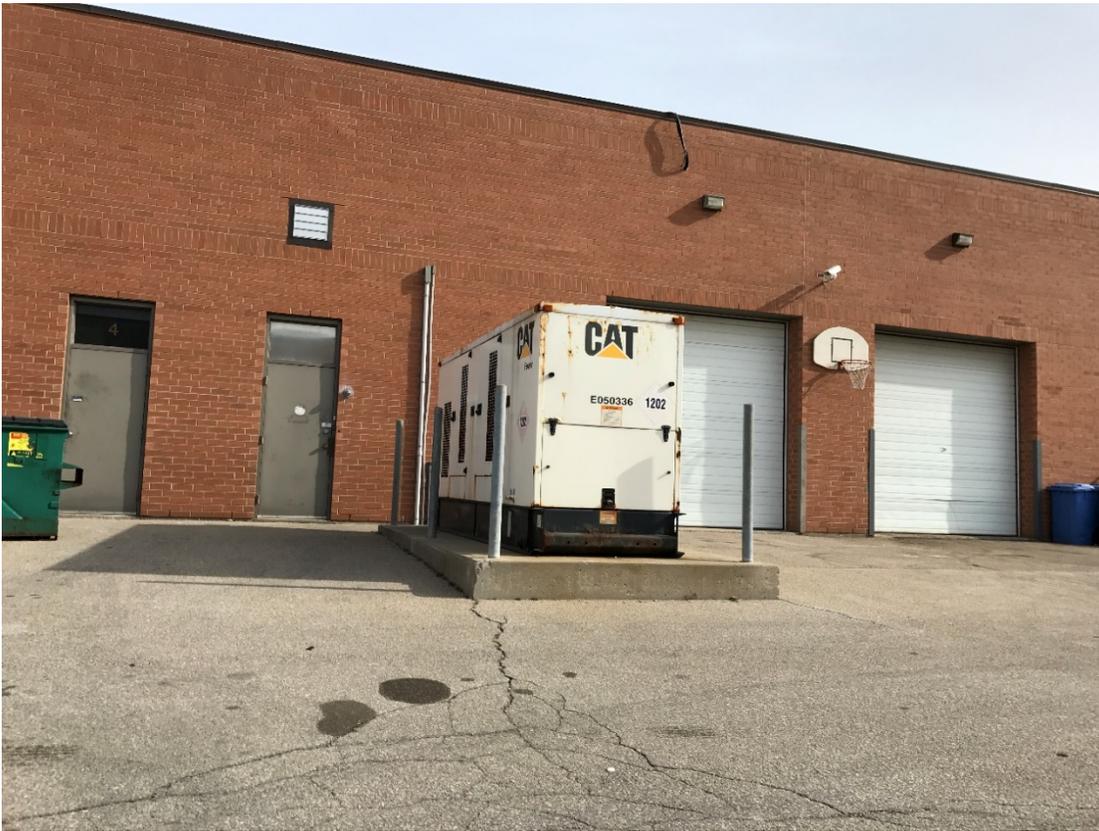
Photo 13: The generator at the back of 3995 Sladeview Crescent (PCA No. 24), facing south.

- Mobile electricity generators at 3995 and 4020A Sladeview Crescent and in the shed adjacent to the telecommunications tower adjacent to 3625 Ninth Line & Burnhamthorpe Road West.

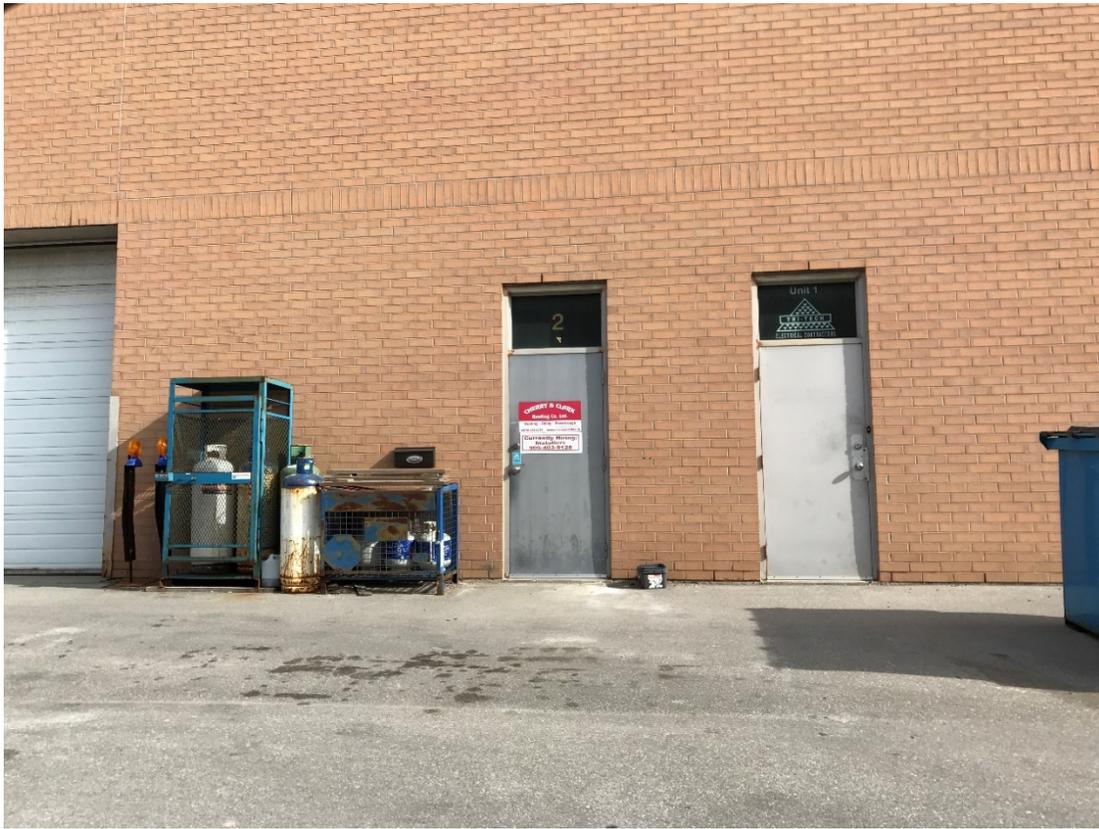
Photo 15: Compressed gas and propane cylinders behind 4025 Sladeview Crescent, facing south.

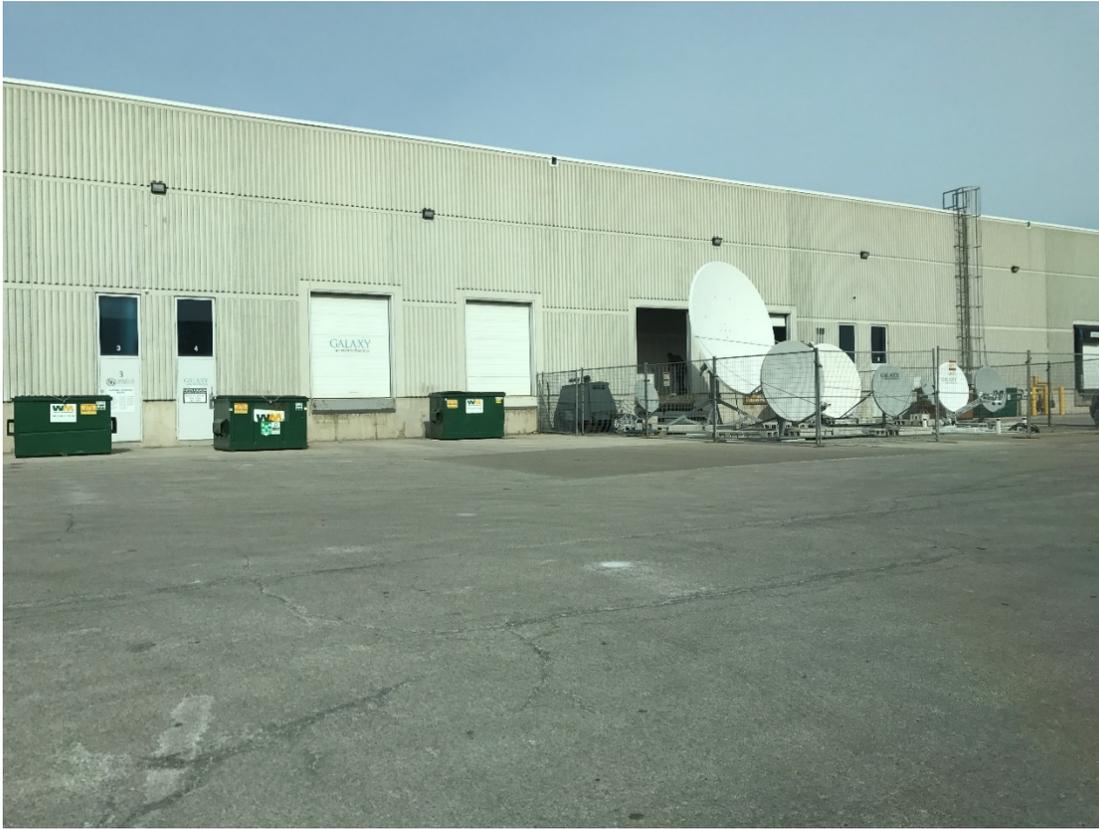
Photo 16: The front of 4020A Sladeview Crescent, facing northwest, former location of Maple Leaf Drives Ltd. (PCA No. 11).

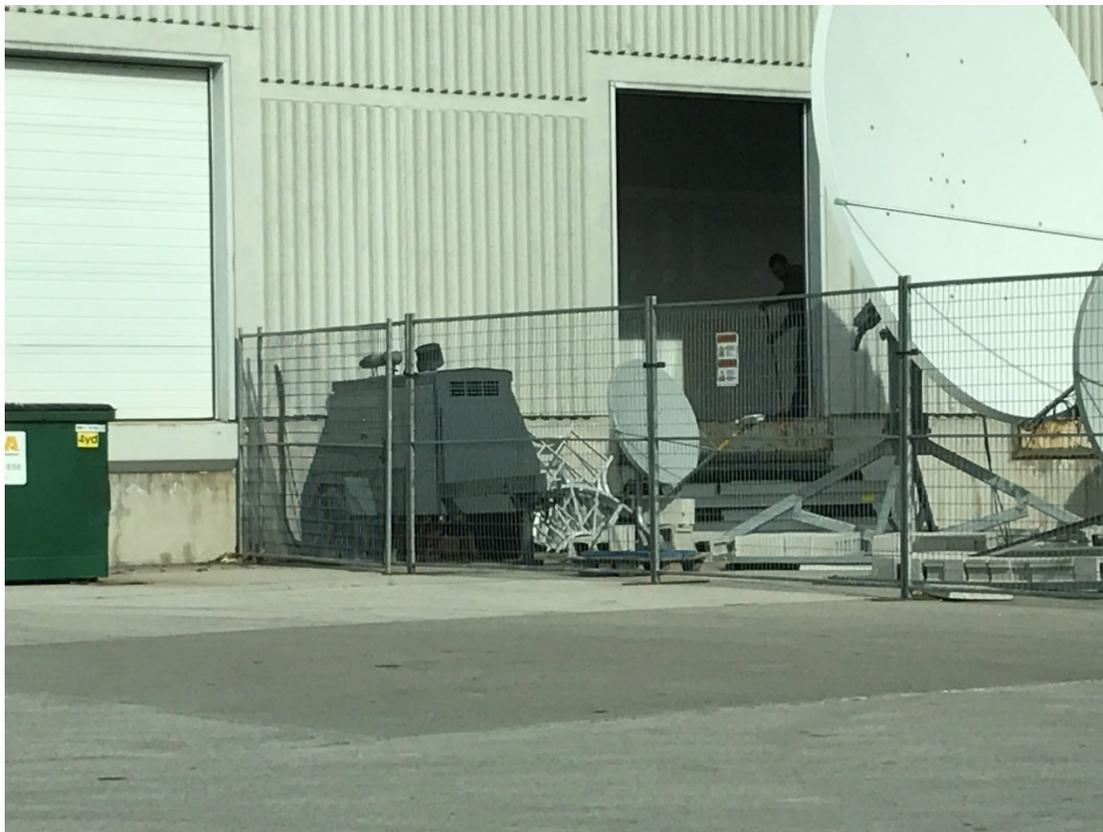
Photo 18: The generator for the satellite station behind 4020A Sladeview Crescent (PCA No. 12), facing southeast.
