**THURBER** ENGINEERING LTD.

**FINAL  
PHASE ONE ENVIRONMENTAL SITE ASSESSMENT  
PART OF BURNHAMTHORPE ROAD WEST  
CLASS ENVIRONMENTAL ASSESSMENT STUDY FOR BURNHAMTHORPE ROAD WEST  
MISSISSAUGA, ONTARIO**

**CIMA+**

Date: April 2, 2018  
File: 20337

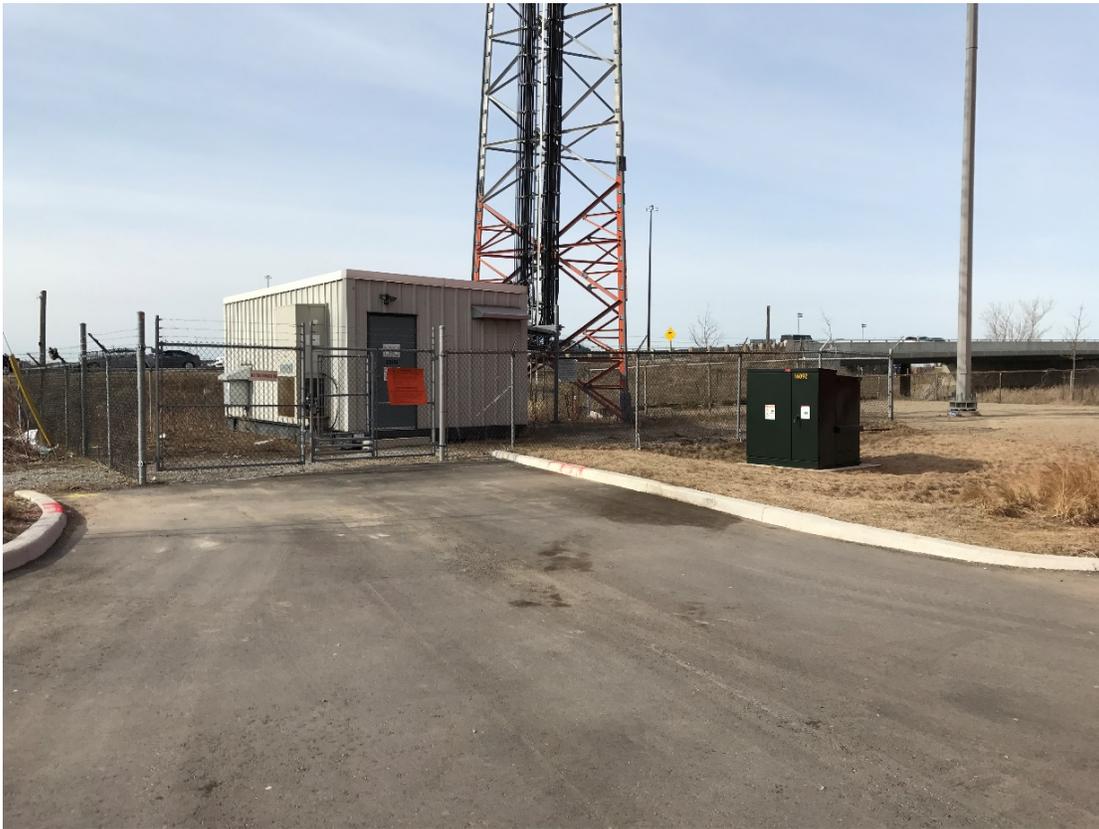
Photo 19: The telecommunications tower with associated shed (with potential generator – PCA No. 20), and the pad-mounted transformer between the tower and the Sentinel Storage building (PCA No. 4).

- Mobile electricity generators at 3995 and 4020A Sladeview Crescent and in the shed adjacent to the telecommunications tower adjacent to 3625 Ninth Line & Burnhamthorpe Road West.

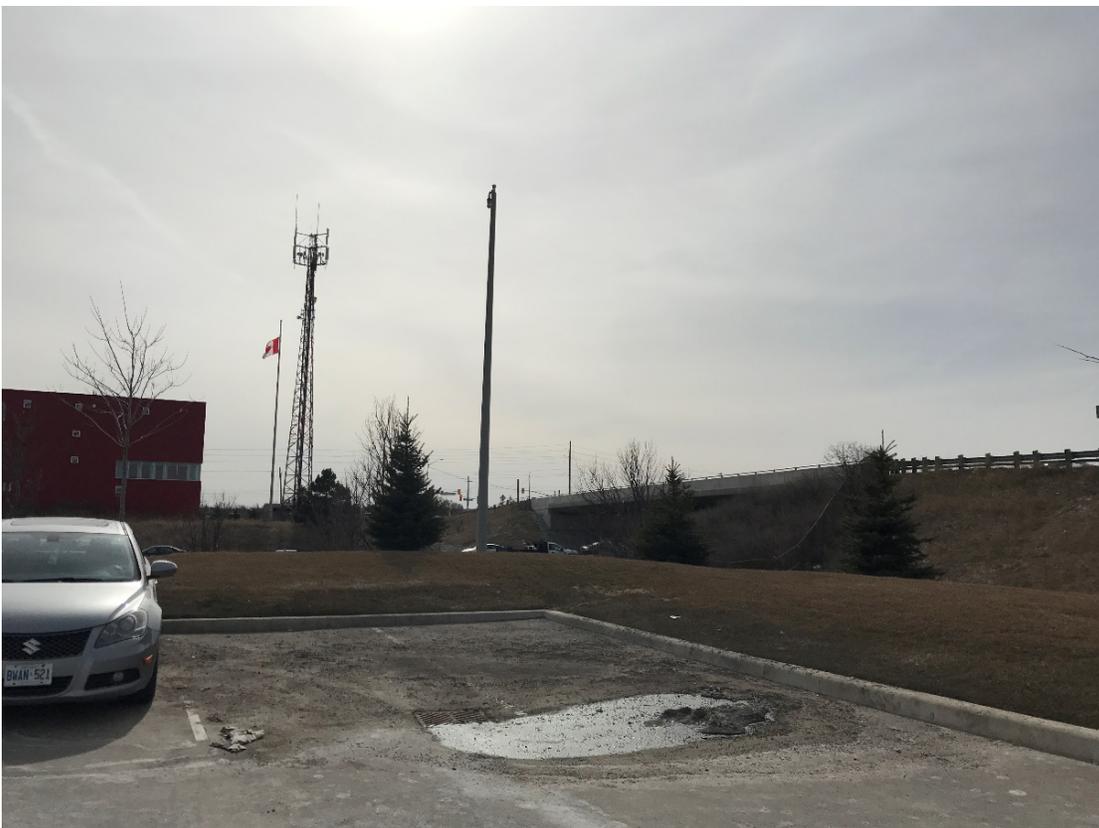
Photo 20: The Highway 403 overpass from the northwest corner of 3800B Laird Road, facing northwest.

Fill materials are likely present within the embankments for the Highway 403 overpass and may have been used for grading during construction of the existing roadway, boulevards and sidewalks. No debris or areas of significant staining on the ground surface were observed.

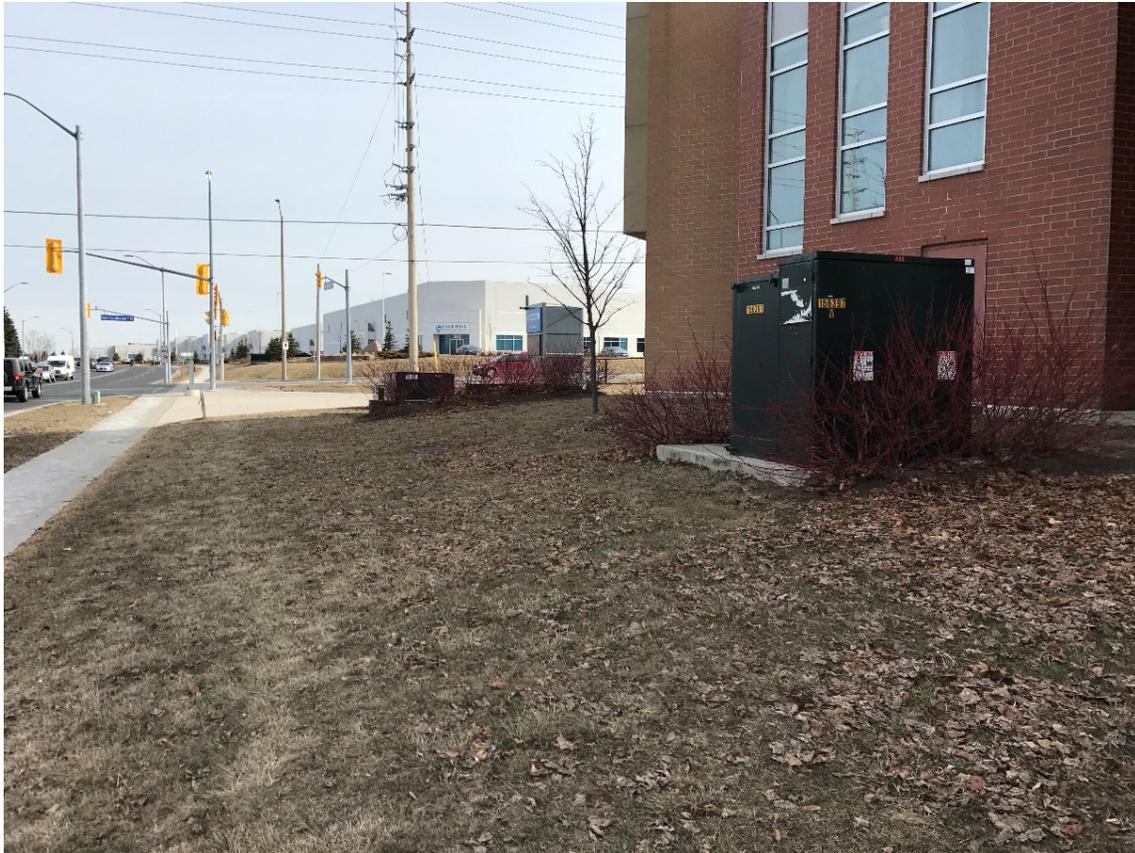
Photo 21: The two transformers northwest of the intersection of Burnhamthorpe Road and Ridgeway Drive (PCA No.3) and one transformer slightly north of the two aforementioned transformers (near the southeast corner of Ignatius Catholic High School).

The transformers closest to the Phase One Property were observed at the following locations: 1) approximately 10 m to the north and south of Burnhamthorpe Road West, on the west side of Ridgeway Drive, and 2) approximately 20 m south of Burnhamthorpe Road West and east of Ninth Line. The transformers are relatively new and appeared to be in good condition with no evidence of staining on the ground surface in the areas surrounding the transformers.
