2019 Water Quality Monitoring & Aquatic Habitat Characterization Report Lakeview Village, Mississauga

Lakeview Community Partners Limited

Beacon Environmental Limited

January 2020 217424.2

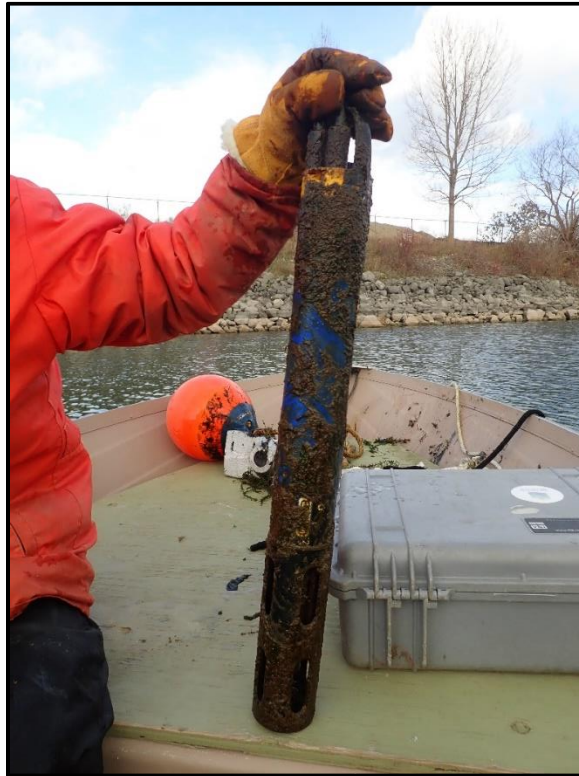
Photograph 1. Water quality multiparameter sonde.

On August 30th, 2019, one YSI 6600 Multiparameter Sonde was installed in the intake channel and another in the discharge channel (**Photograph 1**). The sondes were installed approximately 2.5 m below the water surface and anchored to the channel bed. The sondes recorded continuous measurements of Dissolved Oxygen (DO), pH, turbidity and temperature until they were removed on October 4, 2019.

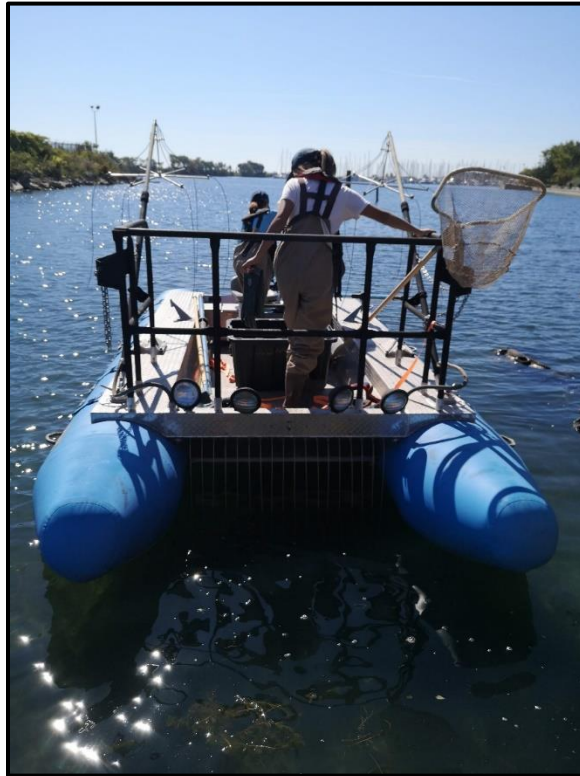
Photograph 2. Electrofishing in the discharge channel.

Fish community sampling of the intake and discharge channels was completed on September 17, 2019 using a SmithRoot Cataraft Electrofisher fishing boat (**Photograph 2**). Fish were caught, identified, measured, photographed and then returned to the channels.

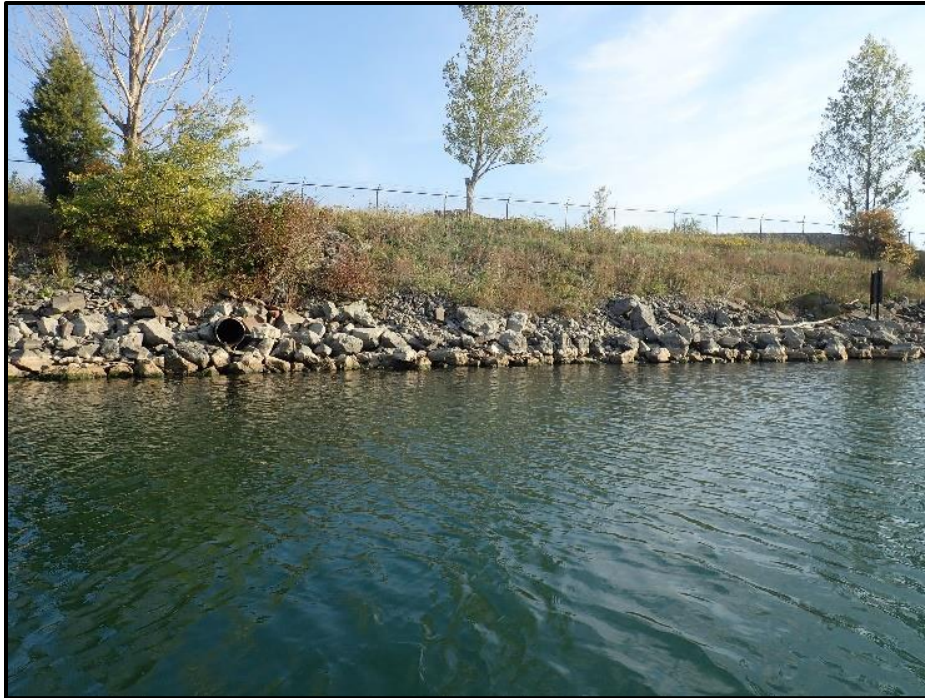
Photograph 3. Bank conditions along intake channel.

The total length of the constructed intake channel is about 1000 m as measured from the intake headwall to the tip of the jetties. The average width of the channel is 35 m. The depth of the channel, measured at its centre, is approximately 6.0 m and is excavated into natural bedrock. The channel is connected to Lake Ontario and provides relatively sheltered lacustrine (lake like) fish habitat without currents or extreme wave action. The channel is straight, and its banks are lined with angular cobble and boulders (rip rap stone) at a 2:1 incline. The intake headwall structure is made of concrete and is vertical. The only vegetation present consists of shrubs and trees which are growing at the top of the constructed banks (**Photograph 3**). These shrubs and trees do not provide cover for fish or shading to the channel. Within the channel, aquatic vegetation is very sparse and consists of non-native Eurasian

water-milfoil (*Myriophyllum spicatum*), curly-leaved pondweed (*Potamogeton crispus*), as well as sago pondweed (*Potamogeton pectinatus*) and Canada water weed (*Elodea canadensis*). Overall, the intake channel provides minimal habitat structure and vegetation cover for fish. This is due to the flat structureless bedrock bottom and uniform rip rap banks.

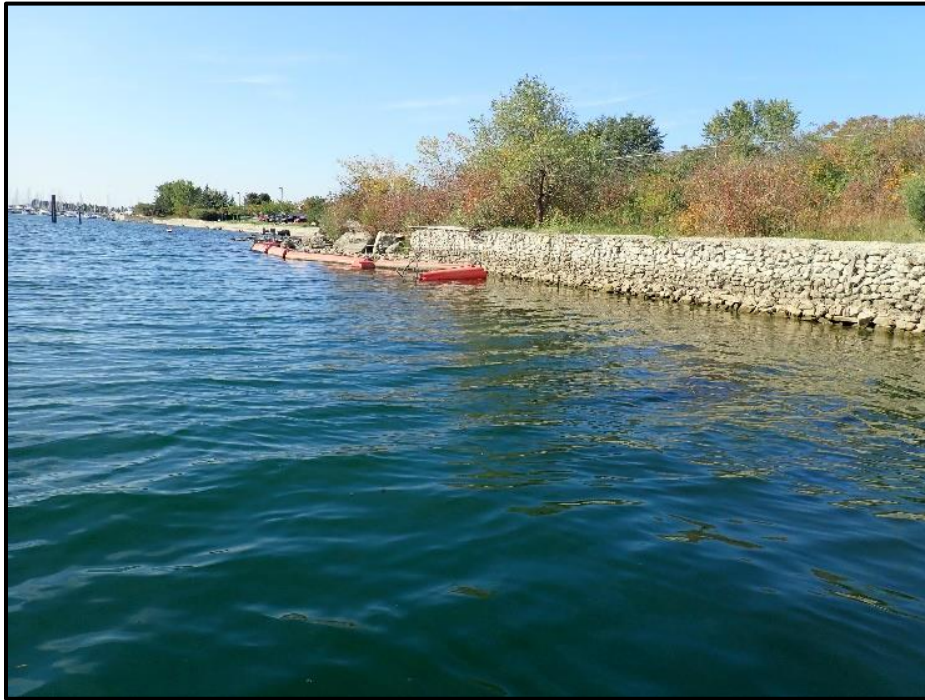
Photograph 4. Armoured banks in discharge channel.

The constructed discharge channel is approximately 140 m long and has a width of approximately 20 m. The channel is excavated into bedrock and is approximately 6.0 m deep at its centre. The discharge channel outlets to the marina basin at Lakefront Promenade Park. The basin is largely enclosed by a 630 m long groyne wall. Like the intake channel, the discharge channel also provides relatively sheltered lacustrine (lake like) fish habitat without flow or extreme wave action. Its structure is also similar to the intake channel. The channel is straight with banks constructed of rip rap stone at a 2:1 incline. Sections of the channel are lined with gabion baskets filled with angular stone and other parts are lined with large concrete slabs (**Photograph 4**). The discharge headwall structure is made of concrete and is vertical. There are several abandoned industrial structures along the shoreline some of which are partially submerged including metal steps, metal pipe, a floating walkway, etc. No aquatic macrophytes were observed, however algal growth is evident during the summer and fall.

Vegetation consisted of shrubs and trees growing at the top of the constructed banks. These shrubs and trees do not provide cover for fish or shading to the channel, however the abandoned industrial structures along the banks provide some cover to fish. Overall, this constructed channel provides minimal cover for fish due to its uniformly shaped banks and channel bottom.

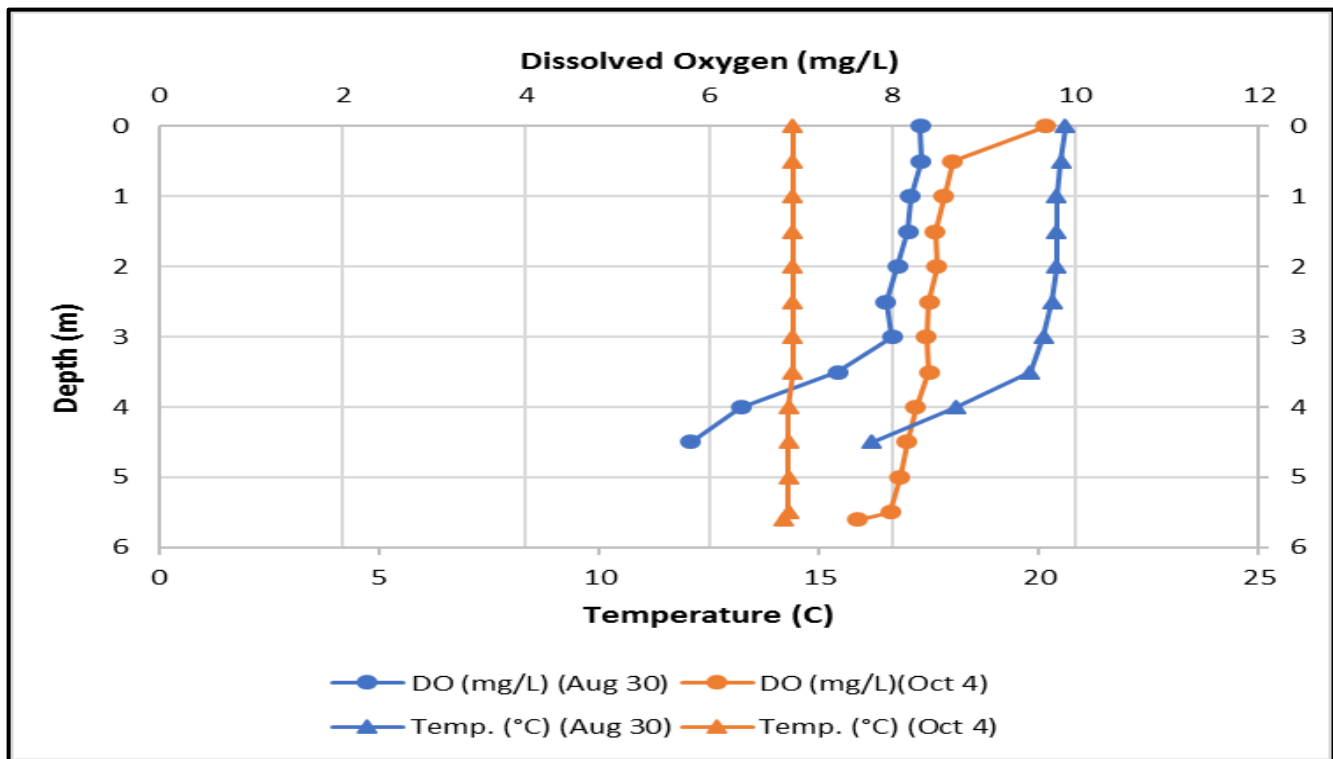
Figure 5. Dissolved Oxygen and Temperature Profile for Discharge Channel (August 30 and October 4, 2019)

The profile for the discharge channel shows different results to the intake channel. The August 2019 profile shows a trend which is referred to as a clinograde. This is a result of the oxygen content in the hypolimnion (lower level of water) being depleted rapidly by oxidative processes (Wetzel 2001). This type of profile is typically seen in eutrophic lakes (high in nutrients). This can result in anoxic conditions along the bottom of the lake as DO declines as a result of biological oxidation of organic matter and oxygen consumption by organisms (Wetzel 2001).

During October 2019, the profile shows that the water column was well mixed and mostly uniform as both temperature and dissolved oxygen have minor changes in their readings. This trend is indicative of fall turnover.

Both the intake and discharge channels are partially isolated from Lake Ontario by the breakwater, groyne and jetties which results in little mixing which consequently leads to increased temperatures, lower dissolved oxygen levels and unsuitable habitat conditions for the cool water fishes that inhabit the lake. Understanding which factors present limitations to recruitment of lake species is important for identifying opportunities to improve water quality and fish habitat. It is recommended that depth profiles be completed in June, July, August and September 2020.

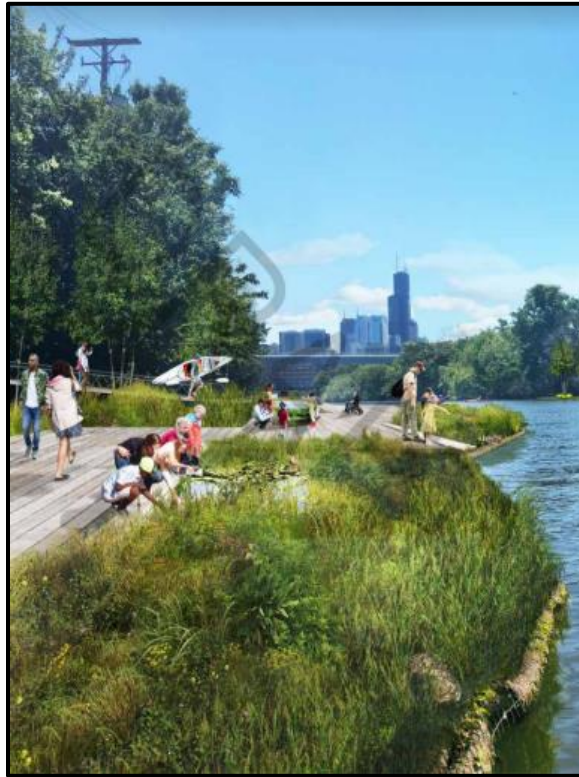
Photograph 8. Example of a floating wetland.

There are several benefits to the installation of floating wetlands from both a water quality and fish habitat perspective. Floating wetlands consist of floating structures for plants that are placed in water of any depth (**Photograph 3**). They provide treatment for water quality by suspending solids, taking up nutrients and providing shade to discourage algae growth. In addition, floating wetlands provide important cover for fish and other aquatic life.

These structures can be custom-made for any size or type of waterbody and can be specifically designed to ensure the appropriate plants are selected to treat water quality concerns.

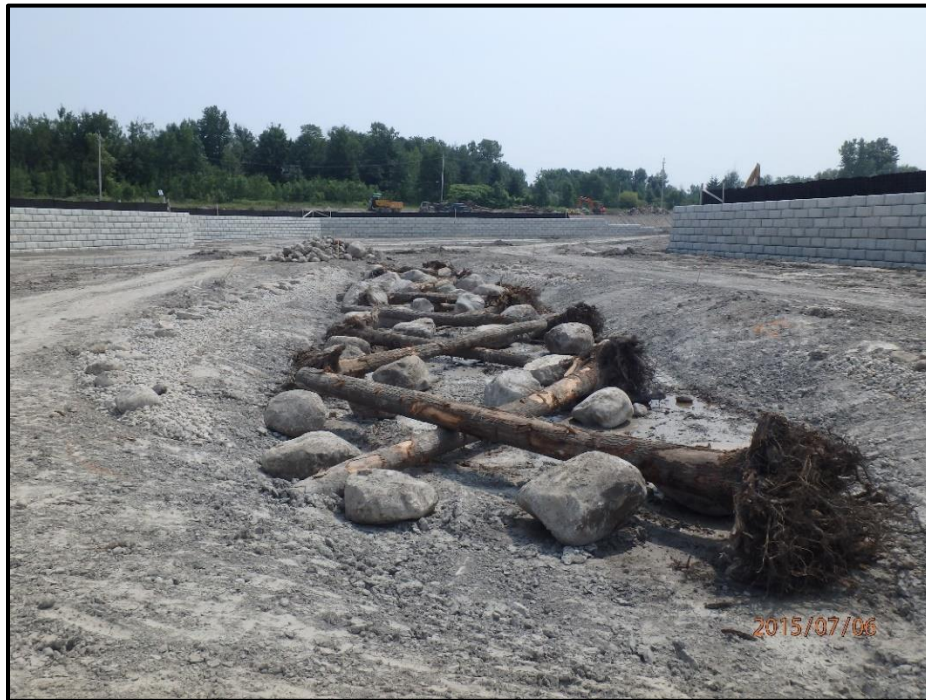
Photograph 9. Example of fish habitat enhancements.

Opportunities to naturalize the Lake Ontario shoreline could be explored to enhance the nearshore aquatic habitat, which would be consistent with the Fish Community Objectives for Lake Ontario (Stewart *et al.* 2017) to maintain a healthy and diverse fishery. Underwater structures would provide areas to protect fish from predators and also carry out other life processes such as feeding and spawning. Possible enhancements include:

- Anchored logs installed along the bottom of the lakebed in shallow areas;
- Brush piles/log cribs that can be anchored or left to drift in the channel;
- Boulder and rock piles/shoals along the littoral areas of the channel, which are ideal for spawning areas for a variety of sunfish species; and
- Brush bundles and rootwads anchored to the littoral areas of the channel would provide habitat for a variety of the species that were captured in both the intake and discharge channels.

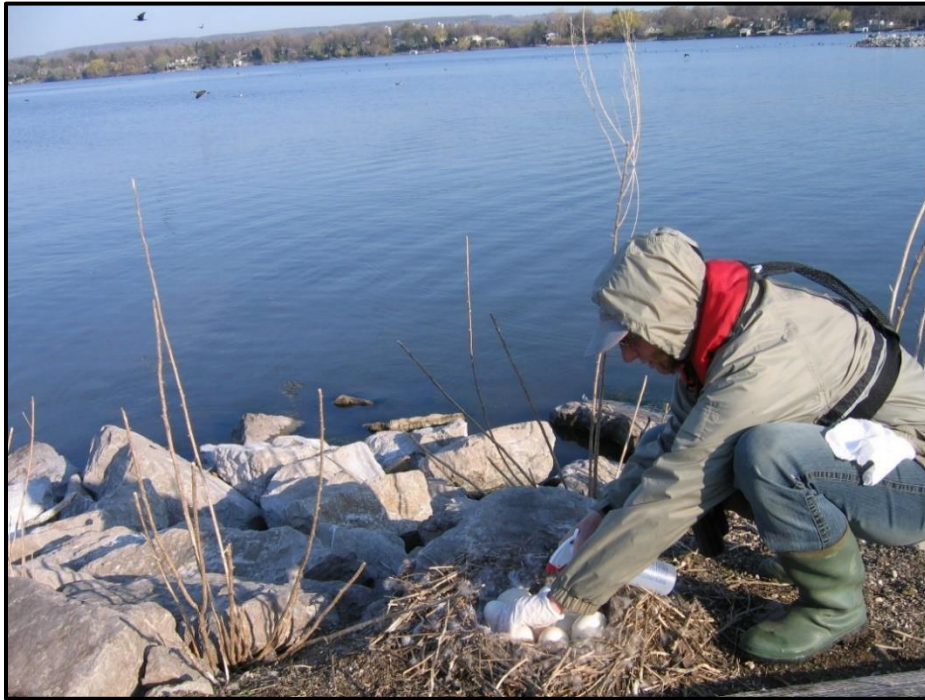
Photograph 11. Egg oiling as a waterfowl management technique.

In areas that must remain open, additional management measures such as egg-oiling can be employed to control resident populations and reduce their impact on the community (**Photograph 11**). It is anticipated that a nuisance waterfowl management strategy will need to be implemented at Lakeview Village to reduce impacts on local water quality.

Waterfowl are known to be a primary source for *Escherichia coli* (*E. coli*) in urbanized lakeshore environments and *E.coli* contamination of waterbodies is one of the more common reasons for beach closures. Waterfowl are generally attracted to open areas and mown lawns that are in close proximity to waterbodies as these areas allow for better detection of potential predators. By reducing the amount of open and turfed areas and replacing these with landscaping using taller vegetation, it is possible to discourage their recruitment and limit the size of the local population. Consideration should be given to this when developing landscaping plans.

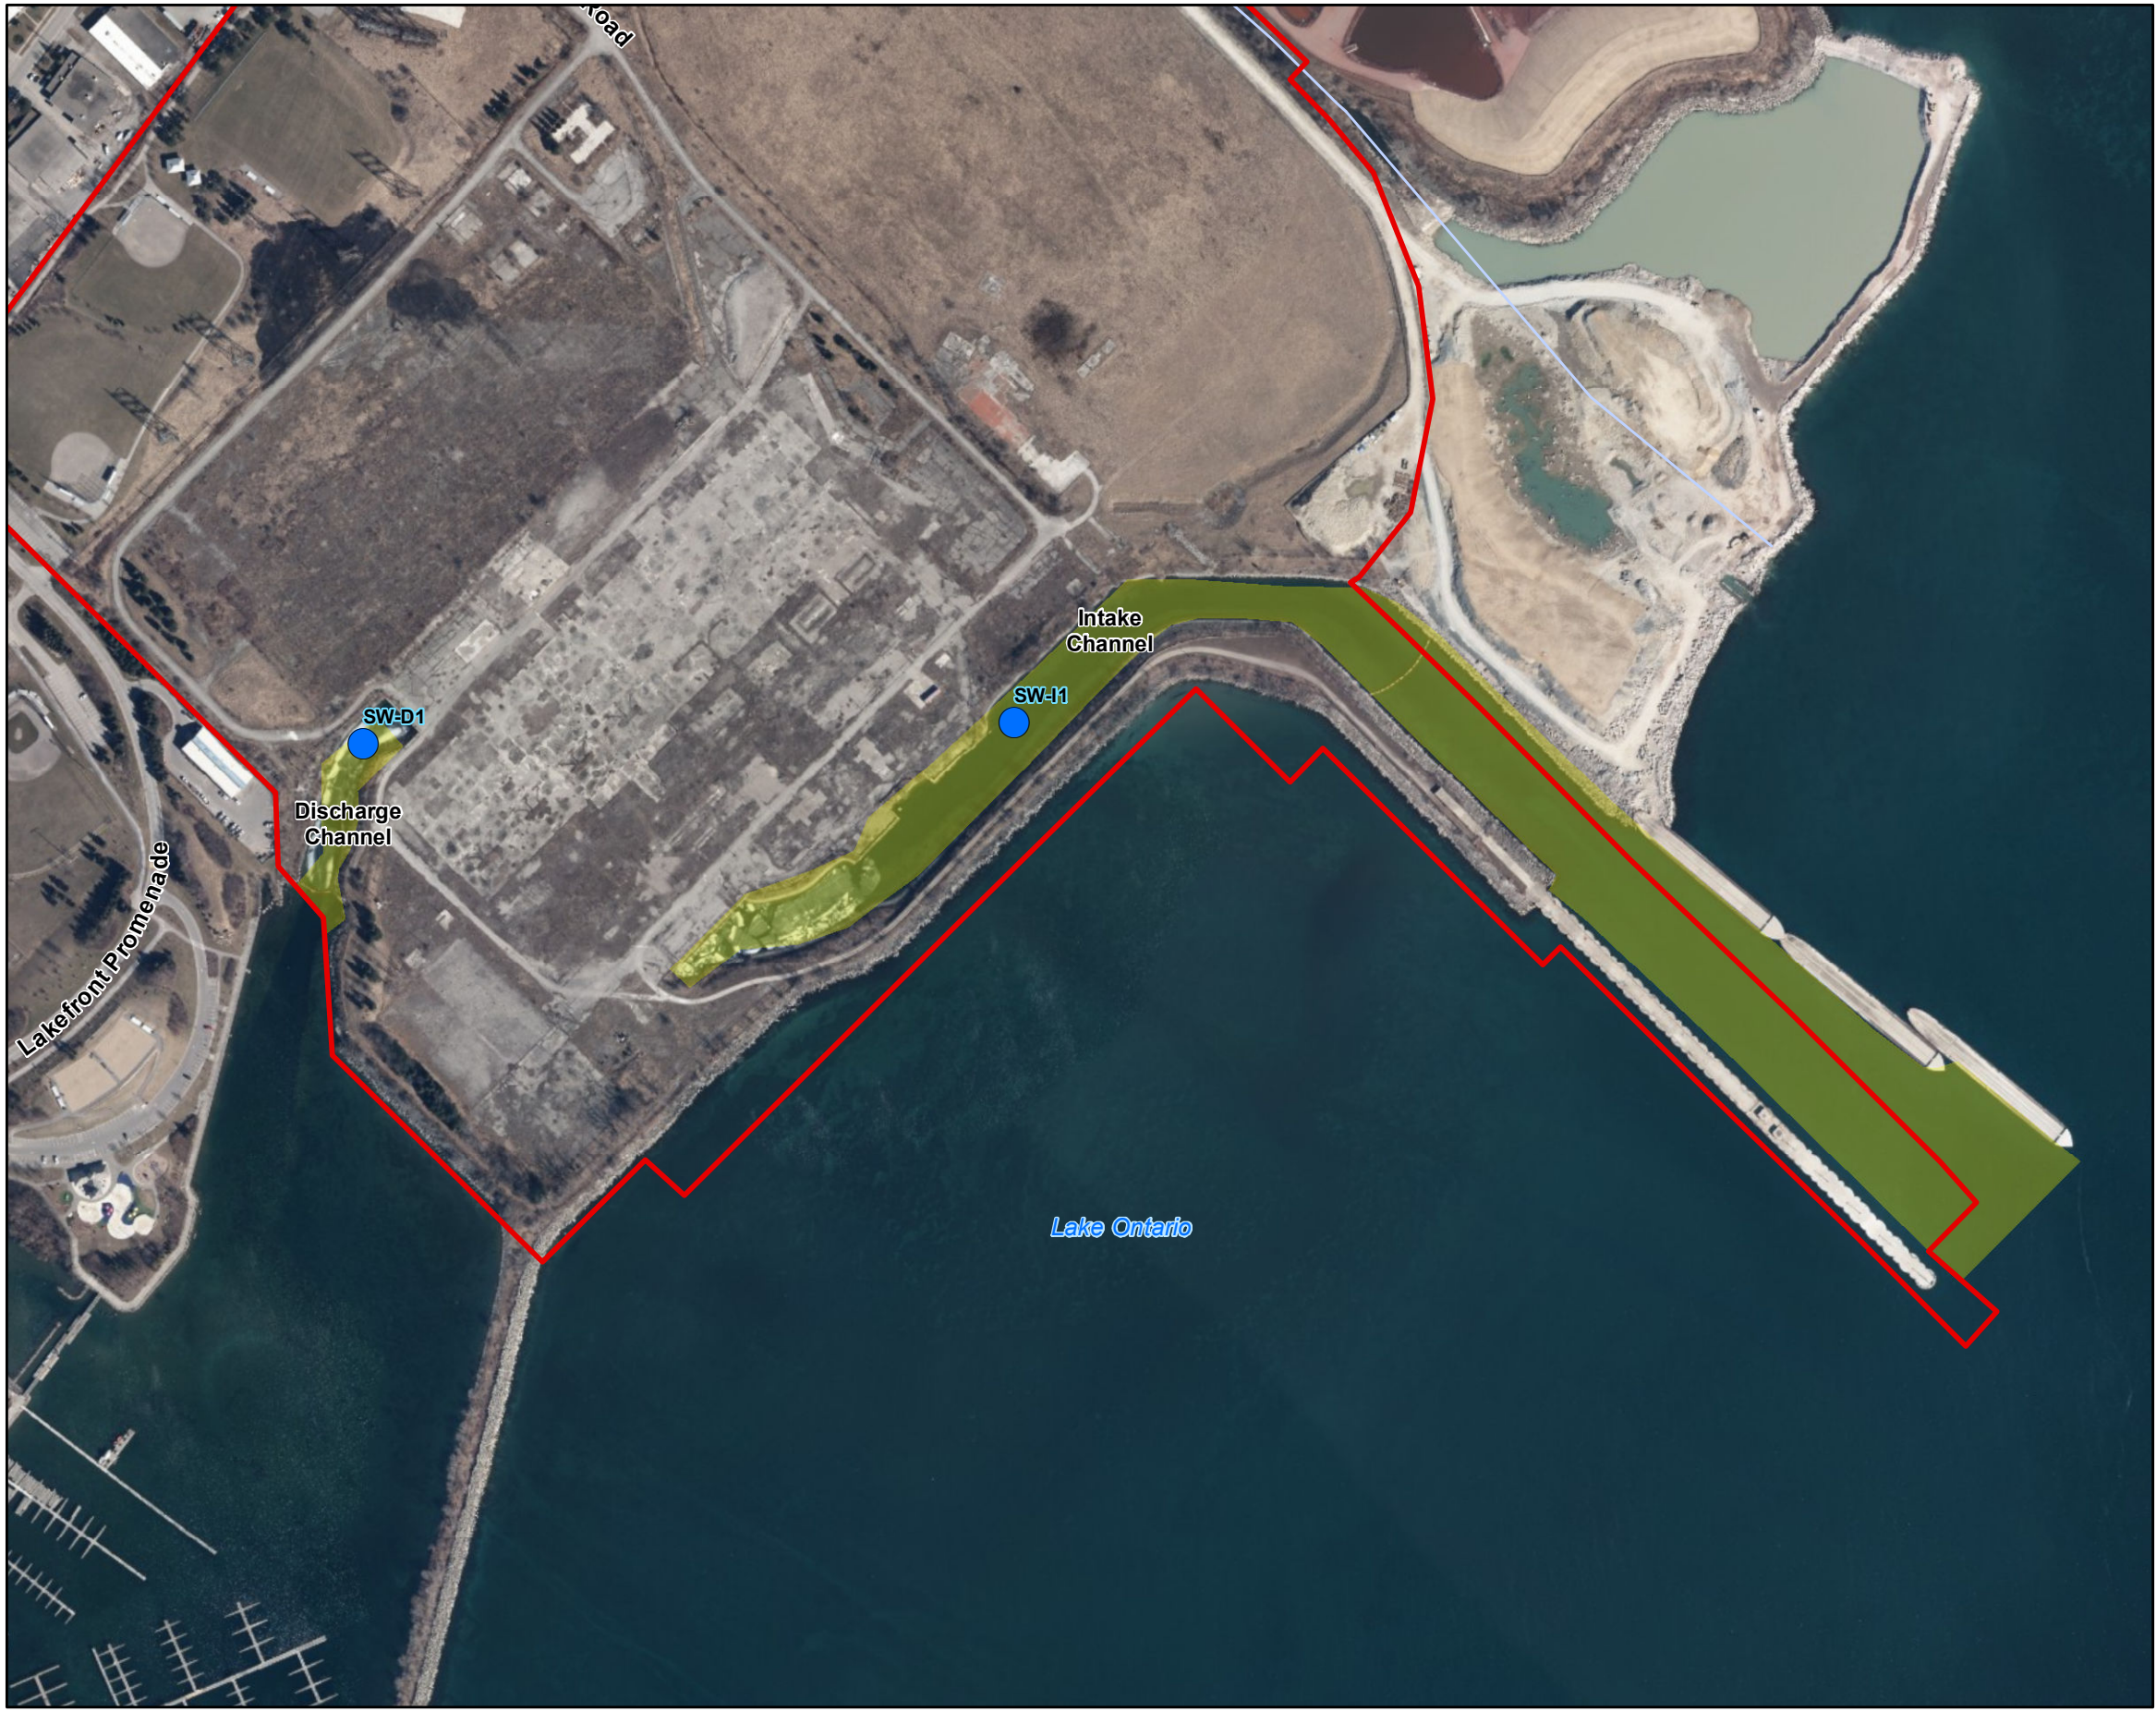
| Baseline Water Quality Sampling Locations | | Figure 1 | |

Water quality sondes were deployed on August 30th, 2019 and retrieved October 4th, 2019 from each of the surface water stations (**Figure 1**). The sondes were programmed to record water temperature, dissolved oxygen, pH and conductivity every 15 minutes.

Baseline water quality samples were collected on August 30th and October 4th, 2019 from each of the surface water stations (**Figure 1**). Measurements were taken for both sampling events with minimal precipitation in the preceding 48 hours. Water quality samples were collected, and *in-situ* water quality parameters were recorded during each of the two site visits. *In-situ* water quality results are presented in **Table 1**.
