Arborist Report

Pre-Construction Report

1444-1458 Cawthra Rd.
Mississauga, ON L5G 4L2

May 10, 2018

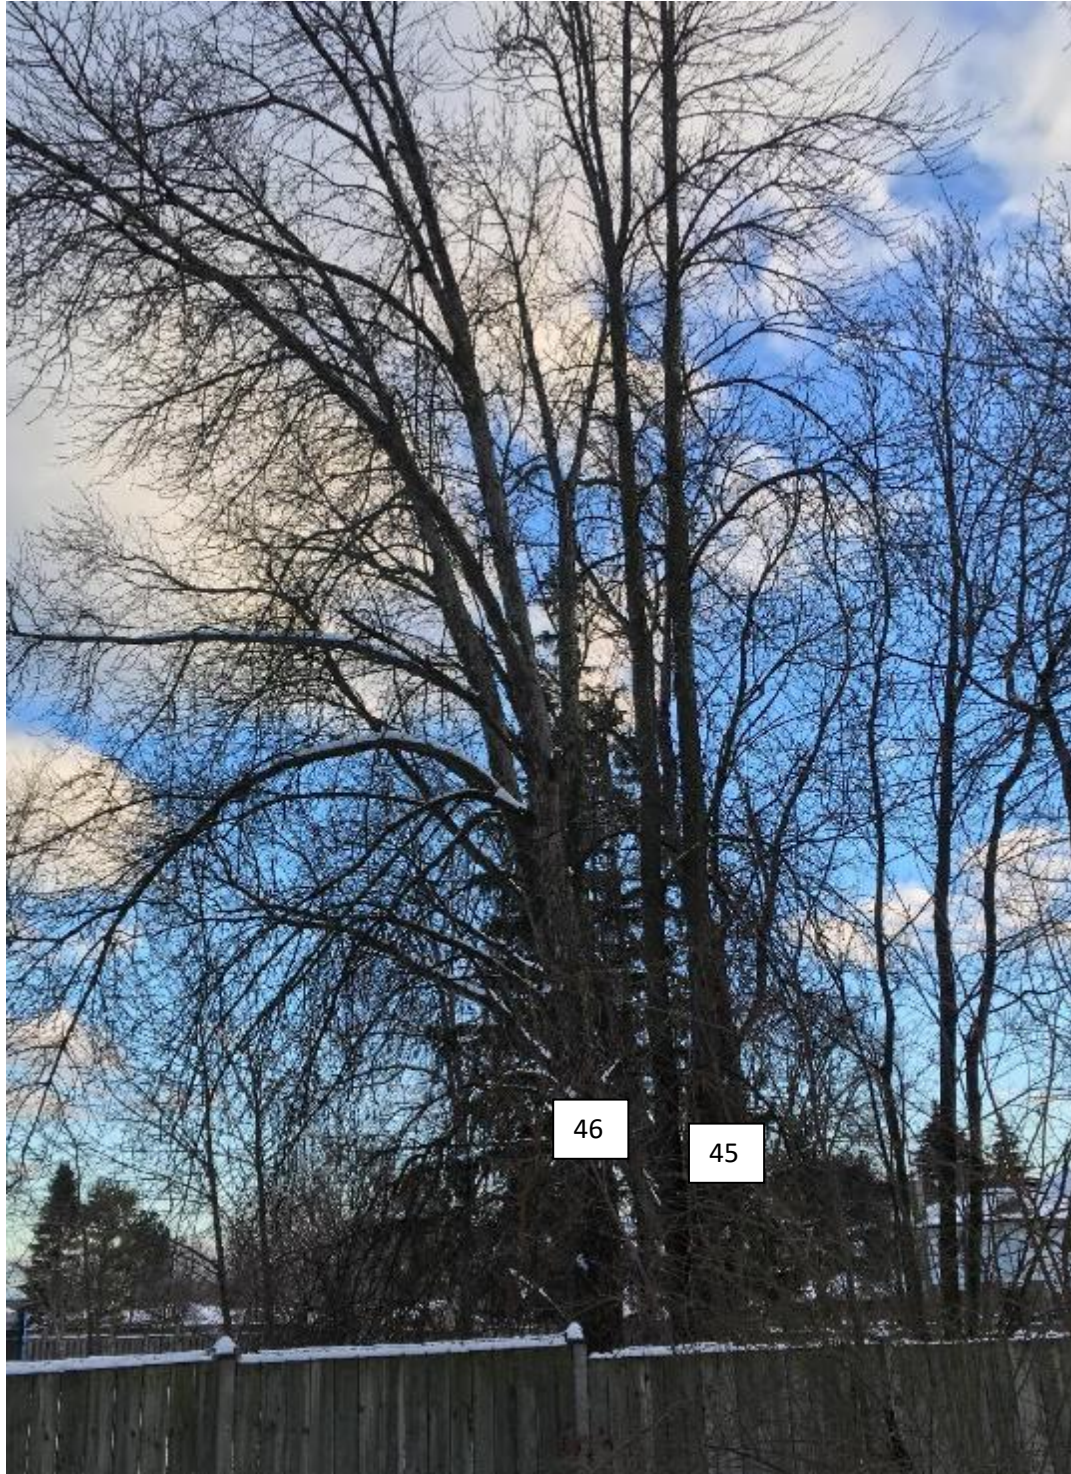
Figure 24: Trees 45 and 46

46	Green Ash	<i>Fraxinus pennsylvanica</i>	56	1. Private	3.6	Dead	Dead	Dead	0	100	5	11				Y		
47	Silver Maple	<i>Acer saccharinum</i>	18	1. Private	2.4	Fair	Fair	Fair	40	10	8	8				Y		Other Stems; 14, 12, 12
48	Silver Maple	<i>Acer saccharinum</i>	44	1. Private	3.0	Good	Good	Good	40	0	6	11			Y		Y	Other Stems; 42
49	Norway Spruce	<i>Picea abies</i>	28	2. Neighbours	2.4	Good	Good	Good	80	0	6	12						
50	Norway Spruce	<i>Picea abies</i>	29	2. Neighbours	2.4	Good	Good	Good	80	0	6	12						
51	Norway Maple	<i>Acer platanoides</i>	12	6. Shared	2.4	Good	Good	Good	40	5	3	6			Y

- We recommend the removal of Trees # 2-16, 23-41, 43-47, and tree #77 from the site property prior to commencement of the project.
- We recommend the client submit an Application to Permit the Injury or Destruction of Trees on Private Property for all trees to be removed from the site.
