**PHASE ONE
ENVIRONMENTAL SITE ASSESSMENT
1575 HURONTARIO STREET
MISSISSAUGA, ONTARIO**

Prepared for: Dream Maker Developments
16 McAdam Avenue, North York
M6A 0B9

File No 1-18-0537-41
October 12, 2018
©**Terraprobe Inc.**

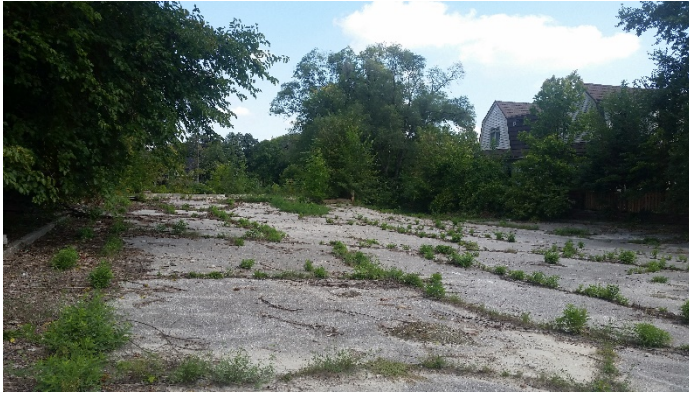
Photograph 1

Location: 1575 Hurontario Street
Viewing: Northeast
Description: Vacant paved lot.

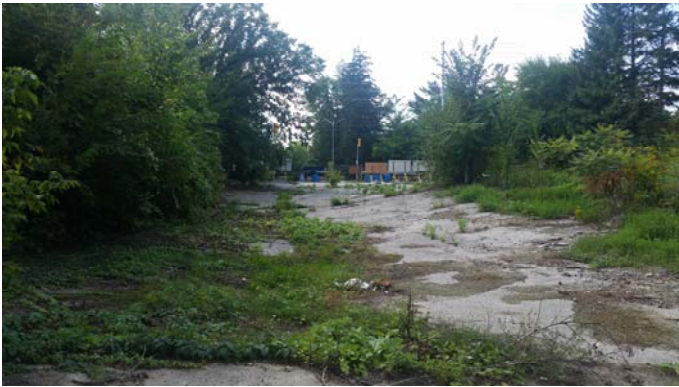
Photograph 2

Location: 1575 Hurontario Street
Viewing: Southwest
Description: Vacant paved lot, ground slopes upwards to historical building foundation.

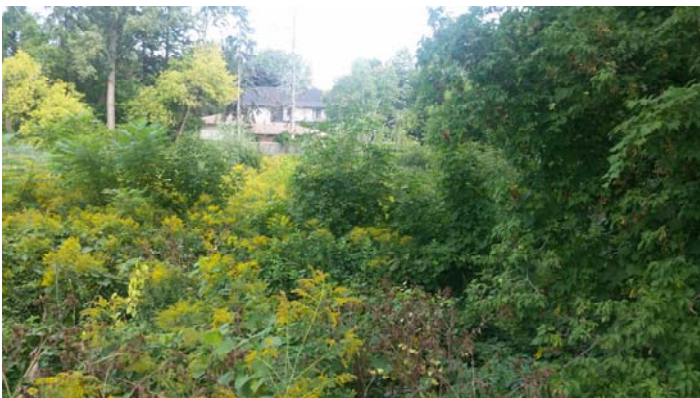
Photograph 3

Location: 1575 Hurontario Street
Viewing: Northeast
Description: Vegetated portion of the Property.

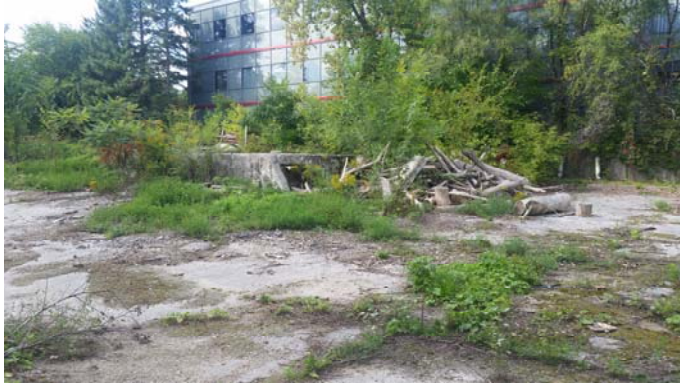
Photograph 4

Description: Pile of debris next to the exposed foundations (one basement level) of the historical building.

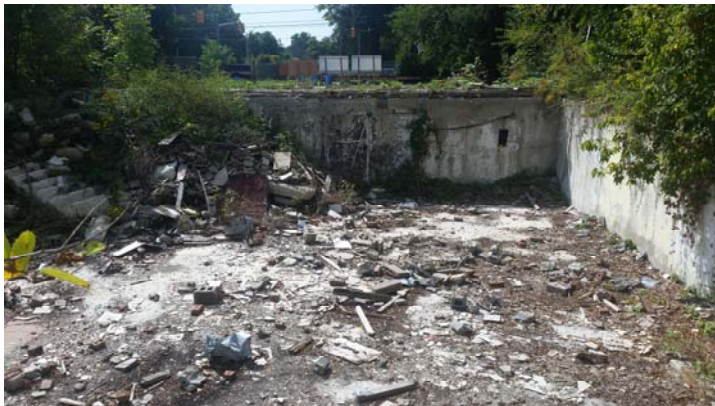
Photograph 5

Description: Exposed foundations (one basement level) of historical building.

The foundations (one basement level) of a former building are exposed and located in the middle of the Property.
